**RE: HYDROCARBON RELEASE NOTIFICATION REPORT UPDATE  
WESTERN REFINING COMPANY, SOUTHWEST, INC., GALLUP REFINERY  
EPA ID # NMD000333211  
AP-111**

Western Refining Southwest., Gallup Refinery ("Western") submits an update to our initial Hydrocarbon Release Notification Report (dated August 20, 2013). The following spill response actions have been taken to address a discovery of hydrocarbons found on the land surface to the west of crude tank T-102 and northwest of the marketing tanks (T1-T8), which was reported in Form C-141 on July 11, 2013. We are providing a copy of this report to the New Mexico Environment Department, Hazardous Waste Bureau (the "Bureau"), in satisfaction of the Bureau's requests in letters dated July 31, 2013 and August 14, 2013 for a written notification report describing all investigation and clean-up actions.

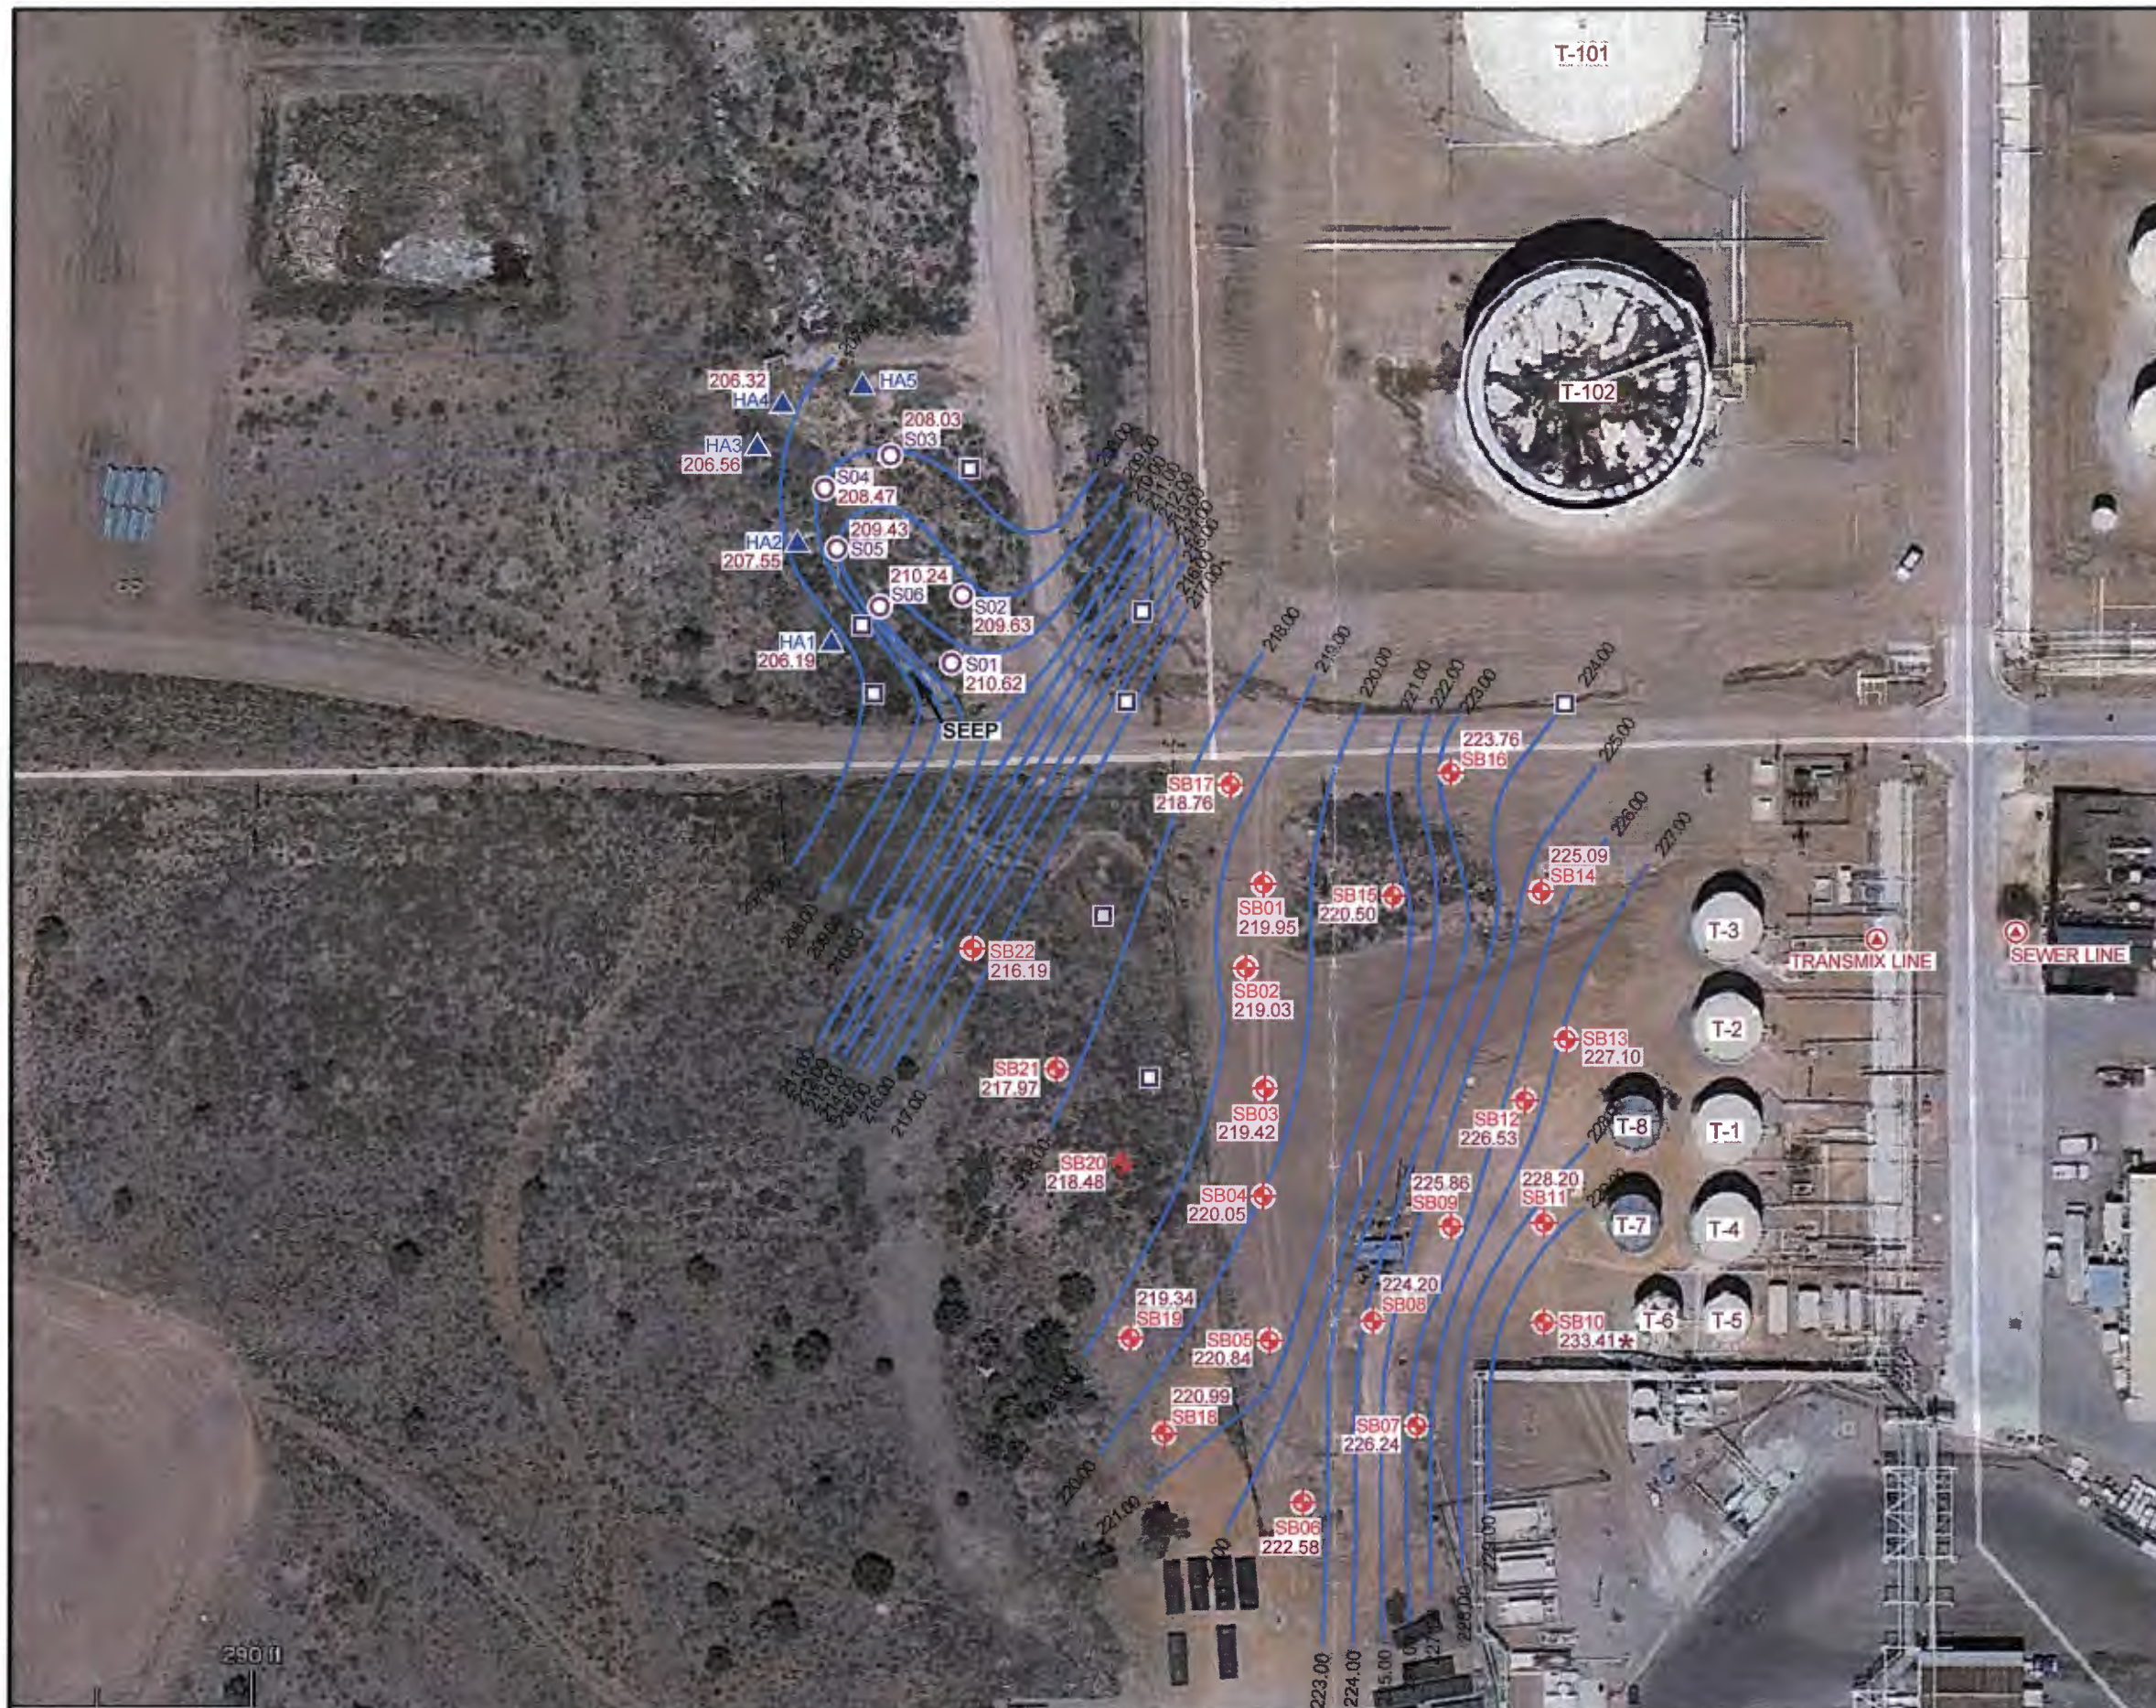
FIGURE 1  
AREA WIDE POTENTIOMETRIC MAP  
AUGUST 2013

A camera survey was conducted on multiple segments of the sewer line in the western portion of the refinery on August 27 and 28. Based on this visual inspection, a hole in the sewer line was identified approximately 20 feet south of the sewer box on the west side of the bundle cleaning pad. The location of the identified release point in the sewer line is shown on the enclosed potentiometric surface map (Figure 1).

Using the new survey data for the temporary monitoring wells, a potentiometric surface map (Figure 1) and cross-sections (Figures 3 and 4) were prepared for the subject investigation area. The potentiometric surface mirrors the land surface topography and slopes to the northwest. Cross-section A-A' runs north-south and extends from the southernmost temporary well SB06 to hand auger location HA4, which is located near the discharge area to the northwest. Two west to east cross-sections B-B' and C-C' are included on Figure 4. All temporary wells appear to be completed in the same hydrogeologic unit, which varies from silty, clayey sand to sandy clay, with the exception of SB10. Temporary well SB10 is completed in a perched zone consisting of silty sand, which may be part of the fill material that is found to overlie native soils over much of the area. A saturated interval of fill composed of clay, sand, and gravel appears at a similar stratigraphic position in SB07 (boring logs provided in August 20<sup>th</sup> report); however, SB07 was completed in the deeper clayey sand interval that does appear to be in direct hydraulic communication with the other temporary wells. The perched zone appears to be of limited aerial extent and does not affect contaminant transport to the northwest as it terminates well short of the currently defined hydrocarbon plume.
