2011 Rhodes Canyon Cap Repair

White Sands Missile Range (WSMR) has the requirement to continue cap inspections at the Rhodes Canyon Landfills (SWMU 114 and 115) and ensure that the site has restricted access. If the cap inspections note areas of concern that could eventually expose landfill material, WSMR is required to complete repairs. During the February 2011 cap inspection, personnel noted a few deficiencies that need to be addressed. Zia will mobilized (27-29 June) to the Rhodes Canyon (SWMU 114-115) cap with suitable rock and construction equipment to complete required repairs noted during the cap inspection. The following repairs were conducted:

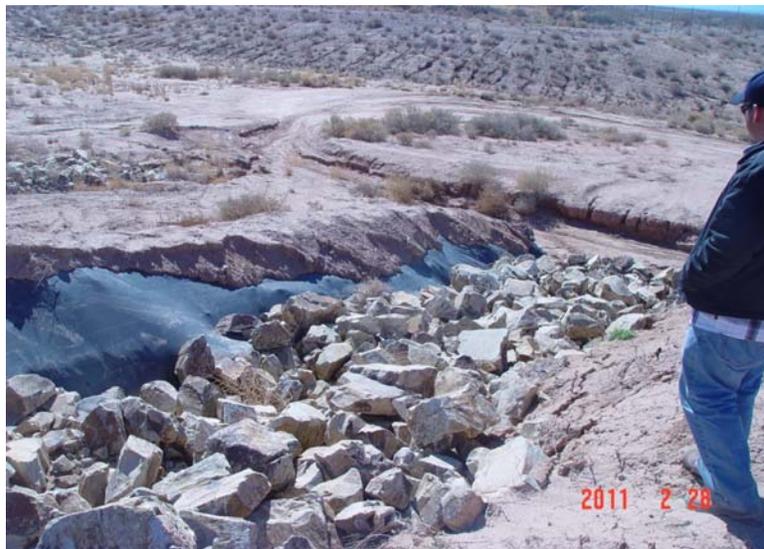
Rock Lined Channel Prior to Repair.

- Used 8 inch size rock (rip rap) to repair the 2 under-cut channels. Added rock to channels as noted in the February 2011 cap inspection. Third channel from entrance gate required additional rock along sides using a front end loader with backhoe. See photos below.

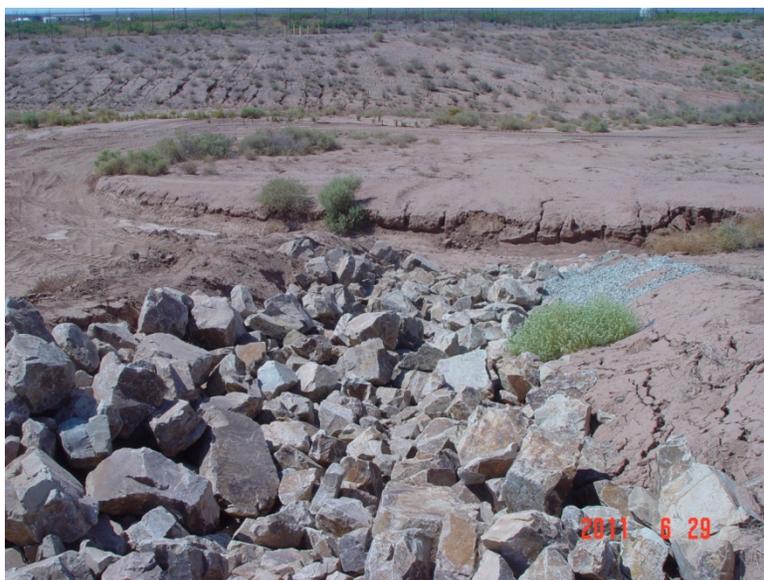
Rock Lined Channel Following Repair.

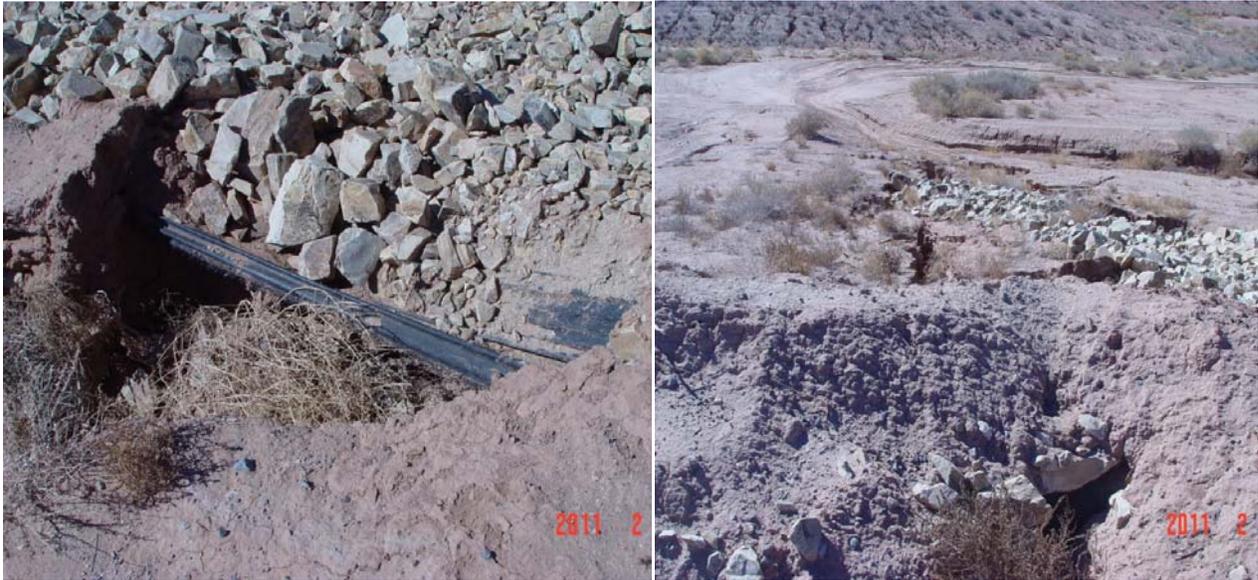
Undercuts of Fourth Rock Lined Channel.

- Reworked sides of fourth channel due to undercuts from water flow. See photos below.

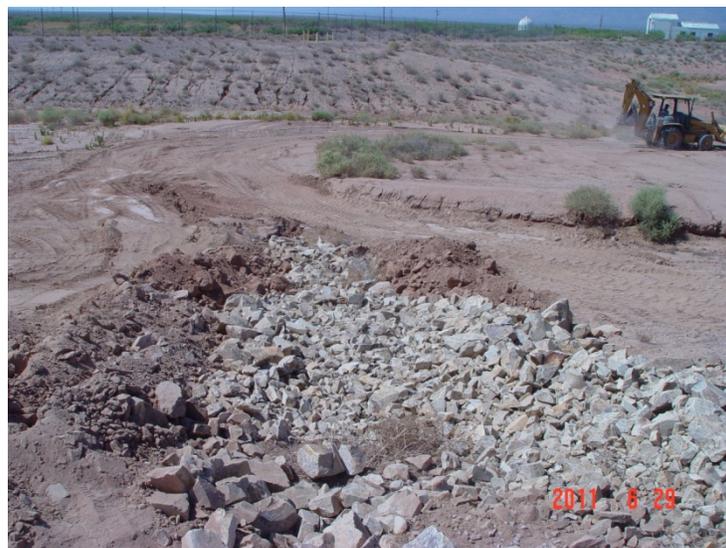
Repaired Sides of Channel.

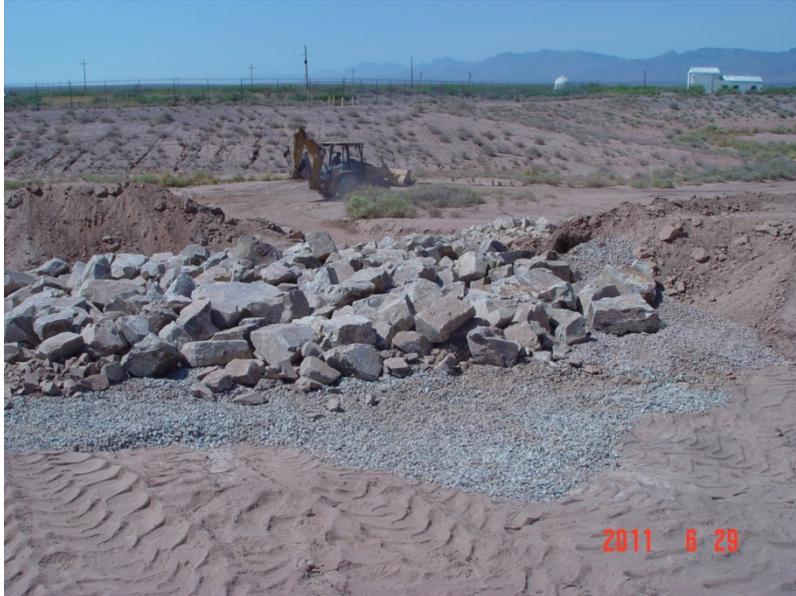
Reworked Head of Channel to help with flow.

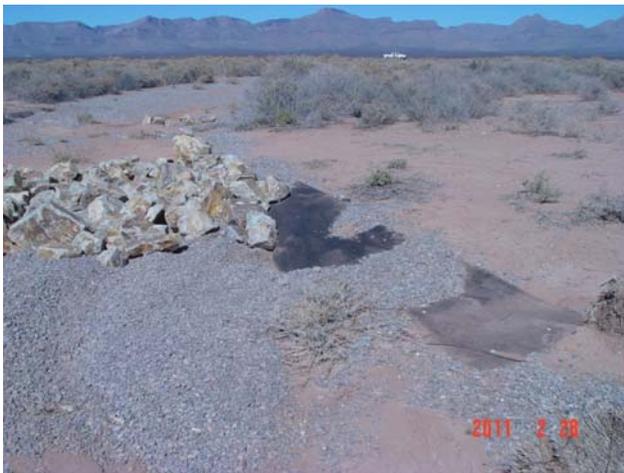
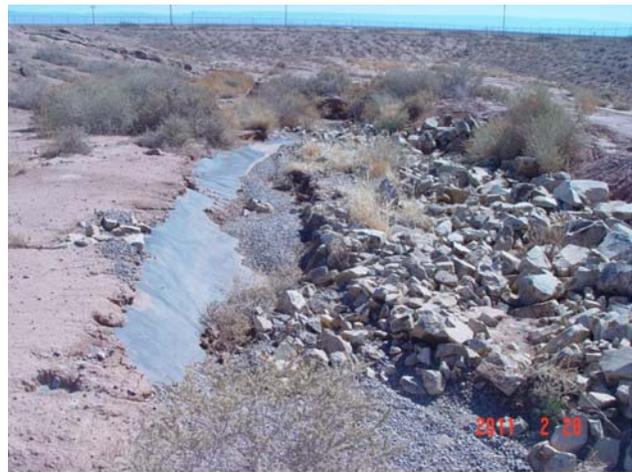
Base of Swale Prior to Repair.

- Removed 8 inch rock acting as a dam (was causing deposition of silt in swale), removed silted gravel, and repaired base of Swale. See photos below.

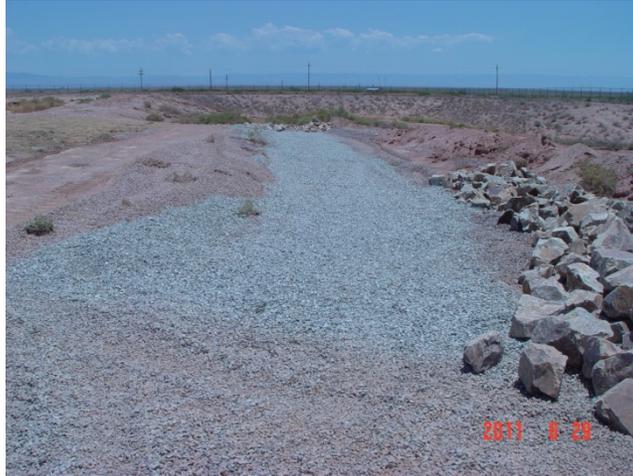
Rock Dam Removed, silted gravel removed, new gravel placed.

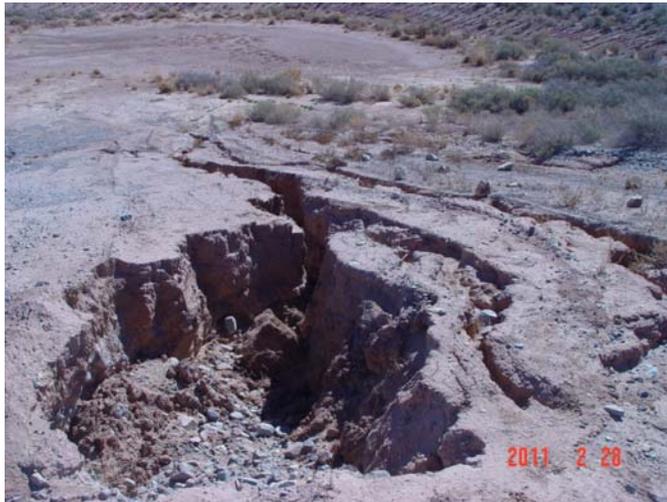
New gullies prior to repair.

- Backfilled gullies forming on slope of borrow area with soil and $\frac{3}{4}$ inch gravel. See photo below.

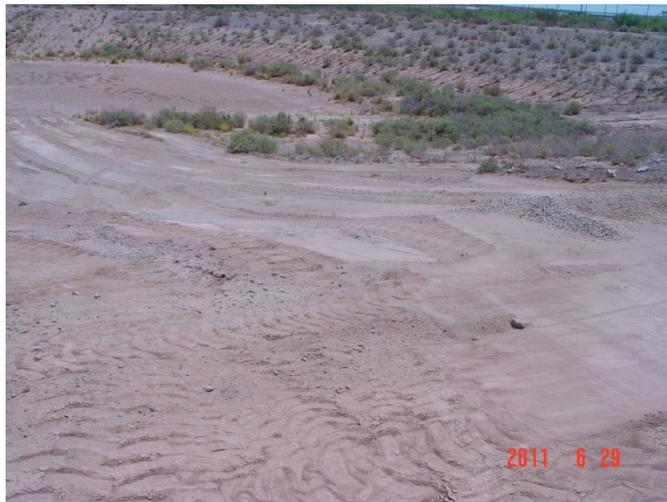
Gullies Repaired.

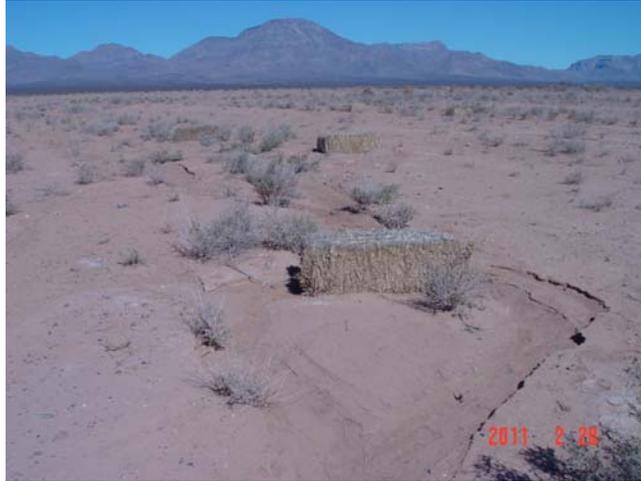
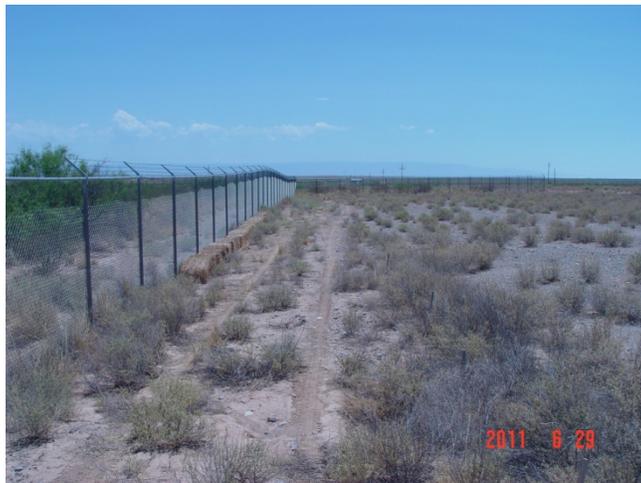
Placed hay bales along north fence line where fence was undercut.

- Removed hay bales where increased rills/gullies were forming. See photo below.

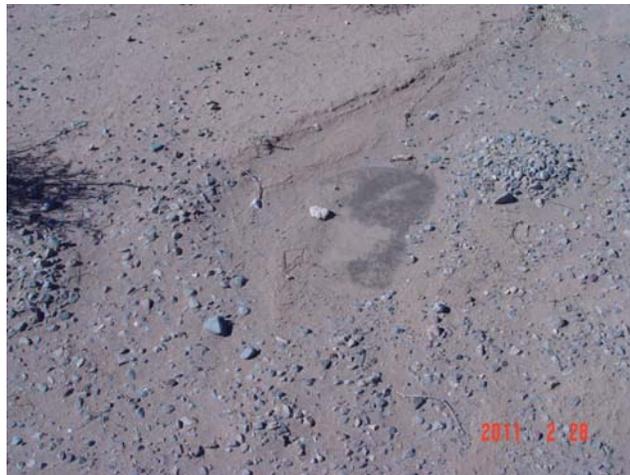
Exposed liner along Swale.

- Cleared dead/dried brush from the inner fence line.
- Shoveled gravel from center of swale to cover exposed liner along sides of swale. See photo below.

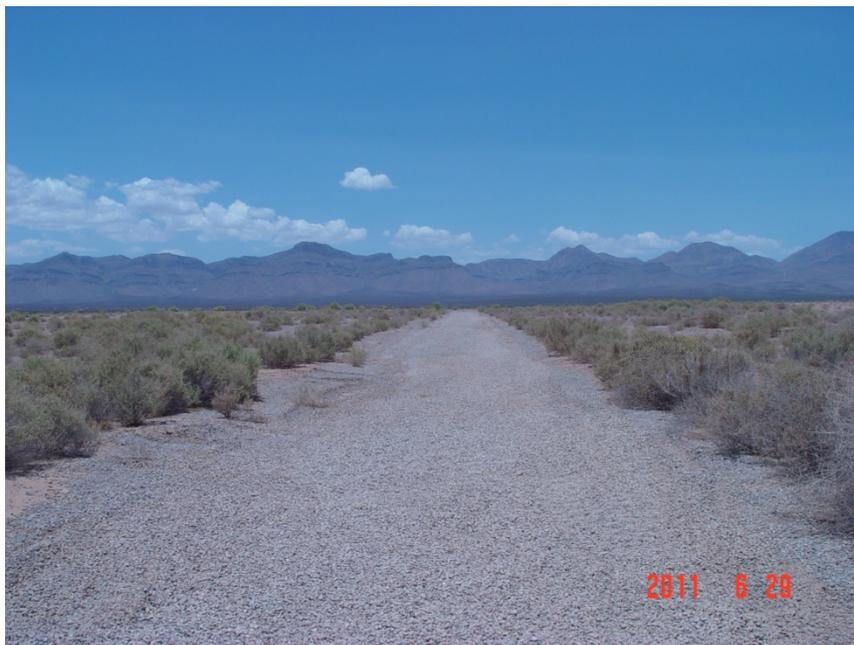
Swale Following 3 inch scrape.

- Backfilled animal burrows with shovel and soil from burrow.
- Scraped remaining length of the Swale down to 3 inches to remove built up silt.
