**UNITED STATES ENVIRONMENTAL PROTECTION AGENCY**

**Date of Inspection:** September 24-28, 2012      **EPA ID Number:** NM2750211235

**Facility Name:** US Army White Sands Missile Range

**Inspection Type:**  EPA Lead    State Lead    CSE    CEI    CDI  
 Sampling    Multi-Media    Other: Corrective Action

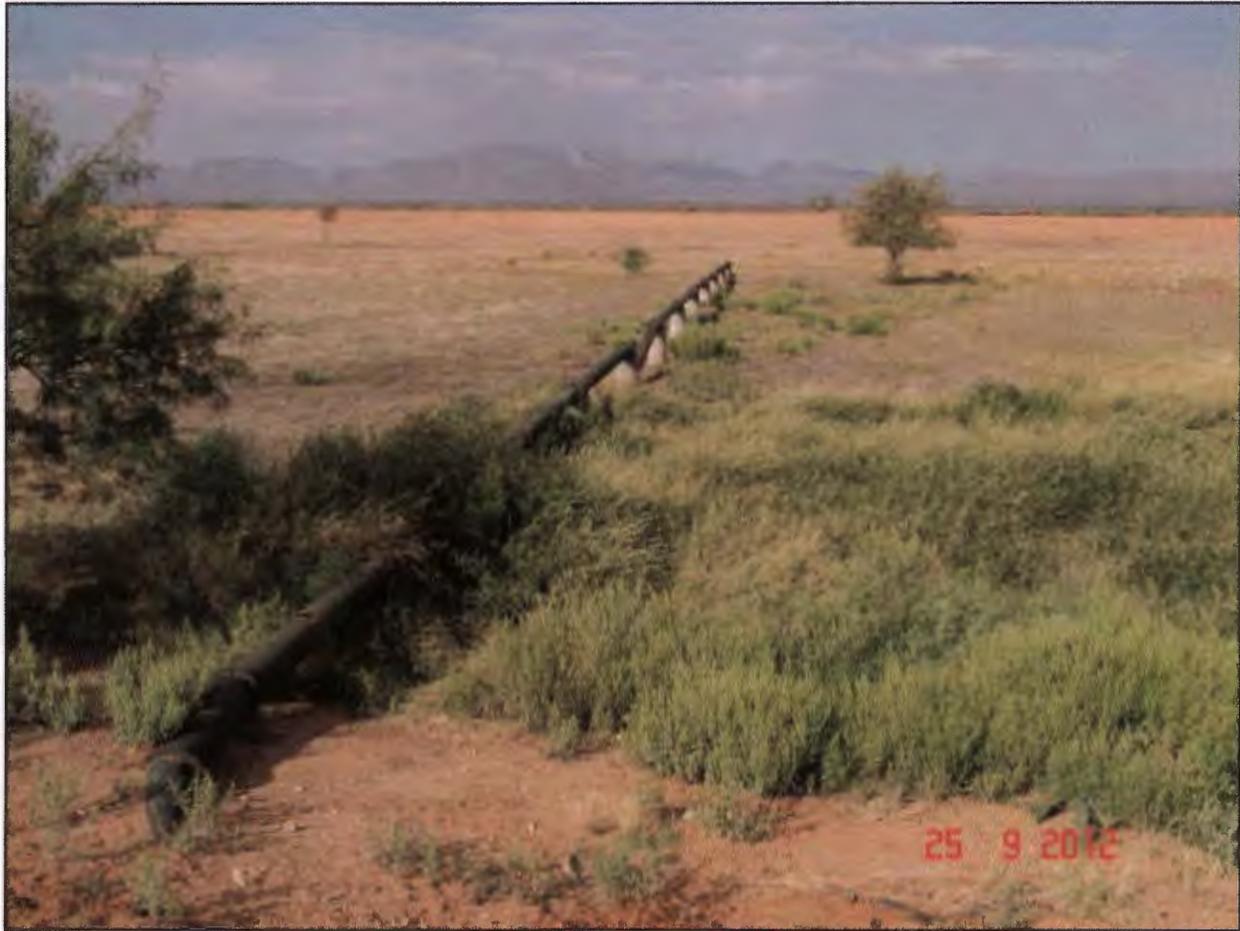
Photo No.: 1

Description: WSMR - SWMU 132 / Orogrande Waste Stabilization Pond: Managed by Ft. Bliss as SWMU-25B, even though it is on WSMR's property and is also in WSMR permit as SWMU 132. Broken steel pipe is coming from Fort Bliss water treatment plant, and the containment berm is being reworked.

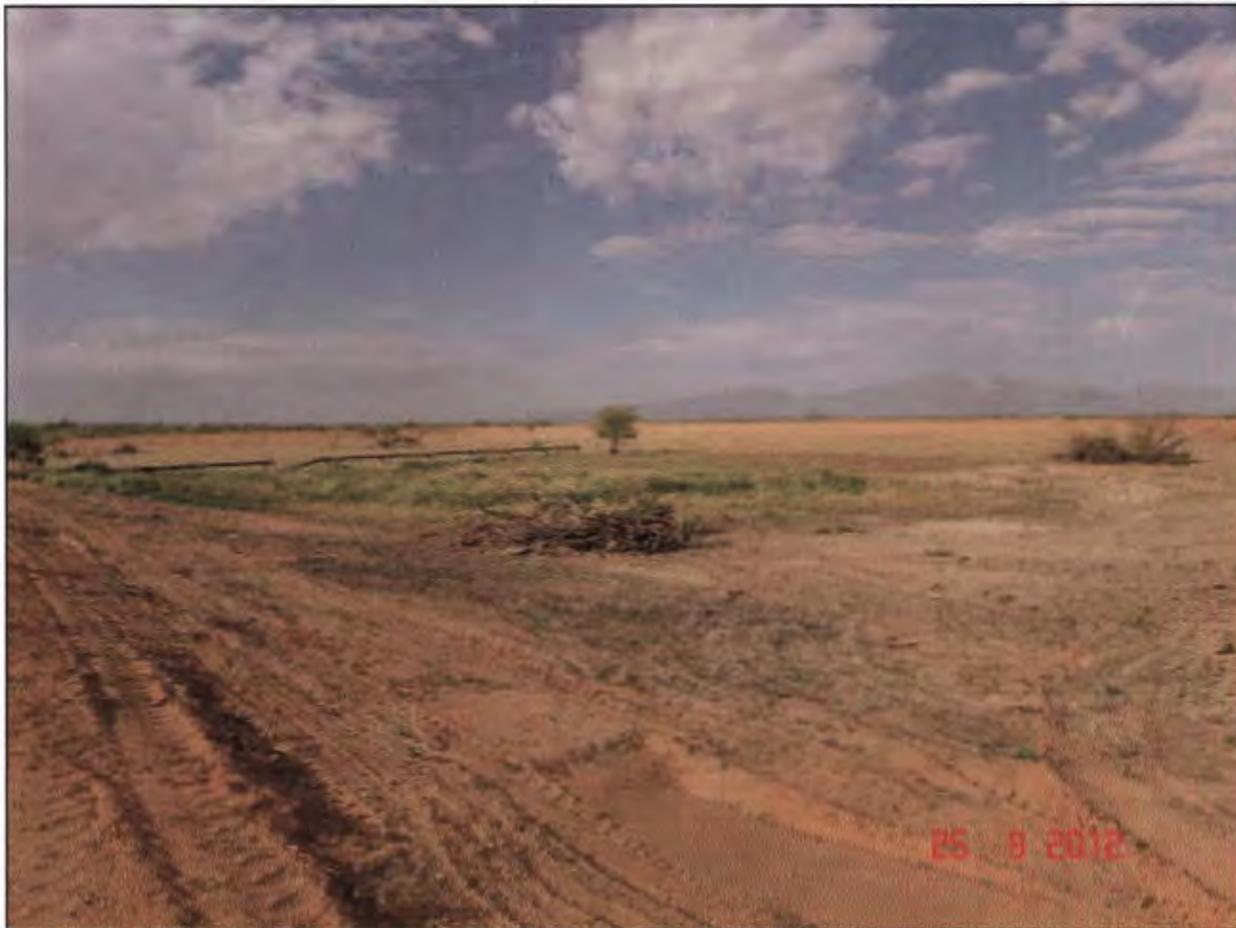
Photo No.: 2

Description: WSMR - SWMU 132 / Orogrande Waste Stabilization Pond: Managed by Ft. Bliss as SWMU-25B, even though it is on WSMR's property and is also in WSMR permit as SWMU 132. Broken steel pipe is coming from Fort Bliss water treatment plant, and the containment berm is being reworked.

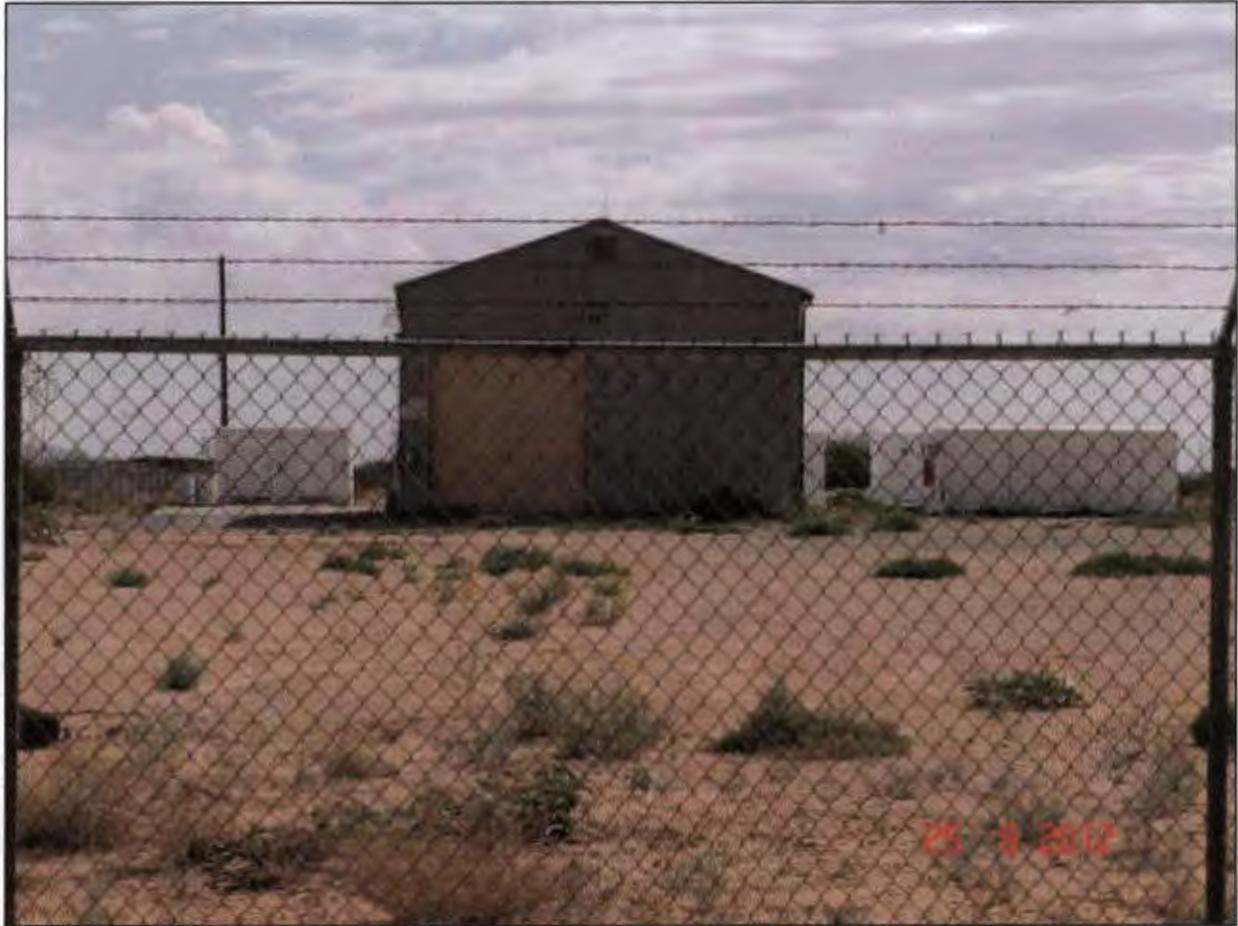
Photo No.: 7

Description: WSMR - SWMU 89 Former Acid Neutralization Unit (left of building) and SWMU 90 Evaporation Tank (at Building 22895), located at the Hazardous Waste Storage Facility. Closure plan submitted for SWMU-89 and Clean Closure submitted for SWMU-90.

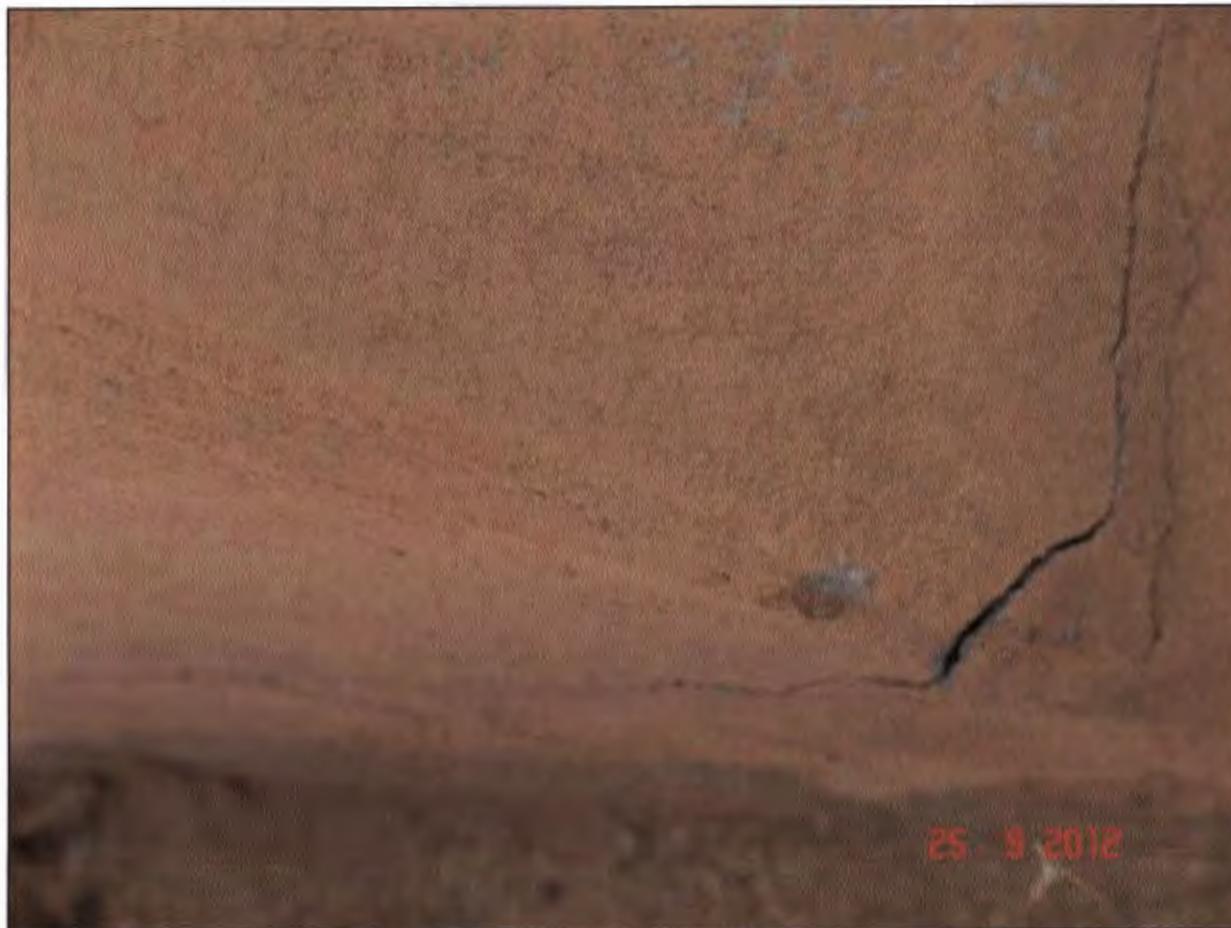
Photo No.: 23

5. **Concern under New Mexico PST Program:** The Main Post POL (Petroleum, Oil and Lubricants), located on the east side of Wesson Street and south of Aberdeen Avenue, has two secondary containments that contain three POL ASTs each. During the inspection, multiple cracks were noted in both secondary containments (photo nos. 23-27). Some cracks went through the entire wall structure, rendering it useless for containment.

Description: WSMR – Main Post POL on east side of Wesson Street (Cracks noted in the secondary containment of the 25,000 gallon tank farm)

**Issue:** Due to the extensive number and size of cracks in various areas of the POL's secondary containments, this became a concern to me under *NMAC 20.5.5.10 (E) and (F): Operation, Maintenance, Repair and Replacement of Secondary Containment for ASTs*.

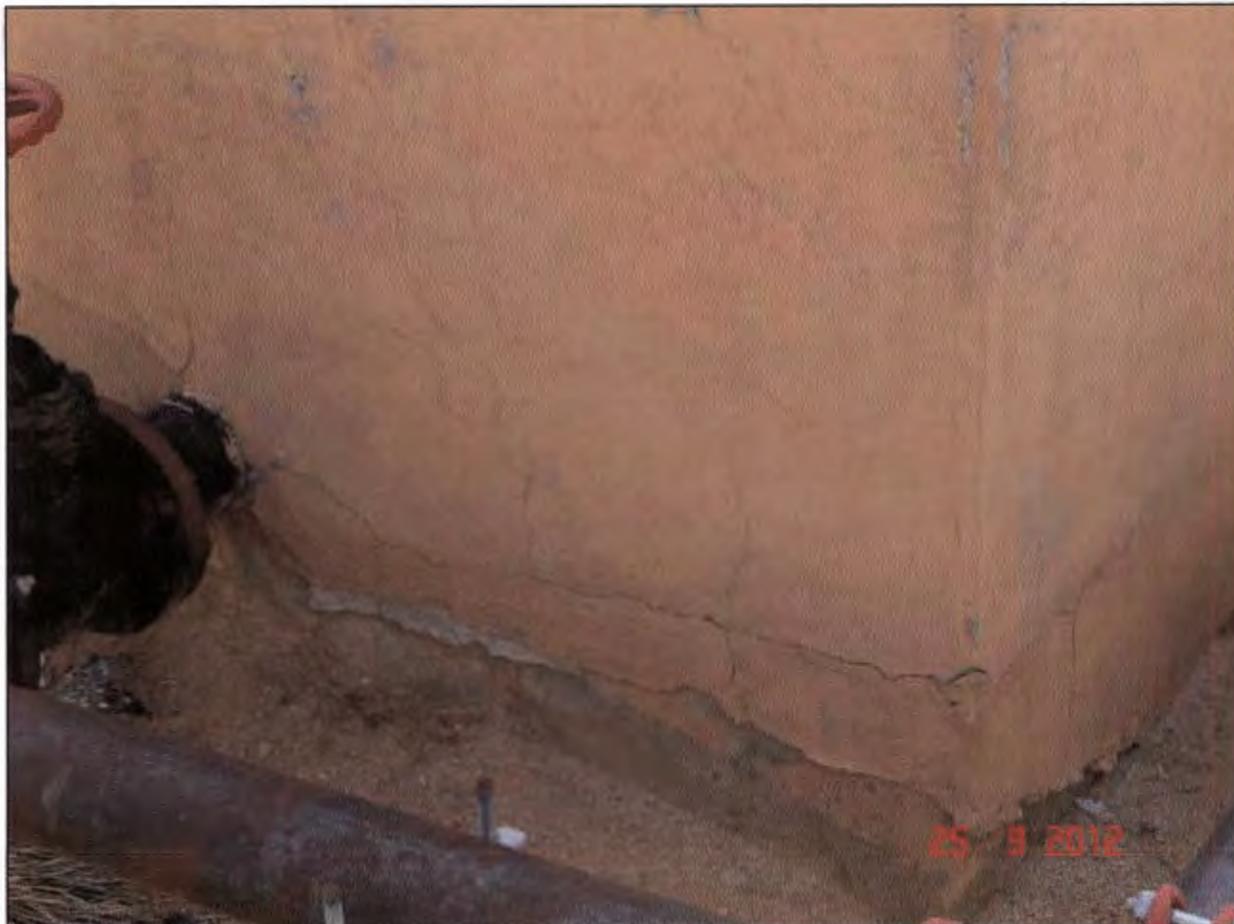
Photo No.: 24

Description: WSMR – Main Post POL on east side of Wesson Street (Cracks noted in the secondary containment of the 25,000 gallon tank farm)

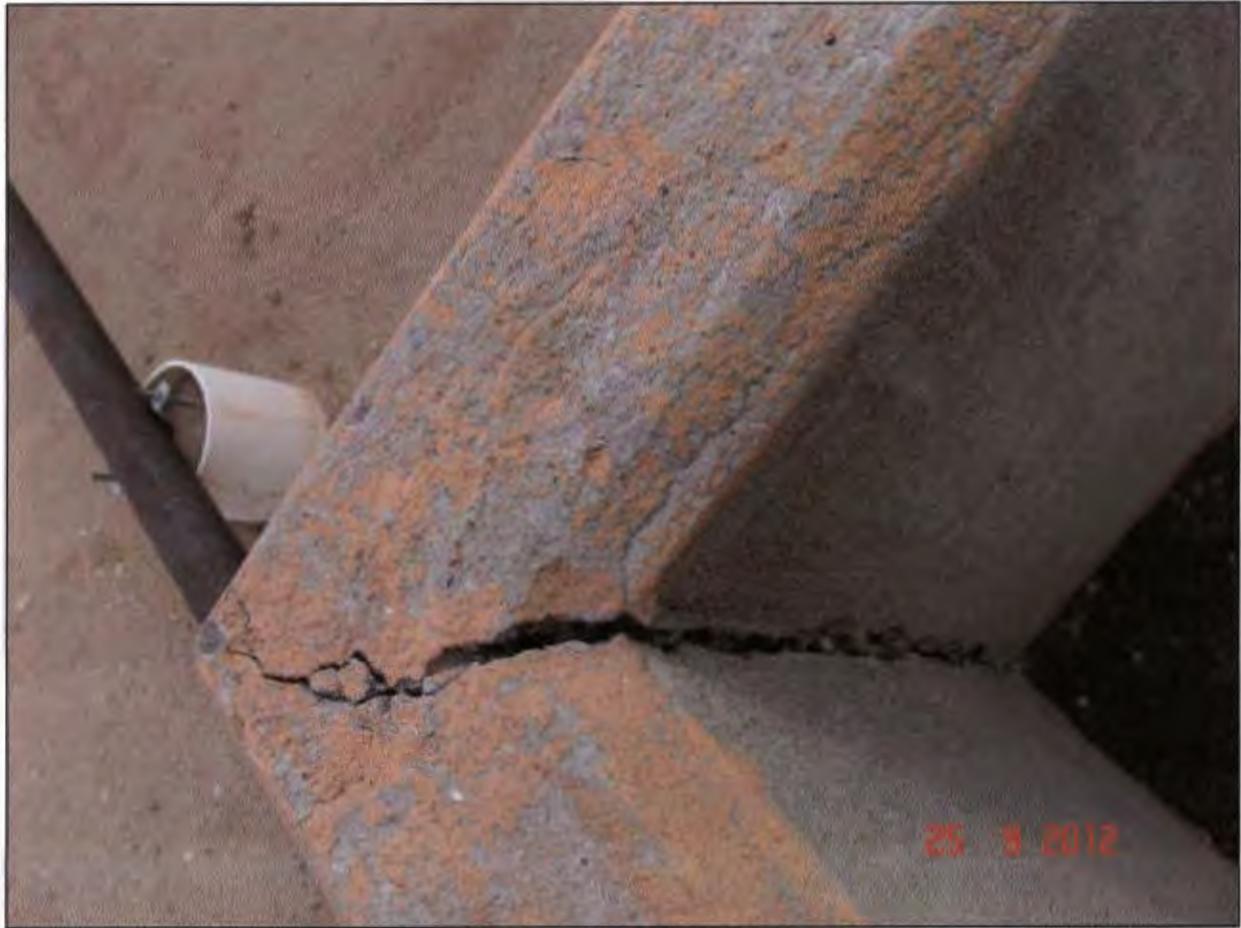
Photo No.: 25

Description: WSMR – Main Post POL on east side of Wesson Street (Cracks noted in the secondary containment of the 25,000 gallon tank farm)

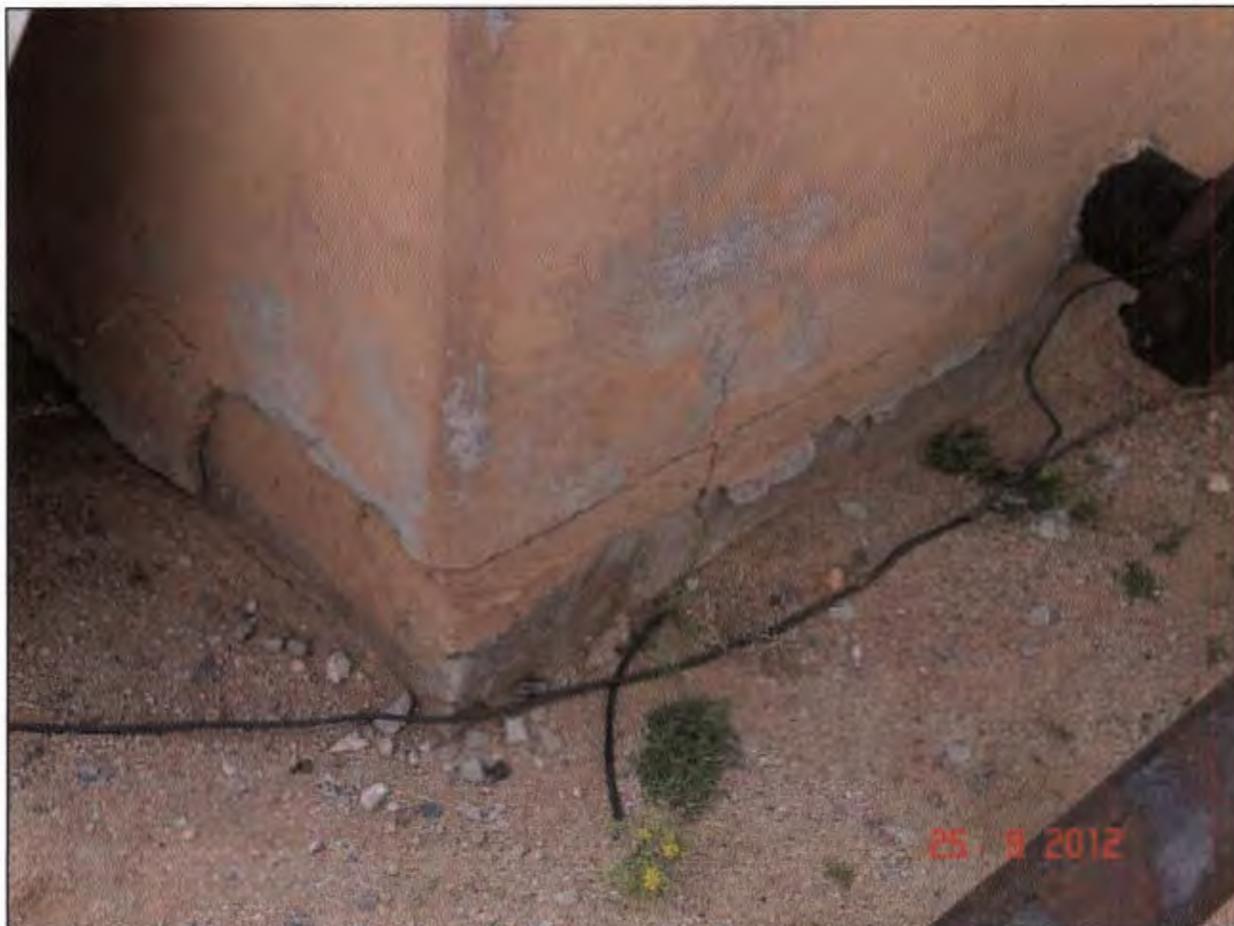
Photo No.: 26

Description: WSMR – Main Post POL on east side of Wesson Street (Cracks noted in the secondary containment of the 25,000 gallon tank farm)

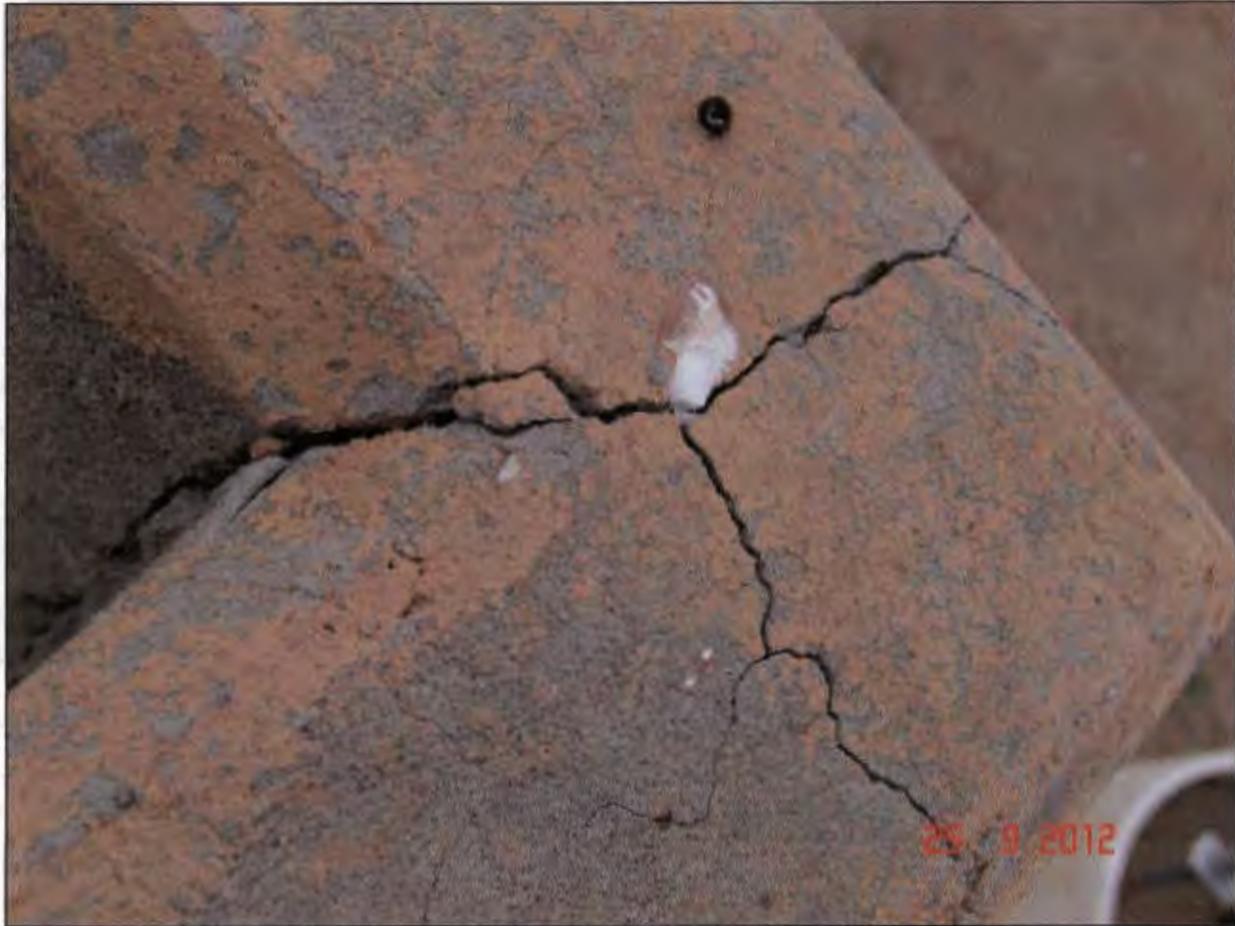
Photo No.: 27

Description: WSMR – Main Post POL on east side of Wesson Street (Cracks noted in the secondary containment of the 25,000 gallon tank farm)

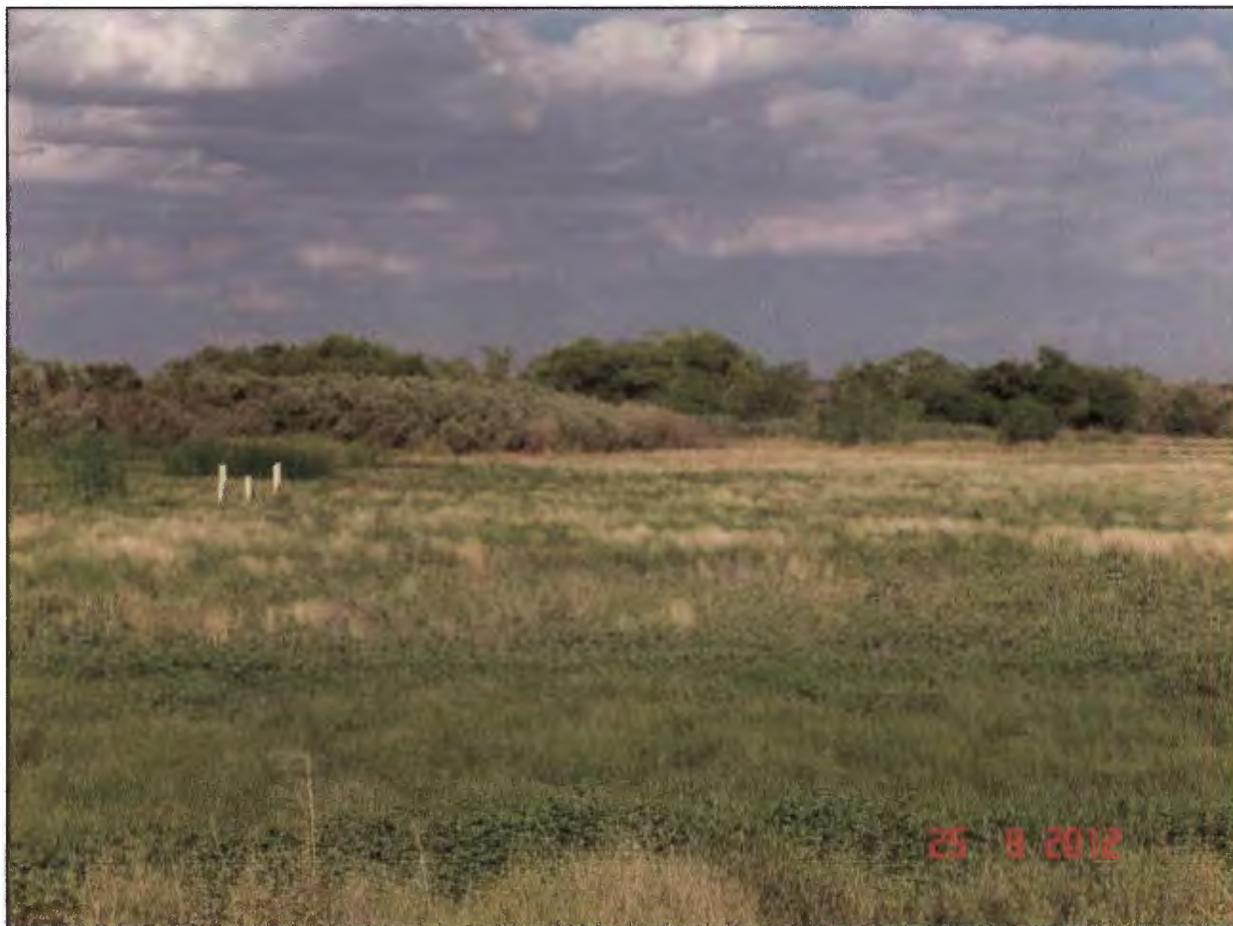
Photo No.: 34

**Issues:** Since in the past and possibly in the present, industrial wastewater with hazardous constituents is being treated at the STP and the treated wastewater is being discharged to Davies Tank. Prior to discharging to Davies tank, wastewater was discharged to the two former STP Ditches (SWMU-82 and SWMU-83) and the former STP Playa Lake (SWMU- 85), which all contained hazardous constituents associated with treated wastewater. Based on this information, I considered the following:

- (1) Under 42 USC § 6939e(b), it is unlawful to introduce into a federally owned treatment works (FOTW) any pollutant that is a hazardous waste [Note: the STP operates as a FOTW but does not meet its entire definition];
- (2) Davies Tank should be listed as a SWMU and not an AOC;

Description: WSMR - AOC W / Davies Tank – This is where the Main Post Sewage Treatment Plant discharges to. Noted monitoring wells adjacent to AOC

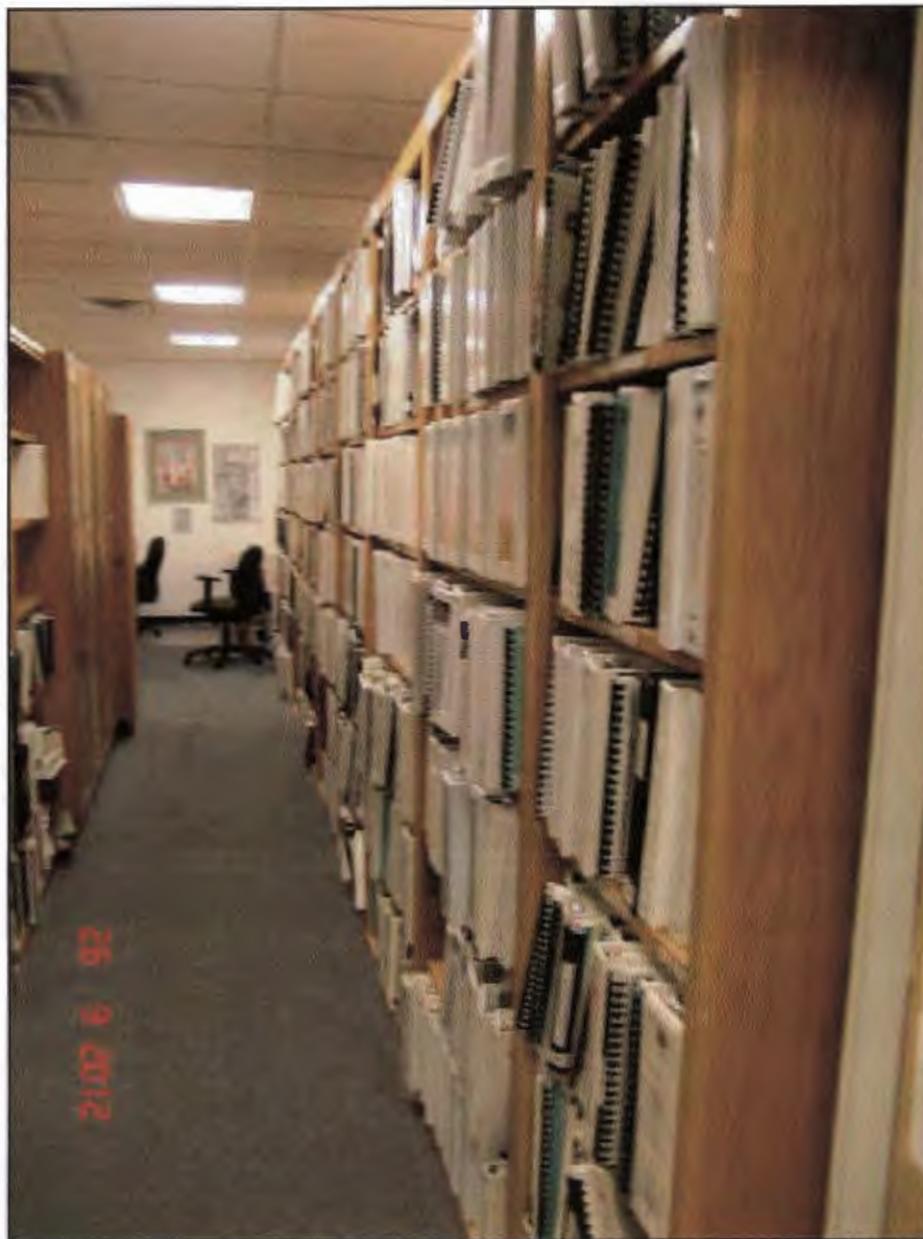
Photo No.: 35

The records and documents listed above are stored in the Environmental Building on the Main Post (photo nos. 35 and 36). A review of these documents was conducted, and I confirmed that the facility was a LQG/TSDF. During the file review and subsequent discussions with Mr. Avalos, Mr. Baca and Ms. Miller, several concerns were noted and are described in the conclusion section of this report.

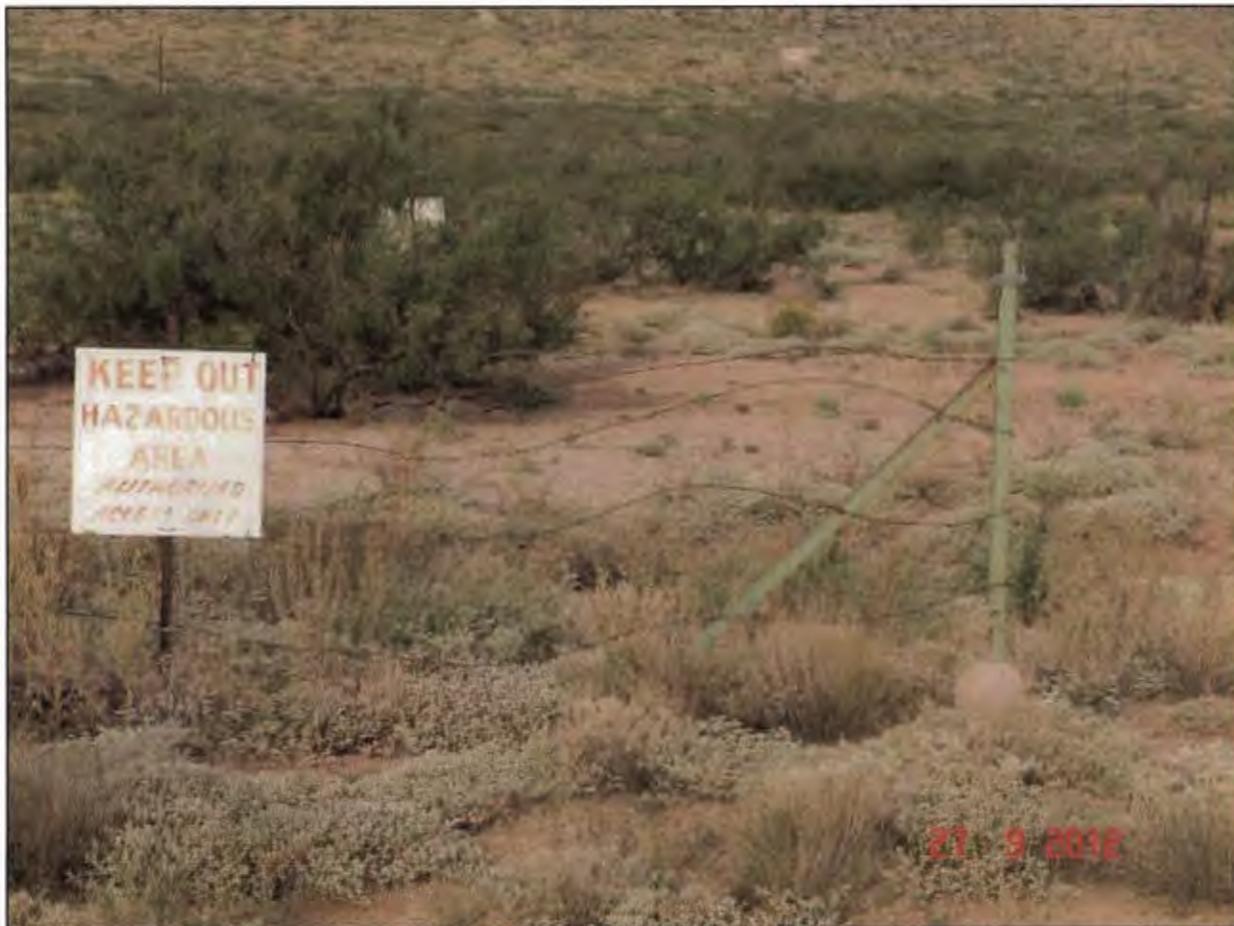
Photo No.: 44

**Issue:** During my inspection, I noted an area fenced in with barbed wire (approximately 15 yards by 20 yards) with a faded sign stating, "KEEP OUT, HAZARDOUS AREA, AUTHORIZED ACCESS ONLY" (photo no. 44). This area was west-southwest of the fenced in scrap yard, and believed be close to or within the boundary of SWMU 65, but uncertain. When reviewing the RFA, RFI Phase I and RFI Phase II, there were no discussions related to this defined area.

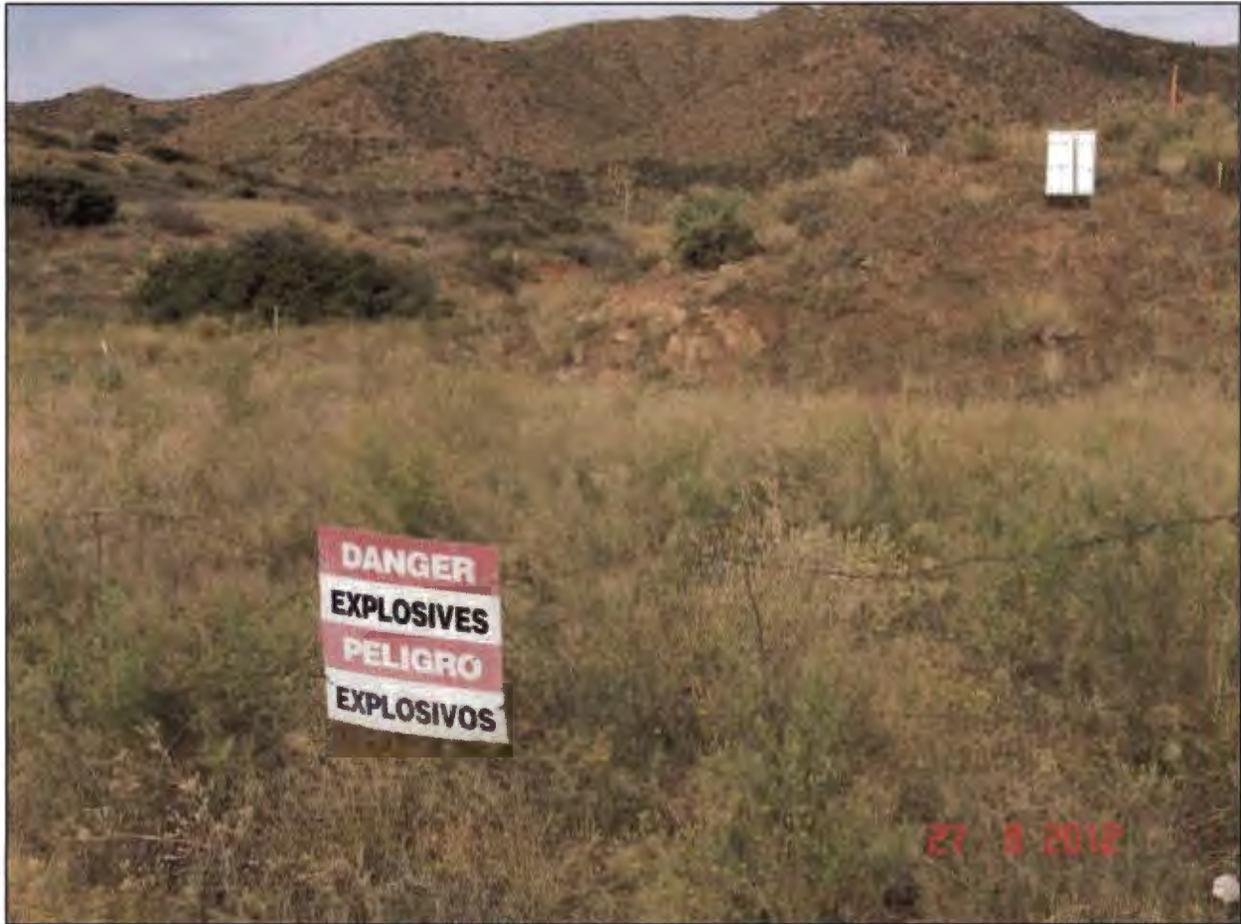
Photo No.: 46

4. **Concern under RCRA Corrective Action:** According to the RFA, the Vandal Burial Site (a.k.a. Talos and Tarter Terrier Site, SWMU-153) at the Open Burn/Open Detonation Area (OB/OD) is believed to have been activated in the mid 1950s for the burial of missile and rocket parts. During a site visit (1988), the unit was found to have been extensively excavated. Exposed missile parts and scrap metal were observed in the fill area. In February 1991, during the field investigations for Phase I of the RFI, the area had been regraded. The unit was excavated in 1995. Scrap metal was taken to the scrap yard, unexploded ordinances were detonated in place and construction debris was taken to the Main Post landfill.

**Issue:** During my inspection, I noted a potential former UXO Pit that was fenced in with a sign stating, "DANGER EXPLOSIVES, PELIGRO EXPLOSIVOS" (photo no. 46). According to a map in the permit application, this area does not appear to be part of Vandal Burial Site (SWMU-153) and lies west and adjacent to the SWMU. My question to the facility: Why was this area not part of the SWMU, and was this area addressed during the removal/remedial action? Since Mr. Avalos was not present during this portion of the inspection, he was going to address my questions after further review. When reviewing the RFA, RFI Phase I and RFI Phase II, there were no discussions related to this defined area.

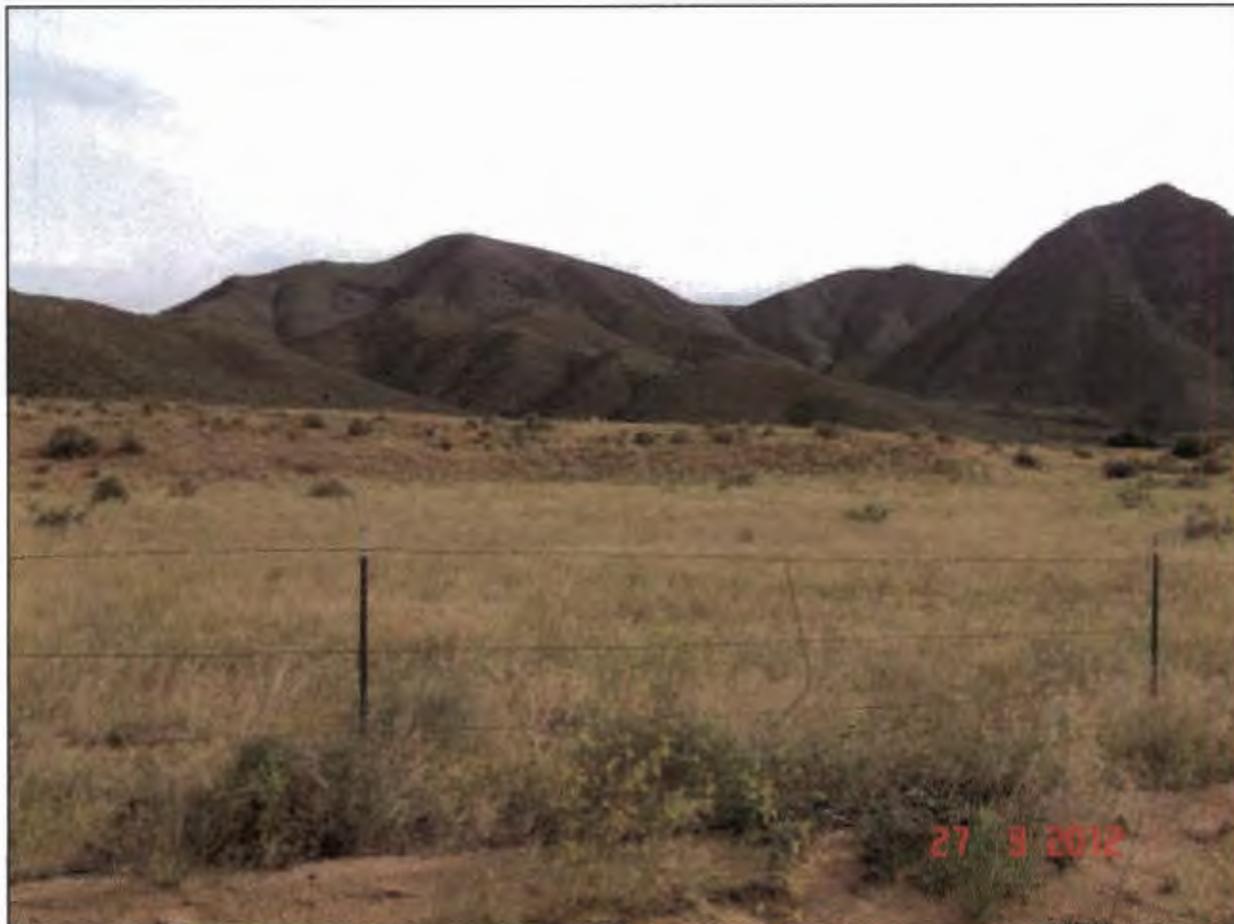
Photo No.: 48

Description: WSMR - SWMU 55 and SWMU 56 Open Burn Pits at the OB/OD. Post Closure Care Plan Required.

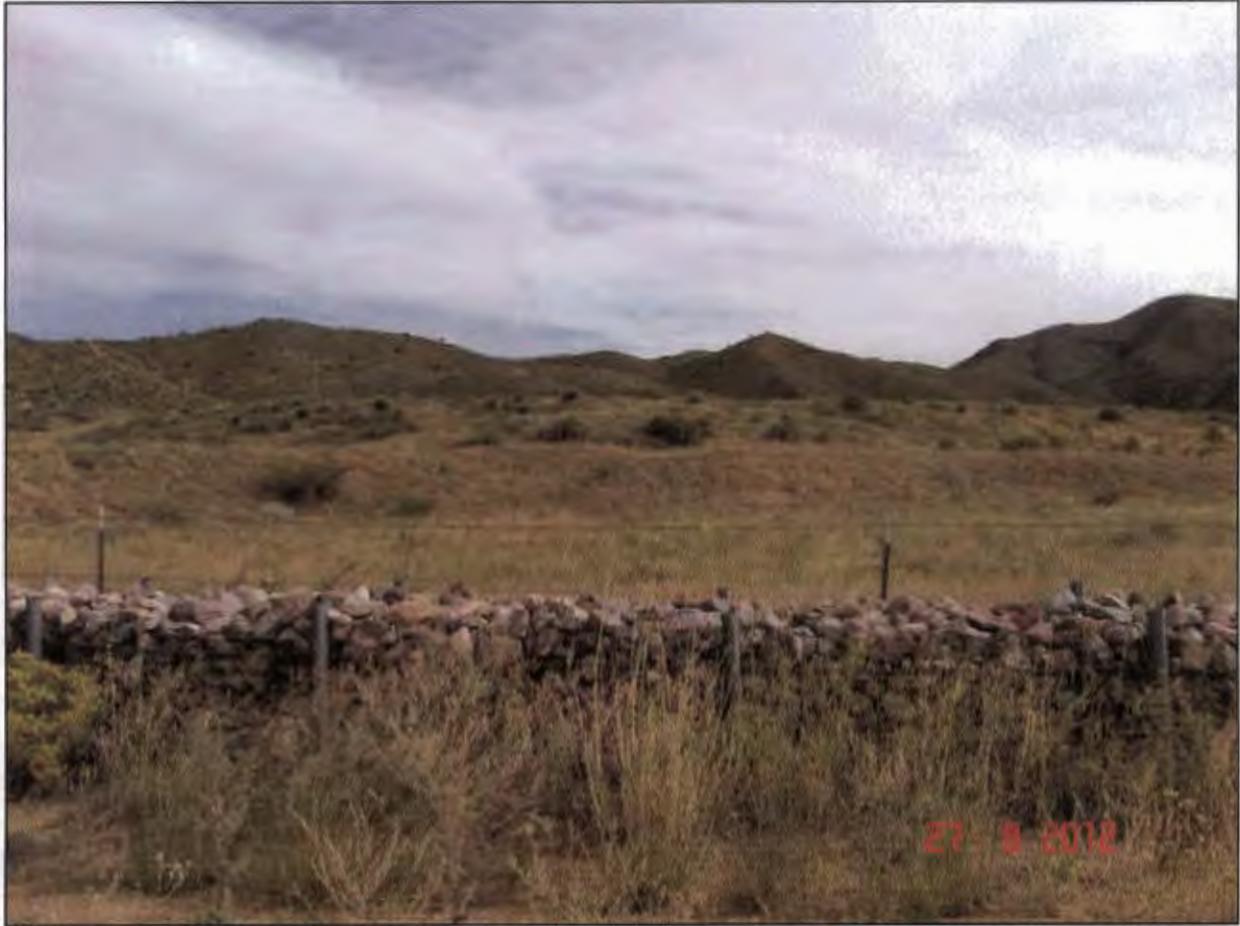
Photo No.: 49

Description: WSMR - SWMU 55 and SWMU 56 Open Burn Pits at the OB/OD. Post Closure Care Plan Required.

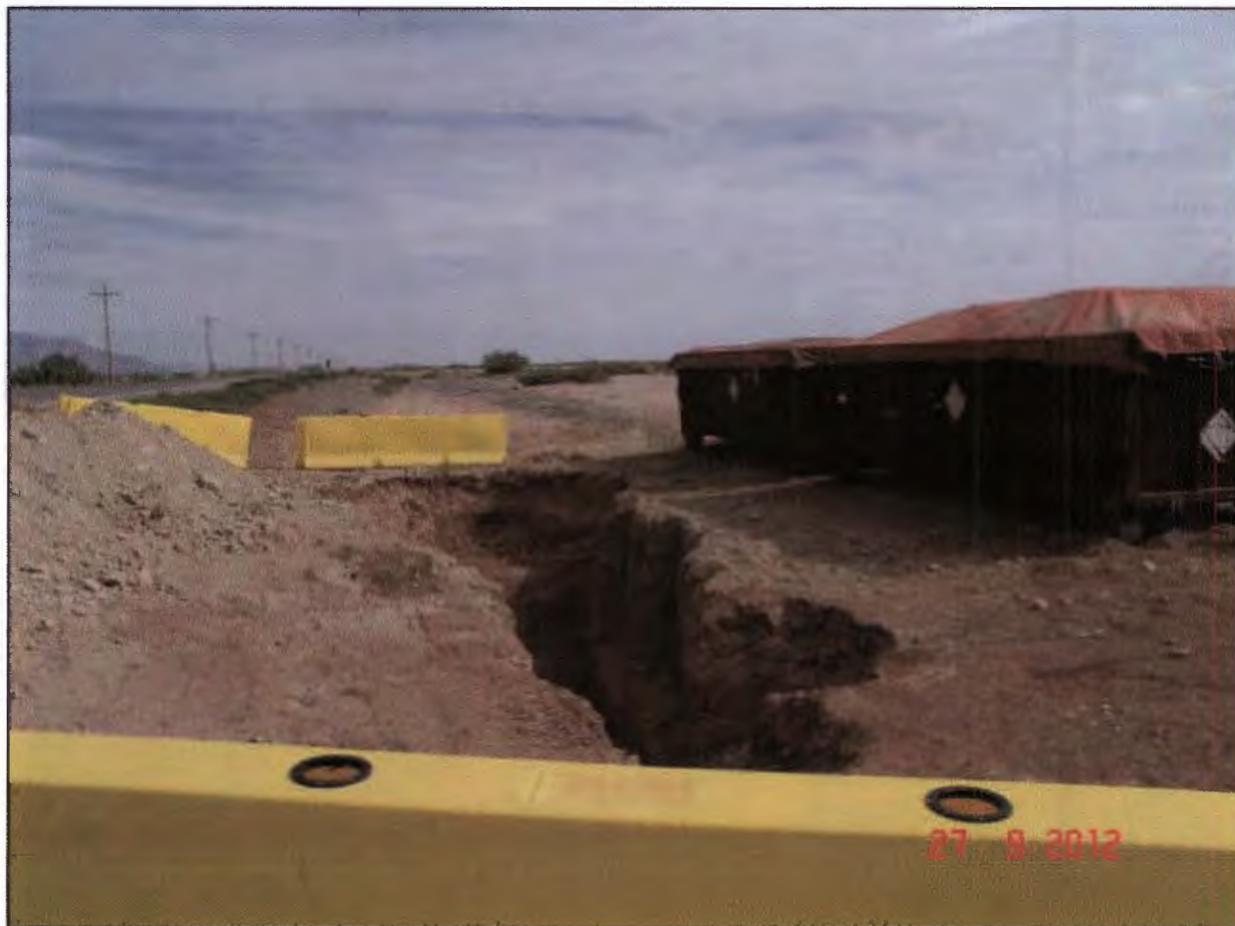
Photo No.: 50

Description: WSMR – Spill response area adjacent to (east) Range Road 7. It is suspected that the generator was not properly attached and came loose and flipped off trailer/truck. It is suspected that most of the missing fuel (200 gallons) was leaked onto the ground. The fuel spillage stained an area of 35' X 5' which was excavated and placed in roll-off boxes.

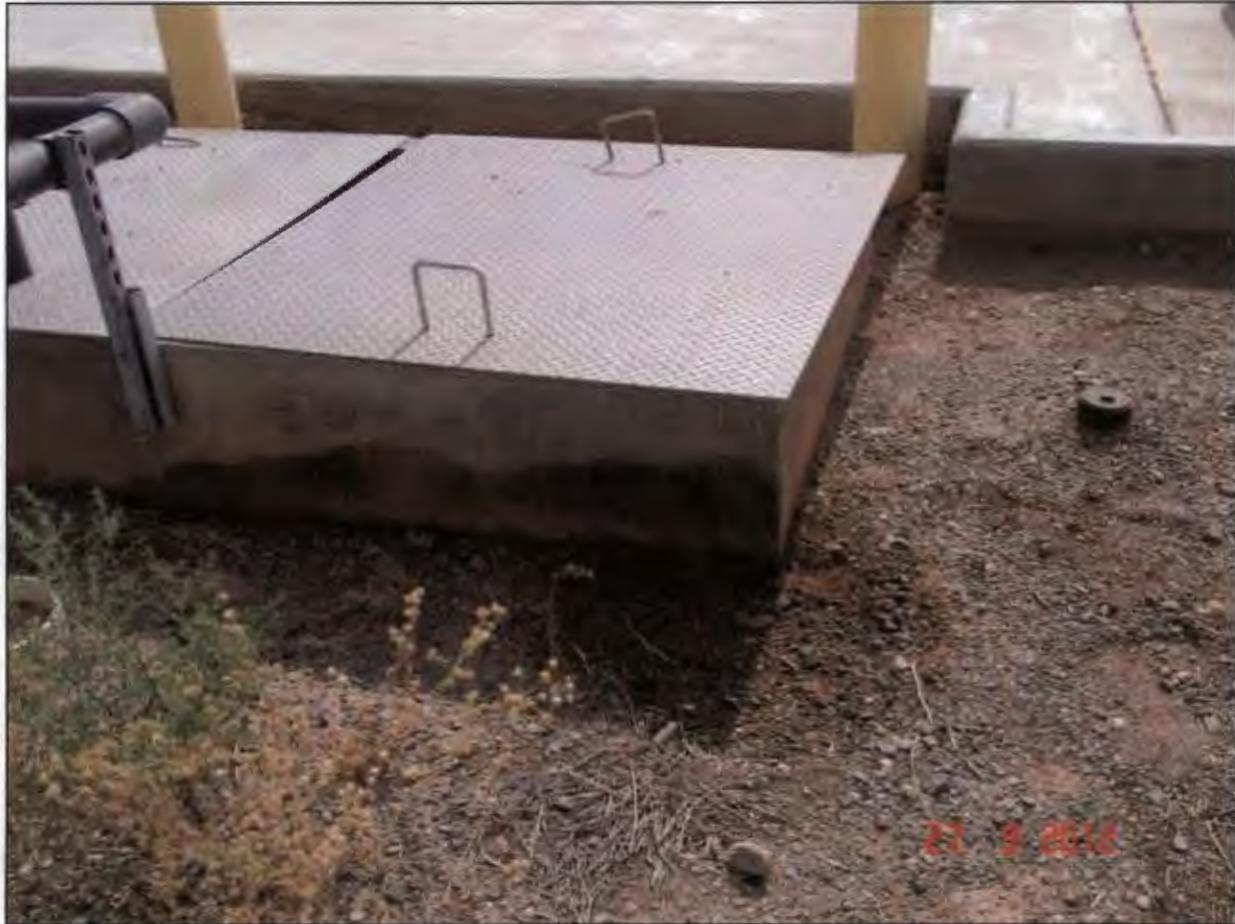
Photo No.: 51

Description: WSMR – Rhodes Canyon POL – Stained soil and concrete with strong diesel like odor adjacent to sump vault.

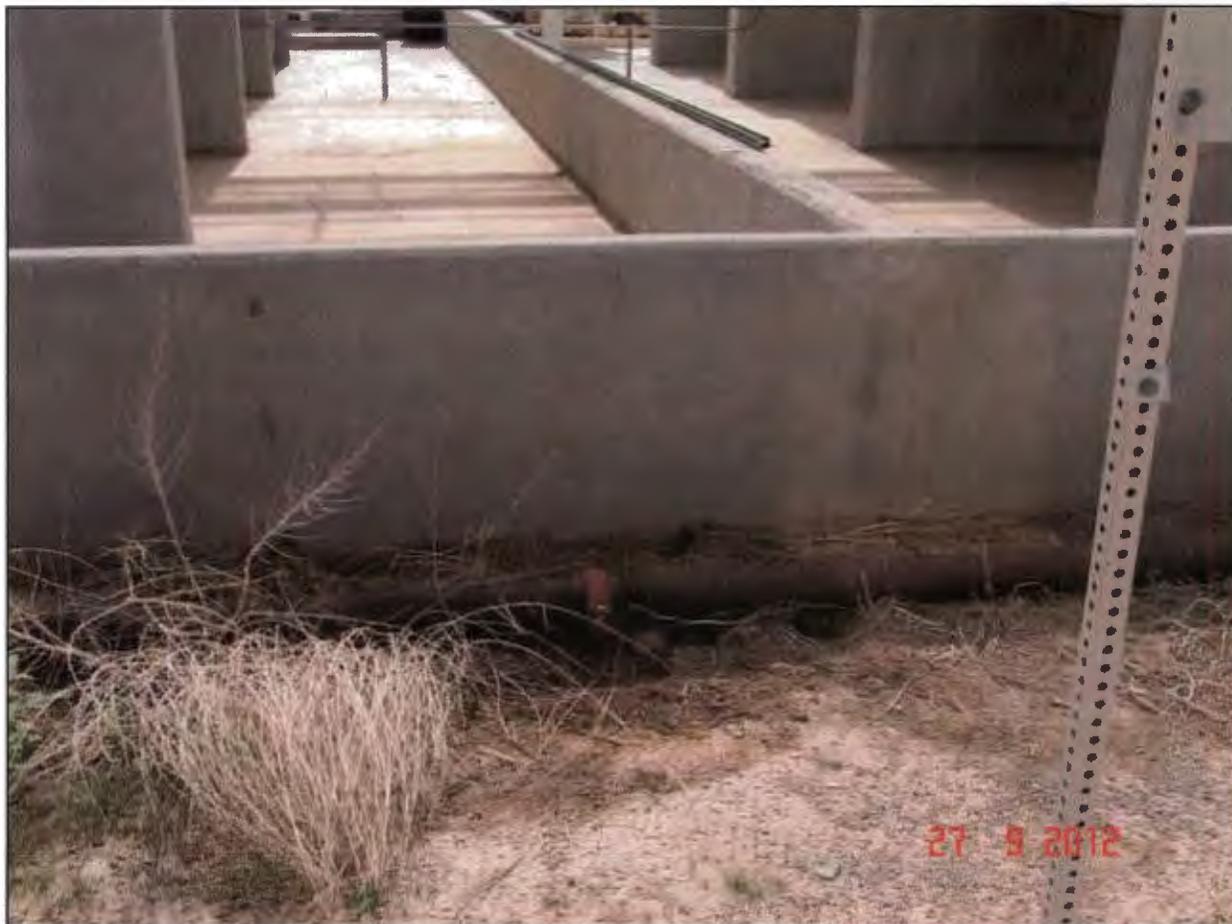
Photo No.: 52

Description: WSMR - WSMR – Rhodes Canyon POL – Stained soil adjacent to secondary containment discharge pipe with strong kerosene like odor.

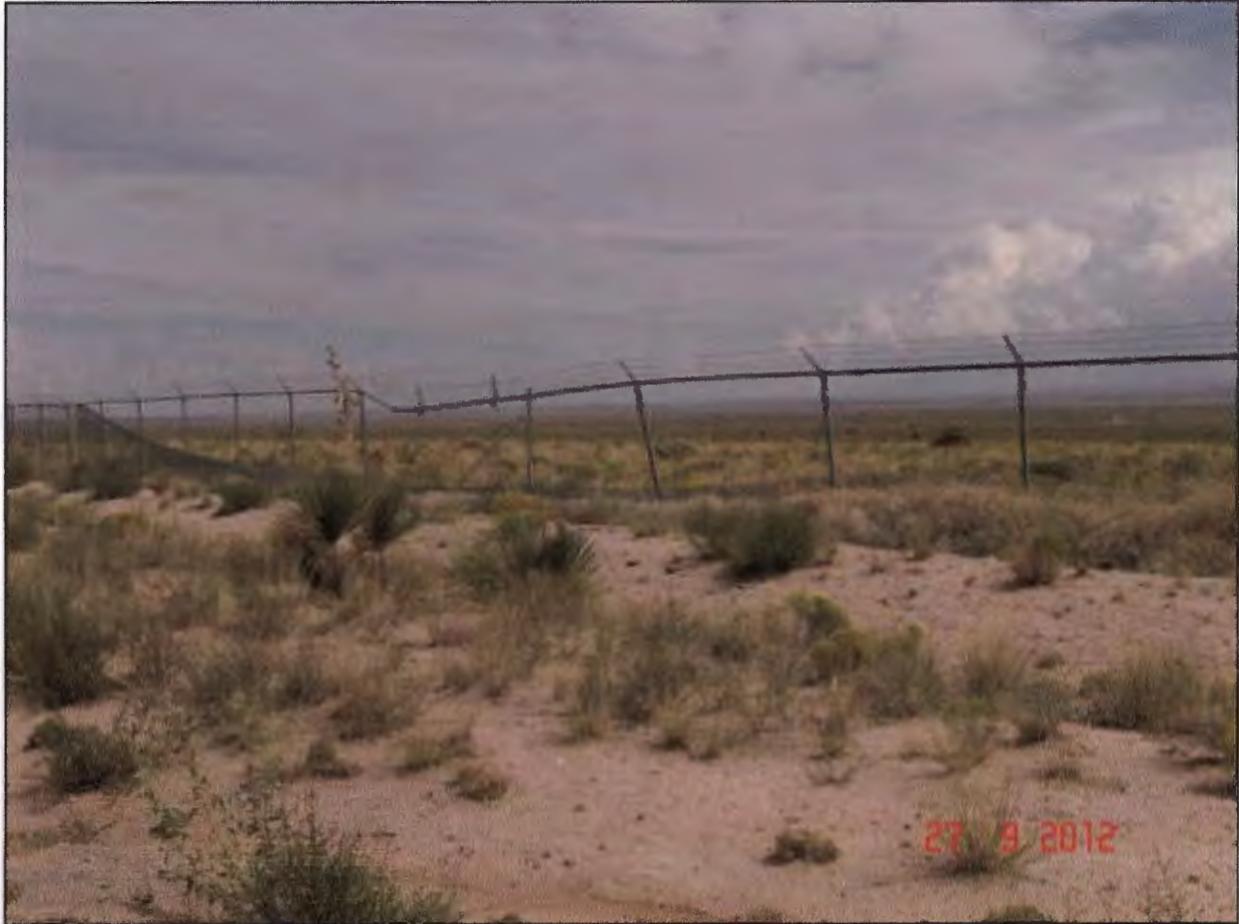
Photo No.: 55

Description: WSMR - SWMU 119 AND SWMU 120 / Stallion Range Landfill – Note: Fence needs repair. WSMR awaiting comments/approval on Revised RFI
