**UNITED STATES ENVIRONMENTAL PROTECTION AGENCY**

**Date of Inspection:** September 24-28, 2012      **EPA ID Number:** NM2750211235

**Facility Name:** US Army White Sands Missile Range

**Inspection Type:**  EPA Lead    State Lead    CSE    CEI    CDI  
 Sampling    Multi-Media    Other: Corrective Action

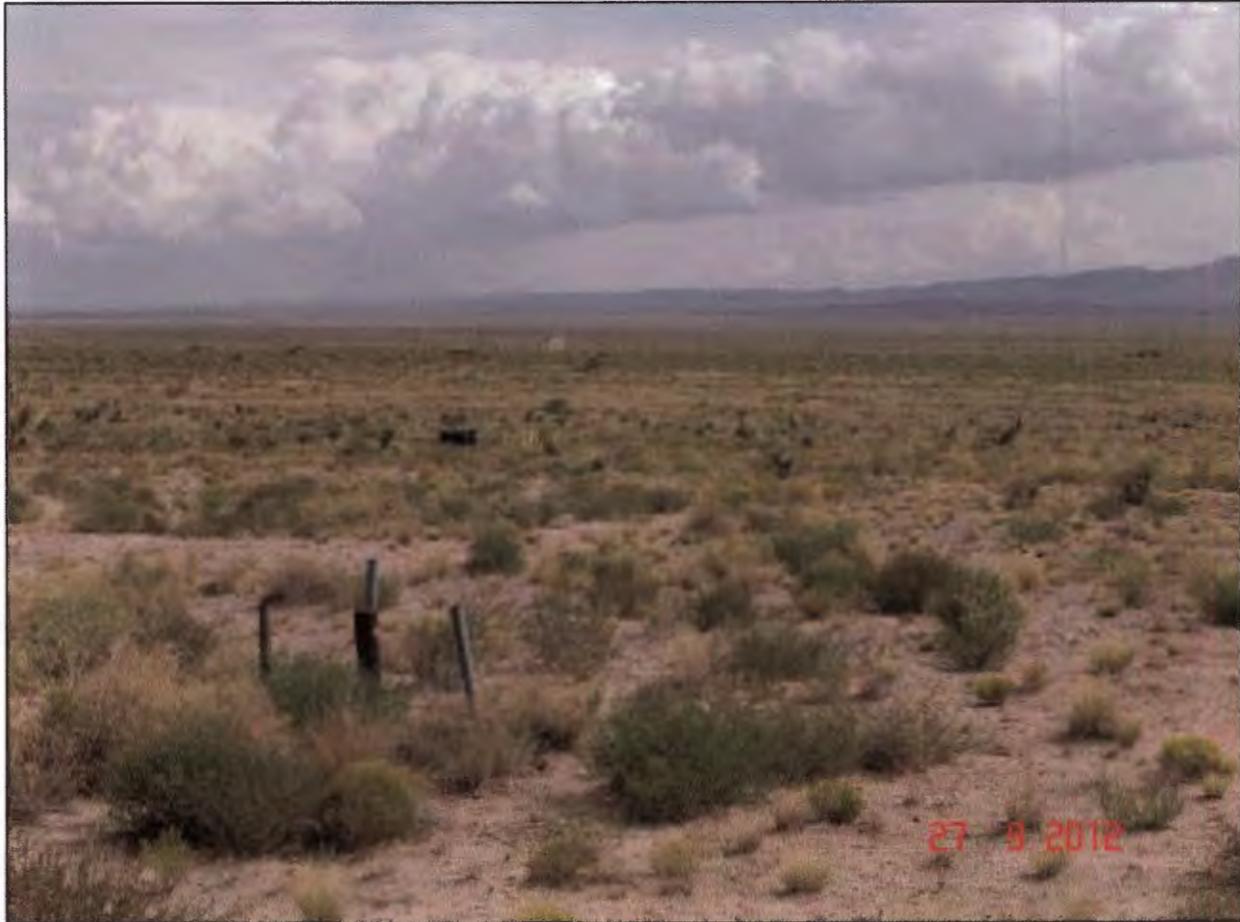
Photo No.: 56

Description: WSMR - SWMU 119 AND SWMU 120 / Stallion Range Landfill – Note: Old monitoring well network that is no longer being used (noted in foreground). Replaced with newer wells (noted in background).

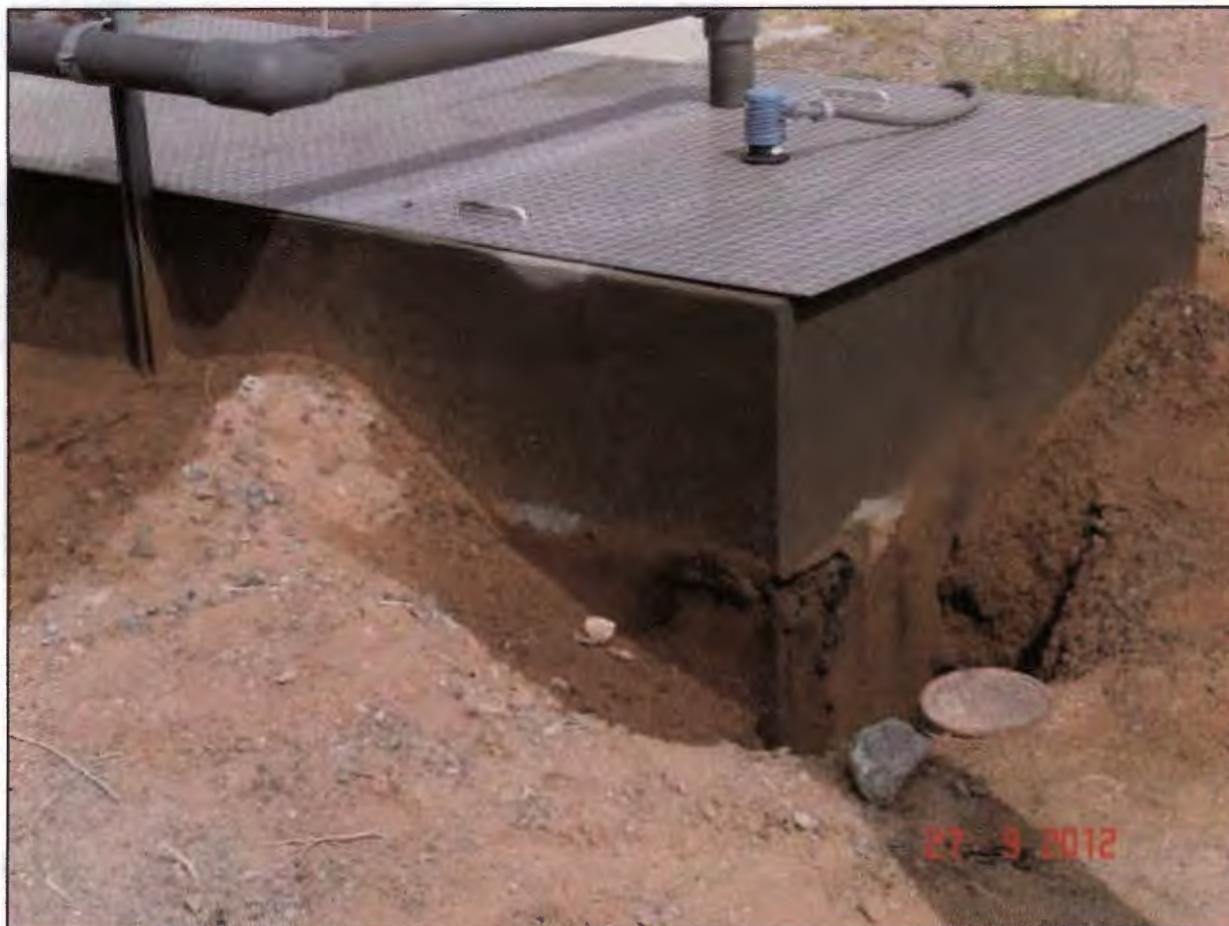
Photo No.: 57

Description: WSMR – Stallion Range POL - Stained soil with strong petroleum like odor adjacent to sump vault that has containment problem(s).

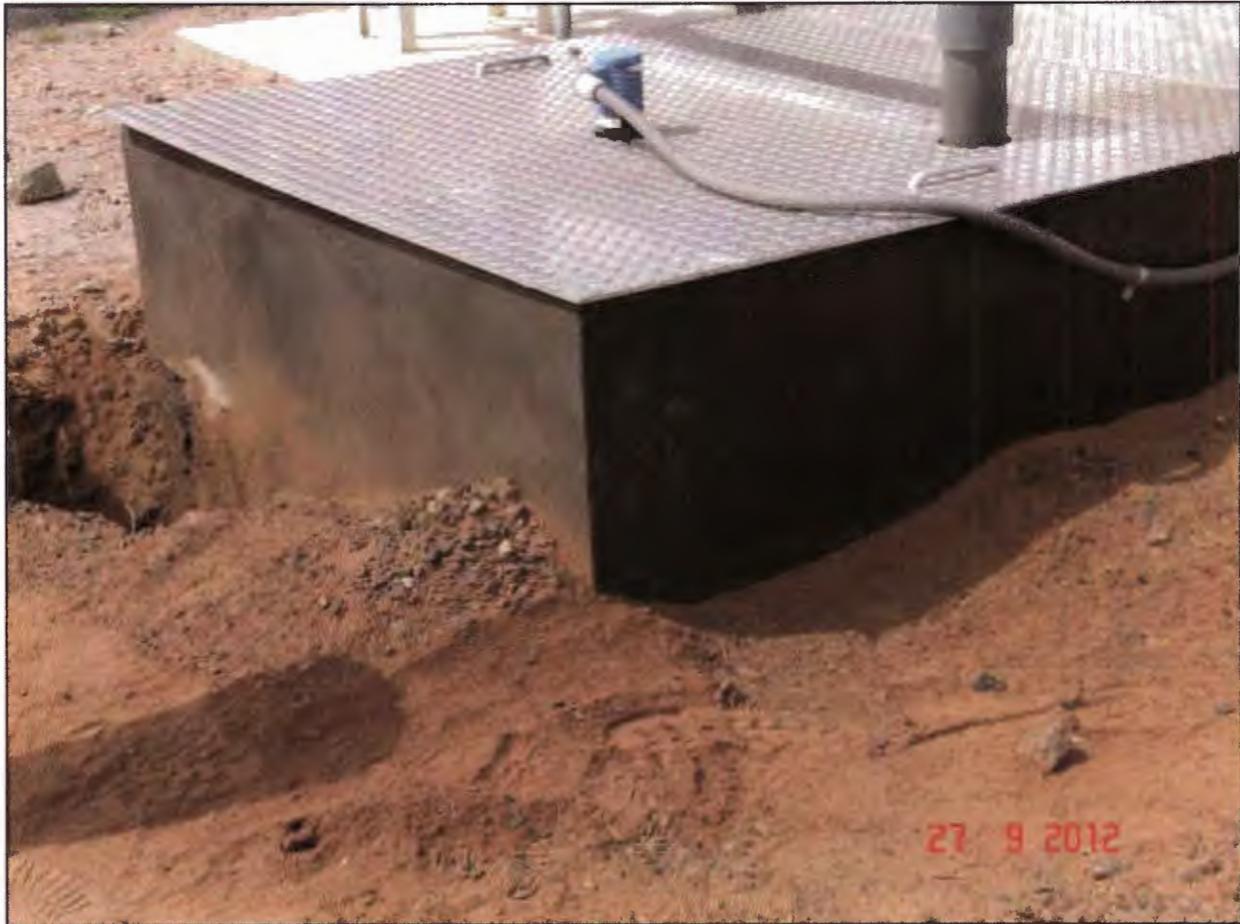
Photo No.: 58

Description: WSMR – Stallion Range POL - Stained soil with strong petroleum like odor adjacent to sump vault that has containment problem(s).

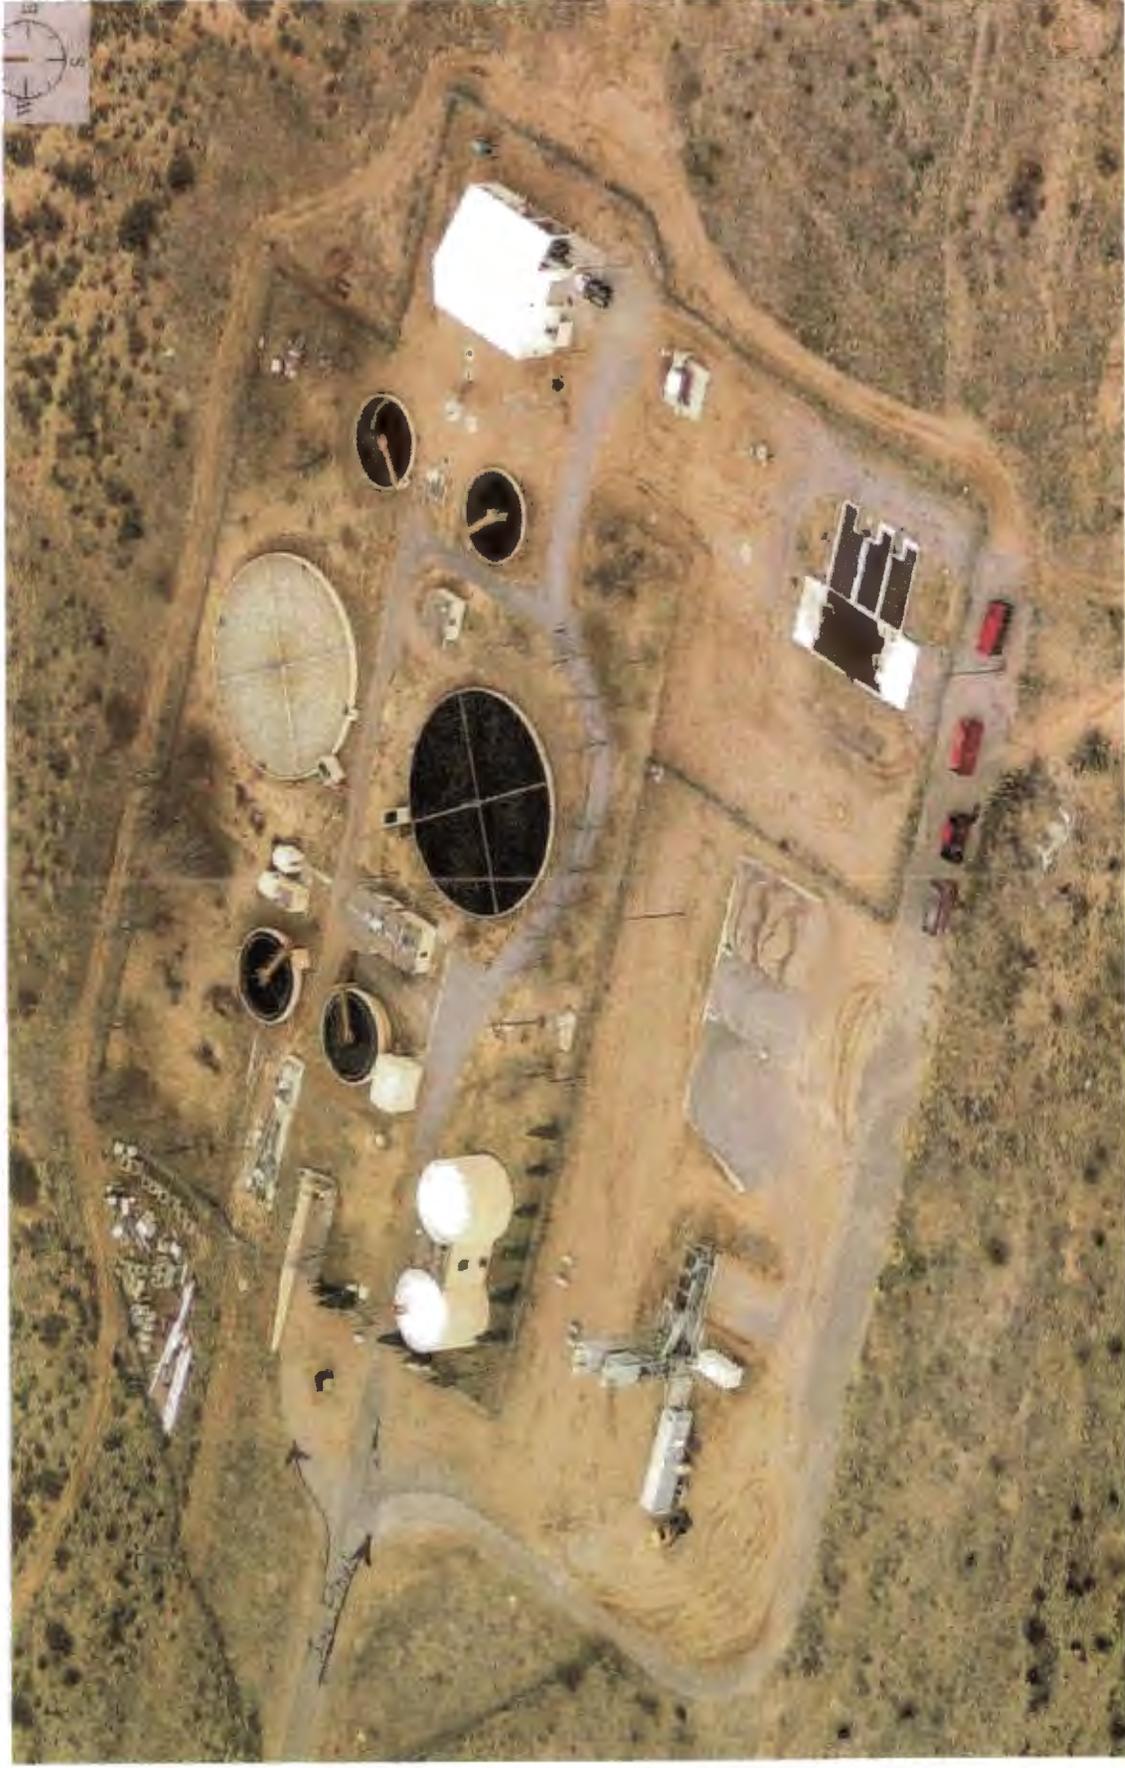
# AERIAL PHOTOGRAPH AND SCHEMATIC DRAWING OF MAIN POST SEWAGE TREATMENT PLANT

Based on the ESA, the STP has been operating since 1958 to present. The unit conveys sewage and wastewater from the Post Area to the STP. RFI investigations report TPHs and heavy metals contamination at the STP facility. Past waste management practices at WSMR have resulted in documented releases of hazardous constituents (metals, cyanides, and toluene) to the STP. At least one incident caused the STP to be shut down for several days. Though current waste management practices at WSMR have emphasized proper disposal of laboratory chemicals and wastes from operational activities, but no routine testing or assessments are done to ensure that hazardous constituents/wastes do not reach the STP.

**Issues:** Since in the past and possibly in the present, industrial wastewater with hazardous constituents is being treated at the STP and the treated wastewater is being discharged to Davies Tank. Prior to discharging to Davies tank, wastewater was discharged to the two former STP Ditches (SWMU-82 and SWMU-83) and the former STP Playa Lake (SWMU- 85), which all contained hazardous constituents associated with treated wastewater. Based on this information, I considered the following:
