# Remediation of Petroleum Hydrocarbons Released to the Subsurface

Stephen G. Reuter  
Geologist Manager

Petroleum Storage Tank Bureau  
New Mexico Environment Department

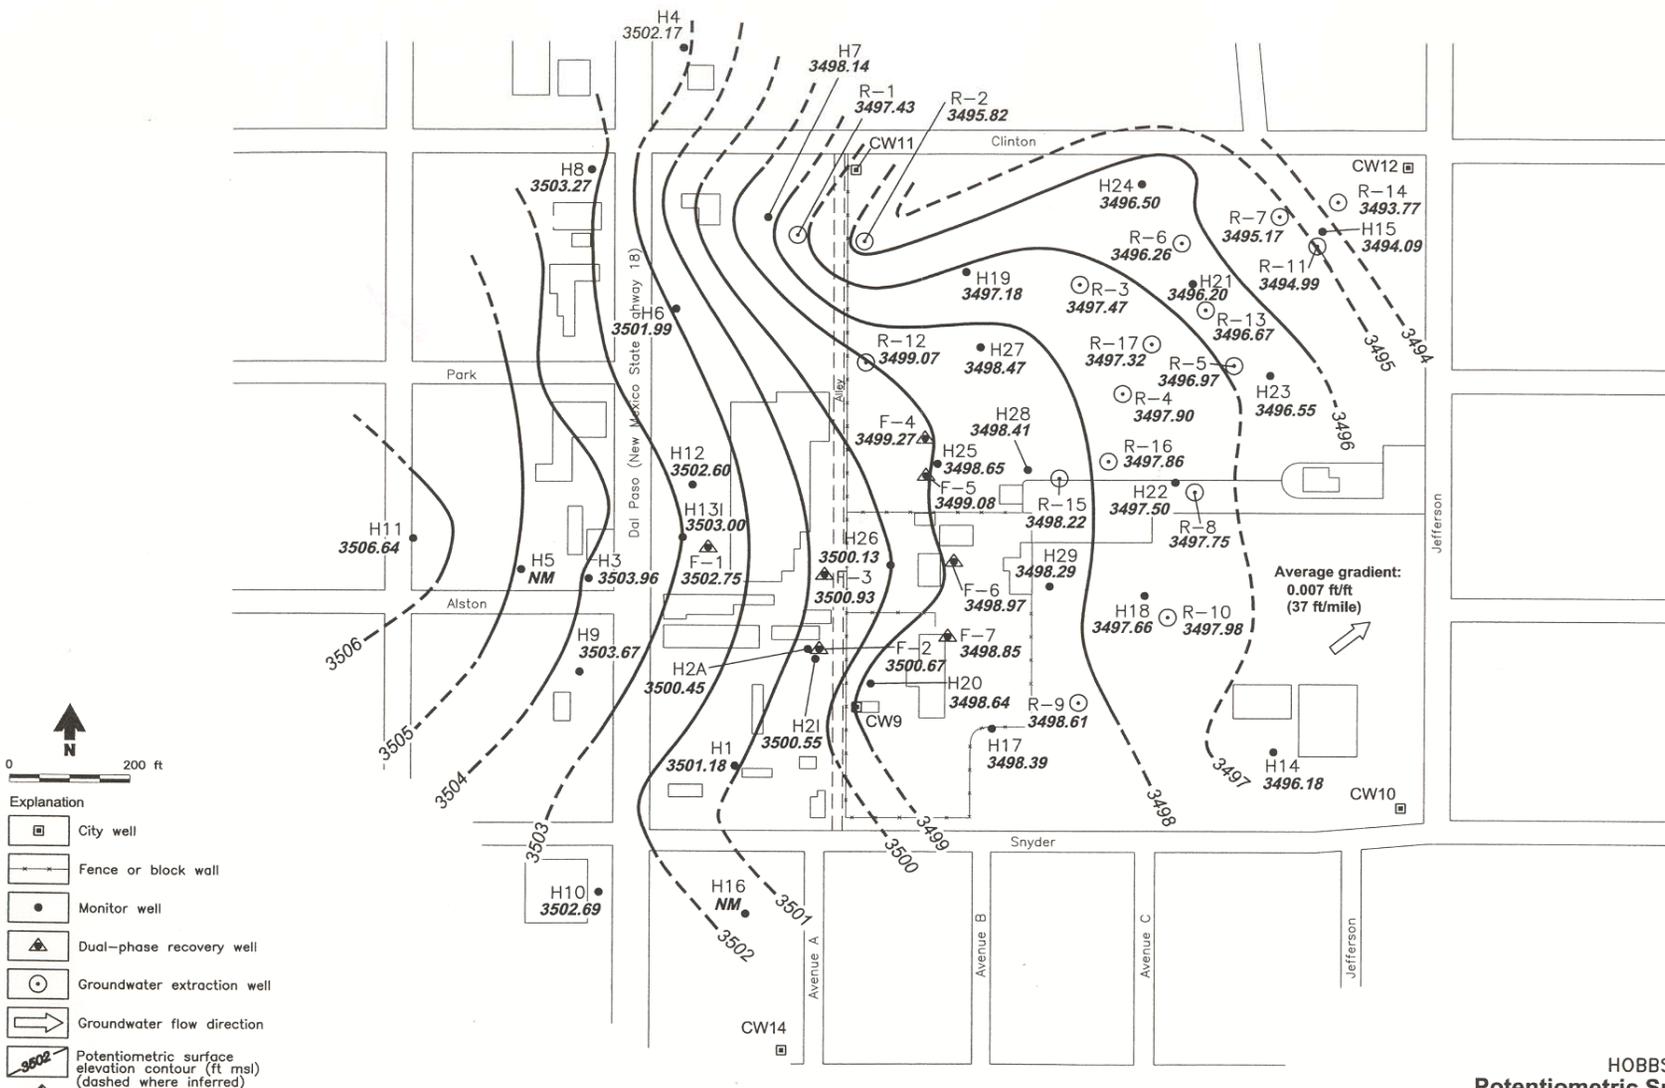
# Site Groundwater Elevations

HOBBS CITY WELLS SITE  
Potentiometric Surface Elevations  
August 4 and 5, 2003

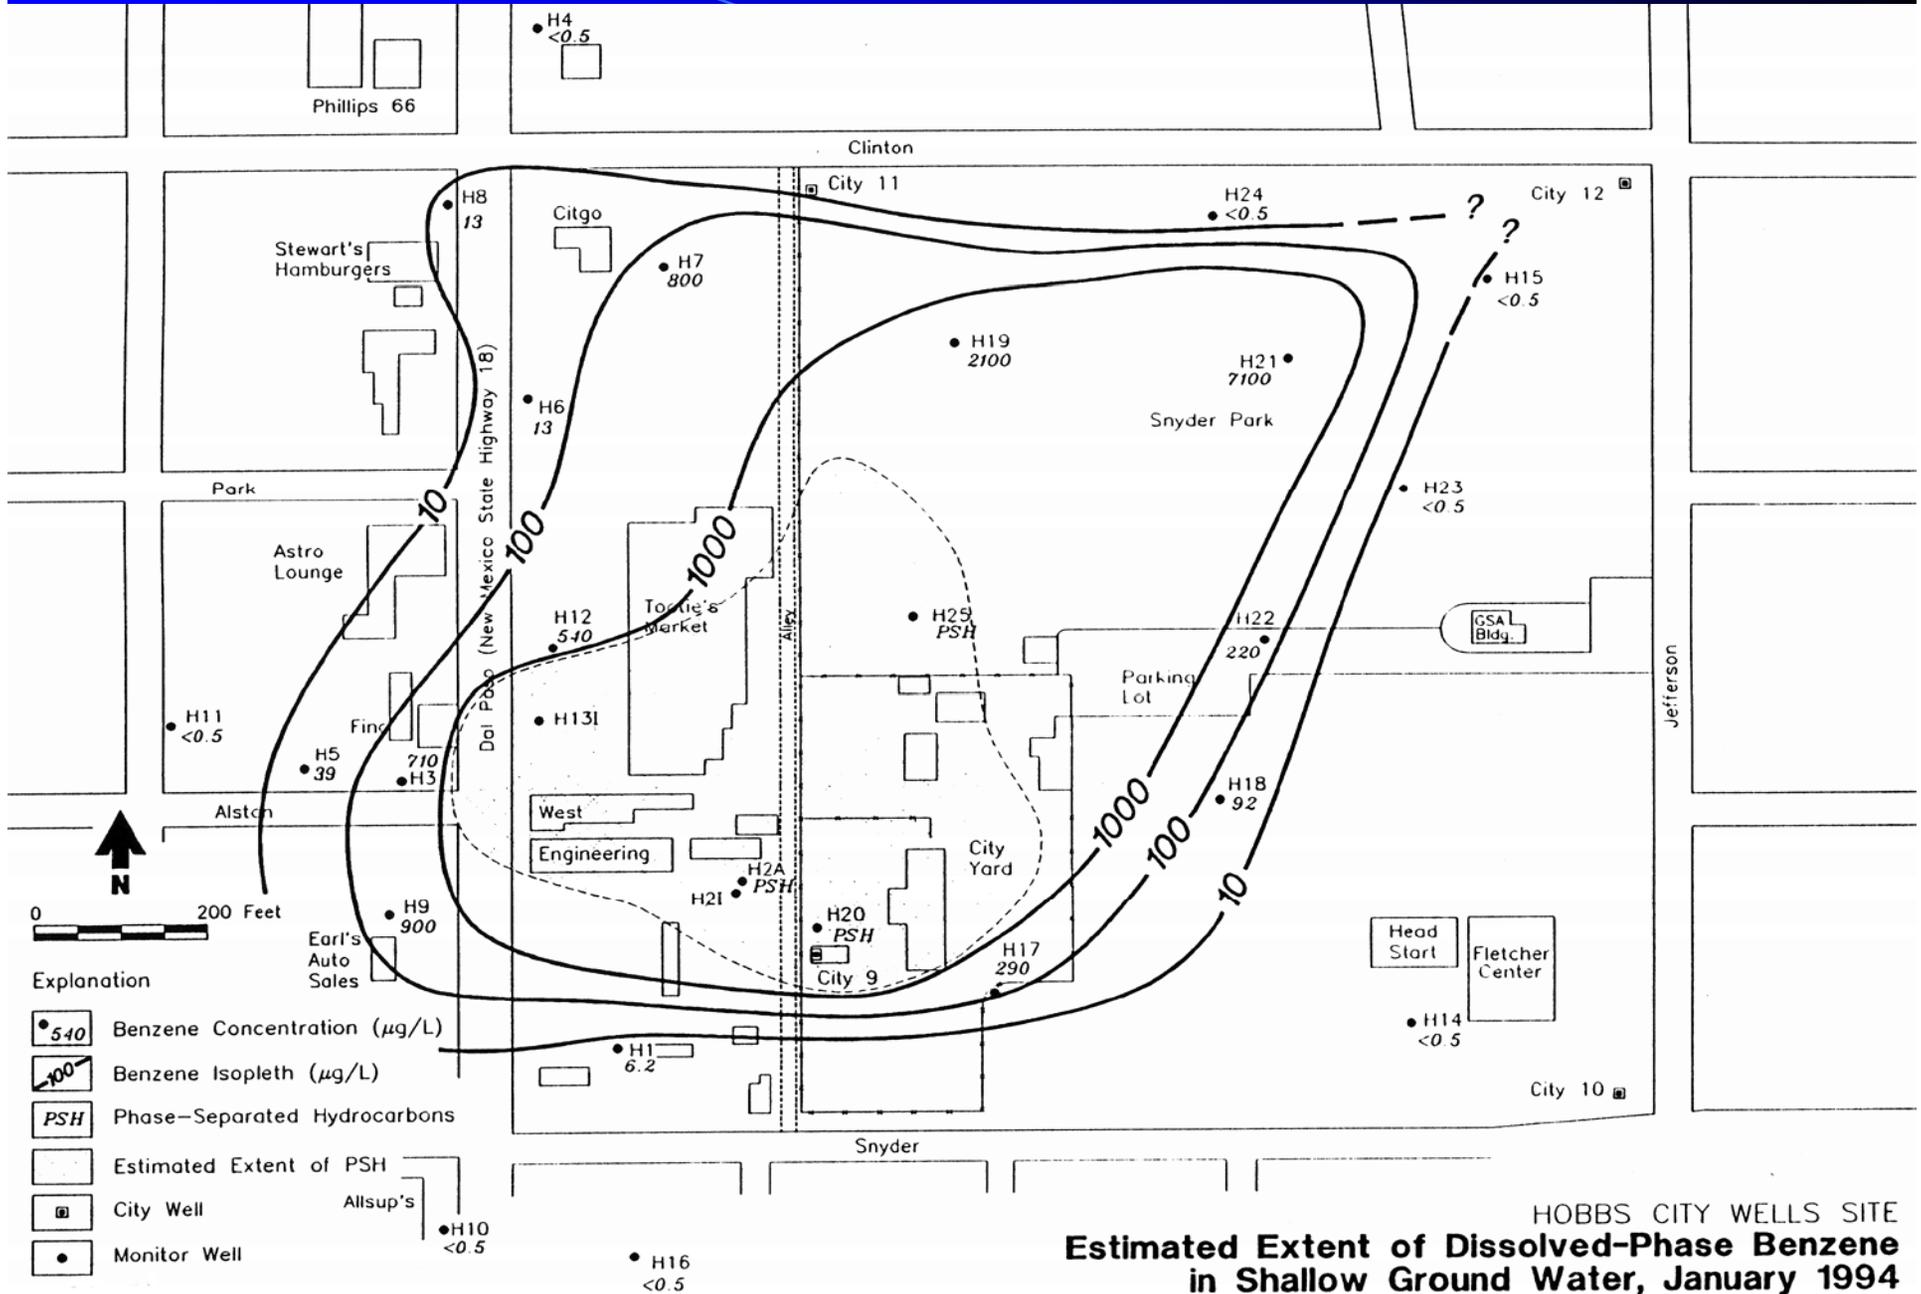
# Contaminant Plume Initial

- Explanation**
- 540 Benzene Concentration ( $\mu\text{g/L}$ )
  - 100 Benzene Isopleth ( $\mu\text{g/L}$ )
  - PSH Phase-Separated Hydrocarbons
  - Estimated Extent of PSH
  - City Well
  - Monitor Well

HOBBS CITY WELLS SITE  
**Estimated Extent of Dissolved-Phase Benzene  
 in Shallow Ground Water, January 1994**

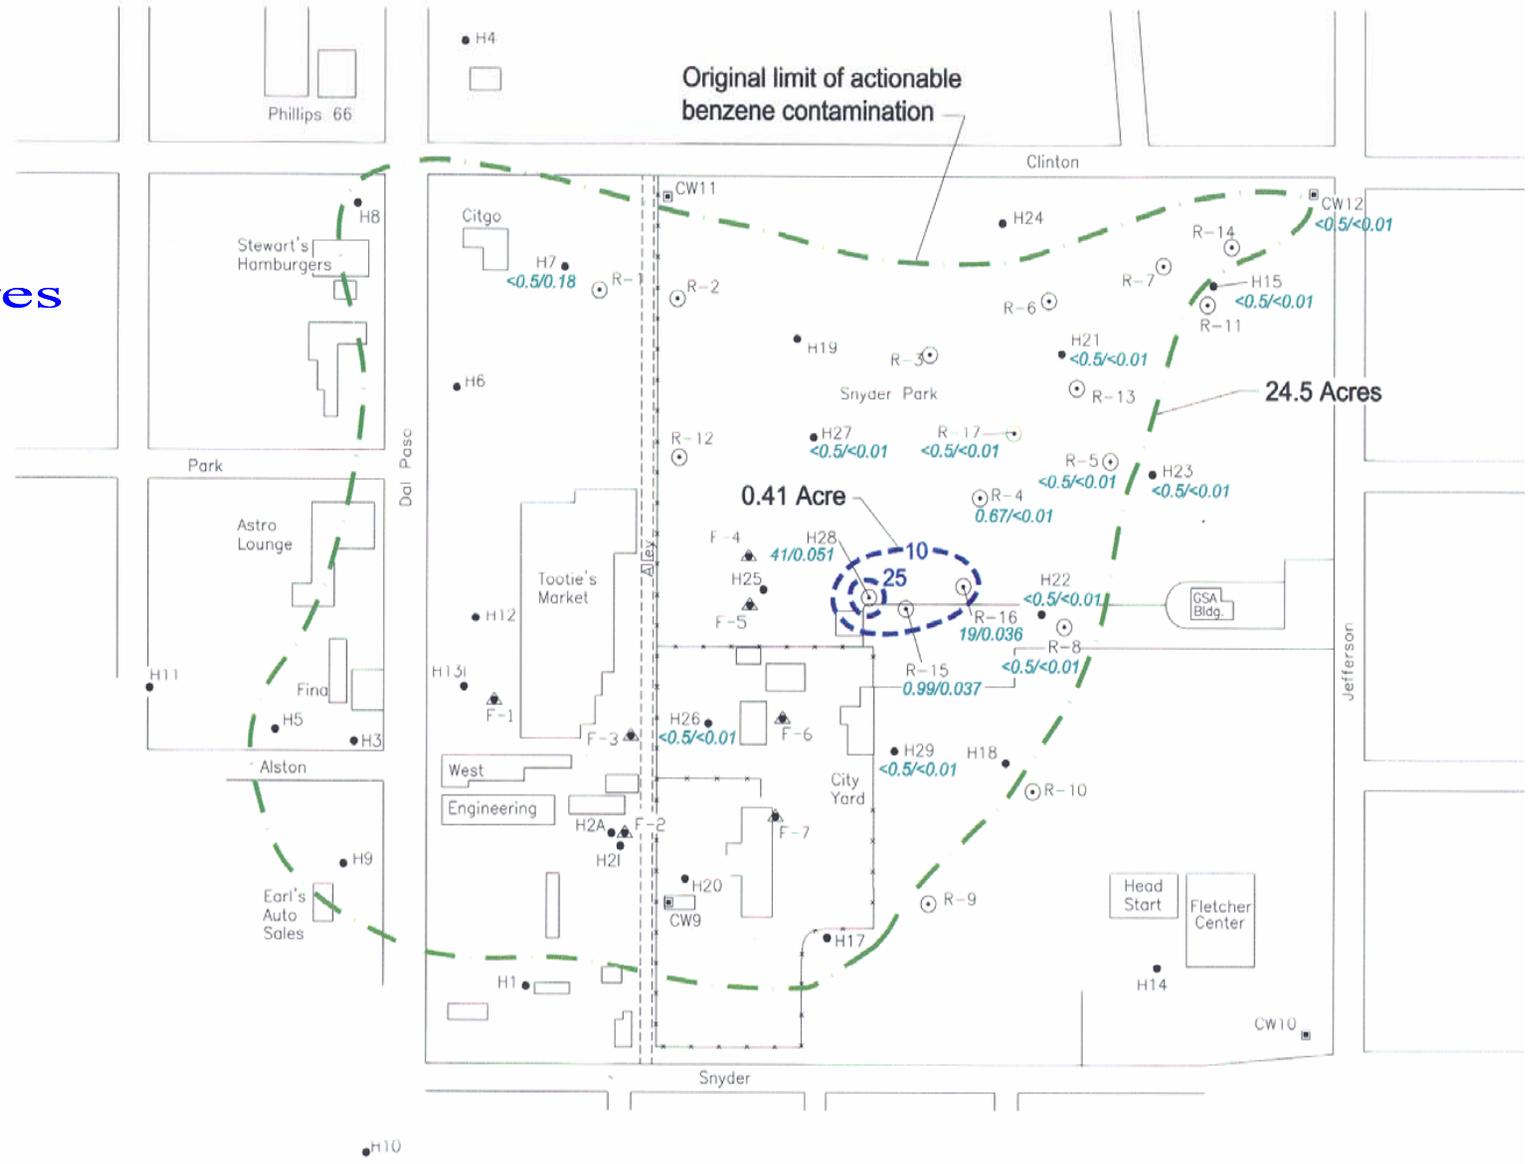
# Contaminant Plume after 8 yrs

0.41 acres

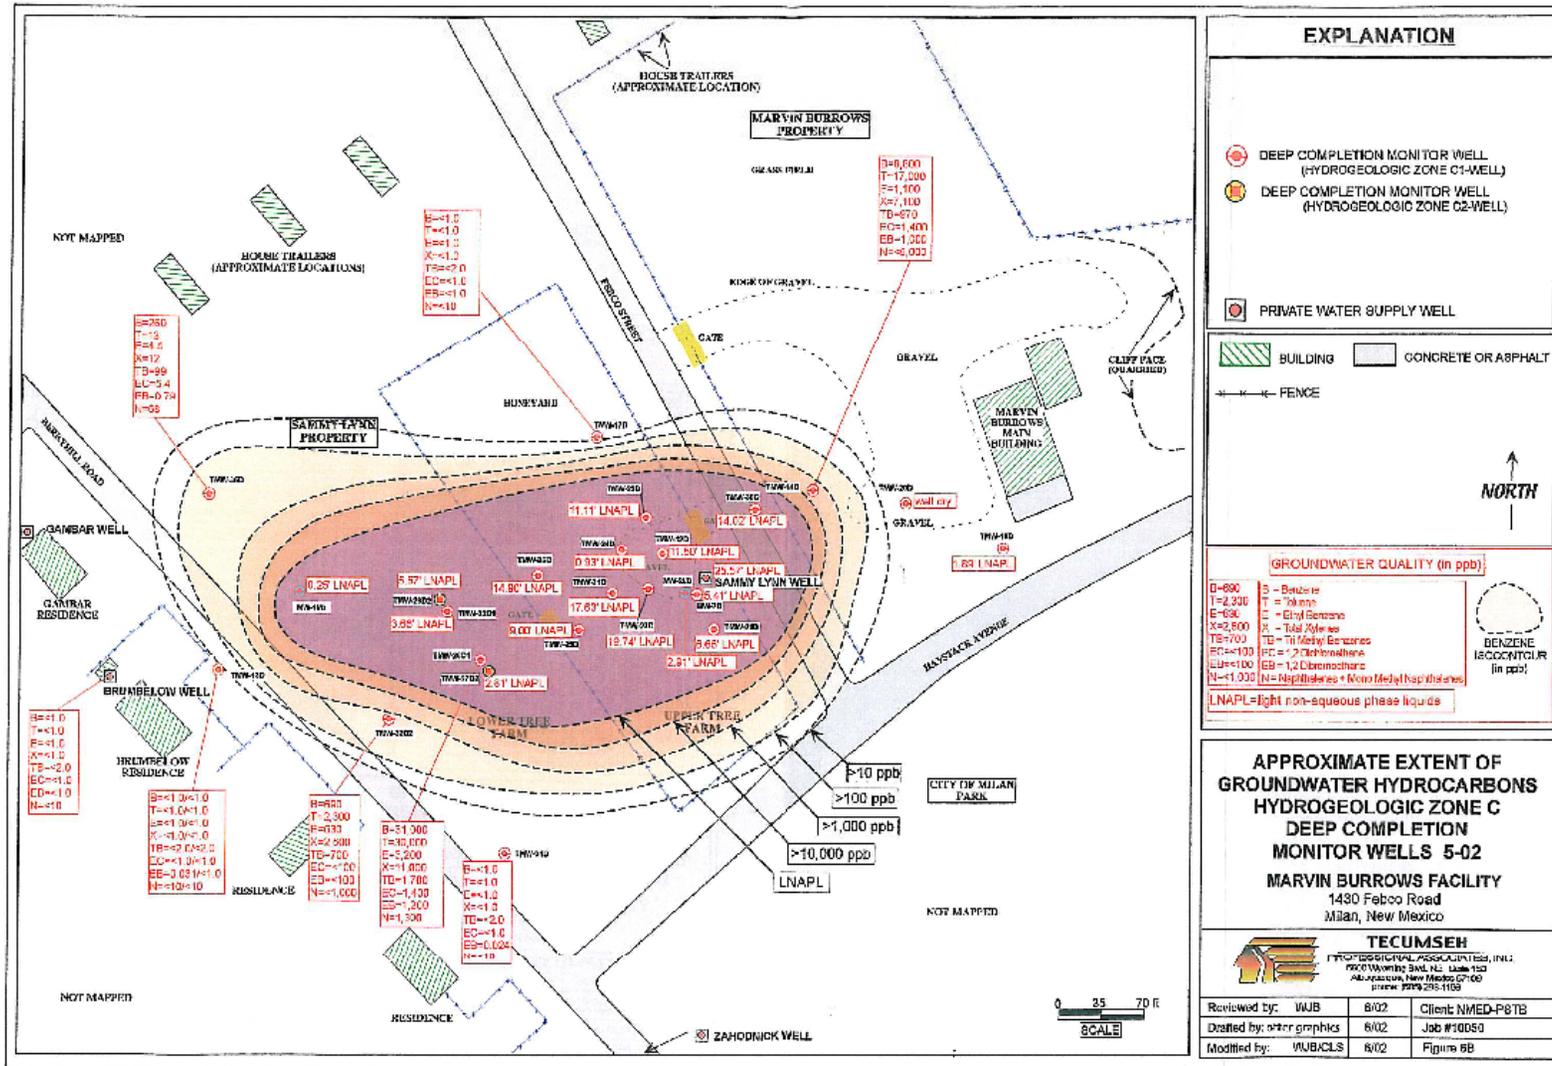
# Contaminant Plume-Initial

- GW Plume 4 acres
- NAPL Plume 2 acres
- Depth to GW ~150' bgs
- Complex geology
