URS

June 29, 2005

**SUBJECT**: Supplementary Investigation Letter Report
Former GE Albuquerque Apparatus Inspection & Repair Service Center
4420 McLeod Road, North East, Albuquerque, New Mexico
General Electric Consent Decree, Civil Action No. 87-1073-jb

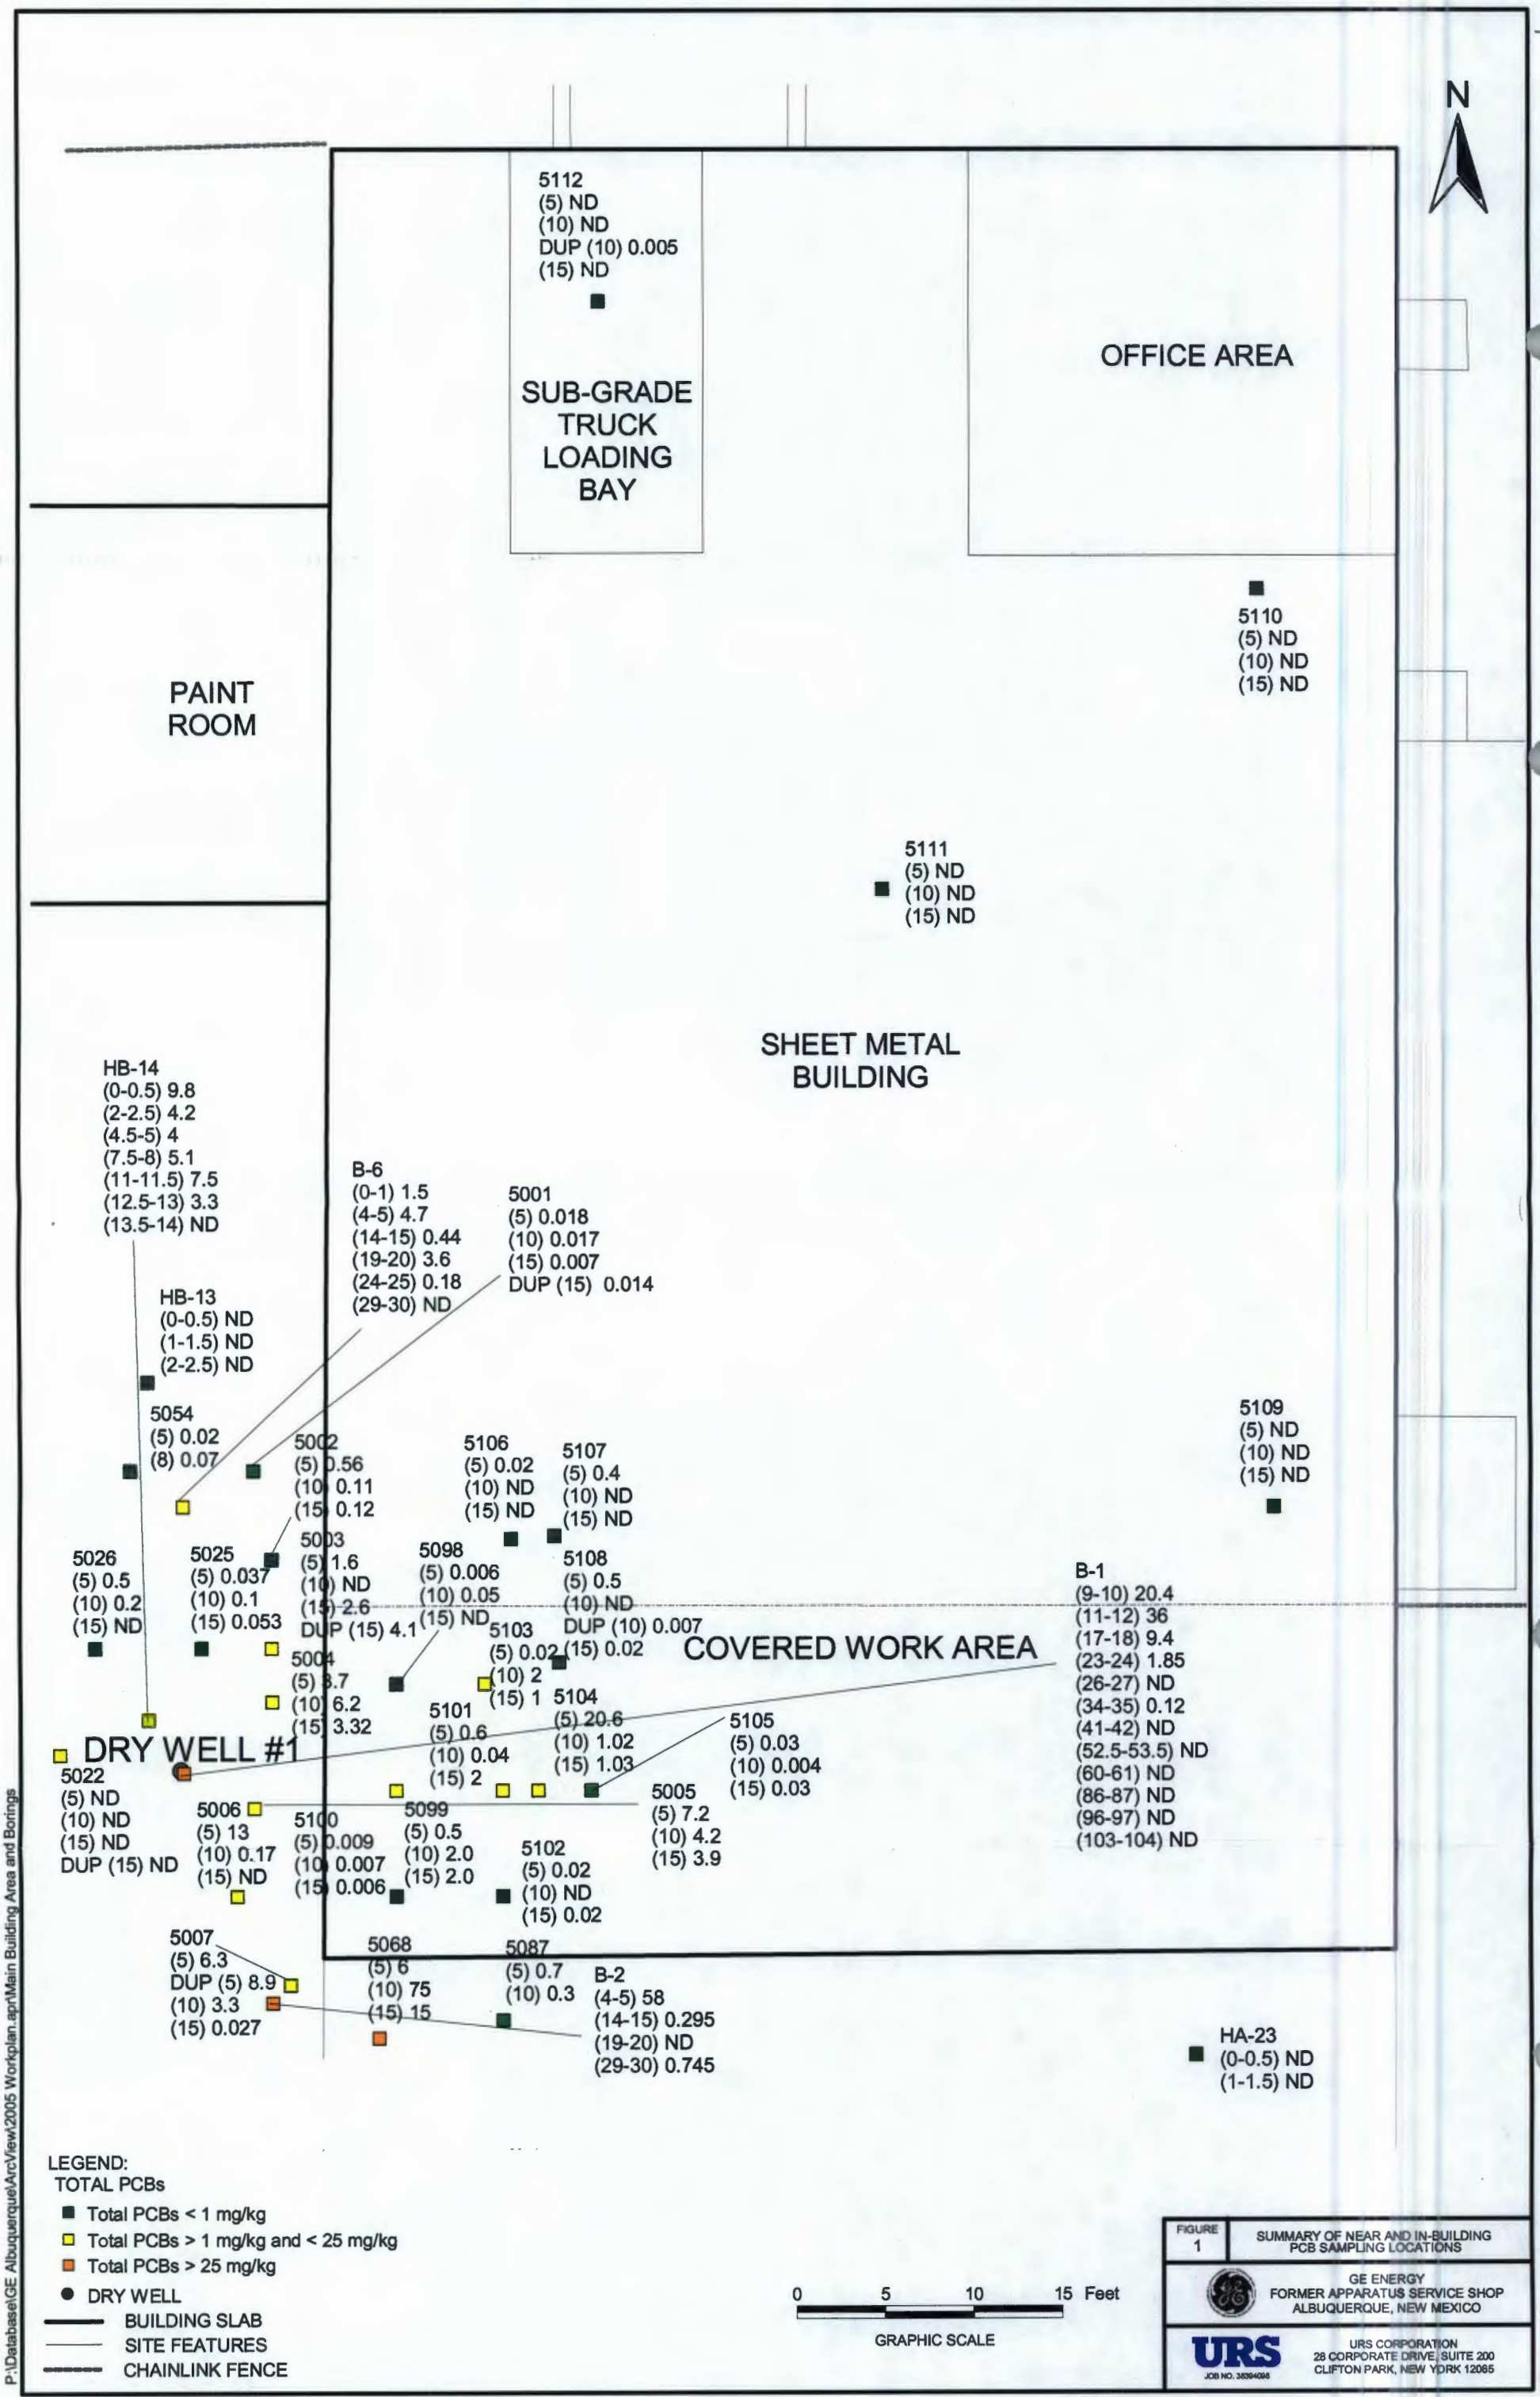
FIGURE 1

With URS oversight, Enviro-Drill, Inc, in Albuquerque, NM, advanced seven soil borings on May 5, 2005. Three of the borings (5106, 5108, and 5109) were advanced to evaluate the extent of PCBs previously identified as beneath the southwest corner of the building. The remaining four borings (5109, 5110, 5111, and 5112) were advanced to evaluate soil quality beneath other portions of the building. The boring locations and sampling results are shown on Figure 1.

As shown in Table 1 and Figure 1, none of the soil samples collected beneath the building during this round of investigation exhibited PCB concentrations greater than 1.0 mg/kg.

- PCBs were not detected above the cleanup objective of 25 mg/kg in soil beneath the building slab. In fact, the highest concentration detected in any of the new borings beneath the building was less than 1.0 mg/kg.
