SUBJECT: FINAL Corrective Measures Implementation and Construction Certification Report
Former GE Albuquerque Apparatus Inspection & Repair Service Center
4420 McLeod Road, Northeast, Albuquerque, New Mexico
General Electric Consent Decree, Civil Action No. 87-1073-jb

FINAL
CORRECTIVE MEASURE IMPLEMENTATION AND CONSTRUCTION CERTIFICATION REPORT
FORMER GE APPARATUS SERVICE CENTER
ALBUQUERQUE, NEW MEXICO
EPA ID. NUMBER NMD047140256

AMEC Project No. 3-4915-0021

29 SEPTEMBER 2006

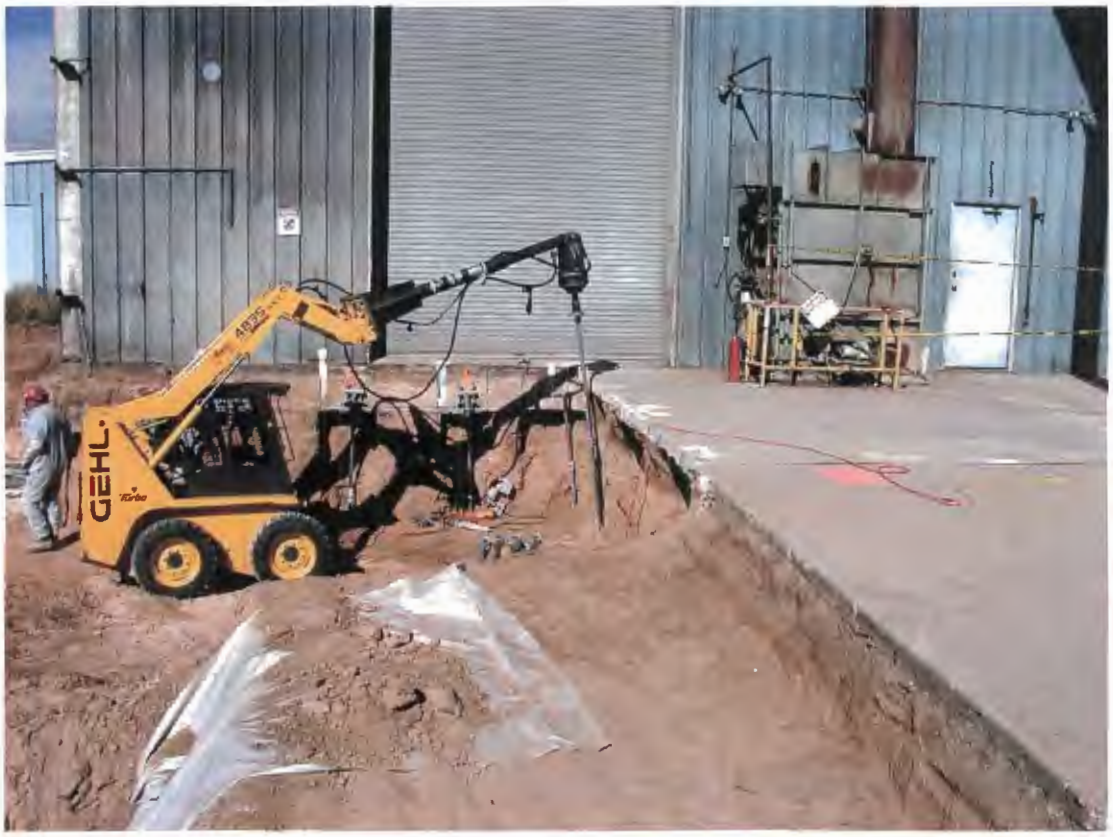
Installation of helical anchors for braced excavation (view north)

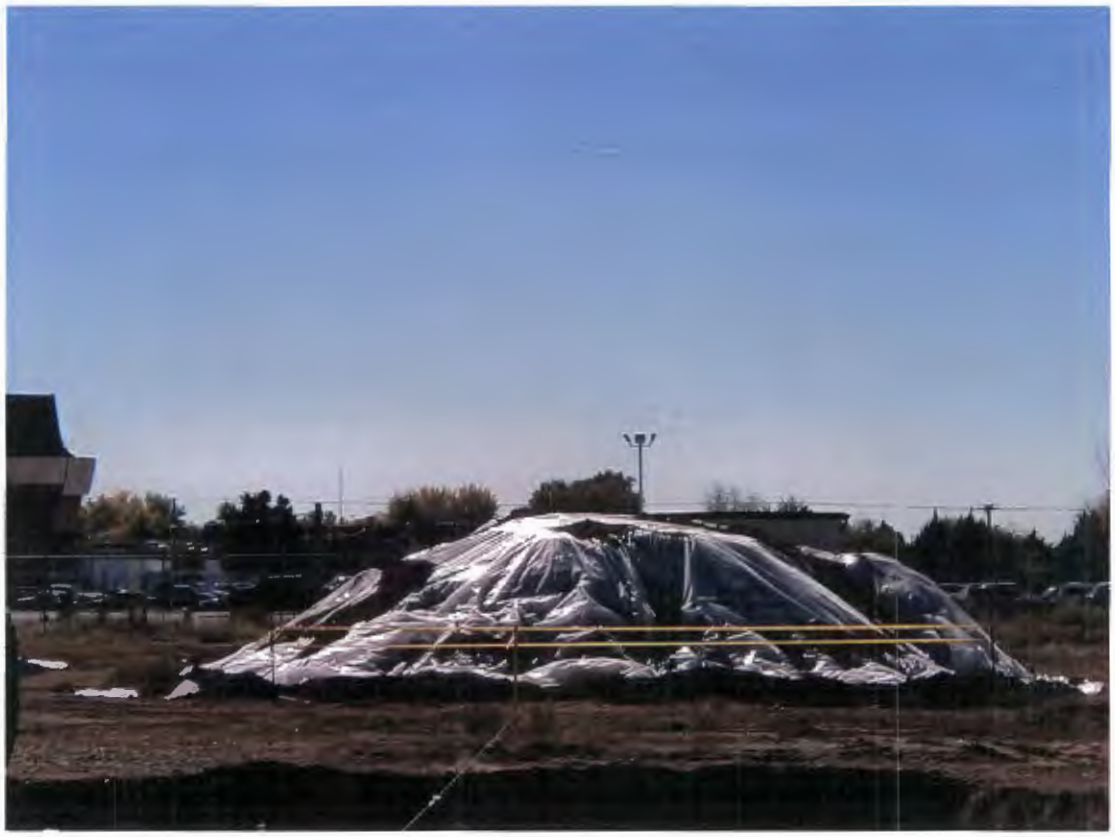
Non-TSCA (<50 ppm) soil waste stockpile (view southwest)

Non-TSCA (<50 ppm) soil waste stockpile (view south)
