LOS ALAMOS NATIONAL LABORATORY
ENVIRONMENTAL RESTORATION
Records Processing Facility
ER Records Index Form

SUBJECT: PROJECT COMPLETION REPORT FOR THE ACCELERATED ACTION AT TA-16, MATERIAL DISPOSAL AREA (MDA) R

LA-UR-01-522
January 2001
ER2001-0024

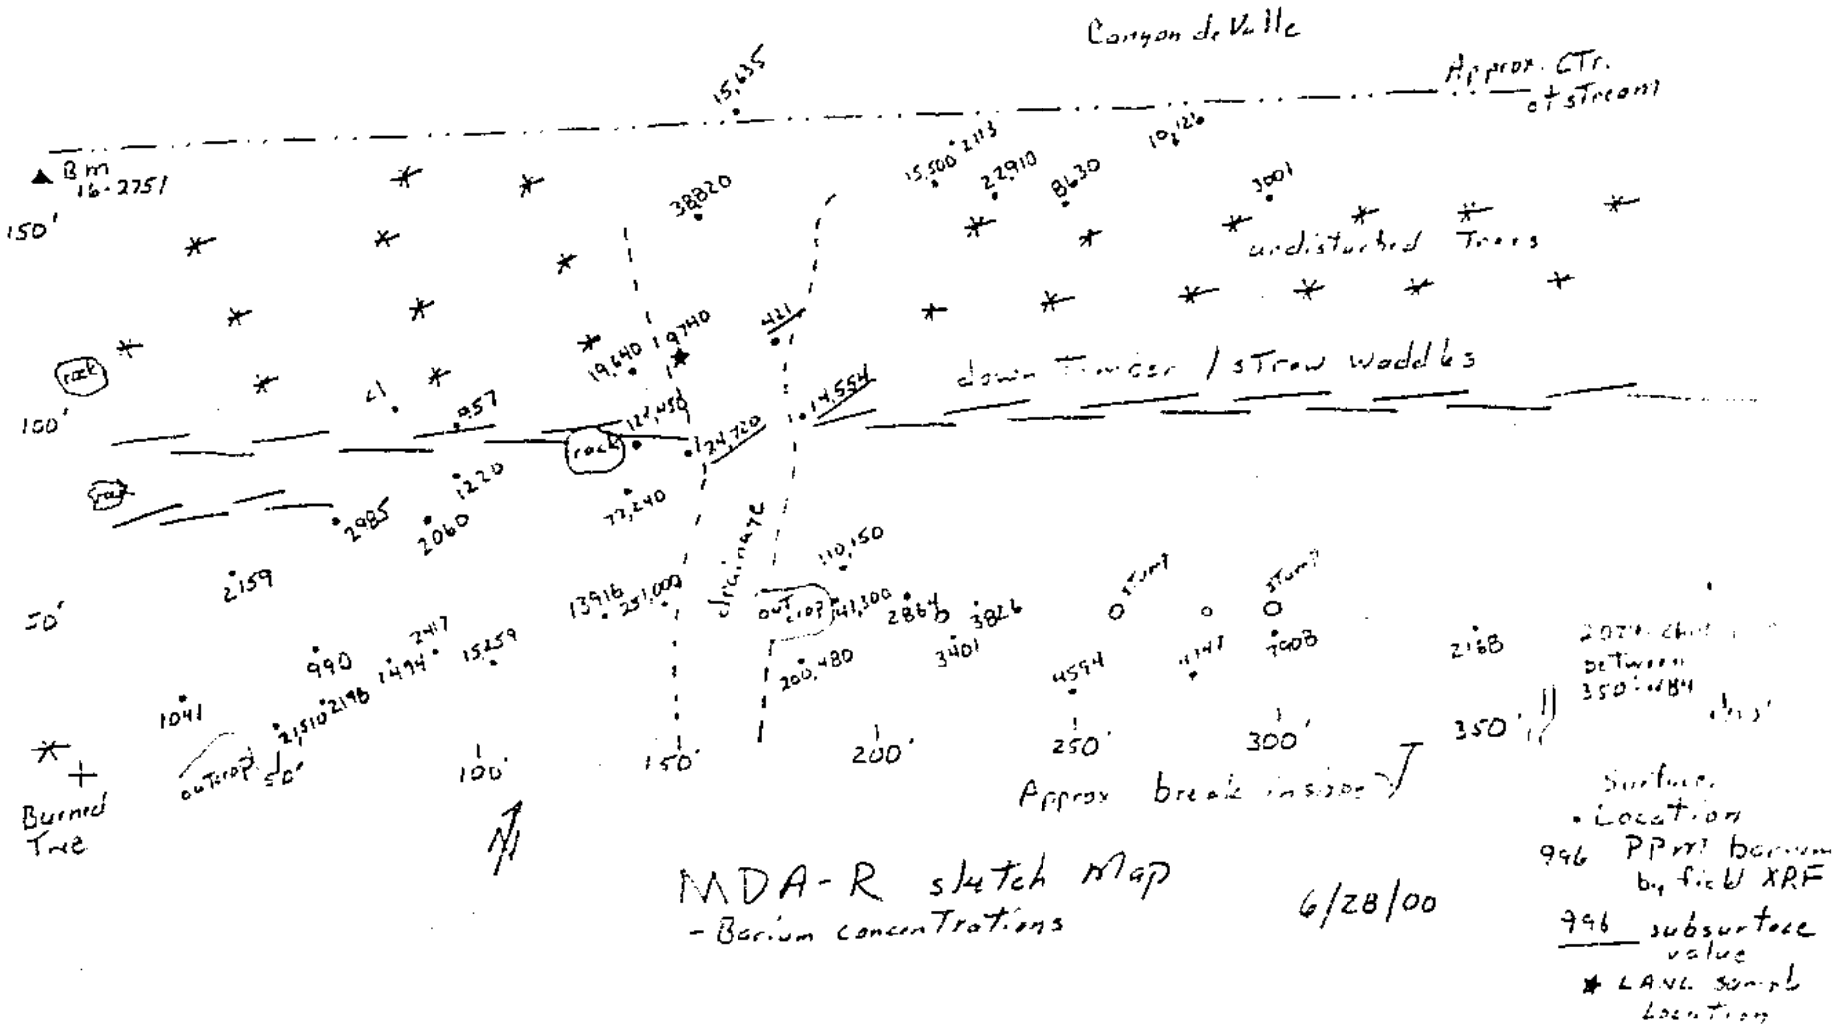
Appendix E
Map Showing Barium Concentrations After Fire Suppression

After the fire was suppressed, an XRF survey was done on the slopes exposed by the excavation. Barium and lead appeared to be the principal remaining contaminants at MDA R. Soils contaminated with barium remain in the central area. The barium contamination in surface soils near the former drainage arroyo exceeded 200,000 ppm. A few shallow (less than 1 ft deep) subsurface samples exceeded 14,000 ppm. A crude map of this XRF survey was prepared and is provided in Appendix E. Approximately 100 lb of barium nitrate pieces were collected and managed as hazardous debris during this survey.

MDA-R sketch Map
- Barium concentrations

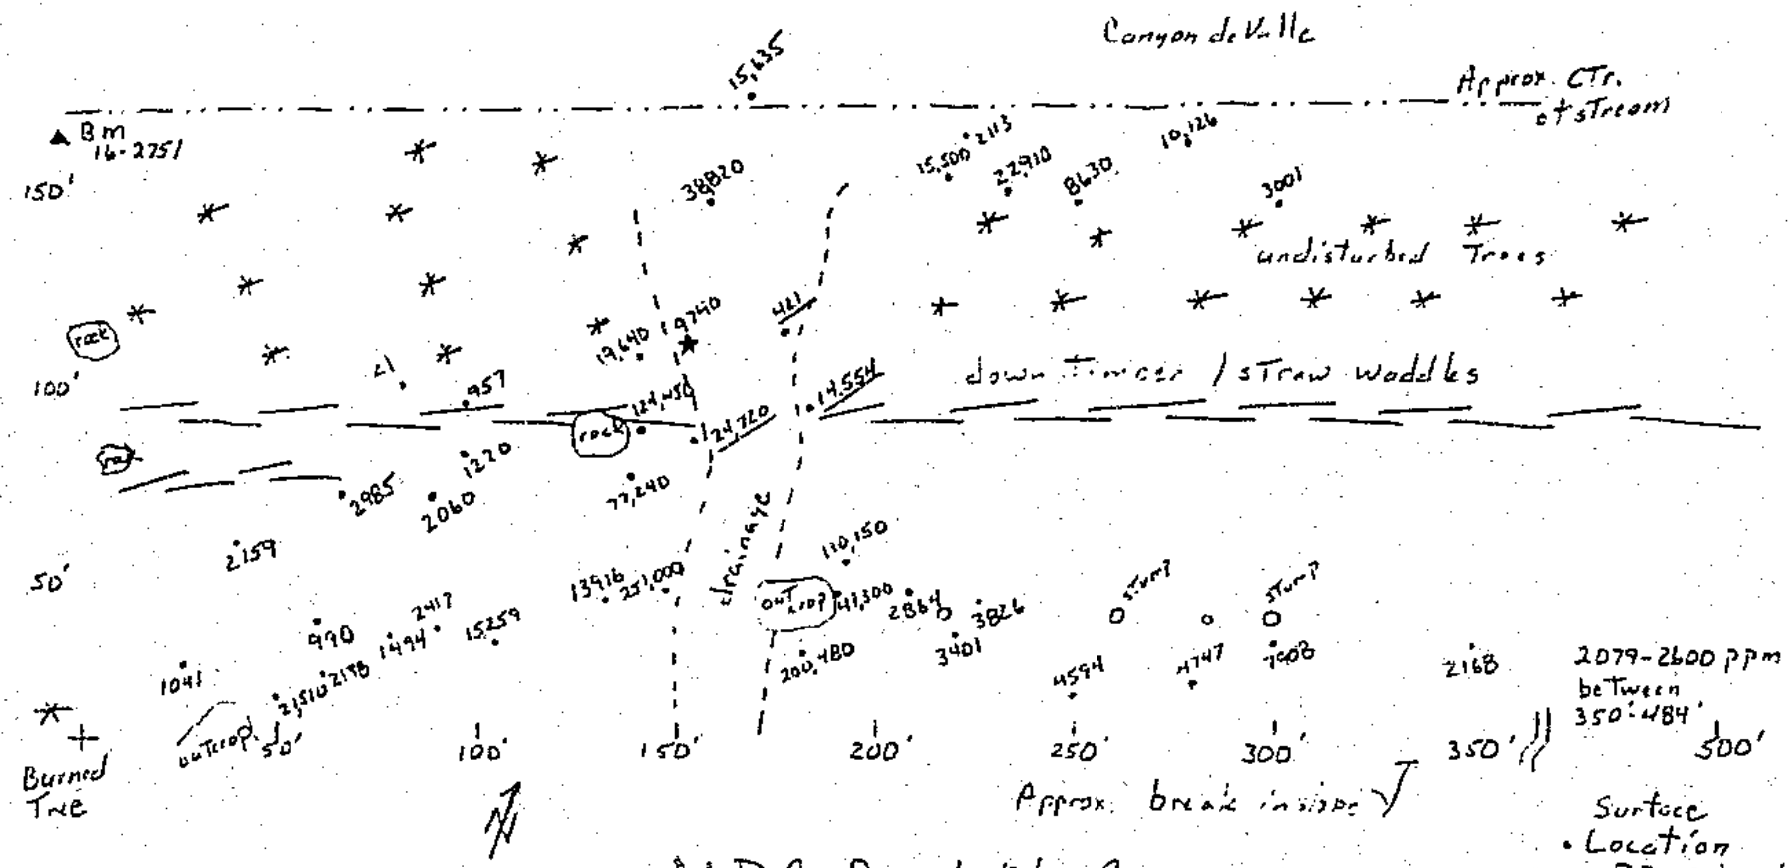
MDA-R sketch Map
- Barium concentrations

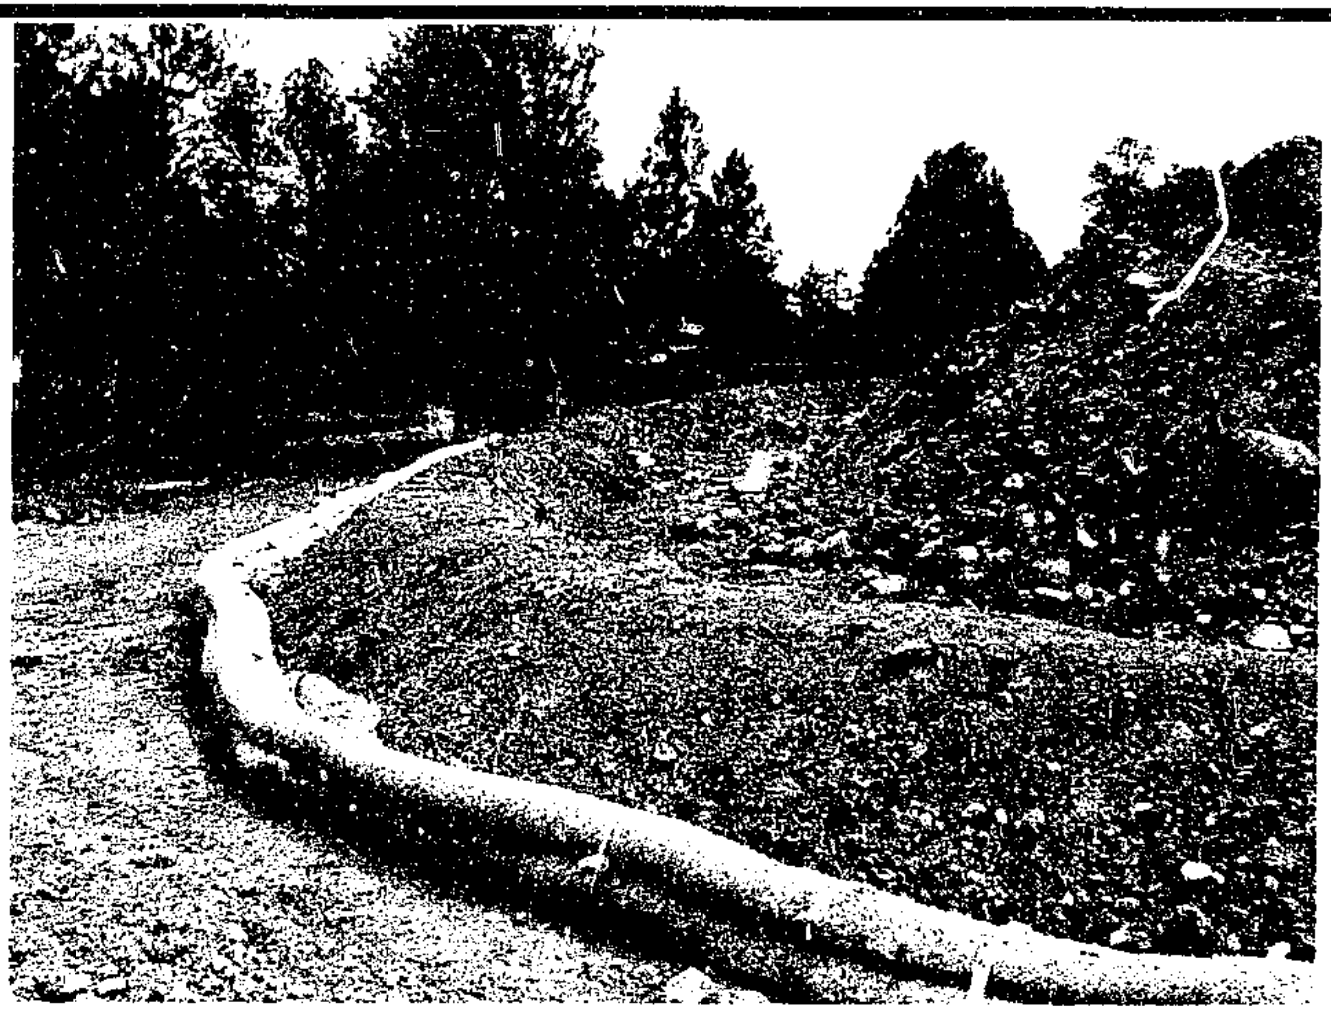
Extinguishing Burning Debris at MDA R

Erosion Control Wattles and berm at MDA R Waste Storage Area

The remaining clean soil from the bench excavation was returned to the upper slopes and contoured to control erosion. Dead and burned trees were cut and placed parallel to Cañon de Valle, along the mid-slope, below the landfill. Straw wattles were placed, then packed, along the trees to act as silt control, attenuating silt migration while allowing water to pass. Straw wattles were also placed at the top of the slope, near the mesa top, to attenuate silt migration.
