LA--12356

Decommissioning the UHTREX Reactor Facility at Los Alamos, New Mexico

Miguel Salazar
John Elder

Los Alamos
Los Alamos National Laboratory
Los Alamos, New Mexico 87545

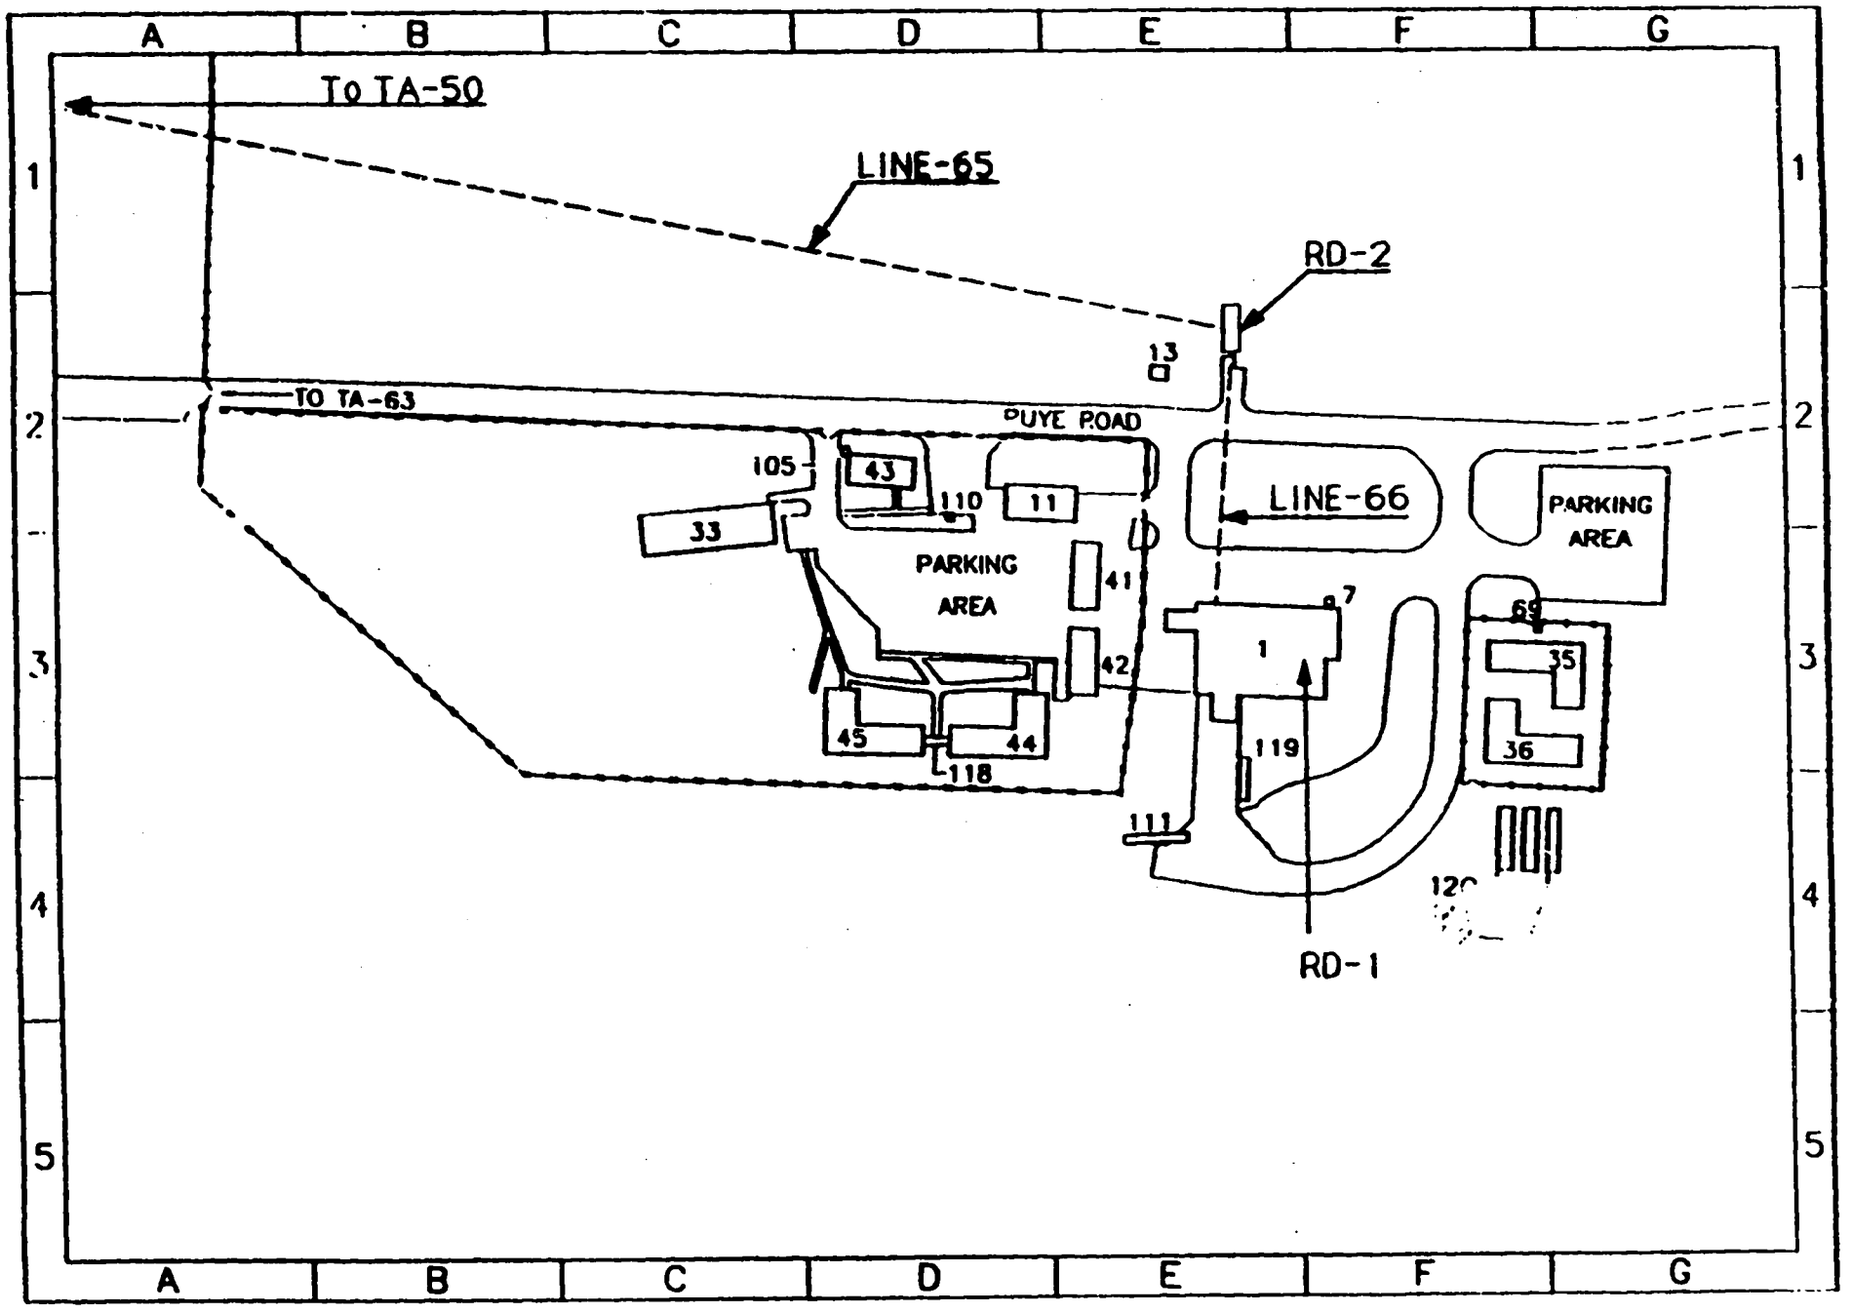
Fig. 6. Contaminated waste line, TA-50 to TA-52; lines 65 and 66.

Alpha Emitters in Soil. Alpha-emitter concentrations in soil above background and above the 25 pCi/g *de minimus* cleanup concentration were found at several locations along Line 65 between Building RD-2 and the Liquid Waste Treatment Site at TA-50. Background concentrations are 0.007 pCi/g average for ^{239}Pu, ^{240}Pu and 2.6 µg/g for total uranium.[15] Although alpha spectrometry of soil samples from these areas was not performed (these samples were disposed of early, as described in Section 9.0), regardless of which alpha emitter contributed the activity, the lowest site-specific residual activity guideline (267 pCi/g) for alpha emitters (^{238}Pu, ^{239}Pu, ^{235}U, and others) developed by RESRAD modeling was not exceeded. See also the RESRAD results in Appendix A. The maximum among the 12 samples above 25 pCi/g among 173 total samples was 126 pCi/g; the average was 67 pCi/g.

Line 66 from the neutralization/pump station (RD-2) to the UHTREX building (RD-1) was removed. Accessible sections within the building were also removed. Sections under the building floor slabs leading to the sump in Room 303 were left in place. No contamination was found at either end of this pipe (Appendix H). All ends were plugged with concrete.

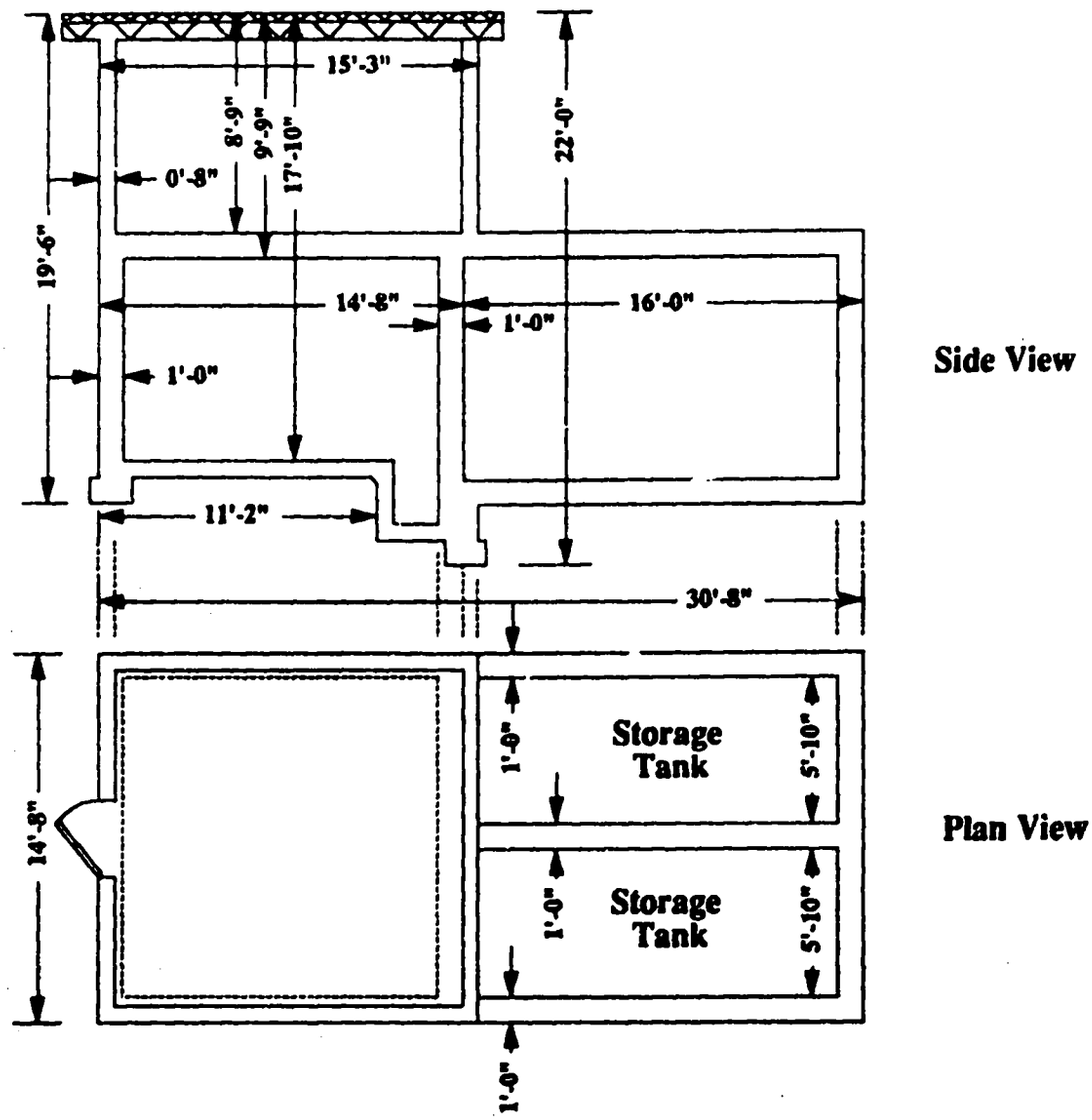
Fig. 7. Neutralization/pumping station (RD-2).

Note: RD-2 was completely removed by the project. The excavation was backfilled with clean soil and revegetated.

Neutralization/pump station (RD-2) - This structure was completely demolished with a backhoe and wrecking ball. It was excavated below the foundation to solid tuff and all materials were disposed of. The area was backfilled, graded, and revegetated with native grasses.

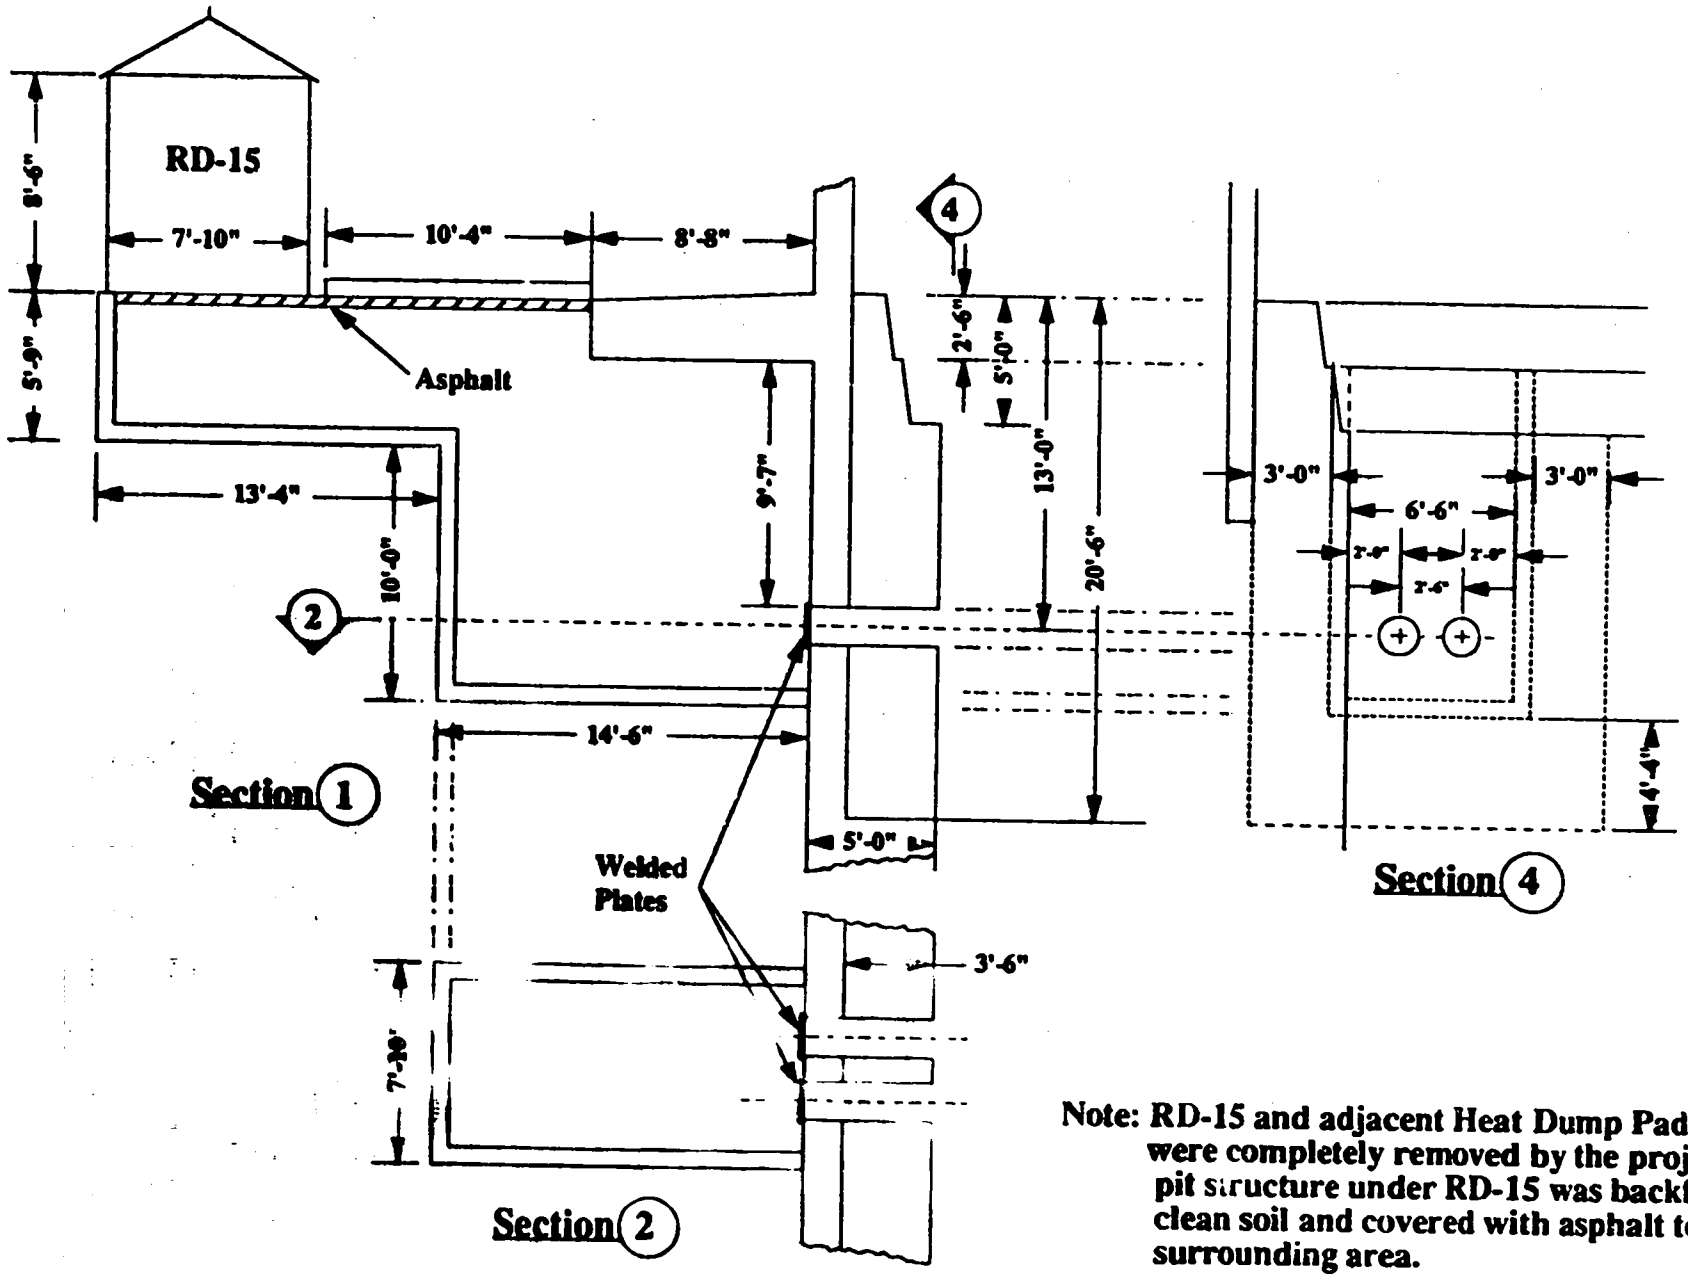
Fig. 8. Heat dump building/heat exchanger (RD-15 and -16) before removal and backfill.

Note: RD-15 and adjacent Heat Dump Pad (RD-16) were completely removed by the project. The pit structure under RD-15 was backfilled with clean soil and covered with asphalt to match surrounding area.

Heat dump building (RD-15) and heat dump pad and exchanger (RD-16) - Both structures and the concrete foundation pad for the heat exchanger were removed. The concrete tunnel from the heat dump building to the main building was left in place after surveys indicated no radioactive contamination (Fig. 8). The tunnel walls were removed 15 cm (6 in.) below grade before backfilling began. The disturbed areas were graded and paved with asphalt to match the existing area.

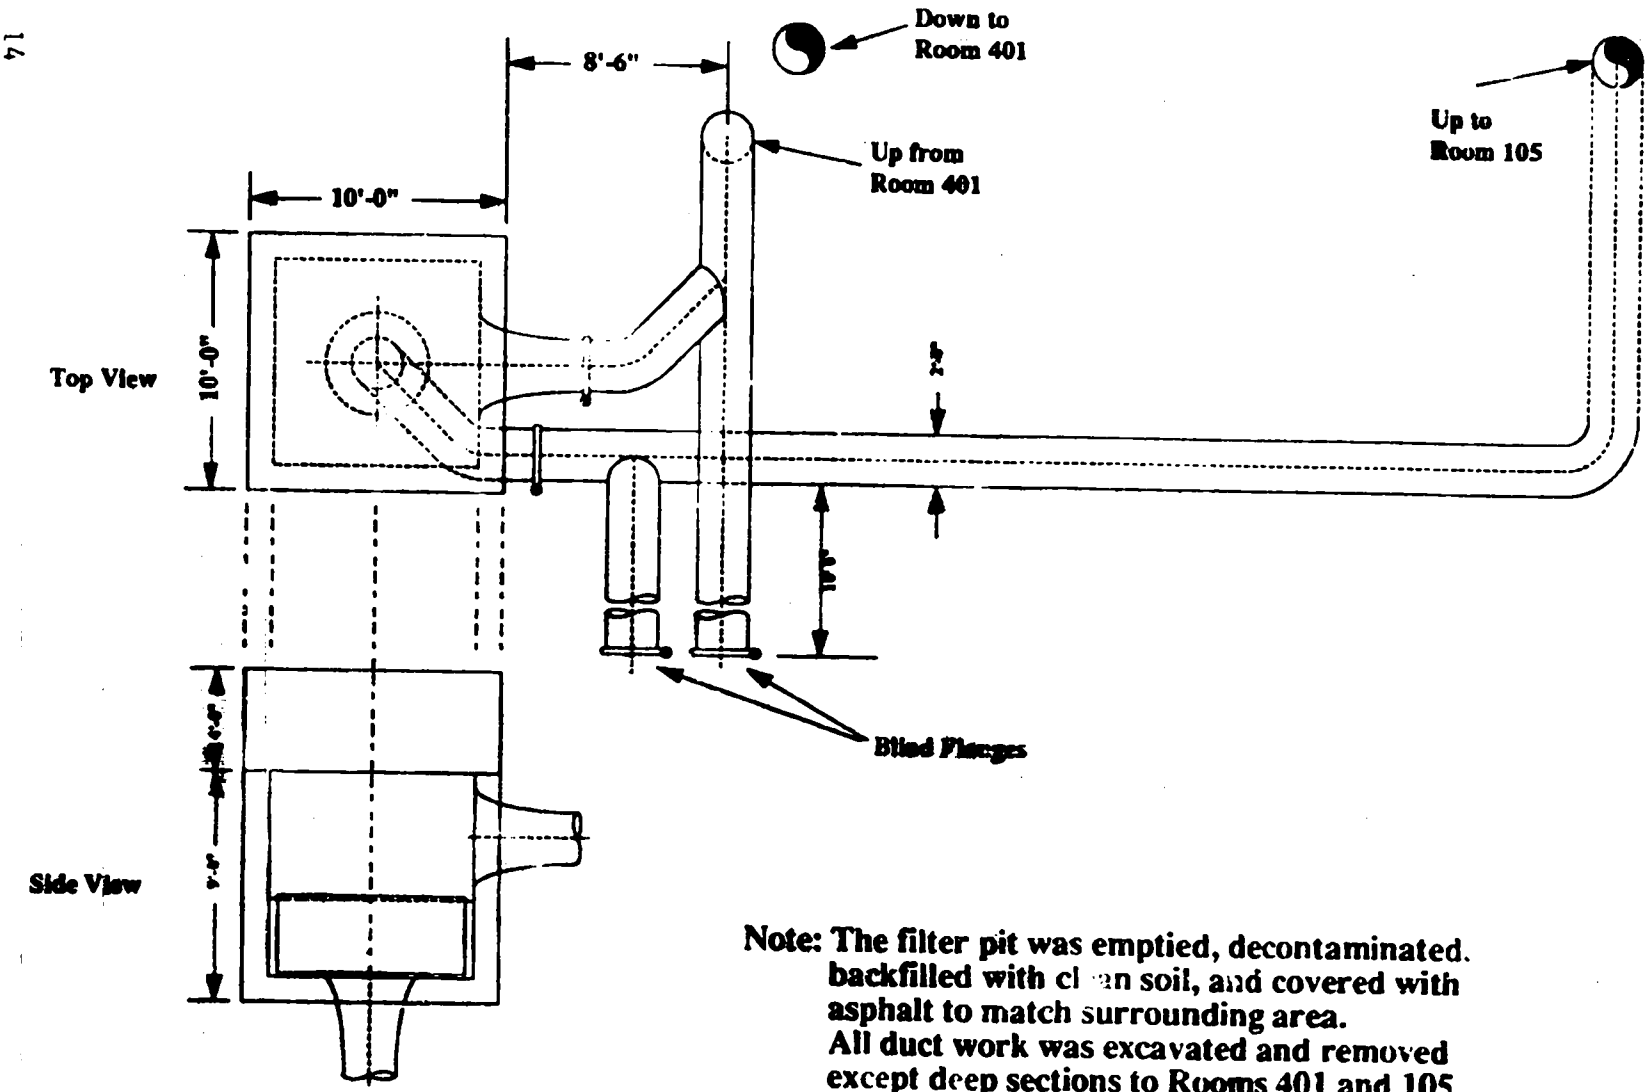
Fig. 9. UHTREX filter pit (KD-14).

Note: The filter pit was emptied, decontaminated, backfilled with clean soil, and covered with asphalt to match surrounding area.
All duct work was excavated and removed except deep sections to Rooms 401 and 105 (see Section 4.3 and Appendix B).

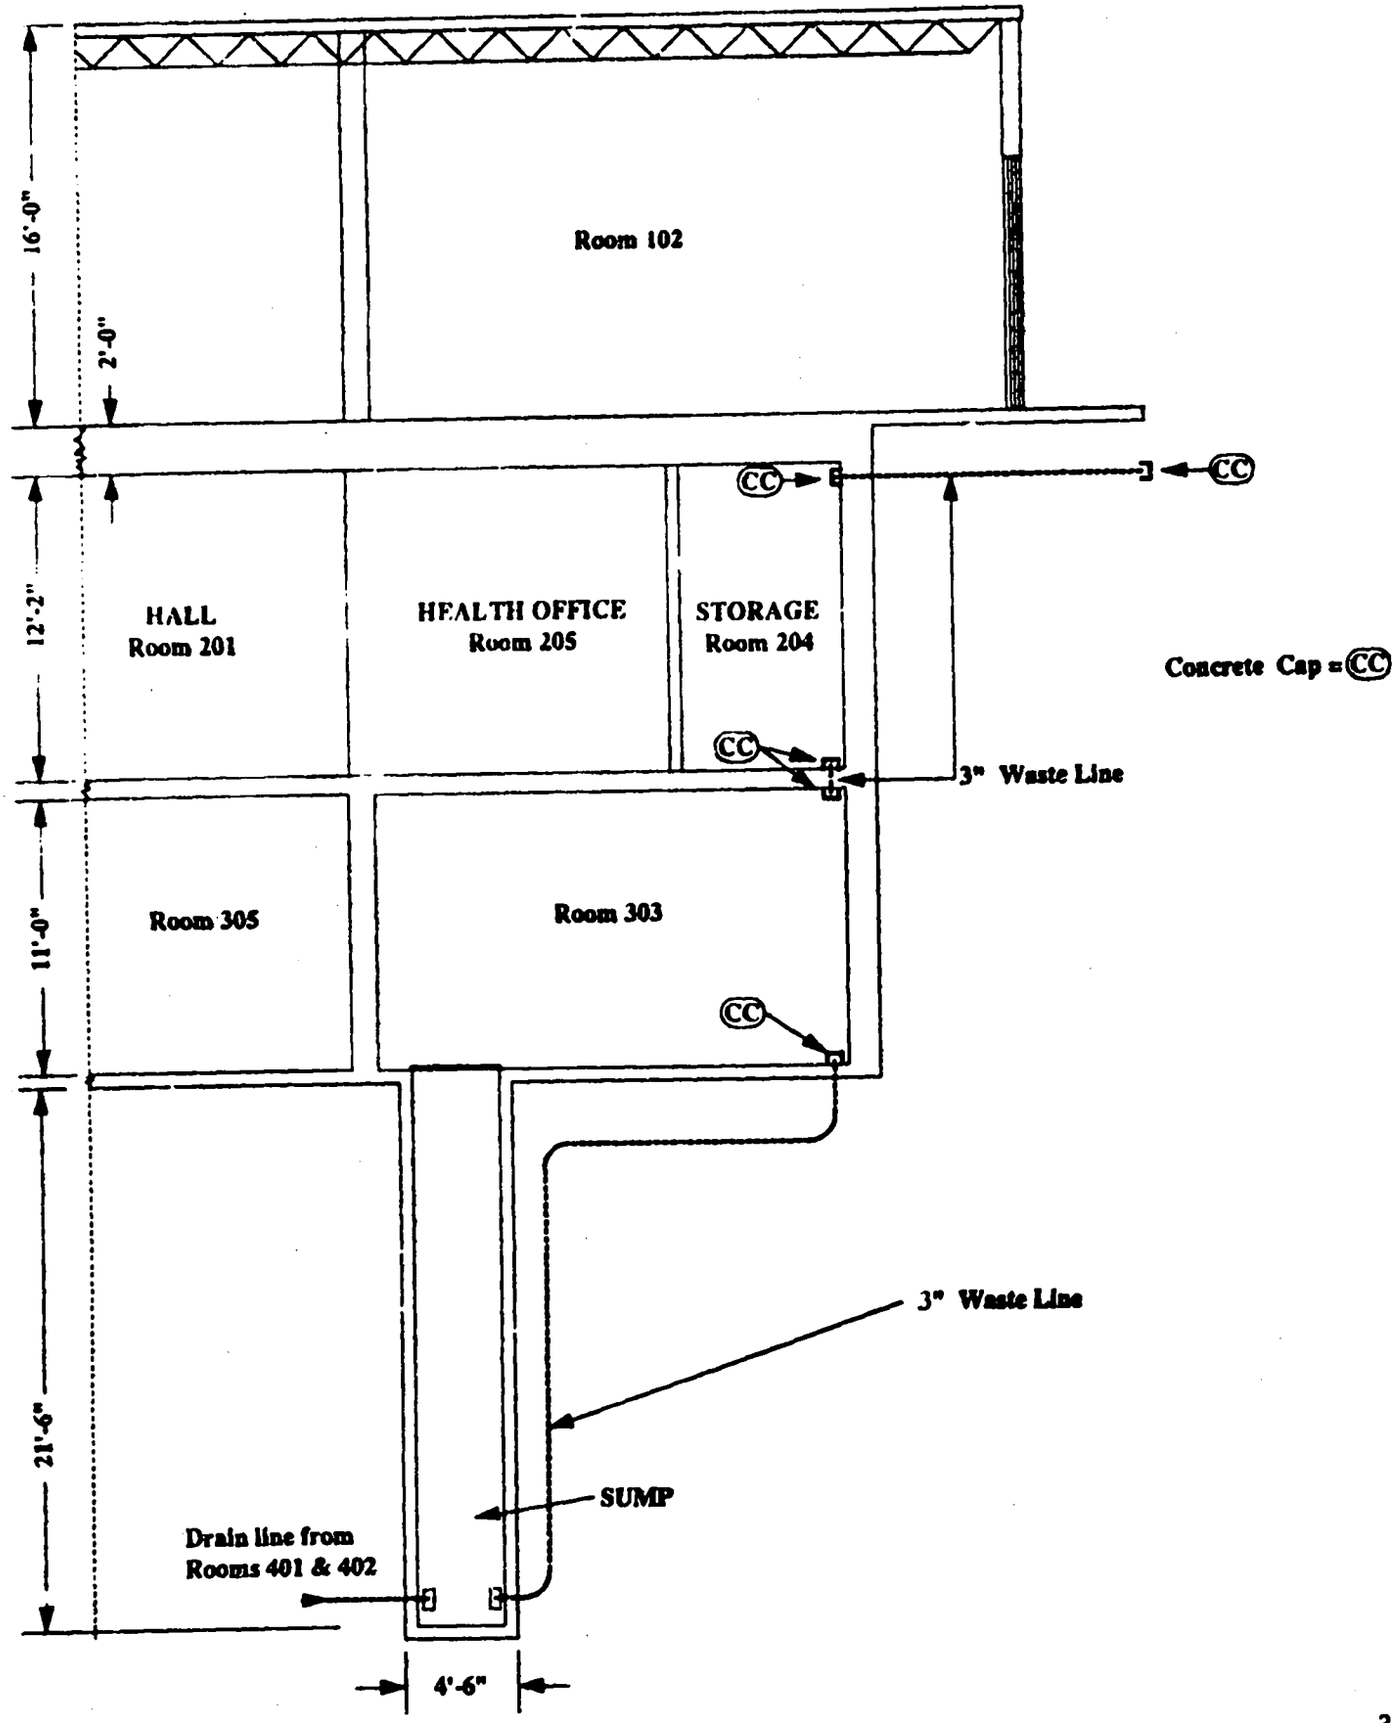
Fig. 13. Lines under UHTREX building and sump in Room 303.

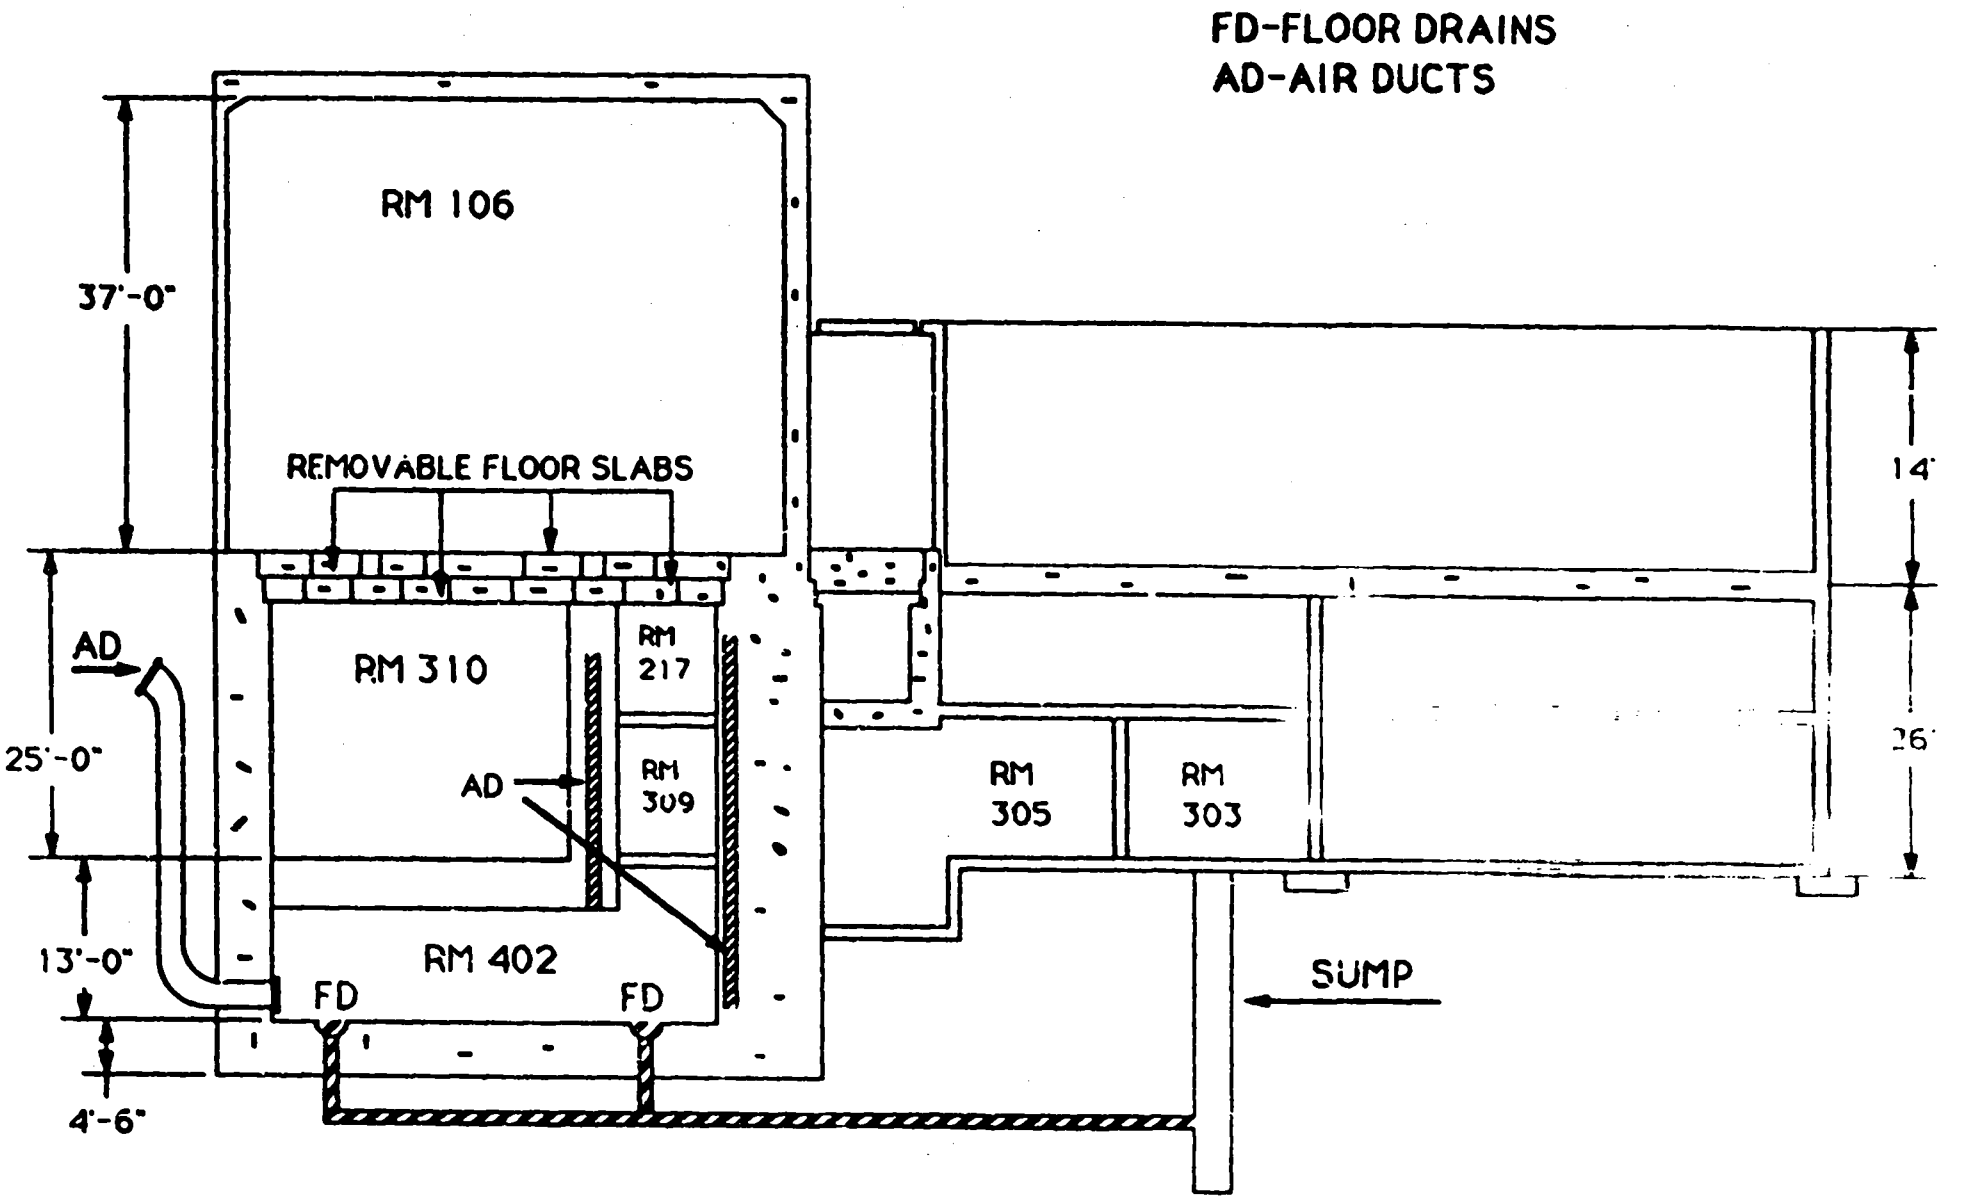
Figure 1. UHTREX cross-sectional view of floor drains and air ducts (hatched areas).

The Laboratory requested an Exception (Appendix B) for the reactor-recuperator room (Room 310); the ducts from Room 217 to Room 402; the duct from Room 401 to the filter pit; and the floor drains in Rooms 401, 402, and 403. The fixed-surface activity exceeded the residual radioactivity guidelines noted in Section 3.3. DOE approved this request (Appendix C). Two other as-left conditions are described in memorandums: a section of uncontaminated piping (part of Line 66) and two uncontaminated ducts left under the UHTREX building (Appendix H).

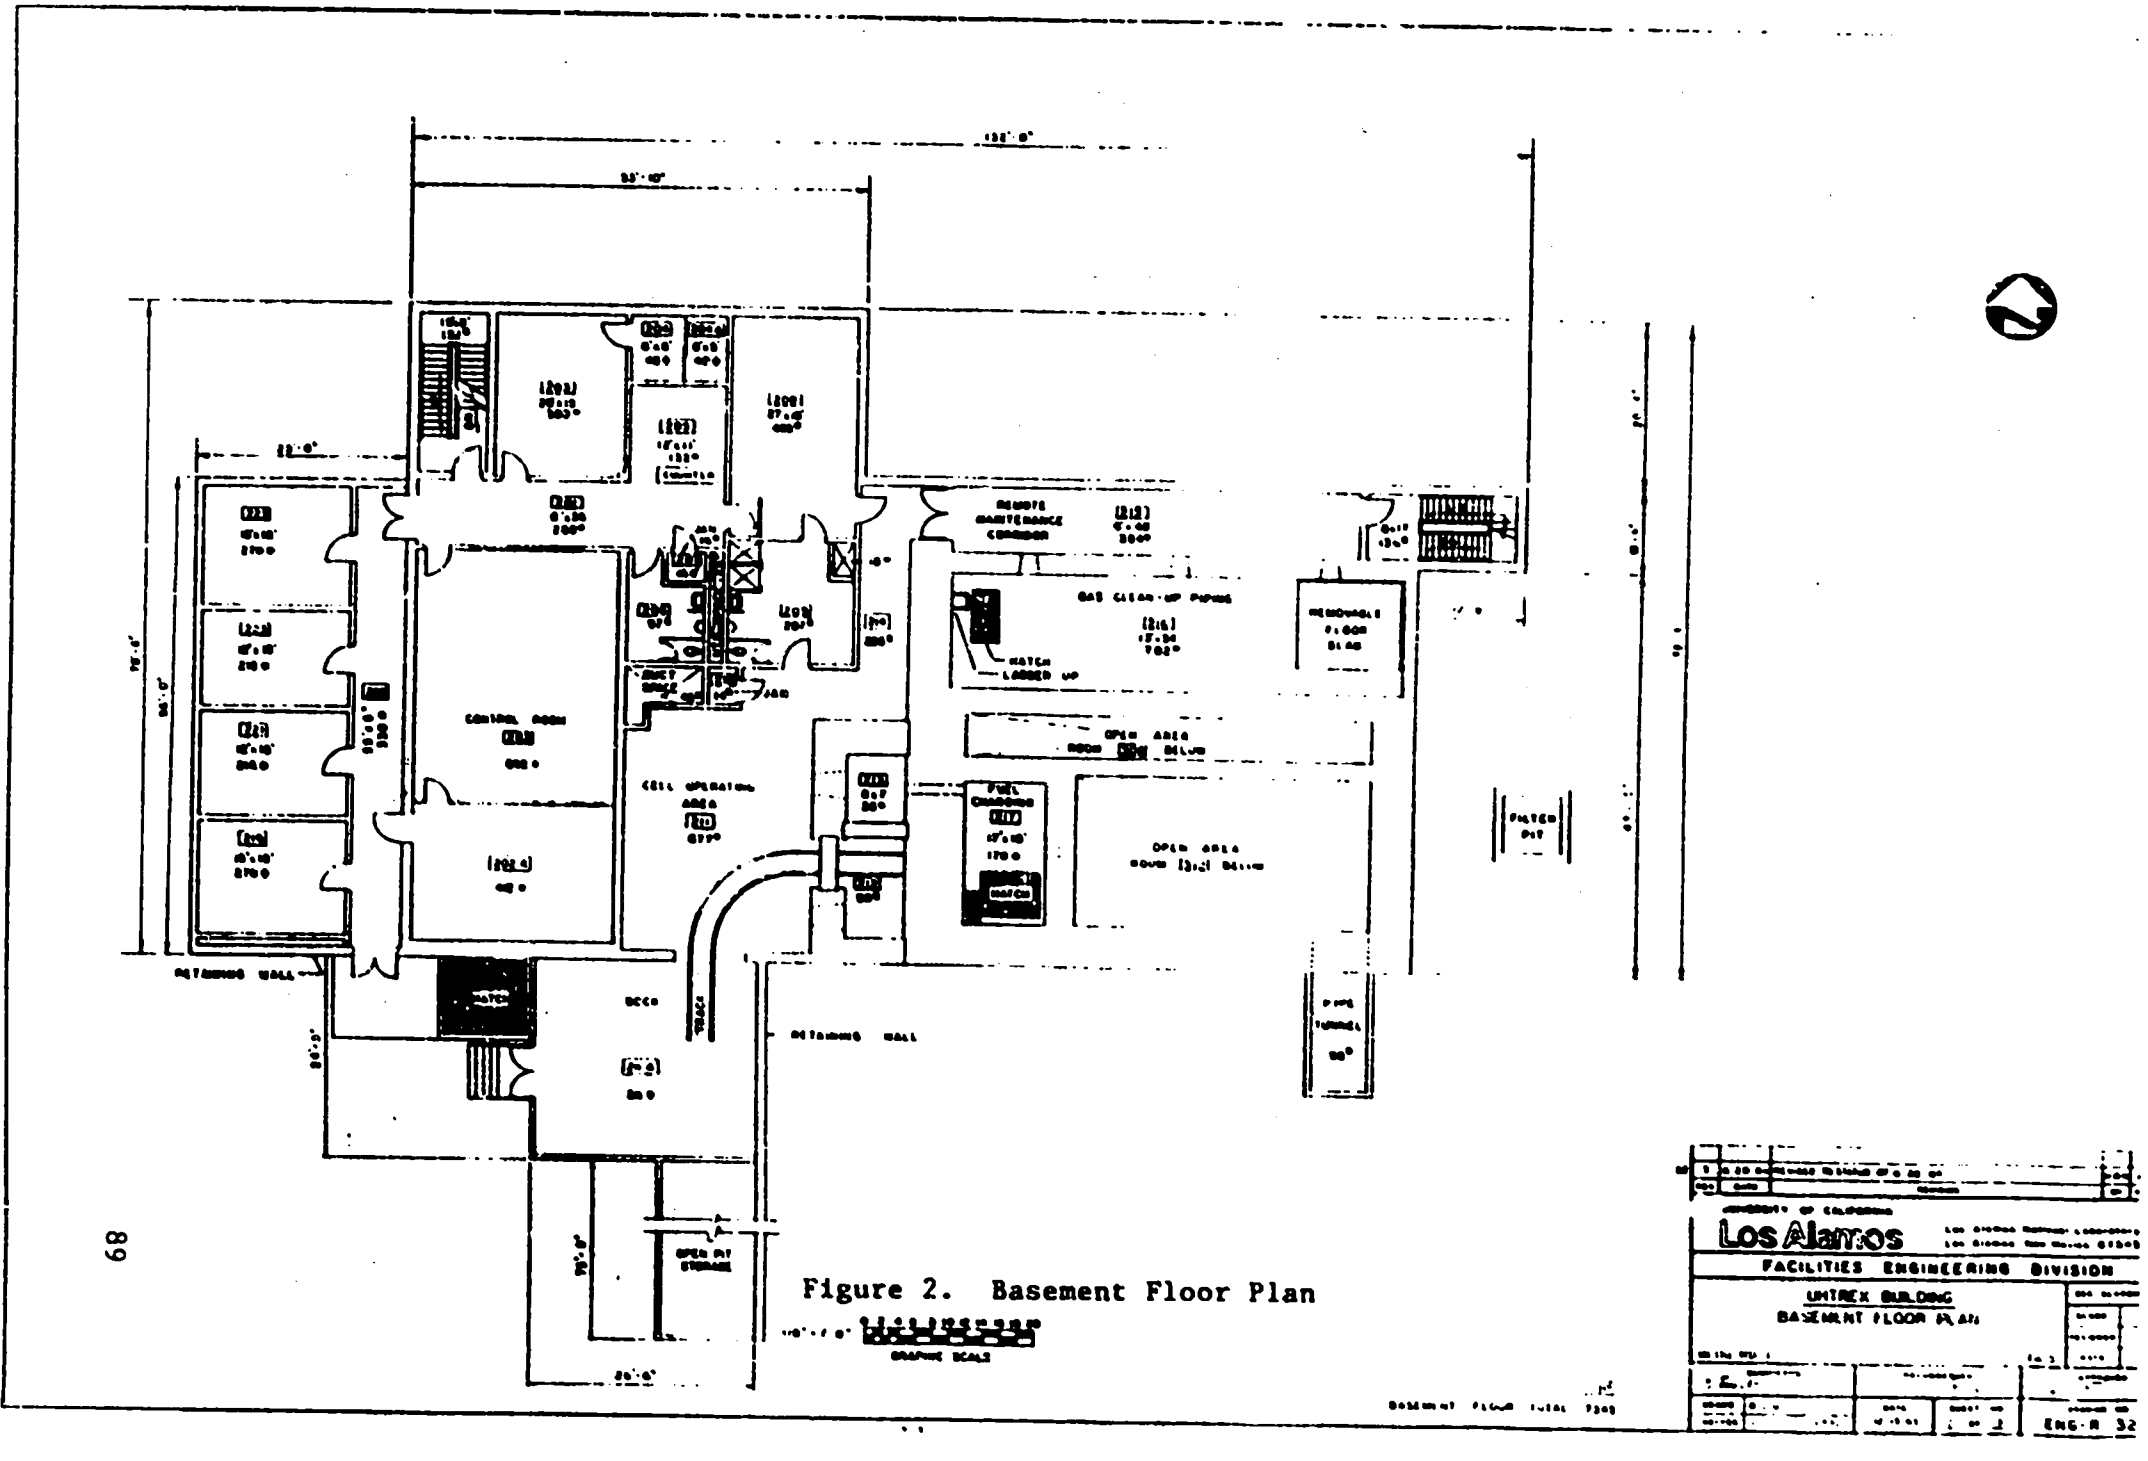
Figure 2. Basement Floor Plan

Table 2 summarizes the fixed contamination on the ducts and drain. Figures 1 through 4 show the locations listed in the table.

ITEM	CONNECTING	LOCATION	CLOSURE	MAX FIXED RADIOACTIVITY (DPM/100 CM^2)
1. Air Duct (25 cm Dia., 9 m; 10 in Dia., 30 ft)	Rm 402 to Rm 217	402/SW Corner	Welded Steel Plate	533
2. Air Duct (25 cm dia, 6 m; 10 in Dia., 20 ft)	Rm 402 to Rm 217	402/NW Corner	Welded Steel Plate	4,400
3. Air Duct (0.6 m Dia., 9 m; 24 in Dia., 30 ft)	Rm 401 to RD-14 (filter pit)	401/E Wall	Welded Steel Plate	9,700
4. Floor Drain	Rm 402 to Rm 303 (sump tank)	402/West	Concrete Plug	5,719
5. Floor Drain	Rm 402 to Rm 303 (sump tank)	402/East	Concrete Plug	36,908
6. Floor Drain	Rm 401 to Rm 303 (sump tank)	401/West	Concrete Plug	3,086
7. Floor Drain	Rm 403 to Rm 303 (sump tank)	403/Center	Concrete Plug	3,232

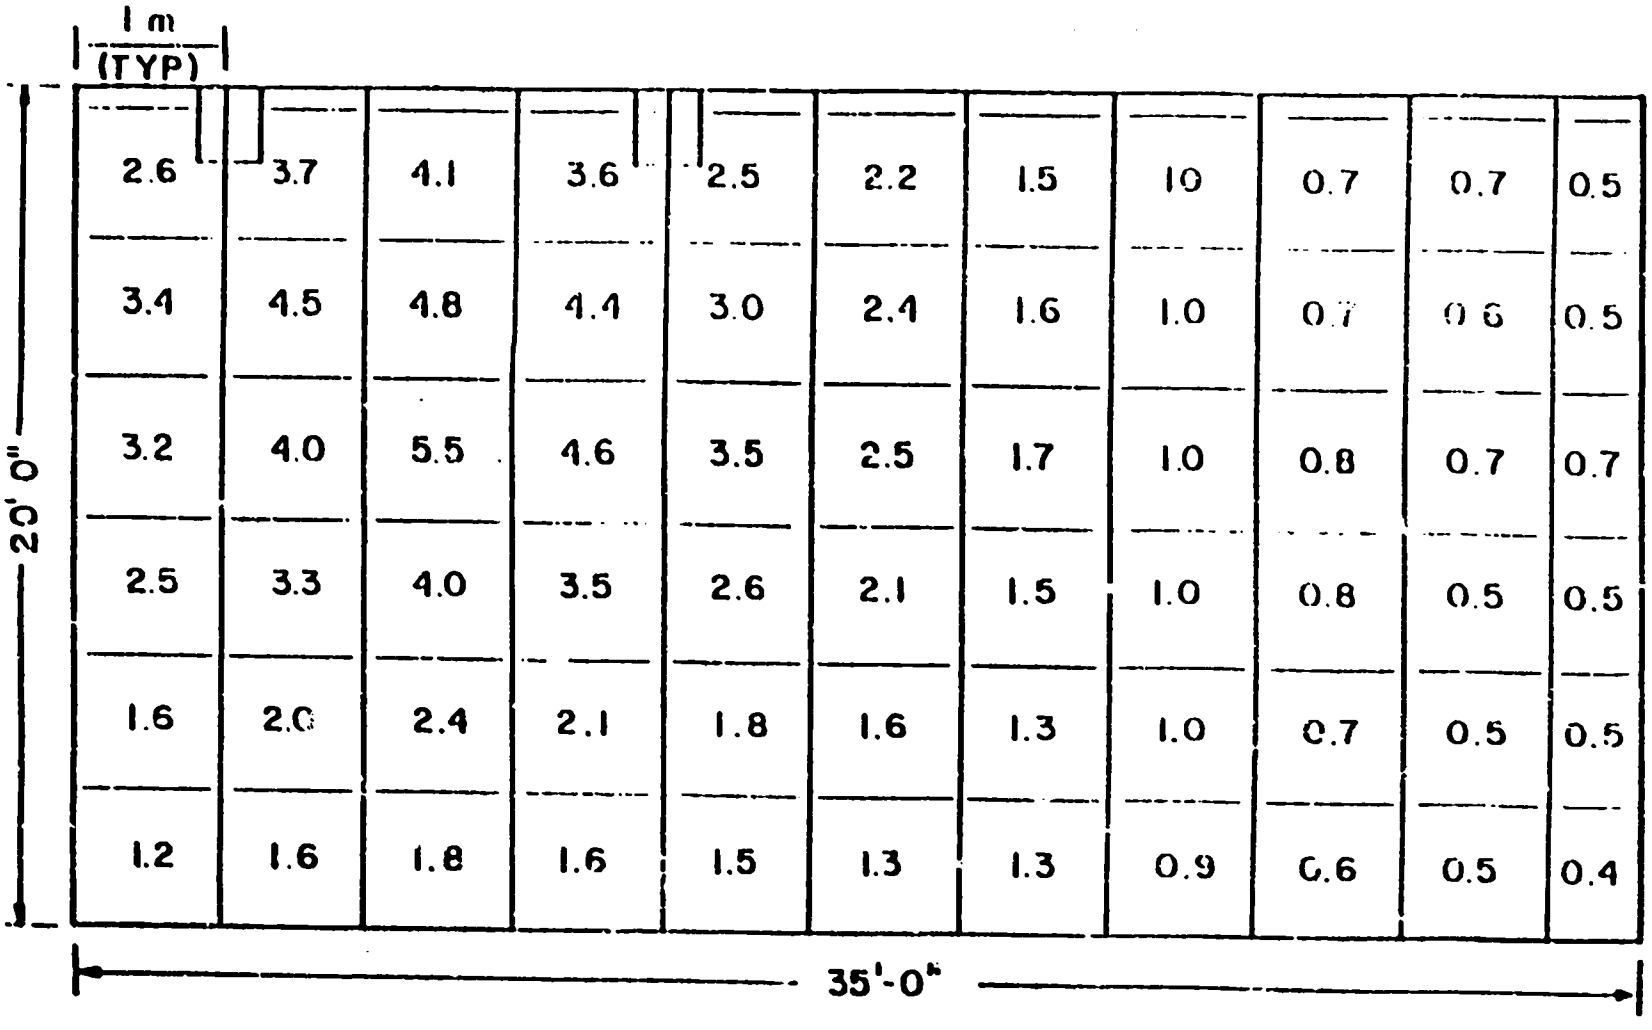
Figure 5. Contact dose rate at north wall in Room 310. Units of exposure rate (mR/h) and absorbed dose rate (mrad/h) from photon radiation can be considered equivalent.

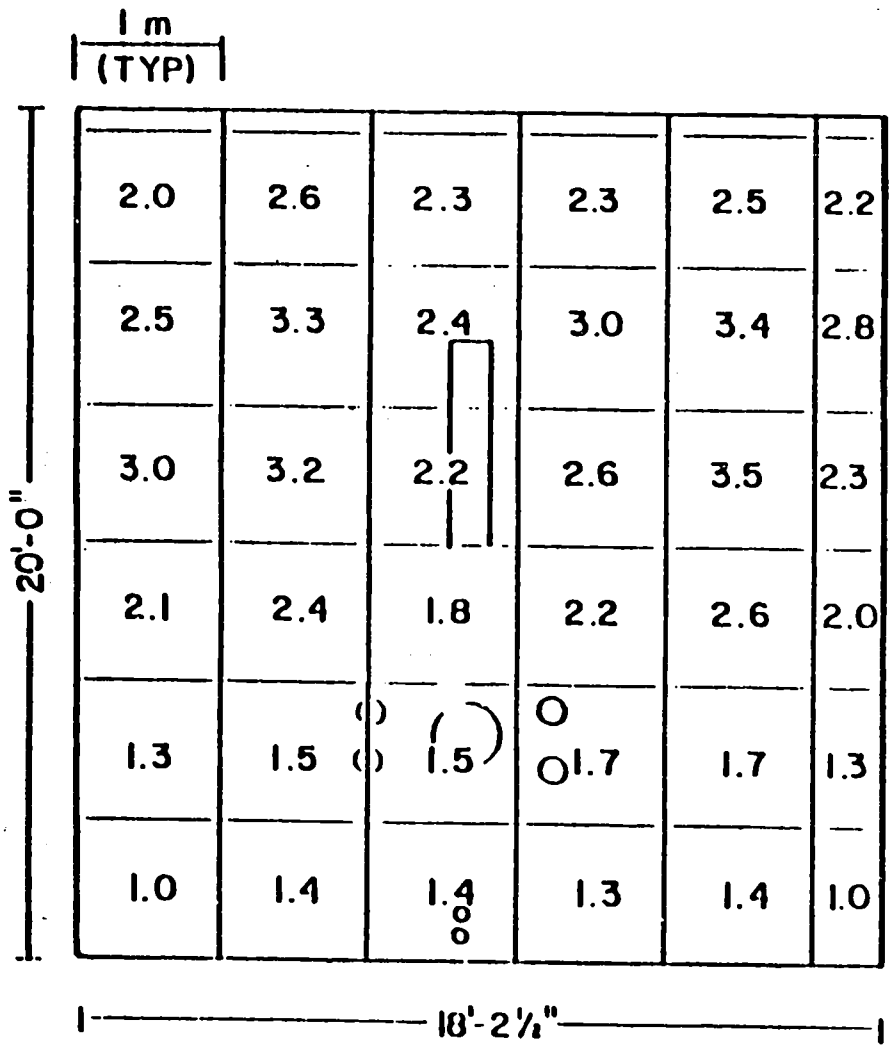
Figure 6. Contact dose rate at west wall in Room 310. Units of exposure rate (mR/h) and absorbed dose rate (mrad/h) from photon radiation can be considered equivalent.
