SUBJECT/TITLE: Building 257 (OP West) Health Physics Survey

SUBJECT: BUILDING 257 (DP WEST) HEALTH PHYSICS SURVEY

BUILDING 257, D.P. WEST

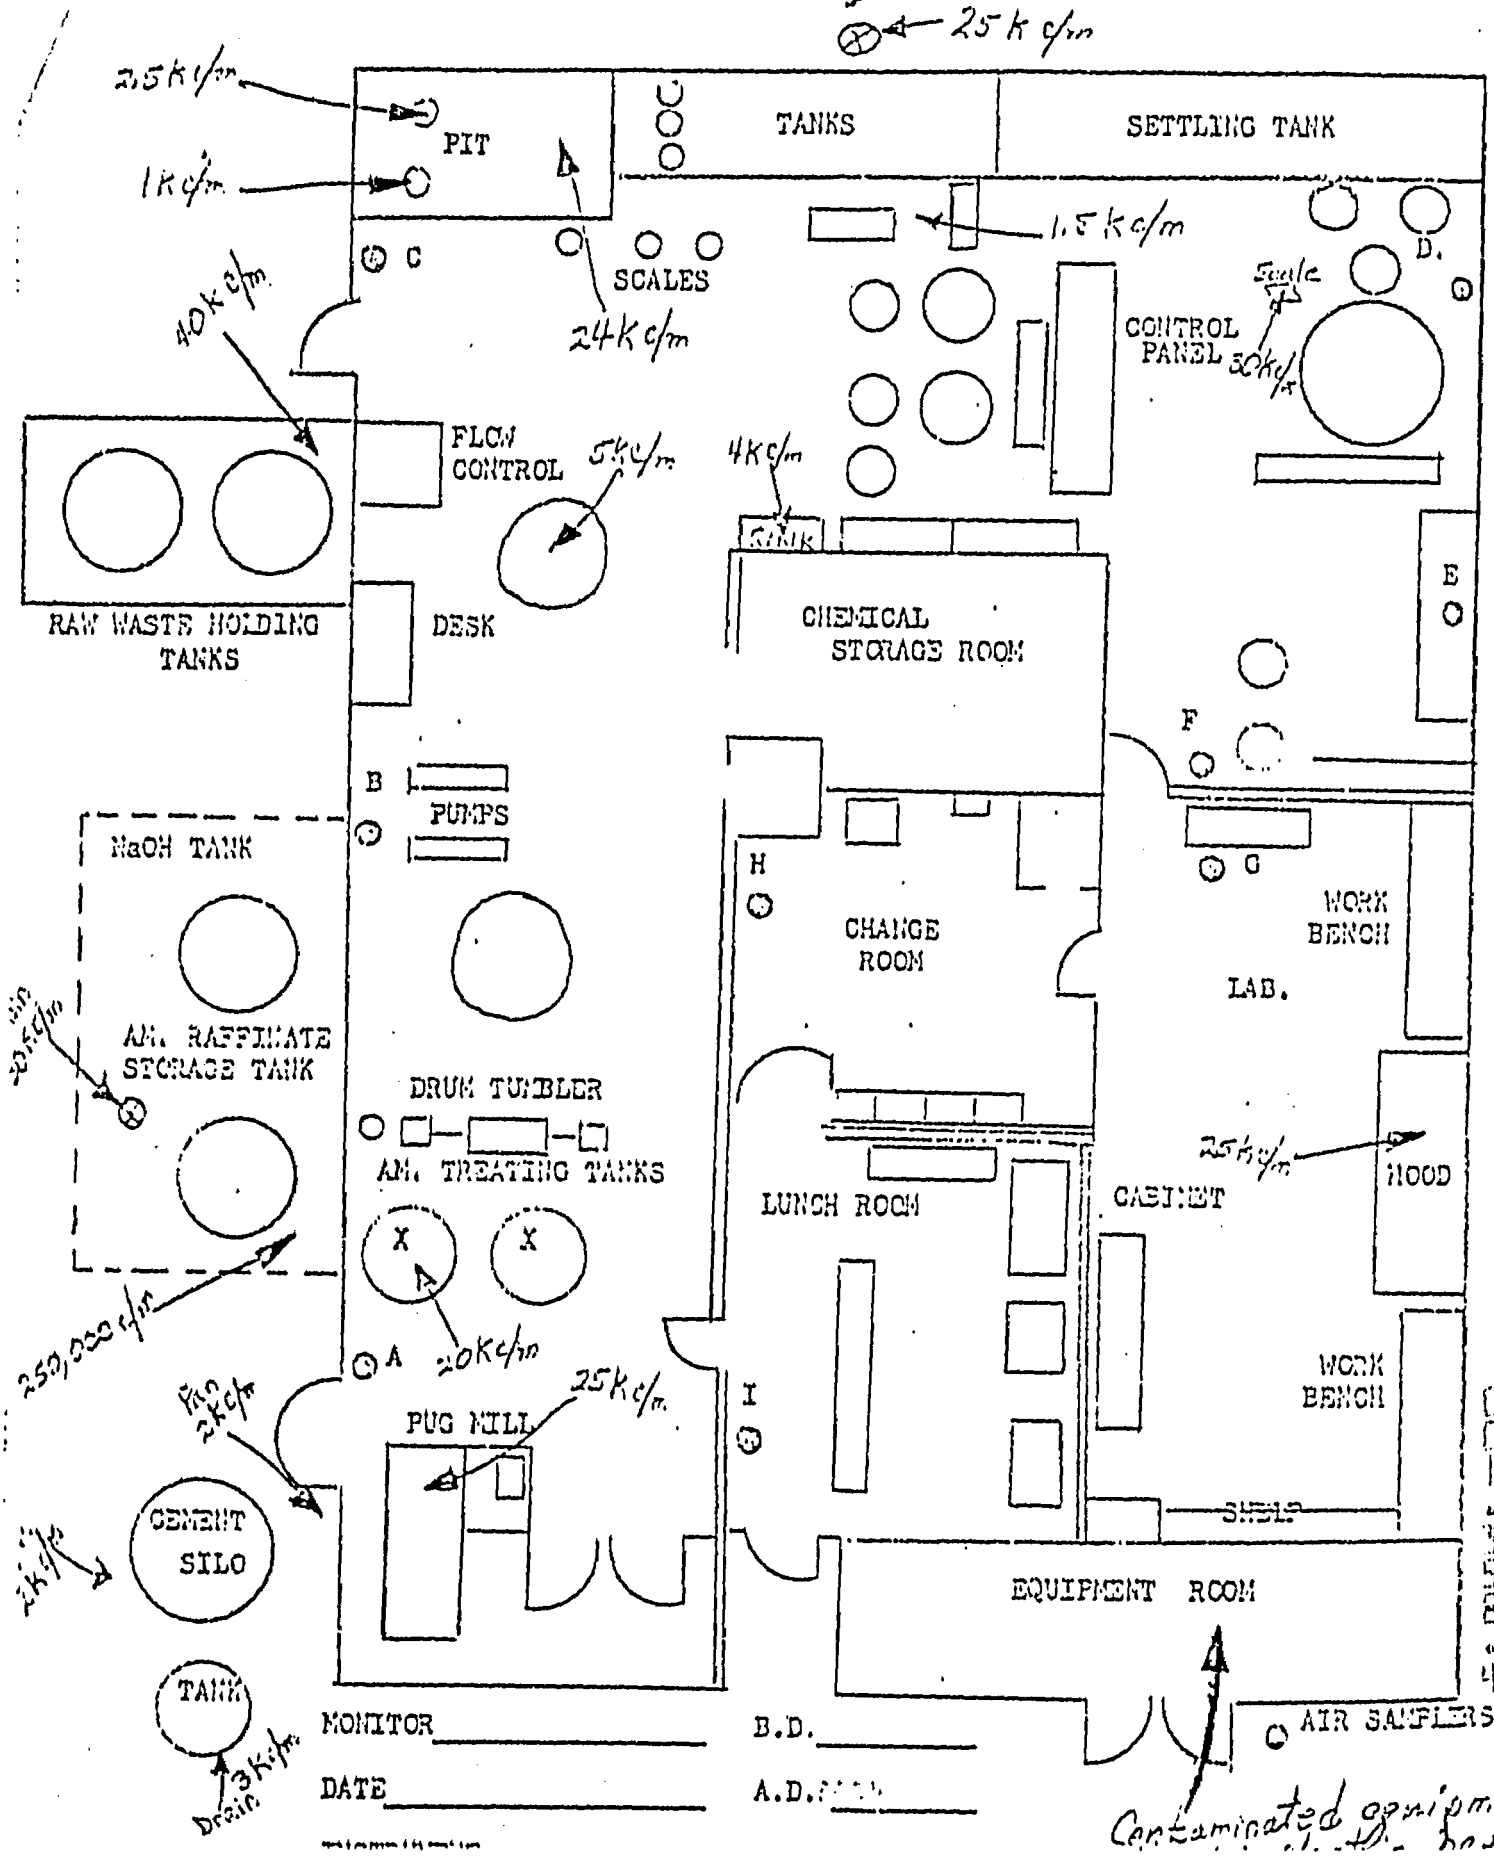
A map of the building and outside area is included to show some of the areas where readings were taken. It was impossible to cover the entire area.
