LA-5755 C.3

UC-70
Reporting Date: September 1974
Issued: January 1975

Demolition of Building 12, An Old Plutonium Filter Facility

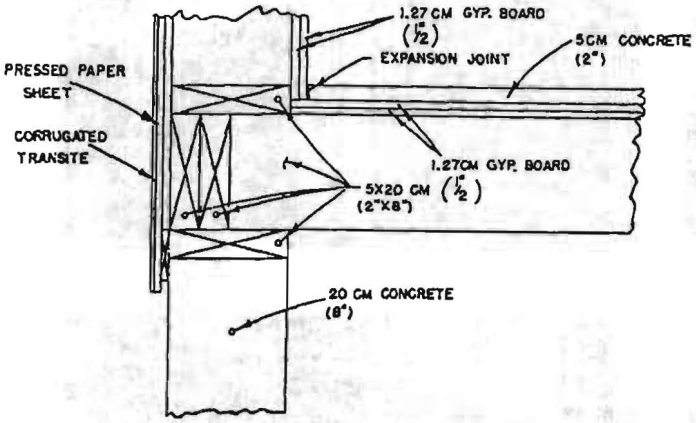
Fig. 14. Details of floor and wall construction.

Figure 14 shows construction of the walls and floor. The walls were made of two layers of gypsum board nailed to the inside of the 5-cm by 20-cm studs. Here, too, the gypsum board could be pulled off without contaminating the studs. All exposed surfaces were immediately covered with a coat of paint to seal porous surfaces.

The wall and floor junction consisted of overlapping layers of gypsum board, expansion joint material, and gunnite. This construction had prevented the sill from becoming contaminated; and by removing the expansion joint material along with a strip of the gunnite, the sill was exposed free of contamination. The remaining gunnite was coated with paint until all of the contamination was covered. It remained on the floor for removal with the foundation.

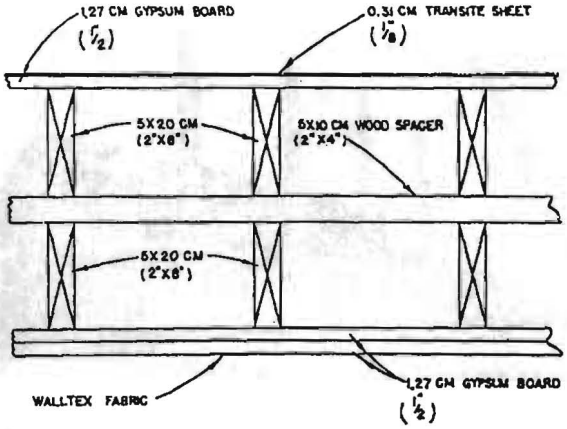
Fig. 13. Details of roof construction.

The construction details indicated that the contamination of walls and ceiling might be restricted to the first layer of material. As shown in Fig. 13, the roof was made of two layers of wood beams, 5 cm by 20 cm (2 in. by 8 in.), supported by metal I beams. The beams were covered with two layers of gypsum board and a 0.3-cm layer of transite. The final layer was a hot tar and roofing paper application. The ceiling was two layers of gypsum board covered by a fabric called "Walltex." A 1.6-mm-thick metal nailing strip was used to prevent the nails from pulling through the gypsum board when the plenum was operating at its lower air pressure. After the metal strips were pulled from the ceiling, the surface fabric layer, covered with several coats of paint, was easily pulled off leaving a nearly contamination-free surface.

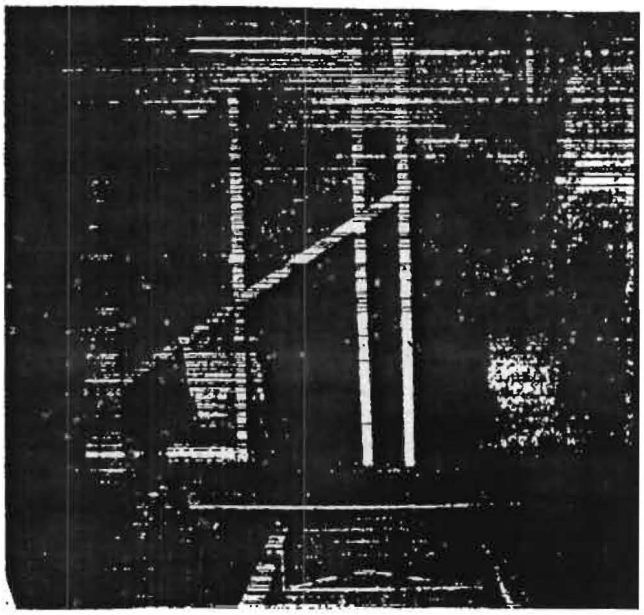
Fig. 17. Interior of penthouse area after stripping and painting.

In the penthouse area the interior wall covering was removed without spreading contamination to the wall studs. The floor, however, was built of 5-cm by 10-cm tongue and groove boards, and the cracks between the boards were filled with contaminated dirt, which could not be fixed, even with several coats of paint. Therefore, all the floor boards were pried loose and painted individually to fix the contamination. These interior floor boards and the gypsum wallboard were packed in plywood boxes, then banded and sealed and hauled to the burial site. The interior, after removal of floor and interior surface of the walls of the penthouse, is shown in Fig. 17.

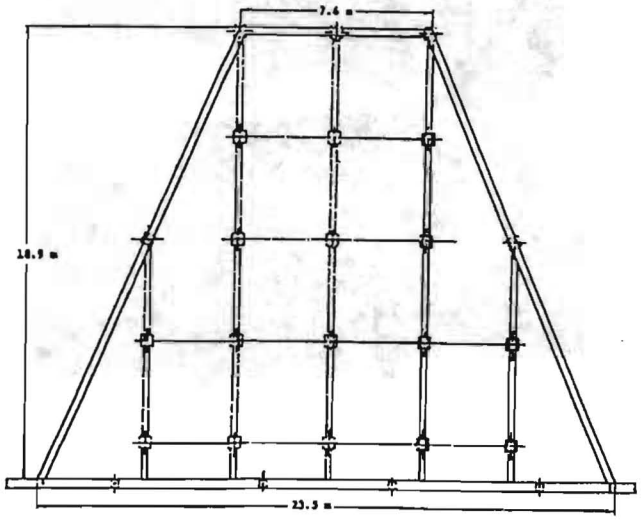
Fig. 22. Foundation for intake plenum.

The next stage was to tear out the intake plenum floor with a payloader. The foundation was extensive, as shown in Fig. 22. The concrete at the point where the external foundation intersects with the internal foundations was often 46 cm thick. The foundation was 1.52 m deep, and because some of the soil inside was contaminated, the decision was made to have the equipment dig deep enough to go beneath the foundation and to load foundation, soil, and floor at the same time. Figure 23 shows the equipment in the process of removing the plenum floor area. When that was completed the building was reduced to the steel, brick and concrete shown in Fig. 24.

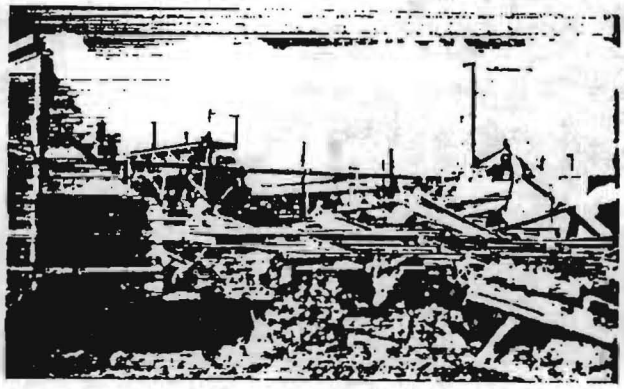
Fig. 25. Appearance of structural steel after attempt to pull down individual pieces.

An attempt was made to pull some of the steel down with a cable and in the process to break some bolts and rivets so that the individual beams could be loaded onto the truck. Unfortunately, the construction was such that when the bulldozer pulled on a piece of steel at the end of the building, the whole steel assembly toppled over and became the tangled mess shown in Fig. 25. The steel then had to be cut apart with cutting torches and loaded onto an open dump truck with a crane. Figures 26, 27, and 28 show various stages of this operation.

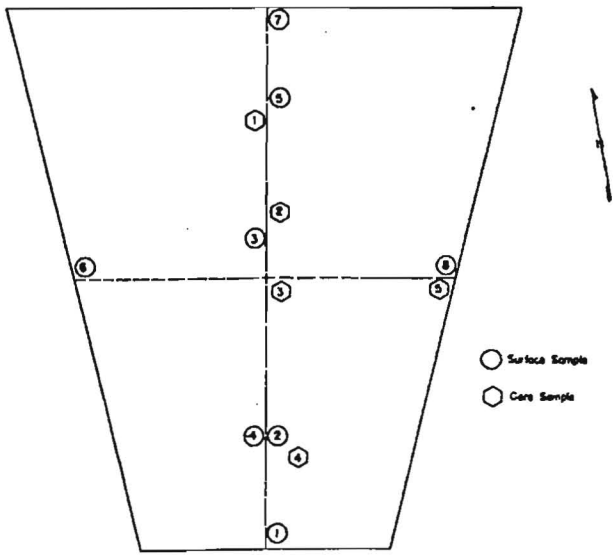
Fig. 37. Locations of soil samples taken underneath intake plenum.

As was mentioned in Sec. IV., water from clean-up operations escaped the building through expansion joints in the concrete floor. For this reason, the concrete was broken and surface and core samples of dirt were collected at suspect locations to determine the magnitude and depth of contamination. The surface samples were collected with a spoon from the top centimeter of soil, and the core samples were collected by driving a 2.54-cm-diam polyvinyl chloride (PVC) pipe into the soil with a hammer. The sample locations and the gross alpha concentrations at those locations are shown in Fig. 37 and Table IV, respectively. The data confirmed expectations that some soil underneath the building would be contaminated.
