Subject: Submittal of the Progress Report for Cleanup Activities at Material Disposal Area B, Solid Waste Management Unit 21-015, at Technical Area 21, Fourth Quarter of Fiscal Year 2010

LA-UR-10-6326
September 2010
EP2010-0402

Progress Report for Cleanup Activities at Material Disposal Area B, Solid Waste Management Unit 21-015, at Technical Area 21, Fourth Quarter of Fiscal Year 2010

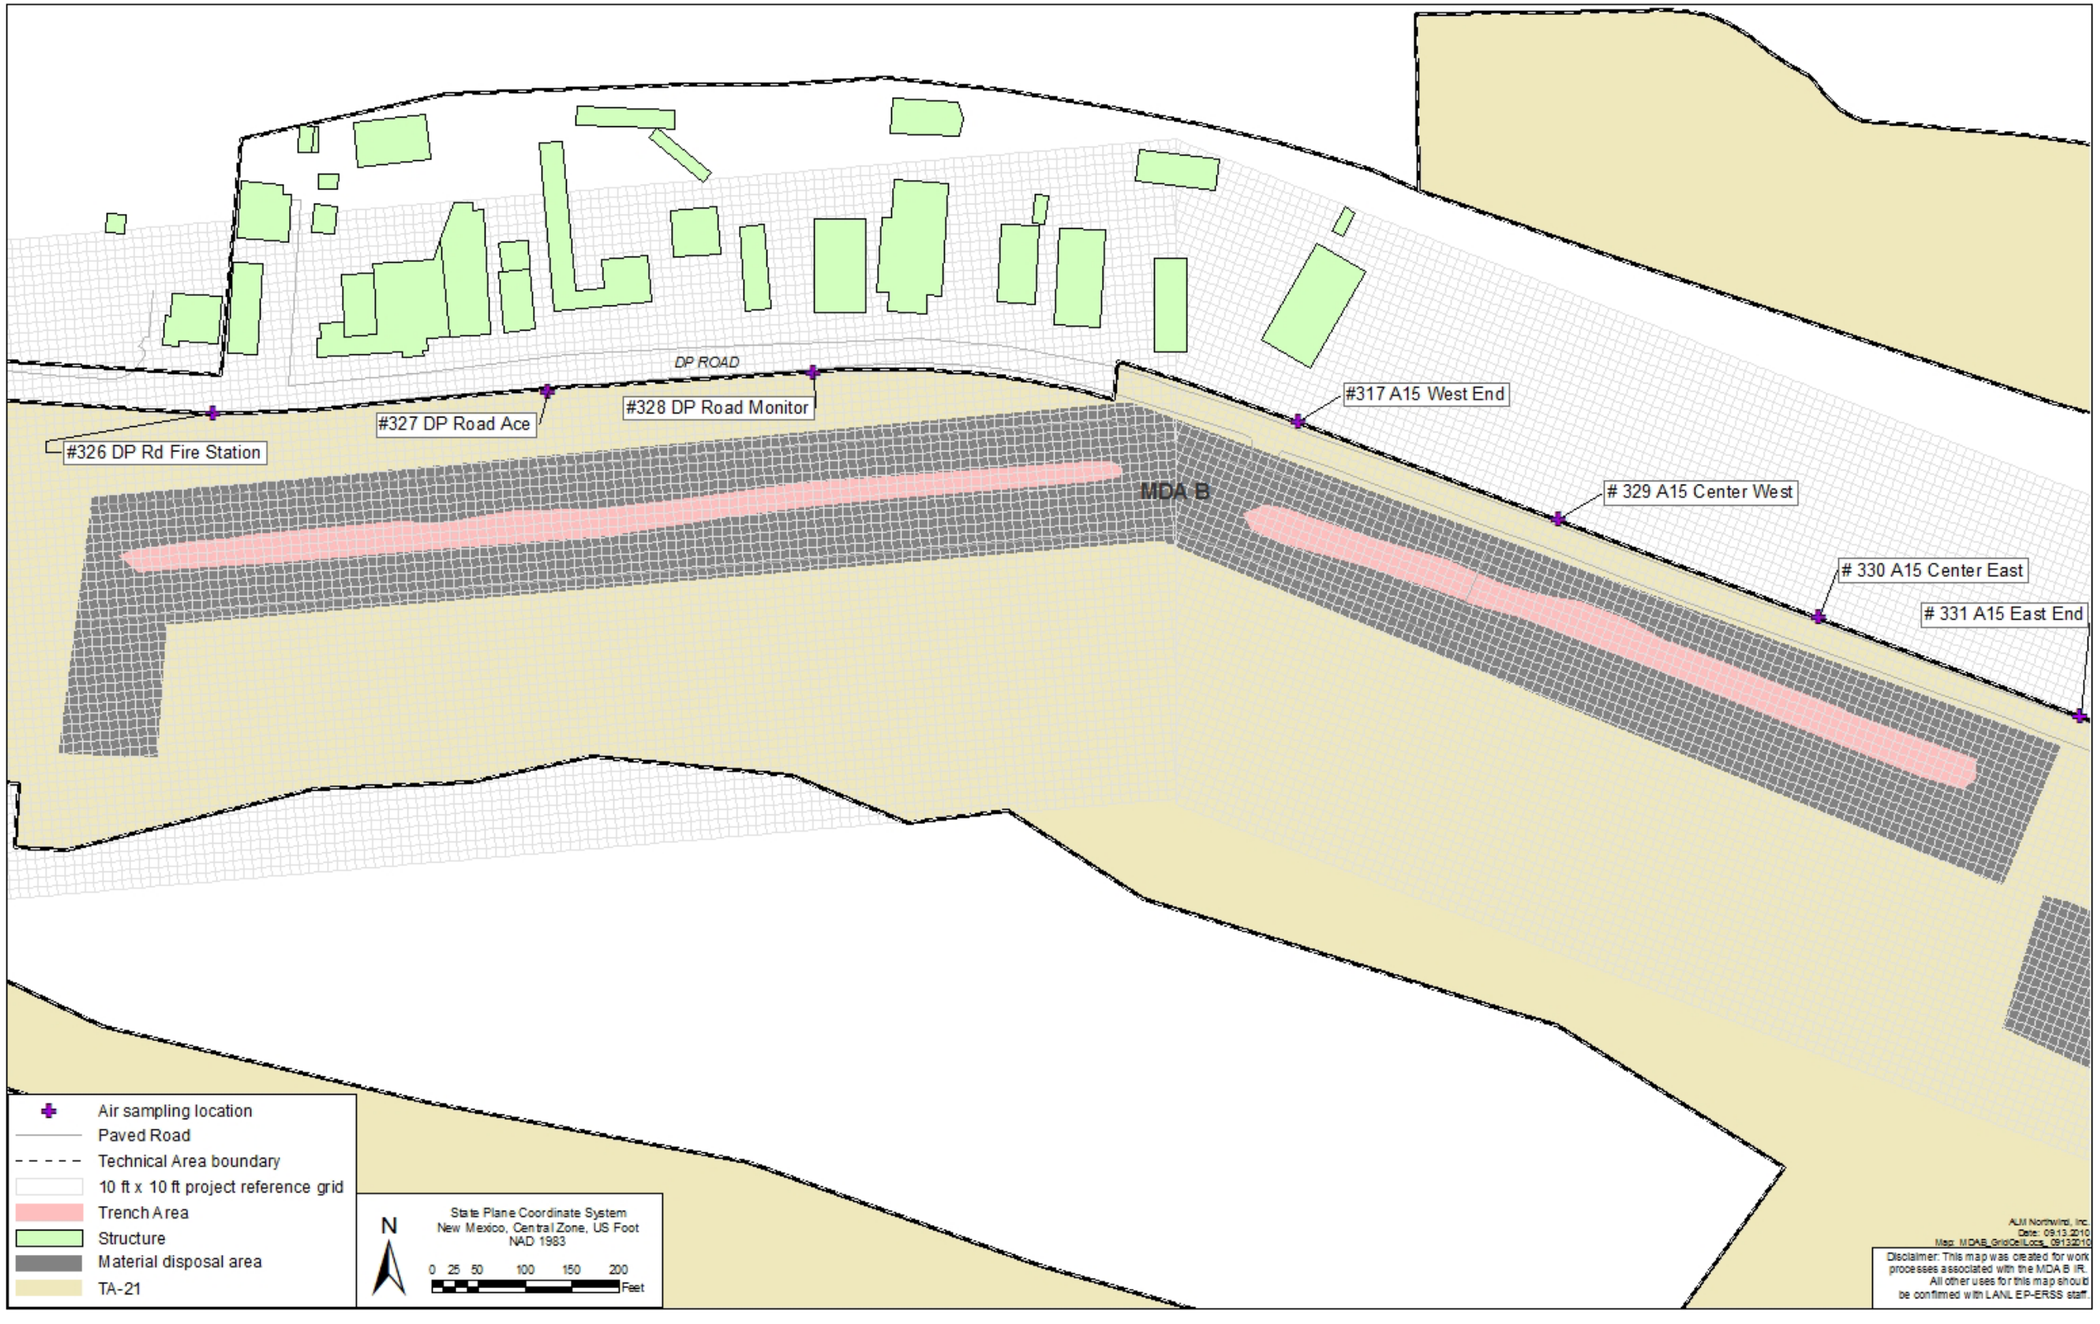
Figure 2.3-1 Grid cell locations within MDA B excavation

MDA B was split into a grid of cells measuring 10–ft long × 10–ft wide, as shown in Figure 2.3-1. Excavation progress was tracked using cell identification (ID) codes composed of letters along an approximate north-south axis and numbers along an approximate east-west axis. Grid cells were excavated within an area currently covered by a movable enclosure to protect equipment and excavation operations from weather. Excavation activities at MDA B commenced in enclosure 1 on June 30, 2010, and in enclosure 2 on July 19, 2010. Exploratory trenches excavated in February 2010 verified that waste was not present in the westernmost portion of MDA B, previously designated as Areas 9 and 10. A separate investigation report (IR) for MDA B Areas 9 and 10 was submitted to NMED in May 2010 (LANL 2010, 109526).

Eight air-monitoring network (AIRNET) stations are located along the northern boundary of MDA B. The location of these monitoring stations is shown in Figure 2.3-1. Each AIRNET station collects airborne radionuclides, such as plutonium, americium, and uranium, on a particulate filter and a water vapor sample (for measuring tritium) in a silica gel cartridge. The particulate filters and silica gel cartridges are changed every two weeks and the sample media are sent to a commercial laboratory for analysis using Environmental Protection Agency- (EPA) approved methods. After sufficient time to allow natural radon and progeny to decay, the particulate filters are measured for gross alpha and beta radioactivity using a gas-flow proportional counter. Each calendar quarter, six or seven of the biweekly filters from a given station are assembled into a single composite sample and prepared for isotopic analysis by dissolution and radiochemical separation techniques. These separated samples are analyzed with alpha spectroscopy and inductively coupled plasma emission spectroscopy according to EPA requirements in 40 Code of Federal Regulations 61, National Emission Standards for Hazardous Air Pollutants, Appendix B, Test Methods. Distillate from the silica gel cartridges is analyzed for tritium using liquid scintillation counting. Annual emissions reporting and compliance evaluations for a station are based on the sum of the four quarterly composite samples (for particulate matter) and the sum of biweekly tritium analyses.

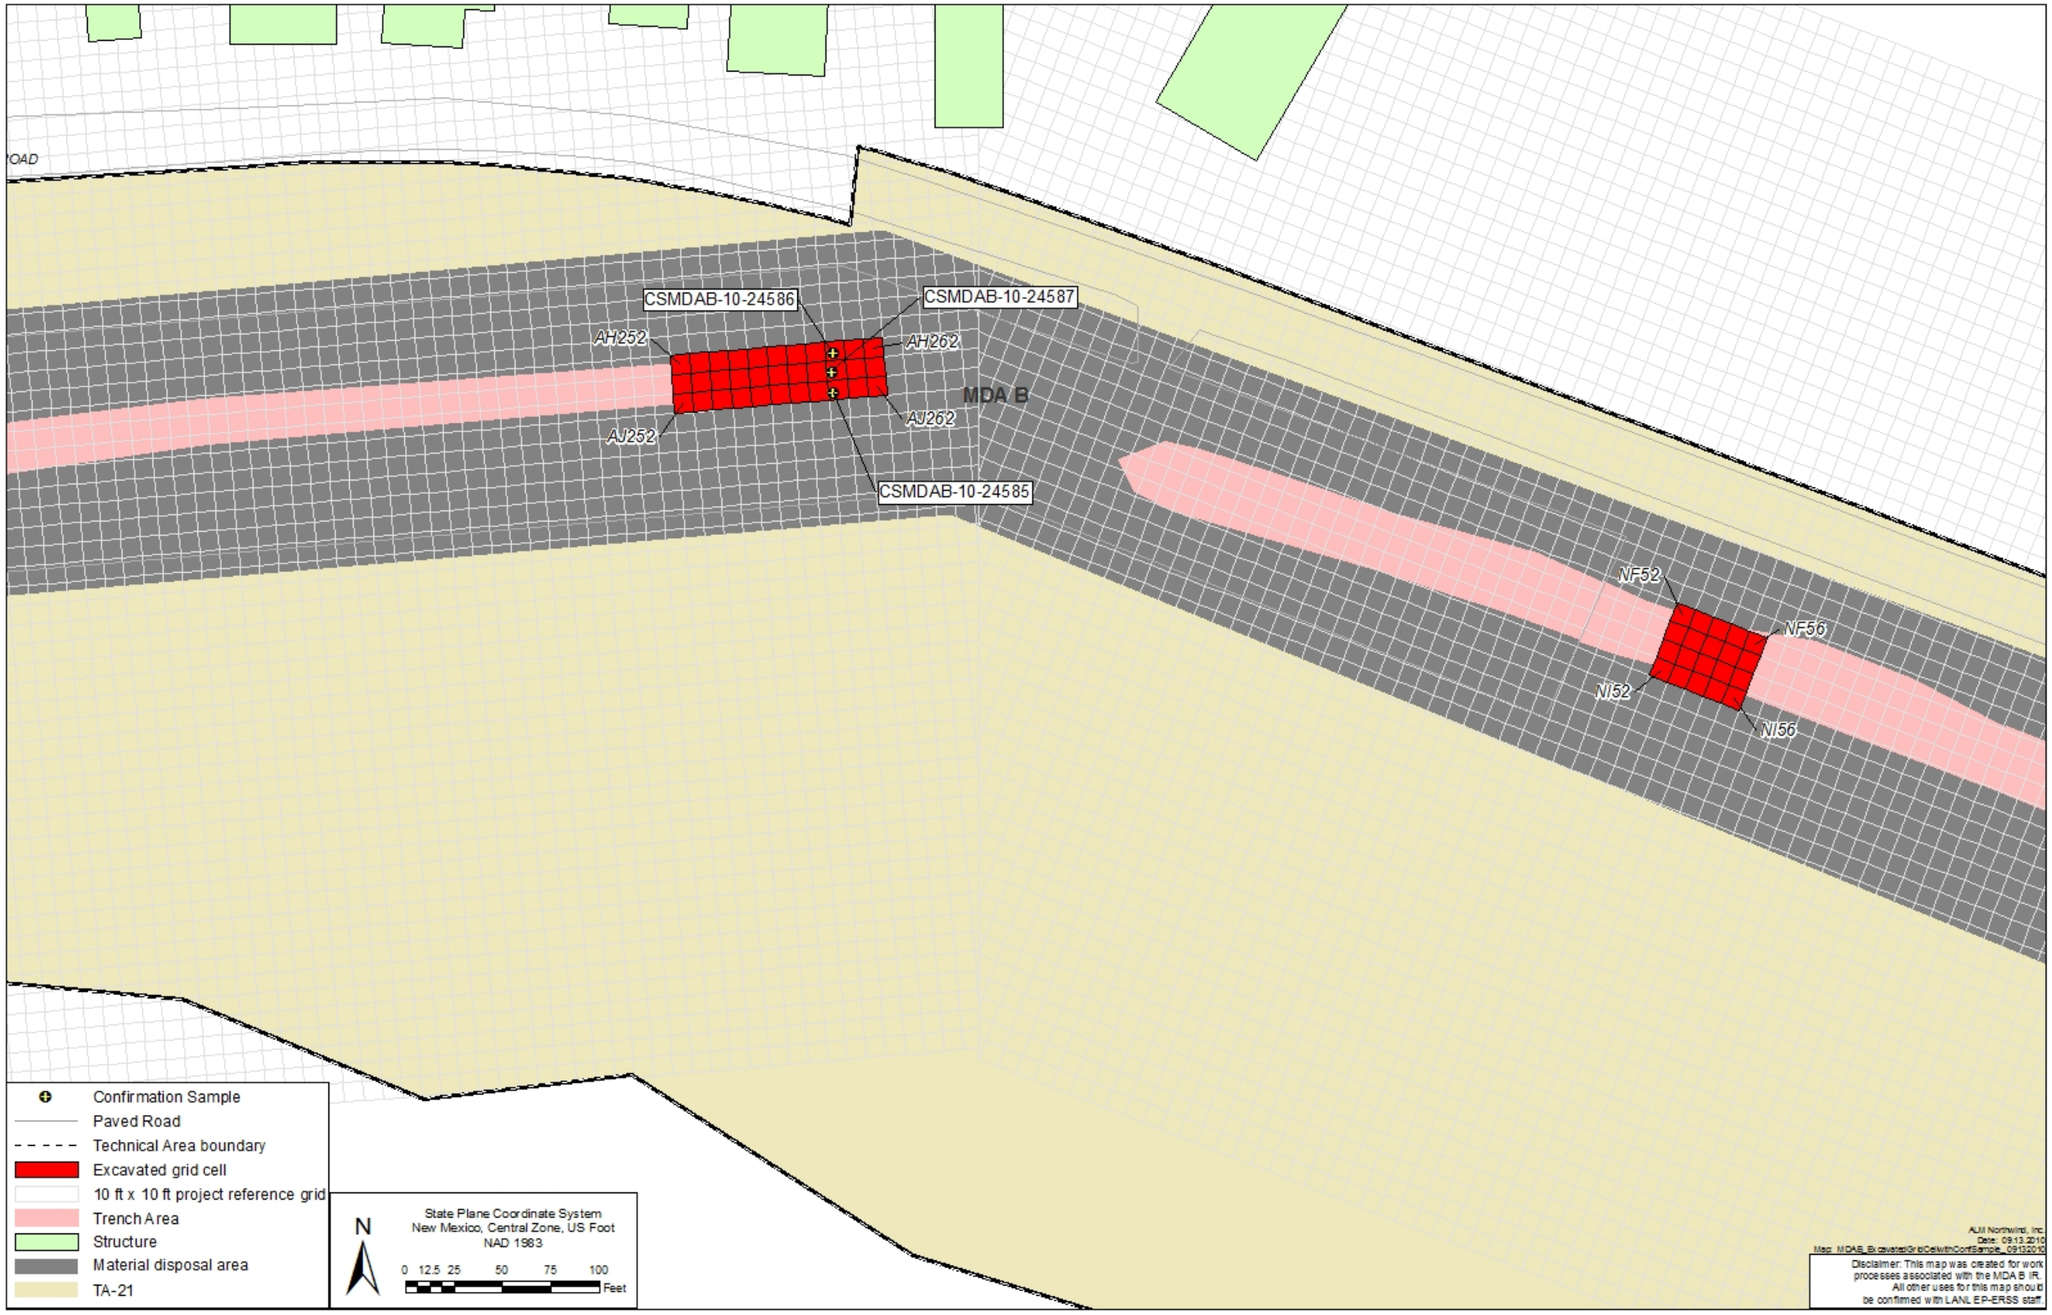
Figure 2.3-2 Excavated grid cells and confirmation sample locations as of August 17, 2010

The overburden material was removed from groups of grid cells before waste excavation. Figure 2.3-2 indicates the grid cells that were excavated from June 30 through August 17, 2010. Overburden material was removed from each grid cell and placed into containers labeled with a unique LANL material-tracking bar code ID.

As of August 17, 2010, three confirmation samples and NMED split samples have been collected as described. The samples were collected from row 260 after soil-screening results did not indicate detectable activity and enclosure 1 had been moved over the next area of the trench to be excavated. Samples were collected from row 260 from the trench bottom, north side wall, and south side wall using the dedicated, clean excavator bucket. The excavator bucket was covered in plastic during sampling to prevent any cross-contamination of the samples. The plastic was replaced and the bucket decontaminated between each confirmation sample. Table 2.5-1 presents location and ID information for

Once confirmation sample results are reviewed, the cells will be backfilled using clean overburden material. Figure 2.3-2 shows the location of the excavated grid cells and the confirmation sampling locations.

As of August 17, 2010, grid cells NE 52 through NI 56 have been excavated. Overburden material, contaminated soil, and waste debris have been removed. Overburden and waste samples have been sent for analysis. Confirmation sampling has not been conducted in these grid locations; therefore, they have not been backfilled. Figure 2.3-2 shows the location of the excavated grid cells in enclosure 2.
