LA-11135-MS

Environmental Status of Technical Area 49, Los Alamos, New Mexico

UC-70
Issued: November 1987

William D. Purtymun
Alan K. Stoker

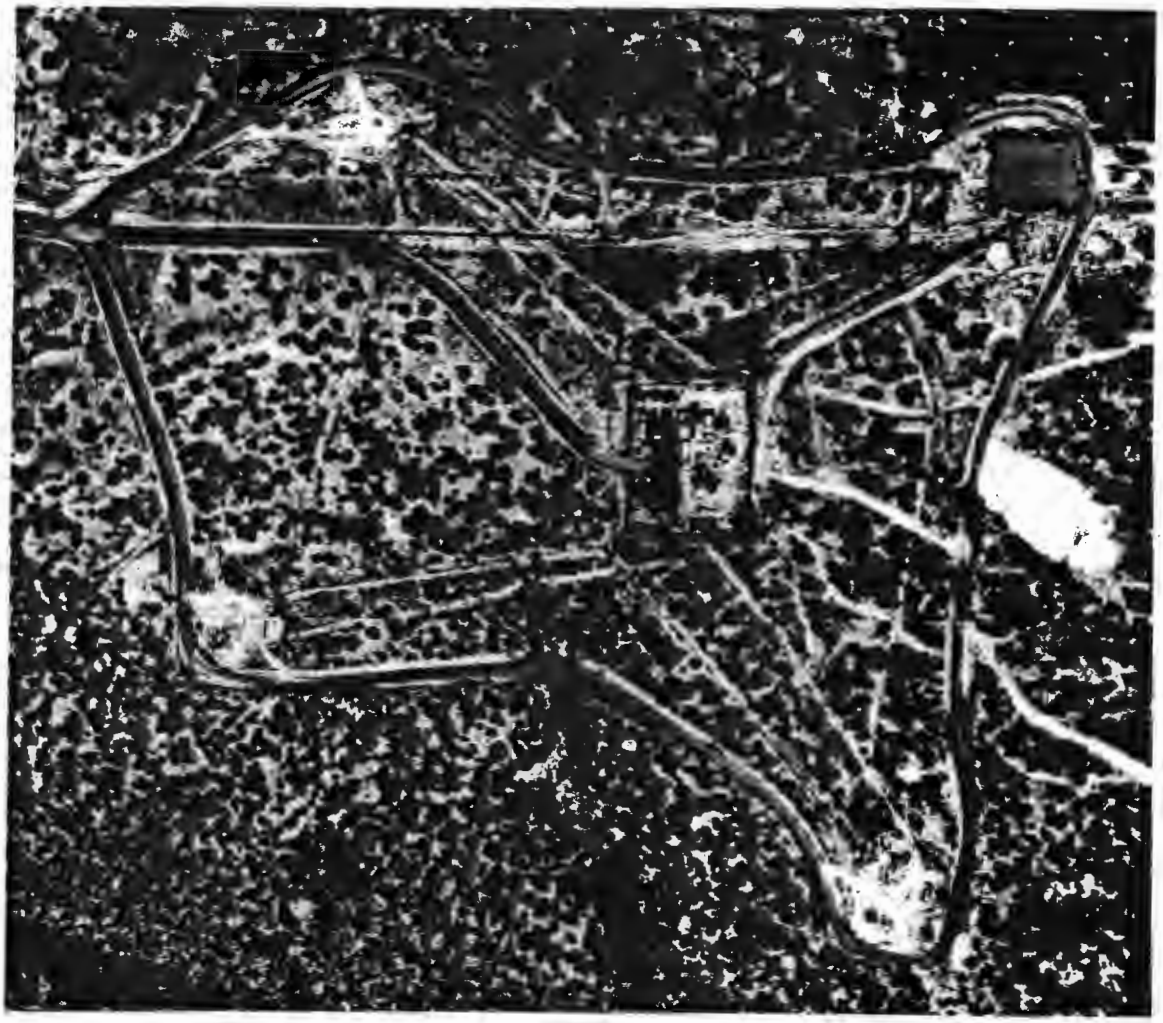
2. Surface Contamination. Some plutonium contamination was measured at the surface in experimental Area 2 in December 1960 and was traced to cuttings from experimental hole 2-M drilled during October and November. Plutonium had apparently been dispersed through fractures in the tuff by detonation of an experiment in an adjacent experimental hole. All surface soil contamination measurable by standard procedures and instruments of the time was collected and placed back in experimental hole 2-M. The experimental hole was then filled with clean sand and capped with concrete. The entire surface of Area 2 was covered with 6 ft of compacted aggregate in January 1961 and sealed with a 4- to 6-in.-thick asphalt pad in September 1961. The asphalt pad can be seen in the upper right portion of the aerial photograph in Fig. 3, which was taken in

Figure 3. Aerial photograph of TA-49 from 1965. Note asphalt pad covering experimental area 2 in upper right.

1965. This inadvertent contamination incident left some remaining trace amounts of plutonium on the surface in the vicinity of TA-49. After closure of the original 100-ft-square experimental Area 2, additional experimental holes were constructed to the west (Area 2A) and south (Area 2B) as indicated in Fig. 2.

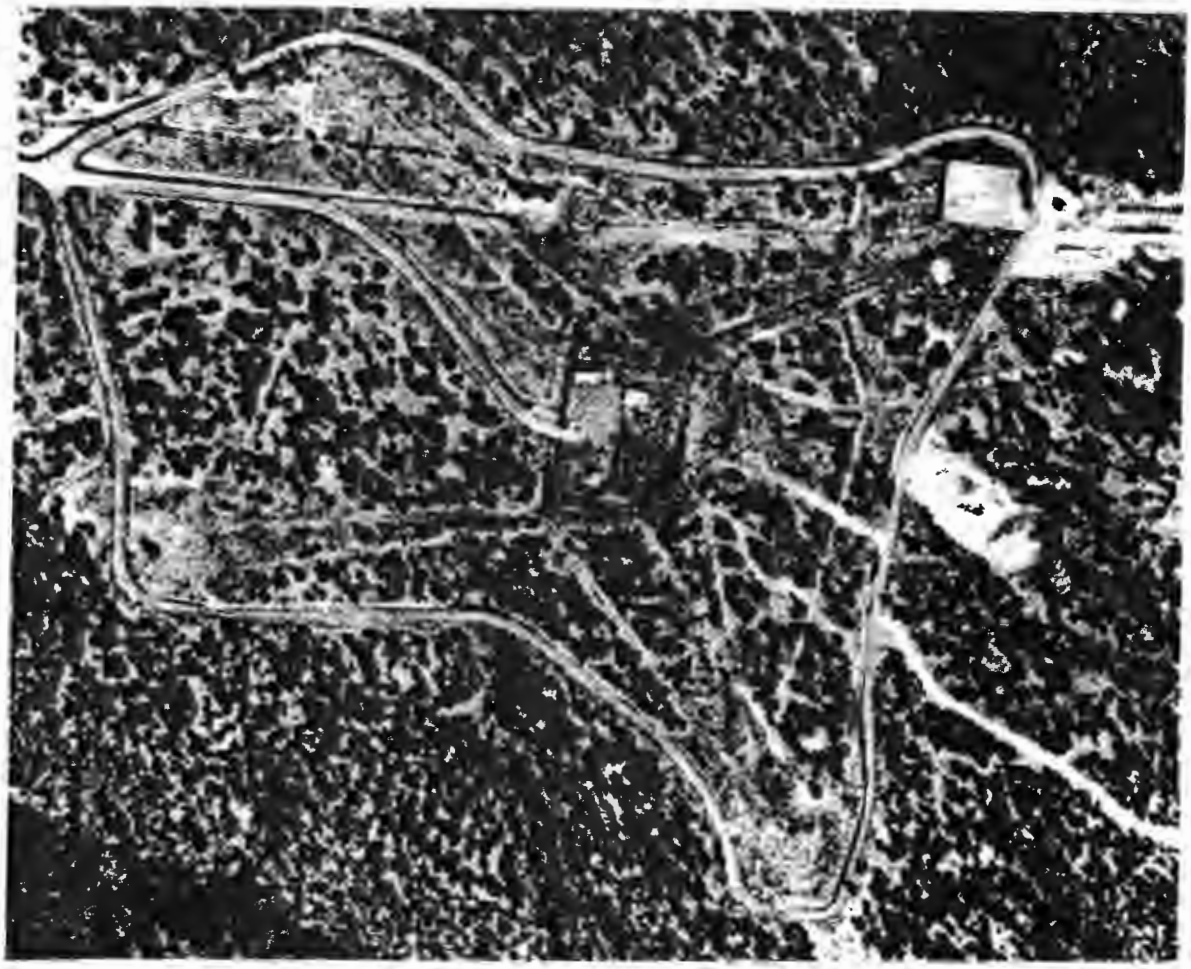
3. Contaminated Structures. Structures located in Area 11 (Fig. 2) of TA-49 were used for radiochemistry. They were decontaminated, demolished, and removed in September of 1971. Close inspection of the aerial photograph in Fig. 4, which was taken in 1974, shows the absence of the structures in Area 11. Contaminated materials were packaged and transported to the Laboratory's radioactive waste disposal facility at TA-54. Uncontaminated materials and debris were buried in a landfill about 1/2 mile northwest of the TA-49 experimental area. A contaminated subsurface drain field that served the radiochemistry facility was left in

Figure 4. Aerial photograph of TA-49 (1974). Note absence of structures in experimental area 11 in top center when compared was photograph in Figure 3 (1965).

place and represents a source of near-surface contamination remaining in the TA-49 vicinity.
