Best Management Practices Report for Installation of Stabilization Measures at Potential Release Sites 49-001(b, c, d, and g)

Environmental Restoration Project
A Department of Energy Environmental Cleanup Program

Los Alamos
NATIONAL LABORATORY
Los Alamos, NM 87545

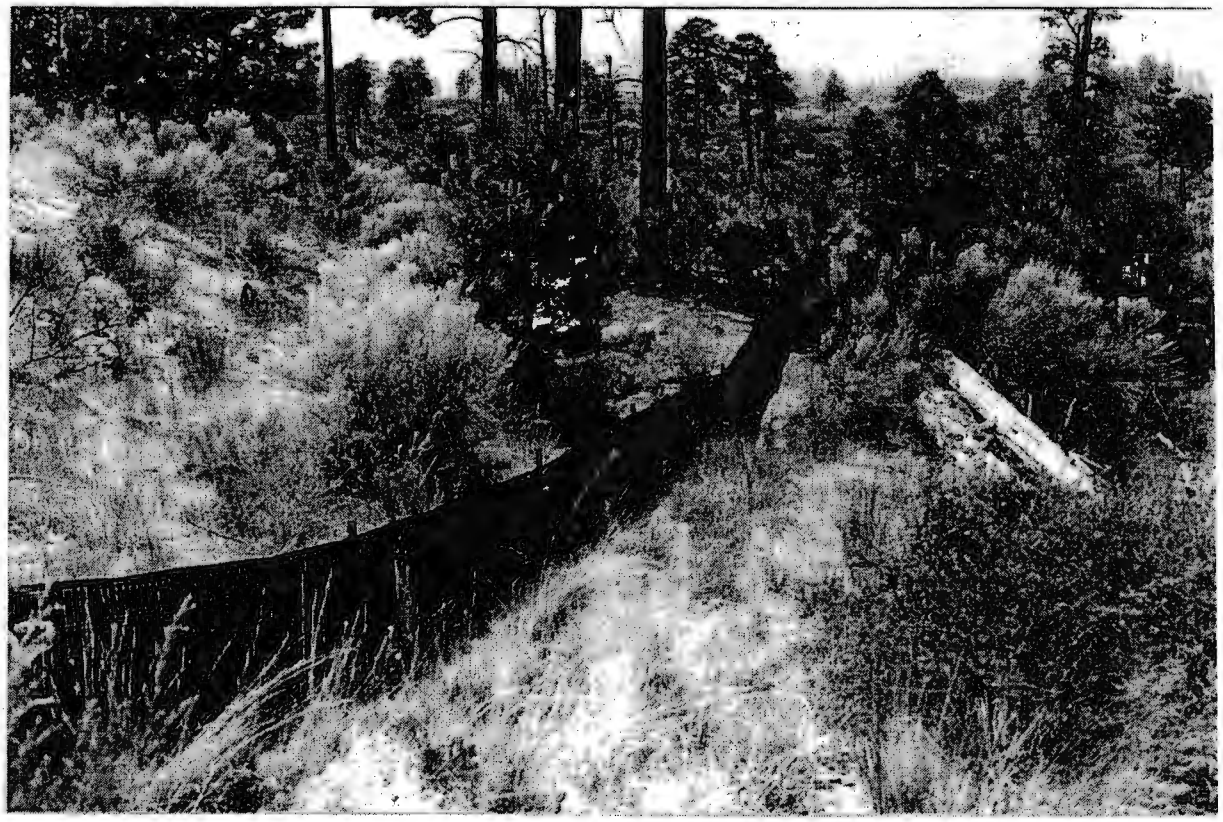
Figure 2-2. Silt fence (view is from the west).

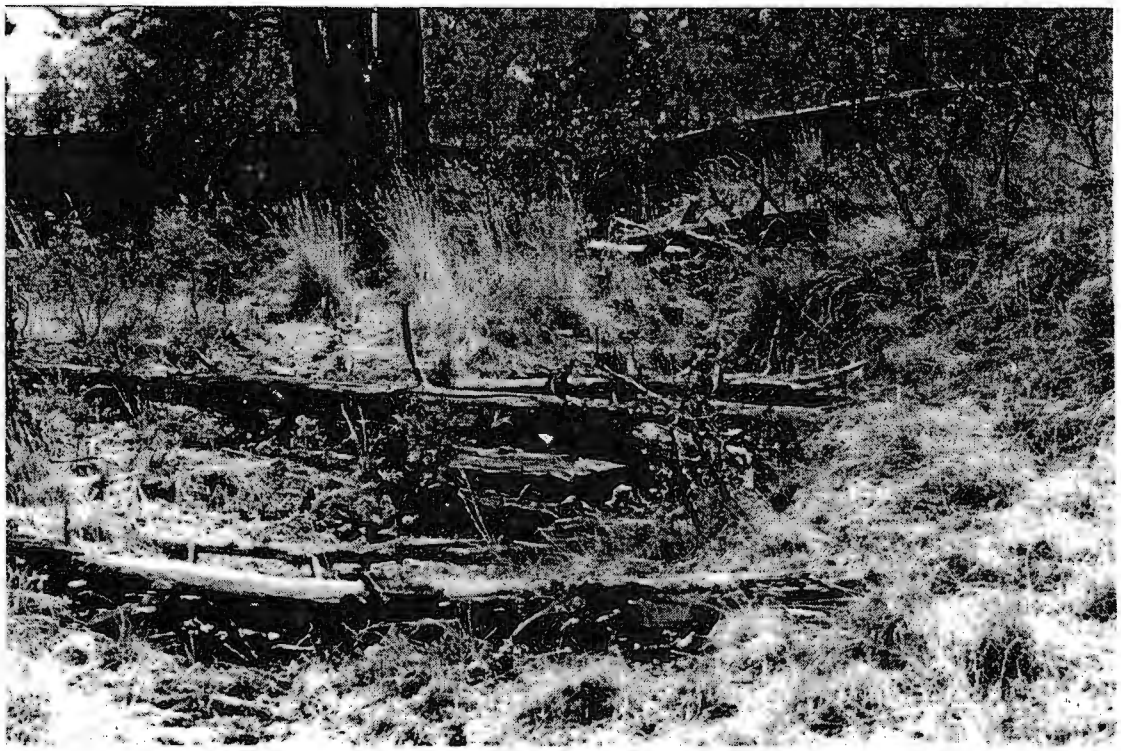
The two principal downgradient channels draining the site were each stabilized in several places with straw bales and by check dams constructed of tree trunks, branches, brush, and rocks. These materials provide energy dissipaters to slow storm water flow and retard sediment migration. The approximate locations of these runoff controls are shown in Figure 2-1. A photograph of a portion of one of the stabilized channels is shown in Figure 2-3.

Figure 2-3. Channel flow dissipaters downstream of the diversion channel.

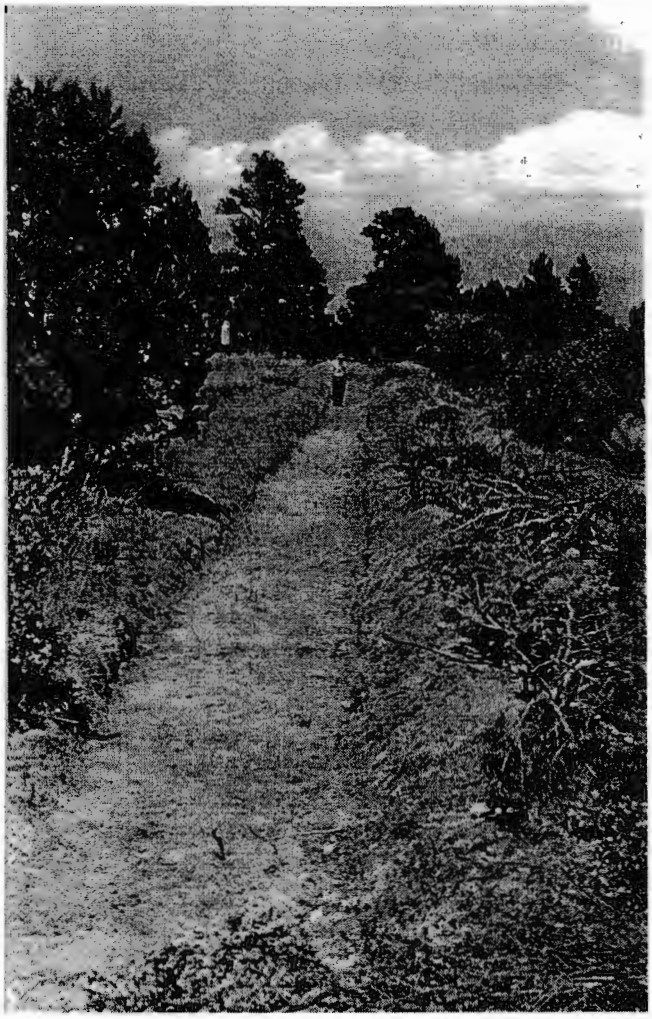
After construction, the surfaces of the channel and berm were compacted with a backhoe and vibraplate to improve erosion resistance. An organic mulch was placed on the berm and

Figure 2-4. Surface water diversion channel (view is from the north).

channel sides to protect against erosion. Brush and limbs removed during construction were placed on top of the berm. Erosion control mats were placed along the entire length of the upgradient (west) bank of the channel and on the downgradient (east) bank across from locations where major drainages enter the channel. These mats are made primarily of biodegradable natural wood fiber. They immediately stabilize the soil by slowing surface water flow and aid in germination of vegetation. The mats were installed following the procedure presented in Storm Water Best Management Practice (BMP) Guidance Document (Merrick Engineers and Architects 1998, 58696, p. 54). Because of evidence from the storm water diversion channel that natural reseeding occurs quickly at the site, artificial reseeding of the matted area was not conducted. Work was completed by cleaning up the site and restoring the site perimeter fence.

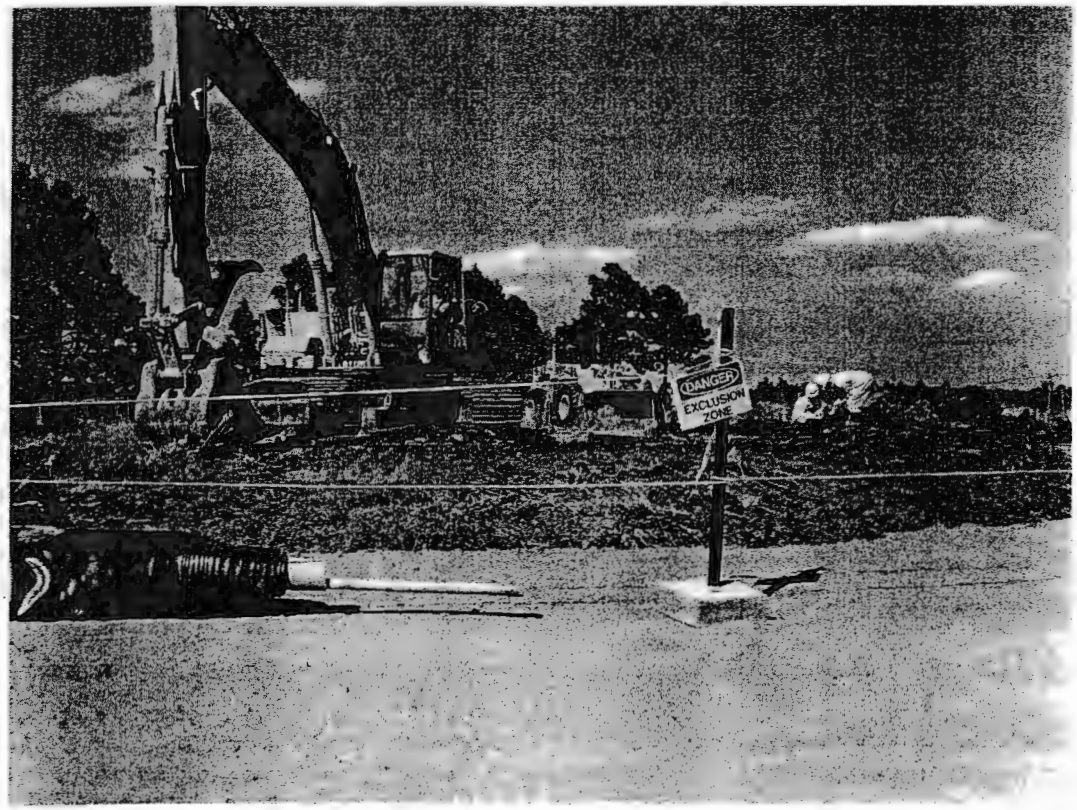
Figure 2-4. Removing the asphalt

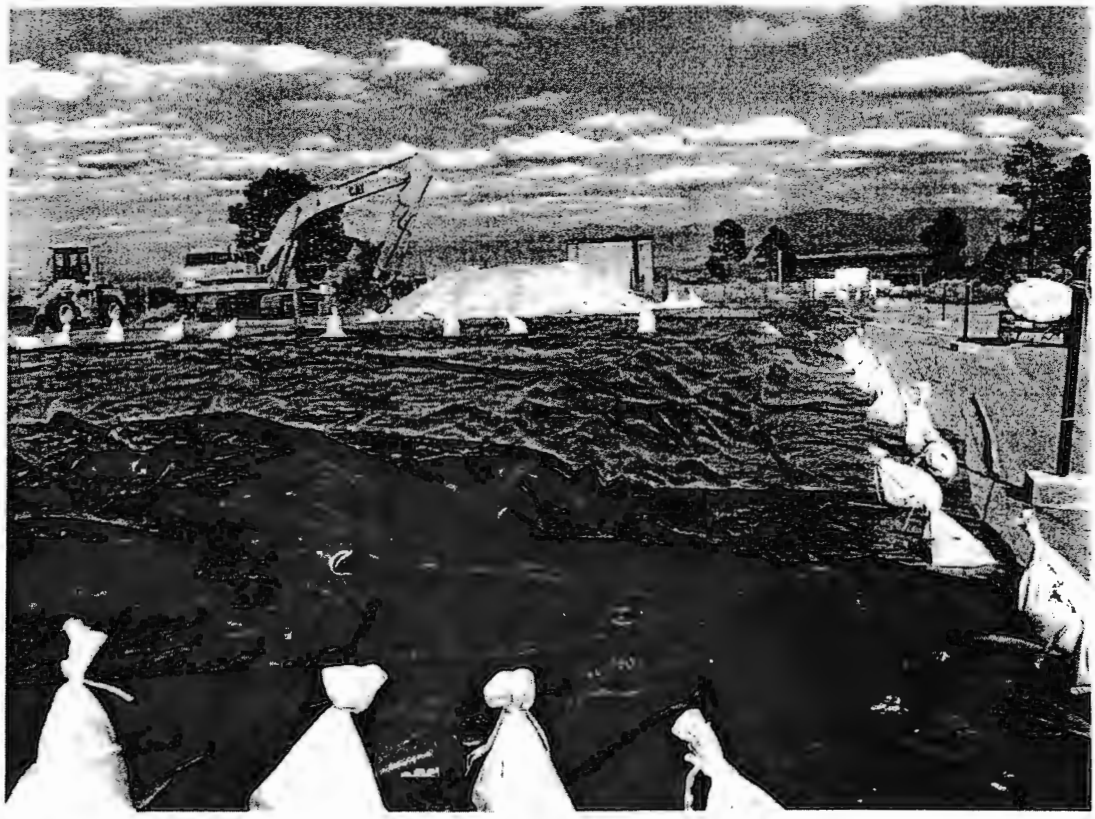
The area where asphalt had been removed was covered with a 20-mil high-density polyethylene (HDPE) liner, and excavated asphalt was covered with polyethylene sheeting during potential rain events. To promote drying, the surface of the underlying fill material was scarified by the backhoe to a depth of about 6 in. during excavation. However, because of the potential for exposing buried radiological contamination, no other reworking or excavation of the underlying fill material was performed. The casings of the two 150-ft-deep Resource Conservation and Recovery Act (RCRA) facility investigation (RFI) boreholes (49-2906 and 49-2907) were marked with orange paint for improved visibility and were not damaged during the excavation. A site map showing the extent of the asphalt that was removed is presented in Figure 2-3. Photographs of the asphalt removal process are presented in Figures 2-4 through 2-7.

Figure 2-7. Covering the area after the asphalt has been removed

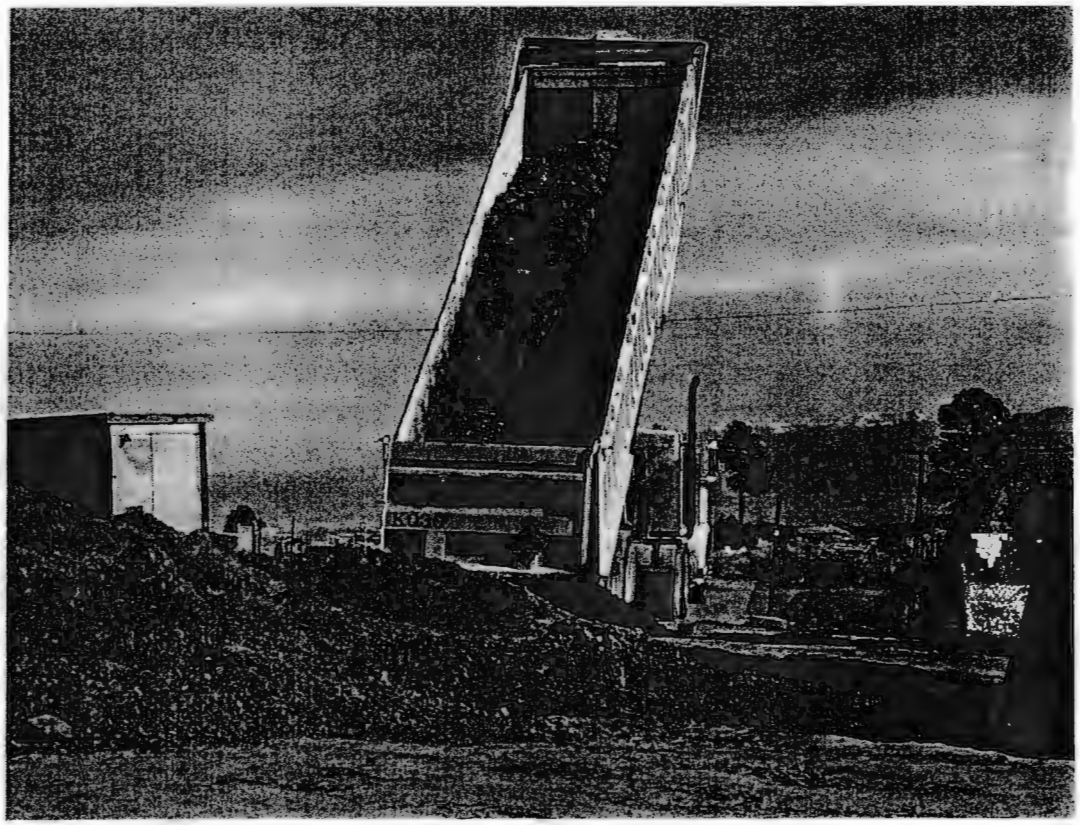
A 6-in. layer of topsoil was placed over the regraded surface of the site in November and December 1998. Approximately 1260 yd^3 of topsoil was used. This volume was greater than originally planned because of the greater extent of the stabilized area. Because of the scarcity and cost of topsoil from sources near Los Alamos, it was most cost-effective to bring in soil from the Albuquerque area. The soil was obtained from several sources; some loads were mixed with organic soil builder to obtain a more uniform quality. Photographs of the soil placement activity are shown in Figures 2-11 and 2-12.

Figure 2-11. Placing soil on the regraded area

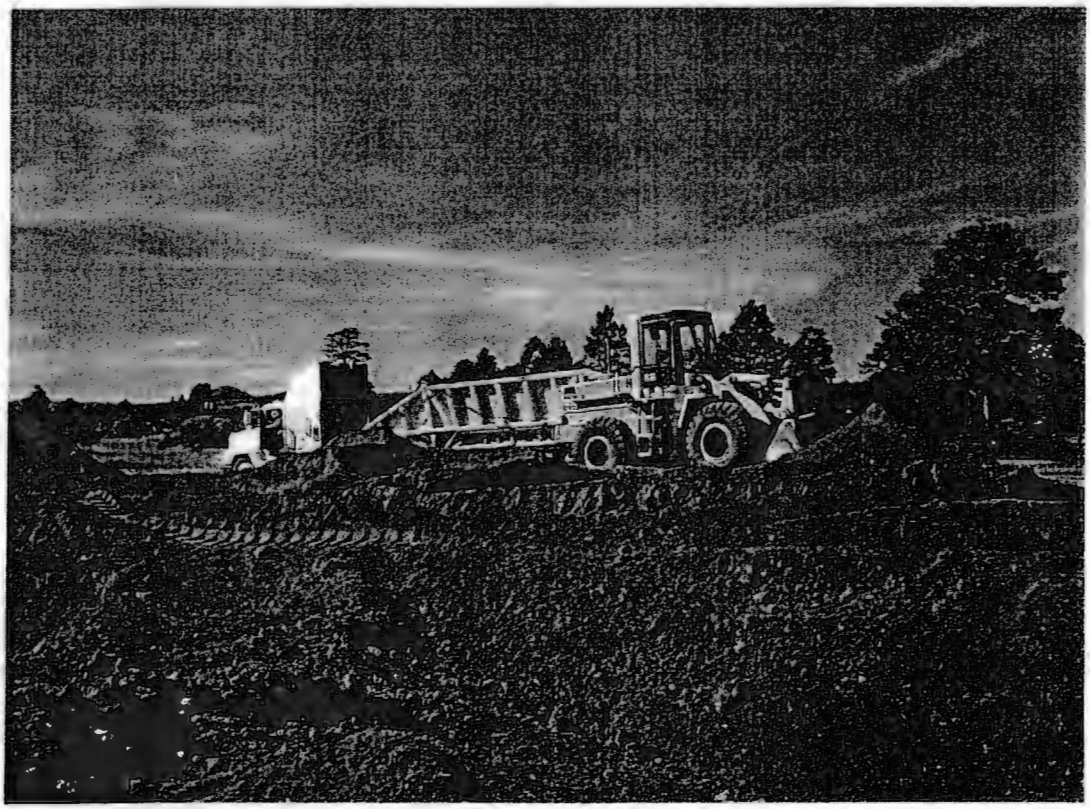
Figure 2-12. Placing soil on the regraded area

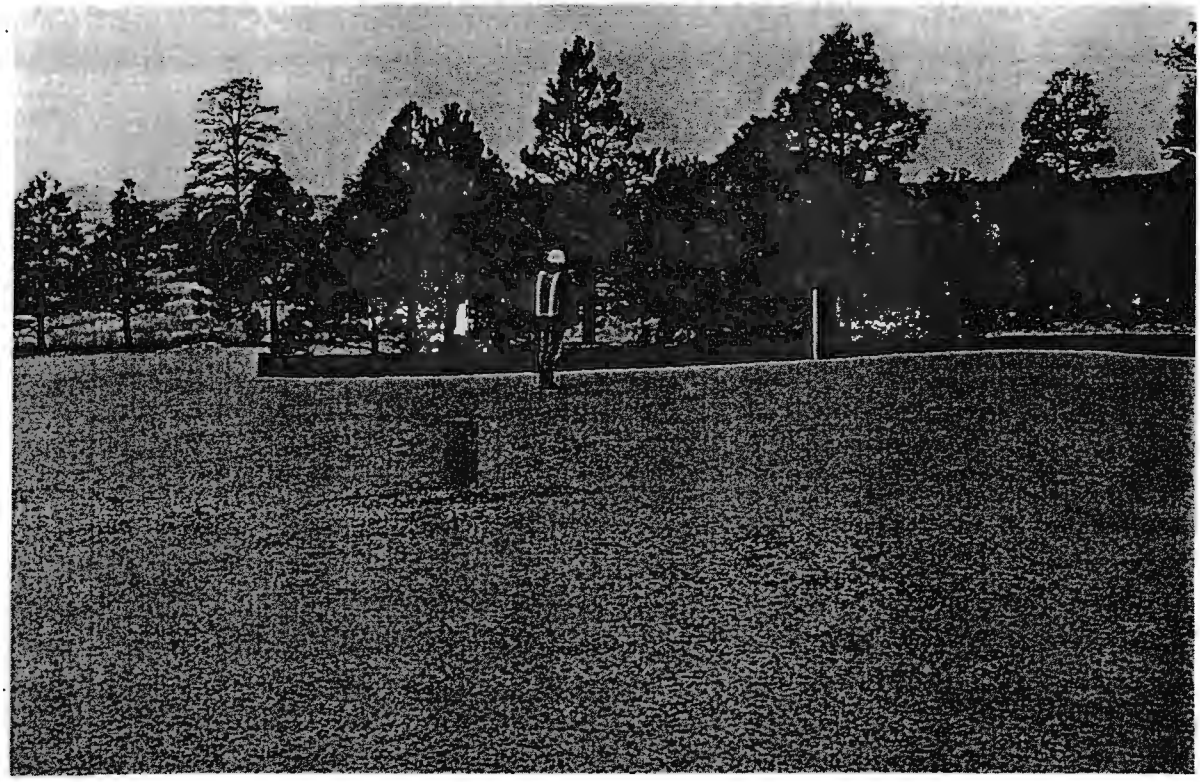
Figure 2-14. Gravel cover on Area 2

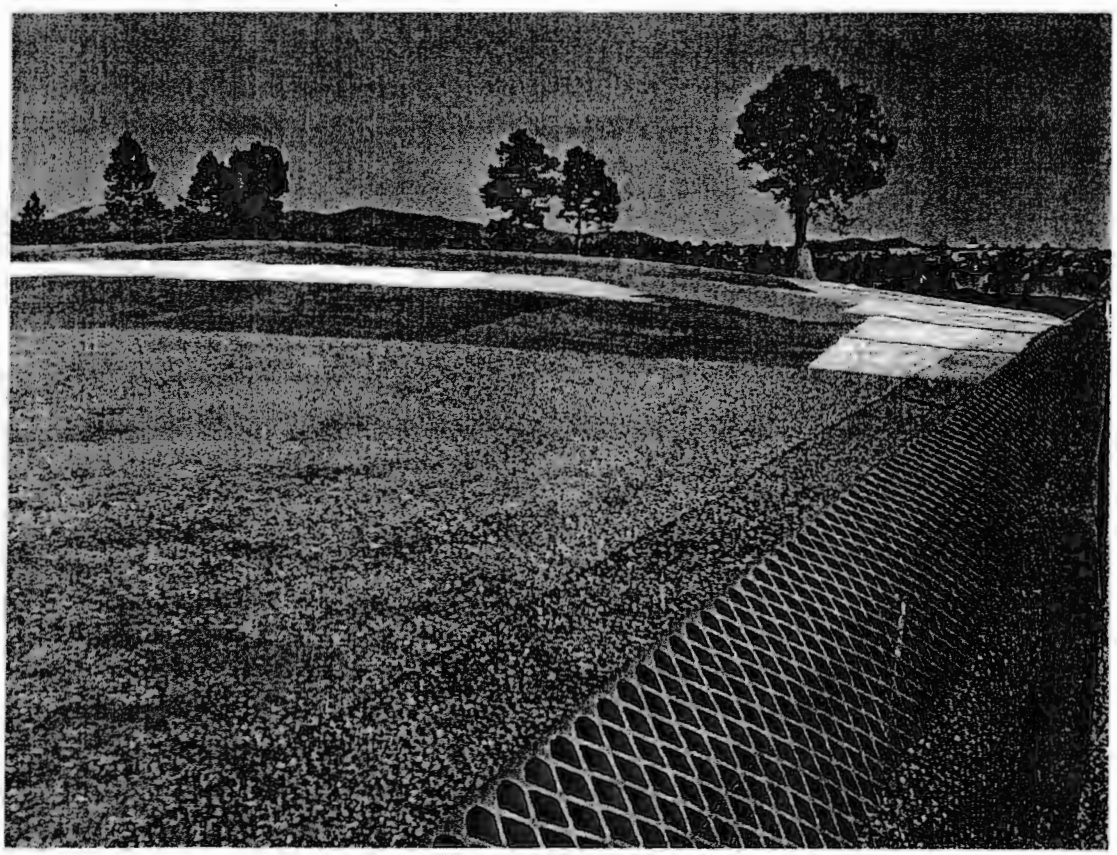
The edge of the wire mesh was buried in a 2-ft-deep vertical trench to keep gophers from burrowing under the edge. Individual sheets of wire mesh were approximately 12 x 25 ft in size and were overlapped a minimum of 6 in. About 140 sheets were used to form the barrier. The individual sheets were clipped together with steel hog rings placed about 12 in. apart. The trunk of a pine tree penetrating the barrier was wrapped with wire mesh to a height of about 3 ft, and the openings between the wire mesh and the two 150-ft RFI wellheads were closed with approximately 2-ft by 2-ft surface seals of concrete. The wire mesh biointrusion barrier covered approximately 33,050 ft^2, or 55%, of the 60,260 ft^2 area affected by the stabilization activities. The area covered by the wire mesh biointrusion barrier is shown in Figure 2-1. Photographs of the barrier and its installation are shown in Figures 2-15 and 2-16.

Figure 2-16. Gopher barrier

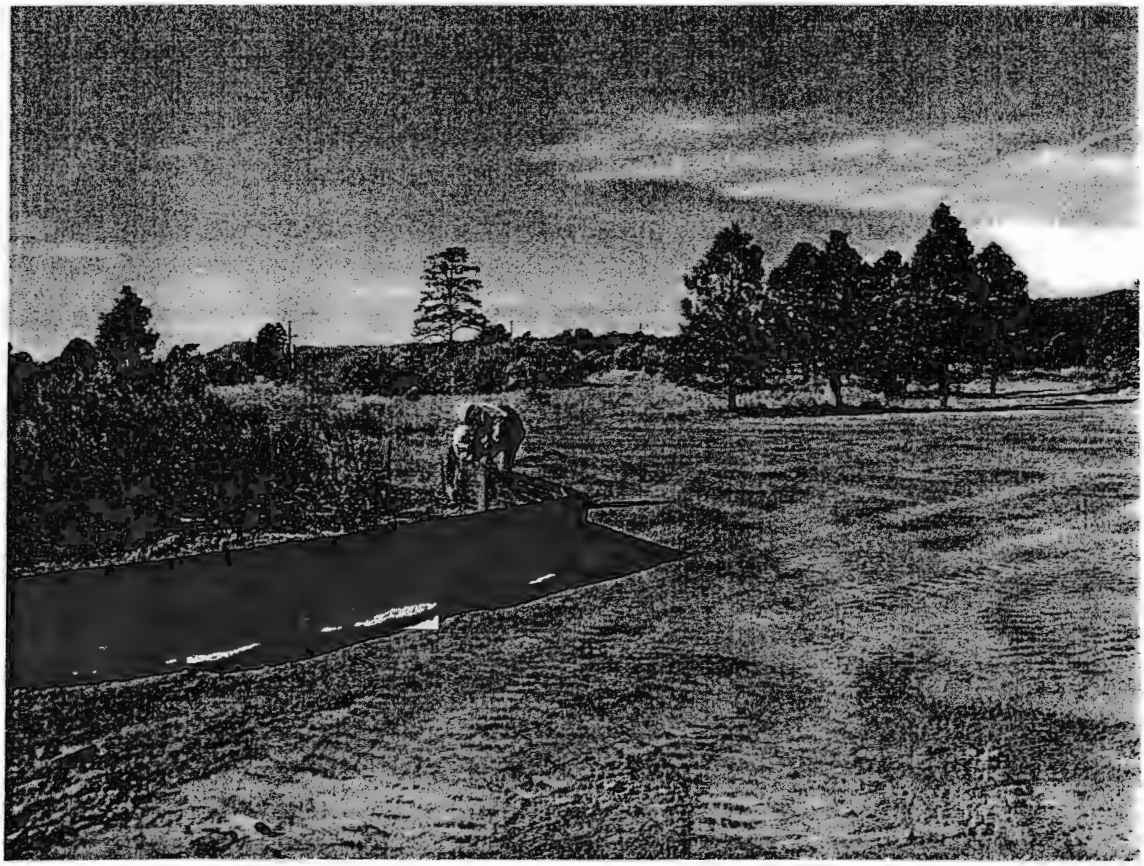
Figure 2-17. Installing the silt fence
