Date: FEB 14 2013
Refer To: EP2013-0002

Subject: Submittal of the 2012 Annual Inspection Report for Los Alamos County Airport Landfill, Solid Waste Management Units 73-001(a) and 73-001(d), Technical Area 73

Enclosures: Two hard copies with electronic files – 2012 Annual Inspection Report for Los Alamos County Airport Landfill, Solid Waste Management Units 73-001(a) and 73-001(d), Technical Area 73 (LA-UR-13-20302)

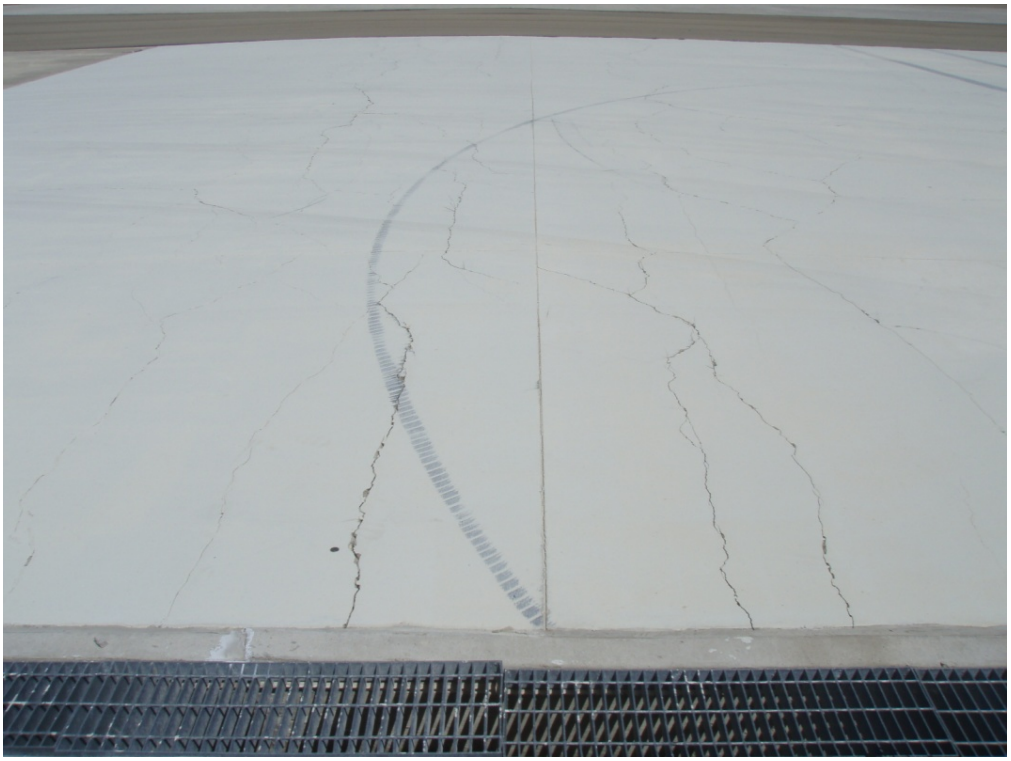
Visible subsidence was observed on the northern half of hangar pads 2 and 3. Subsidence was also noted on the northwest quarter of hangar pads 1 and 4, but to a lesser degree than on pads 2 and 3, as shown in Figure 3.1-3. Cracking associated with the subsidence of the pads was also observed throughout the central portion of each pad. Cracks in pads 2 and 3 had been treated in 2009 using polyurethane sealants; some of the treated cracks have expanded and grown in length and width, as shown in Figure 3.1-4. Separation of the expansion joints was observed at all the pads, with the exception

Figure 3.1-4 Cracks in concrete hangar pad 3

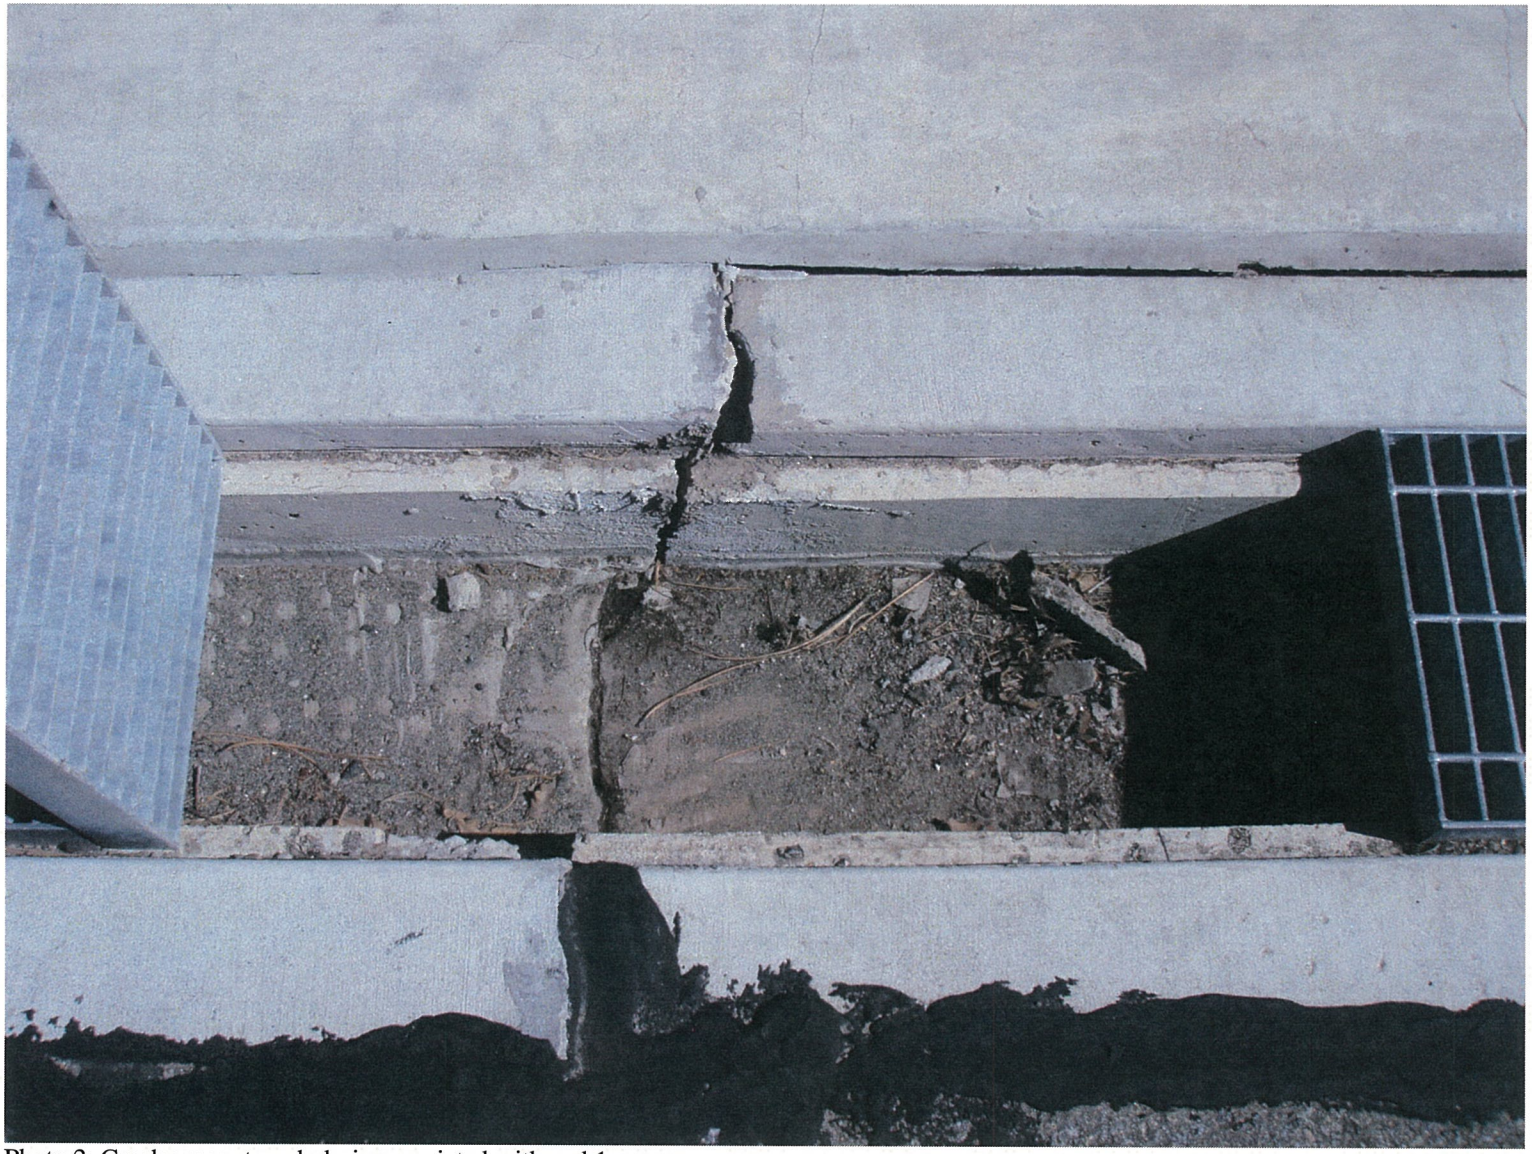
Photo 2: Crack across trench drain associated with pad 1.

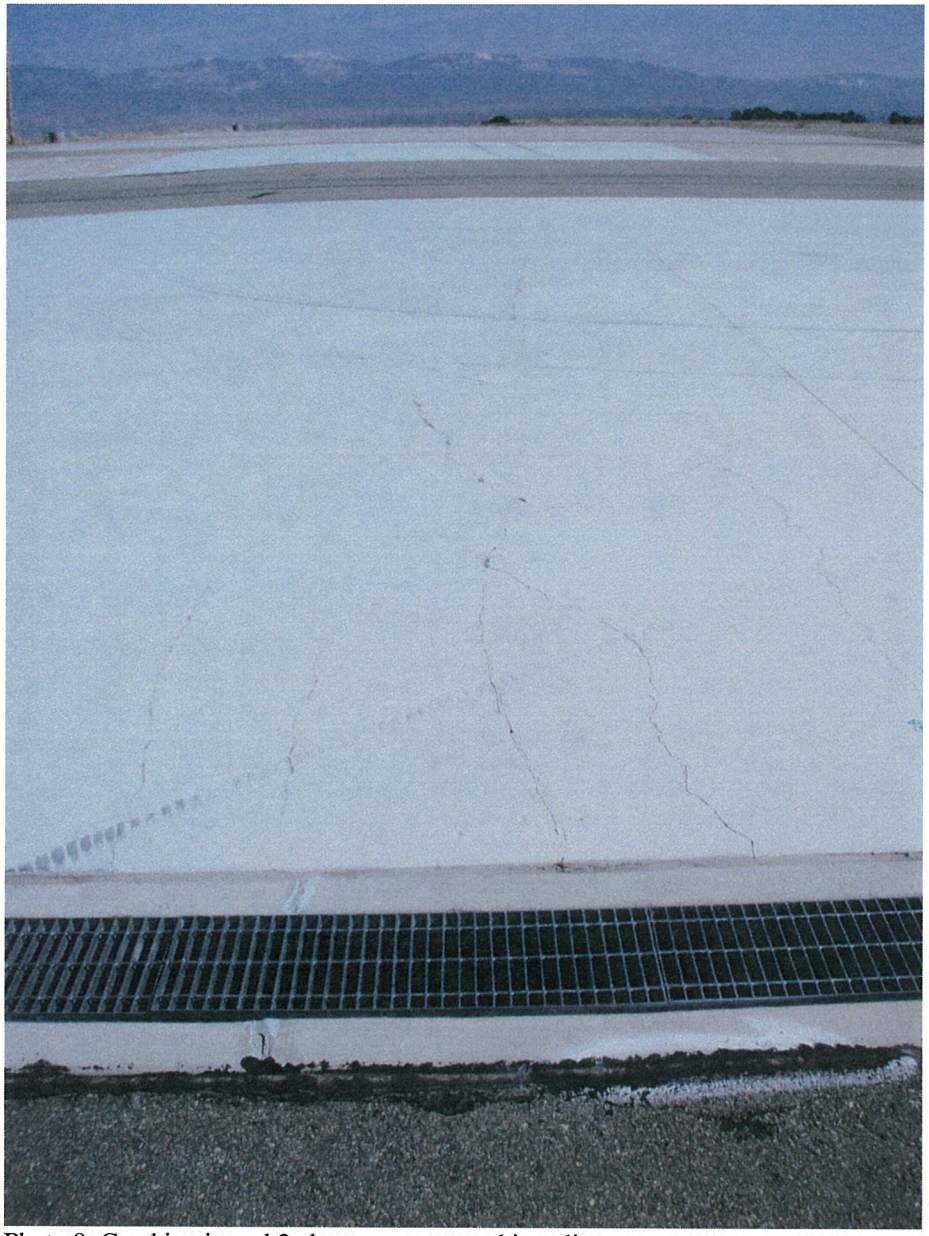
Photo 9: Cracking in pad 2 along an east west hinge line.

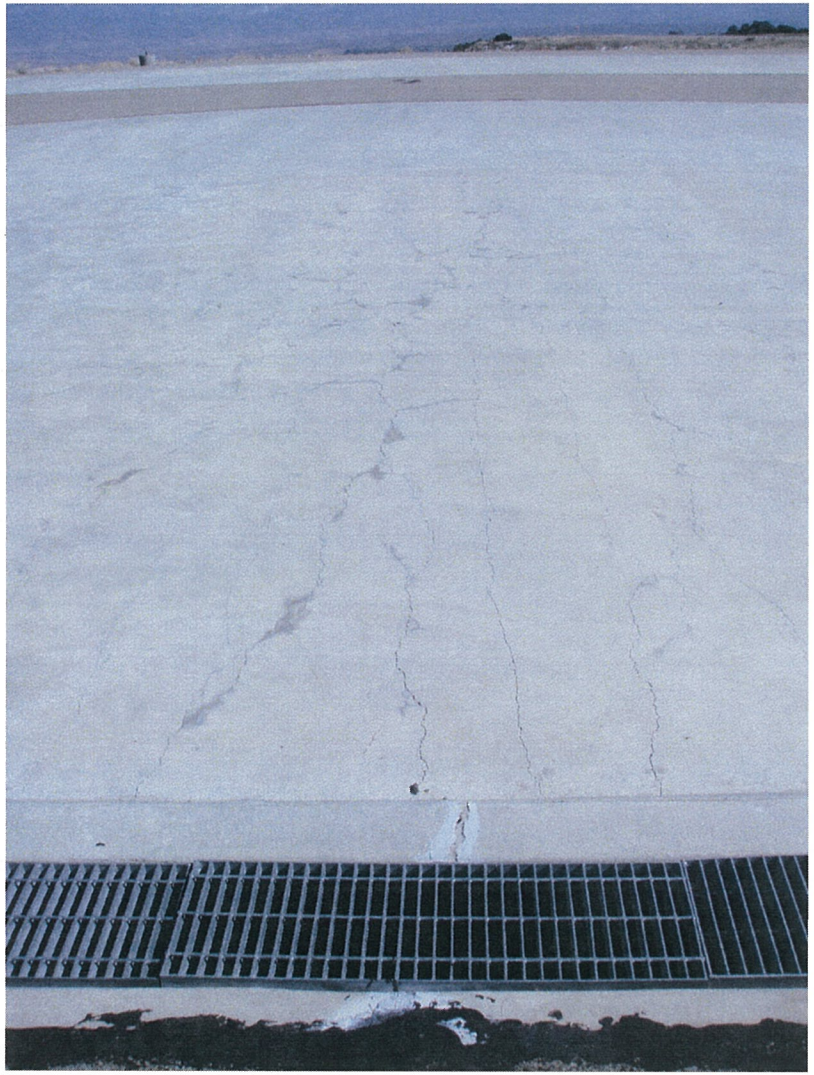
Photo 13: Cracking in pad 4 along hinge line in east-west orientation

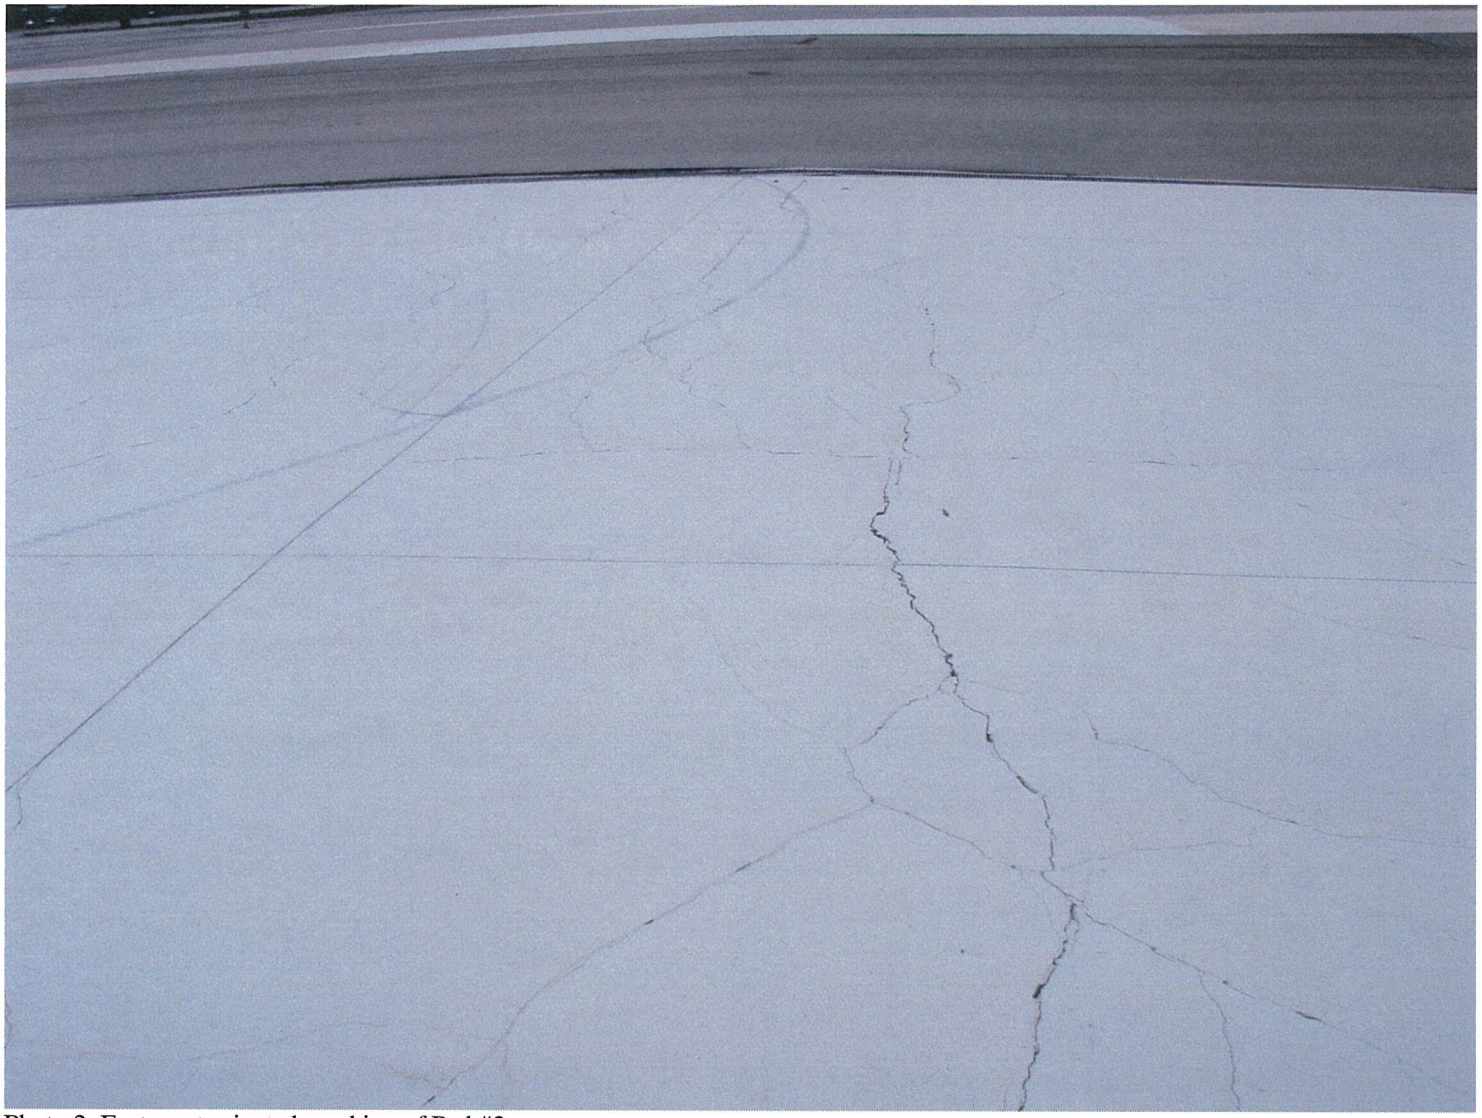
Photo 2: East-west oriented cracking of Pad #2.

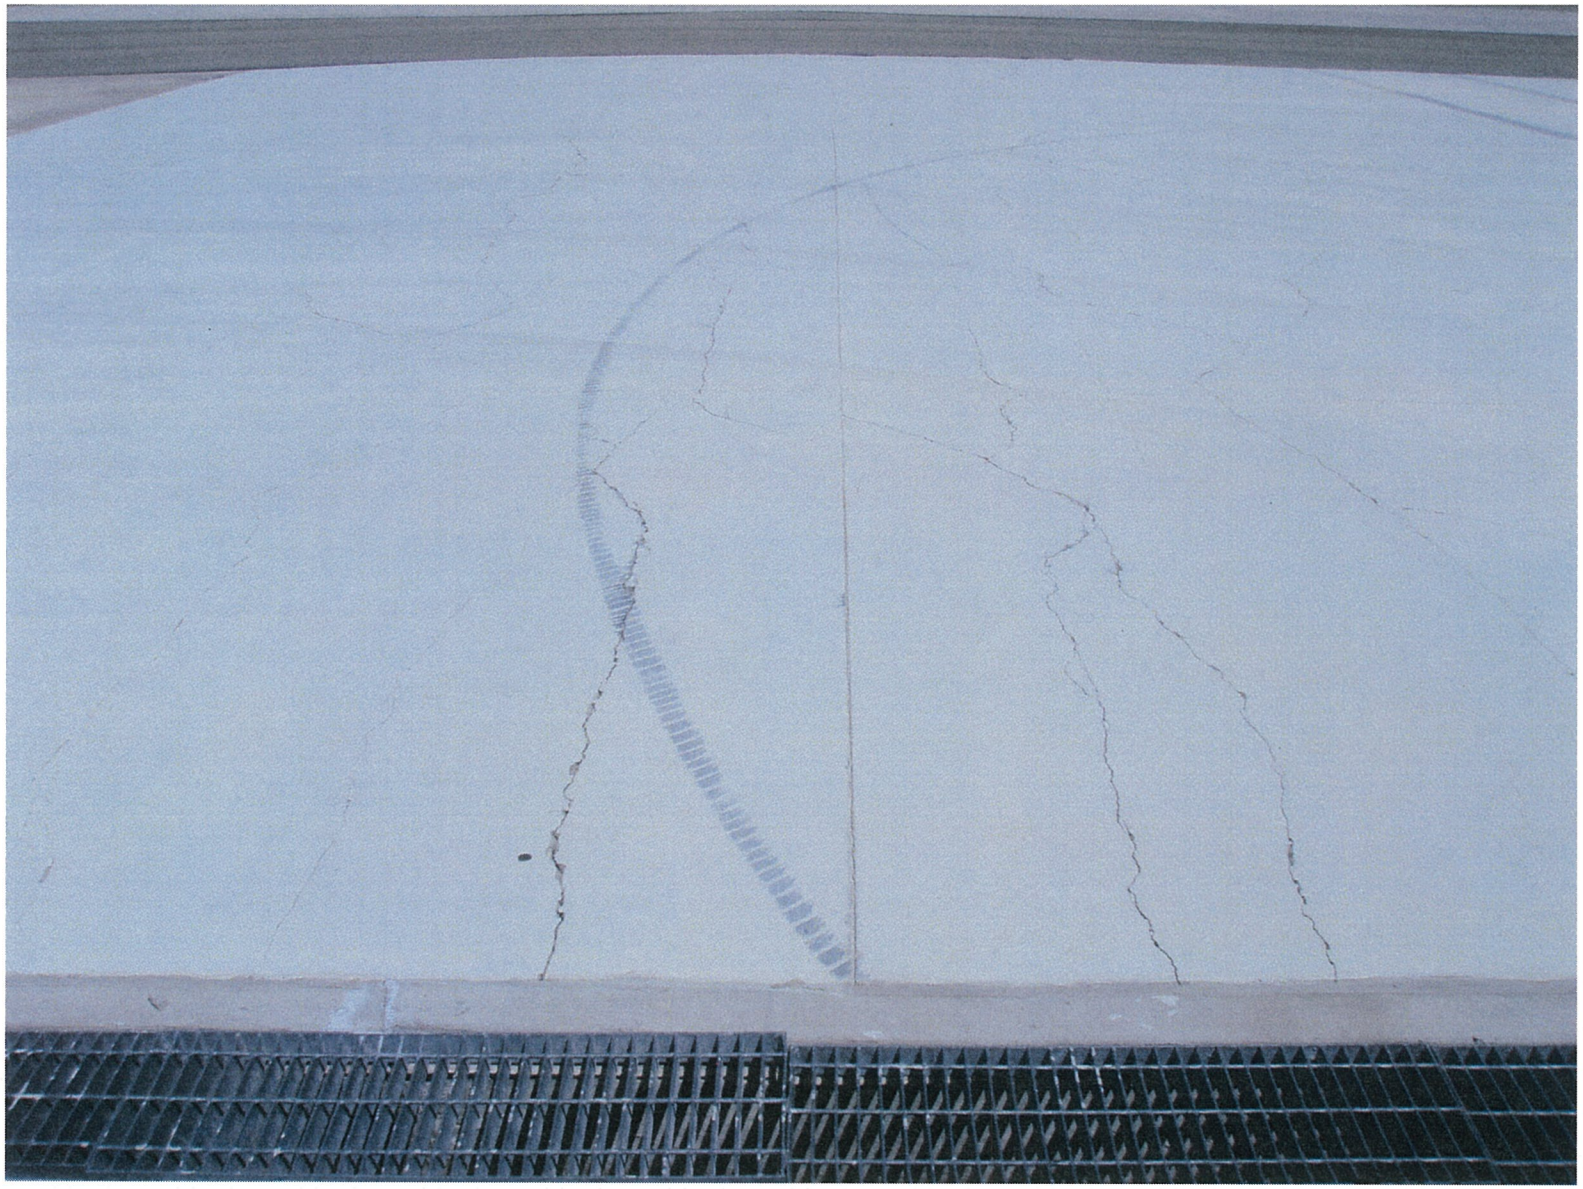
Photo 2: Cracks in Pad #3.

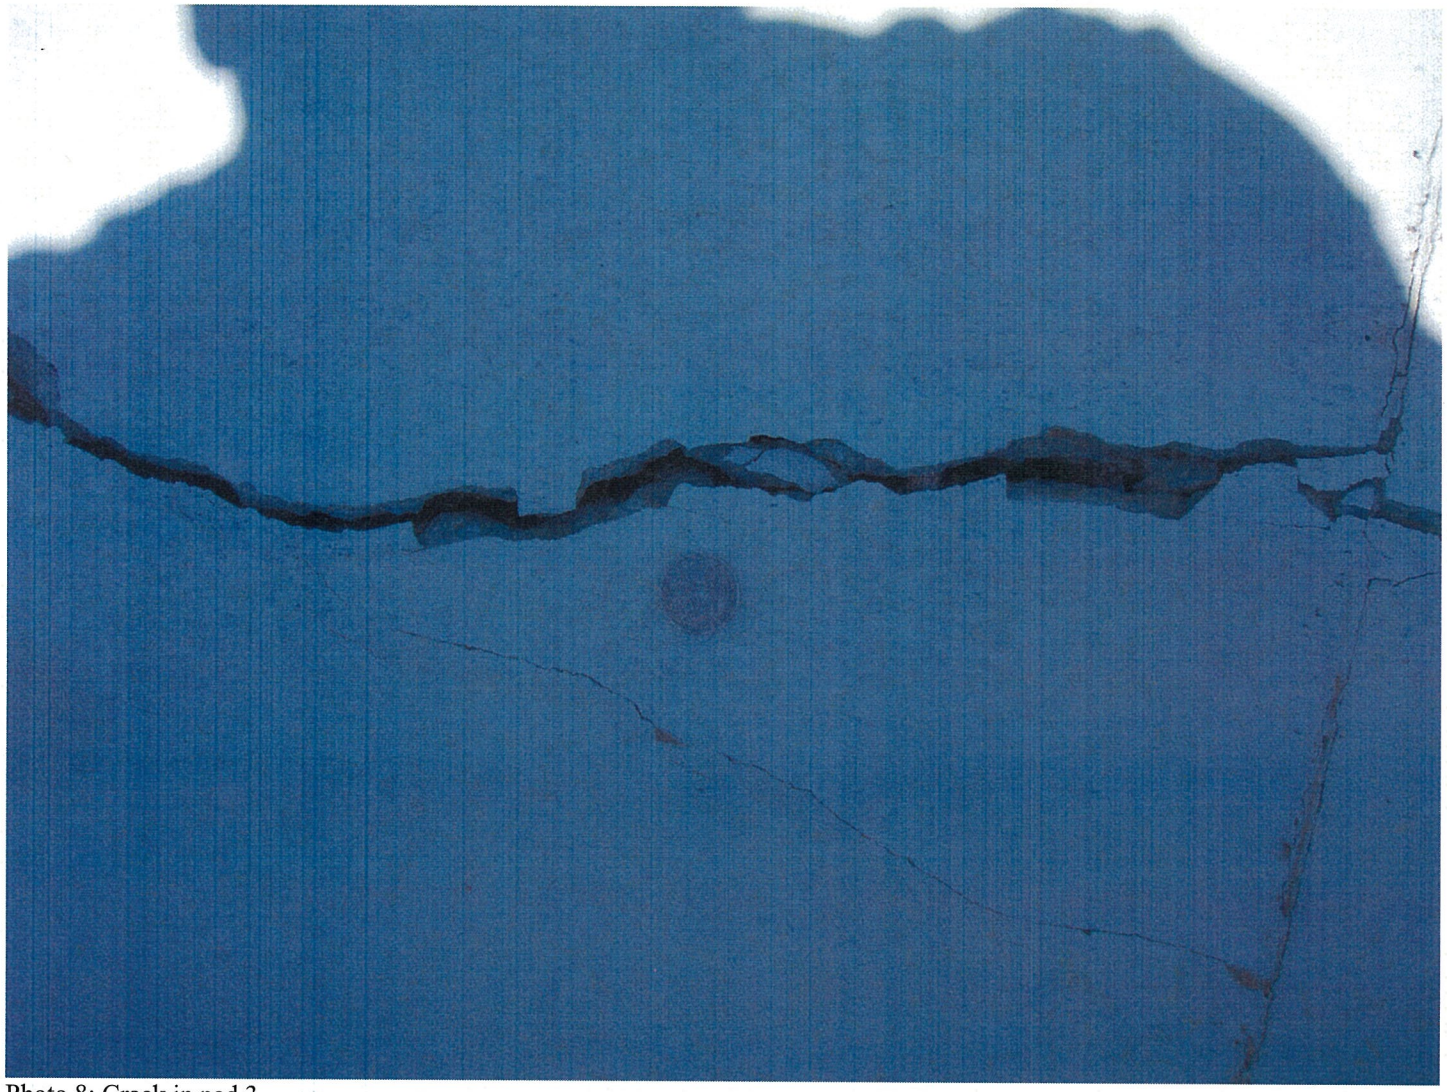
Photo 8: Crack in pad 3.

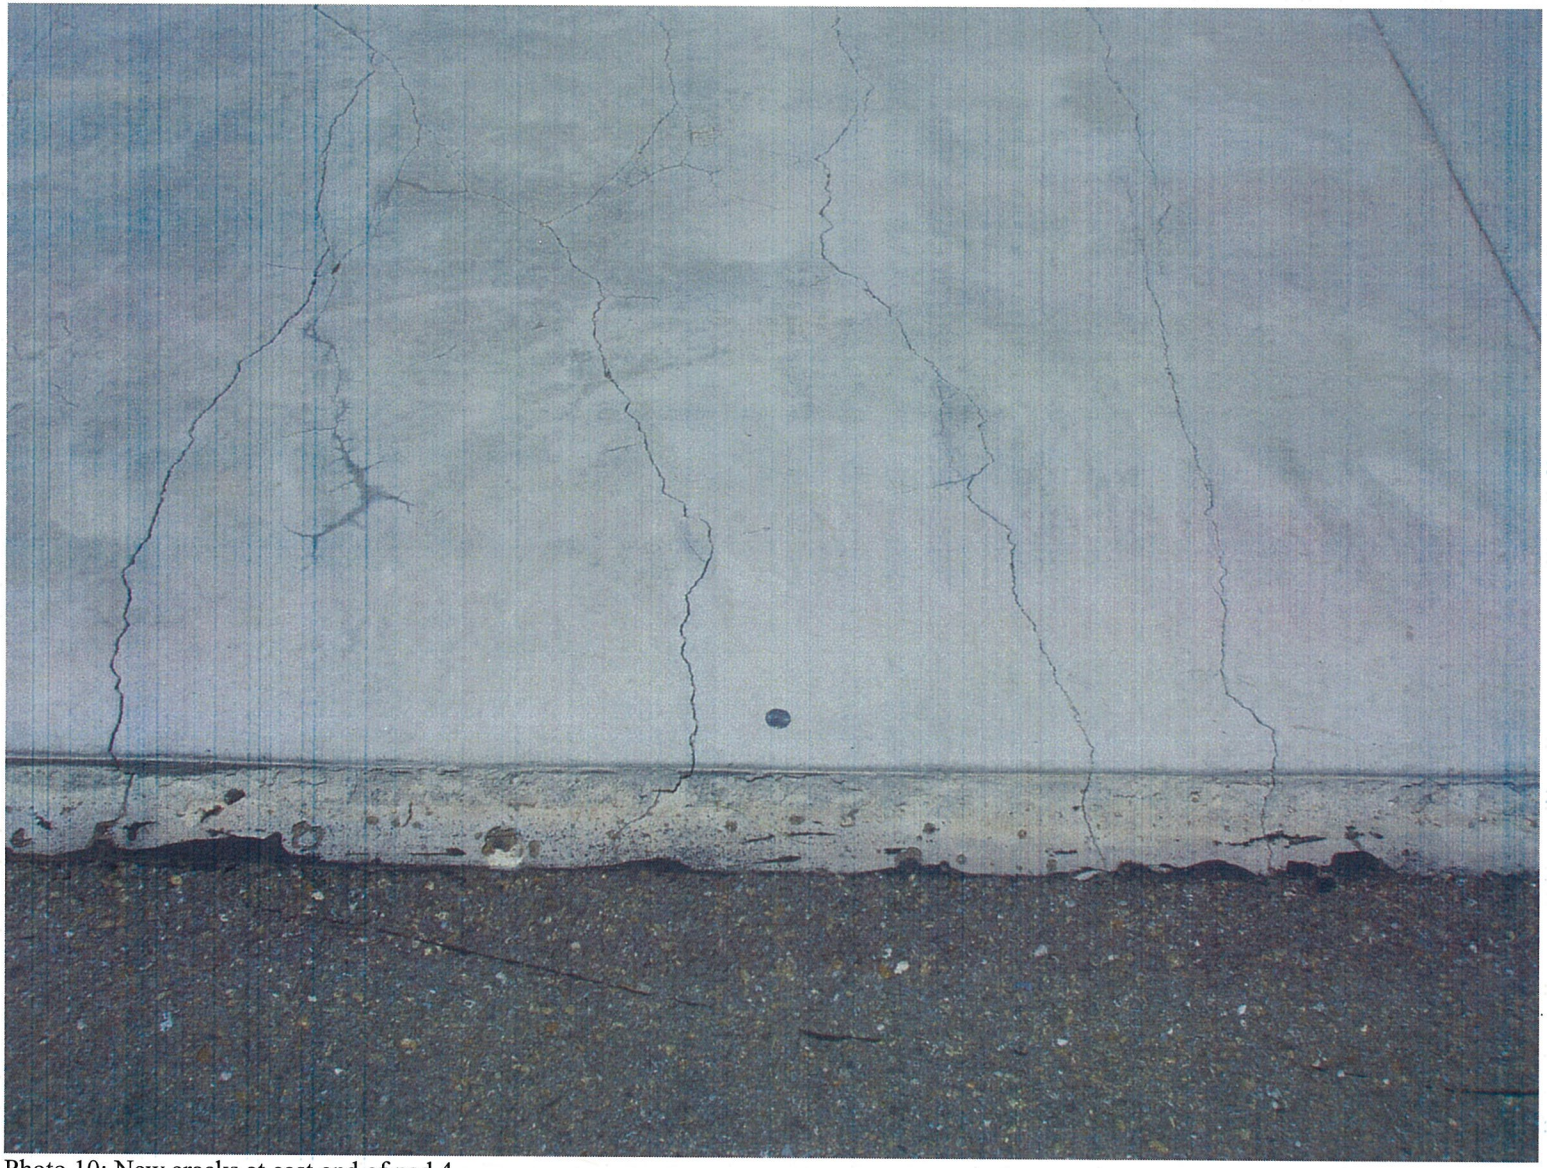
Photo 10: New cracks at east end of pad 4.

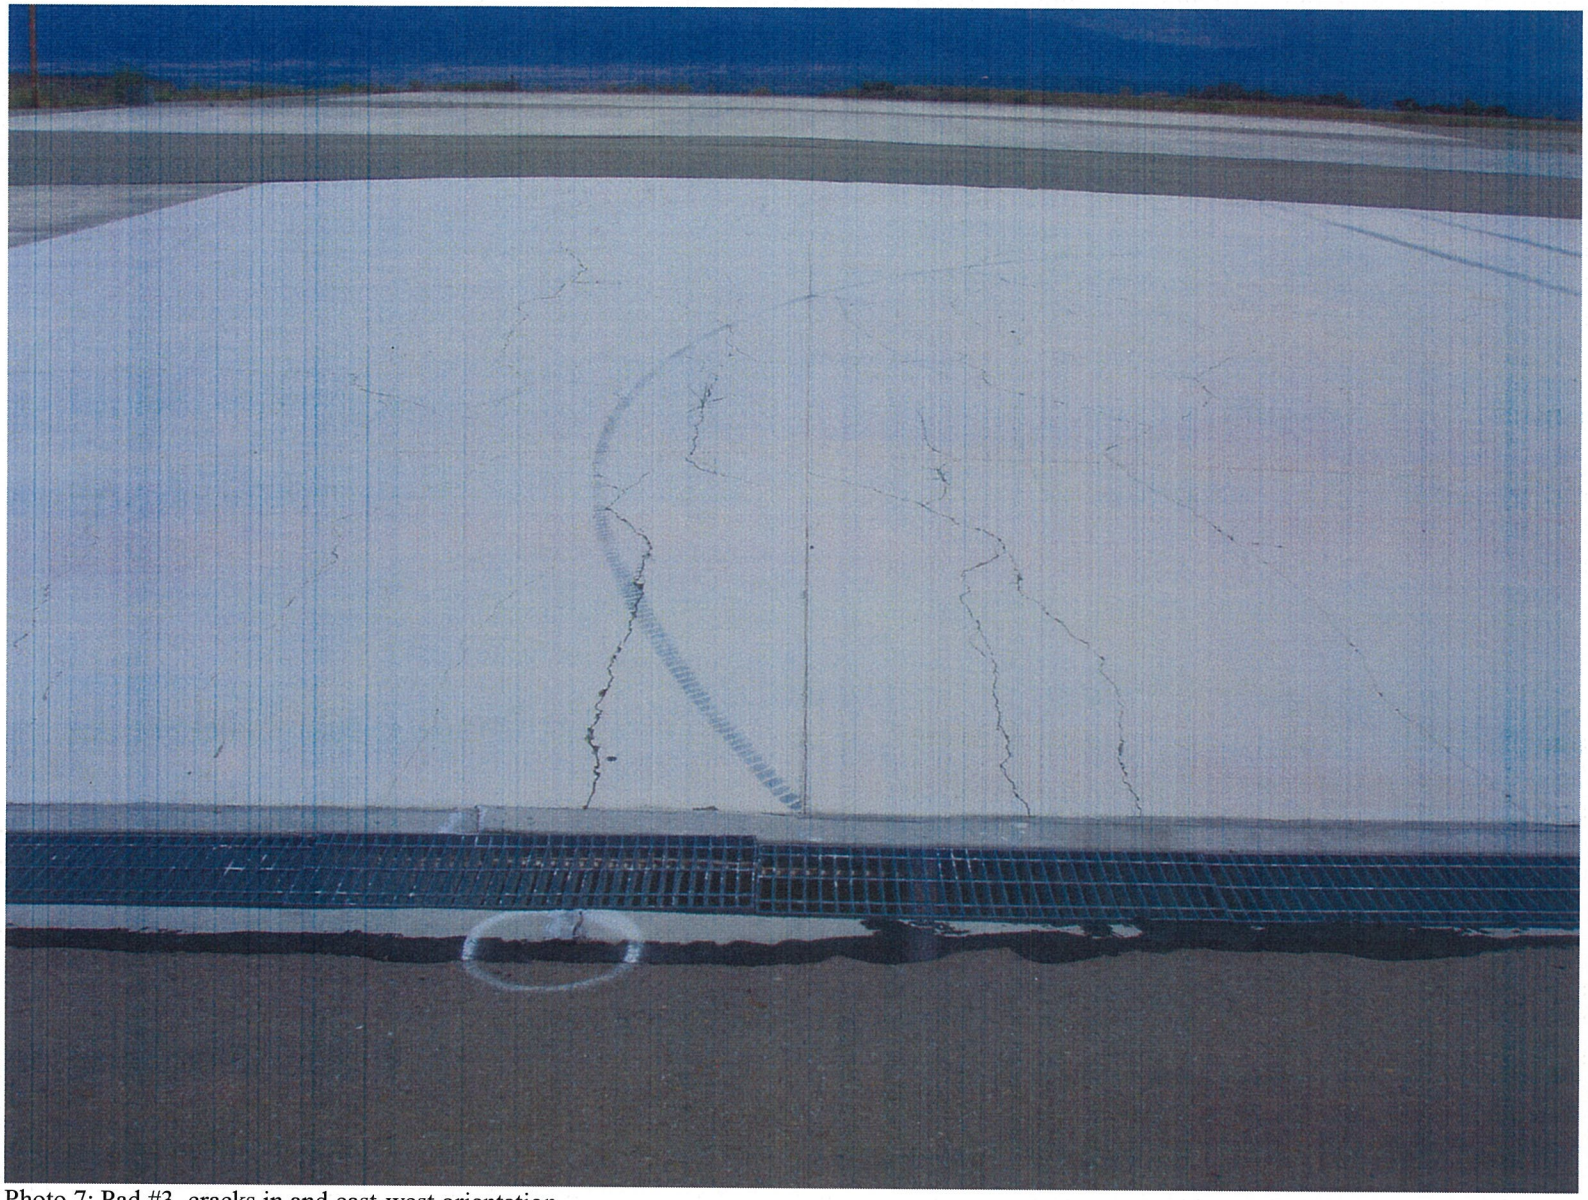
Photo 7: Pad #3, cracks in and east-west orientation.

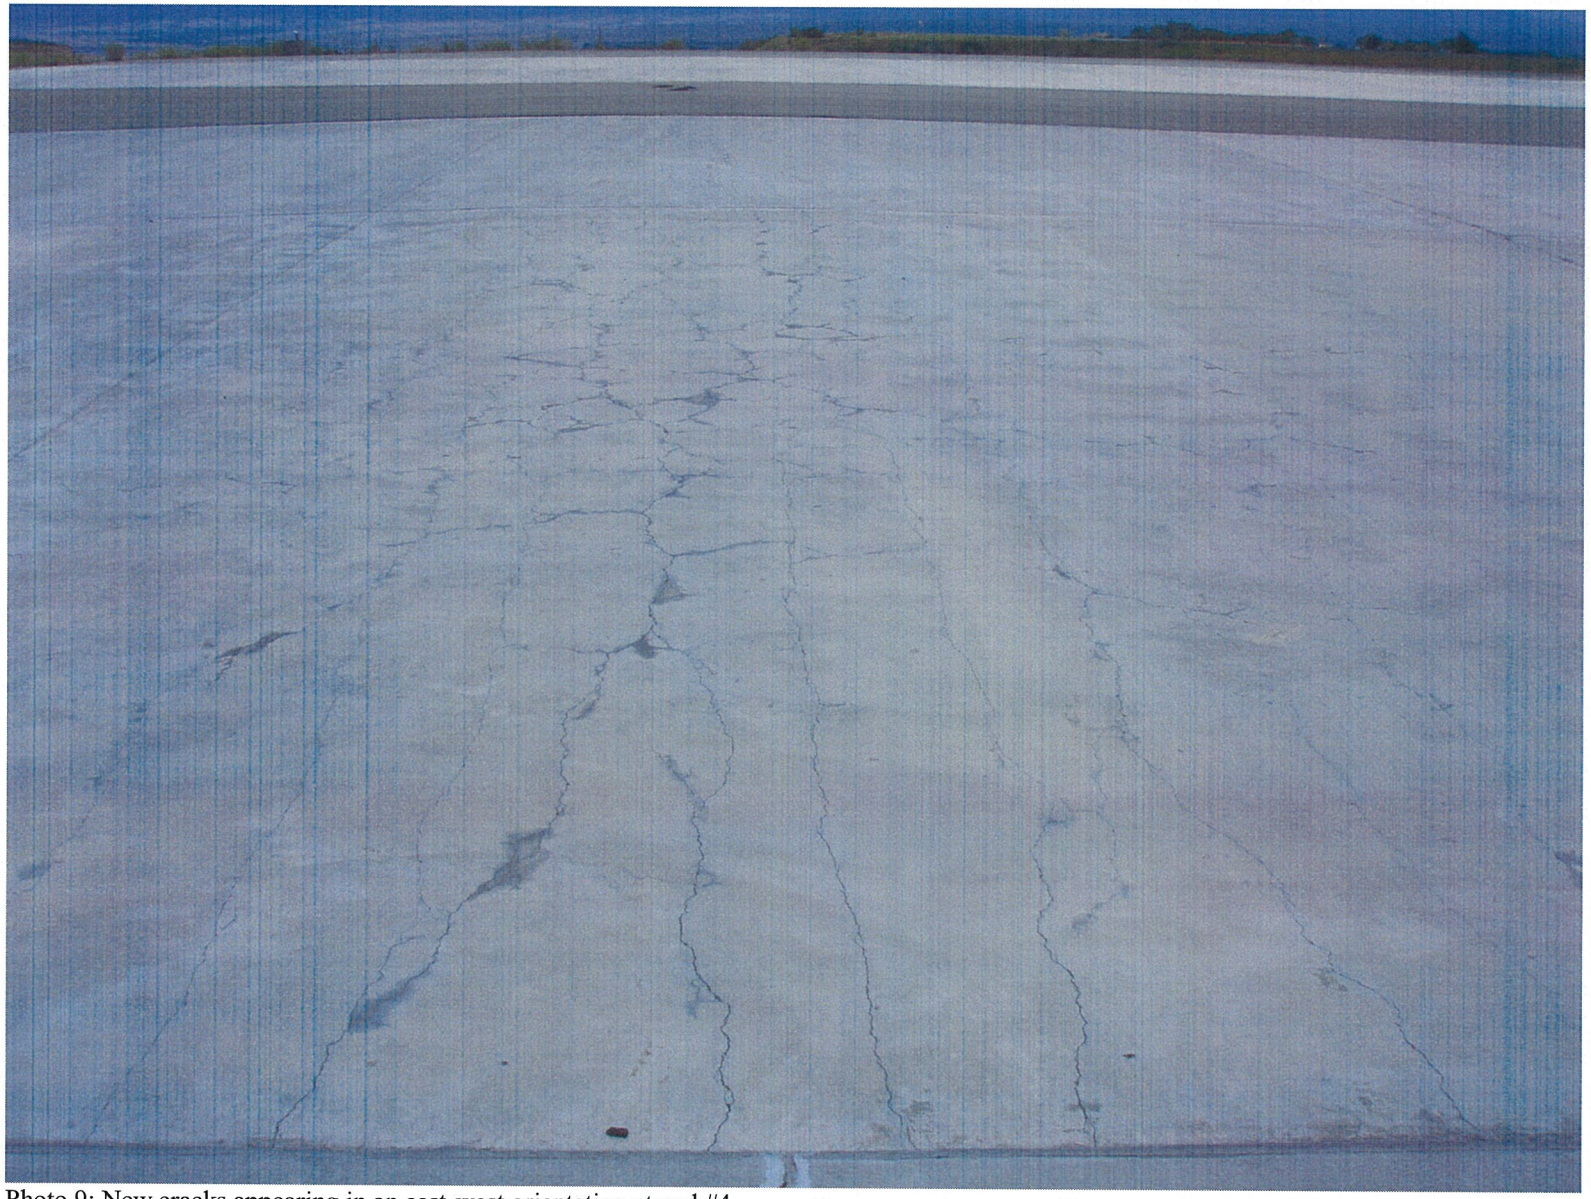
Photo 9: New cracks appearing in an east-west orientation at pad #4.

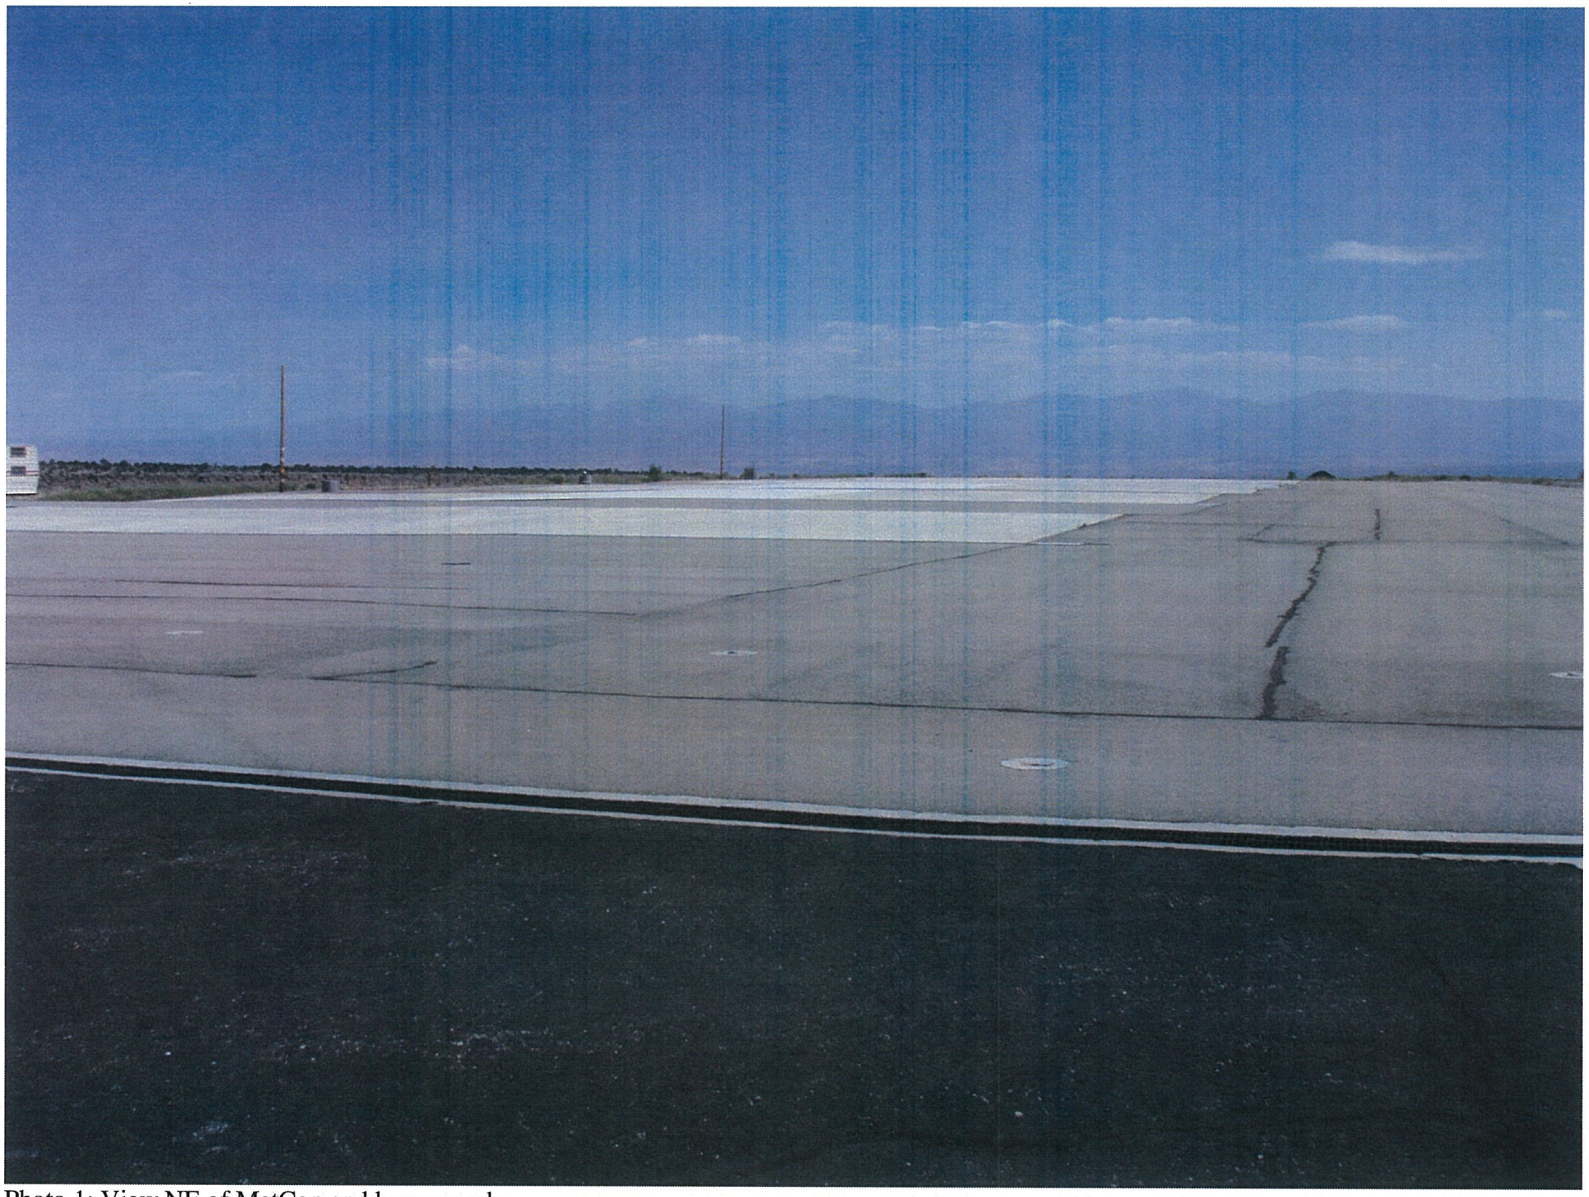
Photo 1: View NE of MatCon and hanger pads

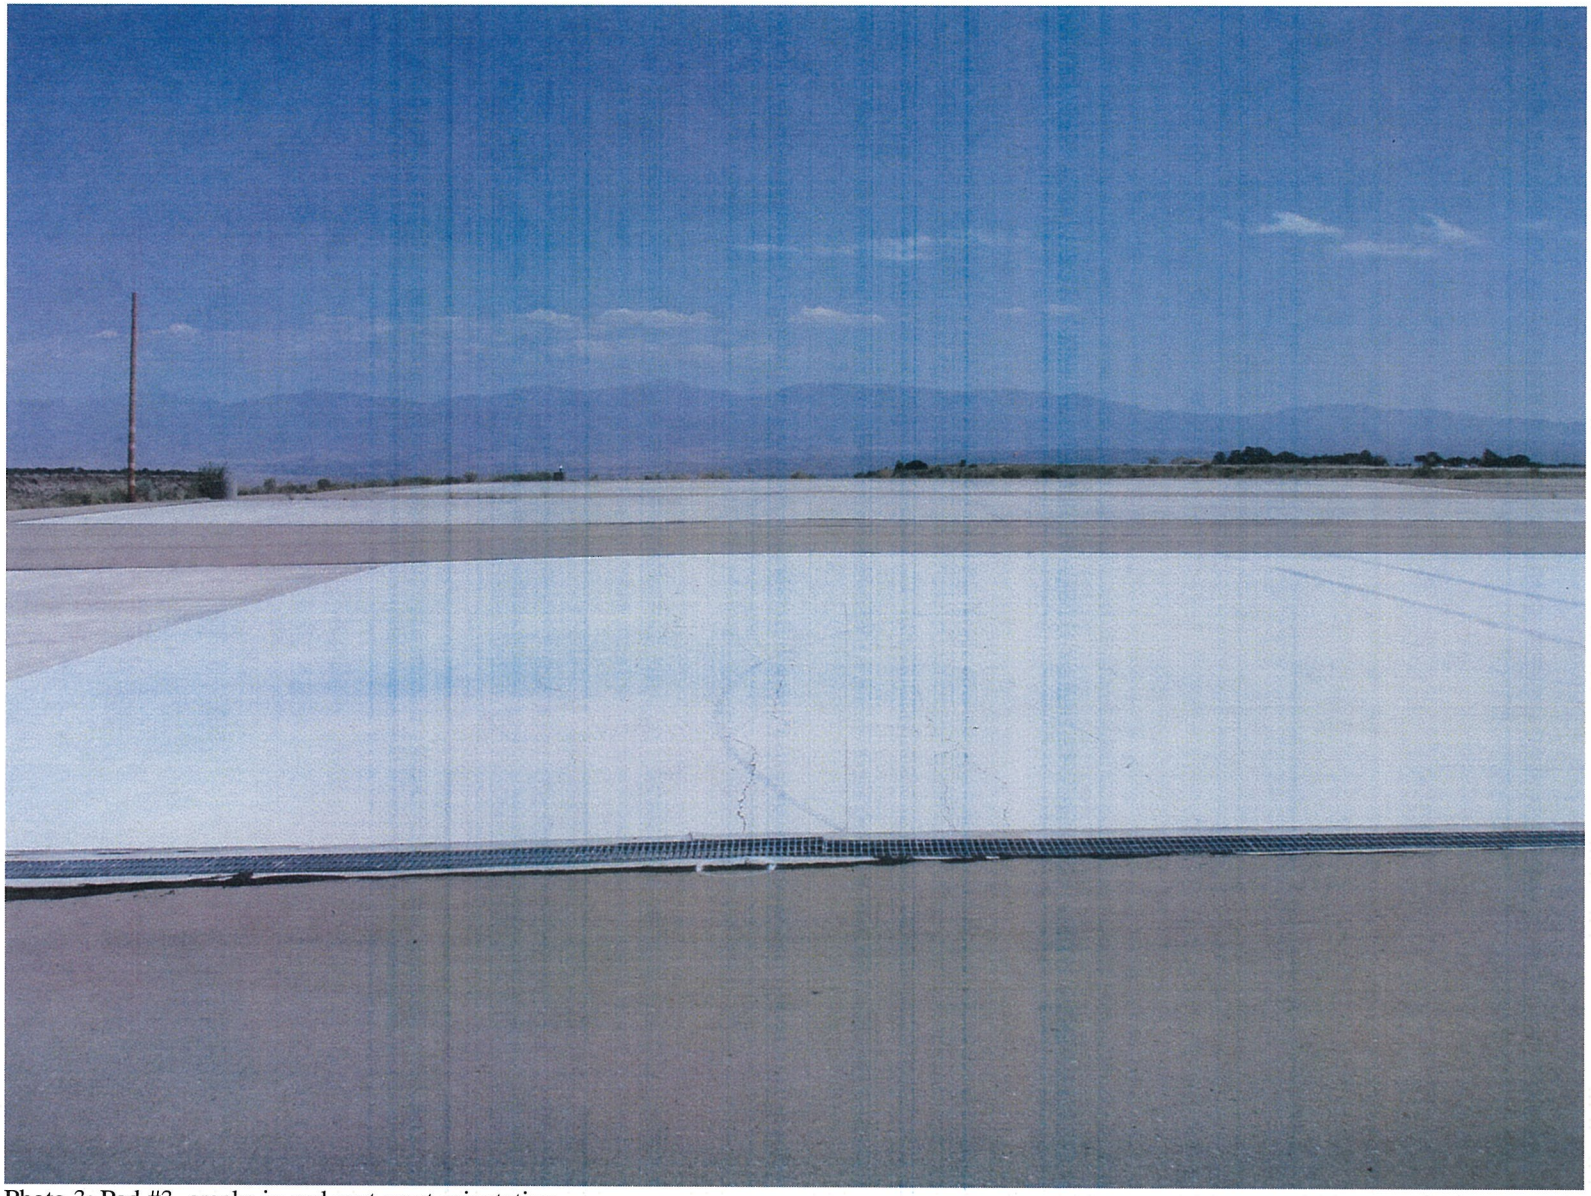
Photo 3: Pad #3, cracks in and east-west orientation.

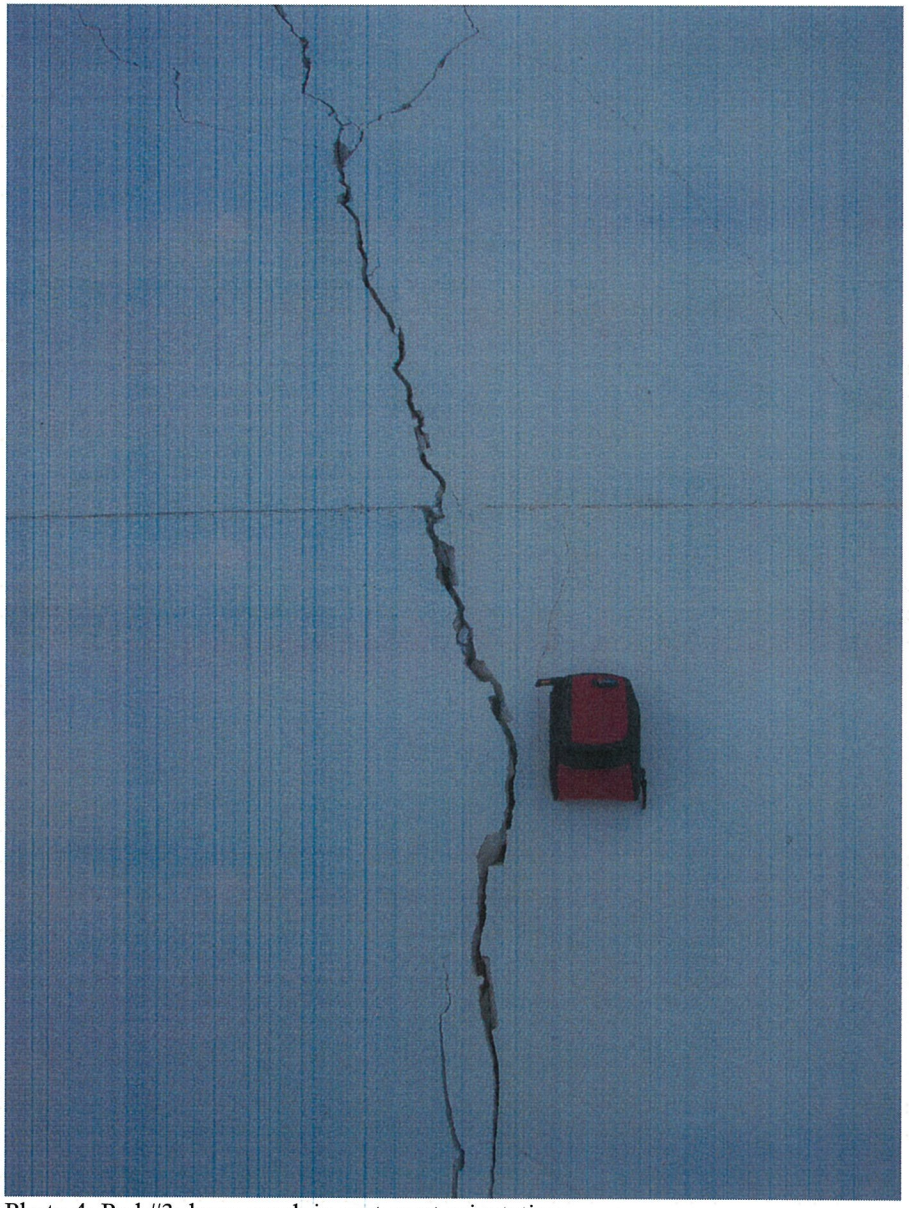
Photo 4: Pad #3, large crack in east-west orientation.

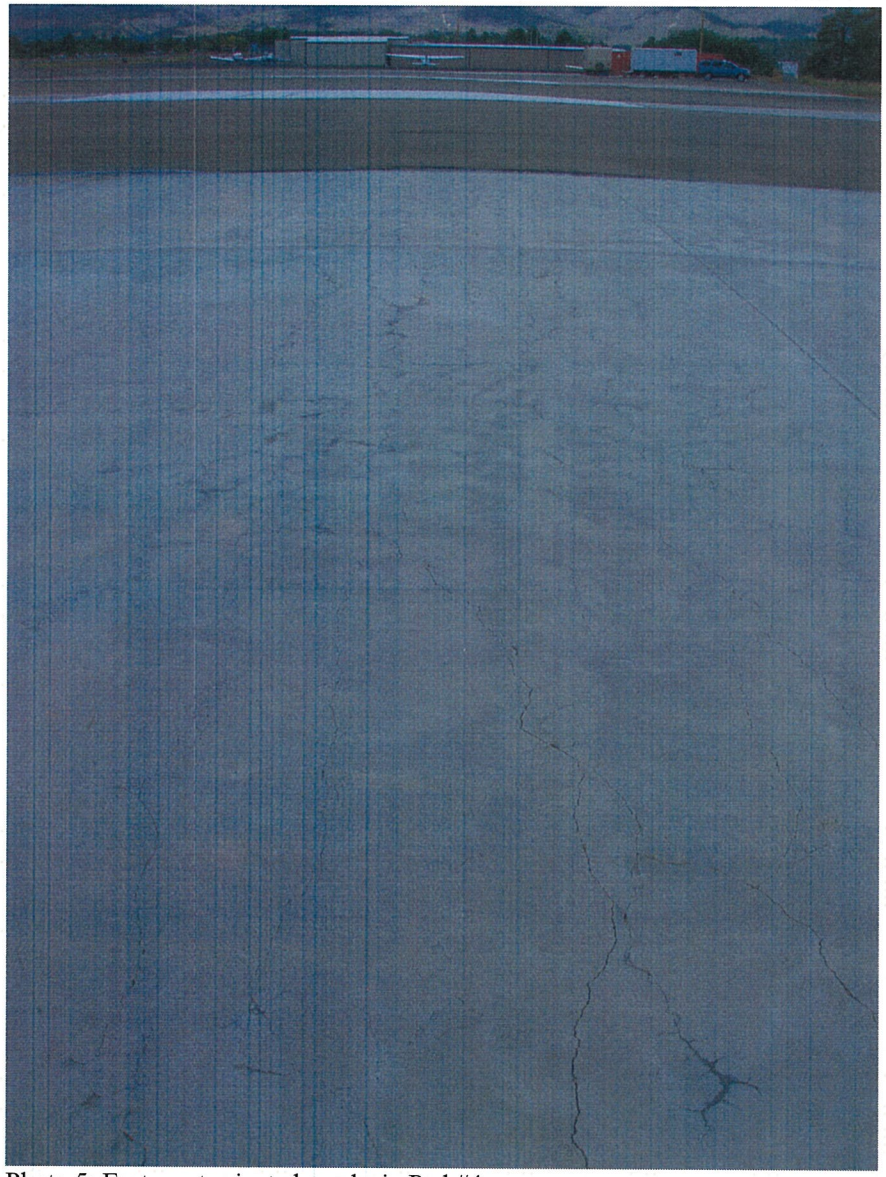
Photo 5: East-west oriented cracks in Pad #4.
