Date: FEB 14 2013
Refer To: EP2013-0002

Subject: Submittal of the 2012 Annual Inspection Report for Los Alamos County Airport Landfill, Solid Waste Management Units 73-001(a) and 73-001(d), Technical Area 73

Enclosures: Two hard copies with electronic files – 2012 Annual Inspection Report for Los Alamos County Airport Landfill, Solid Waste Management Units 73-001(a) and 73-001(d), Technical Area 73 (LA-UR-13-20302)

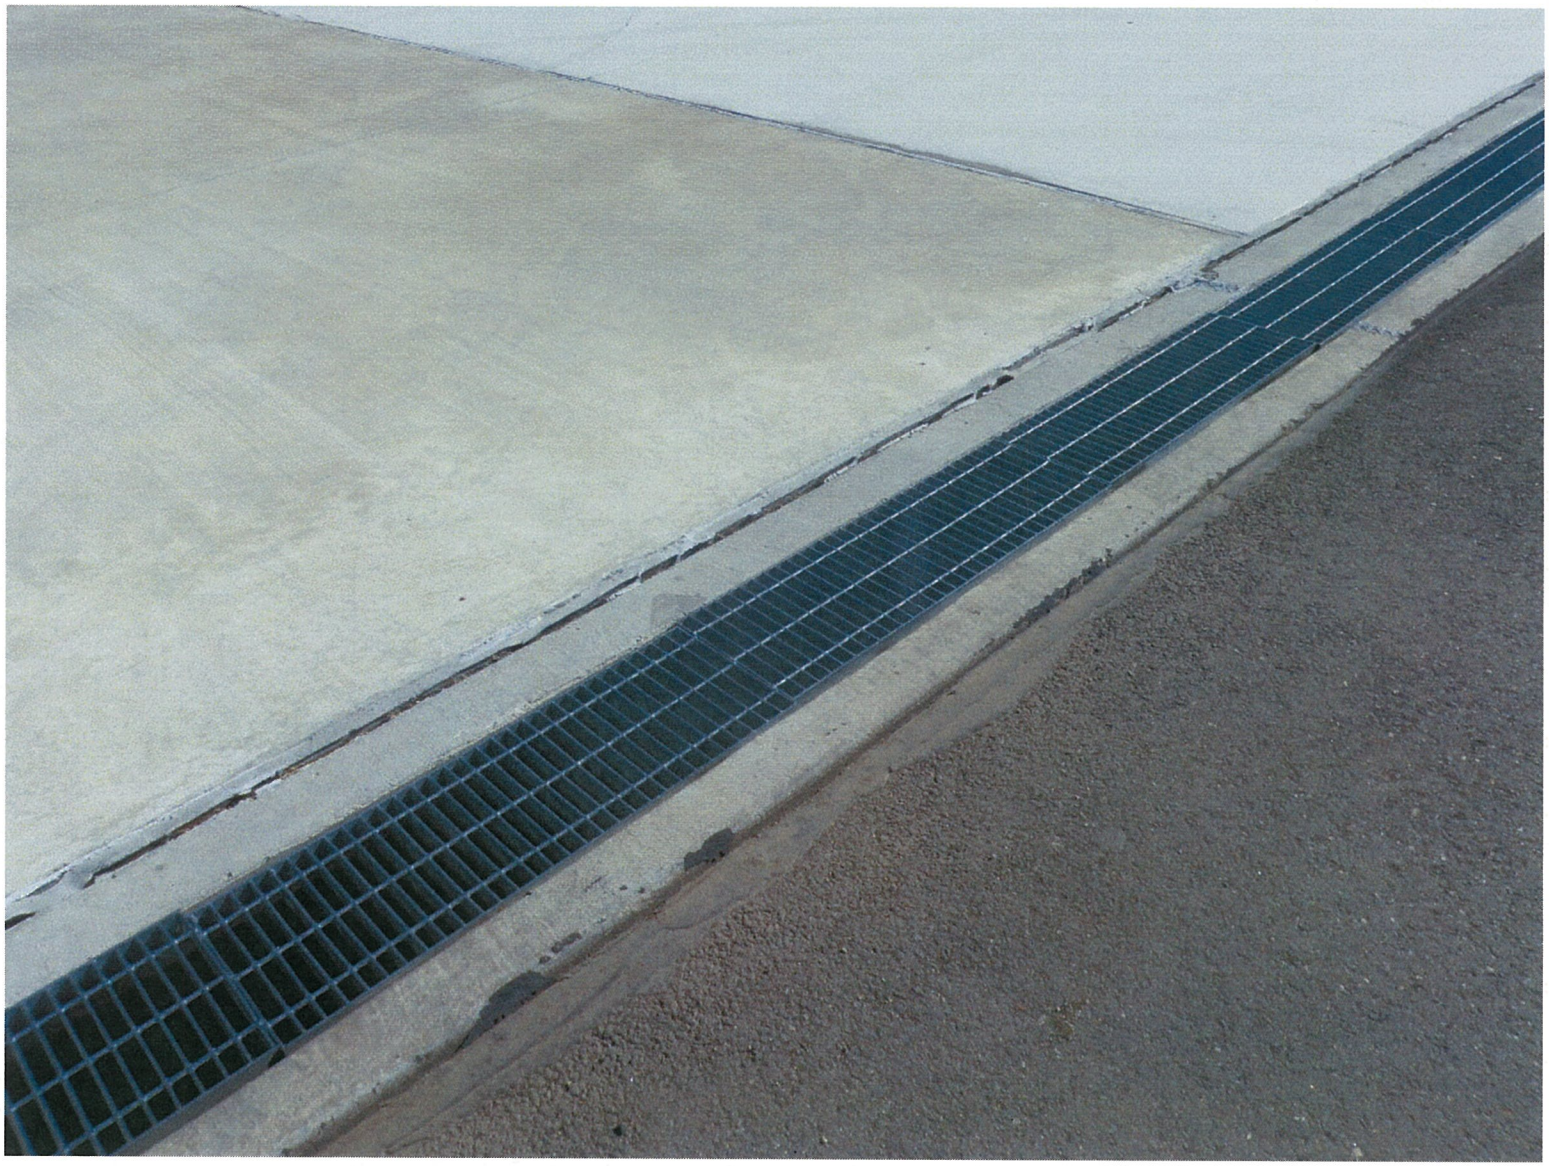
Photo 4: Pad #3 separation of trench drain from pad

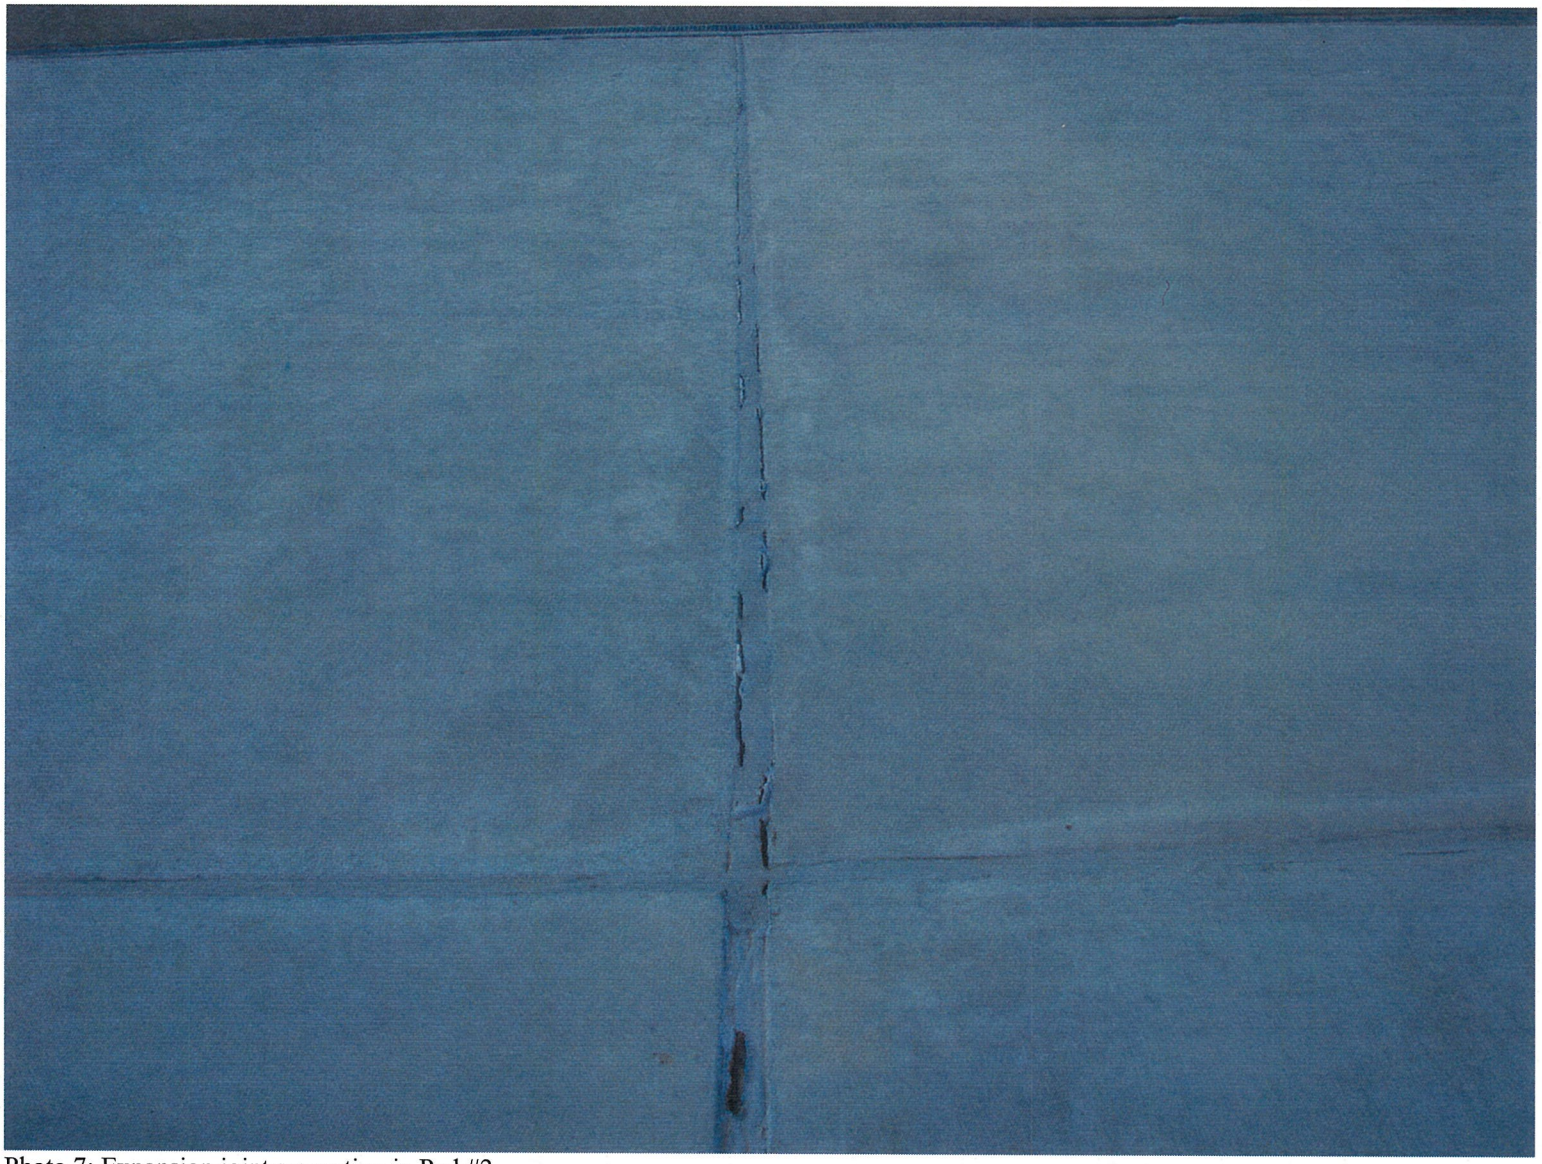
Photo 7: Expansion joint separation in Pad #2.
