DOE Issues WIPP Radiological Release Phase II Investigation Report

Phase II Accident Investigation Board Briefing

On February 14, 2014, an airborne radiological release occurred at the Department of Energy Waste Isolation Pilot Plant (WIPP) near Carlsbad, New Mexico. On March 4, 2014, an Accident Investigation Board (the Board) was appointed by Matthew Moury, Deputy Assistant Secretary, Safety, Security, and Quality Programs to determine the cause of the release. Because access to the underground was restricted following the event, the investigation was broken into two phases. The first phase, Phase 1, focused on how the radiological material was released into the atmosphere and the results were issued on April 22, 2014, in a Phase 1 investigation report.

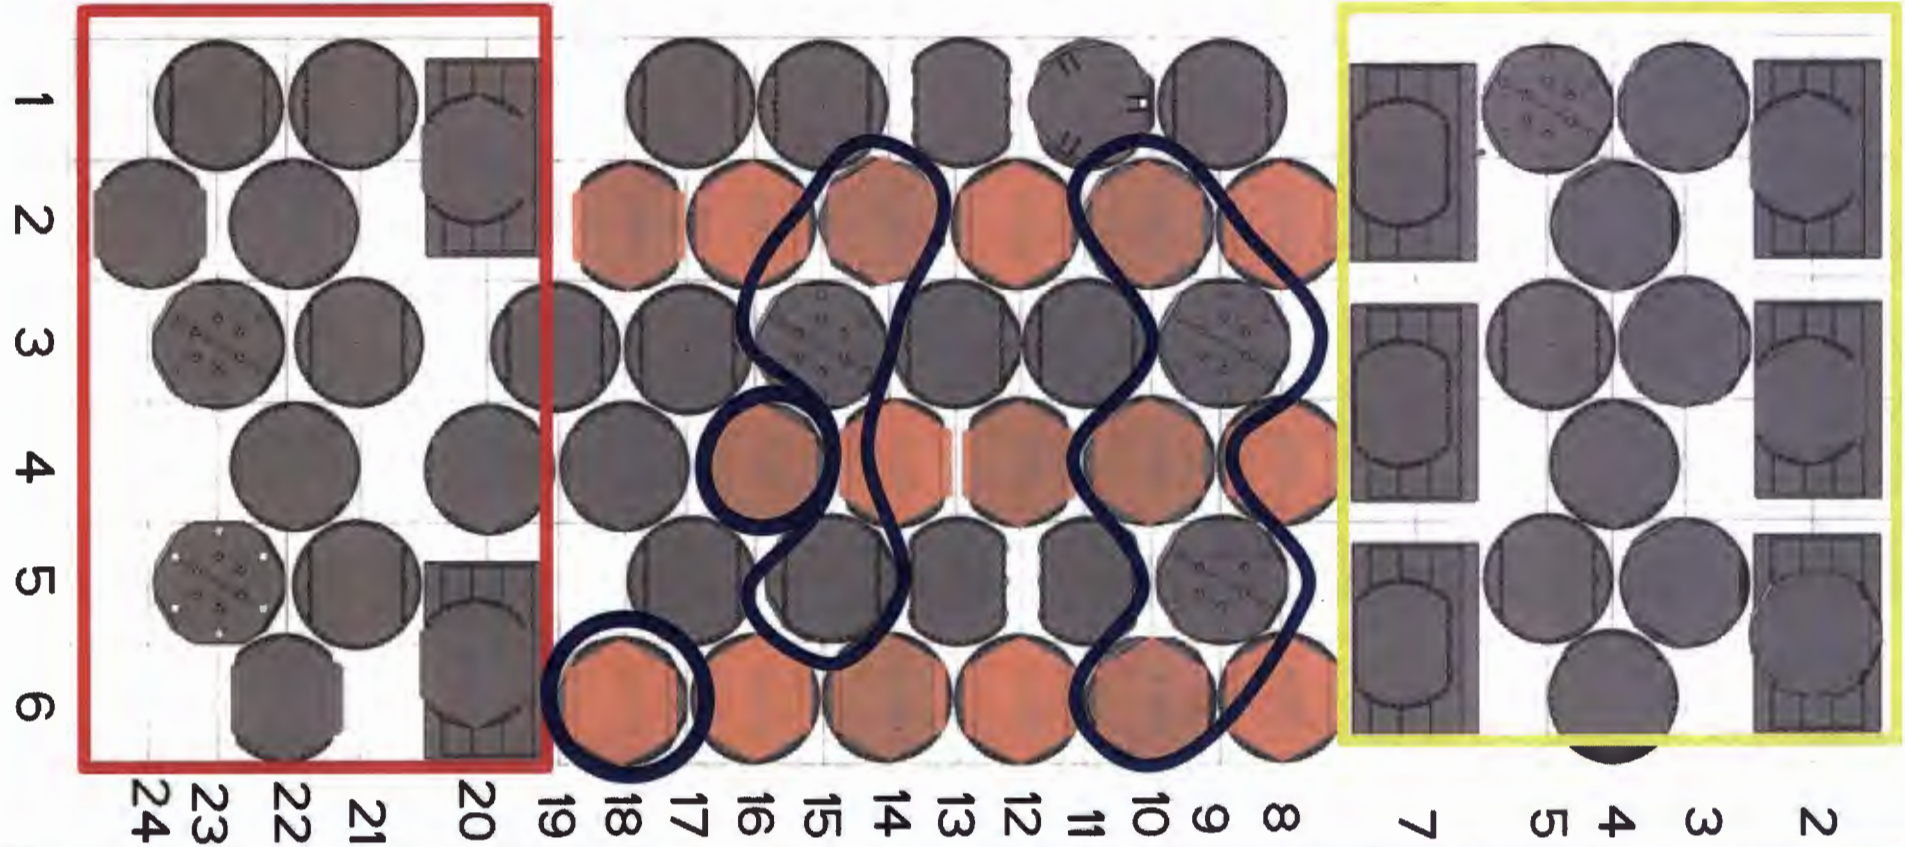
Waste Face & Rows 19 - 24

- **No damage**
  - Waste containers
  - MgO super sacks
  - Emplacement materials

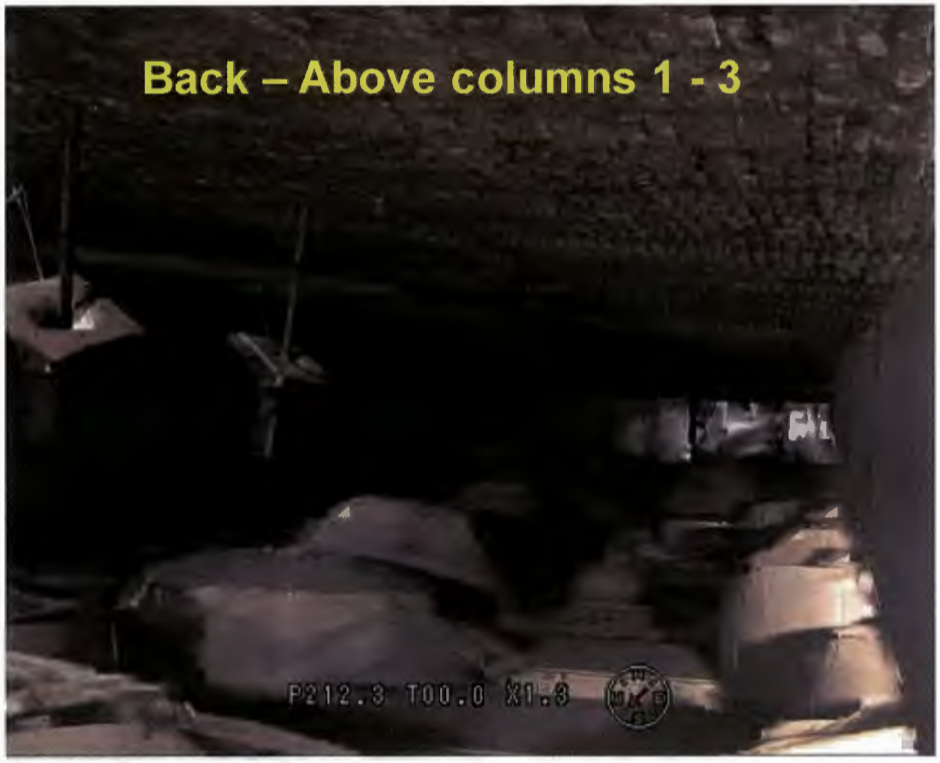
No Damage to Plastics Rows 2 - 7

Isolated Damage at R7:C5

Damage at R18:C6

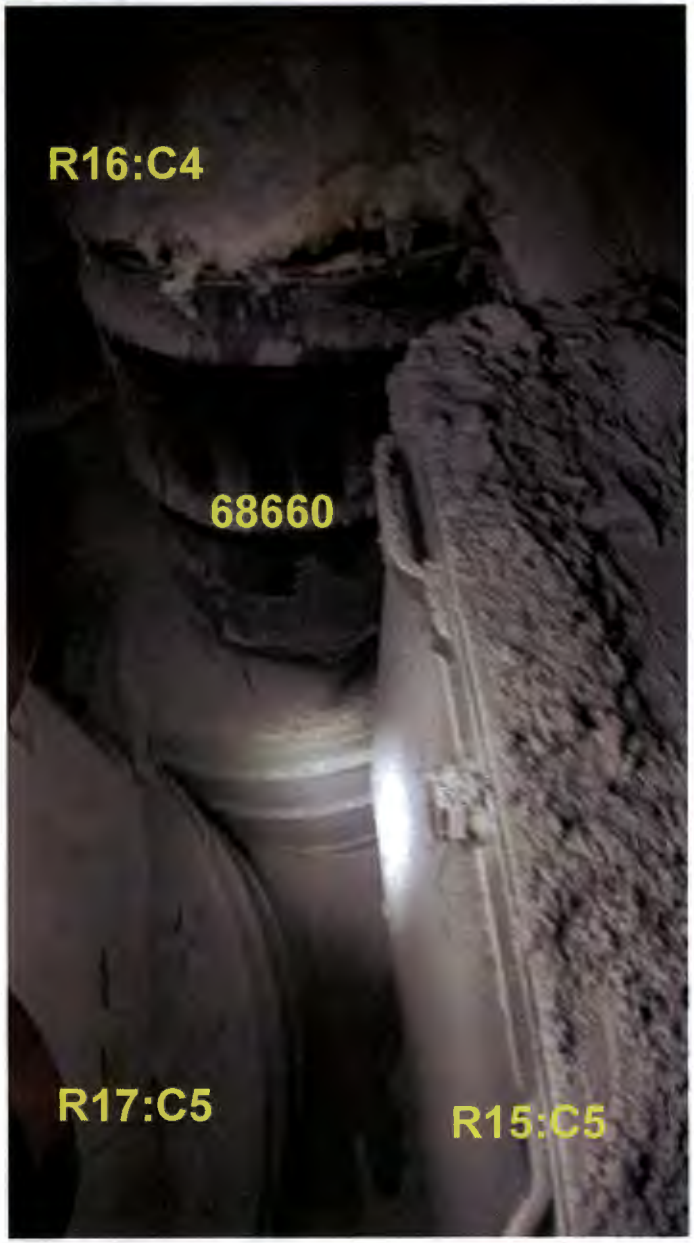
R16:C4
68660
R17:C5
R15:C5

- Event initiated at R16:C4 – Drum 68660
- Ruled out initiation in R15:C5
- Ruled out other start locations
- Greatest damage at areas with most exposed combustibles
- Demonstrated importance of ember transfer propagation
- Radiological and chemical analyses were similar to the TAT results

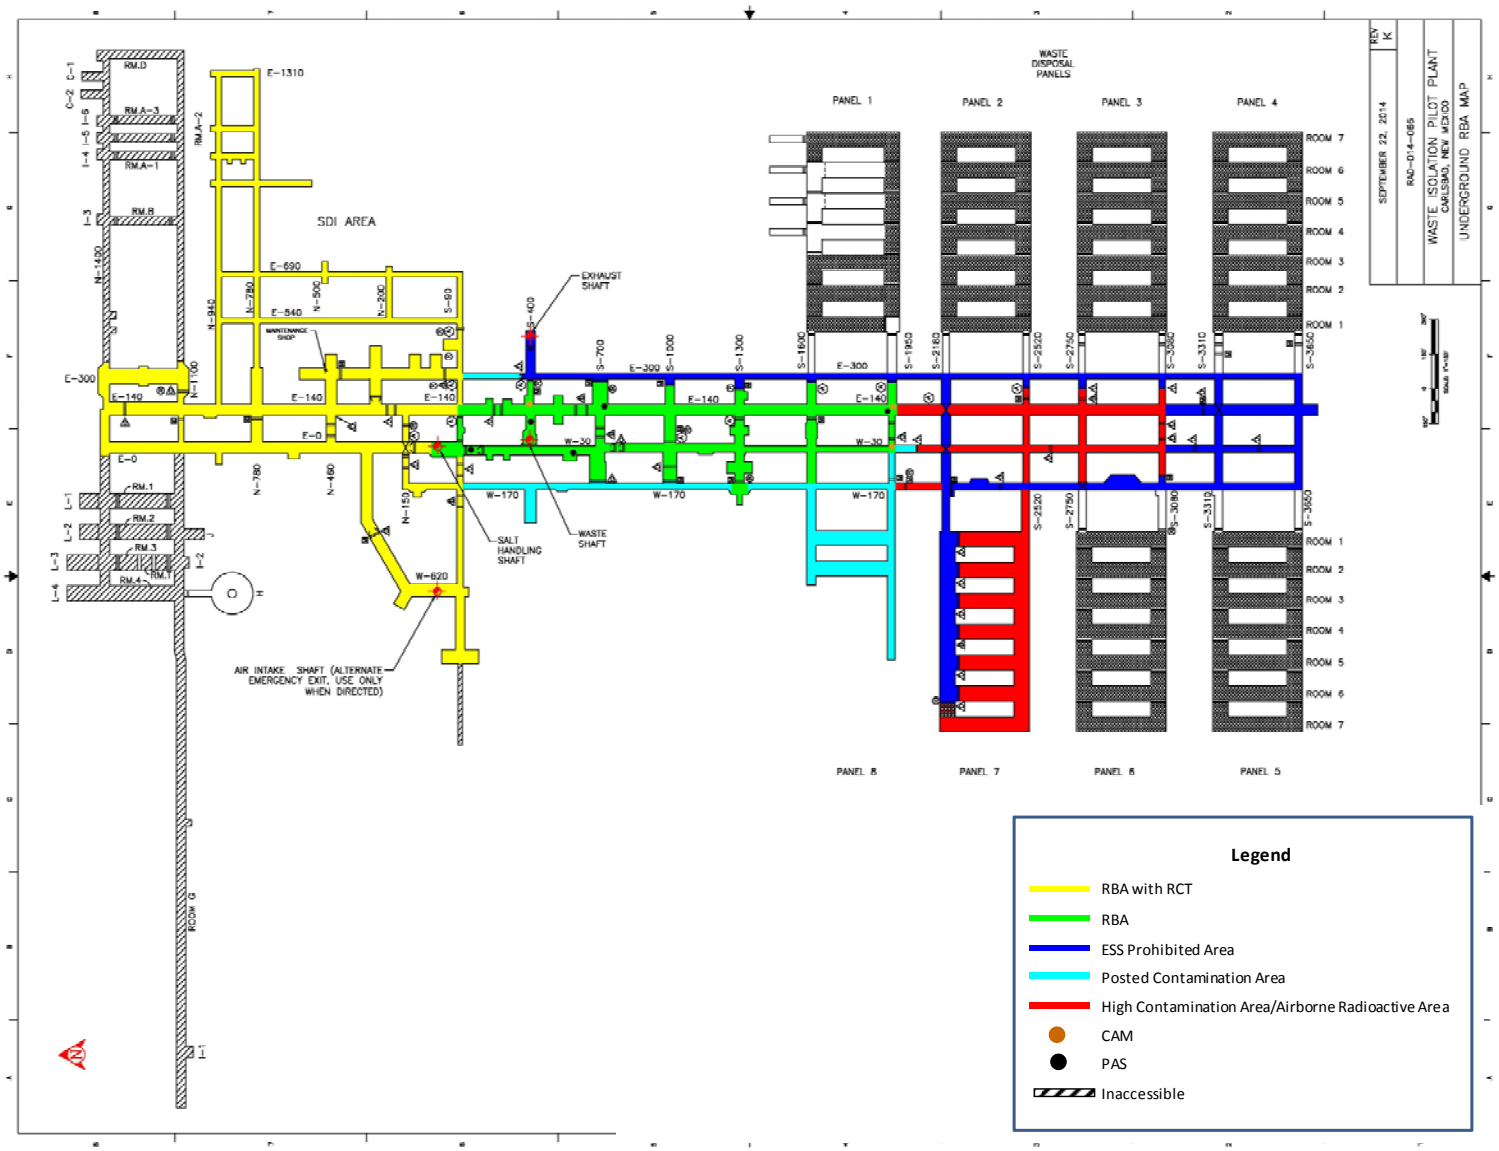
Figure 2-1: WIPP Underground RBA Map

activity contamination levels, with no beta or dose rate information collected. Radiological survey results of Panel 7 indicated that the general surface alpha contamination levels in Room 7 of 8,000 – 40,000 dpm, Room 6 of 10,000 – 20,000 dpm, and Room 1 of 6,000 – 28,000 dpm. More specific details are provided in Section 6.3, Radiological Forensics (Figure 2-1).

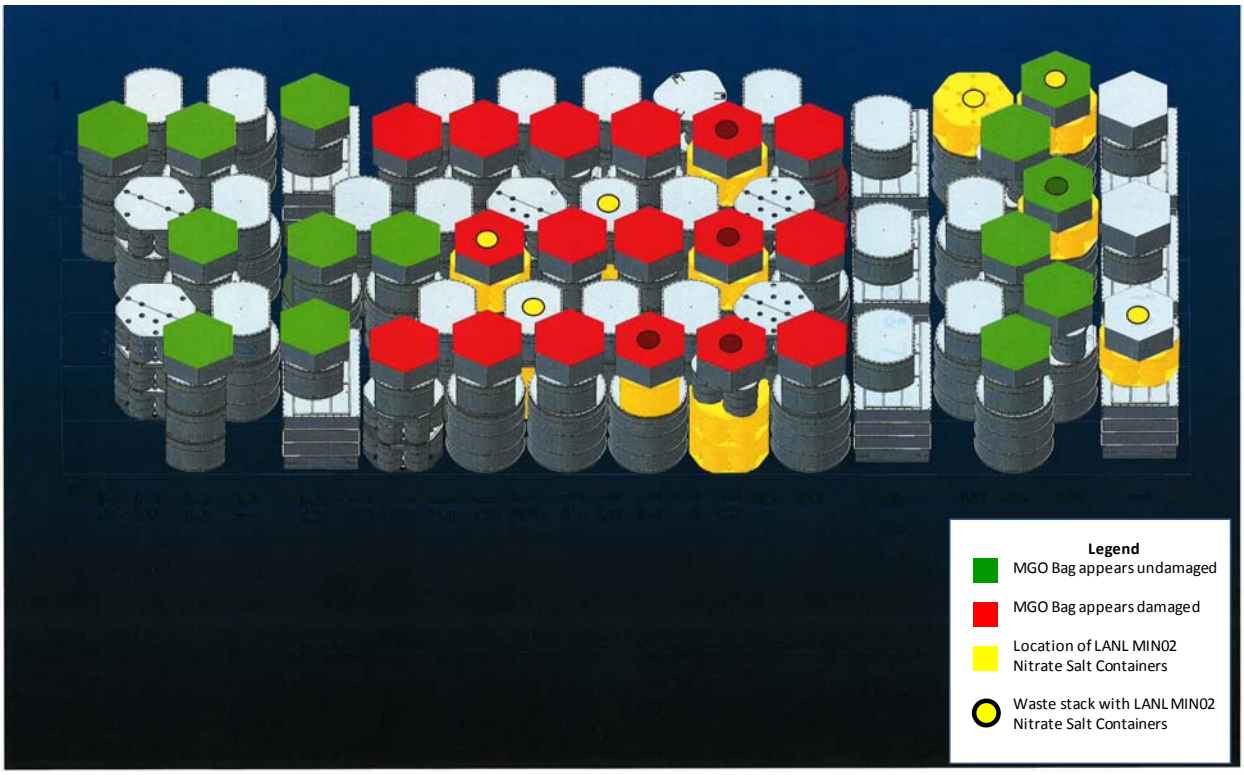
Figure 2-4: Panel 7, Room 7 Location of Damage from Event

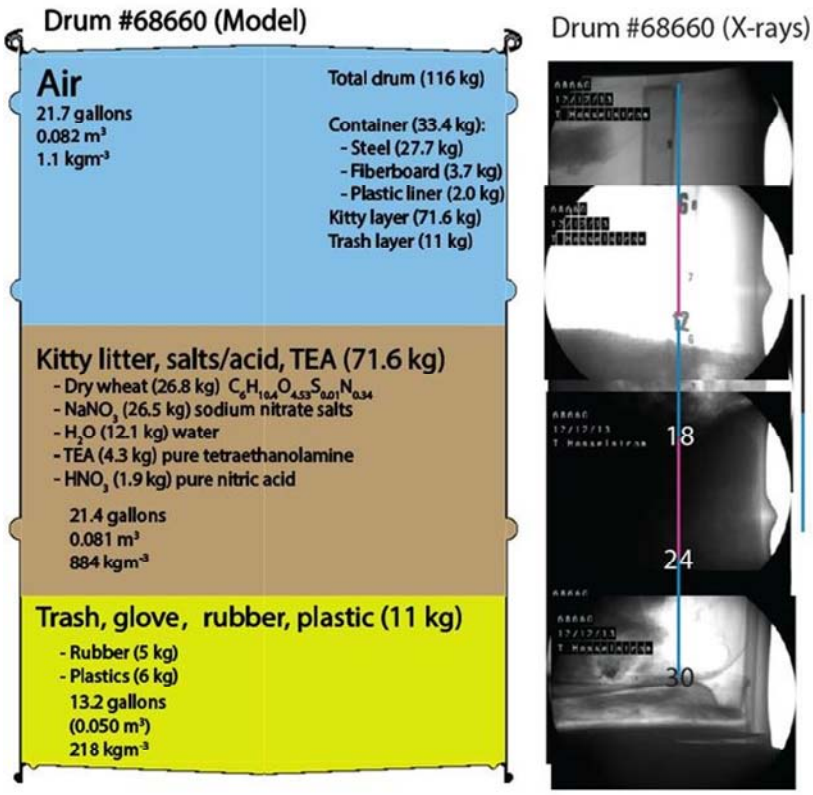
Figure 5-1: Drum 68660 Model Contents

On December 4, 2013, ES remediated parent drum S855793 in accordance with the glovebox procedure, producing daughter drums LA00000068660 (68660) and LA00000068685 (68685). Drum 68660 was repackaged by first adding some secondary waste including a tungsten-lined glovebox glove. Approximately two gallons of free liquid were decanted from the parent drum. The pH was measured and recorded to be 0 (zero). The pH was adjusted using KOLORSAFE® to an un-specified final pH. Swheat Scoop® organic kitty litter was added as the absorbent and was placed in the drum. Additional bags of nitrate salt were absorbed and placed in the drum. See Figure 5-1 for a drum contents model.

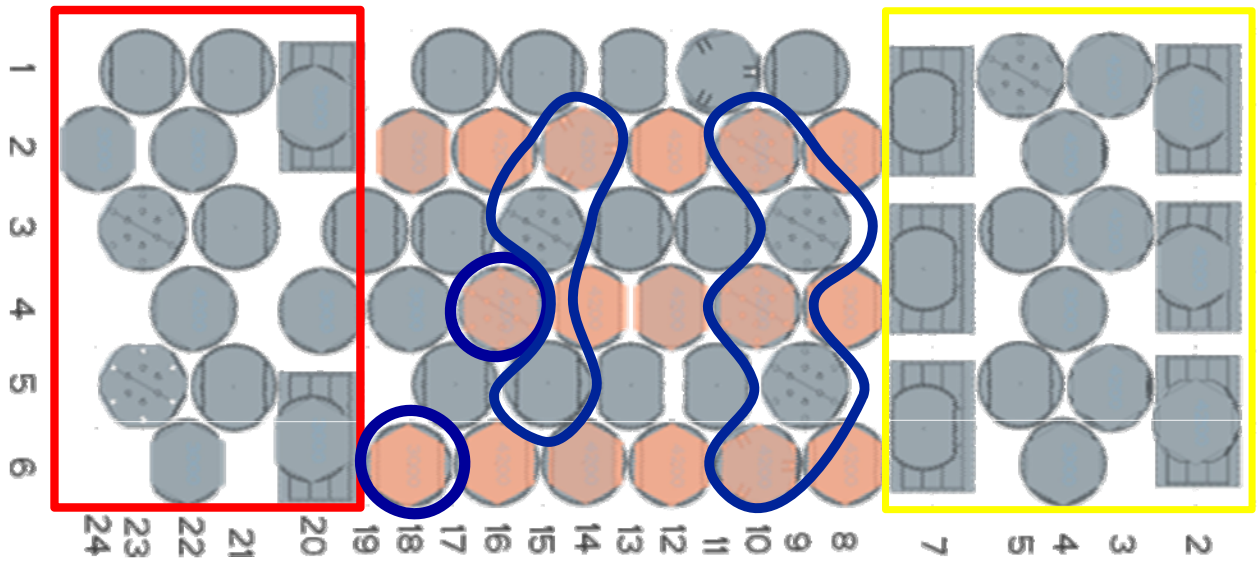
NOTE: Significantly damaged MgO Super Sacks shown in peach.

Visual damage within the waste array was most severe at, or near, locations with 55GD and 100GD. These were locations with higher quantities of combustibles external to the waste containers such as fiberboard and polyethylene slip sheets, reinforcement plates, stretch wrap, cardboard stiffeners and polypropylene super sack fabric (Figure 6-3). Evidence of both melting and ignition were identified at these locations. Polyethylene is categorized as an easy-to-ignite material and has a melting temperature range of 122 – 135°C (NFPA 921, pp 51) and the observed damage was consistent with this information.

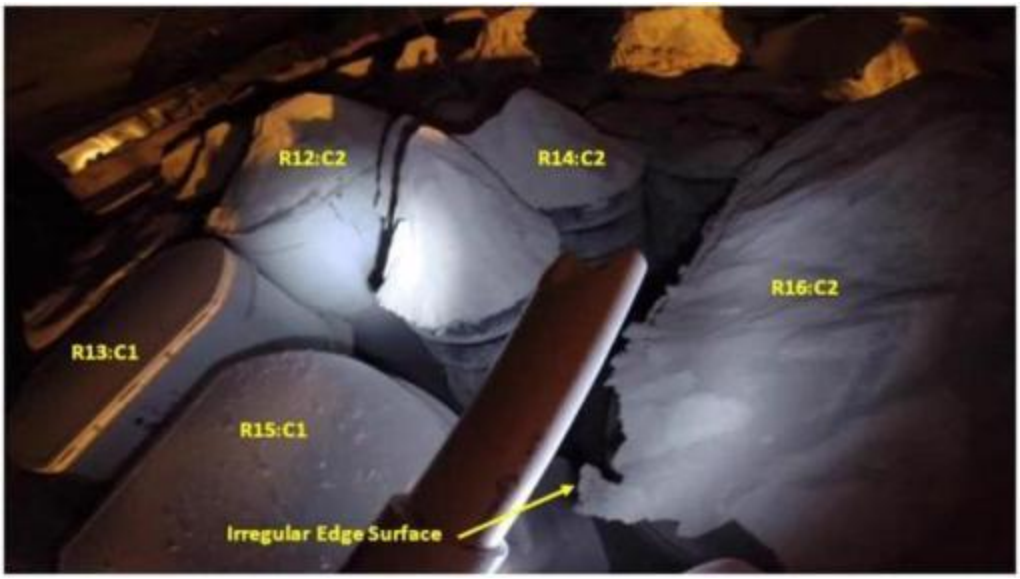
The cardboard stiffeners collapsed into multiple final orientations: hanging from a stack edge, cantilevered over the edge of a waste package, bridging between two stacks, or resting on the floor. Some of the locations where the stiffeners were cantilevered or bridging exhibited irregular edge surfaces (Figure 6-5). At R15:C5 there was a concave burn pattern in the portion of the cardboard that was cantilevered over the edge of the lid of a standard waste box (SWB) (Figure 6-6). The burn-pattern is typical of horizontal material exposed to a flame from below. Similar materials may burn as long as exposed to an external flame, but will likely self-extinguish once the flame is removed. There were also smaller cardboard remnants lying on the lid. These remnants display striations of the corrugated layer within the original cardboard matrix.

Figure 6-5: Evidence of Irregular Edge Surfaces at R16:C2

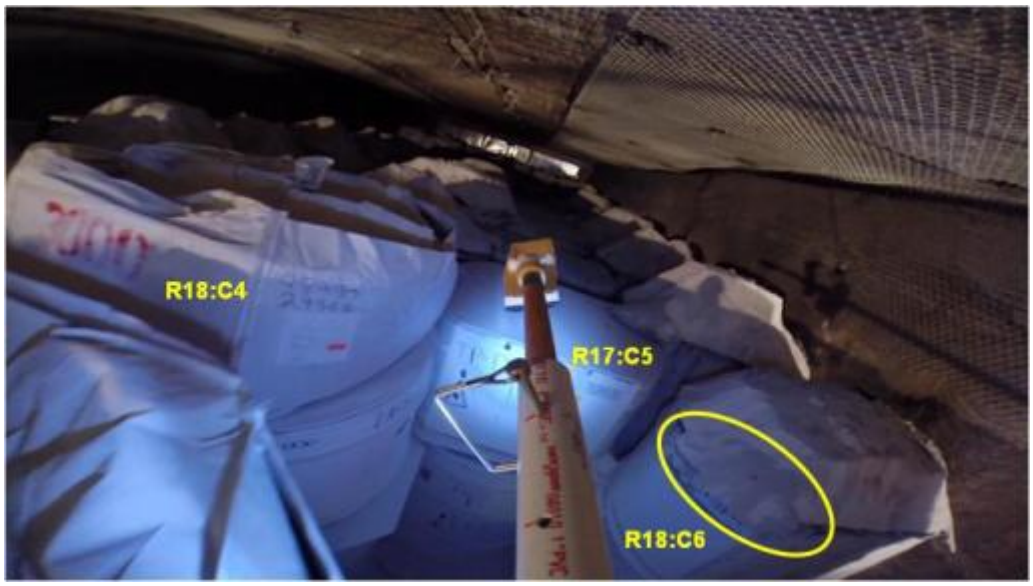
stiffener were partially burned along with a hole through the stiffener. A stiffener on the south side bridges between the SWB and the rib. There was also evidence of flame impingement on the rib (Figure 6-17). The east (bulkhead side) stiffener fell and was not located. The SWB had vertical streaks created by melted polyethylene from the MgO super sack slip sheet flowing down the side and freezing (Figure 6-18). There was no evidence suggesting that any of the waste containers in this stack had an unfiltered release.

Figure 6-15: Cantilevered Bridge at R18:C6

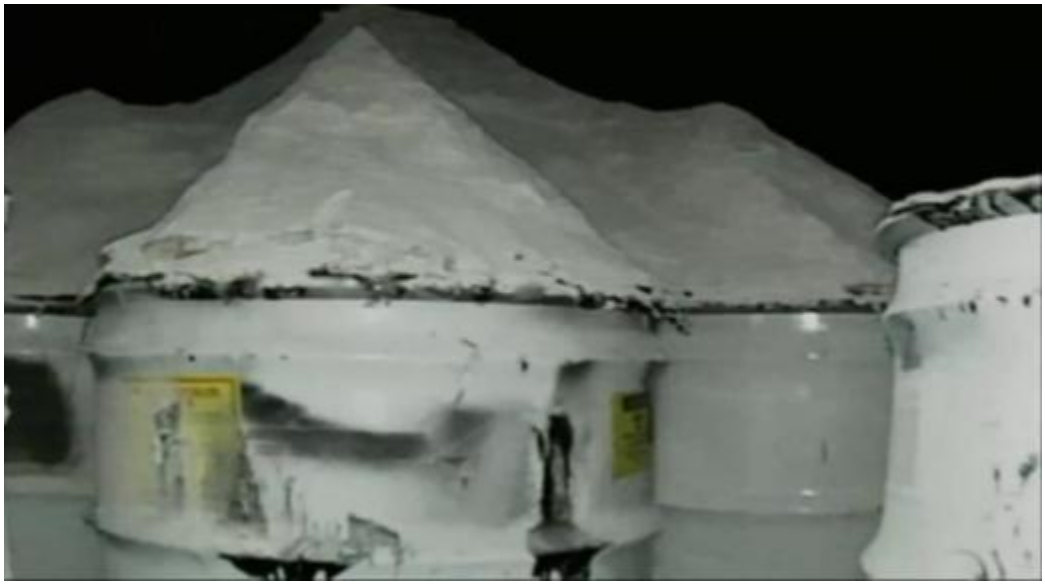
While some of the TDOPs in Rows 9 and 10 exhibited streaks of melted plastic, none had substantive damage. In some instances the depth of the MgO at the floor was so deep that it obscured a substantial portion of the lower stack tier or the lower half of a TDOP.

Figure 6-25: Discoloration and Residual MgO at R10:C4

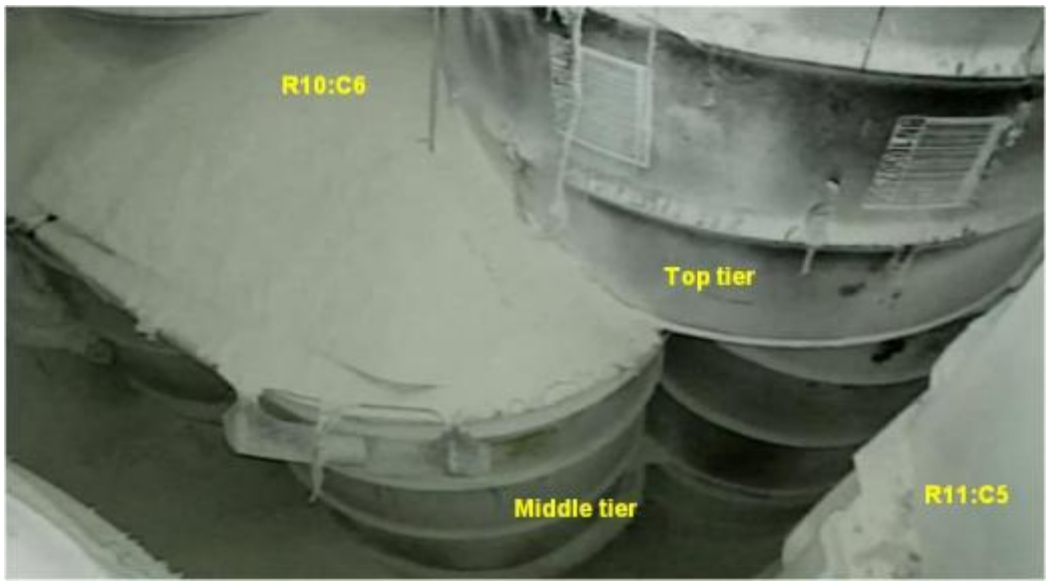
Figure 6-27: R10:C6

The MgO super sacks in Row 10 were damaged, with most of the fabric melted or gone (Figure 6-21, Figure 6-22, Figure 6-24, Figure 6-25, and Figure 6-26). The residual MgO formed conical piles consistent with the outline of the waste containers on the top tier at each stack. At R10:C6 the 100GD assembly slip sheet, the middle tier reinforcement plate and slip sheet, were partially damaged and conformed to the outline of the drums (Figure 6-27). Many locations had

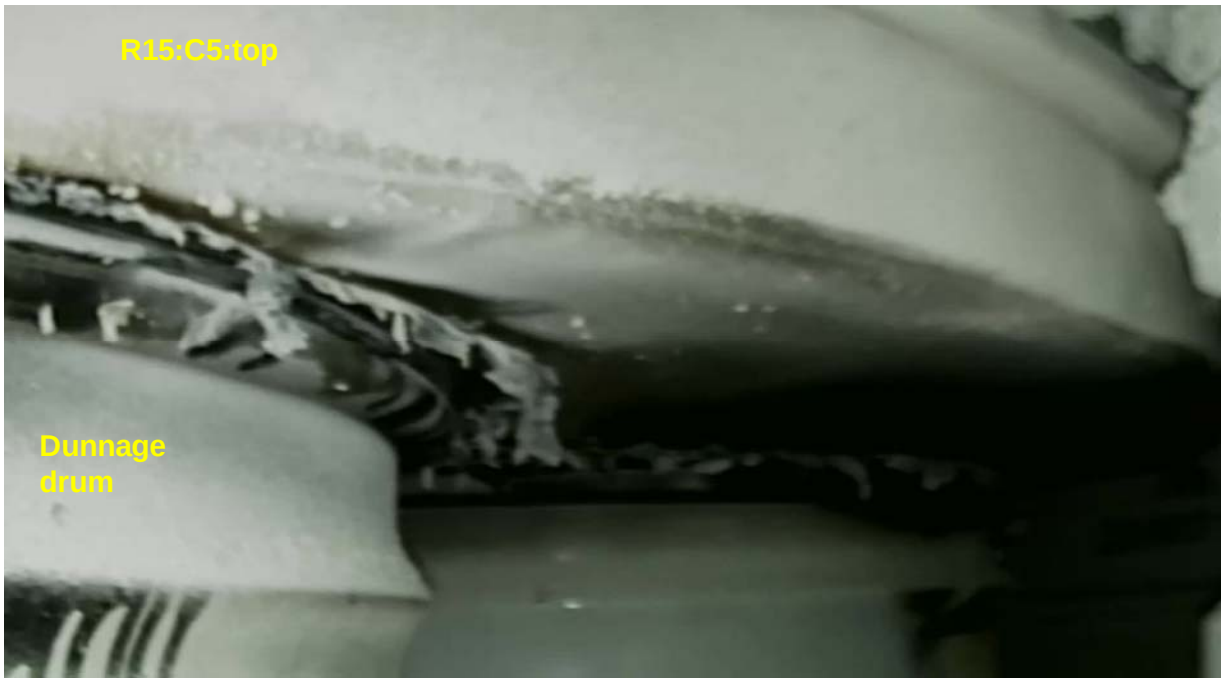
Figure 6-38: North View of R15:C5, Bottom of SWB on Top Tier

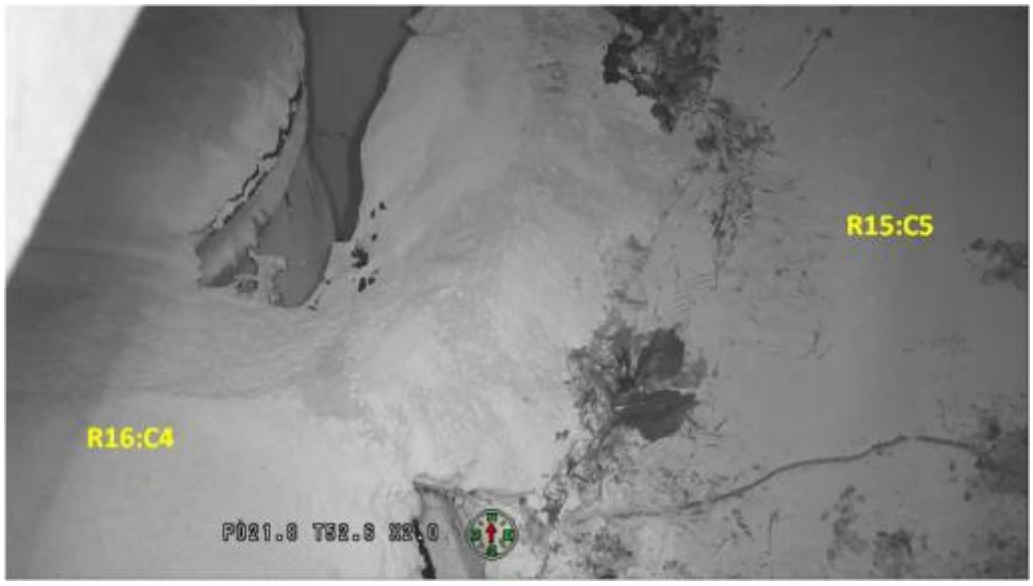
Figure 6-42: Bridge between the R15:C5 SWB Lid and R16:C4

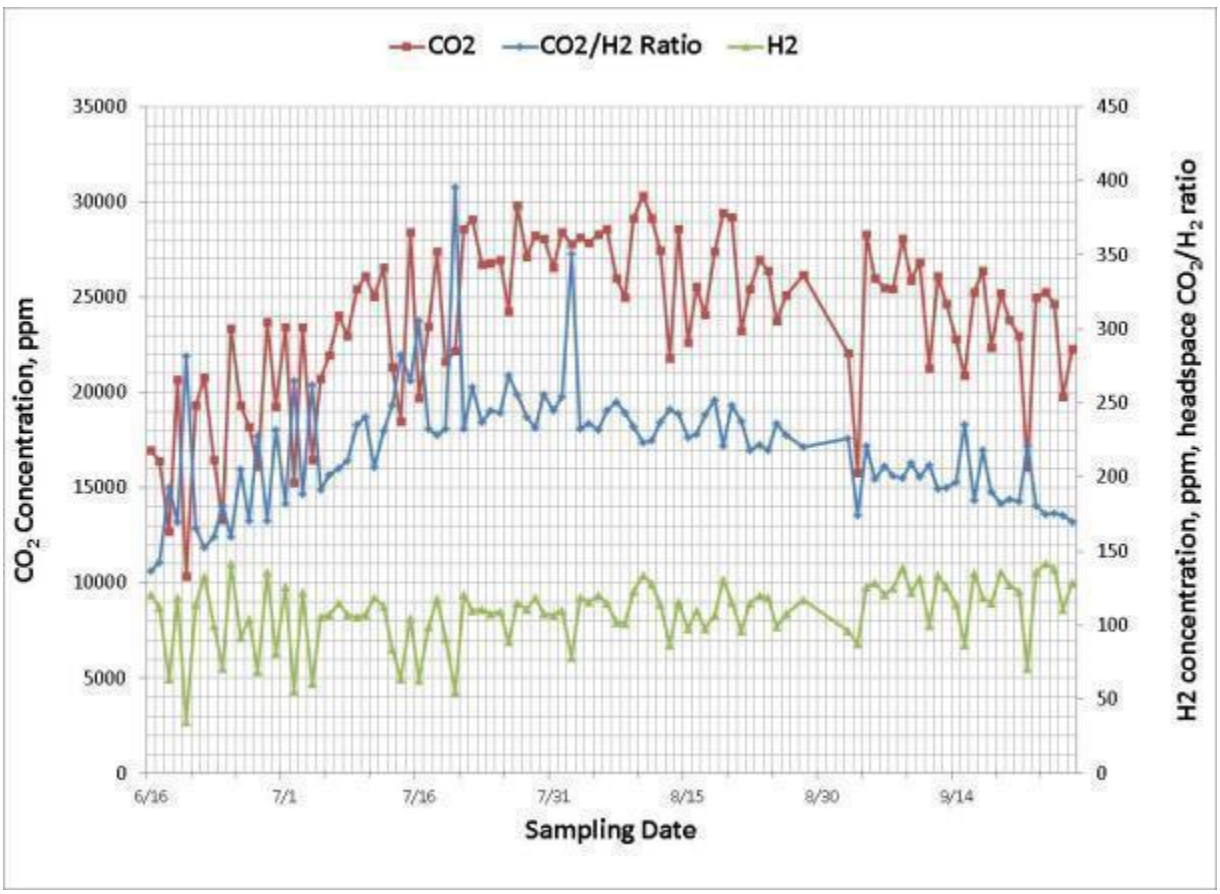
Figure 6-46: Headspace Sampling Results of CO_2 and H_2

LANL conducted headspace gas sampling and thermography monitoring for the SWB containing drum 68685, the sibling drum of drum 68660. In addition, headspace gas sampling and thermography was performed for other remediated waste drums at LANL. The purpose of the gas sample analysis is to determine the presence and/or concentration of potential reaction products. The sampling was conducted via the vent port on the waste box, and thus is not able to directly sample the gases within the suspect drum, nor within any waste bags within the drum. The gases detected in the headspace gas sampling are consistent with oxidation. The headspace gas monitoring results are shown in Figure 6-46. The trend suggests that there is a chemical oxidation reaction occurring.

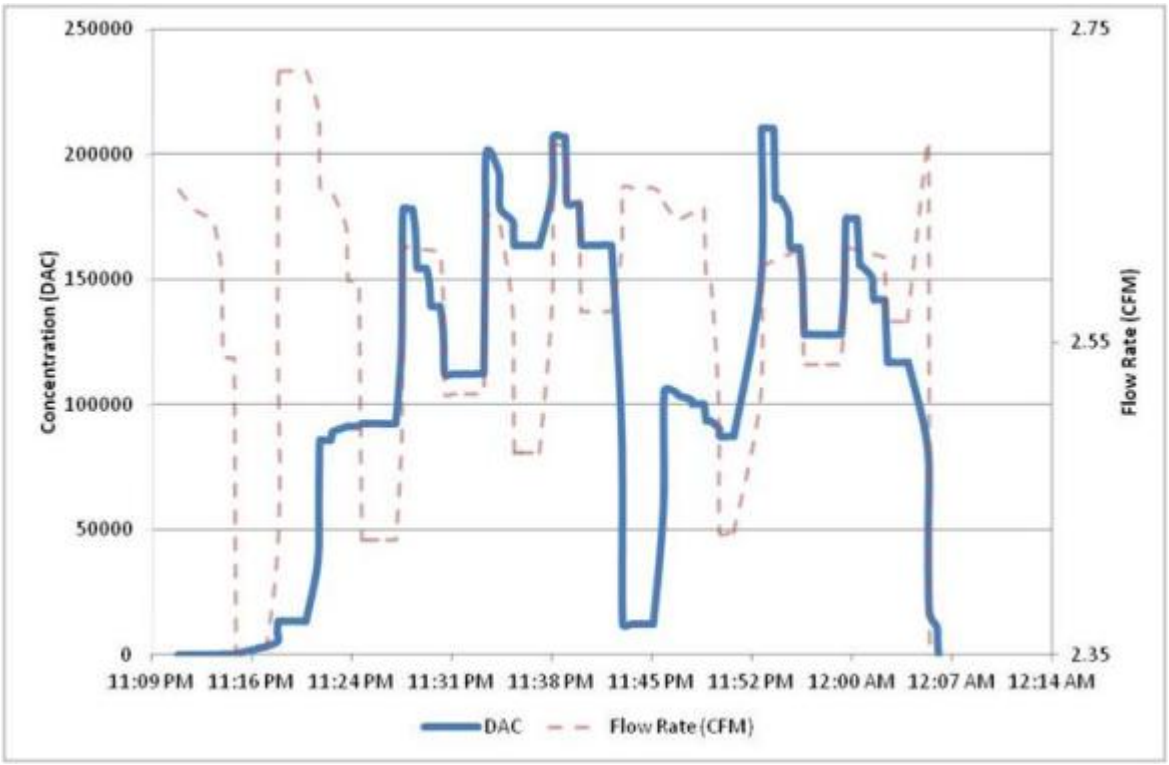
Figure 6-50: Real-Time Air Concentrations Measured By CAM 151 with the CAM Flow Rate

CAM airborne radioactivity data correlates with the timeline for the event initiation, progression, and termination. The data indicated rapid increases/decreases in airborne radioactivity concentration over the duration. Three CAM filters (2, 7, and 11) were selected for extended gamma assays and chemical analyses. Extended gamma assays on those three CAM filters measured an actinide signature similar to what was found on the FAS. Table 6-6 is summary of the results of the three selected CAM filters.

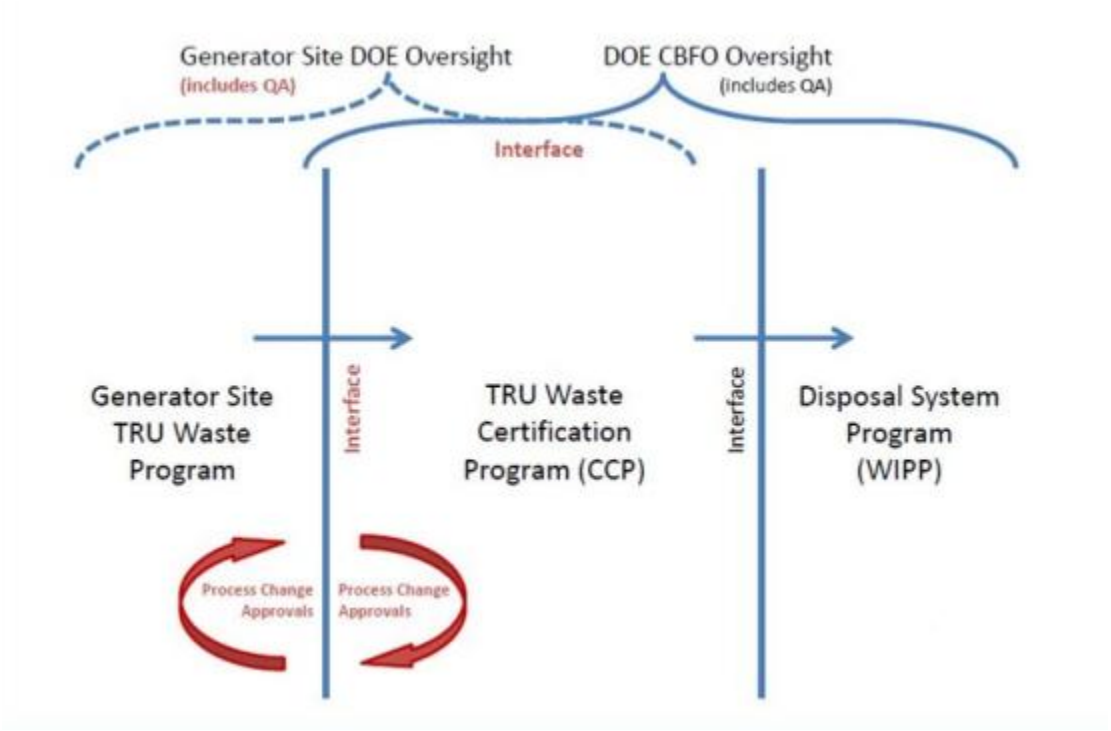
Figure 9-1: Waste Characterization Program Interfaces and Oversight

- Inadequate separation of oversight and line management responsibilities within the CBFO National TRU Program was acknowledged by CBFO during the investigation.
- Lack of external/Headquarters oversight of all three key segments illustrated in Figure 9-1 of the National TRU Program including the generator site (LANL) TRU waste program, TRU waste certification program (CCP), and the disposal system program (WIPP).

CON 18: The Federal roles, responsibilities and execution for oversight of the activities between the generator site transuranic (TRU) waste program (LANL) and the TRU Waste Central Characterization Program (CCP) were inadequate.
