DOE Issues WIPP Radiological Release Phase II Investigation Report

Phase II Accident Investigation Board Briefing

On February 14, 2014, an airborne radiological release occurred at the Department of Energy Waste Isolation Pilot Plant (WIPP) near Carlsbad, New Mexico. On March 4, 2014, an Accident Investigation Board (the Board) was appointed by Matthew Moury, Deputy Assistant Secretary, Safety, Security, and Quality Programs to determine the cause of the release. Because access to the underground was restricted following the event, the investigation was broken into two phases. The first phase, Phase 1, focused on how the radiological material was released into the atmosphere and the results were issued on April 22, 2014, in a Phase 1 investigation report.

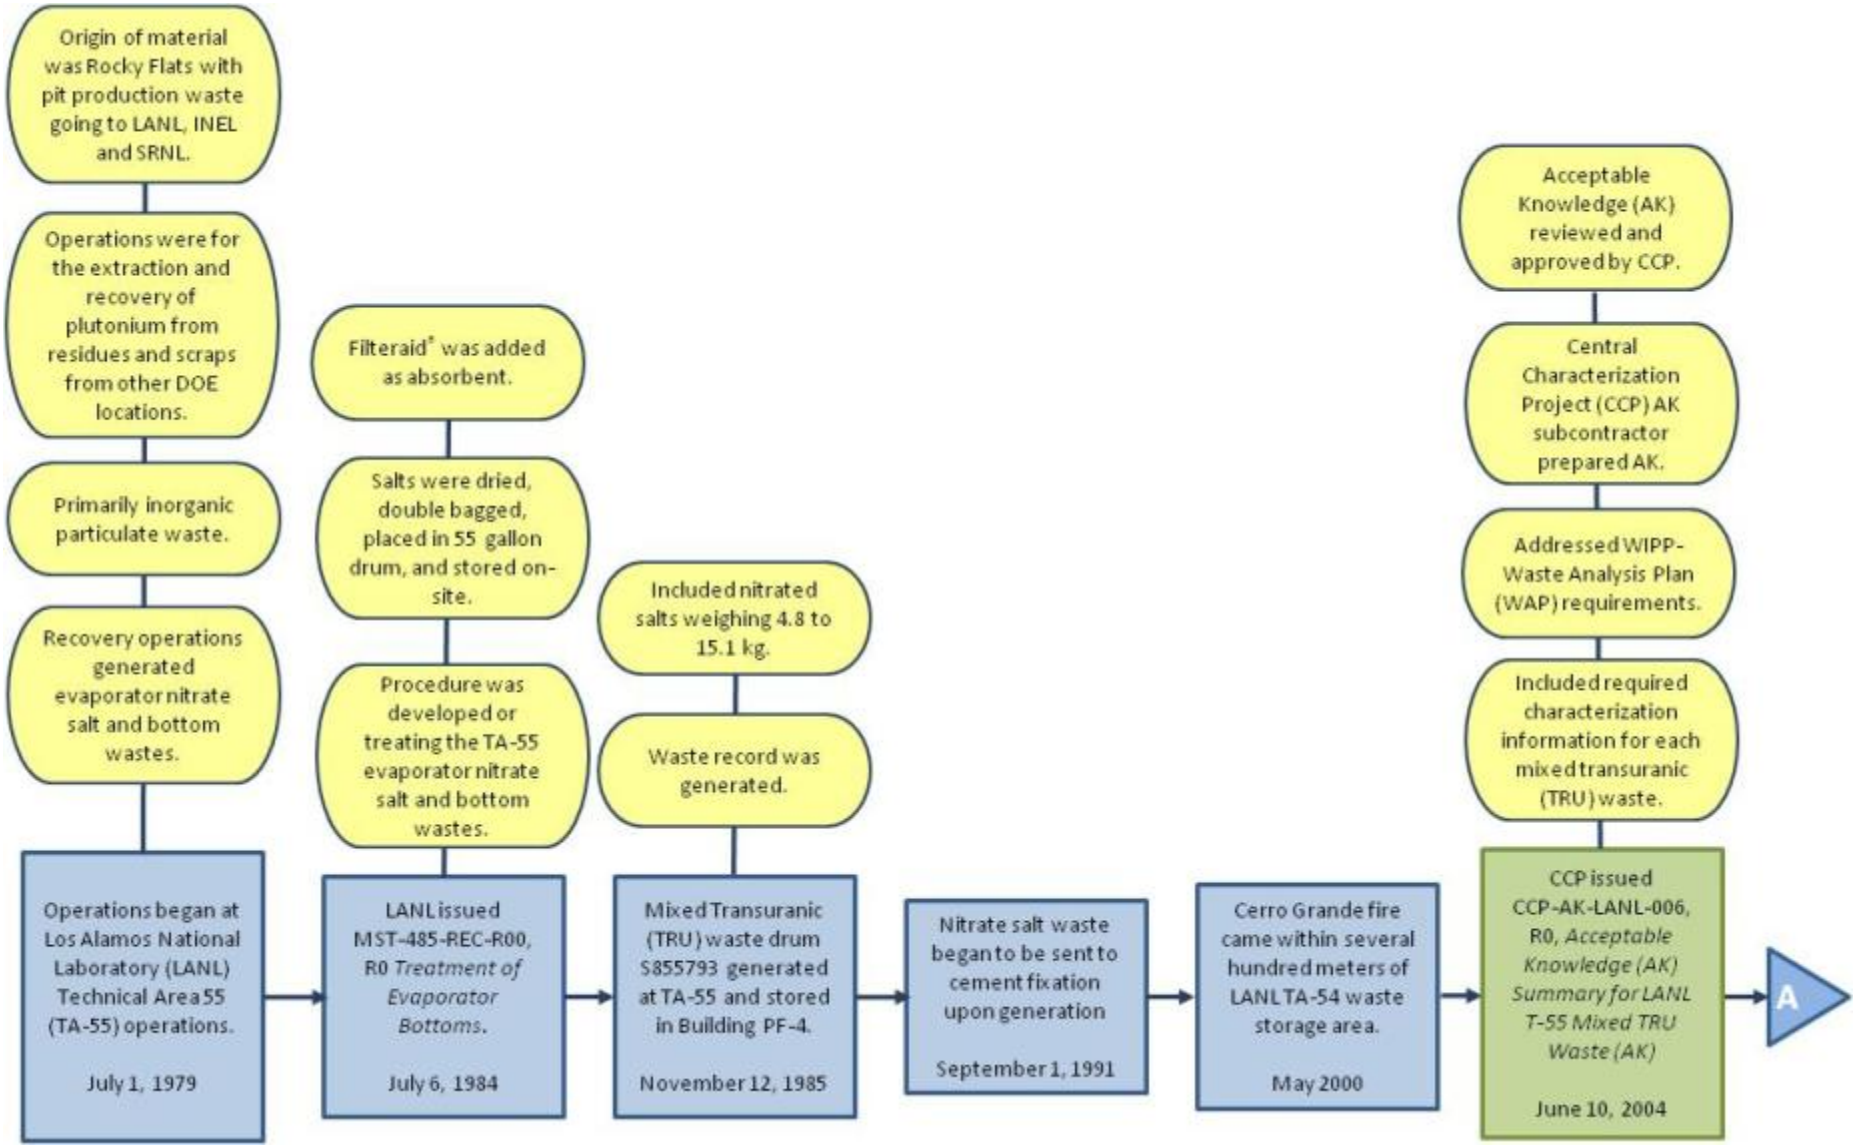
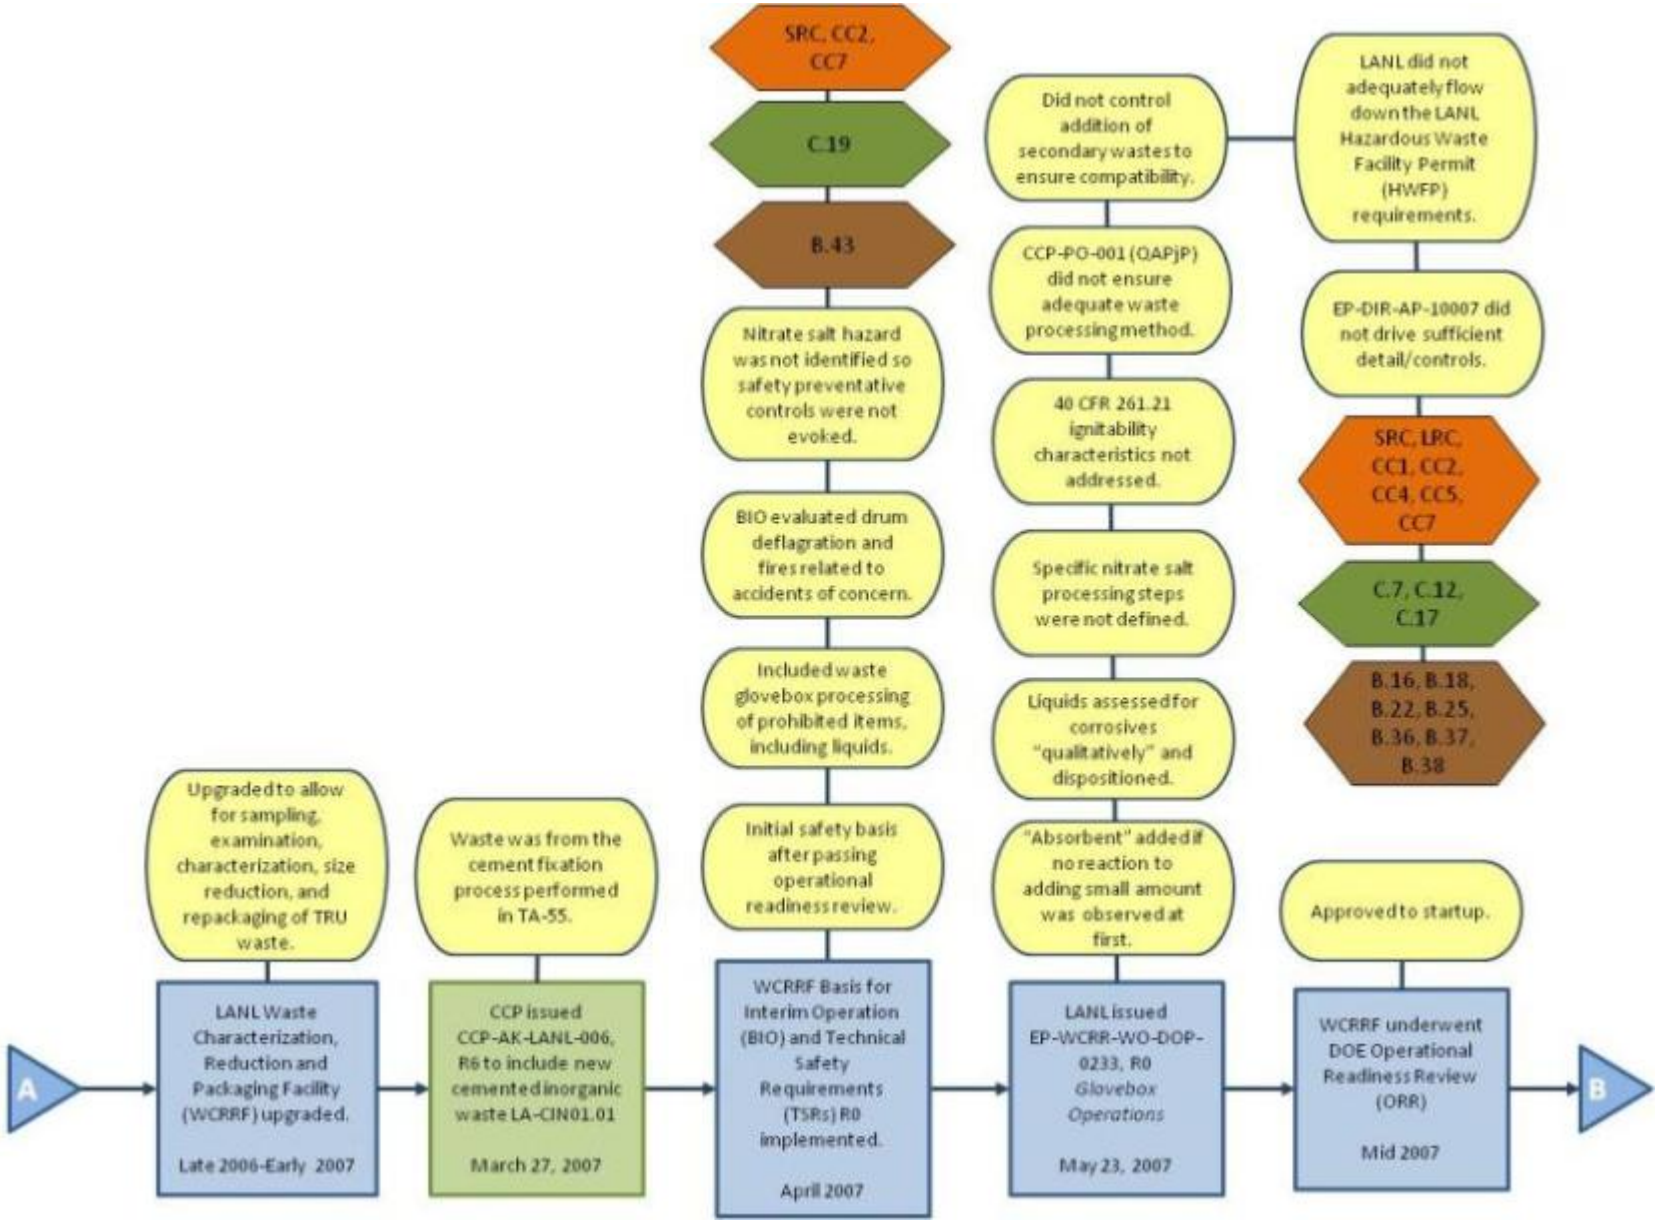
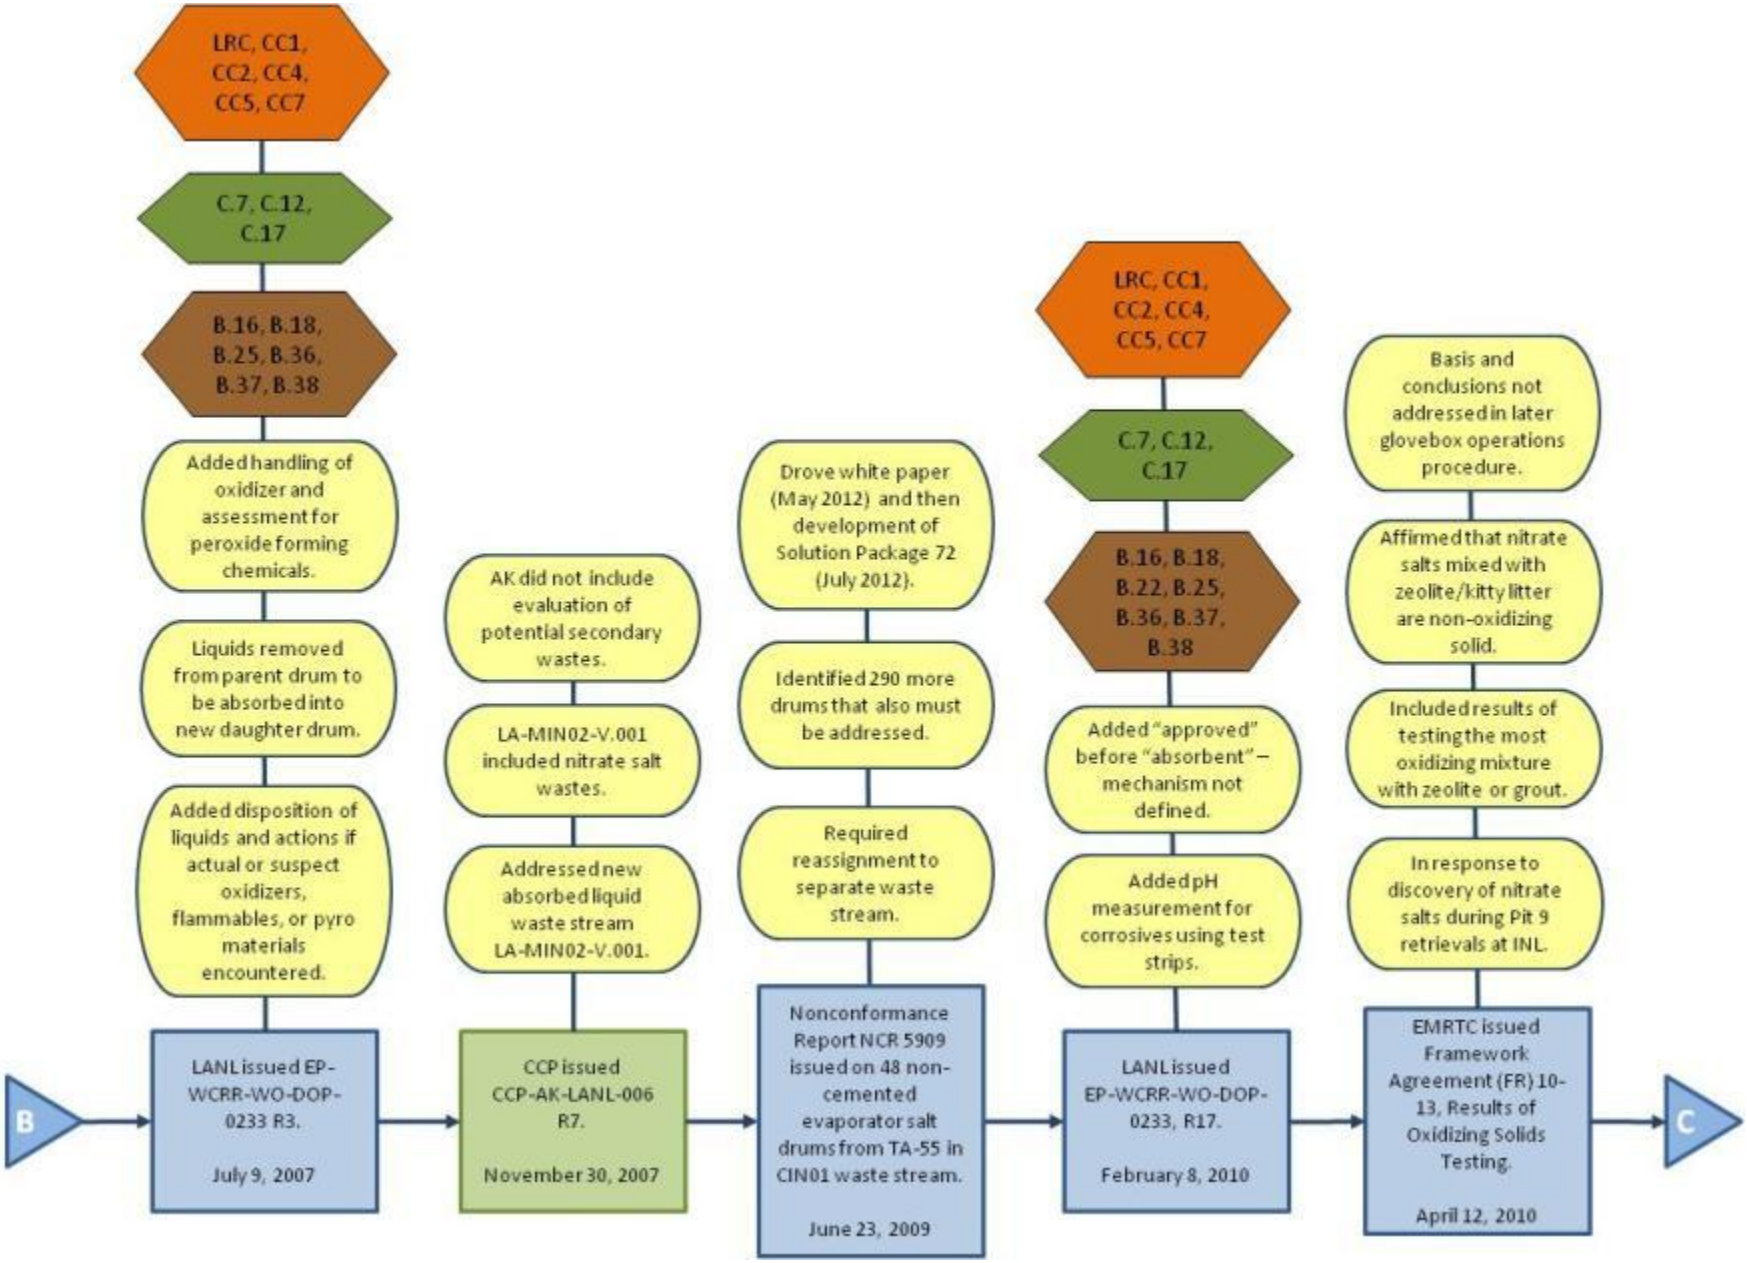
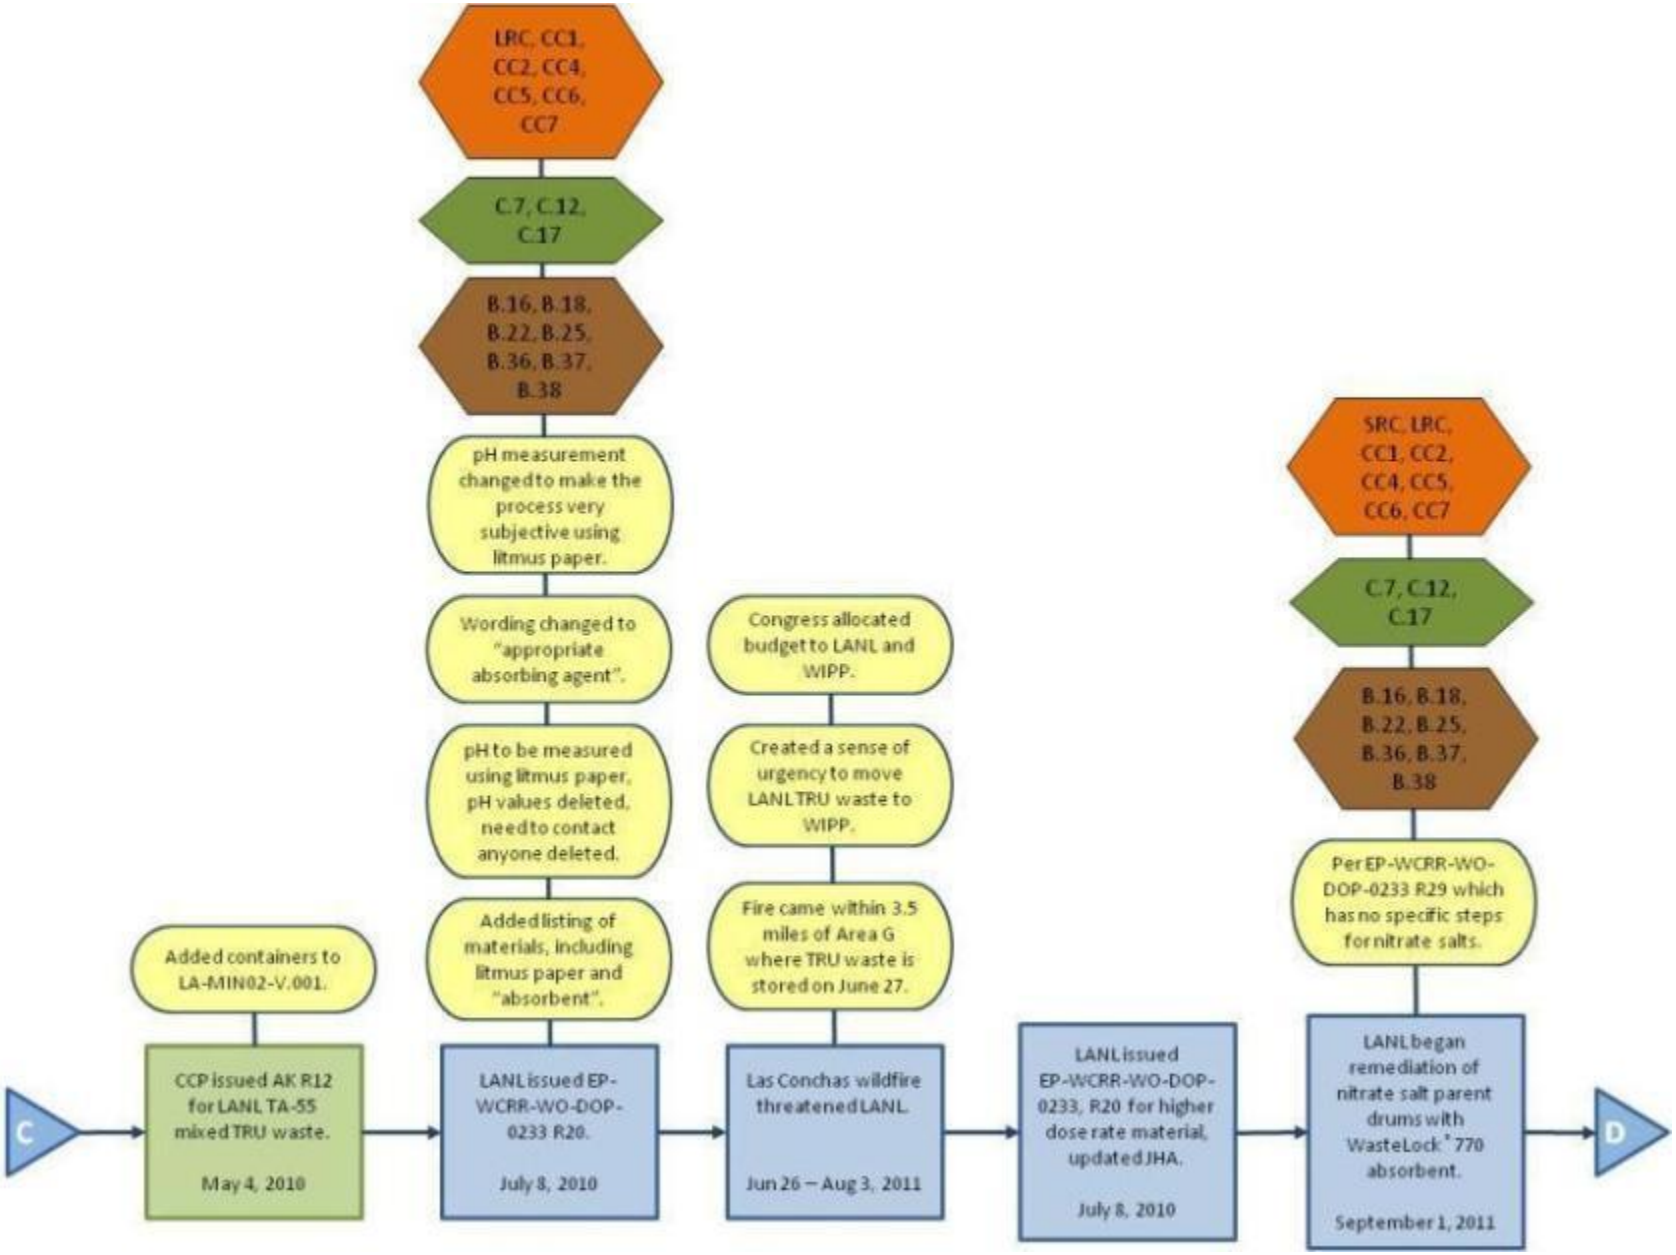
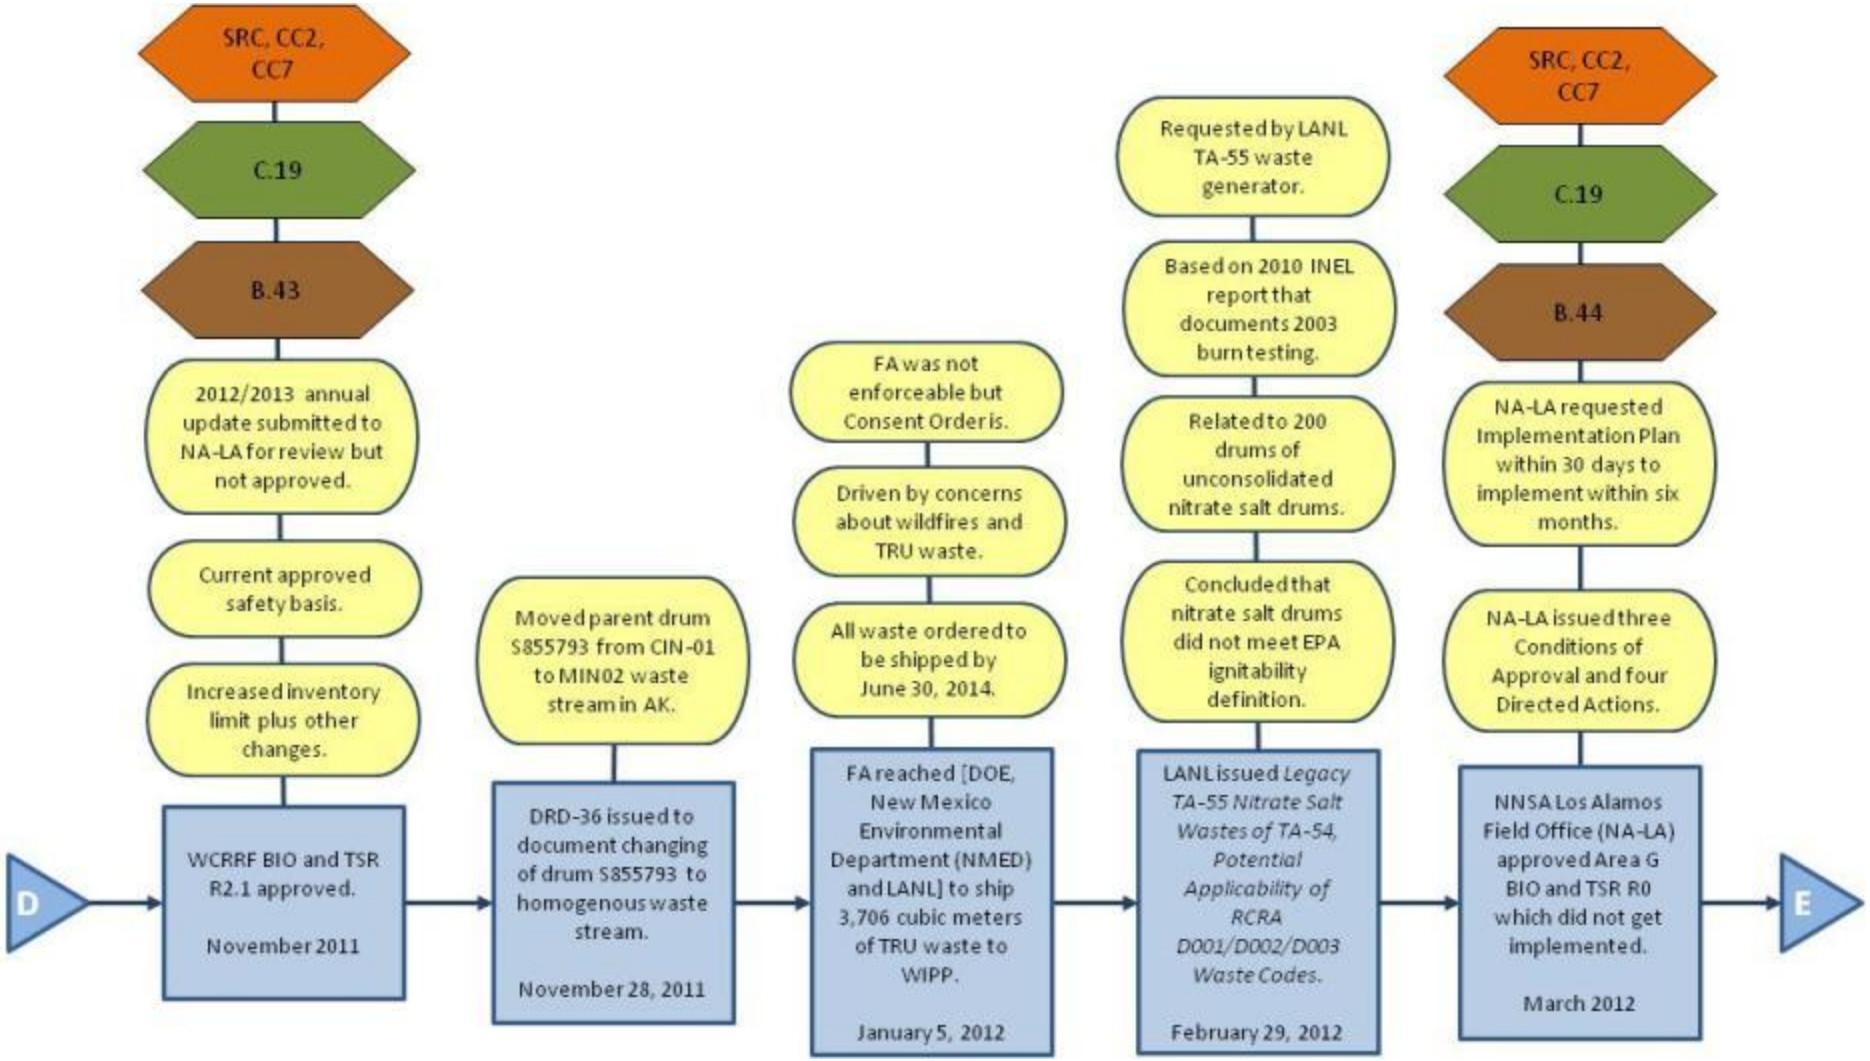
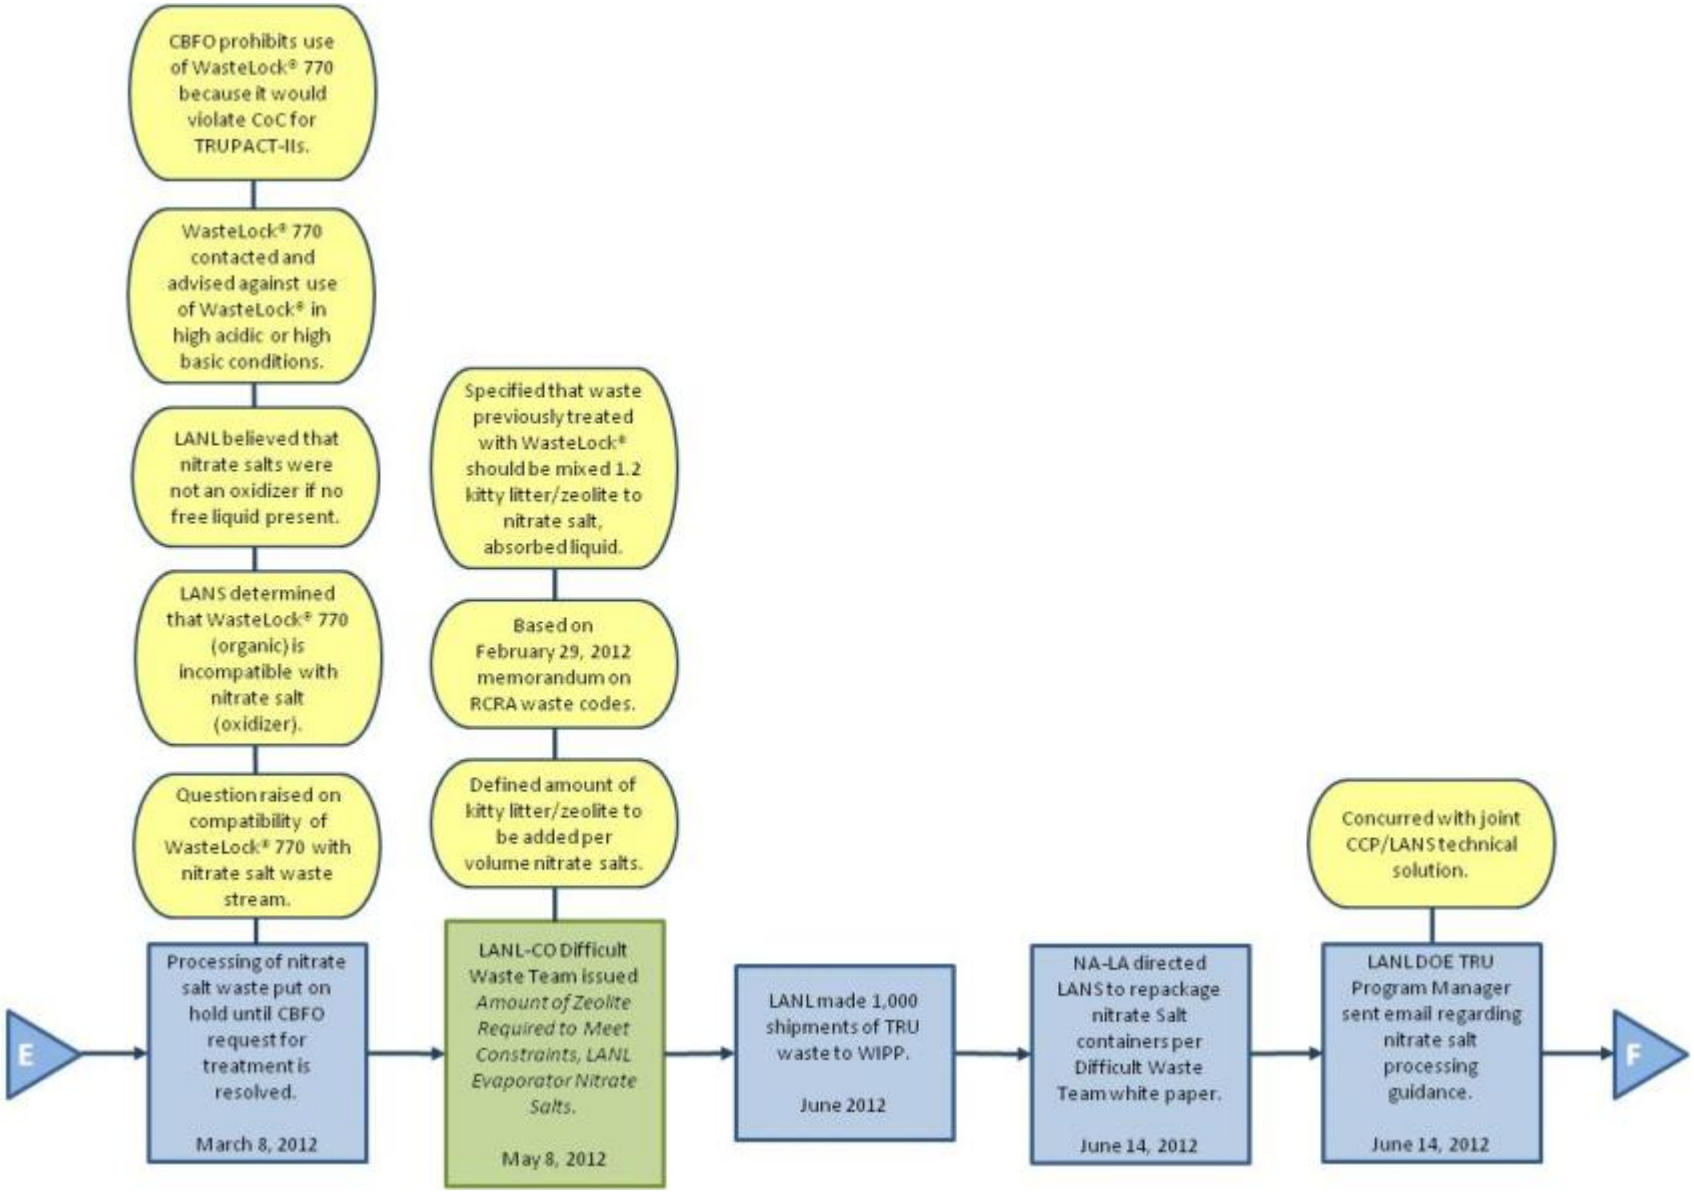
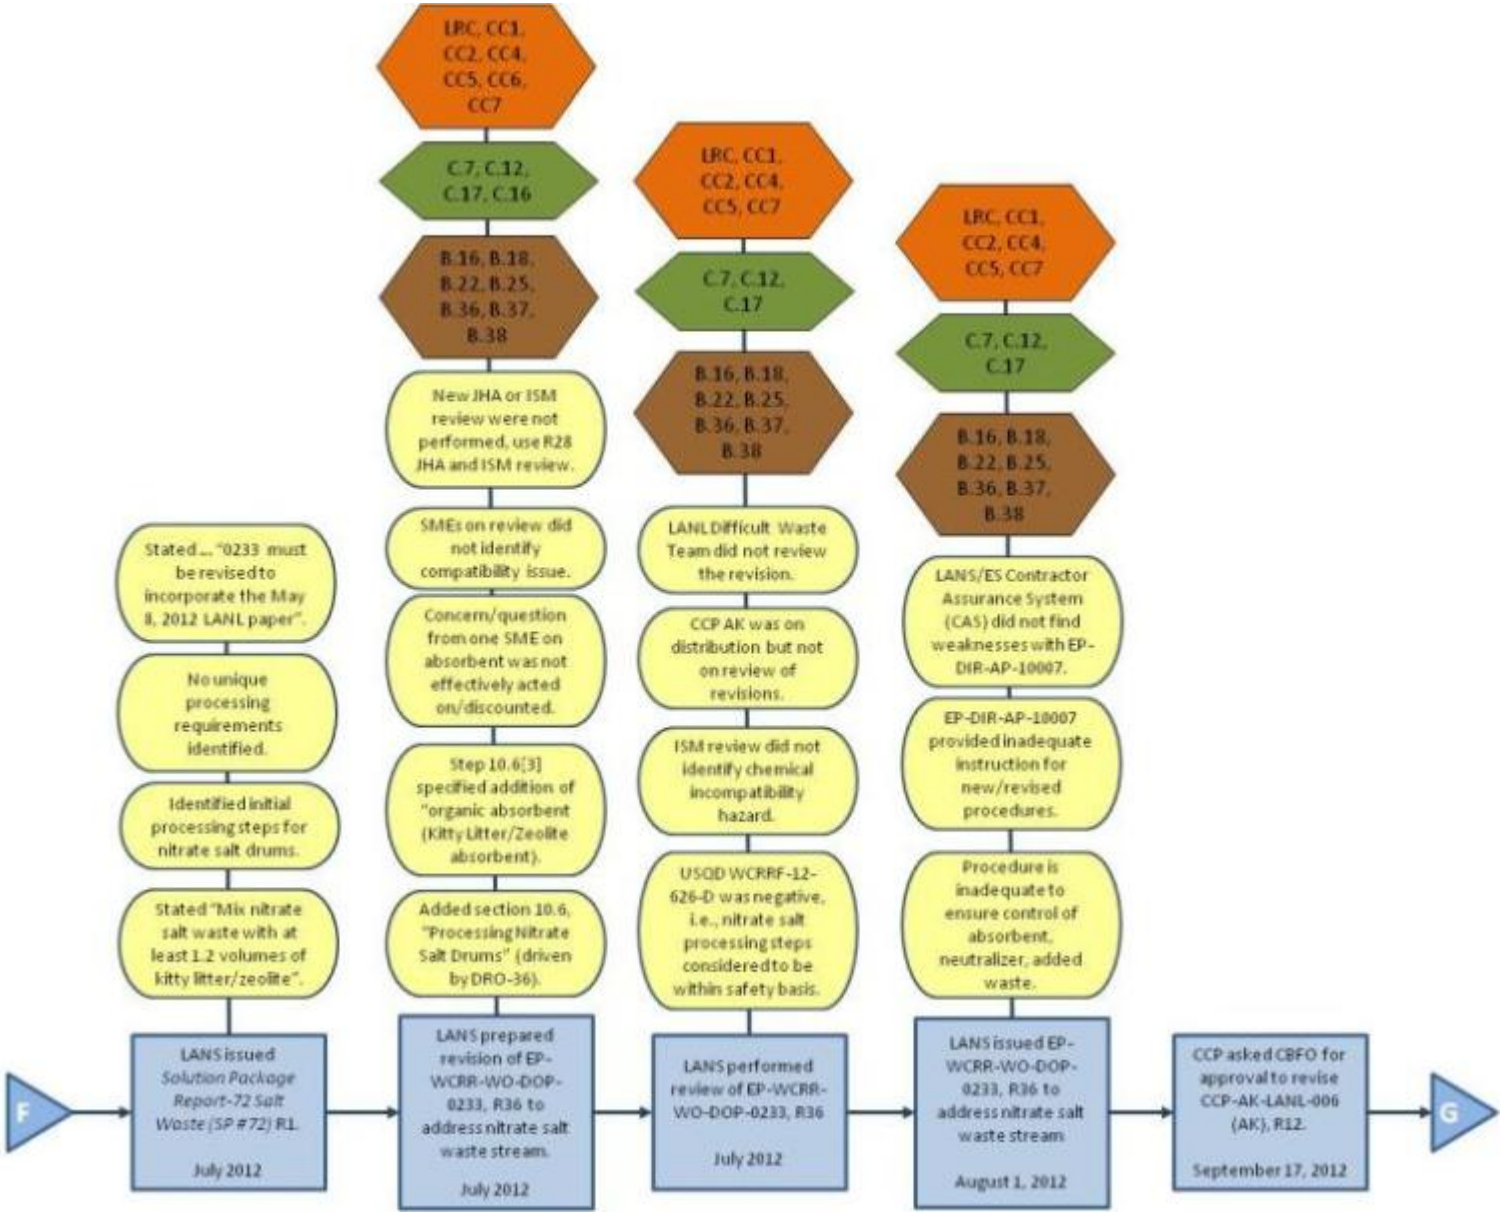
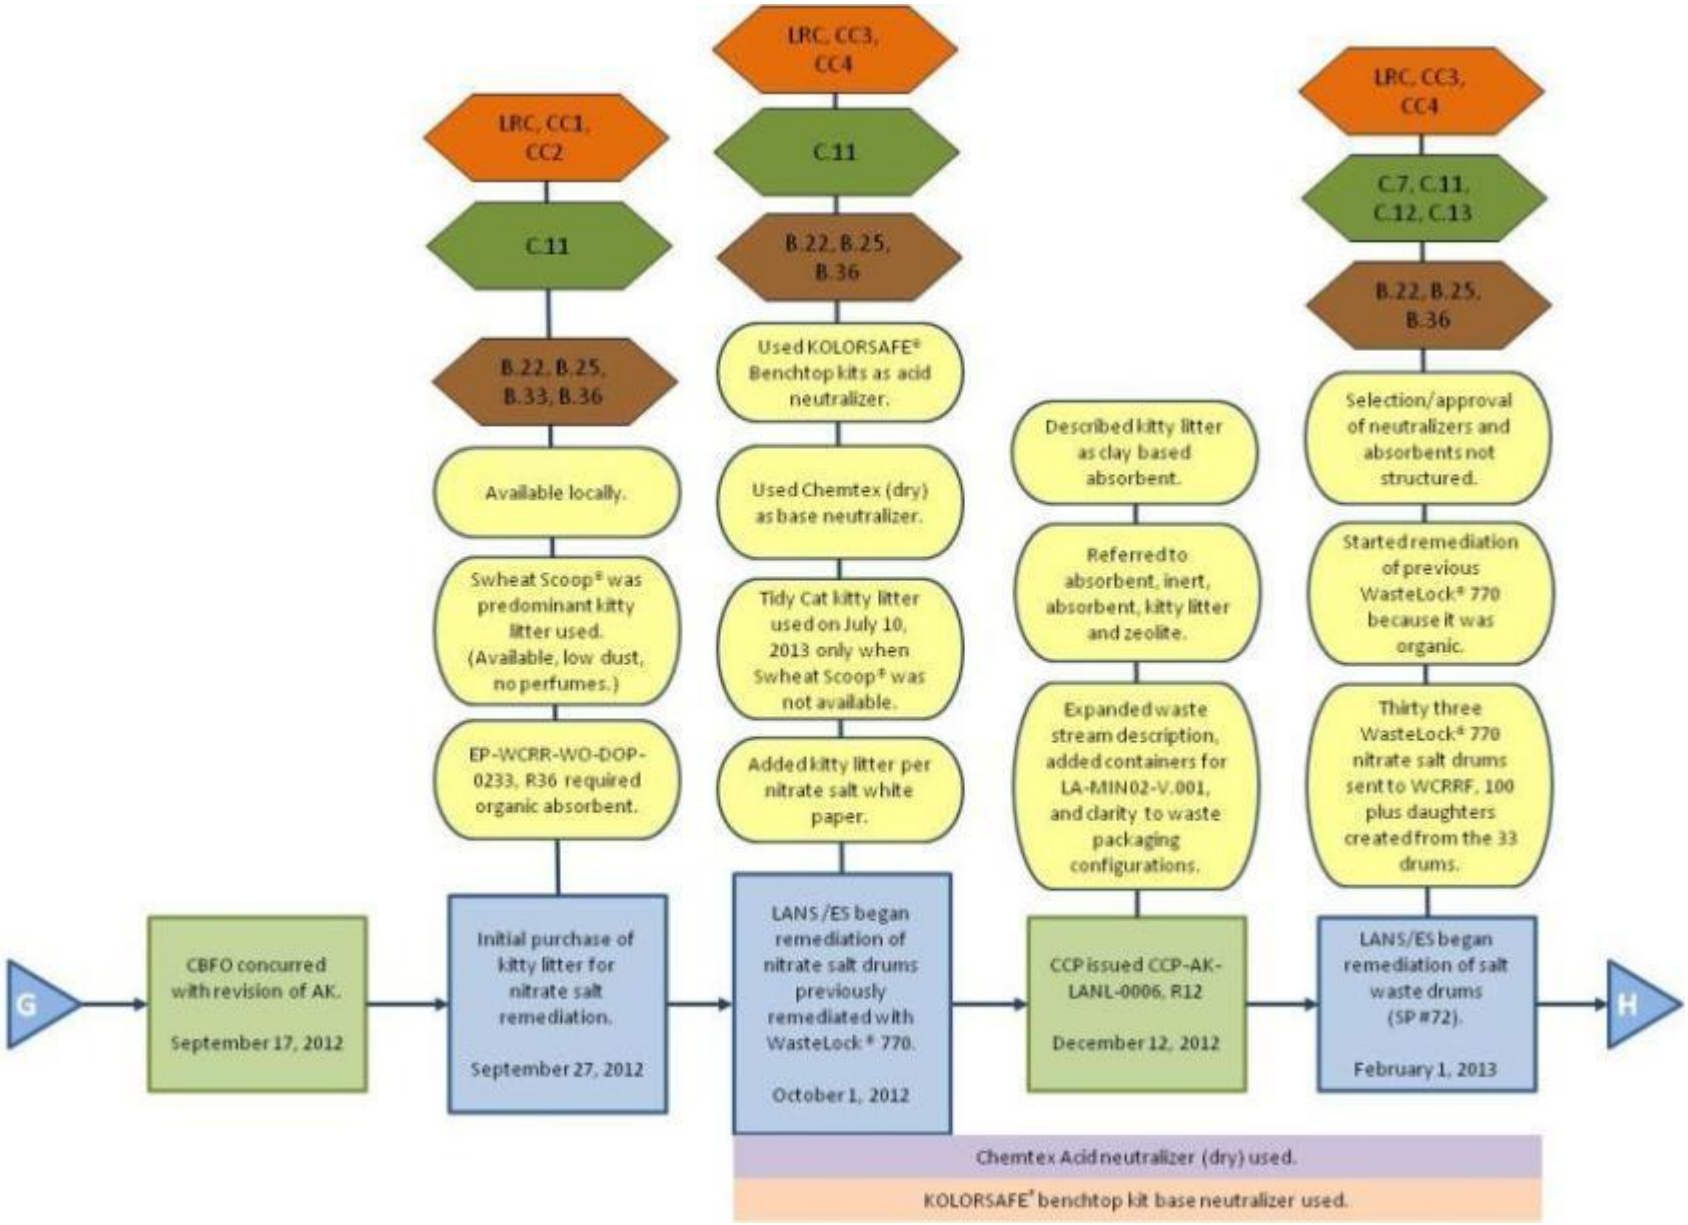
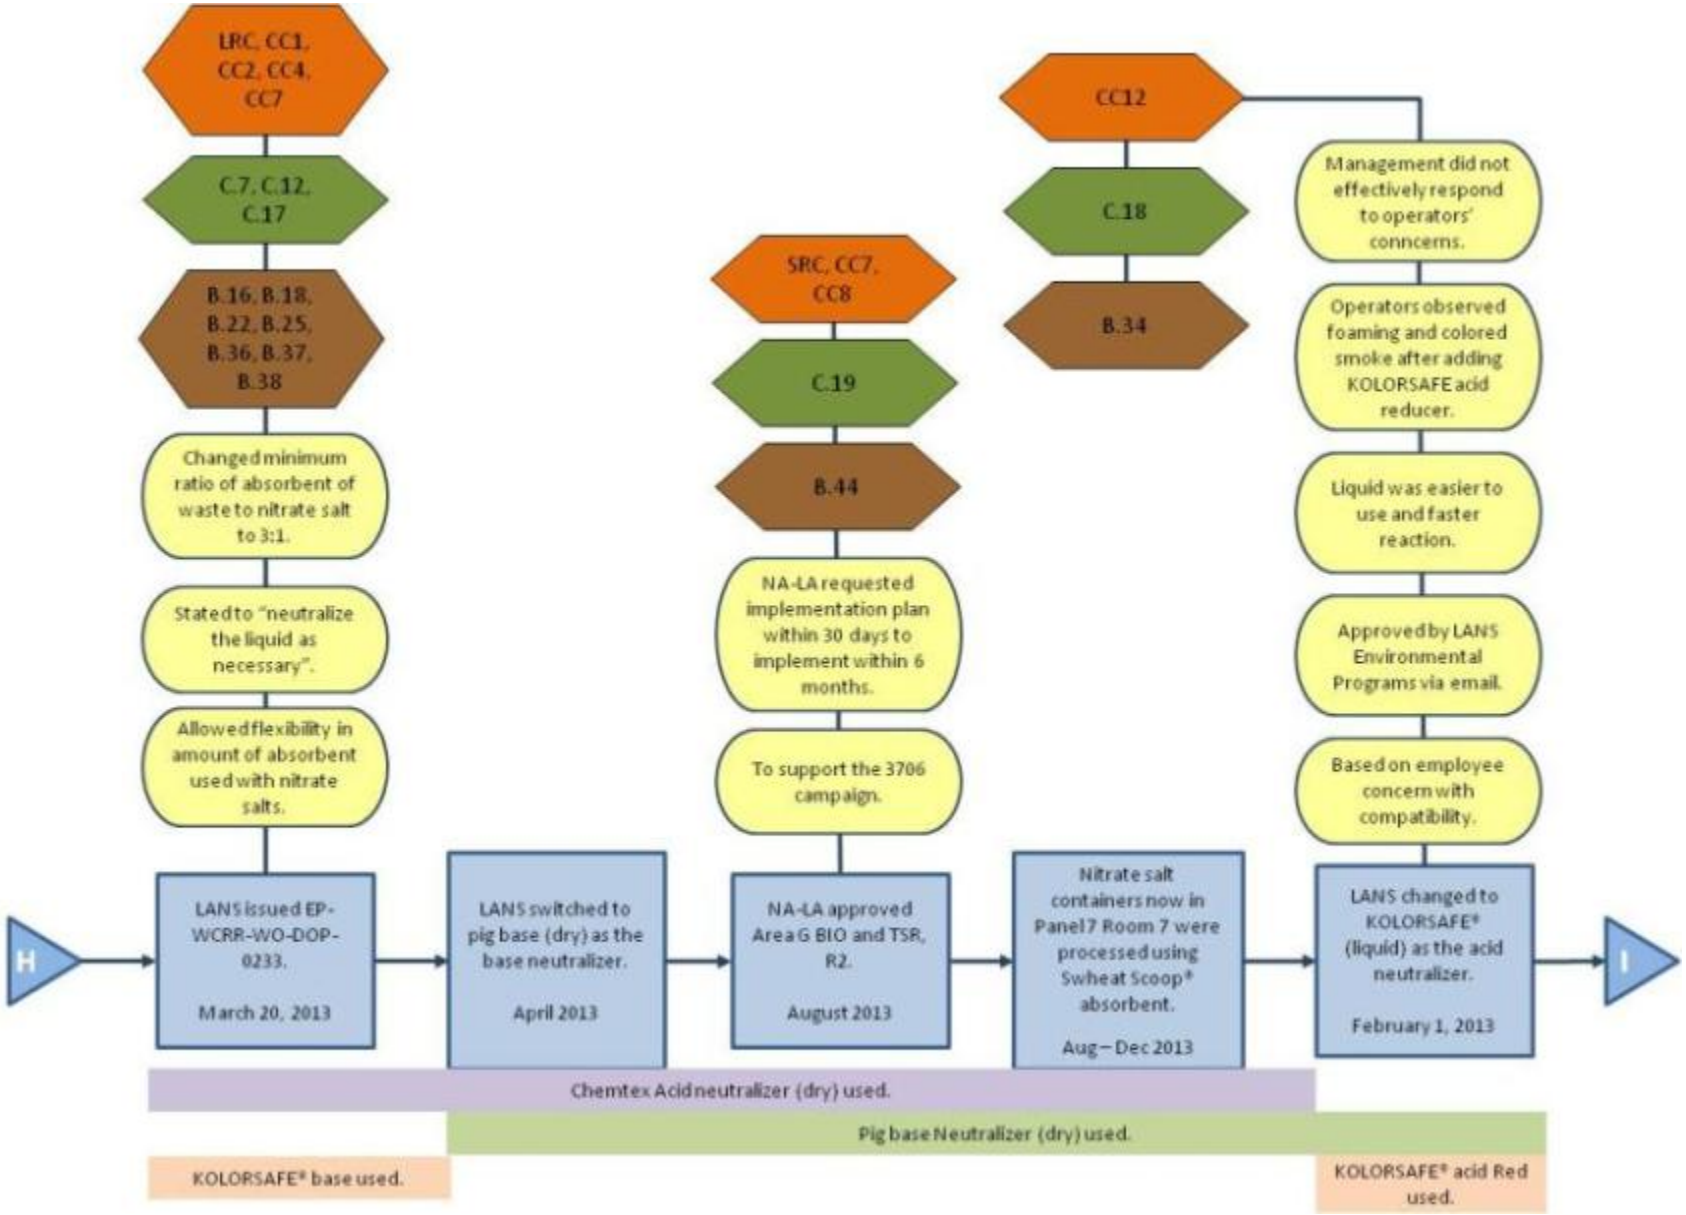
Table E-1: Event and Causal Factors Analysis

Liquids assessed for corrosives "qualitatively" and dispositioned.
Specific nitrate salt processing steps were not defined.
40 CFR 261.21 ignitability characteristics not addressed.
CCP-PO-001 (QAPjP) did not ensure adequate waste processing method.
Did not control addition of secondary wastes to ensure compatibility.
WCRRF underwent DOE Operational Readiness Review (ORR)
Mid 2007
Approved to startup.
LANL did not adequately flow down the LANL Hazardous Waste Facility Permit (HWFP) requirements.
EP-DIR-AP-10007 did not drive sufficient detail/controls.
SRC, LRC, CC1, CC2, CC4, CC5, CC7
C.7, C.12, C.17
B.16, B.18, B.22, B.25, B.36, B.37, B.38
B

December 4, 2013
Swheat Scoop® used as the absorbent.
Drum 68660 records documented use of KOLORSAFE® acid neutralizer – not specific on volume.
Contained incompatible tungsten lined glovebox gloves.
National TRU Program certification process did not include repack operations, RCRA or AK.
LANL CCP did not observe processing activities, is unaware how drum 68660 is treated.
Workers and supervisor had limited training in chemical reactions and compatibility.
Drum 68660 was closed with a drum lid containing a filter vent.
December 4, 2013
B.21, B.32, B.33, B.34, B.35, B.38
C.7, C.12, C.17
LRC, CC1, CC2, CC3, CC4, CC5, CC8, CC11
LANL CCP performed Real-Time Radiography (RTR) on drum 68660.
December 12, 2013
Nothing remarkable or unsatisfactory.
Absorbent was added, not layered.
No free liquids.
Identified this as an inorganic waste matrix.
B.26
SRC, CC4, CC5
J
Pig base Neutralizer (dry) used.
KOLORSAFE® acid reducer (liquid) used.

J
LANL CCP performed non-destructive assay (NDA) on drum 68660.
January 2, 2014
SRC, CC4, CC5
B.26
Identified 45 out of 900 drums with incorrect algorithm.
Corrected algorithm matched LANL drum to WIPP filter paper.
NDA expert analysis was flawed – underestimated Am by 2.4X. Wrong algorithm used.
LANL CCP personnel performed flammable gas analysis (FGA) on drum 68660.
January 3, 2014
SRC, CC4, CC5
C.10
B.3, B.26
LANL CCP certified as WIPP compliant when it was not.
LANL CCP certified without being able to know how drum was processed.
ES glovebox processing records and logs did not accurately reflect how drum 68660 was processed (absorbent, gloves, etc.).
CCP certified drum 68660for shipment to WIPP.
January 21, 2014
Drum 68660 was shipped from LANL to WIPP as part of shipment LA140017.
January 29, 2014
SRC, CC4, CC5
C.10
B.3, B.29
Certified without documentation describing how waste was processed.
Contamination smears were negative.

S
Restricted processing at TA-54 AREA G.
LANL issued EP-AREAG-SO-1242, R0 Restrictions on Processing Nitrate Salt.
May 13, 2014
Drum 68660 was from high risk acidic (pH 0) segment of LA-MIN02-V.001. Not designed for rapid pressurization.
Discoloration and damage noted in R15:C5, middle. Seven pack of MIN02 drums.
Damaged LANL drum 68660 found in Row 16, top of Column 4 (R16:C4) with significant heat discoloration.
Narrowed down potential breached drum as 68660 or 68333.
Identified breached LANL drum in a seven-drum configuration.
Underground entry to examine Panel 7 Room 7.
May 15, 2014
Declared that a PISA exists as credited controls may be inadequate.
EP-WCRR-WO-DOP-0233 R36 authorized use of organic absorbent.
Remediated salt waste containers to be overpacked.
Sister drum to 68660 located at TA-54-412.
LANL critique held on discovery that LANL drum(s) appear to have breached at WIPP.
May 15, 2014
Fifty-seven remediated and 29 unremeditated salt-bearing waste containers at LANL.

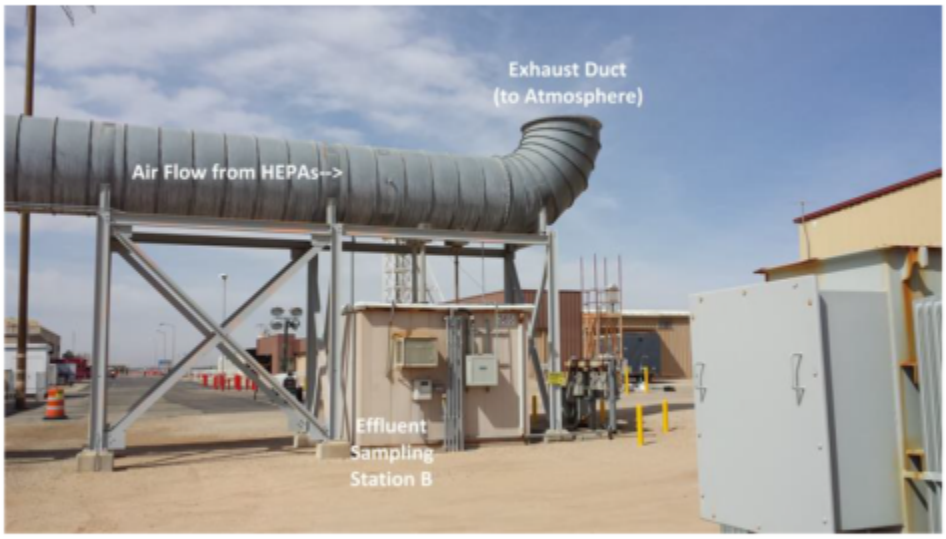
Figure ES-3: Station B and Exhaust Duct

Results from analysis of filters from the effluent sample station downstream of the HEPA filters (Station B) and at the discharge point to the atmosphere (Figure ES-3) were reported at 0915 and indicated 28,000 dpm alpha and 5,900 dpm beta contamination. This was the first indication that there was a release of contamination downstream of the HEPA filters to the environment.
