DYE TRACE STUDY 2006

GIANT REFINING

CINIZA REFINERY

June 19, 2006

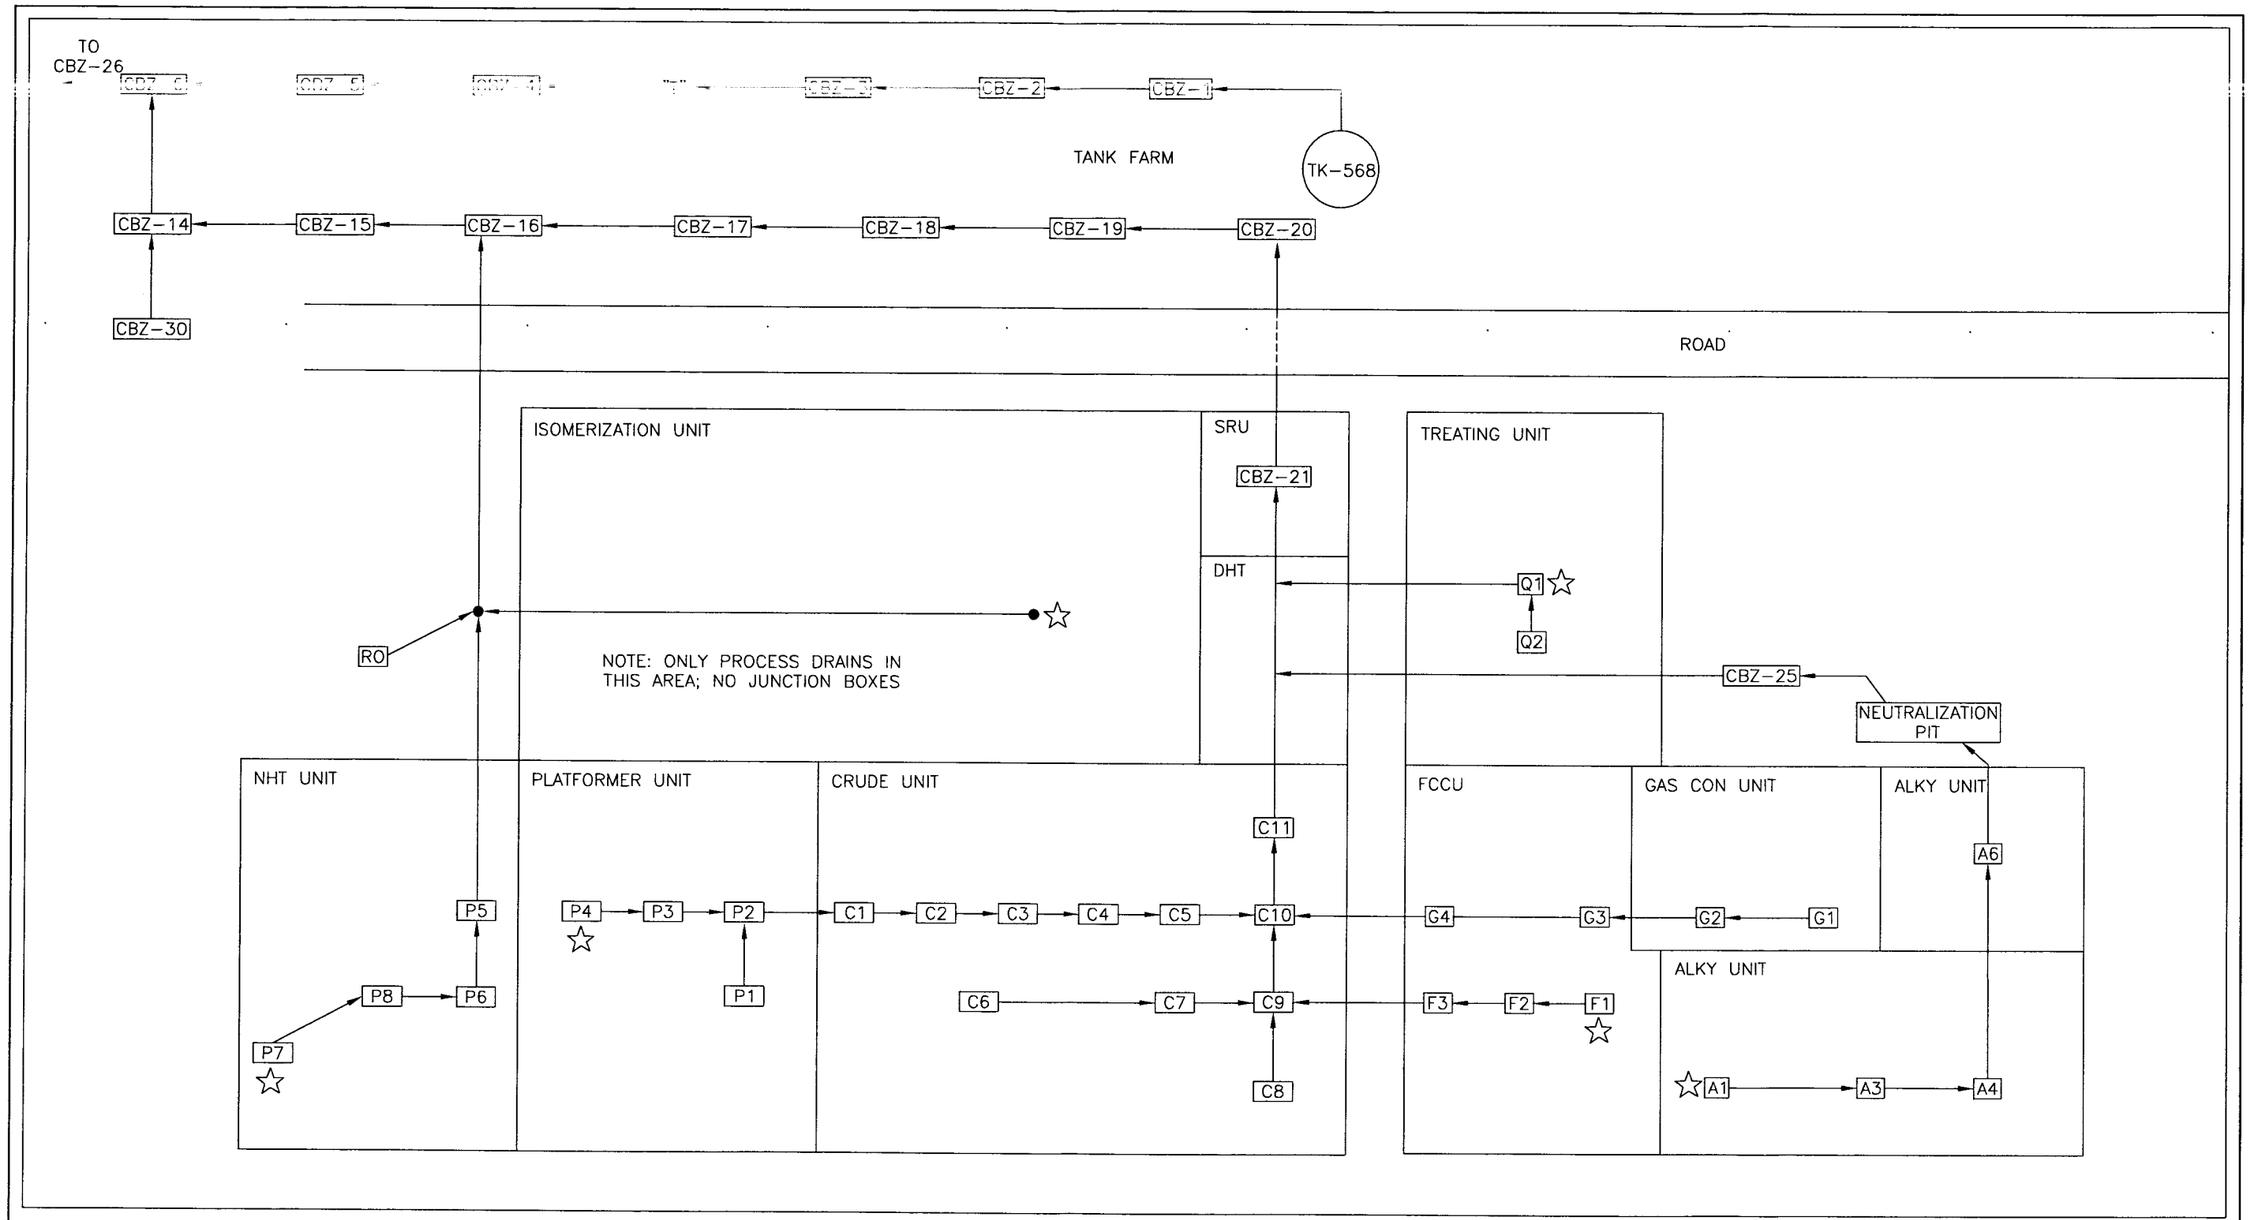
identified in Refinery records as A2 and A5, were removed from service (see Figure 1). Remaining junction boxes were also repaired to ensure that there were no leaks or cracks. In addition, new process sewer lines were installed between equipment drain hubs and the main process sewer line.

Based on observations made during the initial site walk, history of the sewer systems (e.g., the Alky sewer repairs), and the process sewer inspection requirements and procedures, it was decided to conduct an initial test for cross-connects by introducing dye into the process sewer system. To accomplish this, dye was introduced at locations that were the farthest points upstream in each branch of the process sewer. Subsequently, the stormwater sewer system manhole #17 (MH17) was then monitored for evidence of the dye. Stormwater sewer MH17 is the storm sewer end-of-line (EOL) test location for the purpose of this dye trace study. This location was chosen because it was the furthest location down stream in the storm sewer system and that stormwater could be tested before reaching the OAPIS. Figure 1 shows the locations where dye was introduced into the process sewer system.

Fluorescent dyes were used to determine if there were cross-connects between the process and stormwater sewers at the Refinery. Dye was placed in process sewer locations as far upstream as possible in each unit (see Figure 1). The storm sewer was then observed for dye at certain downstream locations. The storm sewer was observed at the EOL location stormwater sewer MH17 and other manholes located outside of individual process units. Water in the storm sewer was also examined at other manhole locations in order to detect dye before it became too diluted. If no feasible location was available, stormwater sewer MH17 was observed and sampled.

The Gas Concentration (Gas Con), Fluid Catalytic Cracking Unit (FCCU), Crude, and Platformer Unit process sewers join together at junction box C10 (see Figure 1). Junction box C10 was observed for green dye beginning at approximately 1440. Dye was not detected visually in this junction box. A sample was collected at this time and examined with UV light. The sample had a light green fluorescence. Therefore it was confirmed that the dye was flowing through the process sewer.

Junction box C-2, (see Figure 1), was observed for dye at approximately 1045 to verify the dye was flowing through the process sewer. There was a strong presence of green dye, visually, in junction box C-2. Therefore dye was confirmed to be flowing through the process sewer.
