**CLOSEOUT REPORT / CONTAMINATION ASSESSMENT  
SWMU 129 - FACILITY 244  
ABOVEGROUND TANK STORAGE AREA  
CANNON AIR FORCE BASE  
CLOVIS, NEW MEXICO**

**July 19, 2000**

**Submitted by:  
Parallax, Inc.  
20201 Century Blvd  
Germantown, MD 20874**

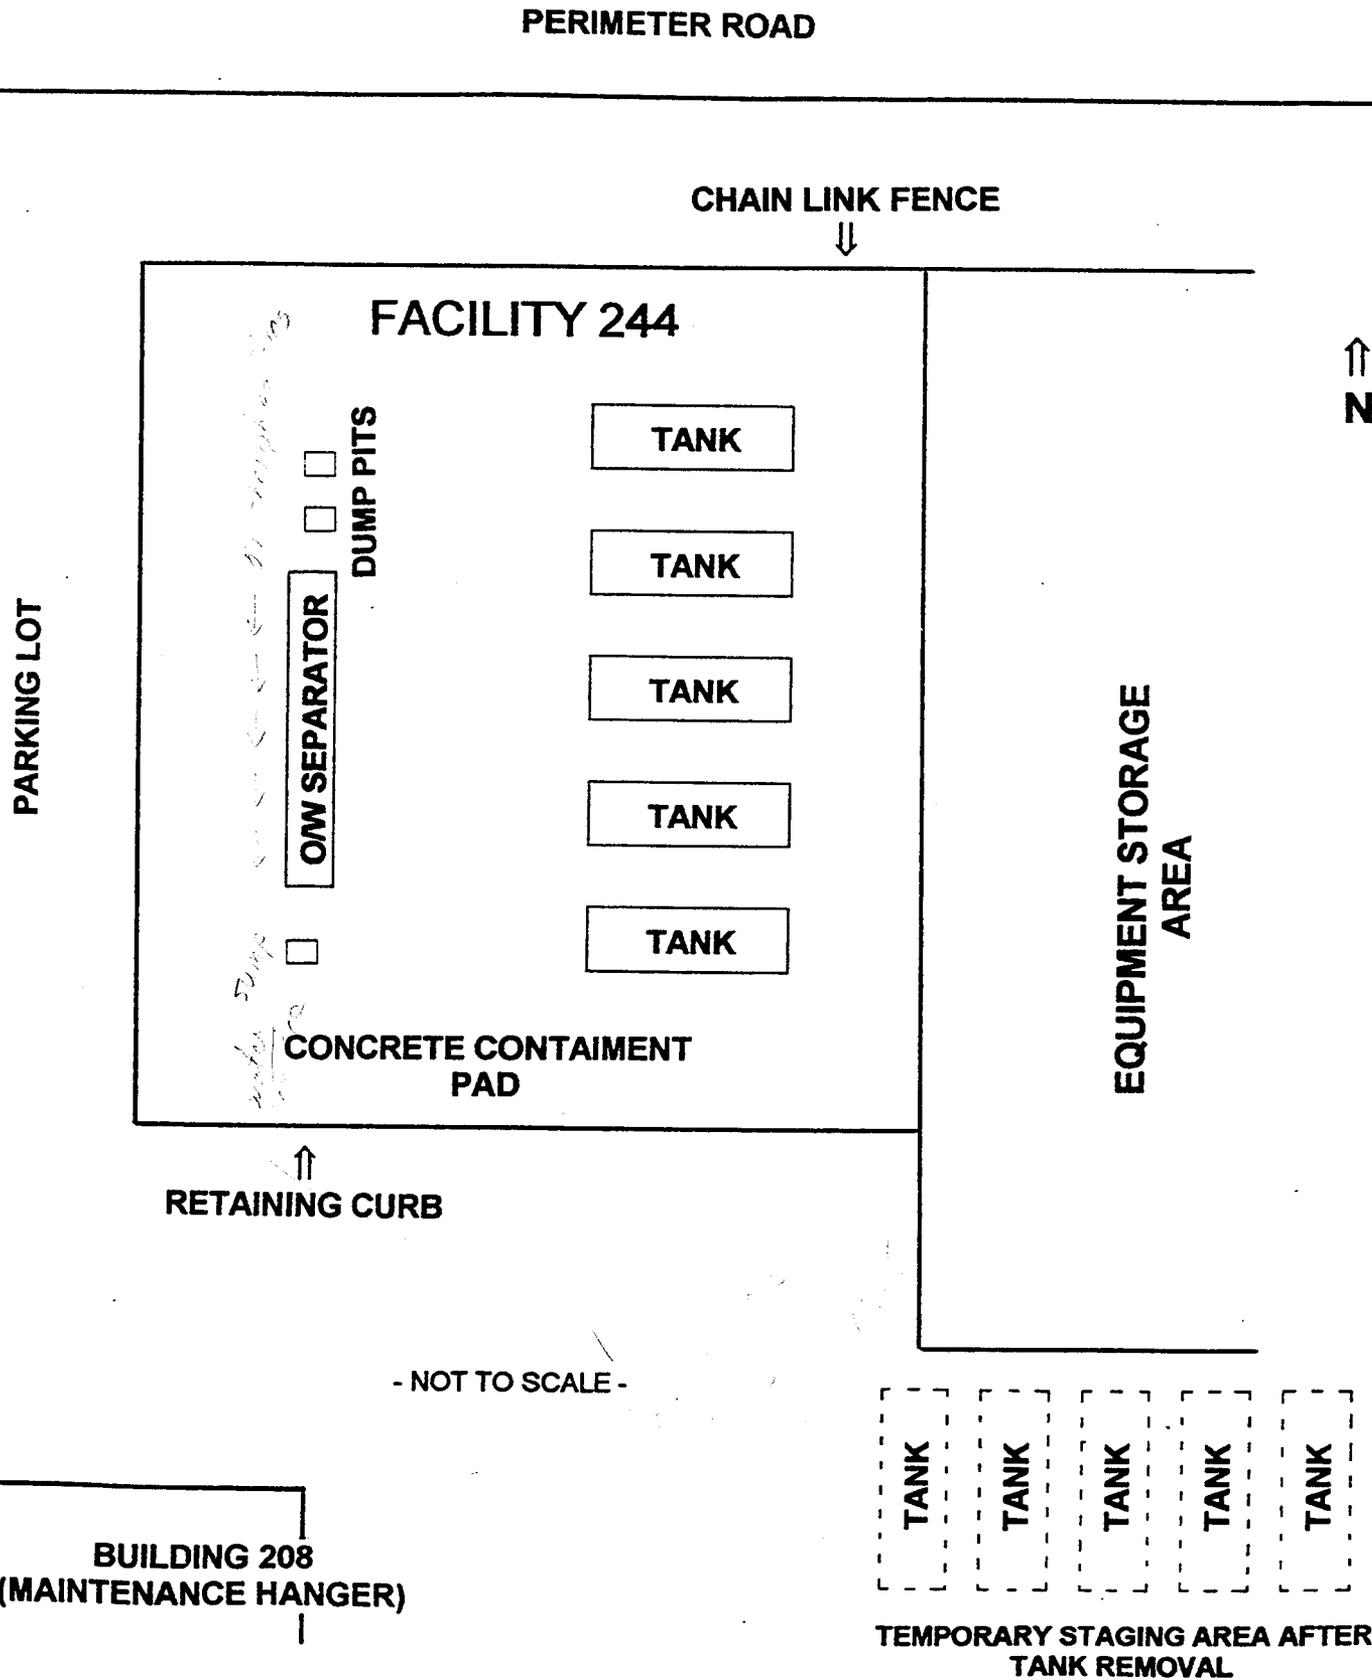
Figure 2-3: Diagram of Tank Locations and Associated Features.

Facility 244 consisted of five 5,000-gallon aboveground storage tanks supported on reinforced concrete saddles. The tanks were surrounded by a 30-foot x 50-foot (approximate) concrete containment pad. A 9-inch retaining curb, designed to contain liquids released in the event of an accidental release or ruptured tank, surrounded the containment area. Photograph 1 is a view of Facility 244 prior to start of the removal action (tanks, saddles, and chain-link fence are intact). Photograph 2 is a view of the Facility with the fence fabric removed and temporary orange security webbing in place.

The water flowed into a leach field, located to the southeast of the Facility. The leach field consisted of perforated plastic piping surrounded by crushed stone that allowed the water to be discharged into the subsurface and percolate into underlying soils without impacting the groundwater. Figure 2-3 is a plan view of Facility 244 showing the original locations of the storage tanks and temporary staging area after removal.
