**KIRTLAND AIR FORCE BASE
ALBUQUERQUE, NEW MEXICO**

**FINAL – CORRECTIVE ACTION REPORT FOR SEWER
RELEASE OF NITRATE AT MANHOLE-13 AFFECTING
BULK FUELS FACILITY GROUNDWATER
MONITORING WELLS KAFB-106005, KAFB-106009,
AND KAFB-106012R**

April 2017

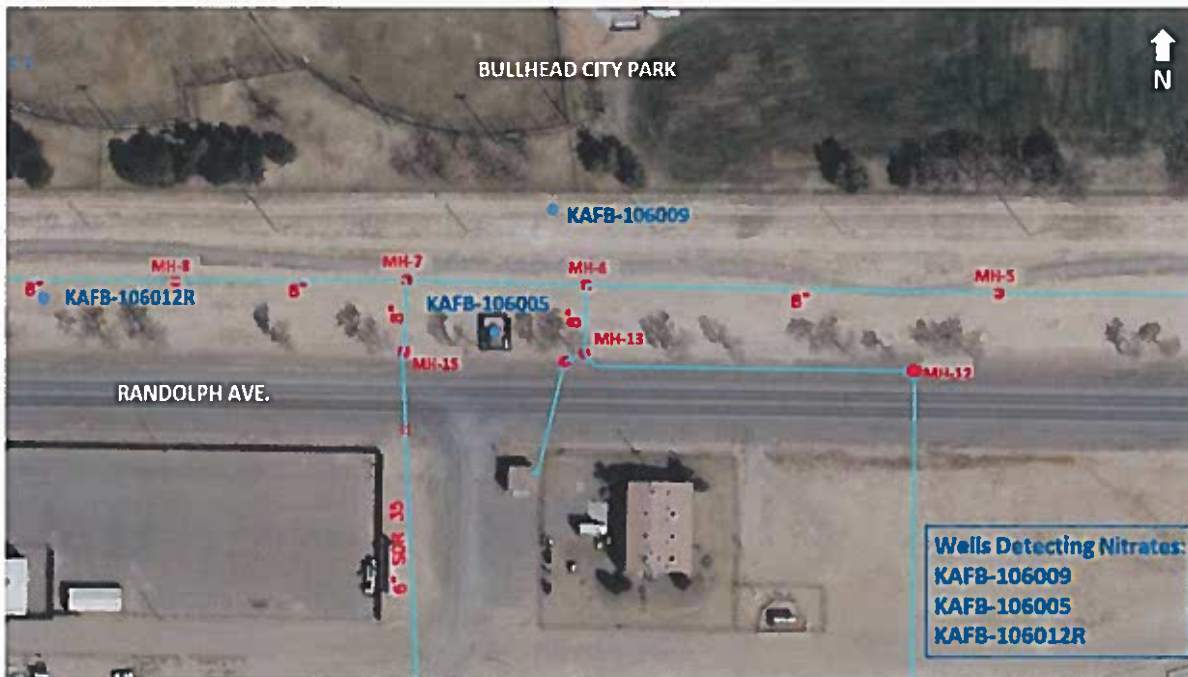
Figure 1: Location of Sewer Lines, Manholes, and Groundwater Monitoring Wells

Upon investigation, manhole-13 (MH-13) was found to have been compromised with tree roots invading the bottom of the manhole structure and causing leakage of sewer water. To address the sewer leak, MH-13 and approximately 10-20 feet (ft) of connective piping will be fully removed and replaced. Sampling of affected BFF groundwater monitoring wells KAFB-106005, KAFB-106009, and KAFB-106012R will continue on a quarterly basis until concentrations demonstrate reduction of total nitrate below MCL of 10 mg/L.

Due to the continued observation of increasing total nitrate in BFF groundwater wells, AFCEC decided to expand the sewer line investigations using assistance from the U.S. Army Corps of Engineers. This led to an investigation of manholes near the nitrate influenced BFF groundwater monitoring wells. During this investigation, MH-13 was found full of water and debris (Appendix A). After removal of the debris for MH-13, it was discovered that there were tree roots growing into the bottom of the cinder block in MH-13 (Appendix A). In addition, there are three sewer lines (two 8 inch and one 4 inch), approximately 12 years old, that feed into MH-13 from two unoccupied buildings. The camera investigations showed that there were no other leaks from the sewer lines (i.e., two 8 inch and one 4 inch), and that the suspected sewer leak is coming from MH-13 and the probable source of increasing total nitrate in the three BFF groundwater monitoring wells (Appendix A). The MH-13 is approximately 80 ft from KAFB-106005, 140 ft from KAFB-106009, and 570 ft from KAFB-106012R (Figure 1).

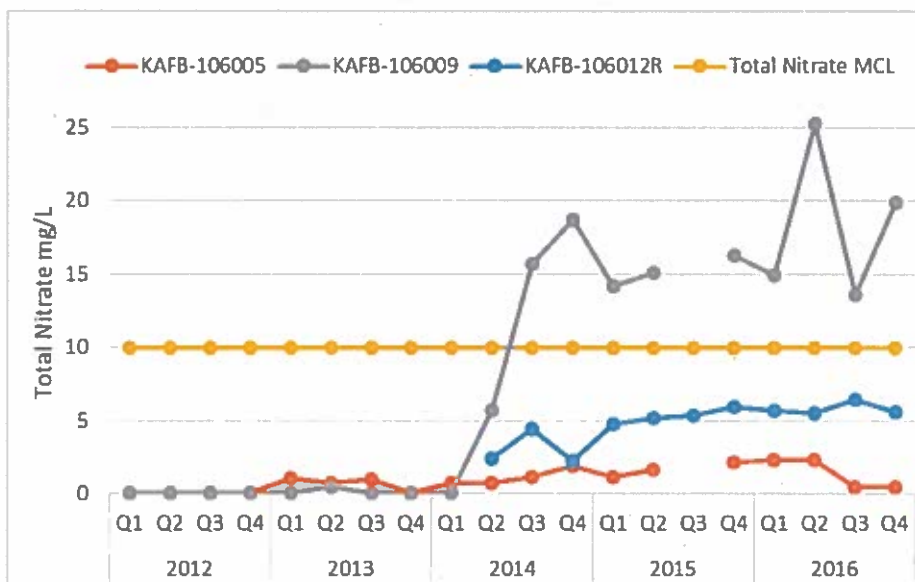
Figure 2: Total Nitrate Concentrations in BFF Groundwater Monitoring Wells KAFB-106005, KAFB-106009, and KAFB-106102R

An evaluation was performed to determine the sources of elevated nitrate, chloride, sulfate, sodium, and potassium concentrations in samples from groundwater monitoring wells KAFB-106005, KAFB-106009, and KAFB-106012R. Concentrations of these five analytes have displayed increasing concentrations in quarterly samples obtained from 2014-2016. The total nitrate concentrations have been increasing in all three groundwater-monitoring locations with KAFB-106009, exceeding the NMAC 20.6.2.3103 MCL of 10 mg/L (Figure 2). The groundwater gradient from MH-13 flows towards KAFB-106009.

In Figure 2, KAFB-106009 had exceeded the MCL for total nitrate in third quarter (Q3) 2014 and continued to rise reaching maximum total nitrate concentration of 25.3 mg/L in second quarter (Q2) 2016. Additionally, KAFB-106005 and KAFB-106012R have seen increasing total nitrate concentrations (Figure 2) but have not exceeded the total nitrate of 10 mg/L MCL. KAFB-106005 and KAFB-106012R maximum nitrate were 2.3 mg/L in Q2 2016 and 6.4 mg/L in Q3 2016, respectively. It is important to note that KAFB-106012 was abandoned in 2014 and replaced by KAFB-106012R well as a result of damage to the original well and quarterly samples were not collected from first quarter (Q1) 2013 through Q1 2014.

The observed increases in nitrate, chloride, sulfate, sodium, and potassium concentrations at these wells are consistent with an impact from a leaking sewage line. A positive correlation is observed between nitrate and chloride at KAFB-106005 and KAFB-106009, suggesting that both analytes have a common source. The increasing concentrations of these five analytes are not related to the BFF fuel leak. BFF leak influenced the groundwater composition, but these changes included decreasing in nitrate and sulfate concentrations, and generally do not affect chloride, sodium, or potassium concentrations.
