TO: John Kieling, Prog. Mgr., DOE Facilities, HRMB
THRU: James H. Davis, Ph.D., Chief, SWQB *JHD*
THRU: *JK* Glenn Saums, Prog. Mgr., SWQB
FROM: *BH* Barbara Hoditschek, Env. Spec., SWQB
DATE: July 6, 1999
SUBJECT: Surface Water Quality Bureau Final Report On 3011 RCRA Grant: The Oversight of Los Alamos National Laboratory Removal Activity

**New Mexico Environment Department-Surface Water Quality Bureau Final Report
For The 3011 RCRA Grant:
The Oversight of Los Alamos National Laboratory Removal Activity**

Submitted to the NMED-Hazardous and Radioactive Materials Bureau, July 2, 1999

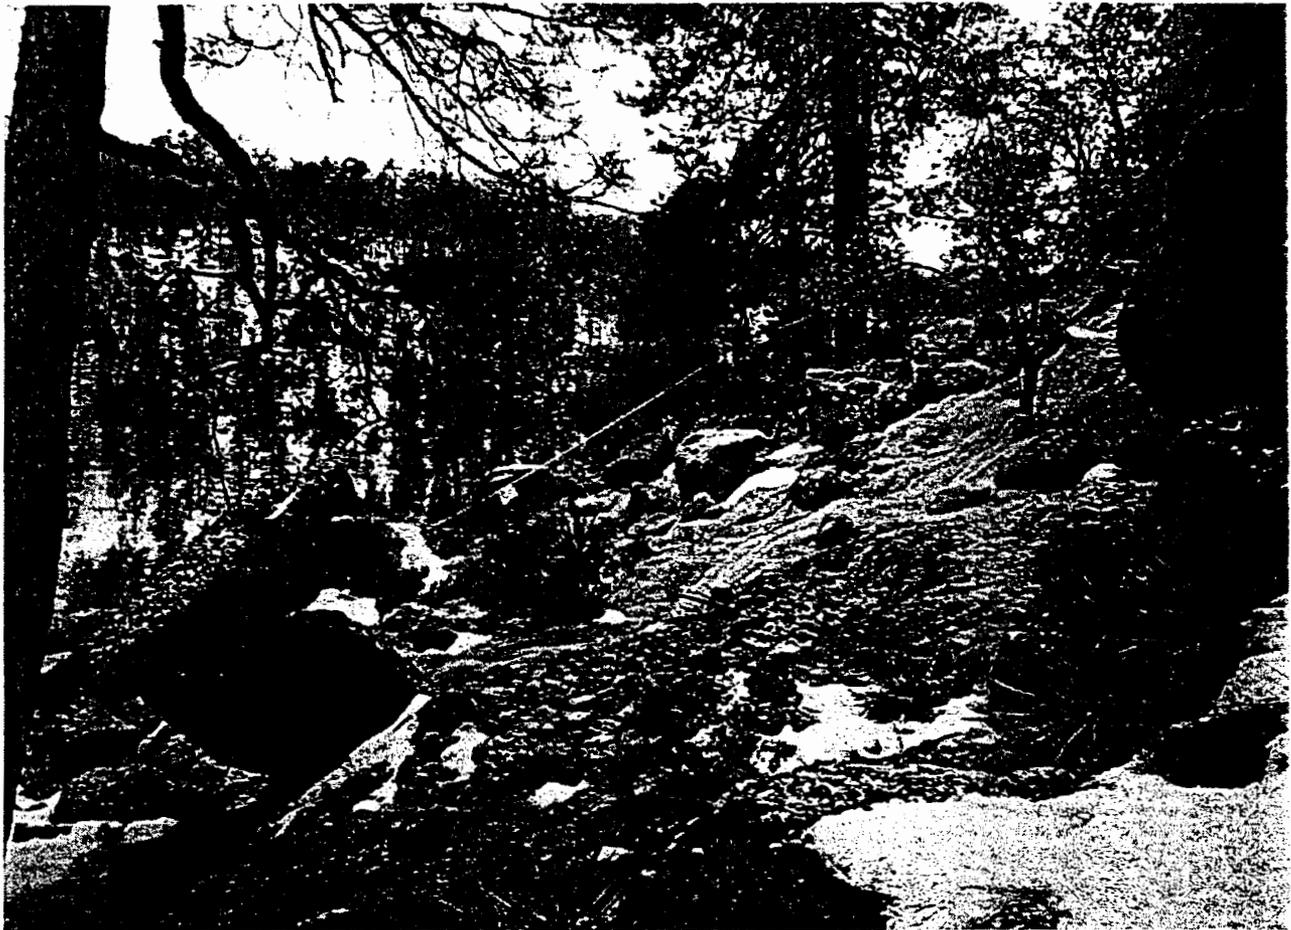
**PRS 1-001(d)
Hillside 138**

Brief Description: PRS 1-001(d) is located in former TA-1 and includes former Septic Tank 138, the associated outfall, and Hillside 138. The septic tank served historical Laboratory buildings K, Y, and V (now removed). Discharges from the outfall flowed over the canyon rim and onto the hillside. Hillside 138 (immediately below the canyon rim) consists of the upper outfall and bench area, a steep cliff, the lower outfall and bench area, a second cliff, and a gradual slope to the bottom of the canyon.

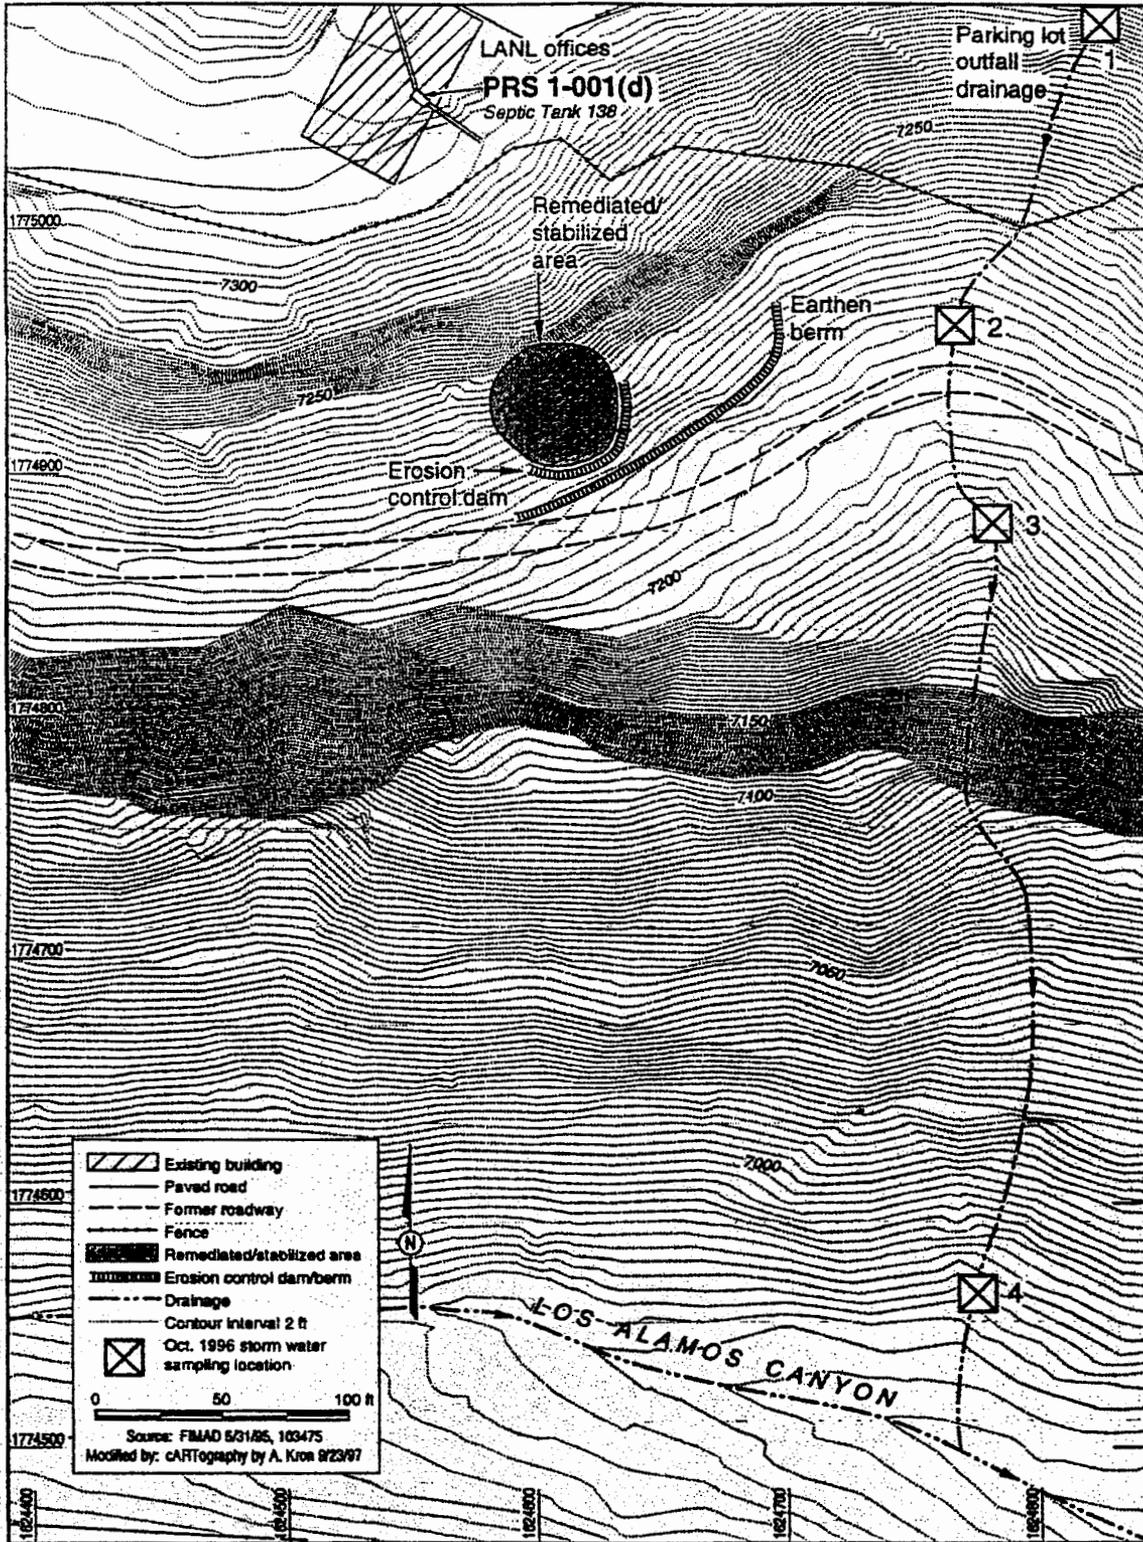
PRS 1-001(d) Hillside 138 storm water sampling locations.

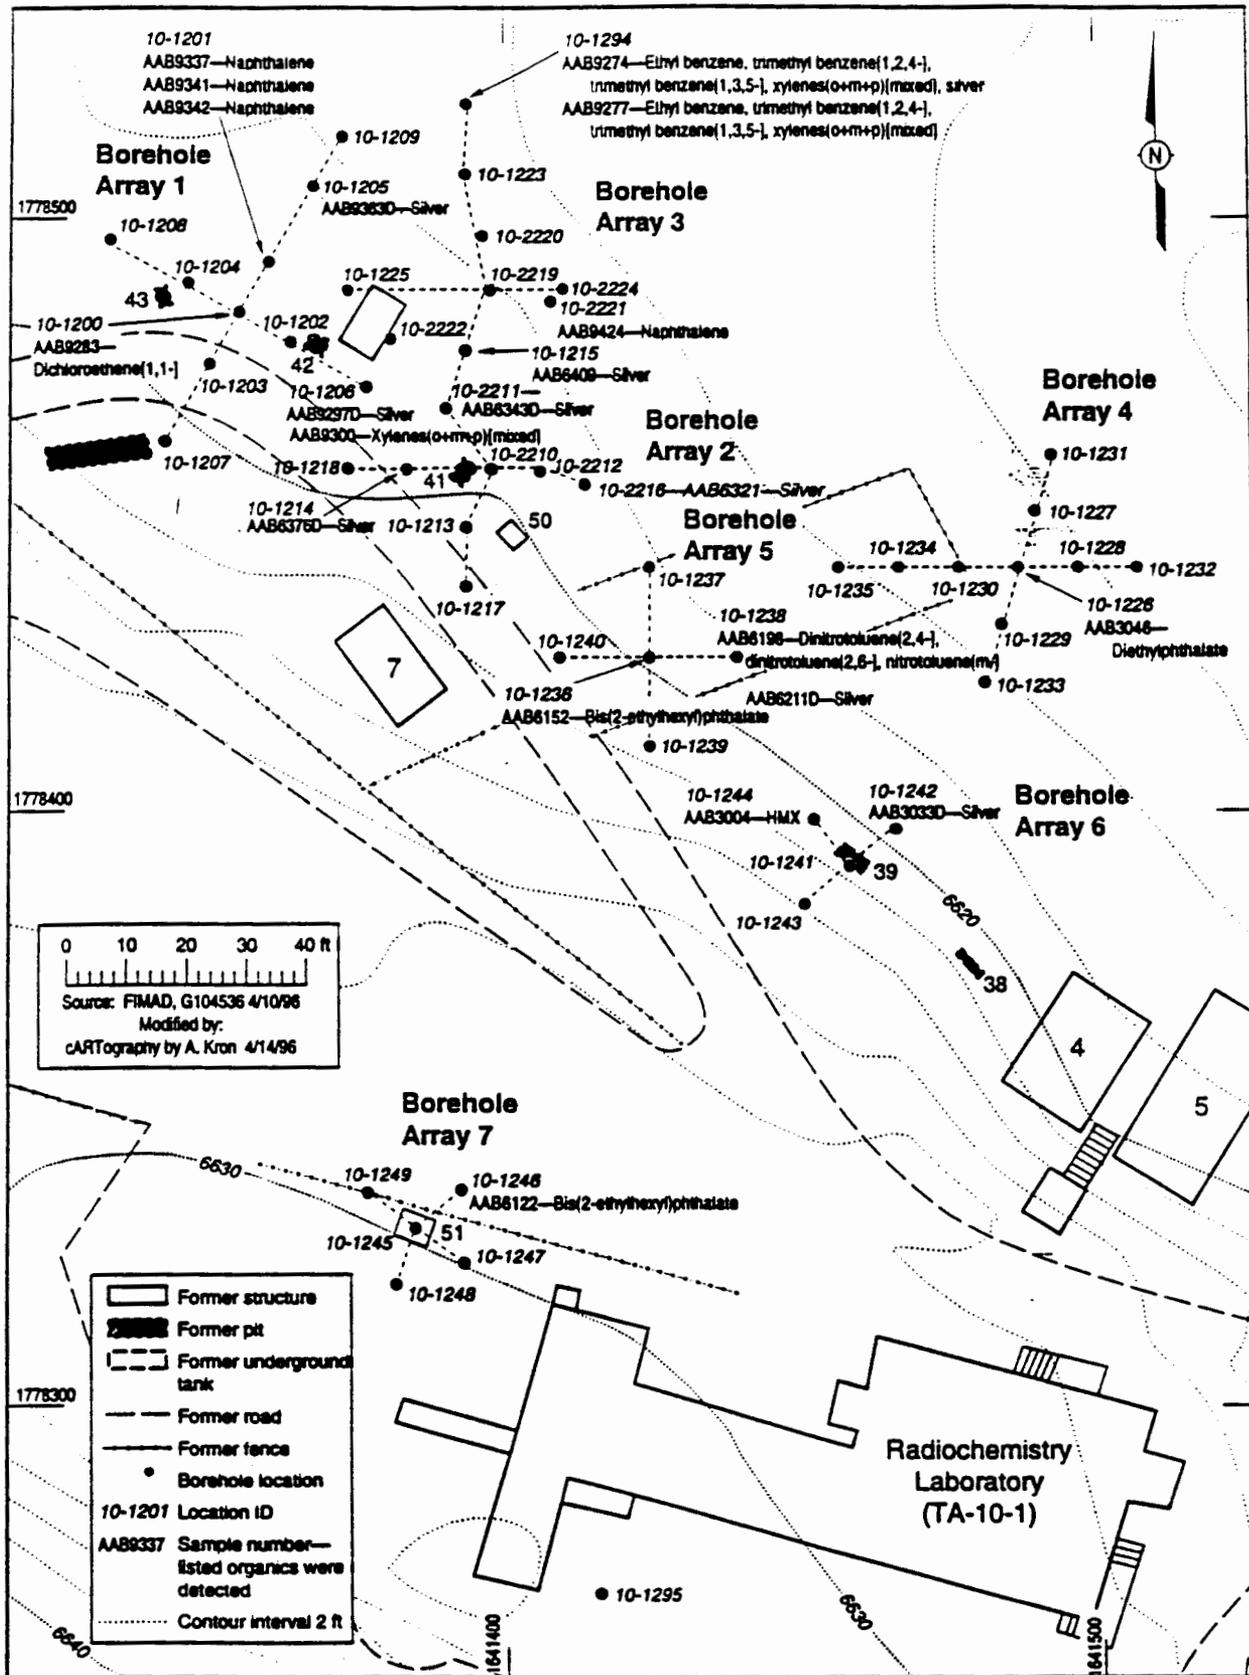
Fig. 5.3.4-1. Locations of samples collected at PRSs 10-003(a-o) and 10-007, and locations of detected organic analytes and inorganic analytes greater than background.
