LA-UR-00-3767

Title: CERRO GRANDE FIRE AFTERMATH:
ENVIRONMENTAL RESTORATION PROJECT
ACTIVITIES TO REDUCE THE MIGRATION OF
CONTAMINATION FROM POTENTIAL RELEASE SITES

Author(s): STEVEN J. VEENIS, CPESC

Submitted to: WATER QUALITY & HYDROLOGY GROUP (ESH-18)
ENVIRONMENTAL RESTORATION PROJECT

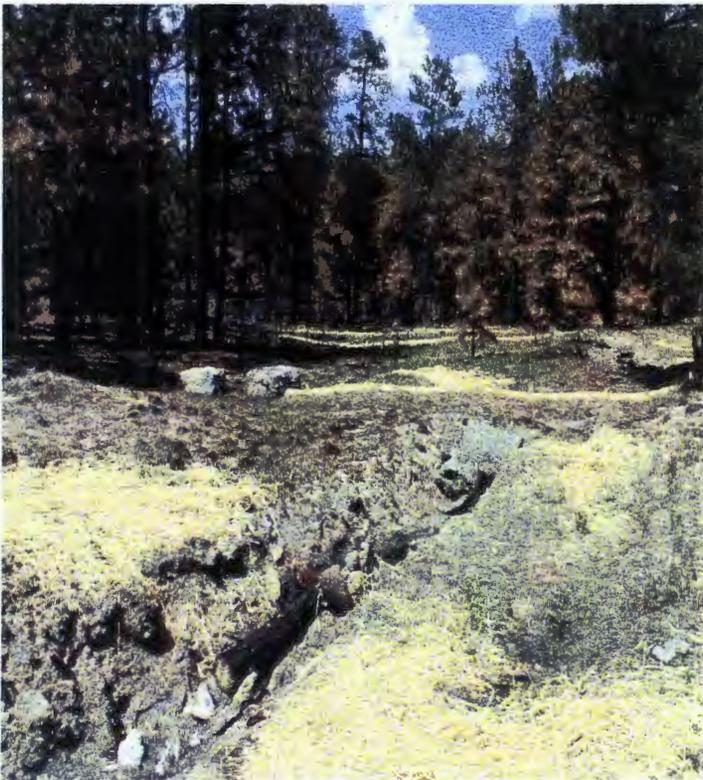
This site is located on the south side of Pajarito Canyon within the Two Mile Canyon Watershed Aggregate. The drainage channel east of building TA-6-6 has minor evidence of fire damage. Miscellaneous debris was observed around the area including concrete, rebar and old building wood. A pre-existing erosional feature was observed.

Wattles were installed both up and down slope within the drainage channel. Rock/log check dams were installed within the channel to dissipate surface runoff.

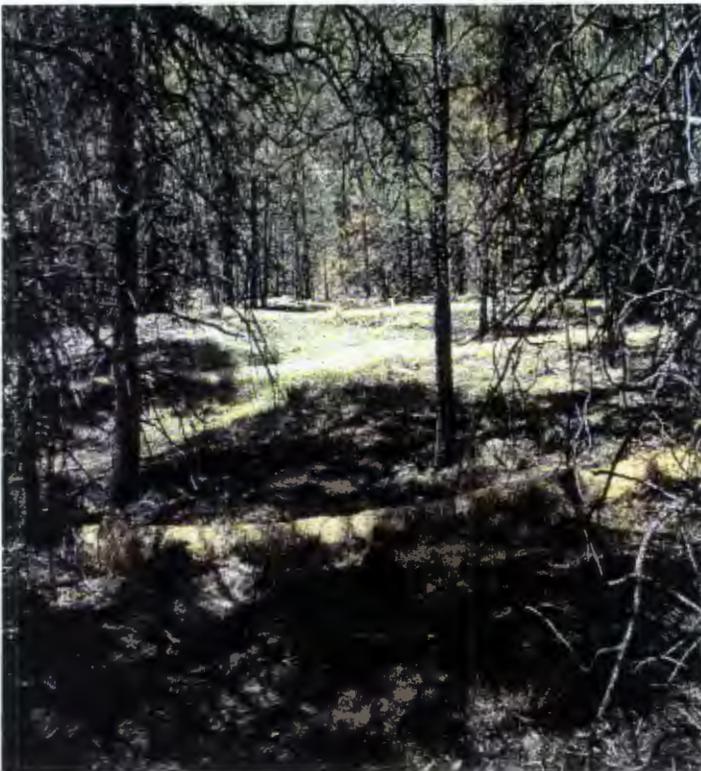
This site is located south of Pajarito Canyon within the Starmer/Upper Pajarito Watershed Aggregate. The area received minor to moderate fire damage. The ground cover was completely burned but the canopy cover was only partially affected. The grasses have recovered quickly in most of the area.

Straw wattles were installed within the drainage swales and rock check dams were placed within the channels to dissipate flow.

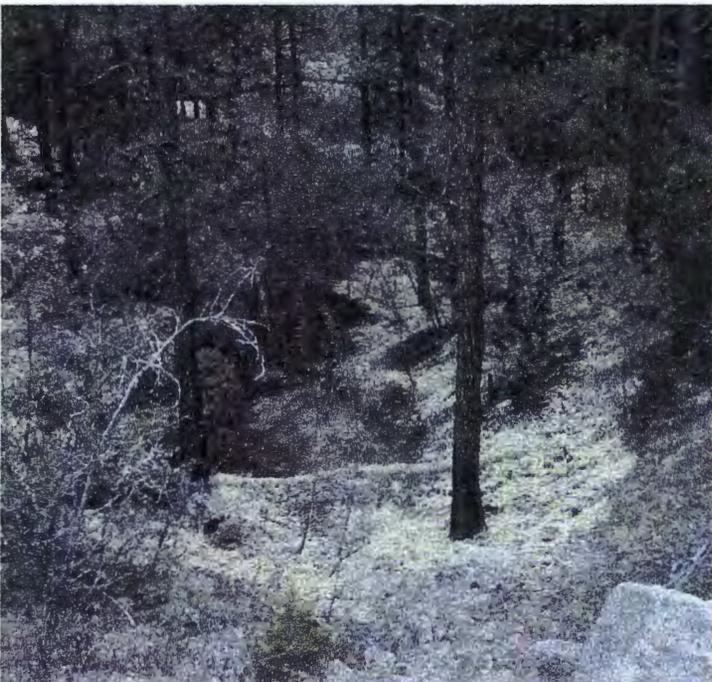
This site is located north of Canon de Valle within the Canon de Valle Watershed Aggregate. The eastern portion of TA-14 was moderately burned with substantial damage to the groundcover.

Straw wattles were installed within all drainage channels and swales. The areas were hand raked, reseeded and mulched.

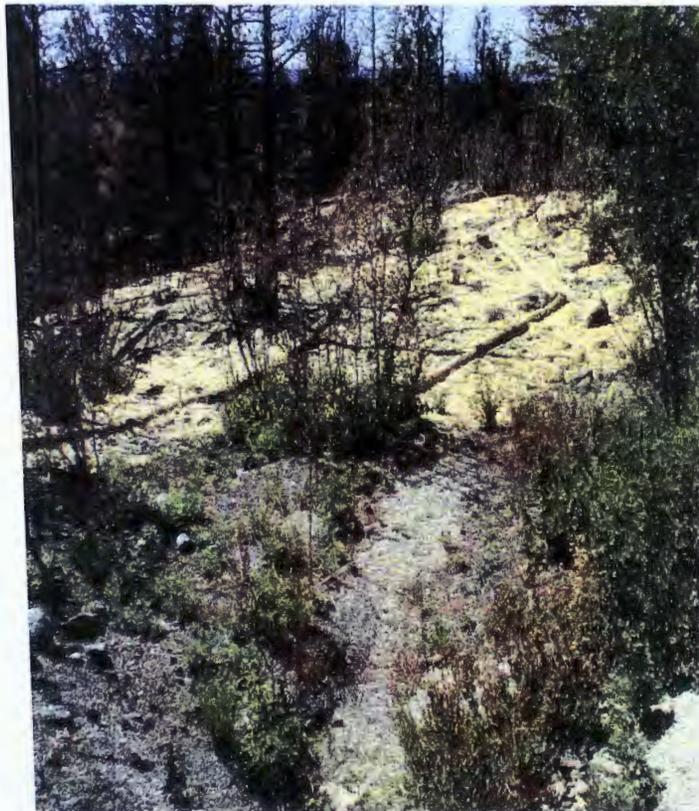
This site is located north of Canon de Valle within the Canon de Valle Watershed Aggregate. The central portion of TA-14 was moderately burned with substantial damage to the groundcover.

Straw wattles were installed within all drainage channels and swales. The areas were hand raked, reseeded and mulched.

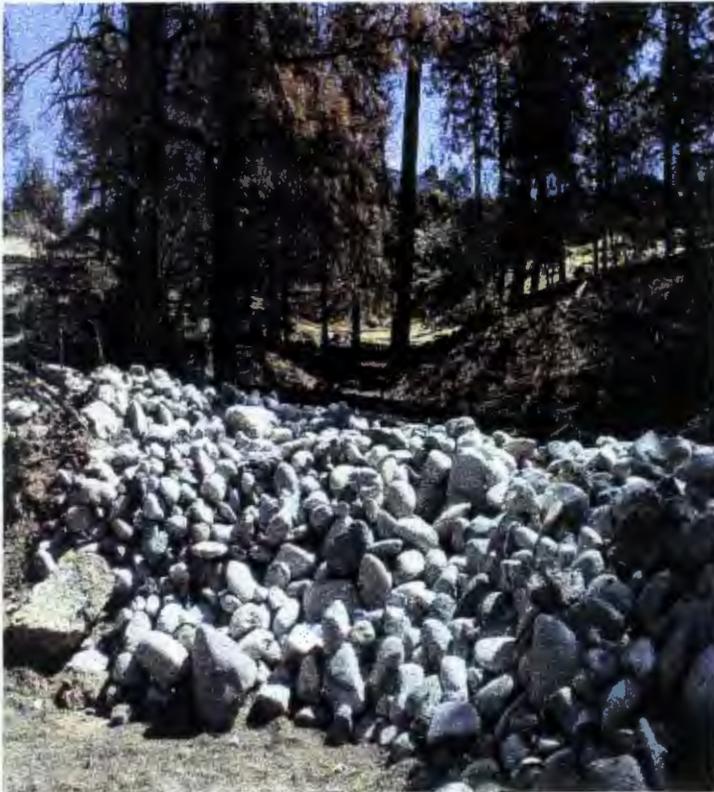
This site is located north of Canon de Valle within the Canon de Valle Watershed Aggregate. The western portion of TA-14 was moderately to severely burned with substantial damage to the canopy and groundcover.

Straw wattles were installed within all drainage channels and swales. The areas were hand-raked, reseeded and mulched. A rock check dam was installed at the bottom of the drainage.

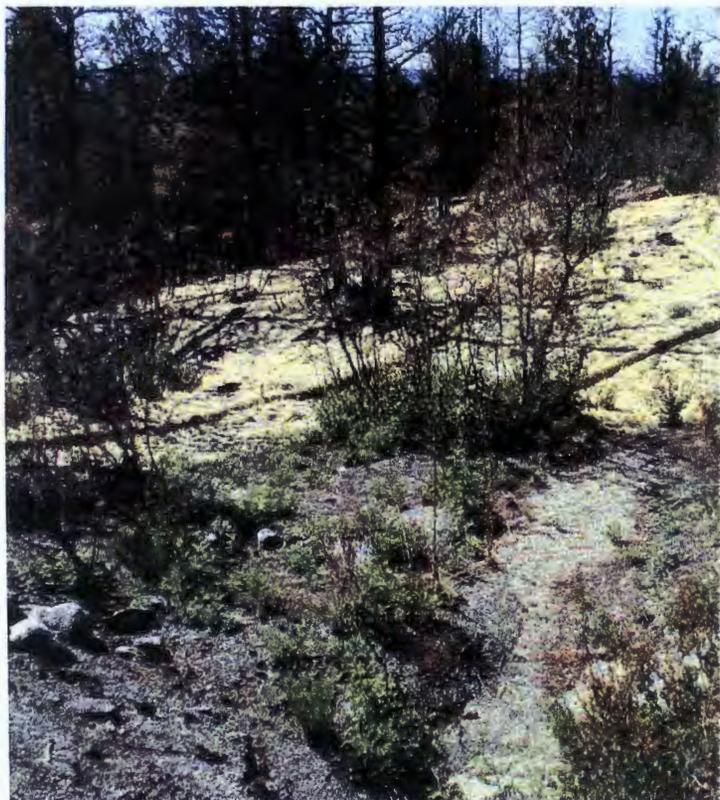
This site is located north of Canon de Valle within the Canon de Valle Watershed Aggregate. The western portion of TA-14 was moderately to severely burned with substantial damage to the canopy and groundcover. Most of the existing BMPs at the site were destroyed. As a result, the erosion potential for the site is moderate to high.

Straw wattles were installed within all drainage channels and swales. The areas were hand-raked, reseeded and mulched.

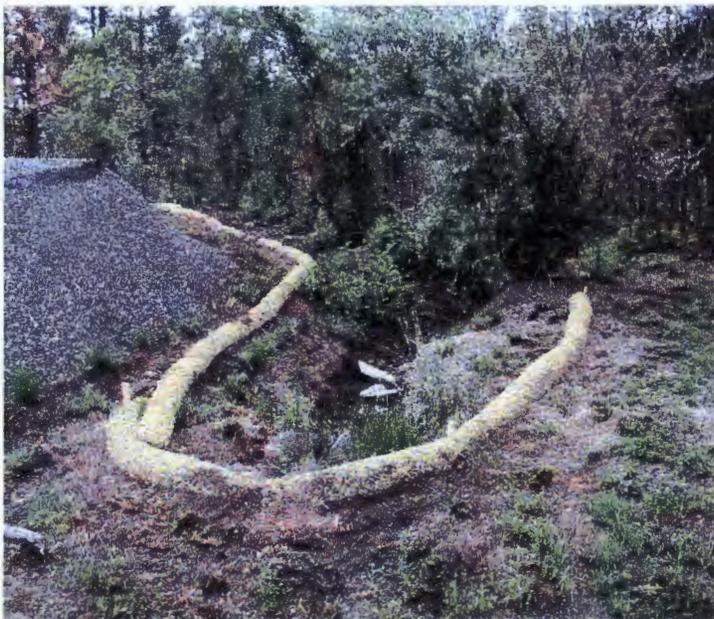
This site is located near the confluence of Canon de Valle and Water Canyon within the Canon de Valle Watershed Aggregate. The site was moderately to severely damaged including several burned structures. The ground cover and canopy surrounding the site was extensively damaged. Runoff from the entire Hollow site discharges into a small tributary (to Canon de Valle) west/southwest of the site near oil storage tank (15-011(b)).

Straw wattles were installed along the western perimeter of the mesa. Several trees were contour felled for erosion control along the drainage channel. The site was hand-raked, reseeded and straw mulched.

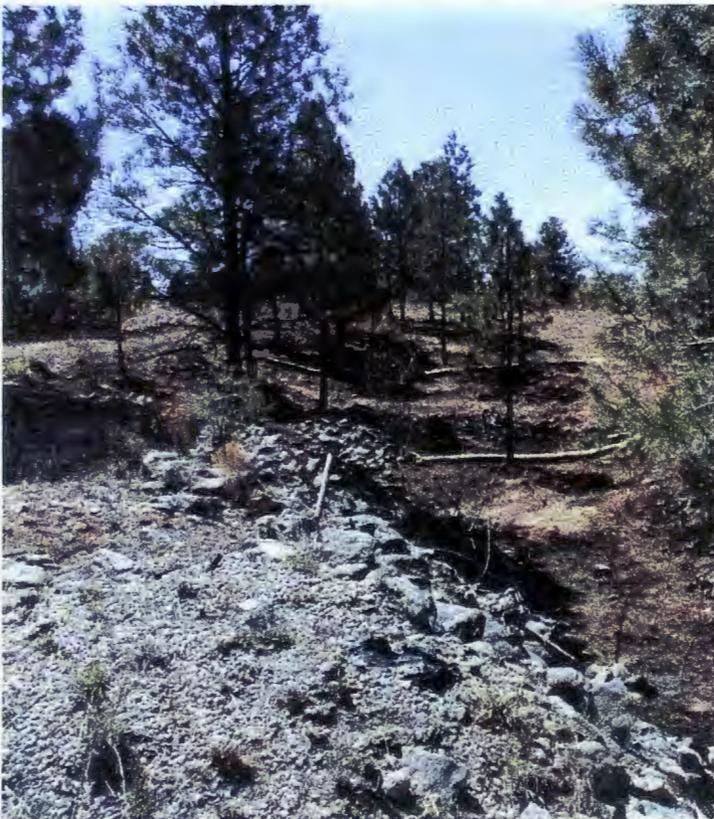
This site is located near the confluence of Canon de Valle and Water Canyon within the Canon de Valle Watershed Aggregate. The area received minor burn damage primarily to the ground cover.

Straw wattles were installed above the site within the existing drainage channel and below the area with exposed debris.

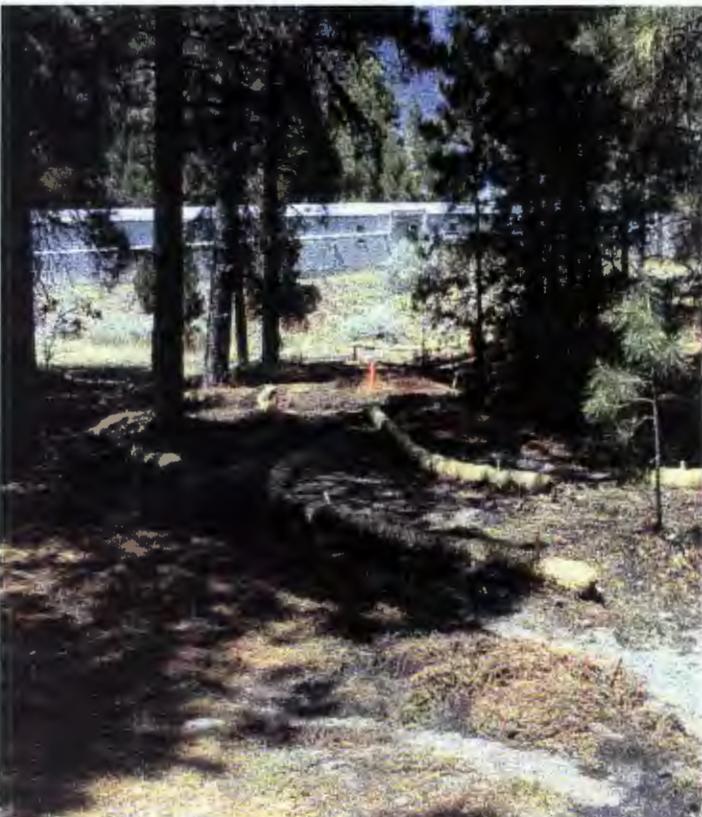
This site is located east of S-Site Road in the upper tributary of Canon de Valle within the Canon de Valle Watershed Aggregate. No damage was observed from the outfall to the first rock check dam. Below the second rock check dam, fire damaged much of the ground cover and several of the ponderosa pine trees. All straw were destroyed.

Straw wattles were installed throughout the outfall area to dissipate run-on. Ashflow from run-on events have been and will continue to be a problem in this area. This site is being considered for an accelerated cleanup.

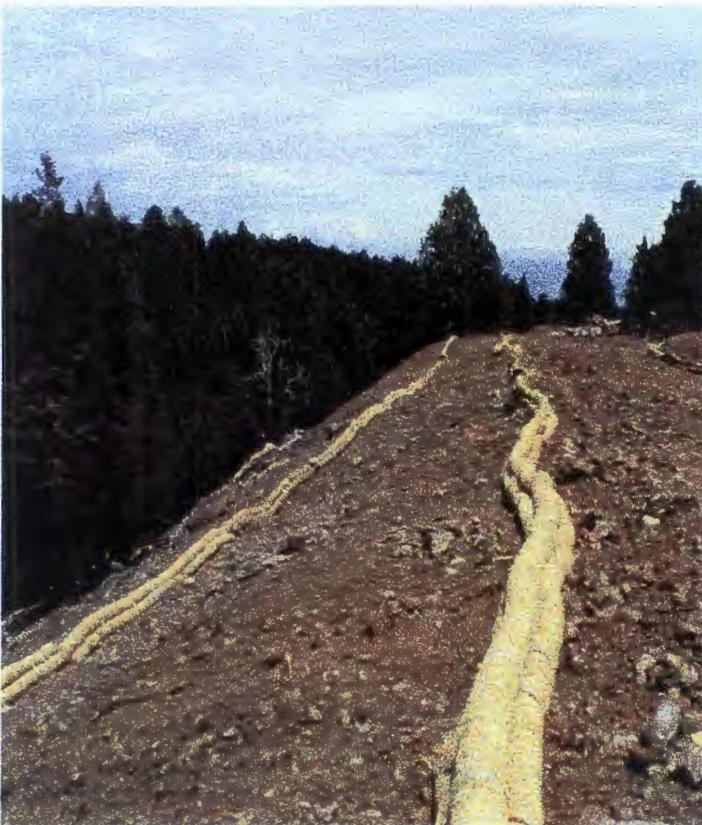
This site is located near building TA-16-260 above Canon de Valle within the Canon de Valle Watershed Aggregate. The site has moderate to severe fire damage over a majority of the area. Miscellaneous debris was exposed on the mesa and slope above canyon channel. The dissipation controls installed within the eastern drainage were destroyed. The ground and canopy cover was completely destroyed. Ash is up to 12” deep in some areas at the toe of slope. Burning occurred in the Canon de Valle leaving severe erosion potential behind.

The fire smoldered for several weeks prior to being extinguished on June 4, 2000. The site was then excavated and 95% of the debris was staged in the area. Trees were contour felled at the toe of the slope to provide sediment retention. Straw wattles were installed across the entire slope at four locations. The entire slope was hydromulched to enhance the vegetation process.

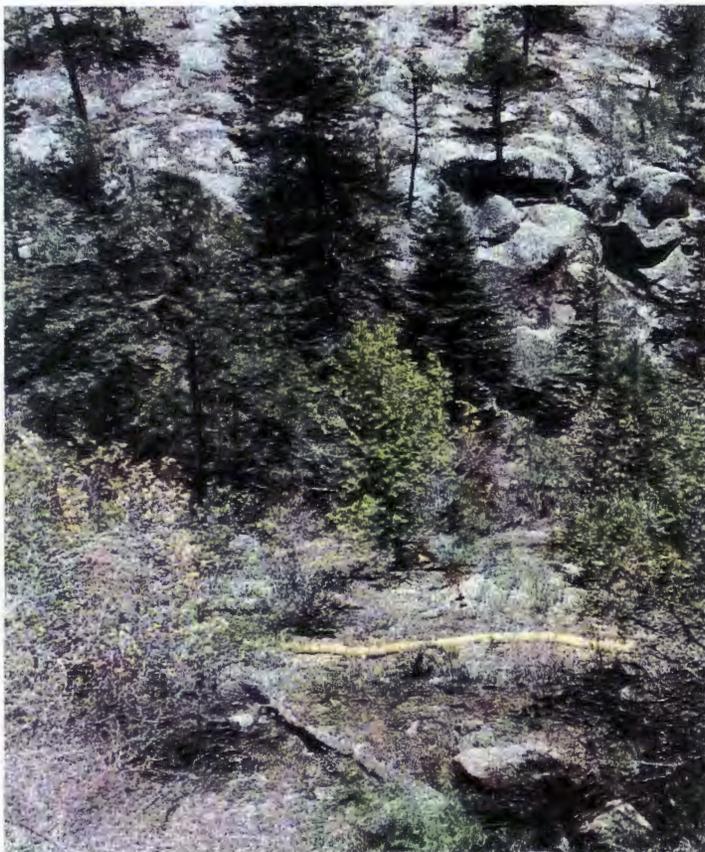
Site is located near a tributary in upper Water Canyon within the Upper Water Canyon Watershed Aggregate. The site has minor to moderate fire damage within the outfall drainage.

Straw wattles were installed near the outfall pipe and below the mesa's edge within the bottom of the tributary drainage. The area around the outfall was hand-raked, reseeded and straw mulched.

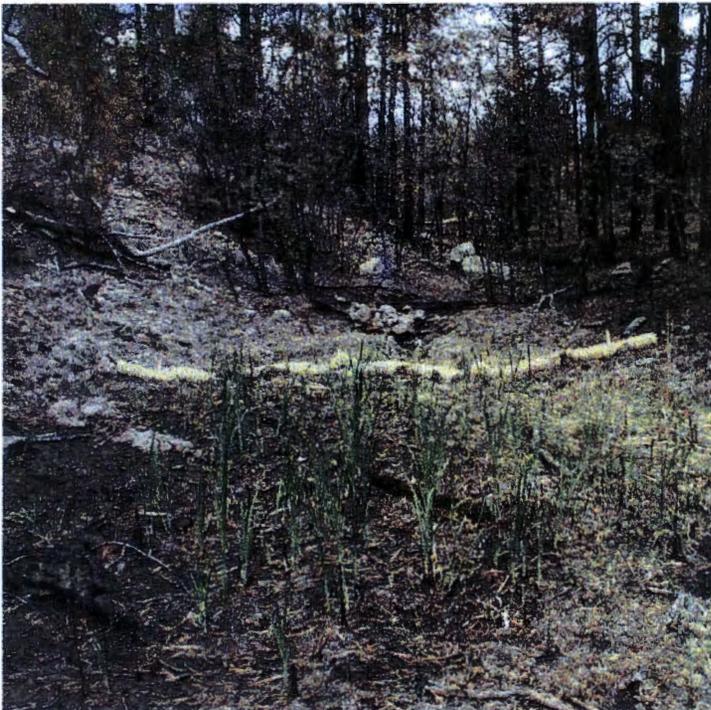
The site is located in a tributary drainage of Water Canyon within the Canon de Valle Watershed Aggregate. The “fish ladder” was destroyed by the fire. The remainder of the site has minor to moderate fire damage within the drainage channel down to the existing wetlands located approximately ¼ mile downstream.

Straw wattles were installed above and below the wetland to help control sediment transport within the channel. Rock check dams (on-site materials used) were installed for flow dissipation. Wetland vegetation has begun to re-establish itself.

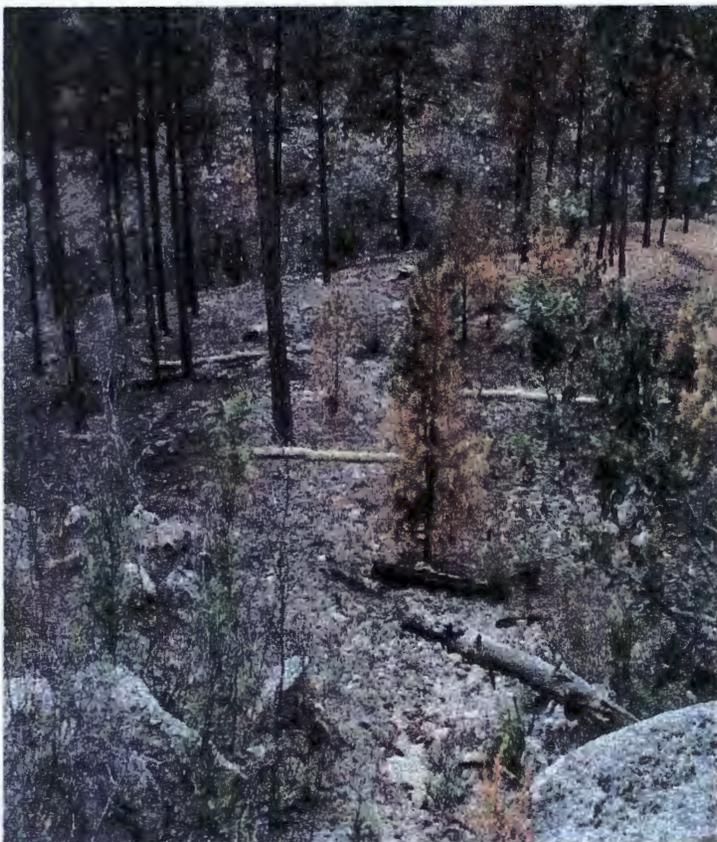
The site is located in a tributary drainage of Water Canyon within the Canon de Valle Watershed Aggregate. The site has minor to moderate fire damage within drainage channel. Debris was exposed within channel near the inactive outfall.

Straw wattles were installed upslope of and within the drainage channel to divert and dissipate storm flows. The debris was removed from the channel and the area was hydromulched to enhance the vegetation process.

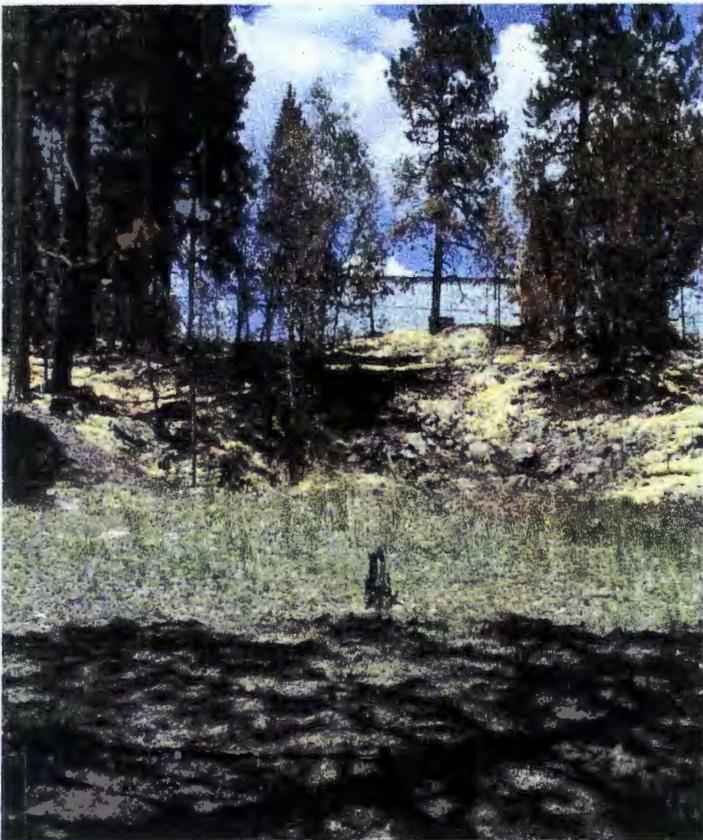
The site is located in a tributary drainage of Pajarito Canyon within the Starmer's/Pajarito Canyon Watershed Aggregate. Moderate fire damage was found at 22-015(c) including the drainage swale below the inactive outfall, the pond area and stained areas leading to the mesa edge. The ground cover was severely damaged leaving little or no protection.

*Photograph is mislabeled.

Straw wattles were installed upslope and within the drainage swale. The area was hand-raked, reseeded and mulched. The pond area has begun to revegetate itself.

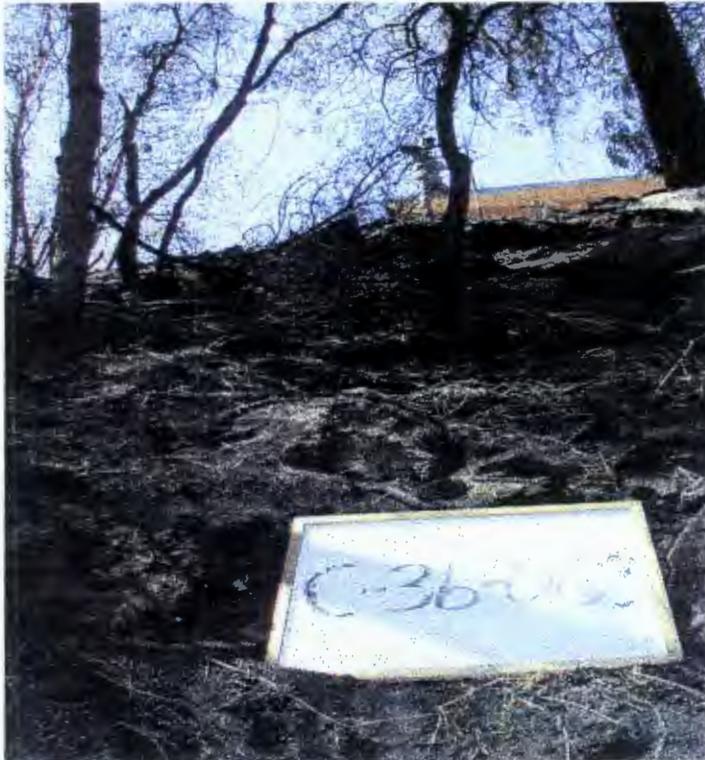
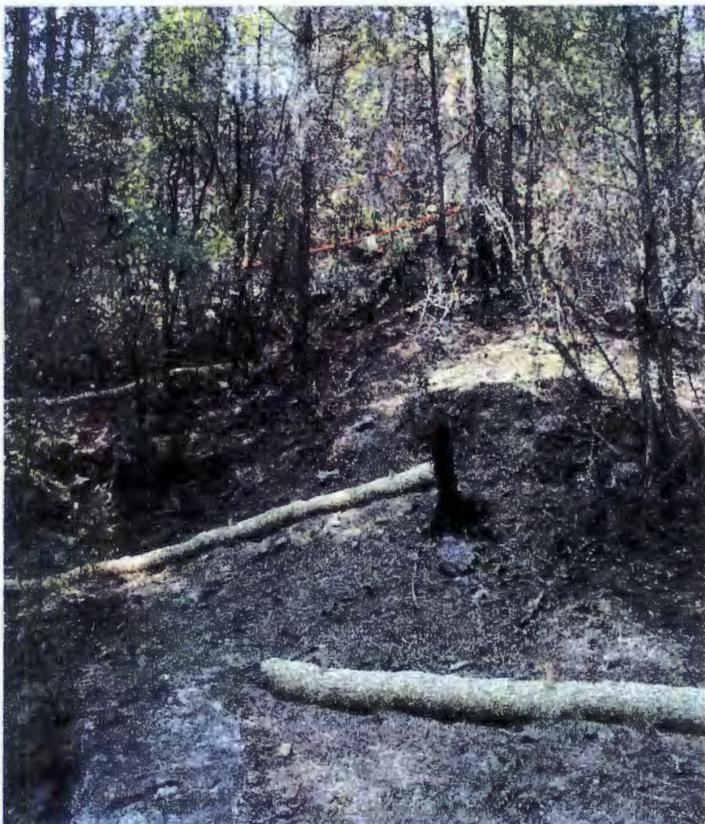
C-36-003 – *Erosion Matrix Score 52.0*. This is an inactive permitted (06A106) outfall that received chemicals from a photo lab within Building TA-36-1. It outfalls a few feet over the steep edge of Three Mile Canyon. It became operational in 1950.

The site is located on the edge of Three Mile Canyon within the Three Mile Canyon Watershed Aggregate. A backfire was set near C-36-003 to help protect TA-18. This fire exposed miscellaneous debris on the slope behind building TA-36-1.

Straw wattles were installed on the mesa's edge to divert storm water run-on from the parking area, within the drainage channels on the slope and at the toe of the slope. The debris that was exposed has been removed, and the area was hand-raked, reseeded and straw mulched.

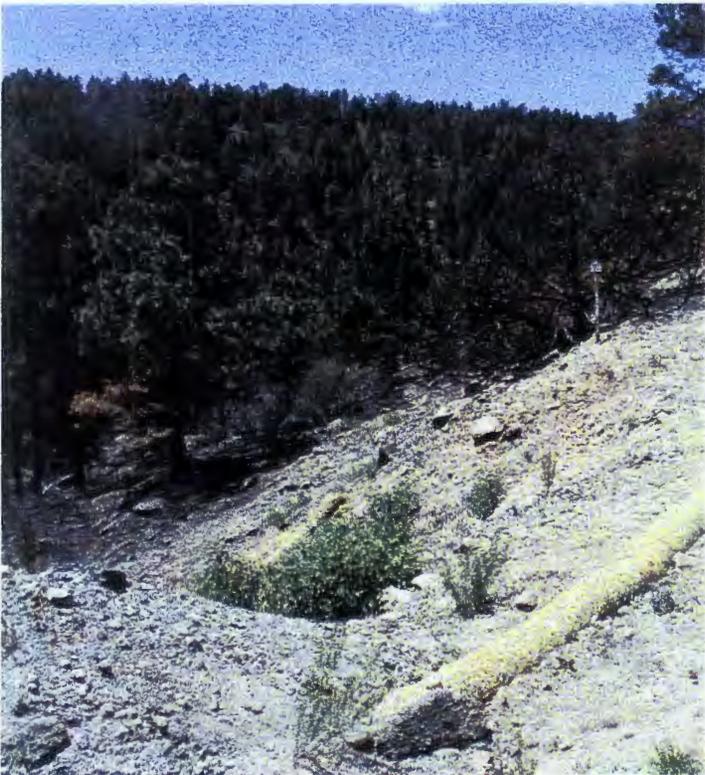
The site is located on the edge of Pajarito Canyon within the Starmer's/Pajarito Canyon Watershed Aggregate. The fire damage was moderate to severe with several buildings destroyed near this site.

Straw wattles were installed on the steep portion of the slope to reduce the sediment migration potential. Wattles were also installed on the mesa's edge to divert run-on from slope.

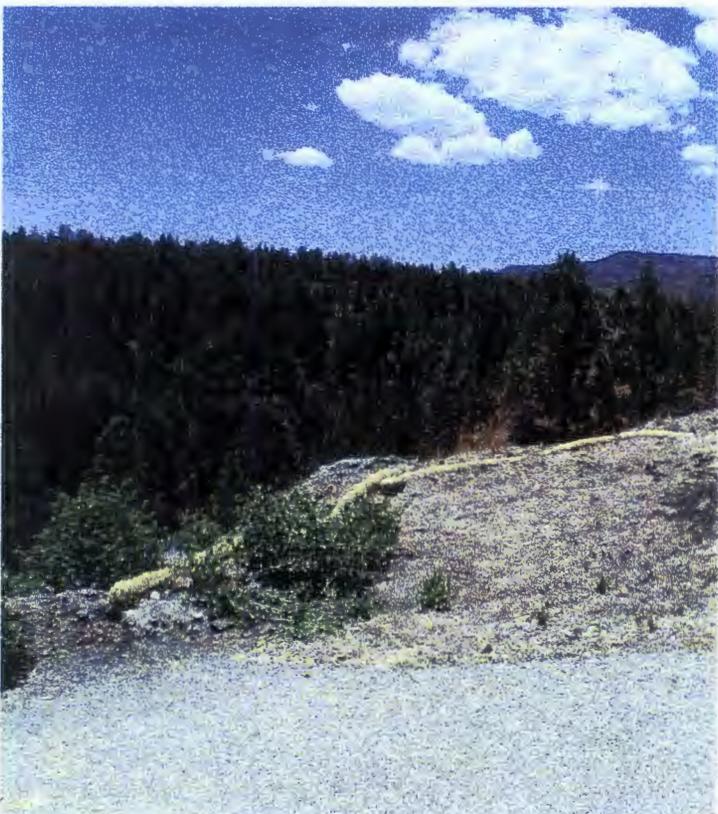
Site is located on the edge of Pajarito Canyon within the Starmer's/Pajarito Canyon Watershed Aggregate. The fire damage was moderate to severe with several buildings destroyed near this site.

Straw wattles were installed on the steep portion of the slope to reduce the sediment migration potential. Wattles were also installed on the mesa's edge to divert run-on from the slope.

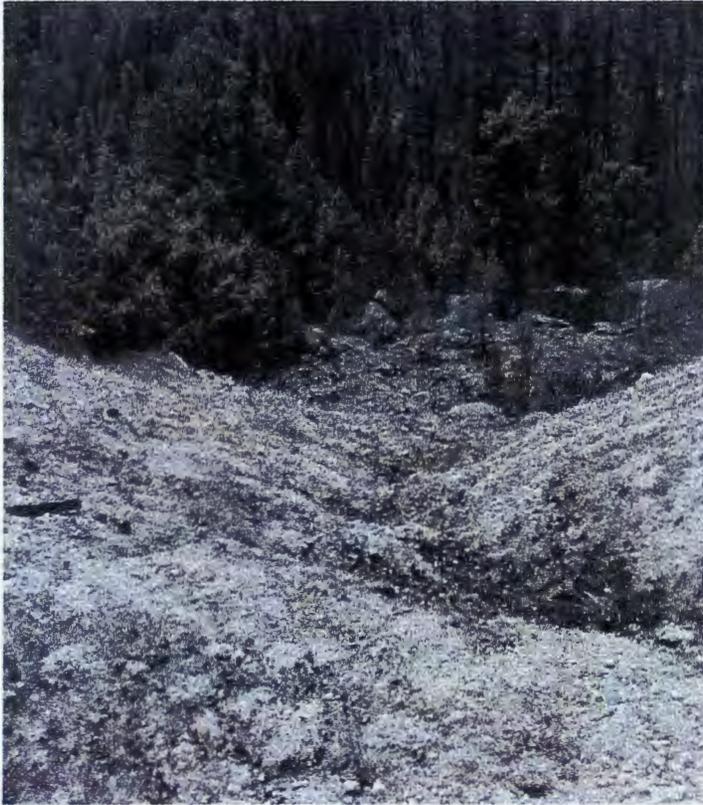
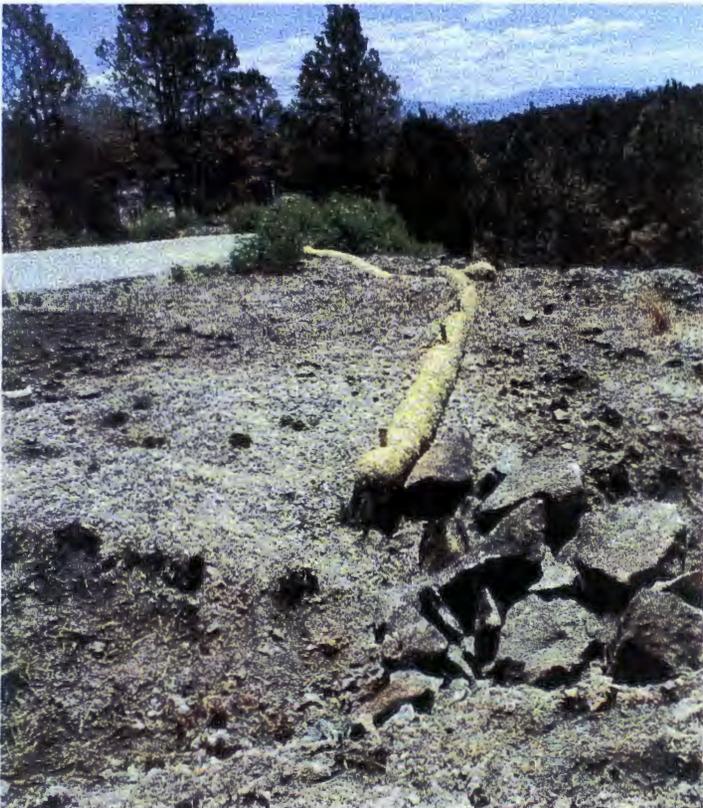
40-009 - Erosion Matrix Score 54.5. Landfill adjacent to firing site at TA-40-9. The landfill contains debris from decommissioning of buildings at TA-15. An inactive NPDES outfall (04A101) is located nearby.

The site is located on the edge of Pajarito Canyon within the Starmer's/Pajarito Canyon Watershed Aggregate. The erosion potential on this slope increased due to lack of vegetative cover as a result of the fire.

Straw wattles were installed along the mesa edge to divert run-on from the slope. Rock check dams (on-site materials used) were provided to dissipate flow within the drainage channels on both the east and west ends of the site.

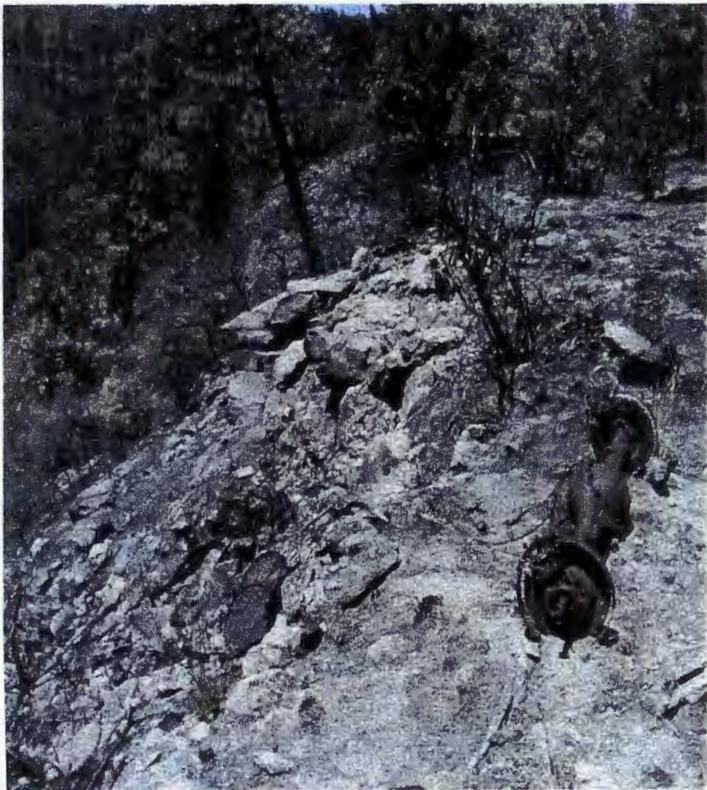
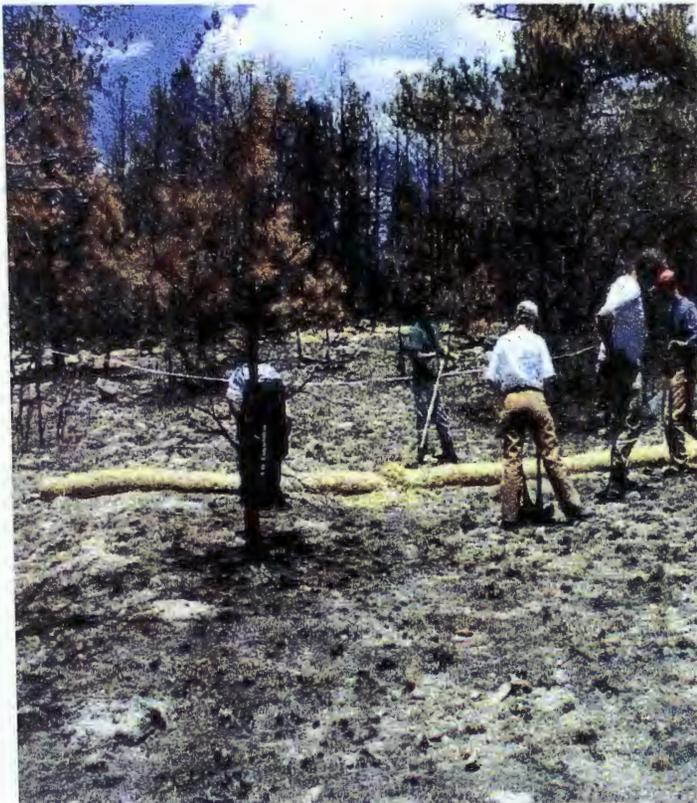
40-010 - Erosion Matrix Score 40.2. An area on the edge of Pajarito Canyon extending about 50-feet along the canyon edge and about 50 feet down the canyon. Debris in this area includes farm and home implements that probably predate the Manhattan Project.

The site is located on the edge of Pajarito Canyon within the Starmer's/Pajarito Canyon Watershed Aggregate. Land disposal area 40-010 was exposed due to the fire, with debris consisting of industrial waste.

Straw wattles were installed upslope from the landfill to reduce run-on impact. Large trees were contour felled to provide run-on diversion. The area was hand-raked, reseeded and straw mulched. The debris near the mesa's edge was removed from the area and disposed of as solid waste.

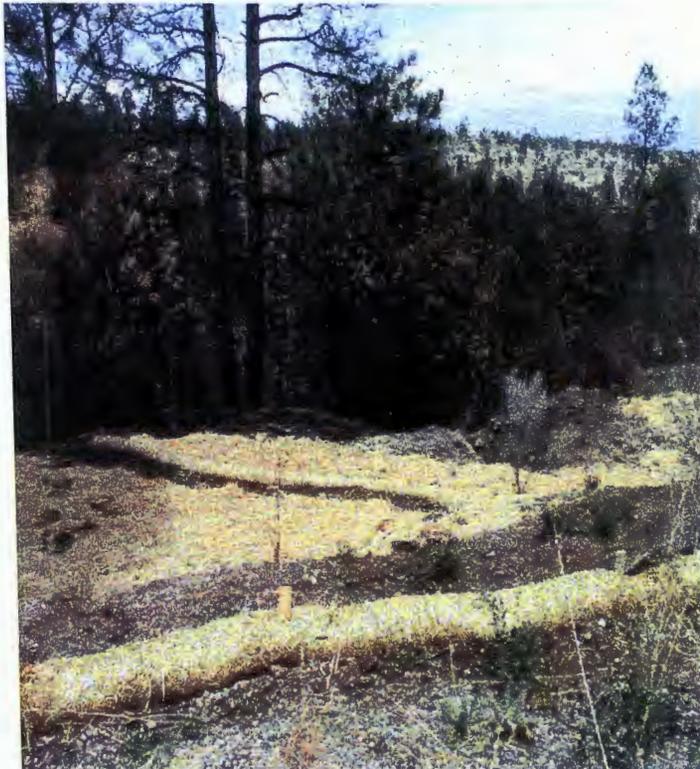
42-004 – Erosion Matrix Score 93.5. A canyon disposal area at former TA-42. Some building debris including pipes, were discarded over the canyon edge north of TA-42. The canyon disposal area is also designated as PRS No. C-42-001. Soil samples collected in 1991 as part of a survey found no contaminants of concern at the site.

The site is located on a tributary drainage to Mortandad Canyon within the Upper Mortandad Canyon Watershed Aggregate. The entire north facing slope below former TA-42 was moderately burned. Debris on the slope was exposed as a result of the fire. Two distinct drainage channels bisect the area behind the new building constructed near TA-55. The run-on to the western most drainage has been diverted away from the area of concern. The other drainage receives only direct rainfall, with minimal upslope sources.

Straw wattles were installed around the area to divert run-on and to impede sediment transport potential. The area was hand-raked, reseeded and straw mulched.

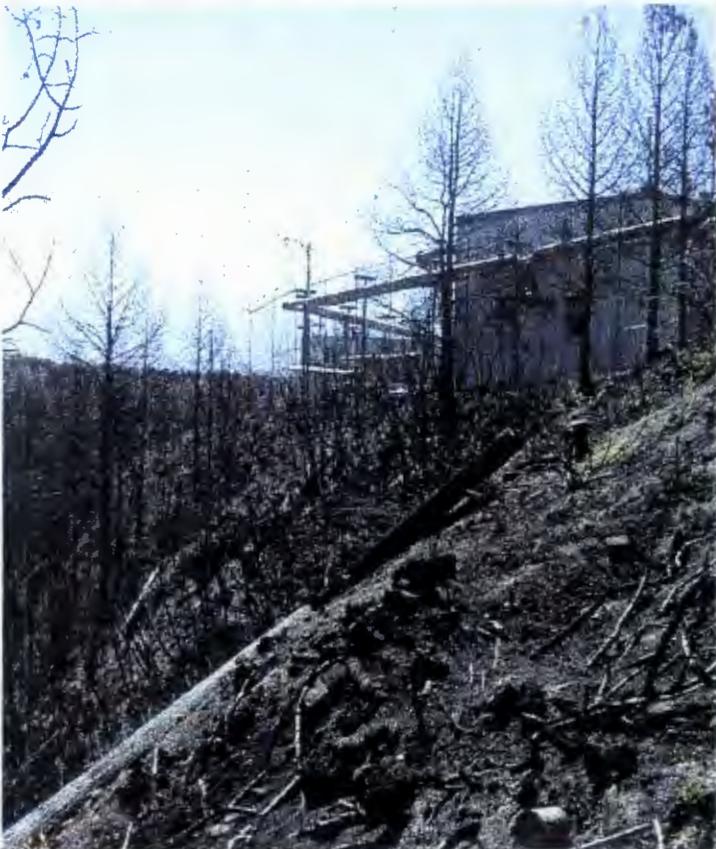
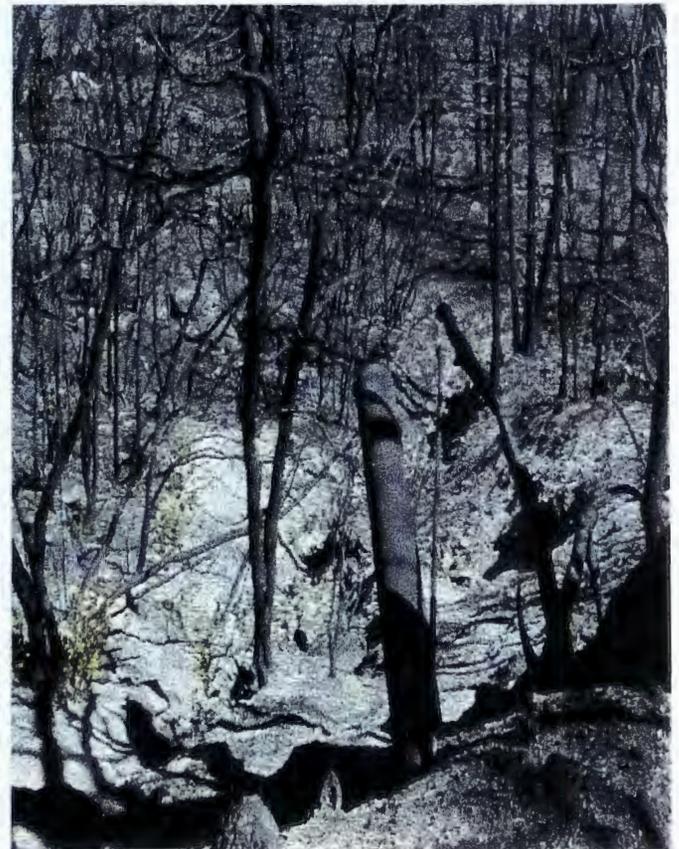
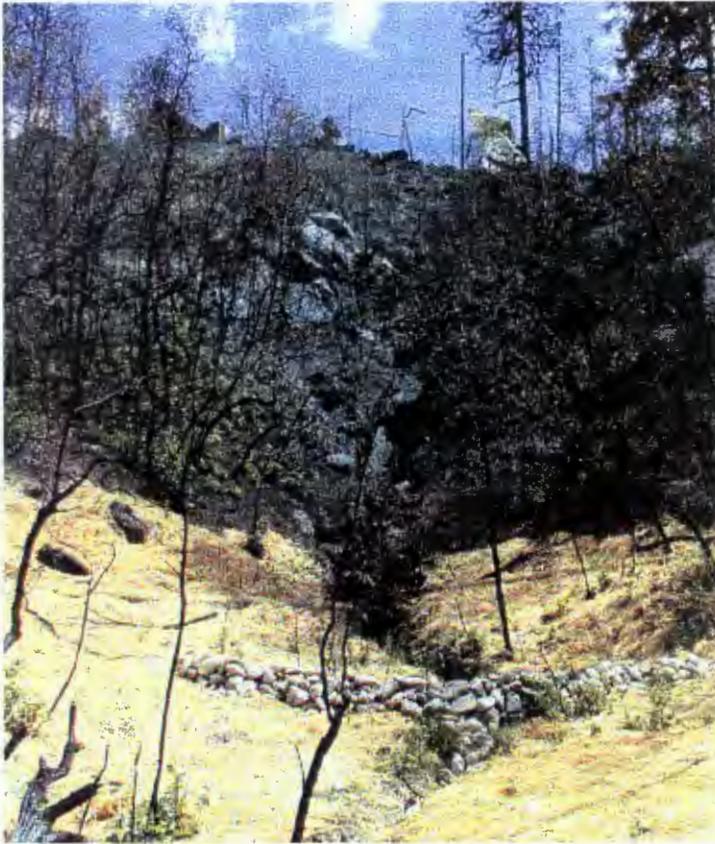
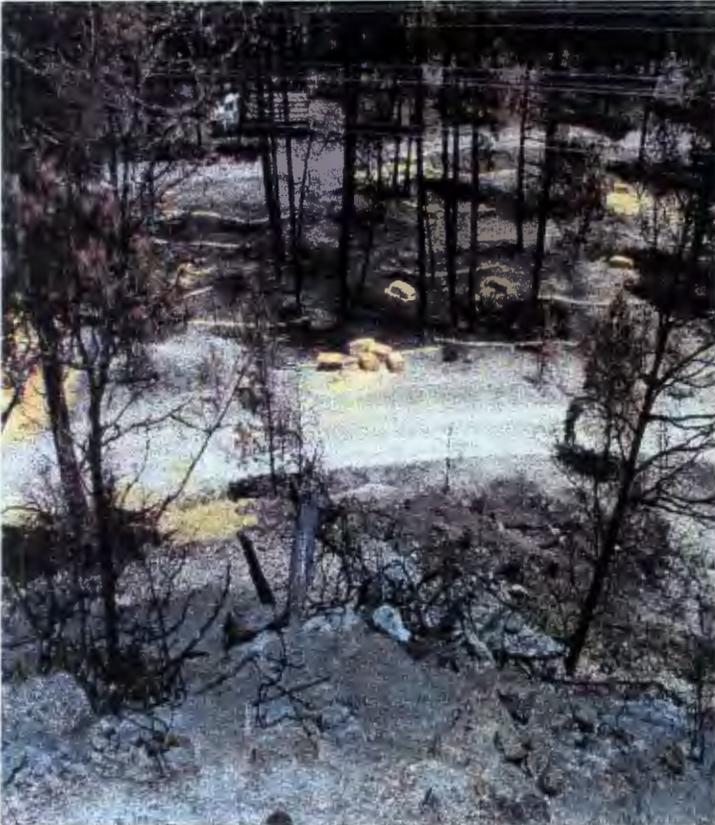
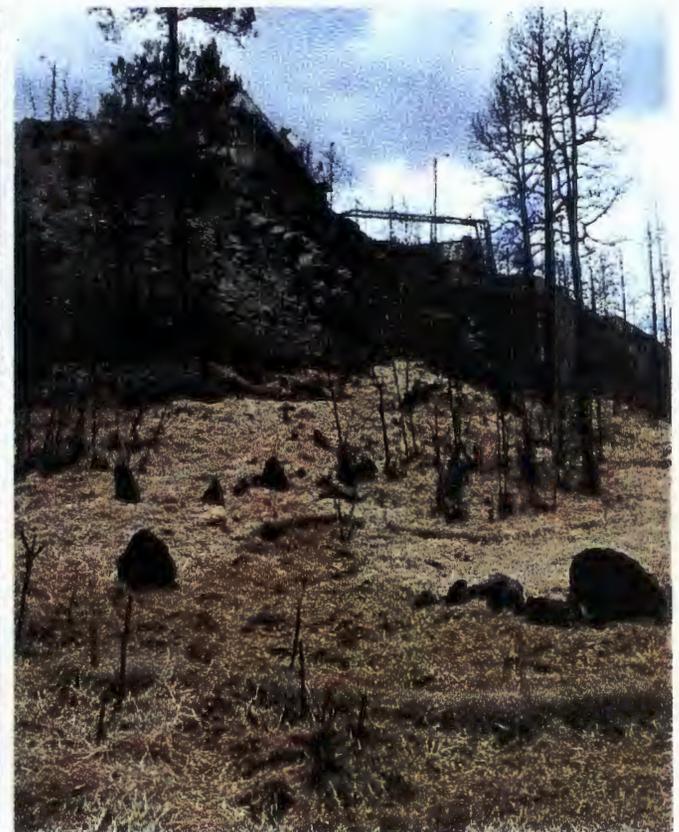
The site is located on the northern edge of Canada del Buey within the Middle Mortandad/Canada del Buey Watershed Aggregate. The entire north-facing slope behind TA-46 was moderately to severely burned. Several buildings along the mesa edge were destroyed. The canopy and ground cover were mostly destroyed. The northern slope is extremely steep with several inactive outfalls, pipes and old infrastructure parts exposed.

Nearly 15 acres were treated below the northern boundary of TA-46. Over 150 wattles were installed on slopes and within the drainages. Rock check dams were placed within the main drainages to dissipate storm runoff from above. Trees were contour felled across a majority of the site to provide erosion and sediment control. The lower portion of the site was hand raked, reseeded and straw mulched. The upper steep slopes were hydromulched from above. An earthen base coarse berm was installed along the access road at the toe of the slope to provide an extra "line of defense" against sediment migration

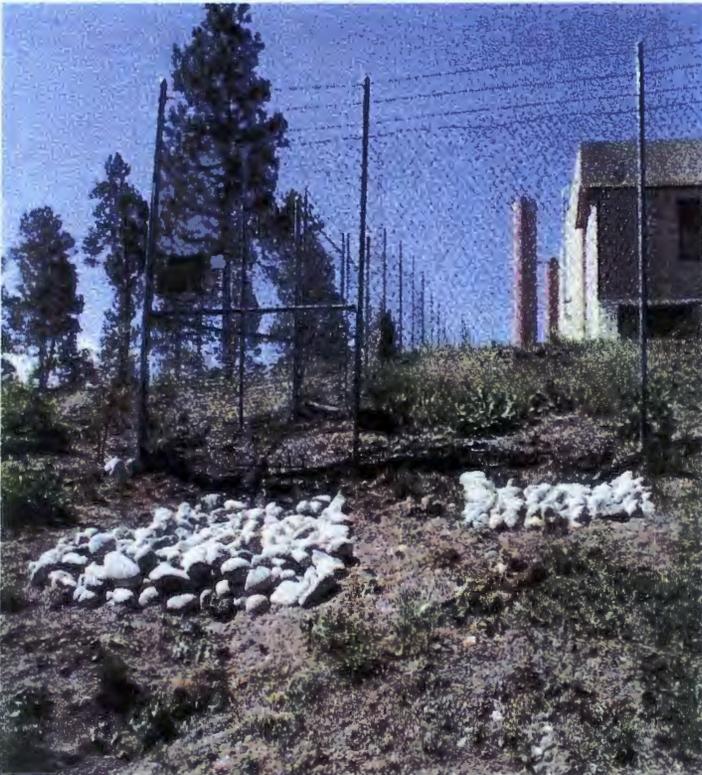
This site is located on the northern edge of Mortandad Canyon within the Upper Mortandad Watershed Aggregate. The northern part of TA-48 was moderately burned, with damage to ground cover and canopy.

Rock check dams were installed at the northeastern corner of the Technical Area to provide for flow dissipation from runoff events. Straw wattles were installed at the mesa edge. The area was hand-raked, reseeded and straw mulched.

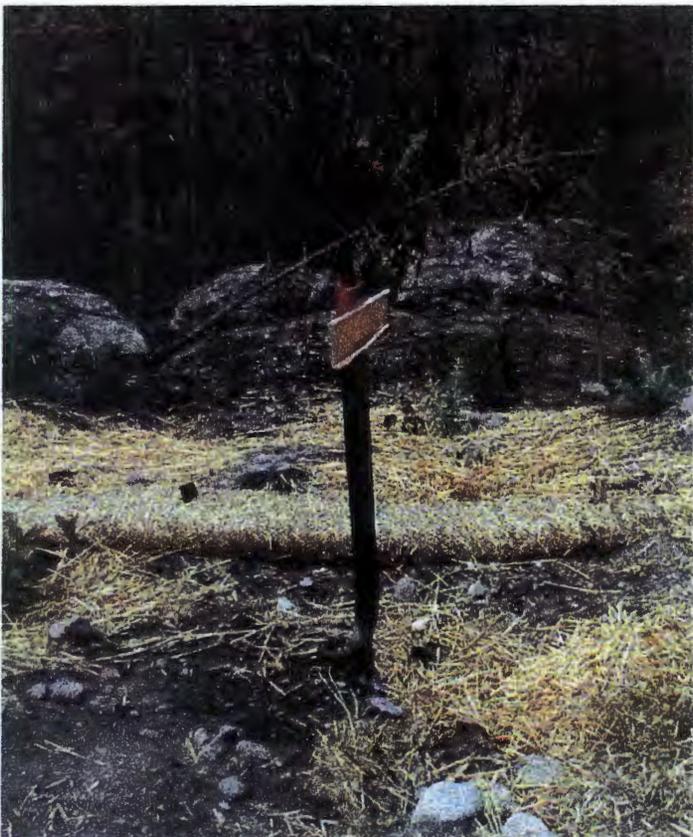
This site is located on the northern edge of Mortandad Canyon within the Upper Mortandad Watershed Aggregate. The northern part of TA-48 was moderately burned, with damage to ground cover and canopy.

Straw wattles were installed at the mesa edge to impede sediment migration. The area was hand-raked, reseeded, and straw mulched to enhance the revegetation process.

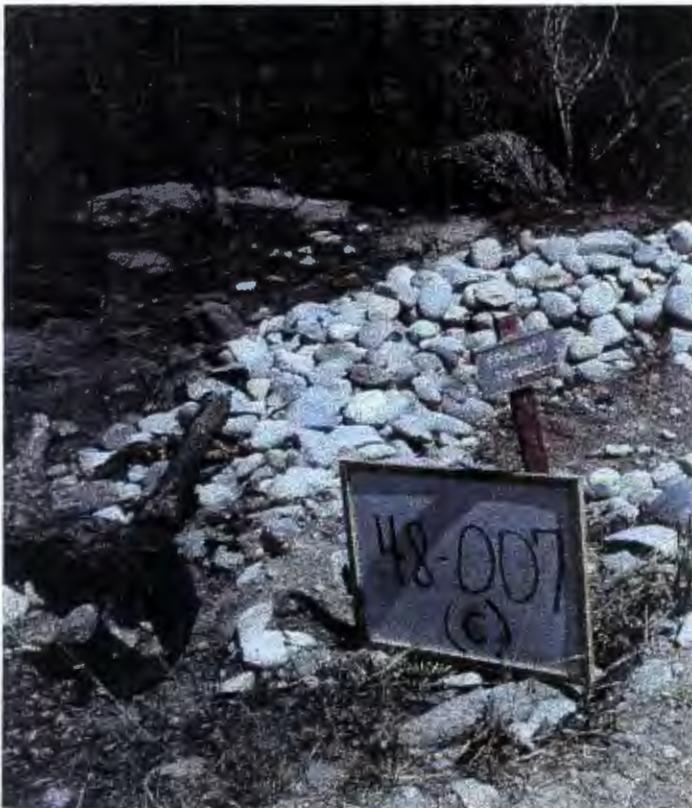
This site is located on the northern edge of Mortandad Canyon within the Upper Mortandad Watershed Aggregate. The northern part of TA-48 was moderately burned, with damage to ground cover and canopy.

A rock check dam was installed to provide for flow dissipation from runoff events. Straw wattles were installed at the mesa edge. The area was hand-raked, reseeded and straw mulched.

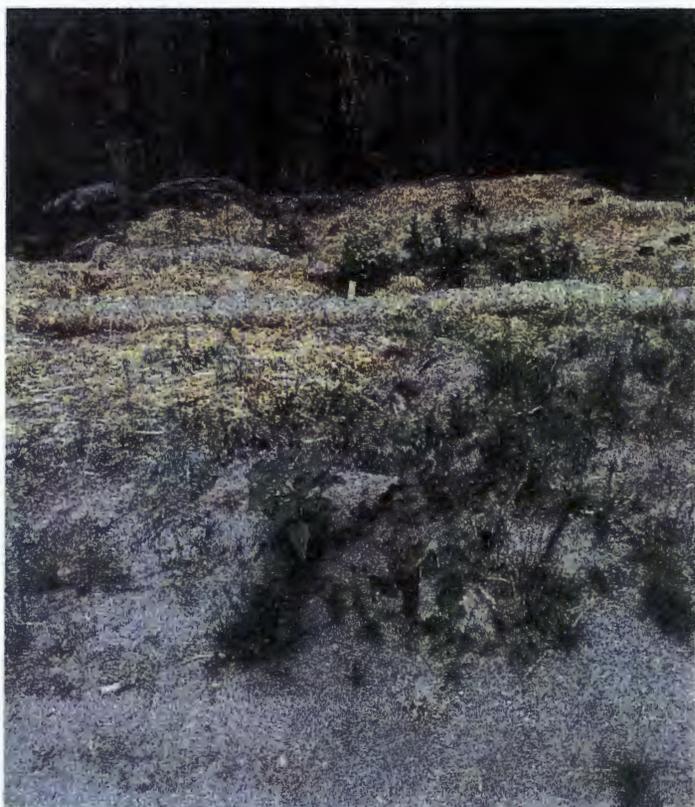
This site is located on the northern edge of Mortandad Canyon within the Upper Mortandad Watershed Aggregate. The northern part of TA-48 was moderately burned, with damage to ground cover and canopy.

Rock check dams were installed upslope to provide for flow dissipation from runoff events. Straw wattles were installed at the mesa edge. The area was hand-raked, reseeded, and straw mulched.

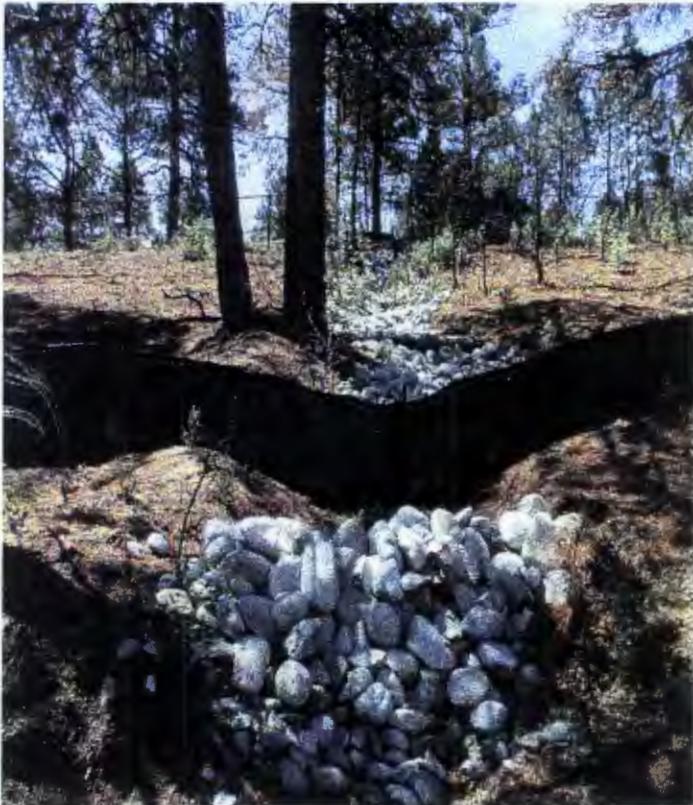
This site is located on a tributary to Water Canyon within the Lower Water/Indio Watershed Aggregate. The area was lightly to moderately burned from MDA AB towards the canyon edge. All existing BMPs were destroyed

Trees were contour felled to provide erosion controls on the slopes. Rock check dams were installed within all main drainages for flow dissipation. Four hundred linear feet of silt fence was installed on the upper part of site below the access road. The area was spot hand-raked, reseeded and straw mulched to enhance the revegetation process.
