LA-UR-00-3767

Title: CERRO GRANDE FIRE AFTERMATH:
ENVIRONMENTAL RESTORATION PROJECT
ACTIVITIES TO REDUCE THE MIGRATION OF
CONTAMINATION FROM POTENTIAL RELEASE SITES

Author(s): STEVEN J. VEENIS, CPESC

Submitted to: WATER QUALITY & HYDROLOGY GROUP (ESH-18)
ENVIRONMENTAL RESTORATION PROJECT

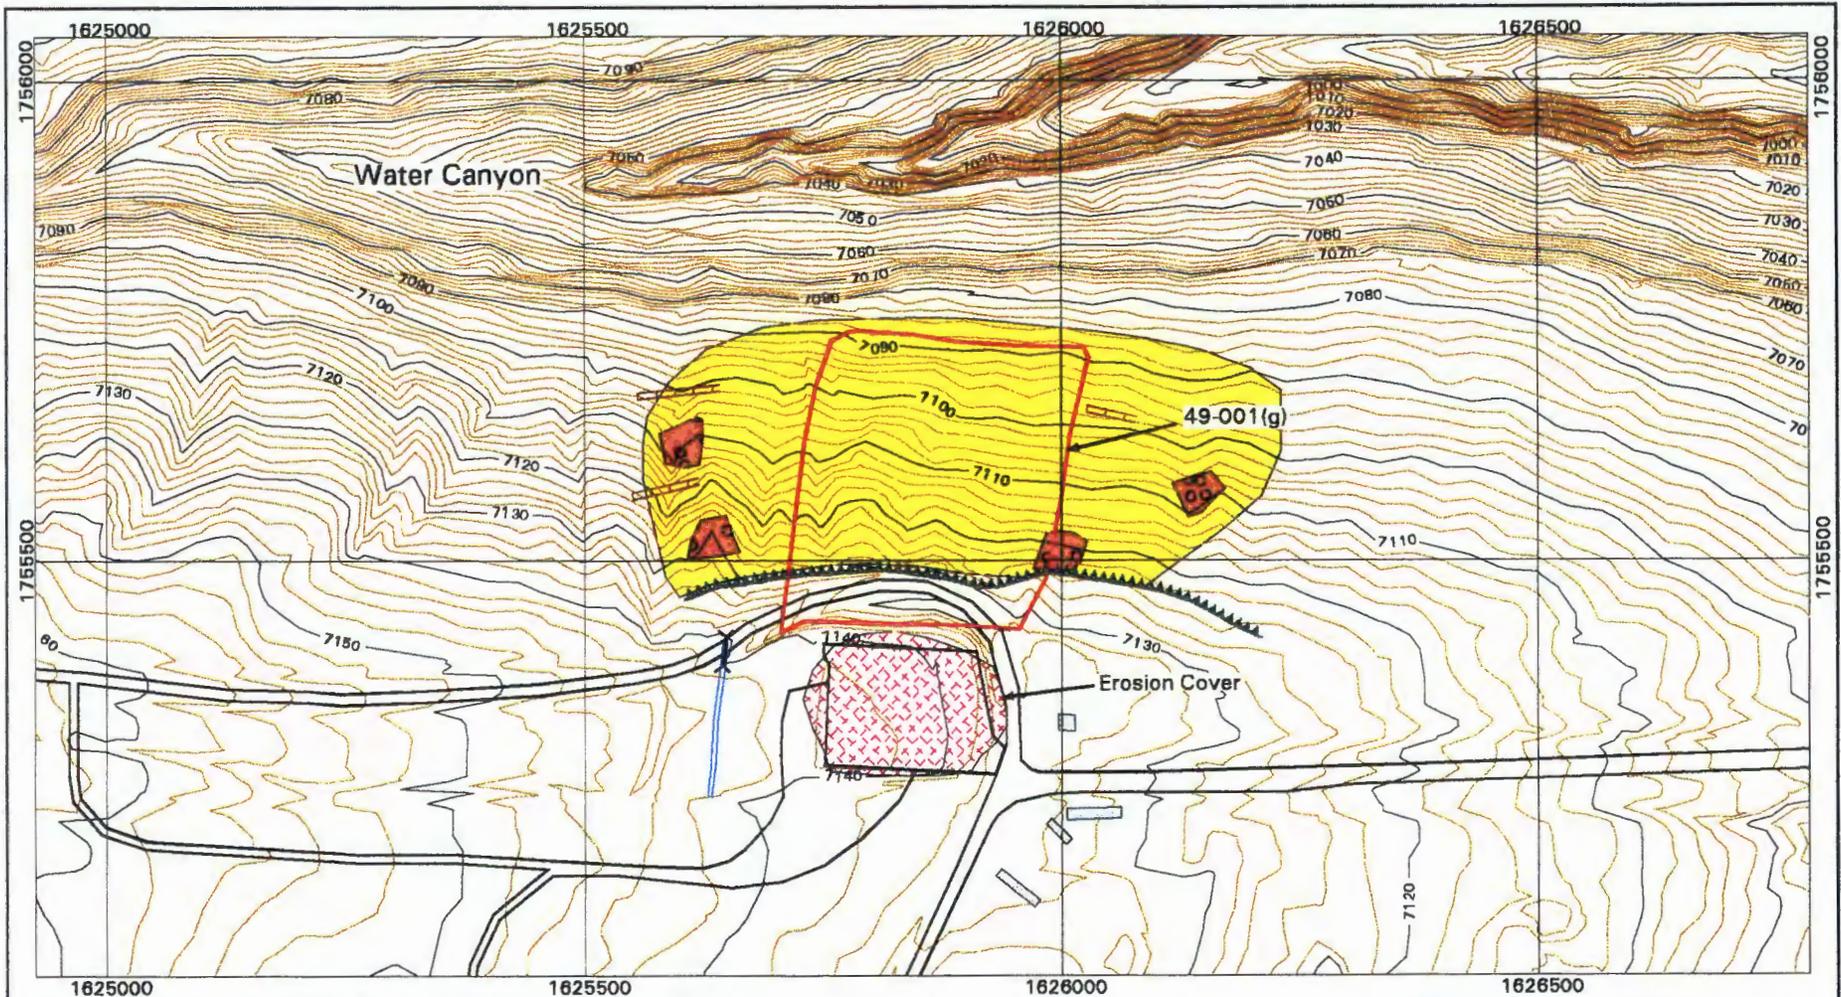
Best Management Practices at PRS 49-001(g)

This site is located on a tributary to Water Canyon within the Lower Water/Indio Watershed Aggregate. The area was lightly to moderately burned from MDA AB towards the canyon edge. All existing BMPs were destroyed

ESTIMATED MATERIALS USED:

- 2 acres treated
- 50 straw wattles
- 16 cubic yards river rock
- 40 pounds seed
- 400 linear feet silt fence
- 30 straw bales
