Title: CERRO GRANDE FIRE ONE YEAR AFTER:

AN UPDATE ON ER ACTIVITIES TO REDUCE
THE POTENTIAL MOVEMENT OF
CONTAMINATION AT POTENTIAL RELEASE
SITES

Authors: STEVEN J. VEENIS, CPESC
RANDY JOHNSON, IT CORPORATION

Submitted to: WATER QUALITY & HYDROLOGY GROUP (ESH-18)
ENVIRONMENTAL RESTORATION PROJECT

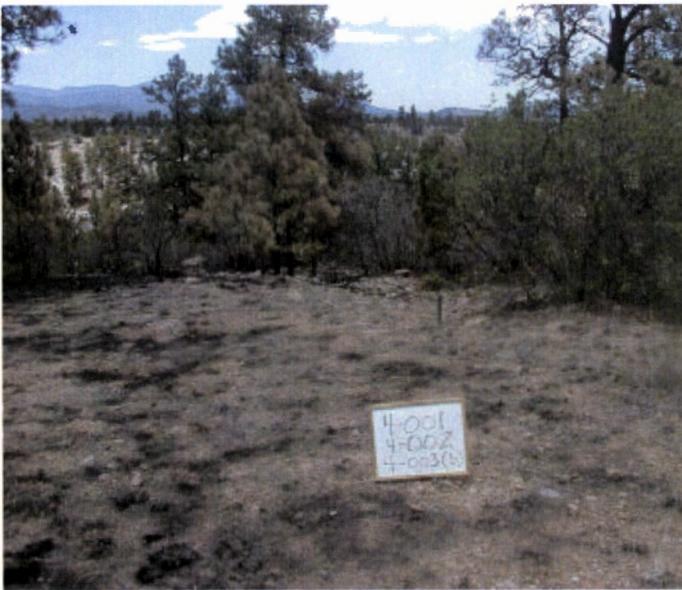
TECHNICAL AREA-4 SITES BEFORE AND AFTER THE CERRO GRANDE FIRE

These sites are located on the south rim of Ten Site Canyon within the Upper Canada del Buey Watershed Aggregate. The fire damage was minor to moderate with a majority of the damage to the ground cover and undergrowth.

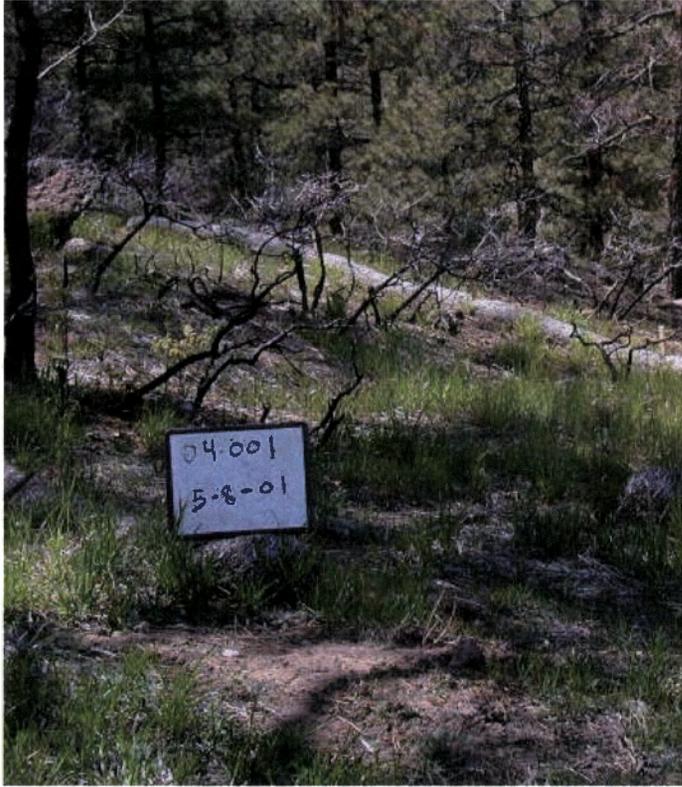
TECHNICAL AREA-4 SITES ONE YEAR AFTER THE CERRO GRANDE FIRE

Site is in good condition, with vegetative cover of greater than 50%. The area appears stable with evidence of sediment migration being minimal.

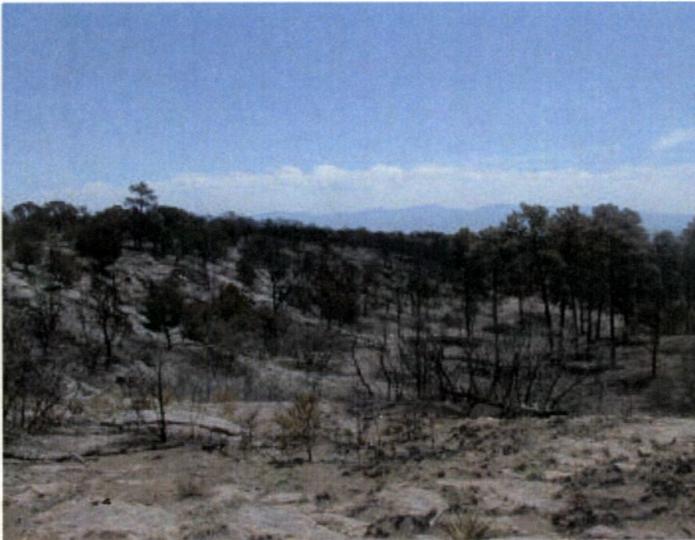
This site is located on the south rim of Mortandad Canyon within the Upper Canada del Buey Watershed Aggregate. The fire damage was moderate to severe with nearly complete damage to the ground cover and canopy.

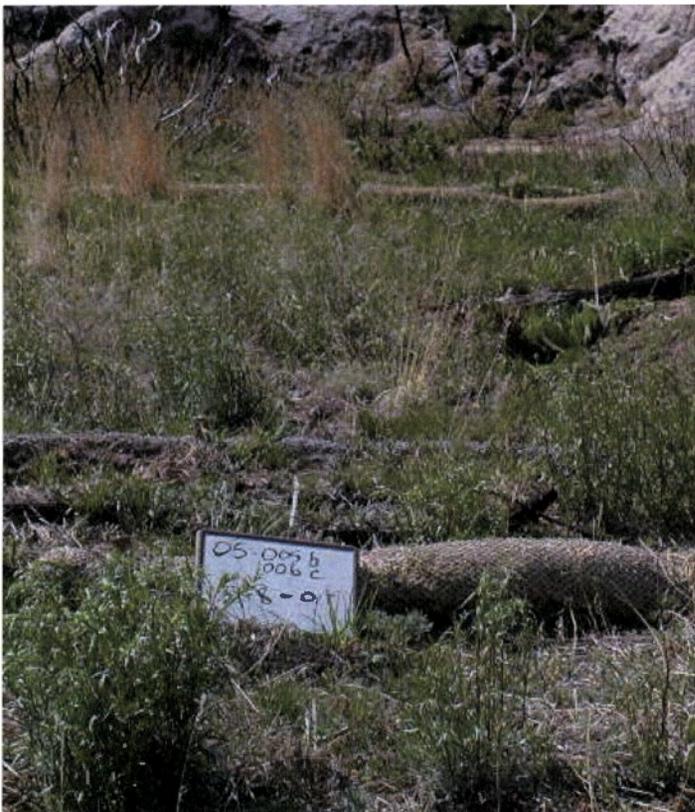
Site is in good condition, with vegetative cover of greater than 70%. The area appears stable with evidence of sediment migration being minimal.

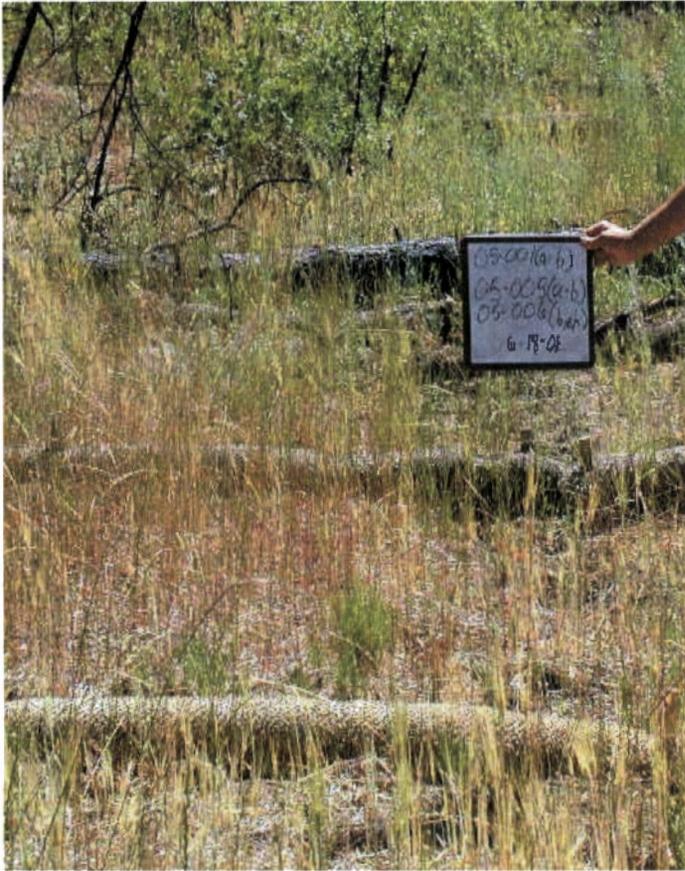
Site is in good condition, with vegetative cover of greater than 70%. Sediment migration is occurring in the steepest part of several drainage channels, but the straw wattles on the flatter bench appear to be keeping sediment from entering into Canada del Buey.

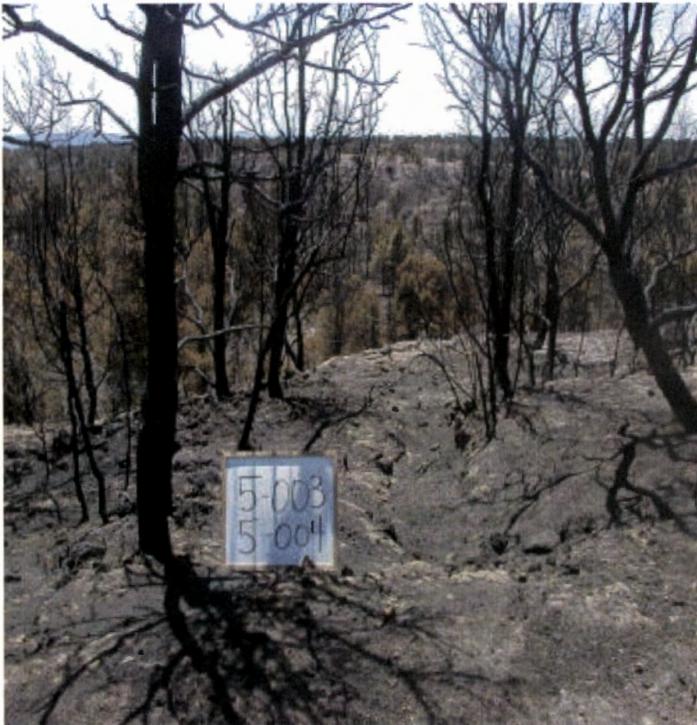
This site is located on the south rim of a tributary to Mortandad Canyon within the Upper Canada del Buey Watershed Aggregate. The fire damage was moderate to severe with nearly complete damage to the ground cover and canopy.

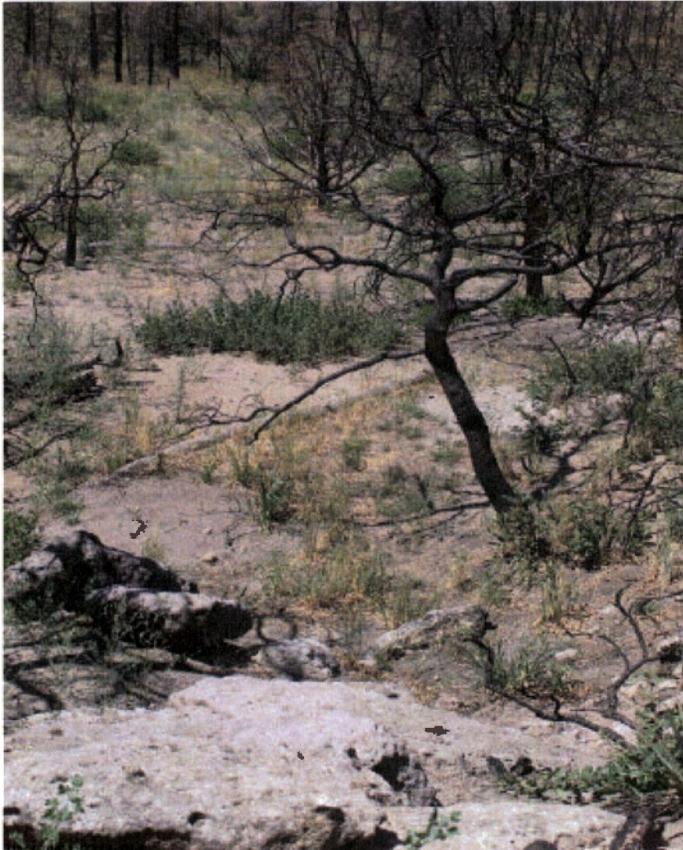
Site is in good condition, with vegetative cover of greater than 50%. Sediment migration is occurring in the steepest part of several drainage channels, but the straw wattles on the flatter bench appear to be keeping sediment from entering into tributary drainage.

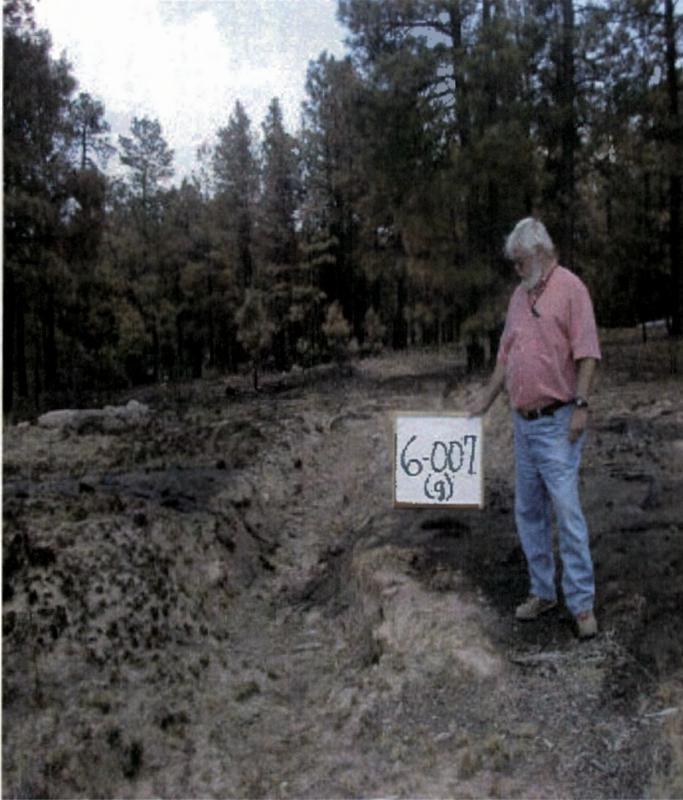
TECHNICAL AREA-6 SITE BEFORE AND AFTER THE CERRO GRANDE FIRE

This site is located on the south side of Pajarito Canyon within the Two Mile Canyon Watershed Aggregate. The drainage channel east of building TA-6-6 has minor evidence of fire damage.

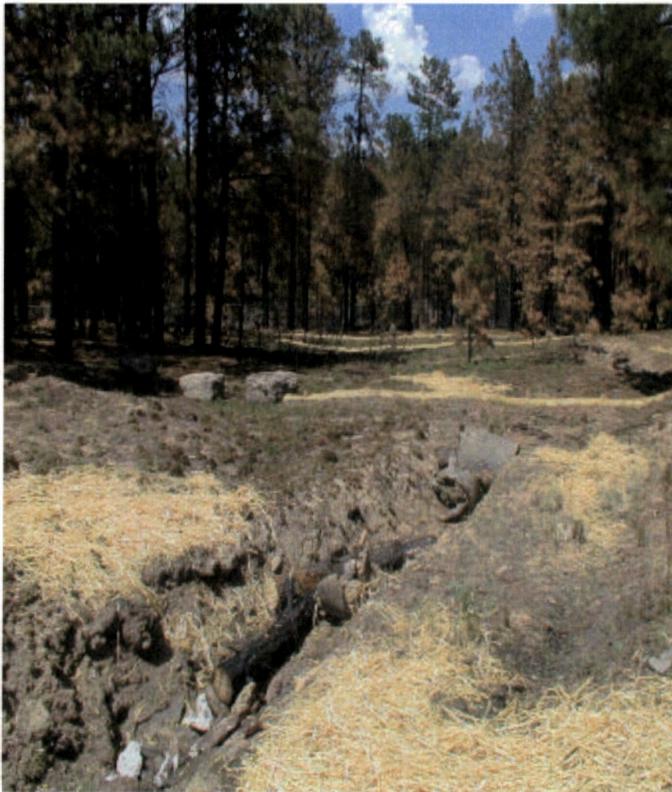
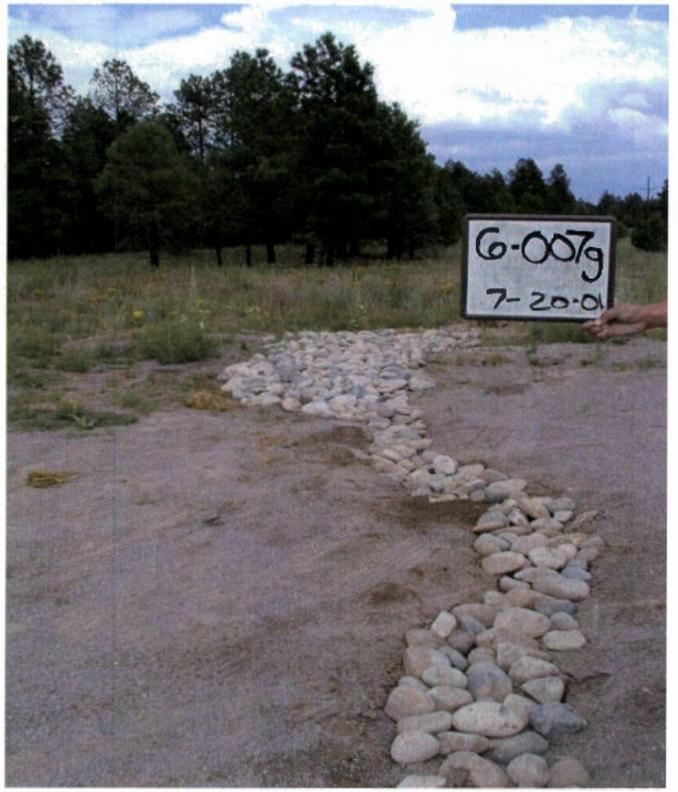
Site is in good condition, with vegetative cover of greater than 70%. The area appears stable with evidence of sediment migration being minimal.

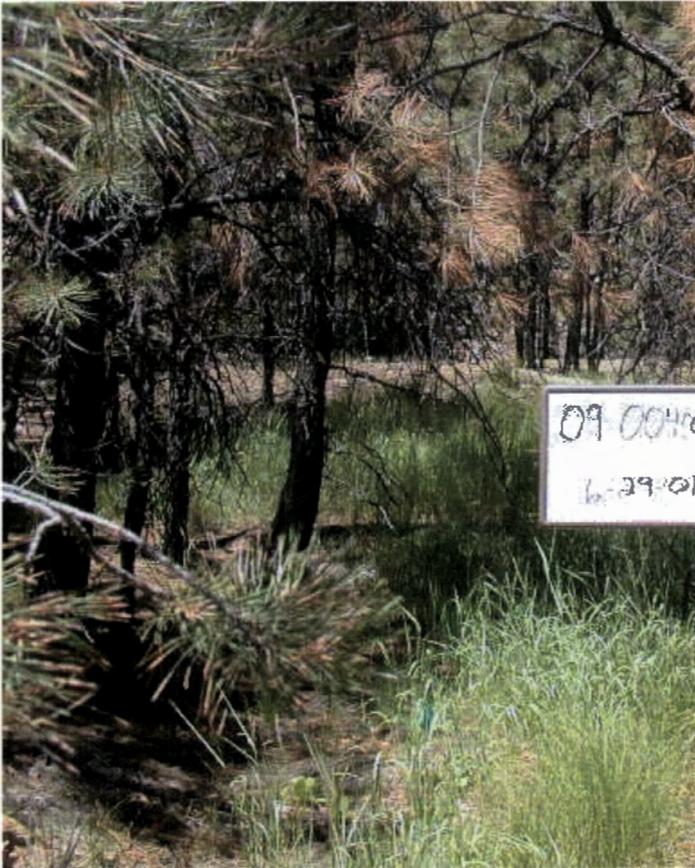
TECHNICAL AREA-9 SITES BEFORE AND AFTER THE CERRO GRANDE FIRE

This site is located south of Pajarito Canyon within the Starmer/Upper Pajarito Watershed Aggregate. The area received minor to moderate fire damage. The ground cover was completely burned but the canopy cover was only partially affected.

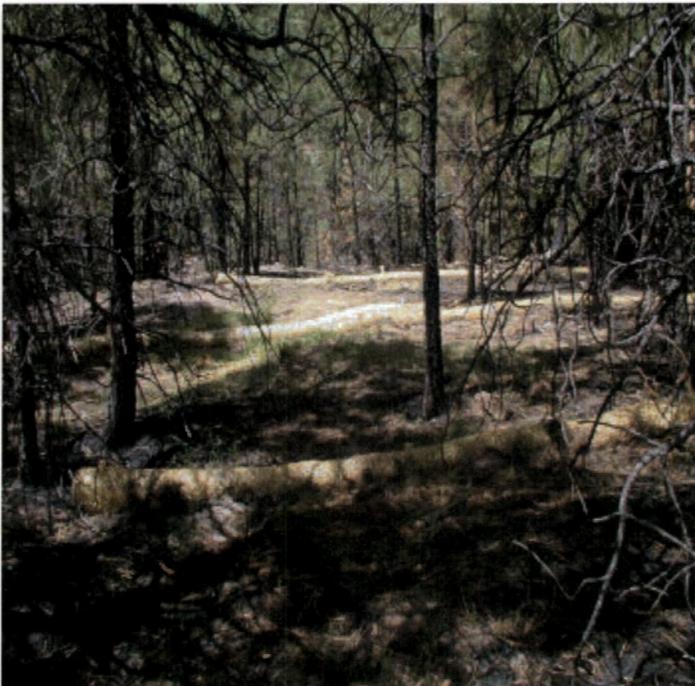
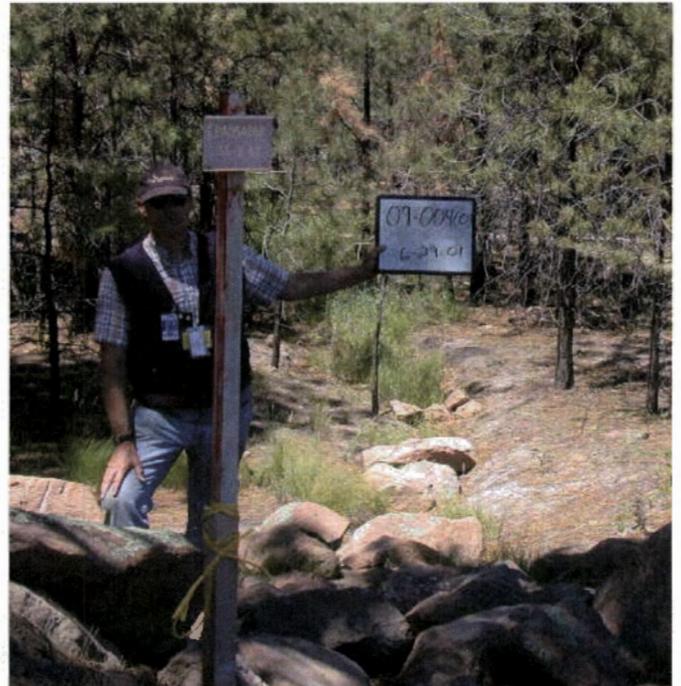
Site is in good condition, with vegetative cover of greater than 70%. The area appears stable with evidence of sediment migration being minimal.

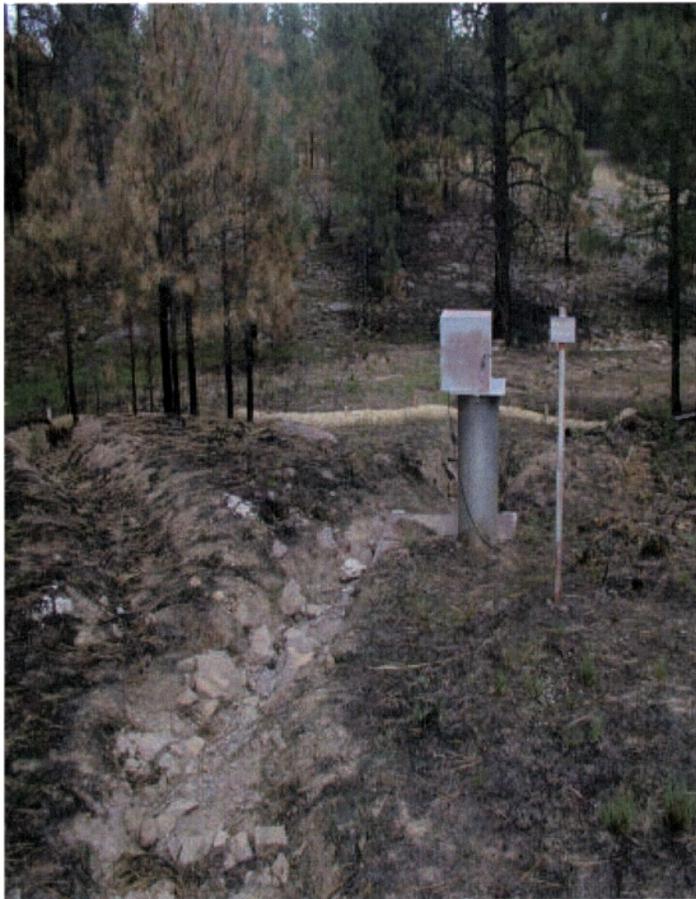
This site is located south of Pajarito Canyon within the Starmer/Upper Pajarito Watershed Aggregate. The PRS is the former Sanitary Wastewater Treatment Facility north of TA-9. Site has moderate fire damage with ground and canopy cover being impacted.

Straw wattles were installed in the drainage swales and rock check dams were placed in the channels to dissipate flow (using existing materials found on-site). Wattles were also provided upslope for run-on diversion.

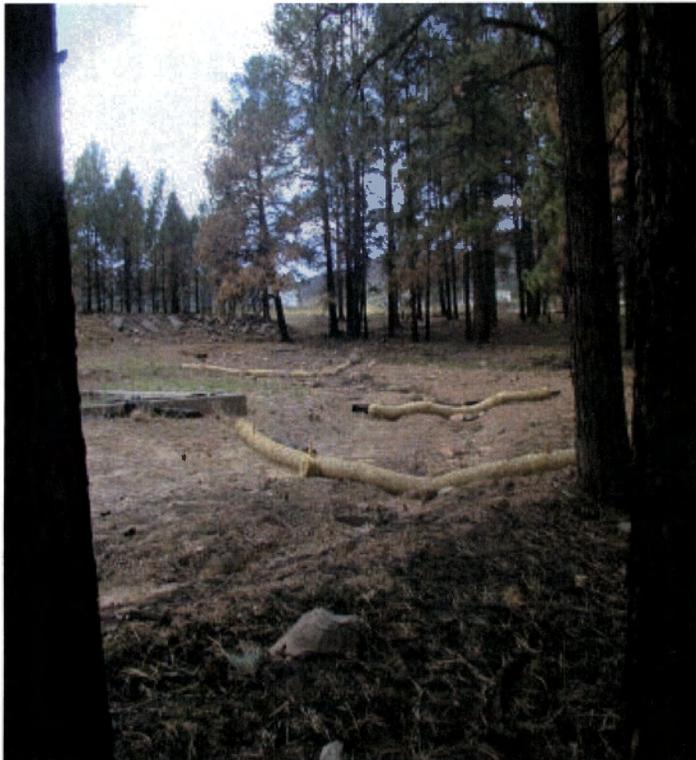
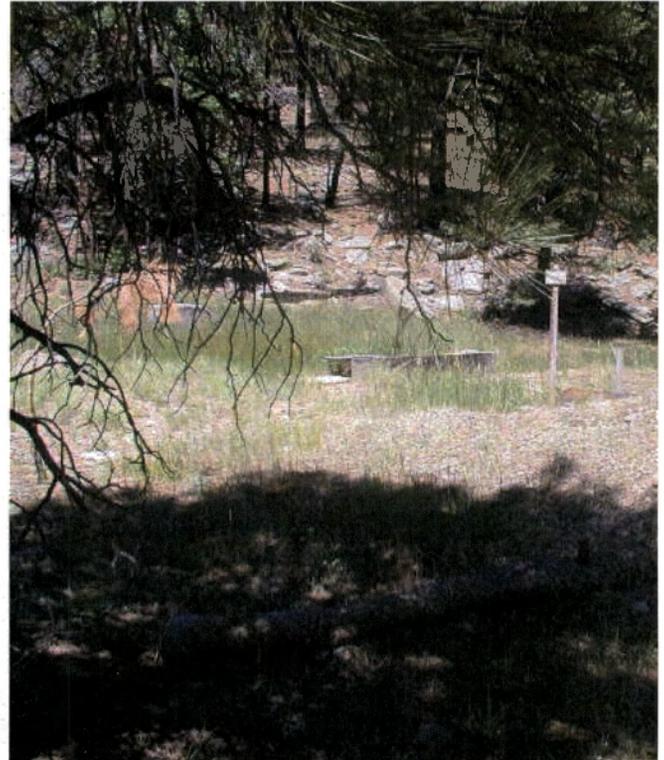
Site is in good condition, with vegetative cover of greater than 40%. The area appears stable with evidence of sediment migration being minimal.

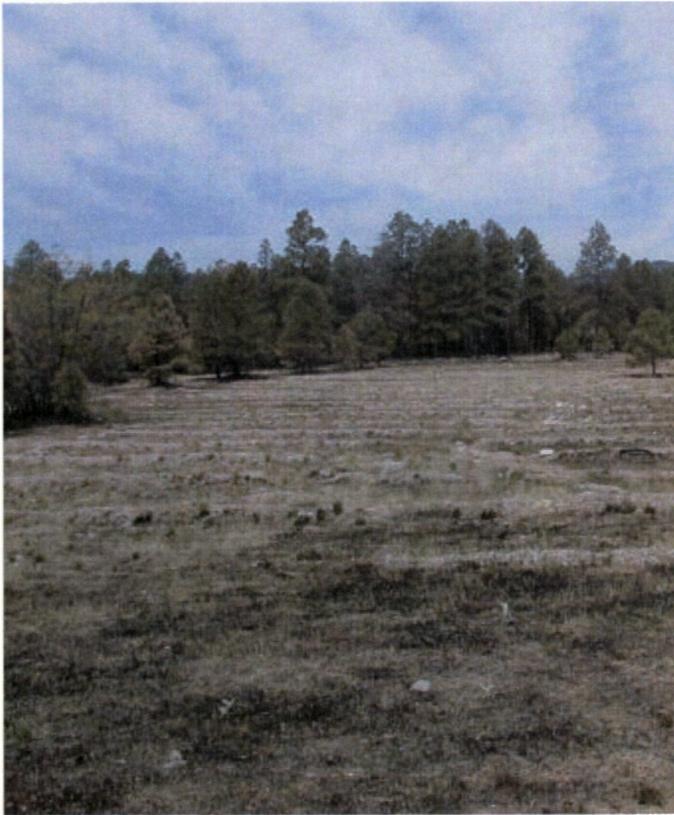
This site is located south of Pajarito Canyon within the Starmer/Upper Pajarito Watershed Aggregate. The area surrounding MDA M was moderately to severely burned as was a majority of the upper Pajarito Watershed. All of the existing erosion controls at the site were destroyed.

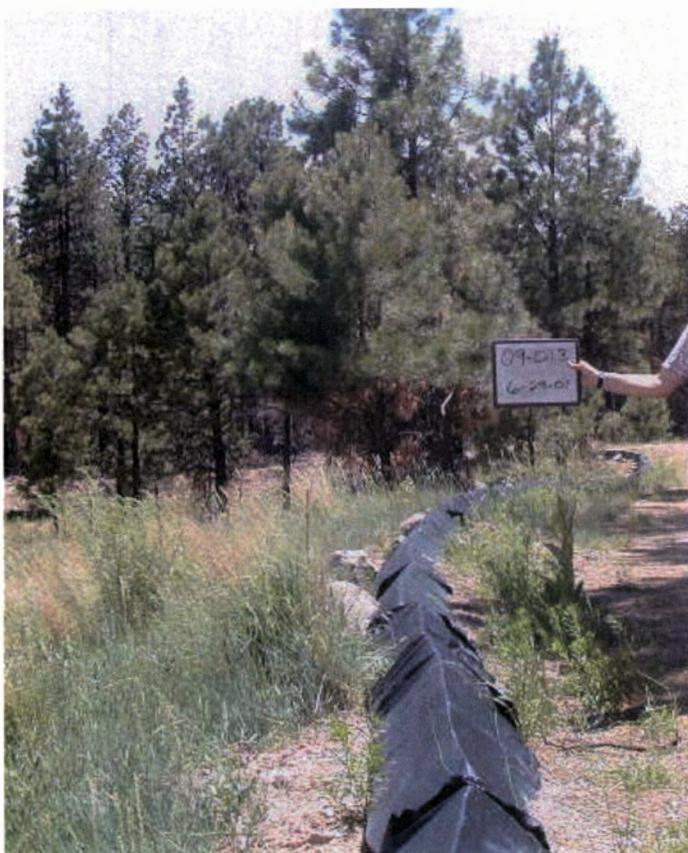
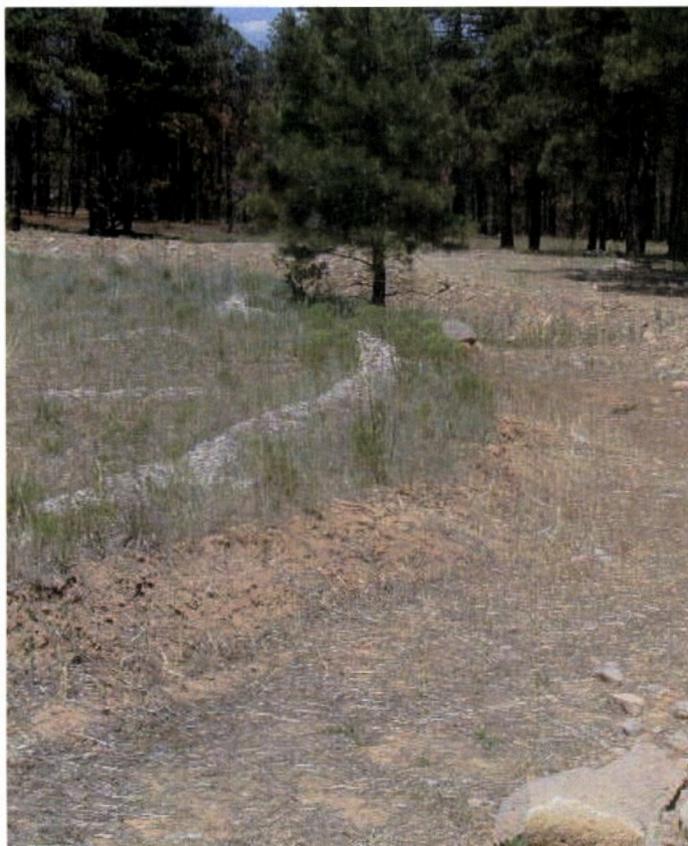
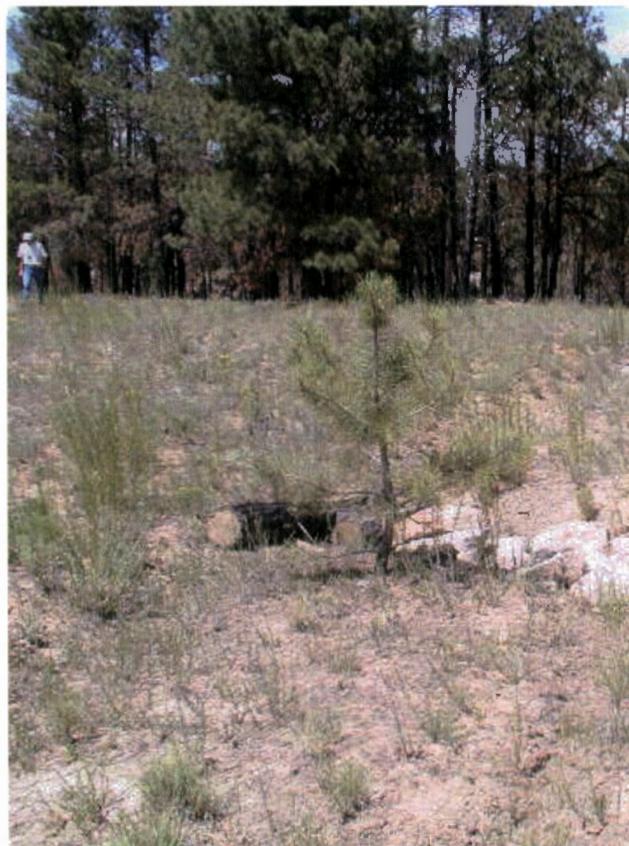
Site is in good condition, with vegetative cover of greater than 70%. The area appears stable with evidence of sediment migration being minimal.

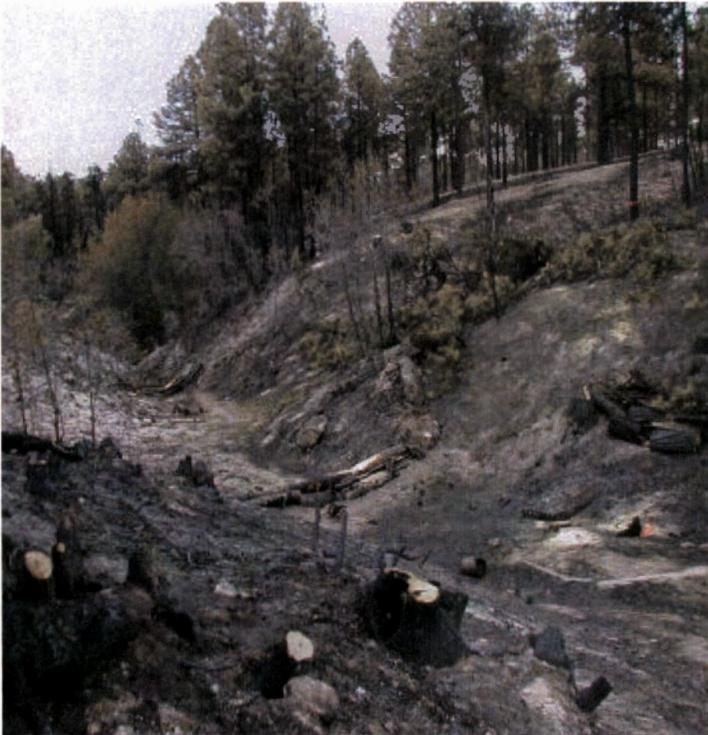
This site is located north of Water Canyon within the S-Site Watershed Aggregate. The site has moderate to severe fire damage in the area surrounding the TA-11 Drop Tower. Log check dams within the major drainages received partial damage. All straw barriers installed around site were destroyed.

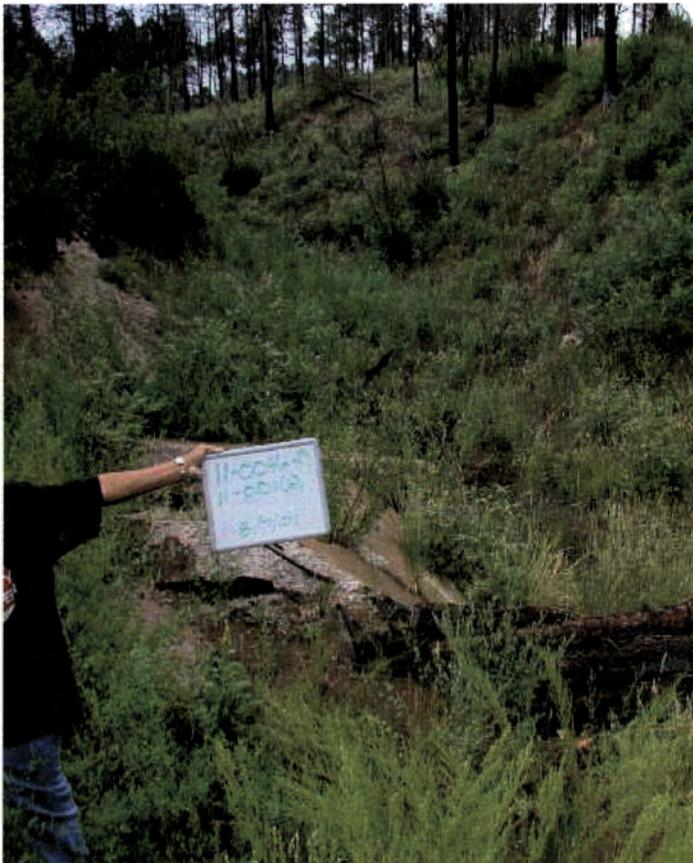
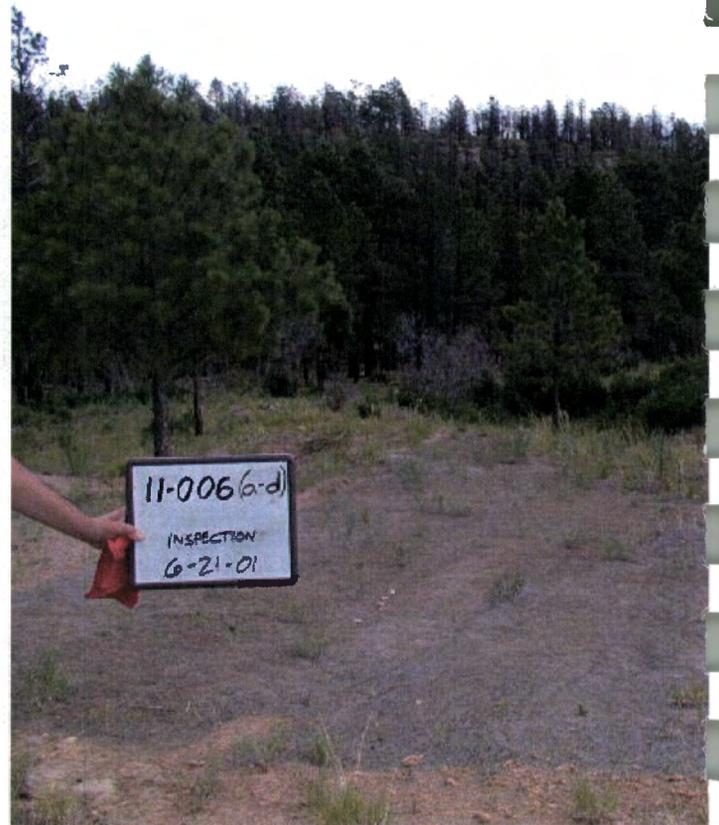
Site is in good condition, with vegetative cover of greater than 60%. The area appears stable with evidence of sediment migration being minimal.

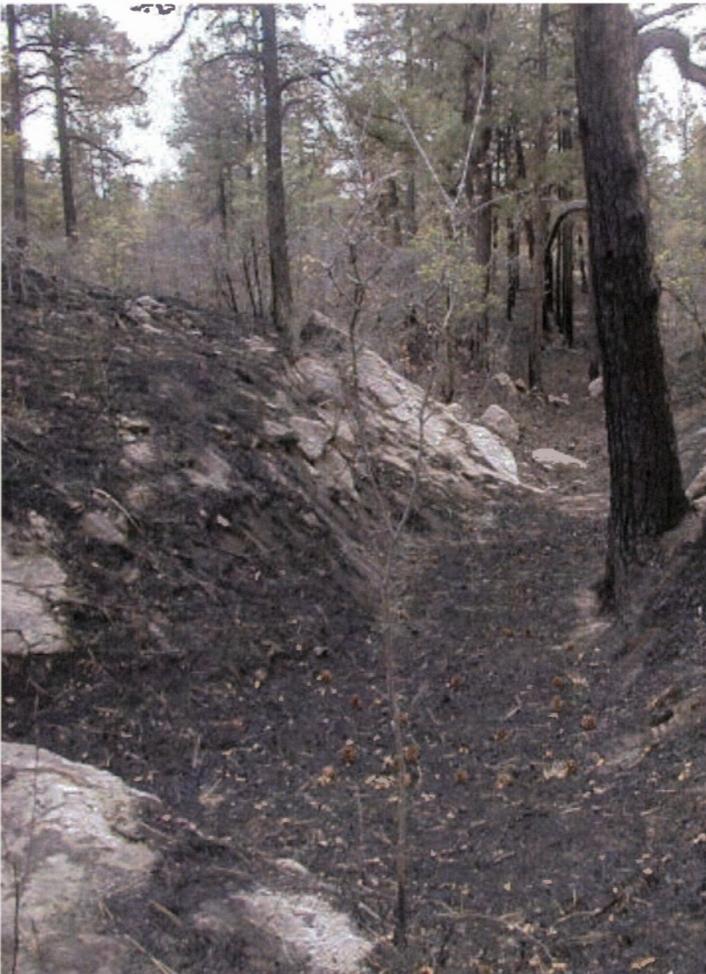
This site is located north of Canon de Valle within the Canon de Valle Watershed Aggregate. The entire south facing slope located to the south of TA-14 structures was moderately burned with substantial damage to the groundcover.

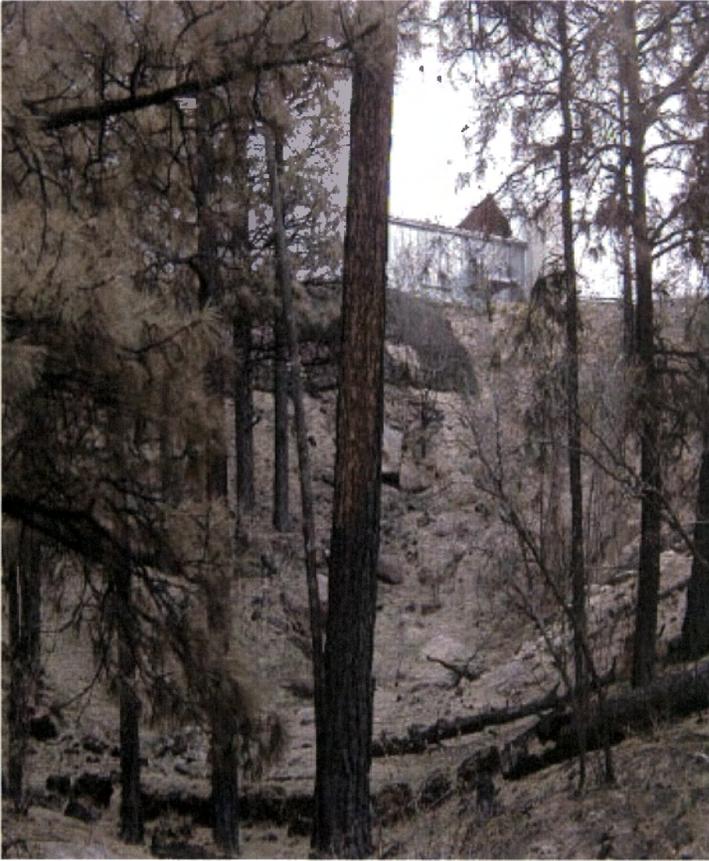
PHOTOGRAPH:

This photograph was taken on June 8th, 2000. The drainage shown is located below building 14-43.

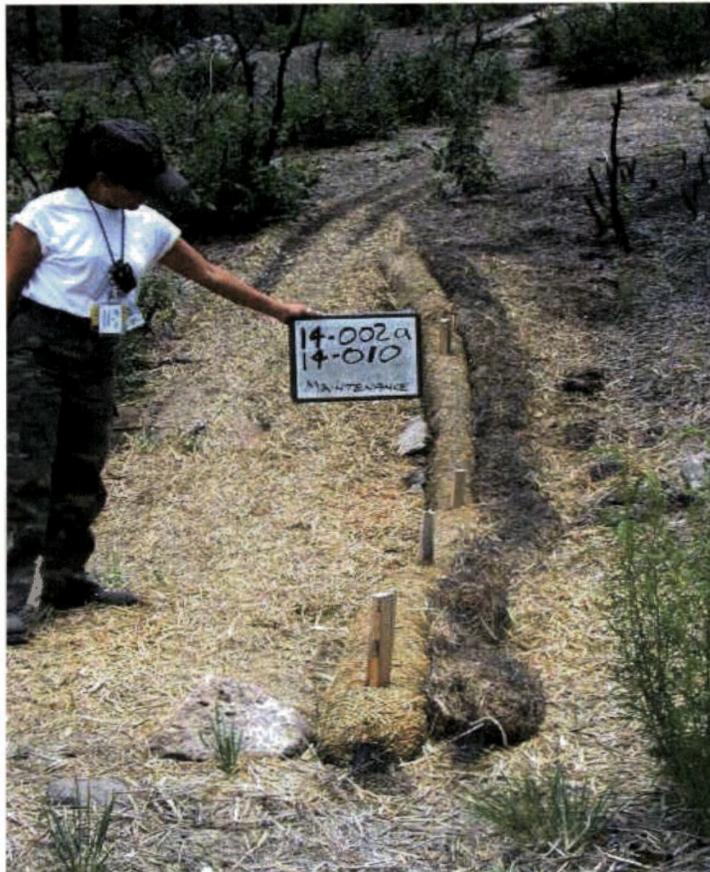
Site is in good condition, with vegetative cover of greater than 70% throughout the site. The area appears stable with evidence of sediment migration being minimal.

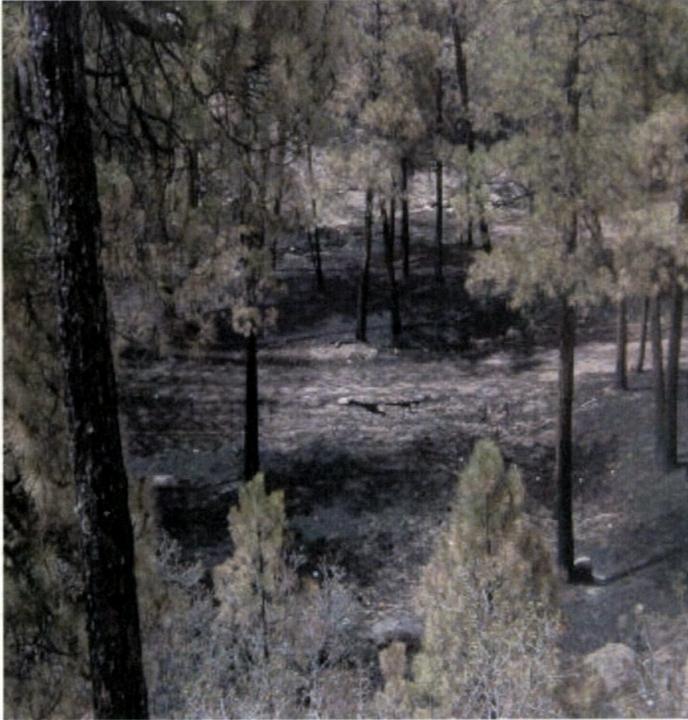
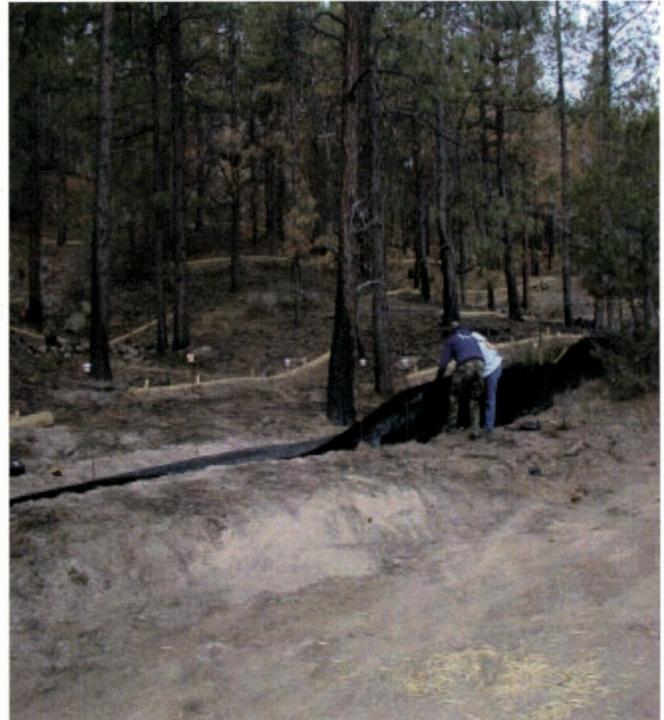
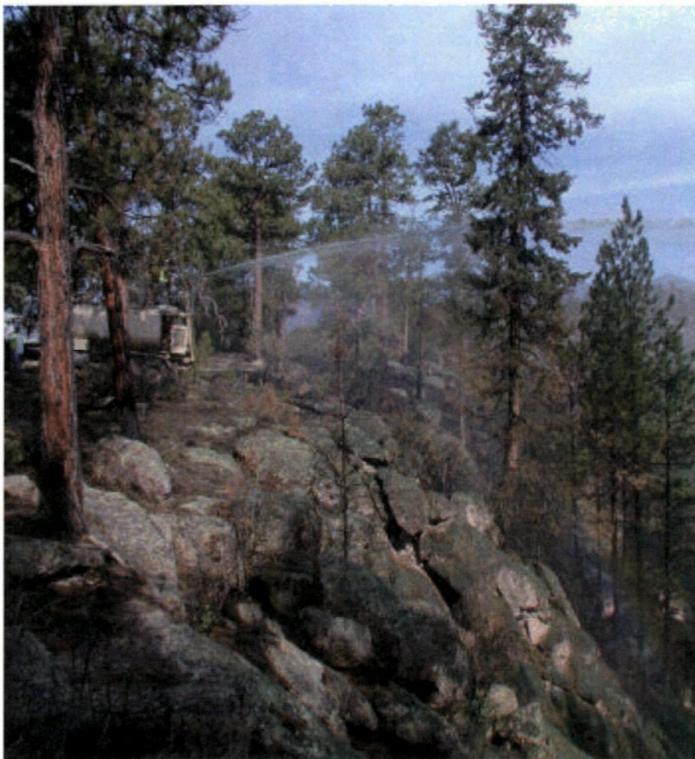
TECHNICAL AREA-15 – INACTIVE FIRING SITE R44 BEFORE AND AFTER THE CERRO GRANDE FIRE

15-006(c) – *Erosion Matrix Score 64.5*. PRS 15-006(c) was the third most extensively used firing site at TA-15, used from the 1950s until 1992. Approximately 7,000 Kg of uranium and other materials, including lead and beryllium were expended. **15-008(b)** - *Erosion Matrix Score 67.2*. Surface disposal area north of PRS 15-006(c), R-44 Firing Site. Remnants and debris from tests were pushed over the edge of the canyon.

This site is located on the south rim of Three Mile Canyon within the Three Mile Watershed Aggregate. 15-006(c) has moderate to severe burn damage with most of the damage adjacent to the former R-44 Firing Pad. A large amount of firing site related debris has been exposed throughout the site (especially towards the east).

Straw wattles, rock check dams and silt fencing were installed throughout the burned areas. The area was then hydromulched to enhance the revegetation process.

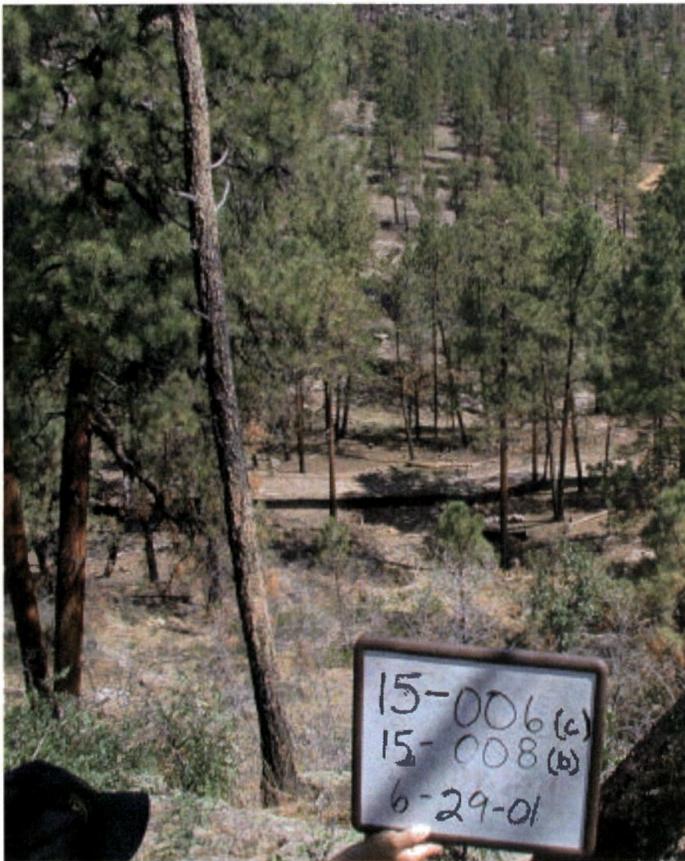
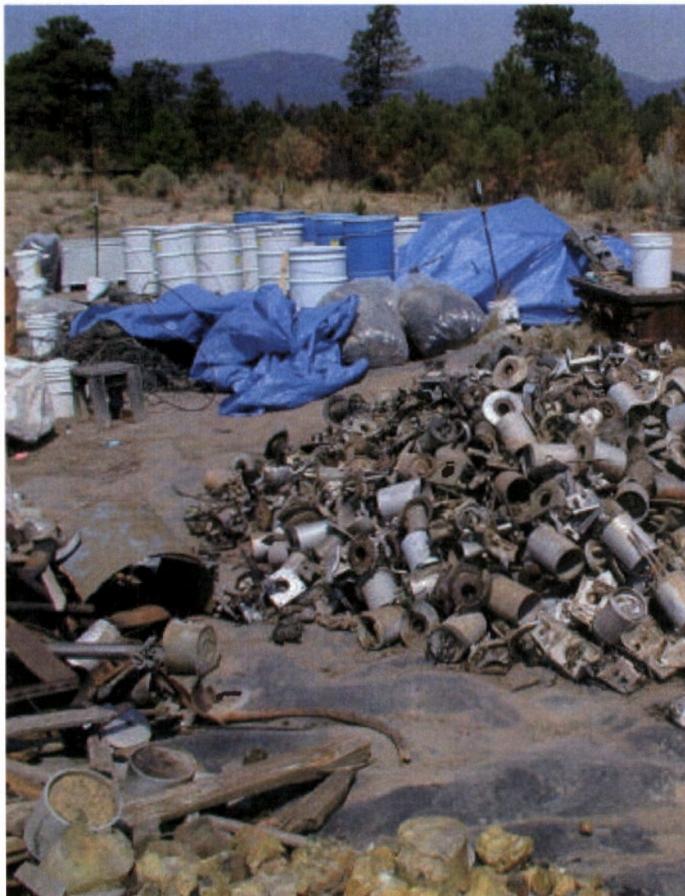
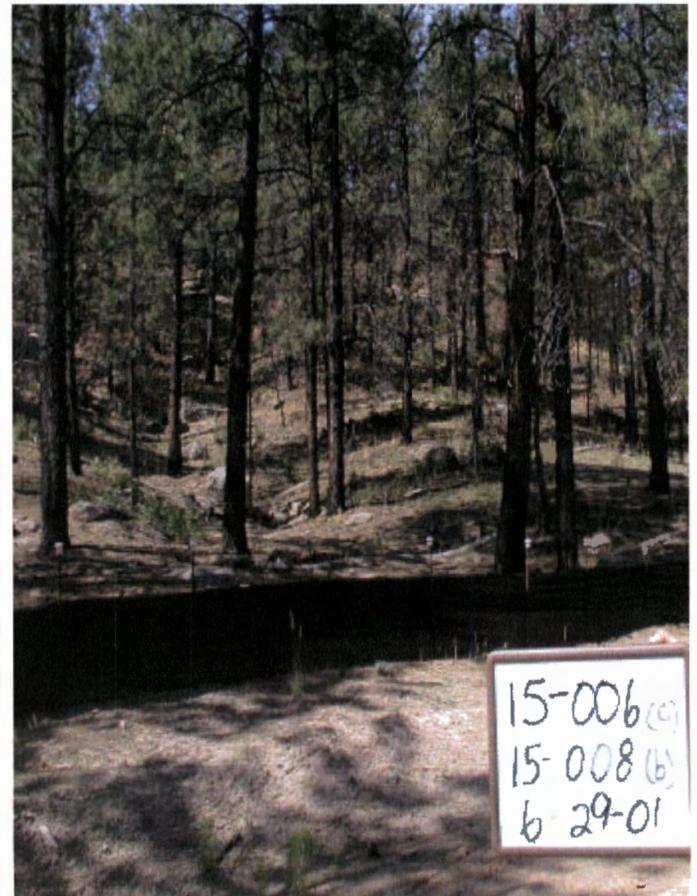
Over 20 cubic yards of firing site debris was removed from the surrounding area. Site is in good condition, with vegetative cover of greater than 70%. The area appears stable with evidence of sediment migration being minimal.

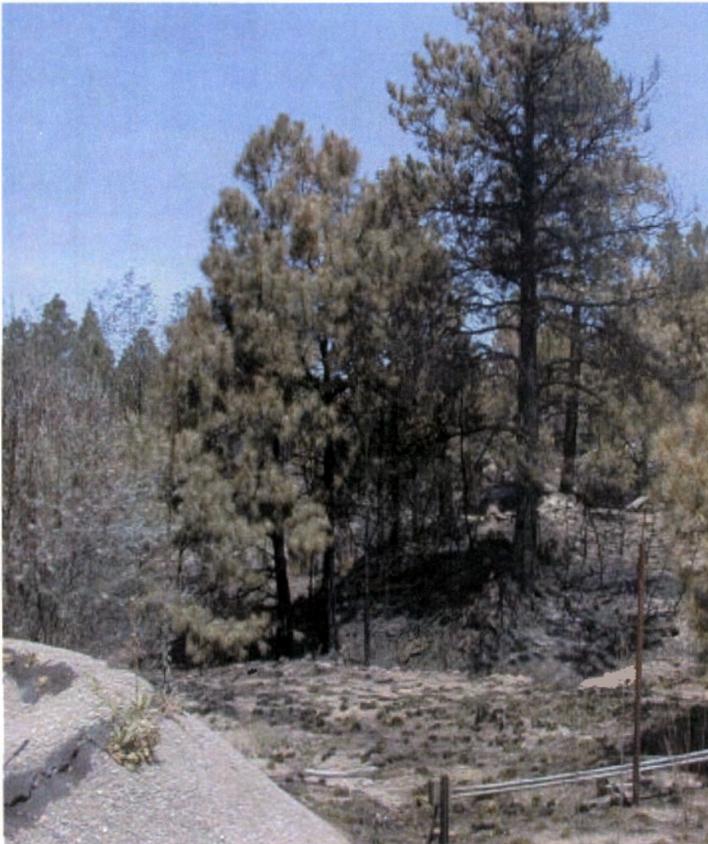
TECHNICAL AREA-15 – HOLLOW SITE BEFORE AND AFTER THE CERRO GRANDE FIRE

C-15-007 - *Erosion Matrix Score 51.5*. Stained soil noted during a 1988 ER site reconnaissance visit. A transportable building was placed over it. The area was sampled in 1997. **C-15-010** - *Erosion Matrix Score 8.8*. Removed inactive underground fuel storage tank. **15-014(k)** - *Erosion Matrix Score 3.6*. Concrete open trench drains. **15-011(a)** - *Erosion Matrix Score 3.6*. Concrete trench drains. **15-014(i)** - *Erosion Matrix Score 3.6*. Drain line from roof of building TA-15-194. **15-011(b)** - *Erosion Matrix Score 87.0*. Dirt drainage ditch located southwest of Building R-194. Drainage may have received degreasers, solvents containing sulfuric acid, and/or hydrochloric acid. **15-011(c)** - *Erosion Matrix Score 87.0*. Drainage, PRS 15-011(c), serves the outfalls from buildings within The Hollow that have had various uses as assembly building, laboratories, and shops. **15-014(j)** - *Erosion Matrix Score 61.3*. PRS 15-014(j) consists of three outfalls from Building R-50 and a drainage channel that is partially asphalt just below the outfall leading towards the canyon.

This site is located near the confluence of Canon de Valle and Water Canyon within the Canon de Valle Watershed Aggregate. The site was moderately to severely damaged including several burned structures.

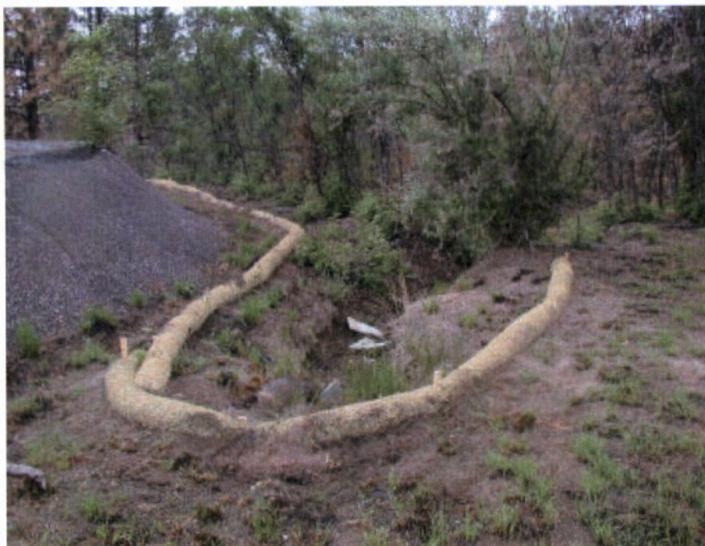
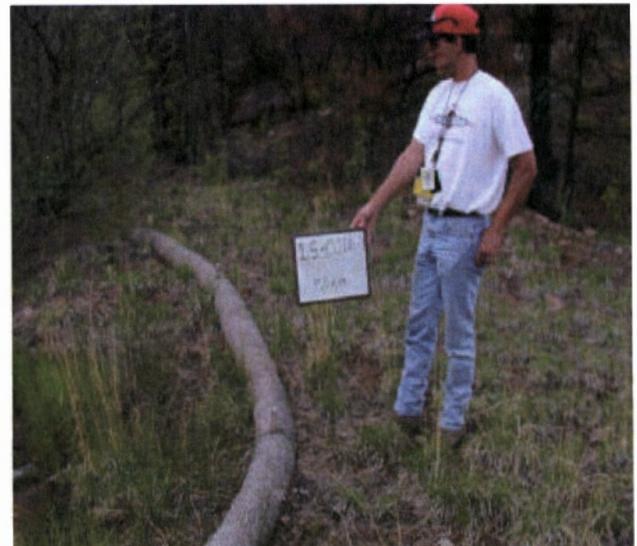
Site is in good condition, with vegetative cover of greater than 70%. The area appears stable with evidence of sediment migration being minimal.

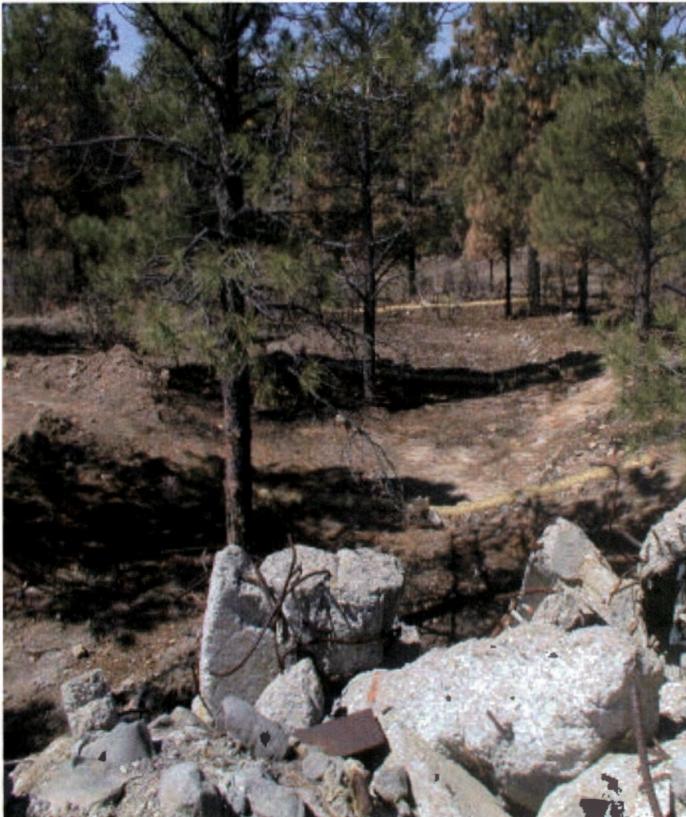
TECHNICAL AREA-15 - MDA-Z BEFORE AND AFTER THE CERRO GRANDE FIRE

15-007(b) – *Erosion Matrix Score 40.2*. MDA Z is an inactive disposal area that was used from 1965 to 1981 for construction debris, steel blast matting from PHERMEX, and other debris.

This site is located near the confluence of Canon de Valle and Water Canyon within the Canon de Valle Watershed Aggregate. The area received minor burn damage primarily to the ground cover.

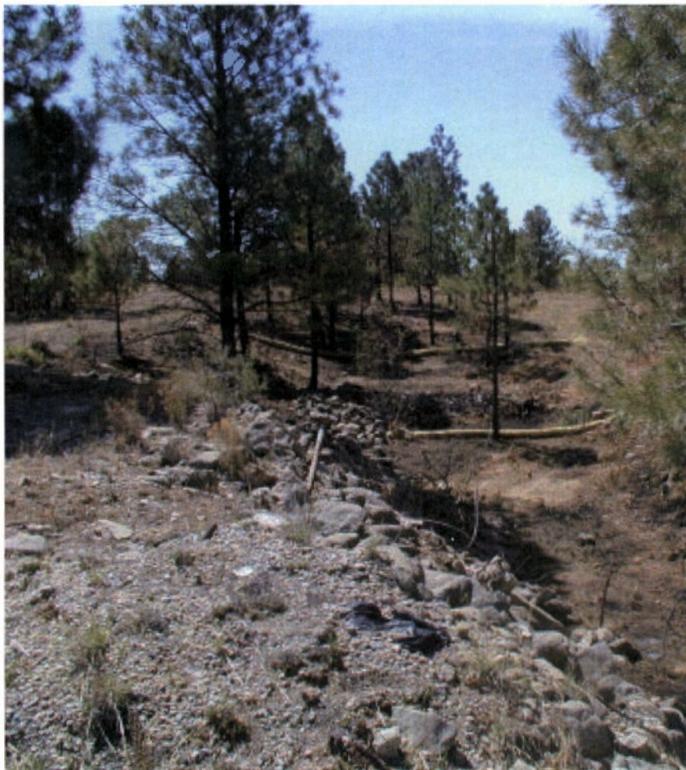
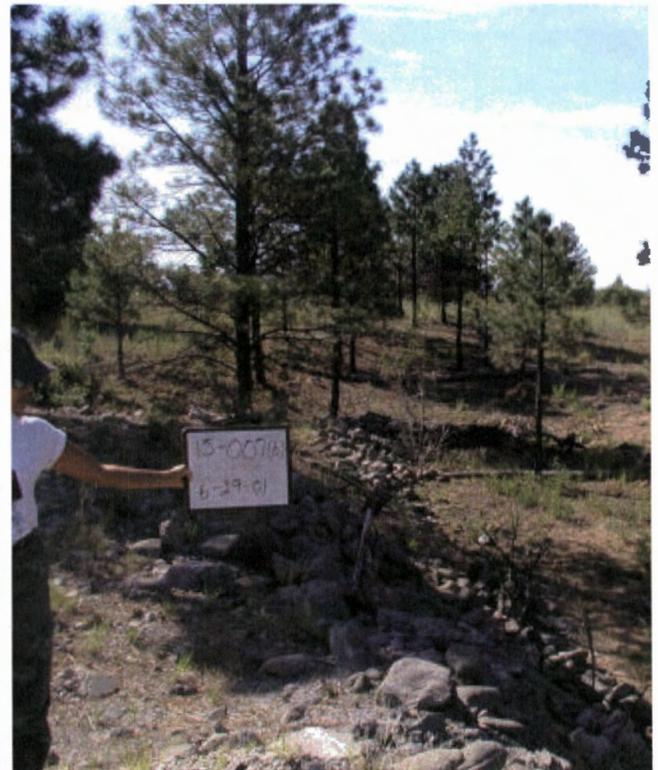
Site is in good condition, with vegetative cover of greater than 50%. The area appears stable with evidence of sediment migration being minimal.
