Title: CERRO GRANDE FIRE ONE YEAR AFTER:

AN UPDATE ON ER ACTIVITIES TO REDUCE
THE POTENTIAL MOVEMENT OF
CONTAMINATION AT POTENTIAL RELEASE
SITES

Authors: STEVEN J. VEENIS, CPESC
RANDY JOHNSON, IT CORPORATION

Submitted to: WATER QUALITY & HYDROLOGY GROUP (ESH-18)
ENVIRONMENTAL RESTORATION PROJECT

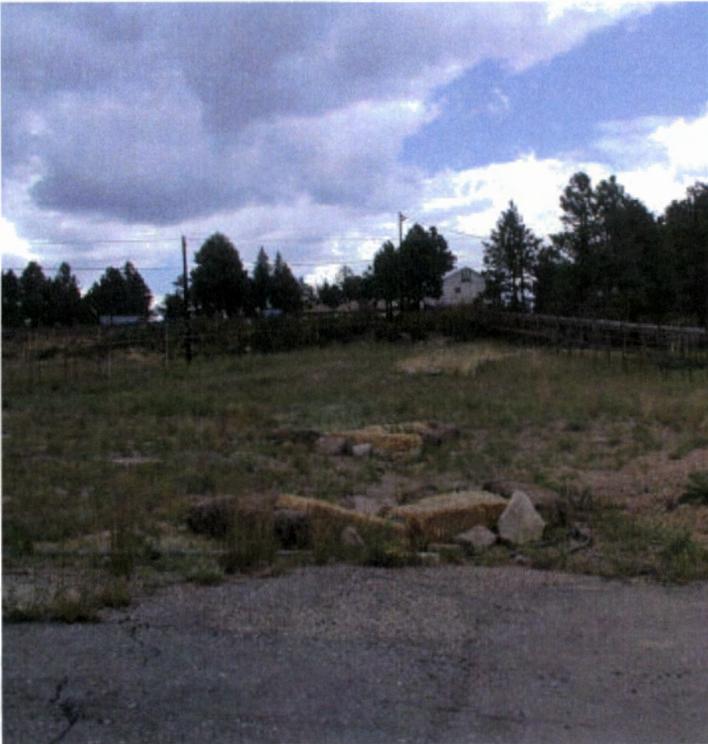
TECHNICAL AREA-16 SITES AFTER THE CERRO GRANDE FIRE

16-028(a) – *Erosion Matrix Score 51.5*. An active outfall drainage associated with TA-16-228 High Explosive Wastewater Treatment Facility. The discharge enters the canyon between TA-16-228 and the liquid impoundment SWMU (16-008(b)).

This site is located near a tributary of Water Canyon within the Canon de Valle Watershed Aggregate. The site has minimal fire damage to the west and south. Some minor burning occurred within the SWMU boundary, but consisted mostly of destroyed grasses. The HEWTF remains operational.

Straw barriers and rock check dams (existing materials found on site) were placed within the drainage swale to reduce sediment transport potential.

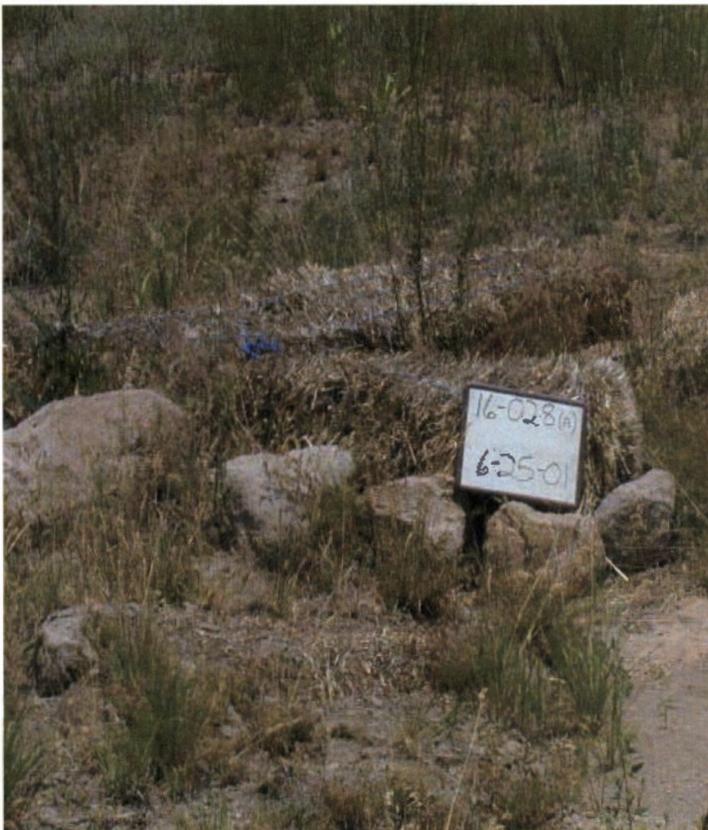
Site is in good condition, with vegetative cover of greater than 50%. The area appears stable with evidence of sediment migration being minimal.

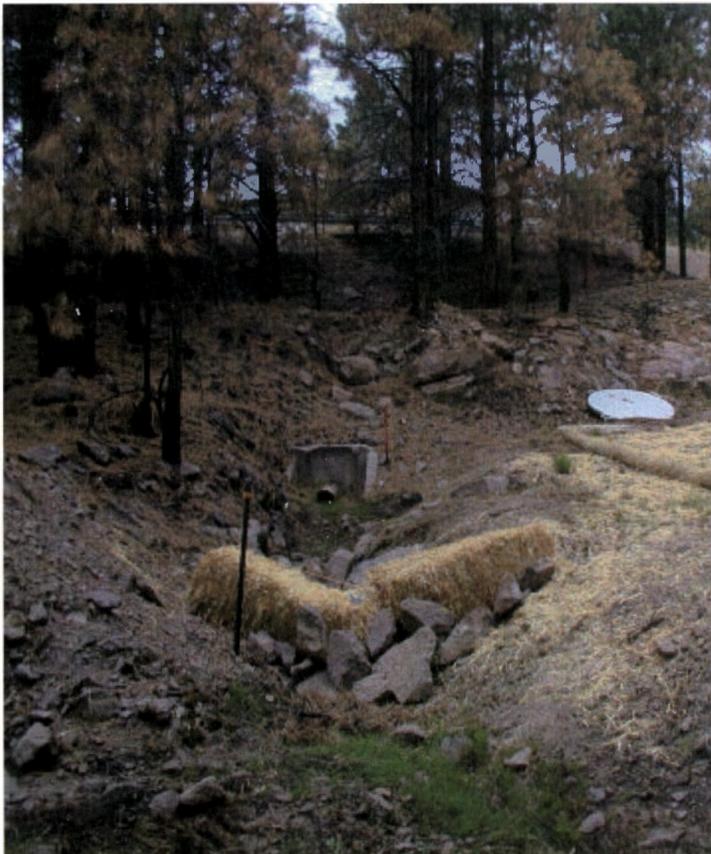
16-003(f) – *Erosion Matrix Score 8.8*. An inactive HE sump associated with TA-16-304. No HE is currently used and the probability of HE in the sump is low.

Site is located in a small tributary drainage to Water Canyon within the S-Site Watershed Aggregate. Site has minor to moderate fire damage within the outfall drainage.

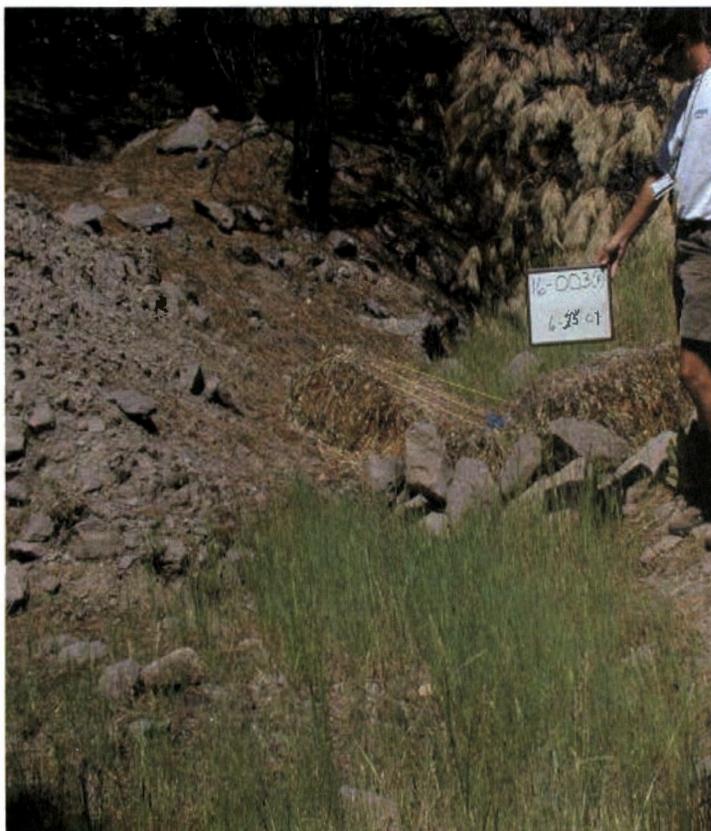
Site is in good condition, with vegetative cover of greater than 70%. The area appears stable with evidence of sediment migration being minimal.

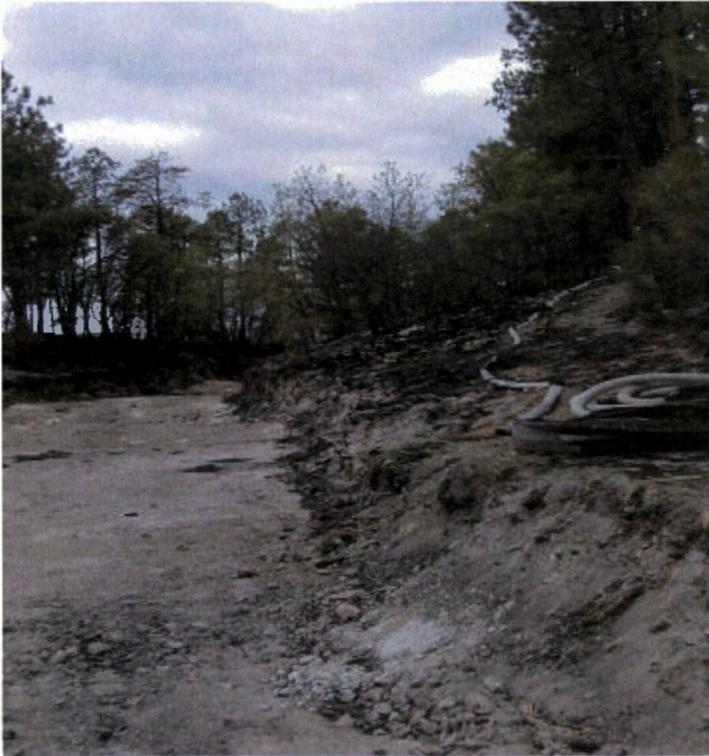
16-021(c) – *Erosion Matrix Score 73.3*. The outfall associated with the 13 HE sumps on the northeast side of TA-16-260. The drainage channel from the outfall flows about 600 feet to the bottom of Canon de Valle. A small pond, 55 feet long is formed by a rock dam located 93 feet from the outfall. The longitudinal axis of the pond is oriented east-west. The site is undergoing an Interim Measure at this time. **16-003(k)** - *Erosion Matrix Score 38.6*. 13 HE sumps and drain lines associated with outfall.

This site is located in a tributary drainage of Canon de Valle within the Canon de Valle Watershed Aggregate. Burn damage is minor to moderate within the SWMU boundary. Heavy equipment on-site was not affected by the fire, although some hoses, drums and misc. equipment were damaged. The upper drainage pond was not burned. The lower drainage received minimal damage from the fire.

Straw barriers were replaced within the drainage channel and jute matting was installed to protect the exposed slopes. All excavated material remains covered with HDPE liners and is surrounded by an earthen berm. The storm water retention pond was unharmed and remains effective as a retention area.

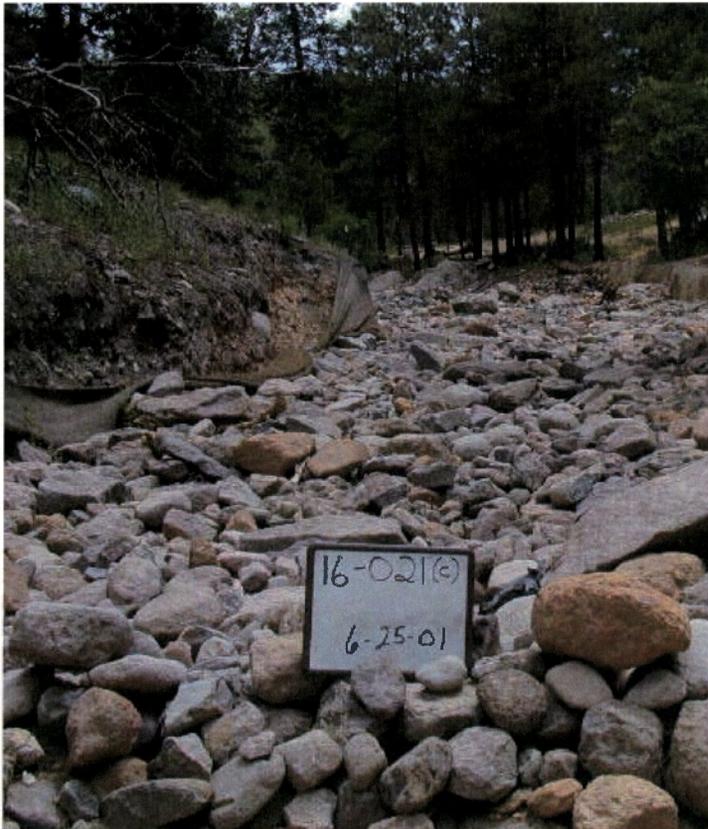
Site is in good condition, with vegetative cover of greater than 60% along the channel banks. The channel has been completely excavated of contaminated soil and river rock was placed to dissipate any future storm water runoff.

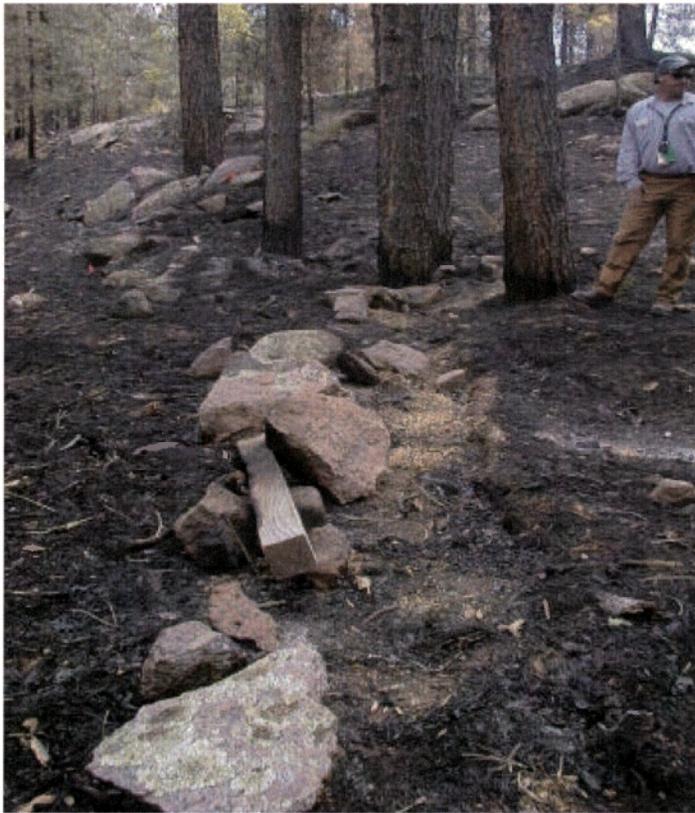
16-020 – *Erosion Matrix Score 61.3*. A small outfall within a drainage channel on the south side of TA-16-222 that slopes gently for approximately 295 ft. to a confluence with the main channel of Canon de Valle.

This site is located east of S-Site Road in the upper tributary of Canon de Valle within the Canon de Valle Watershed Aggregate. No damage was observed from the outfall to the first rock check dam. Below the second rock check dam, fire damaged much of the ground cover and several of the ponderosa pine trees. All straw were destroyed.

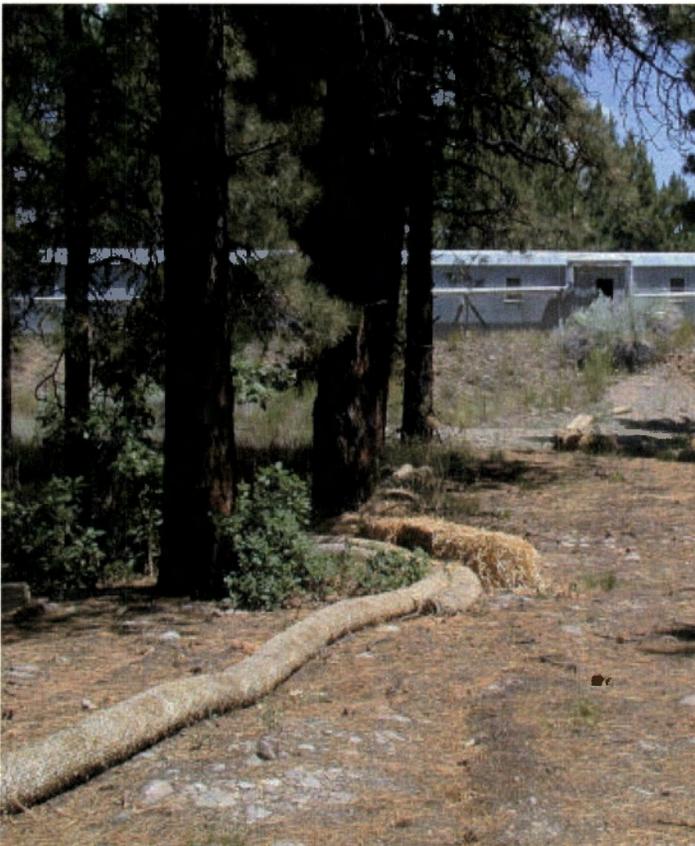
The site has a vegetative cover of around 50%. The site appears stable, but evidence of sediment migration is evident after large rain events. Upstream flood control efforts have reduced the flood potential at the site, but additional work remains. The site will be inspected frequently to assure that sediment migration is minimized.

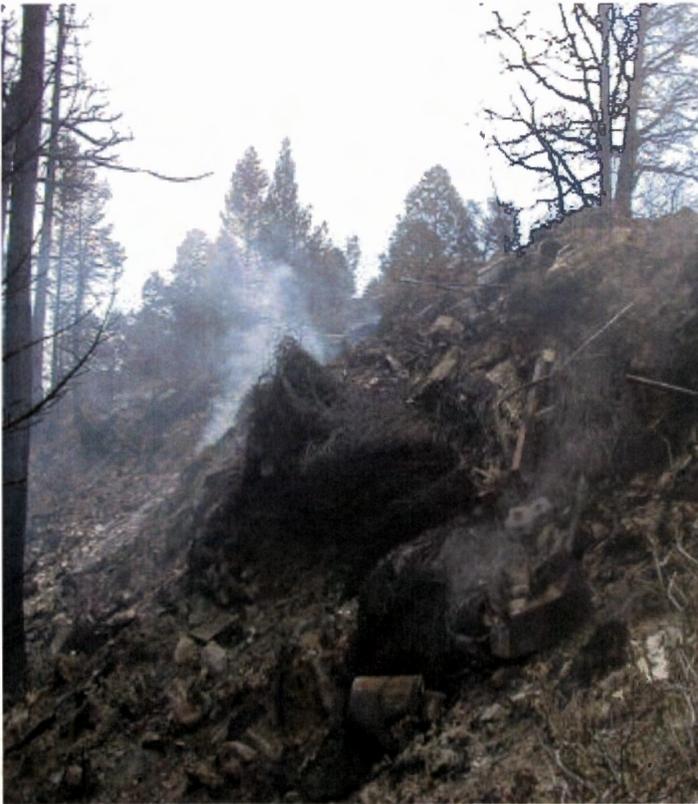
16-019 – *Erosion Matrix Score 83.0*. A material disposal area (MDA R) that consists of the WW II S-Site burning ground and its waste disposal site. This site was found smoldering on May 18th, 2000.

This site is located near building TA-16-260 above Canon de Valle within the Canon de Valle Watershed Aggregate. The site has moderate to severe fire damage over a majority of the area. Miscellaneous debris was exposed on the mesa and slope above canyon channel. The dissipation controls installed within the eastern drainage were destroyed. The ground and canopy cover was completely destroyed. Ash is up to 12" deep in some areas at the toe of slope. Burning occurred in the Canon de Valle leaving severe erosion potential behind.

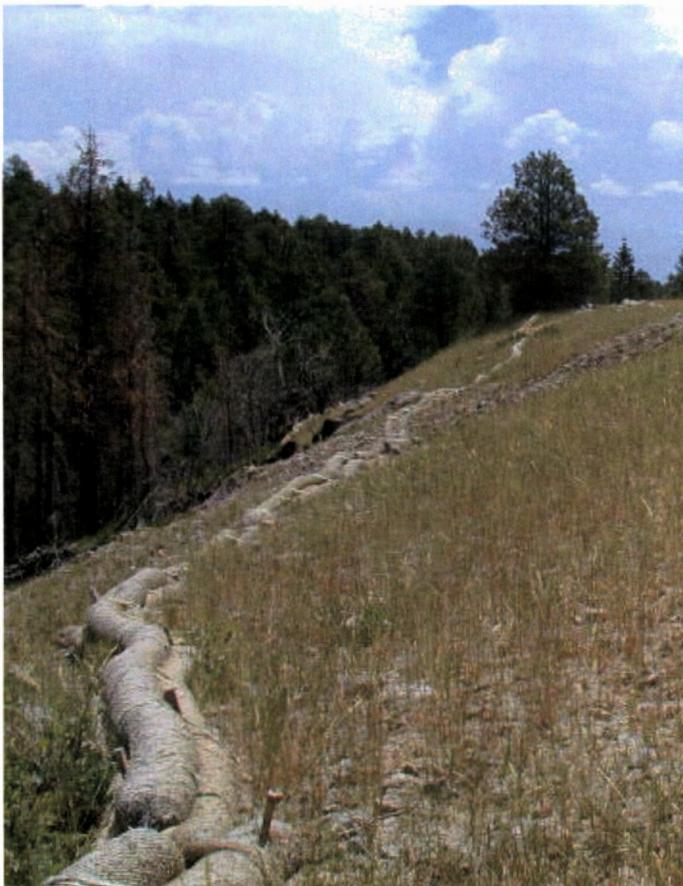
All excavated soil and debris have been removed from the site. The controls installed at the site have been very effective in stabilization of the slope. The run-on diversion trench has reduced storm water flow onto the site by more than 75%. The vegetative groundcover has reduced erosion potential on the slope and the migration of sediment at the site is minimal.

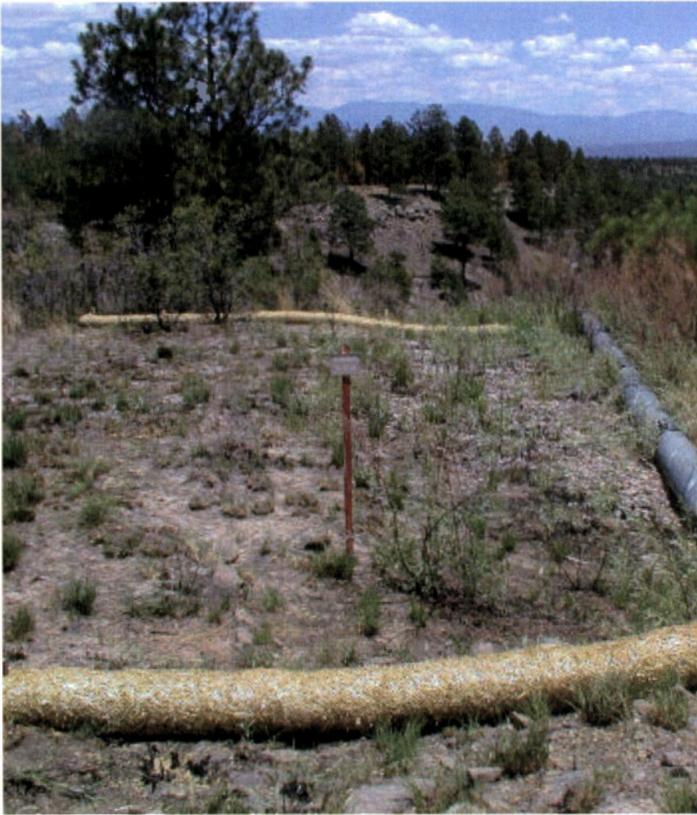
16-003(a) – *Erosion Matrix Score 55.5*. A single inactive HE sump and an outfall associated with TA-16-410 (former NPDES outfall 05A053).

Site is located near a tributary in upper Water Canyon within the Upper Water Canyon Watershed Aggregate. The site has minor to moderate fire damage within the outfall drainage.

Straw wattles were installed near the outfall pipe and below the mesa's edge within the bottom of the tributary drainage. The area around the outfall was hand-raked, reseeded and straw mulched.

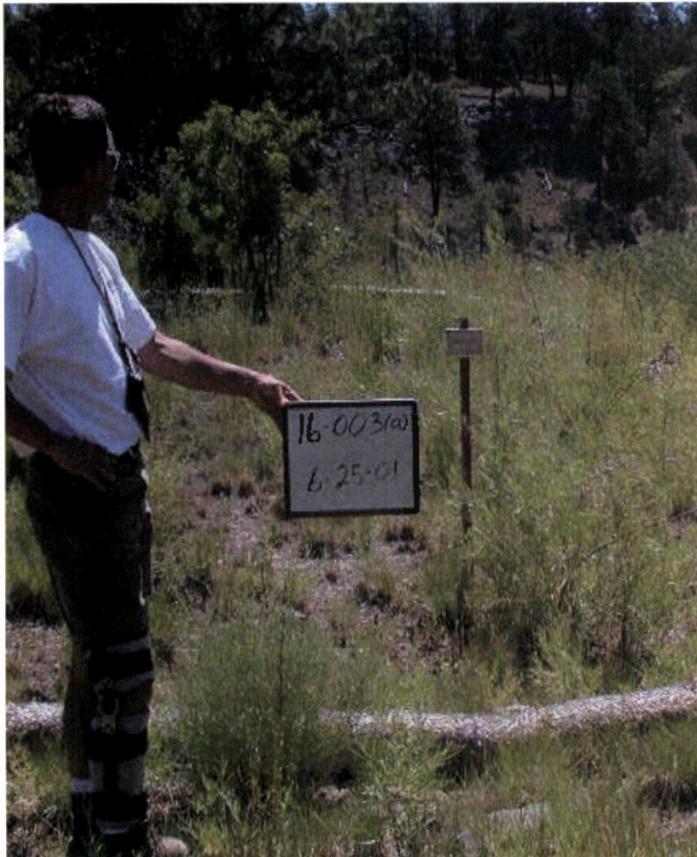
Site is in good condition, with vegetative cover of greater than 70%. The area appears stable with evidence of sediment migration being minimal.

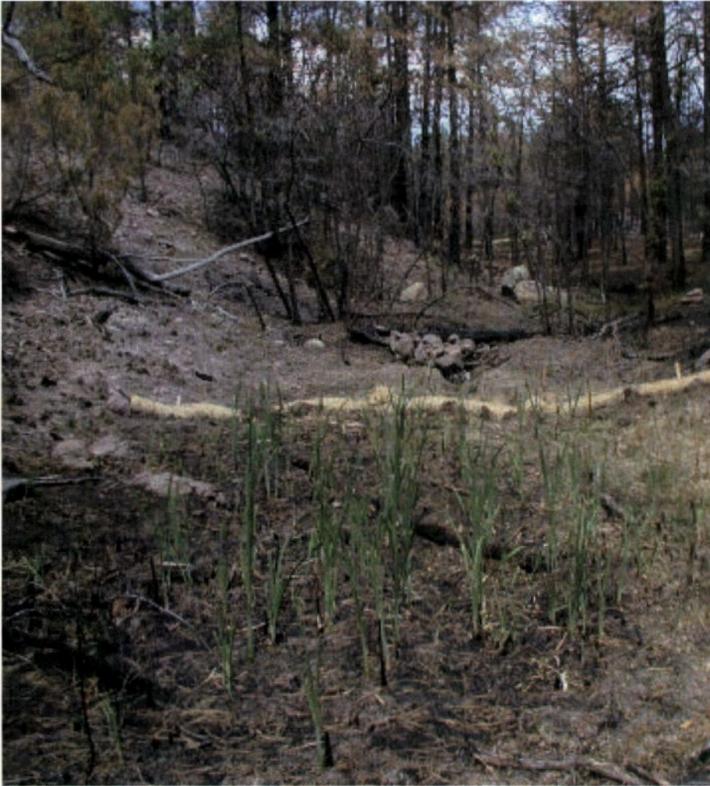
16-003(n) – *Erosion Matrix Score 25.0*. An active HE sump associated with TA-16-342. The outfall, EPA 05A062, receives effluent from a HE sump on the northeast corner of TA-16-342. The outfall discharges into a tributary of Canon de Valle. **16-003(o)** – *Erosion Matrix Score 27.3*. Six active HE sumps associated with TA-16-340. The outfall, EPA 05A054, discharges effluent from the six HE sumps on the northeast side of TA-16-340. The effluent flows into a common drain line that discharges into a short tributary of Canon de Valle.

The site is located in a tributary drainage of Water Canyon within the Canon de Valle Watershed Aggregate. The site has minor to moderate fire damage within the drainage channel down to the existing wetlands located approximately ¼ mile downstream.

Straw wattles were installed above and below the wetland to help control sediment transport within the channel. Rock check dams (on-site materials used) were installed for flow dissipation. Wetland vegetation has begun to re-establish itself.

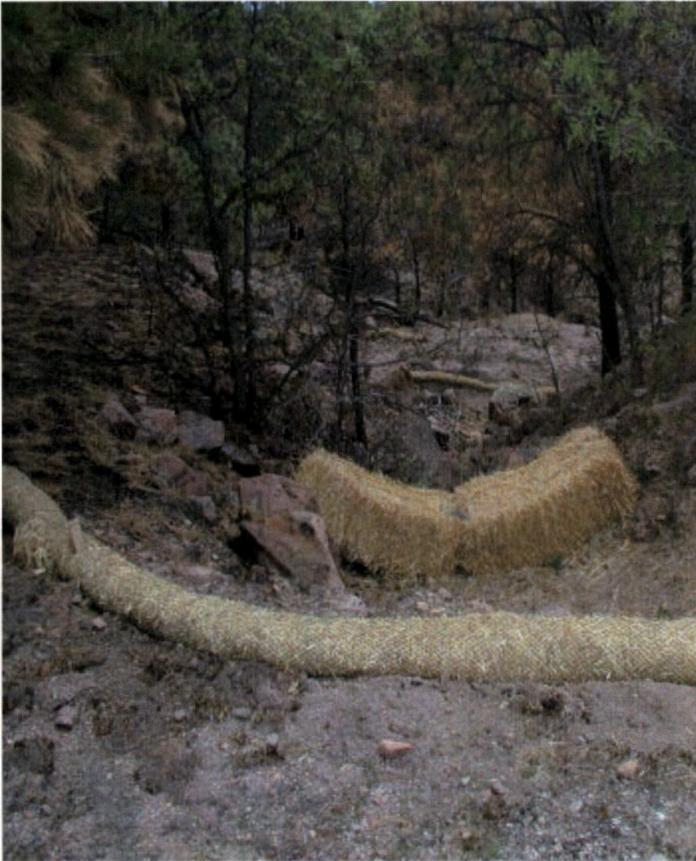
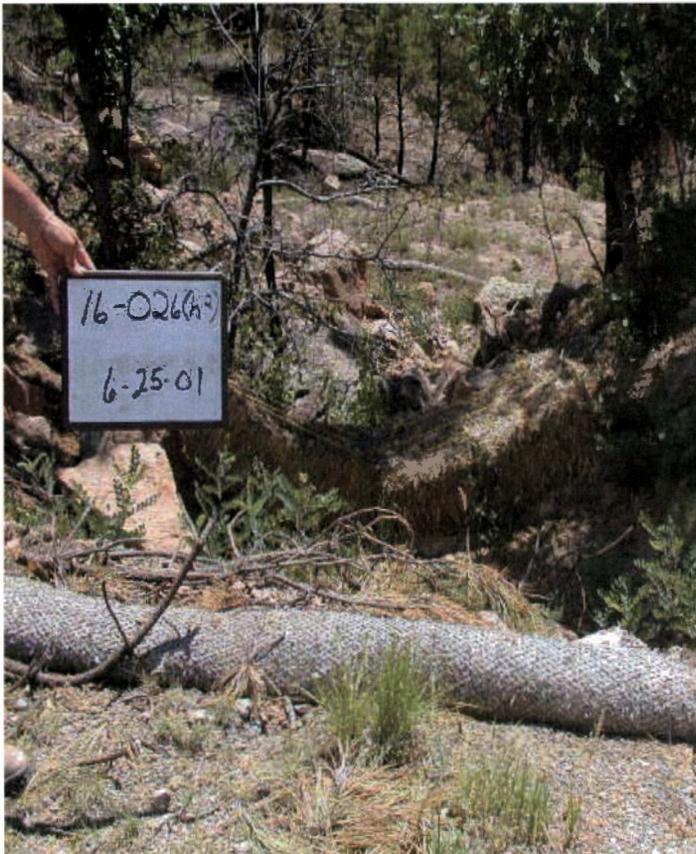
16-026(h2) – Erosion Matrix Score 61.0. An outfall associated with the HE sump (PRS 16-029(e)) at TA-16-360.

The site is located in a tributary drainage of Water Canyon within the Upper Water Canyon Watershed Aggregate. The site has minor to moderate fire damage within drainage channel.

Revegetation efforts within the tributary drainage have been successful. The wetland grasses as well as the surrounding channel bank grasses have achieved a greater than 70% cover. The site appears stable and sediment migration at the site is minimal.

Straw wattles and straw bale barriers were installed within the drainage channel to retain sediment and dissipate flow. Areas adjacent to the drainage were hand-raked, reseeded and covered with straw mulch.

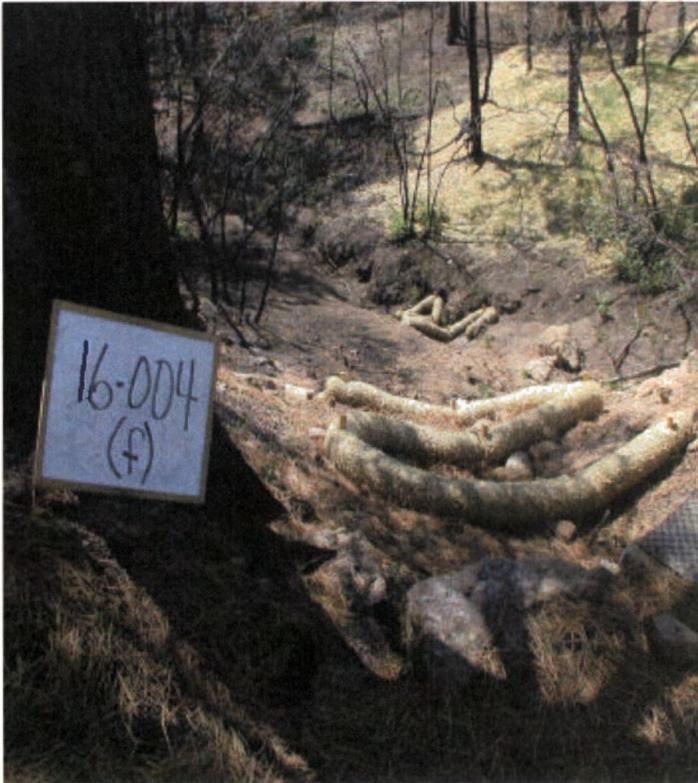
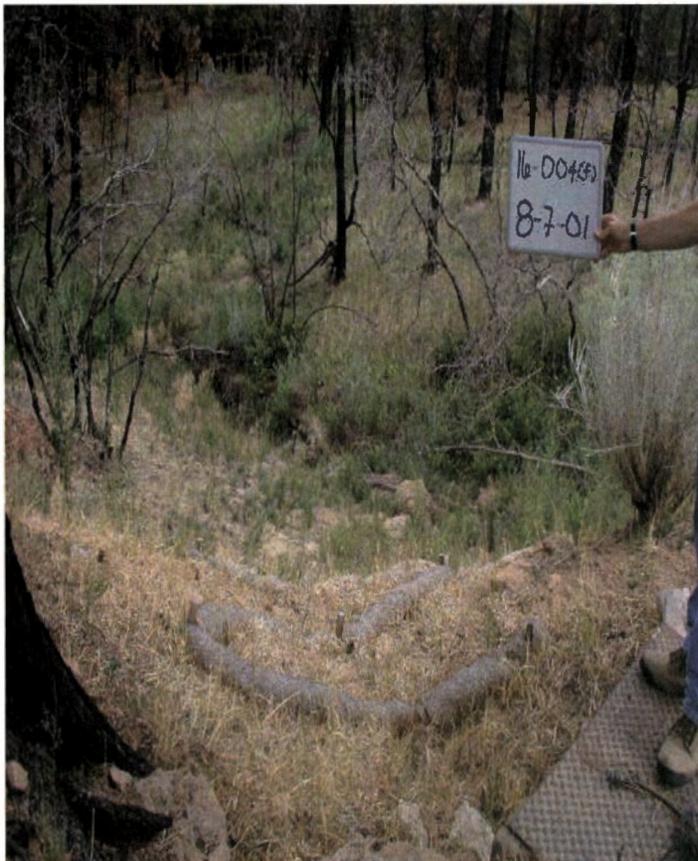
16-004(f) – Erosion Matrix Score 31.0. Sludge drying bed and associated outfall near Sanitary Wasterwater Treatment Facility at 16-535.

The site is located in a tributary drainage of Water Canyon within the S-Site Canyon Watershed Aggregate. The site has minor to moderate fire damage within drainage channel.

Revegetation efforts within the tributary drainage have been successful. The surrounding channel bank grasses have achieved a greater than 70% cover. The site appears stable and sediment migration at the site is minimal.

Straw wattles and straw bale barriers were installed within the drainage channel to retain sediment and dissipate flow. Areas adjacent to the drainage were hand-raked, reseeded and covered with straw mulch.

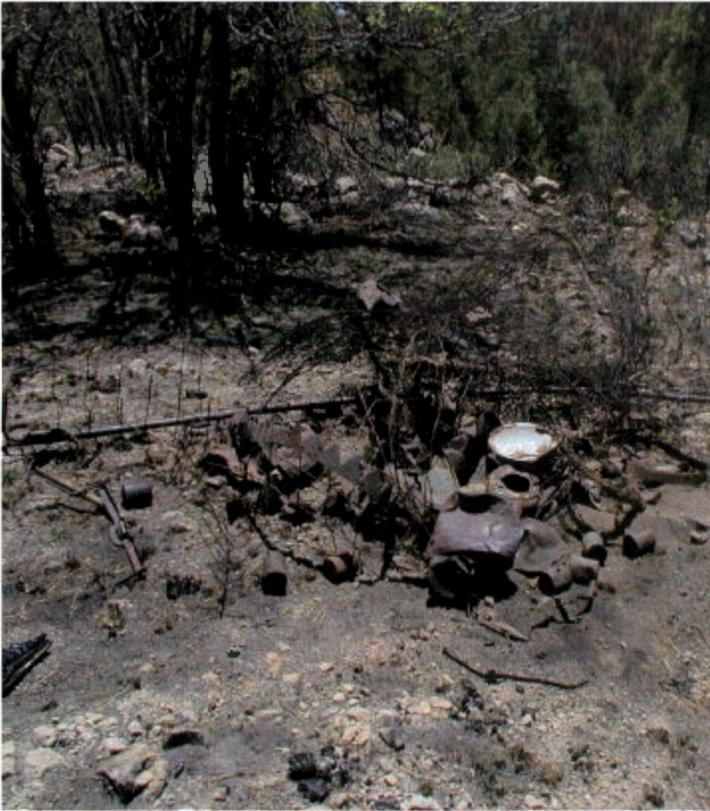
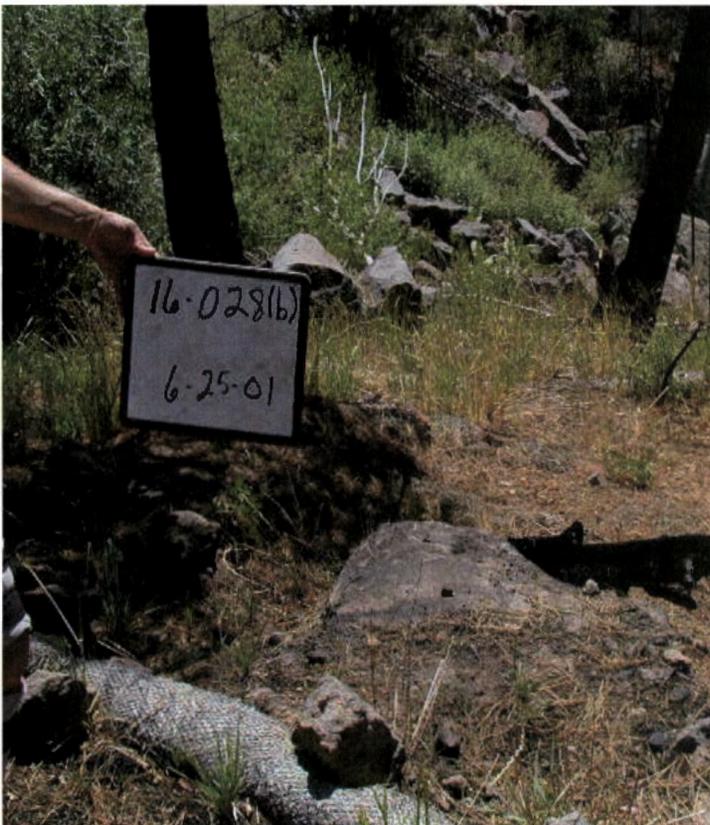
16-028(b) – *Erosion Matrix Score 83.0*. Potentially contaminated soil from a permitted outfall at TA-16-370 (former NPDES outfall 04A092). The outfall drains from the west side of the building and daylights approximately 50 ft. south of the building in a steep, rocky area of Water Canyon.

The site is located in a tributary drainage of Water Canyon within the Canon de Valle Watershed Aggregate. The site has minor to moderate fire damage within drainage channel. Debris was exposed within channel near the inactive outfall.

Revegetation efforts within the tributary drainage have been successful. The surrounding channel bank grasses have achieved a greater than 70% cover. The site appears stable and sediment migration at the site is minimal.

Straw wattles were installed upslope of and within the drainage channel to divert and dissipate storm flows. The debris was removed from the channel and the area was hydromulched to enhance the vegetation process.

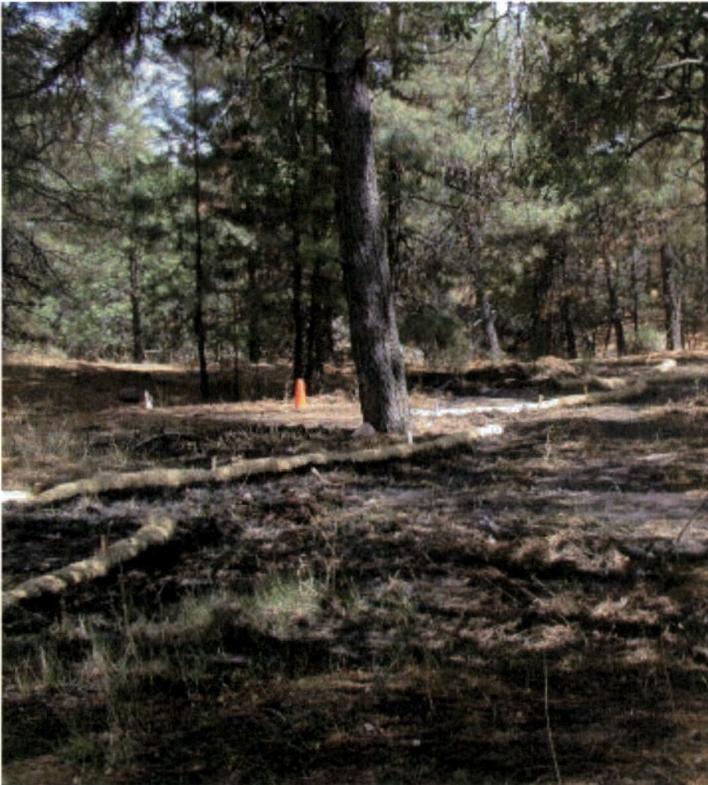
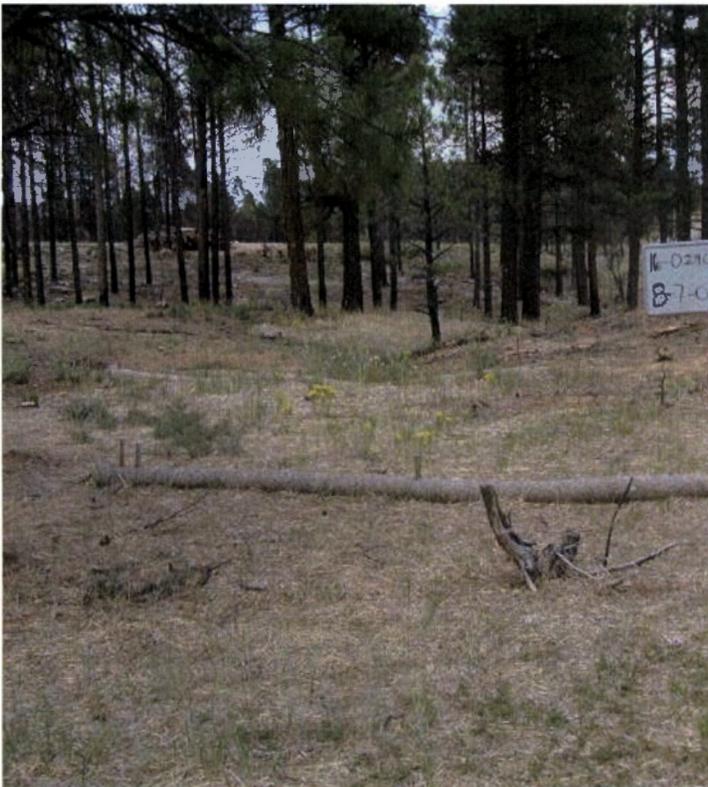
16-029(g) – Erosion Matrix Score 21.5. An active HE sump associated with TA-16-450. The outfall, EPA 04A091 located to the southeast of TA-16-450, receives effluent from the sump.

The site is located in a tributary drainage of Water Canyon within the Upper Water Canyon Watershed Aggregate. The site has moderate fire damage of the ground cover with minor canopy damage.

Revegetation efforts throughout the site have been successful. The surrounding grasses have achieved a greater than 70% cover. The site appears stable and sediment migration at the site is minimal.

Straw wattles were installed throughout the site for sediment retention. The area was then hand-raked, reseeded and straw mulched.

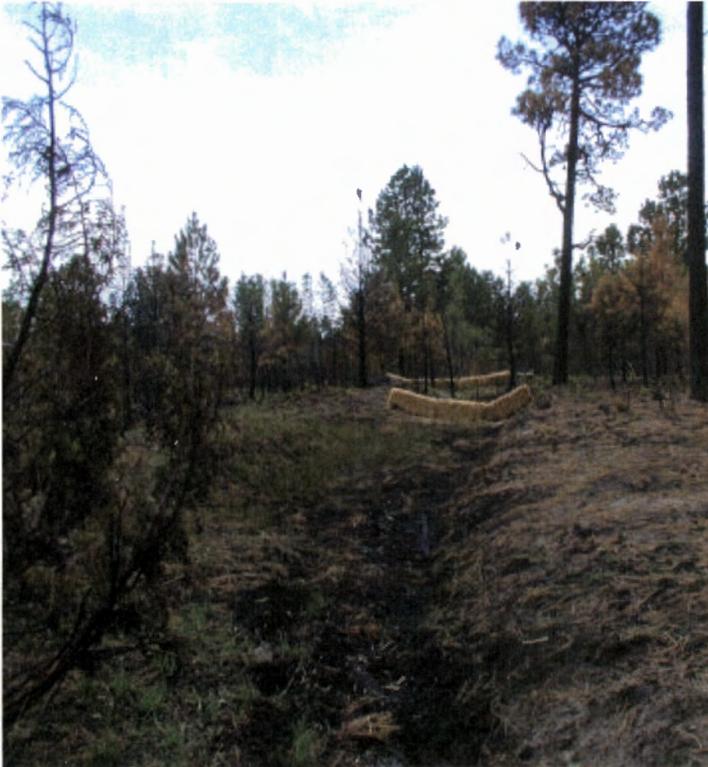
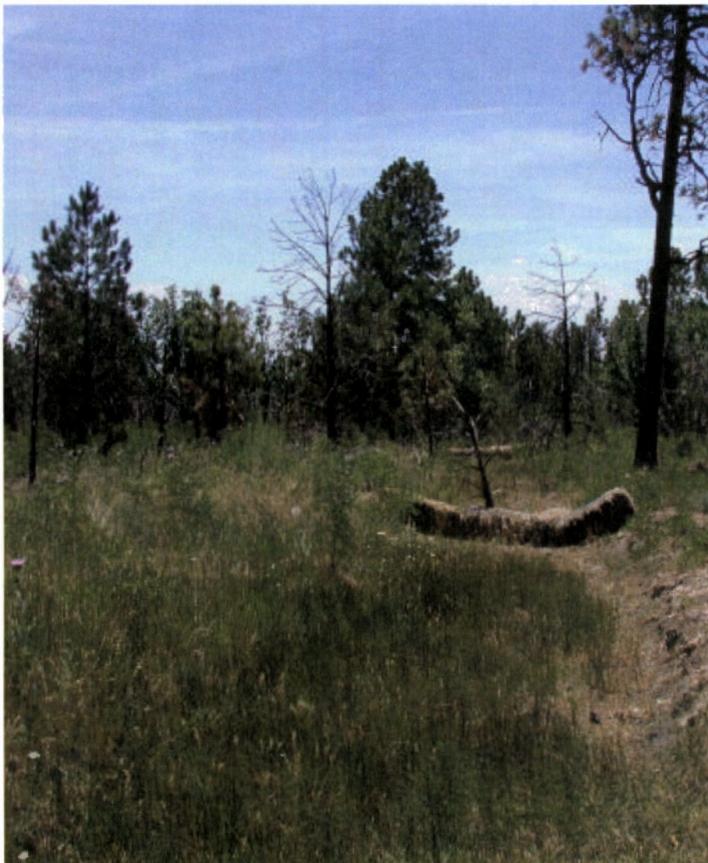
16-030(h) – *Erosion Matrix Score 29.1*. Building TA-16-430 functions as a high explosives pressing facility. Plastic-bonded explosives and mock HE powders are pressed to shape. The site consists of three outfalls associated with the three HE sumps at TA-16-430.

The site is located in a tributary drainage of Water Canyon within the Upper Water Canyon Watershed Aggregate. The site has moderate fire damage of the ground cover with minor canopy damage.

Revegetation efforts within the tributary drainage have been successful. The surrounding channel bank grasses have achieved a greater than 70% cover. The site appears stable and sediment migration at the site is minimal.

Straw barriers were installed within the drainage channel for sediment retention. The area was then hand-raked, reseeded and straw mulched.

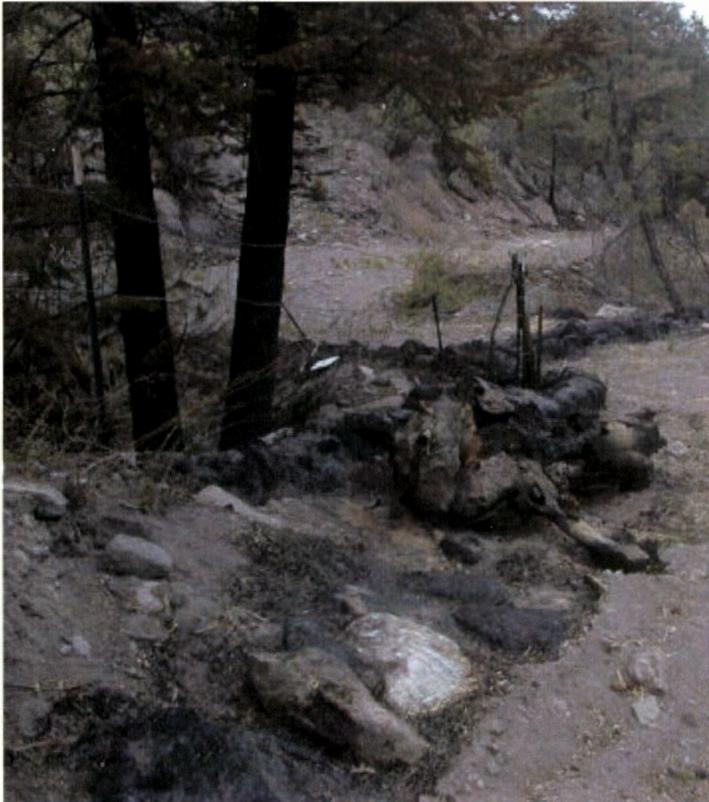
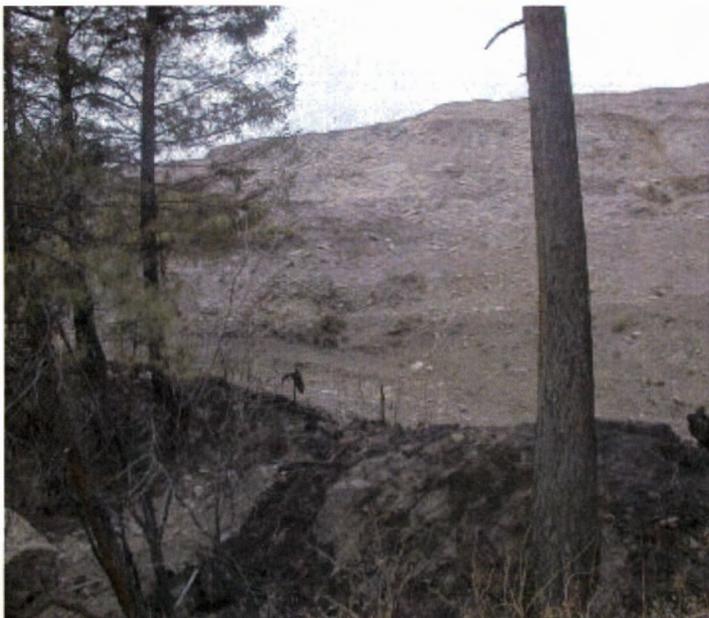
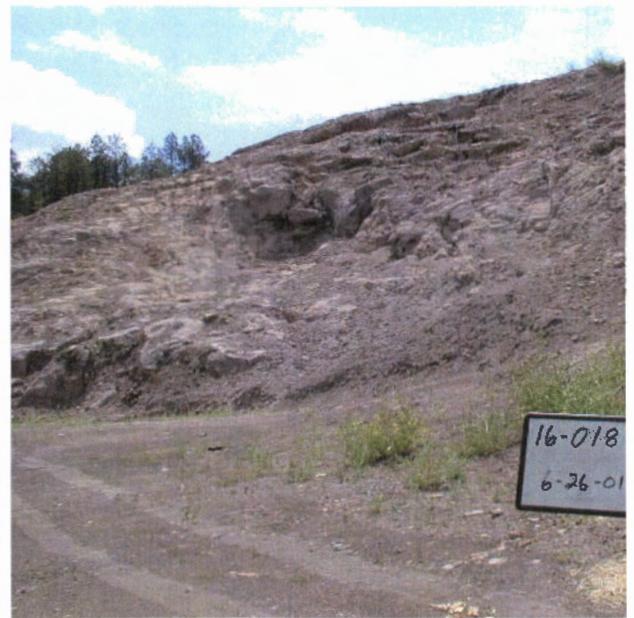
This site is located on the edge of Canon de Valle within the Canon de Valle Watershed Aggregate. MDA-P received only peripheral fire damage on the lower portion of the site. The existing straw barriers and silt fencing were destroyed. No construction equipment and project infrastructure were damaged.

Site is stable and the Clean Closure Project is near completion. Final restoration will occur at that time.

The straw barriers and silt fencing were replaced and fortified with an earthen berm below the site. Soil-Sement (polymer based emulsion) was applied to exposed slopes to reduce sediment transport potential.

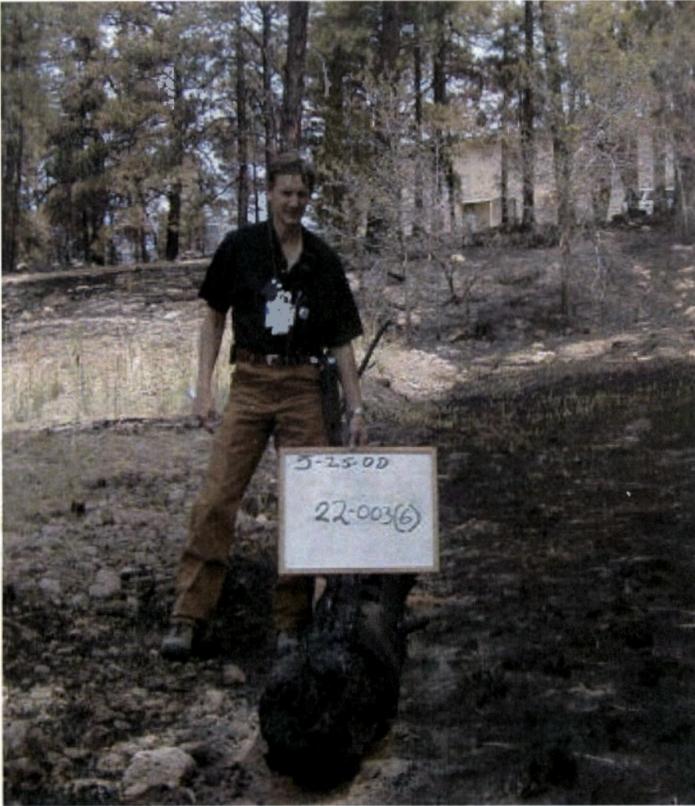
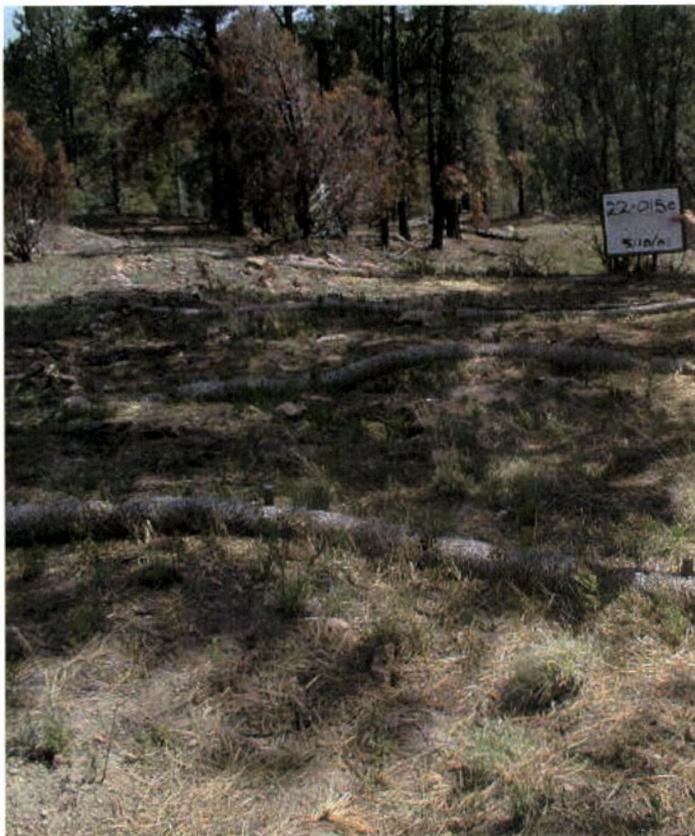
22-015(c) – Erosion Matrix Score 51.5. Former outfall from plating & etching operation.

The site is located in a tributary drainage of Pajarito Canyon within the Starmer's/Pajarito Canyon Watershed Aggregate. Moderate fire damage was found at 22-015(c) including the drainage swale below the inactive outfall, the pond area and stained areas leading to the mesa edge. The ground cover was severely damaged leaving little or no protection.

Revegetation efforts throughout the site have been successful. The surrounding channel bank grasses have achieved a greater than 70% cover. The site appears stable and sediment migration at the site is minimal.

Straw wattles were installed upslope and within the drainage swale. The area was hand-raked, reseeded and mulched. The pond area has begun to revegetate itself.

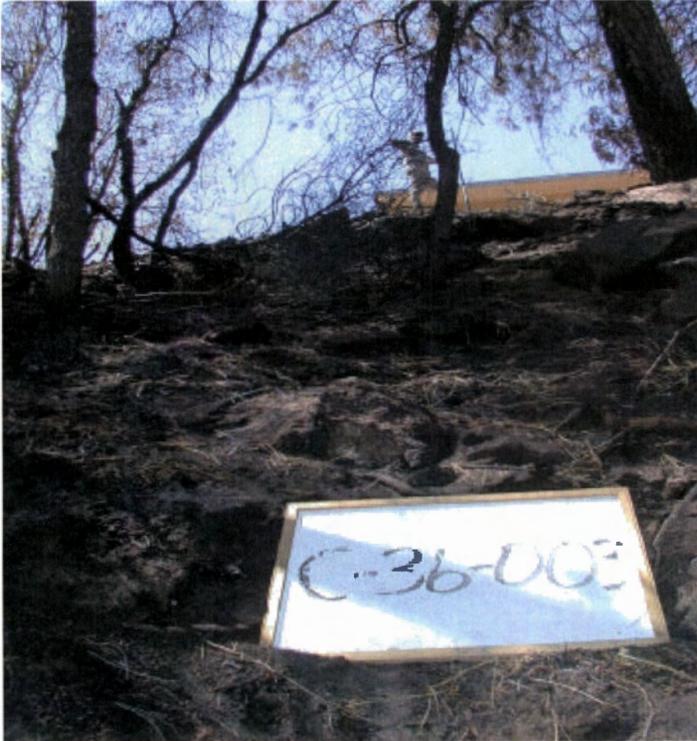
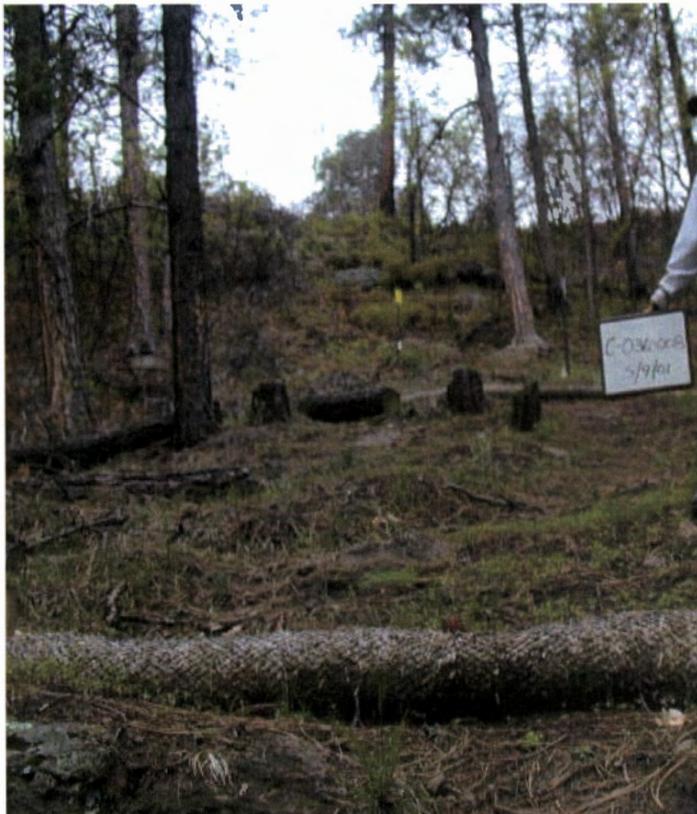
The site is located on the edge of Three Mile Canyon within the Three Mile Canyon Watershed Aggregate. A backfire was set near TA-36-1 to help protect TA-18. This fire exposed miscellaneous debris on the slope and PRS 36-008 was identified.

Revegetation efforts throughout the slope have been successful. The surrounding grasses have achieved a greater than 70% cover. The site appears stable and sediment migration at the site is minimal.

Straw wattles were installed on the mesa's edge to divert storm water run-on from the parking area, within the drainage channels on the slope and at the toe of the slope. The debris that was exposed by the fire has been removed, and the area was hand-raked, reseeded and straw mulched.

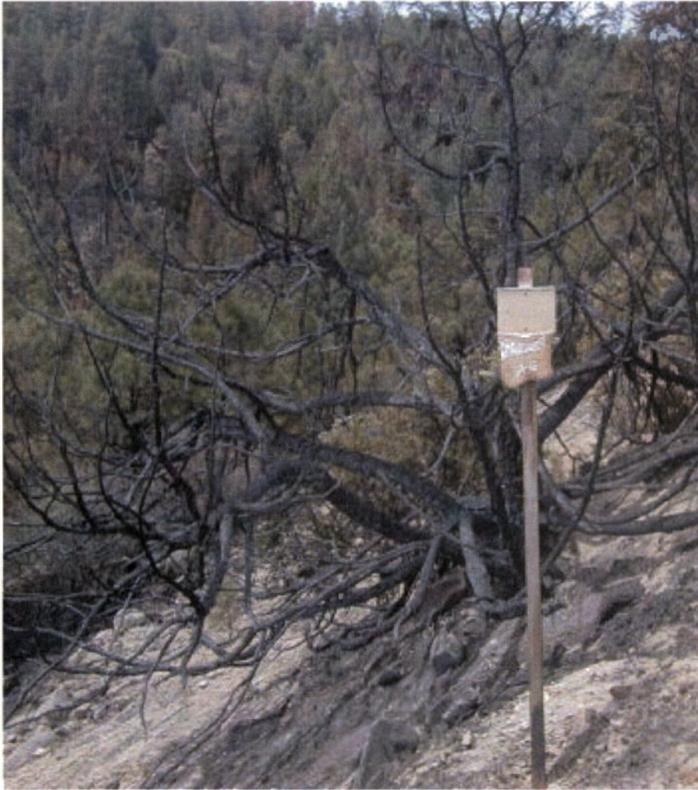
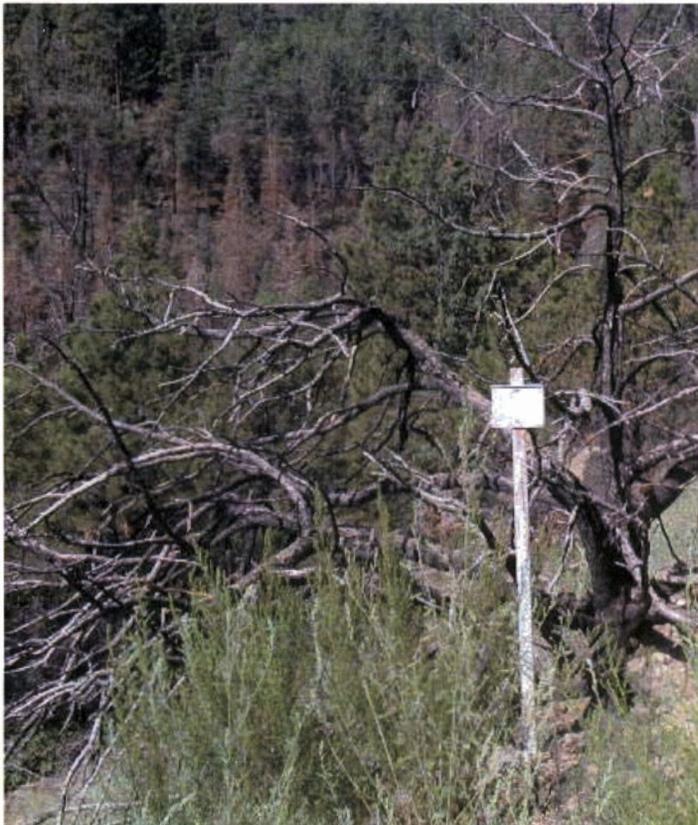
40-006(b) – *Erosion Matrix Score 62.0*. Active firing site used only for testing and development of small explosive devices and not for waste disposal. An inactive NPDES outfall (06A081) is shown.

The site is located on the edge of Pajarito Canyon within the Starmer's/Pajarito Canyon Watershed Aggregate. The fire damage was moderate to severe with several buildings destroyed near this site.

Revegetation efforts around the site have been successful. The surrounding channel bank grasses have achieved a greater than 50% cover. The site appears stable and sediment migration at the site is minimal.

Straw wattles were installed on the steep portion of the slope to reduce the sediment migration potential. Wattles were also installed on the mesa's edge to divert run-on from slope.

Several wattles that were damaged due to wildlife were replaced.
