Title: CERRO GRANDE FIRE ONE YEAR AFTER:

AN UPDATE ON ER ACTIVITIES TO REDUCE
THE POTENTIAL MOVEMENT OF
CONTAMINATION AT POTENTIAL RELEASE
SITES

Authors: STEVEN J. VEENIS, CPESC
RANDY JOHNSON, IT CORPORATION

Submitted to: WATER QUALITY & HYDROLOGY GROUP (ESH-18)
ENVIRONMENTAL RESTORATION PROJECT

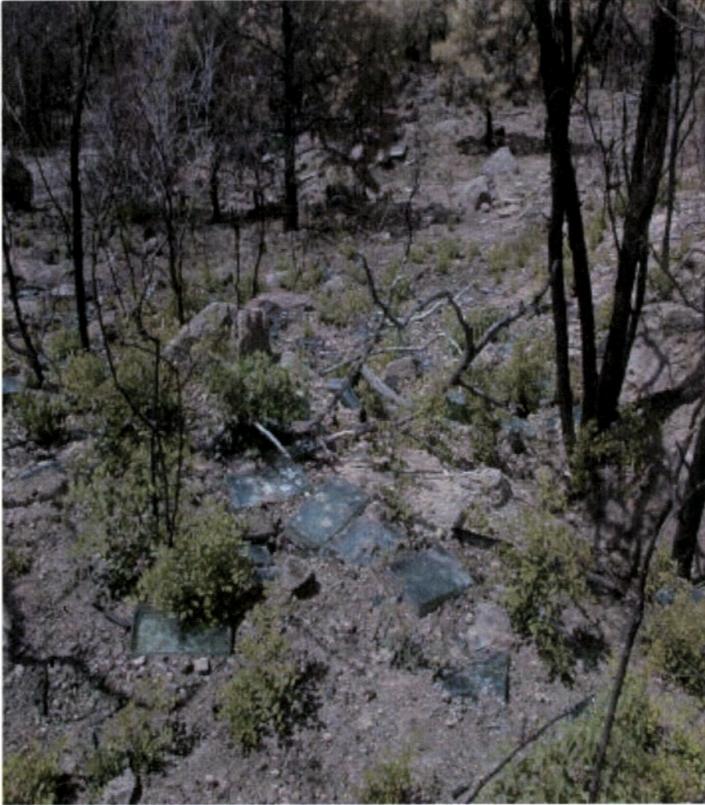
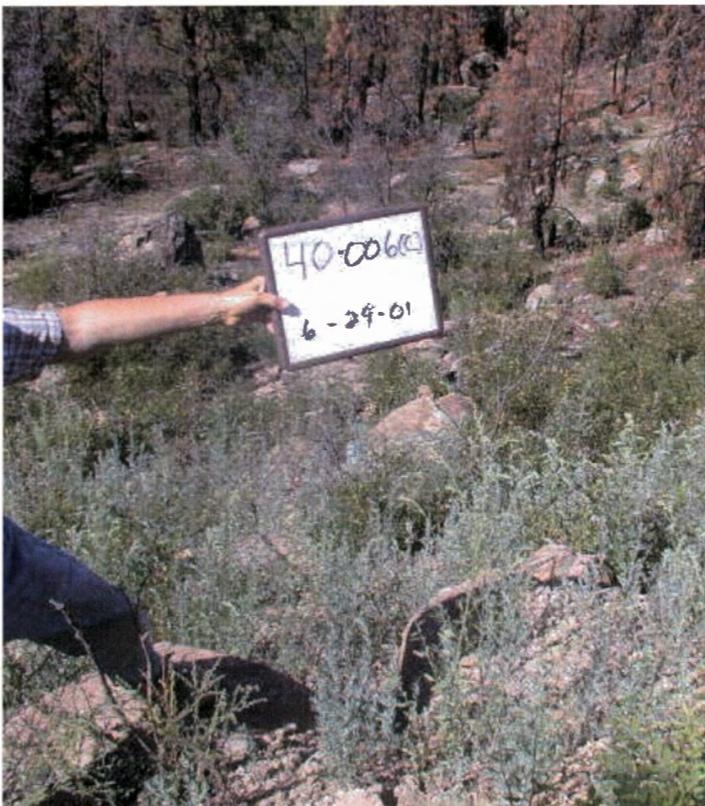
40-006(c) - Erosion Matrix Score 62.0. Active firing site used only for testing and development of small explosive devices and not for waste disposal. An inactive NPDES outfall (06A080) is shown at the site.

Site is located on the edge of Pajarito Canyon within the Starmer's/Pajarito Canyon Watershed Aggregate. The fire damage was moderate to severe with several buildings destroyed near this site.

Revegetation efforts around the site have been successful. The surrounding channel bank grasses have achieved a greater than 50% cover. The site appears stable and sediment migration at the site is minimal.

Straw wattles were installed on the steep portion of the slope to reduce the sediment migration potential. Wattles were also installed on the mesa's edge to divert run-on from the slope.

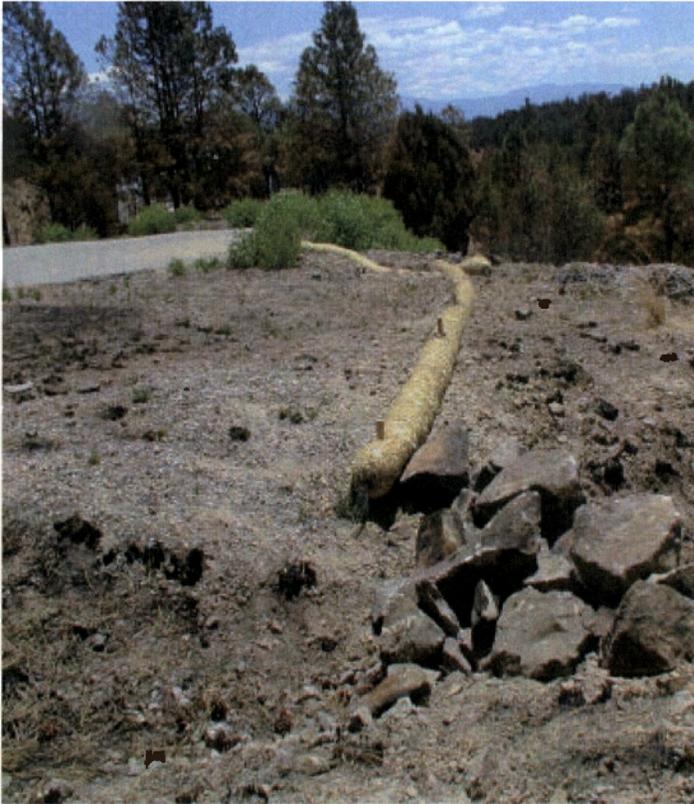
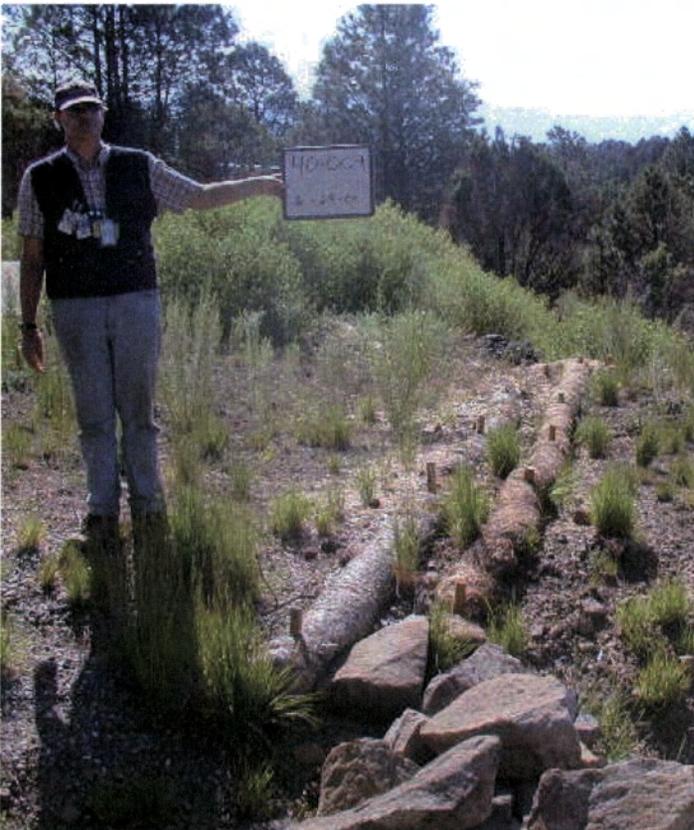
40-009 - Erosion Matrix Score 54.5. Landfill adjacent to firing site at TA-40-9. The landfill contains debris from decommissioning of buildings at TA-15. An inactive NPDES outfall (04A101) is located nearby.

The site is located on the edge of Pajarito Canyon within the Starmer's/Pajarito Canyon Watershed Aggregate. The erosion potential on this slope increased due to lack of vegetative cover as a result of the fire.

Revegetation efforts around the site have been mostly successful. The surrounding channel bank grasses have achieved a greater than 50% cover. The site appears stable and sediment migration at the site is minimal.

Straw wattles were installed along the mesa edge to divert run-on from the slope. Rock check dams (on-site materials used) were provided to dissipate flow within the drainage channels on both the east and west ends of the site.

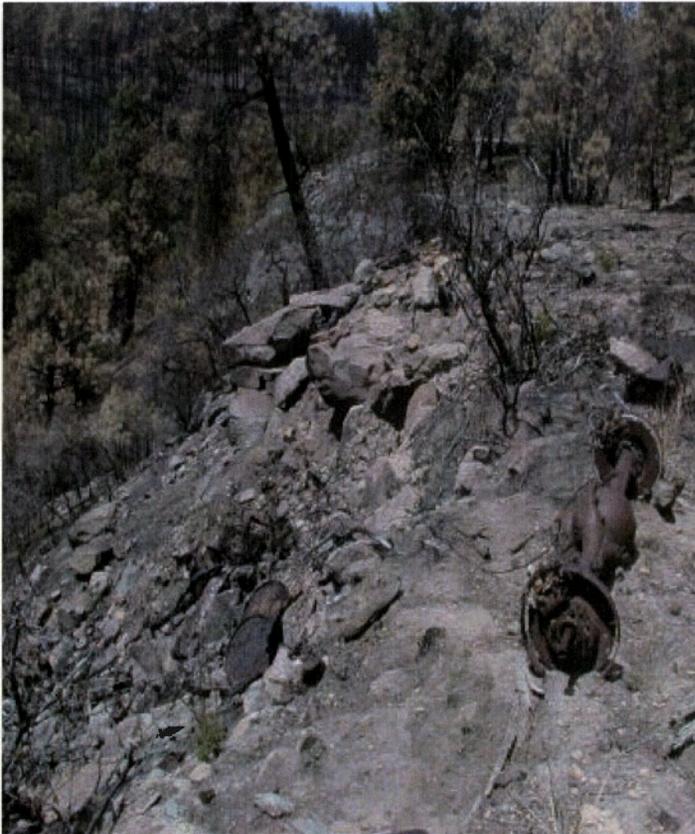
40-010 - Erosion Matrix Score 40.2. An area on the edge of Pajarito Canyon extending about 50-feet along the canyon edge and about 50 feet down the canyon. Debris in this area includes farm and home implements that probably predate the Manhattan Project.

The site is located on the edge of Pajarito Canyon within the Starmer's/Pajarito Canyon Watershed Aggregate. Land disposal area 40-010 was exposed due to the fire, with debris consisting of industrial waste.

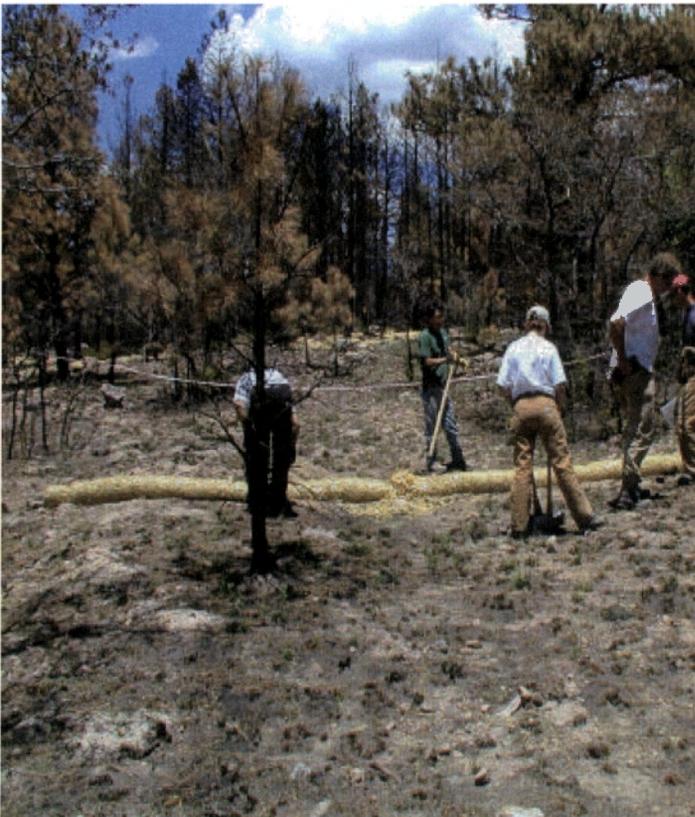
Revegetation efforts around the site have been successful. The surrounding channel bank grasses have achieved a greater than 50% cover. The site appears stable and sediment migration at the site is minimal. The debris near the mesa's edge was removed from the area and disposed of as solid waste.

Installation of two additional straw wattles for sediment retention.

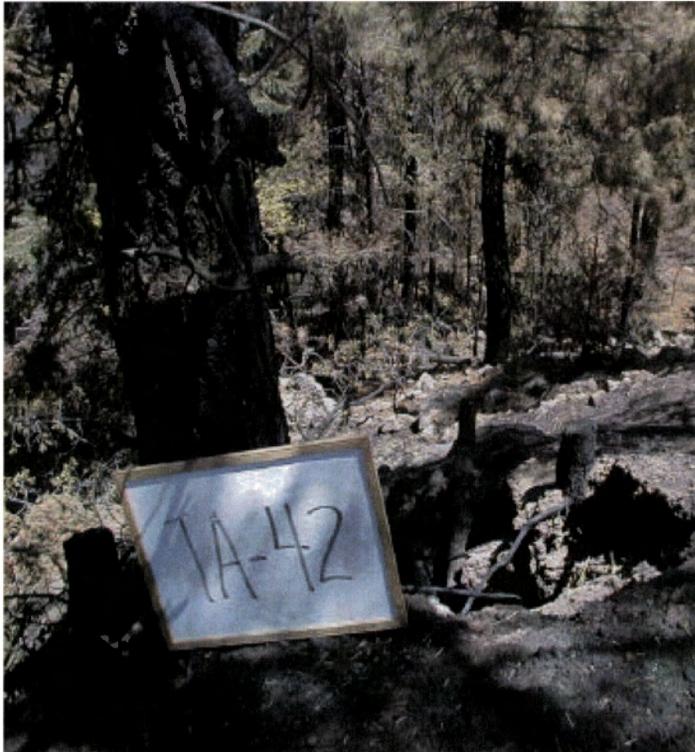
The site is located on a tributary drainage to Mortandad Canyon within the Upper Mortandad Canyon Watershed Aggregate. The entire north facing slope below former TA-42 was moderately burned. Two distinct drainage channels bisect the area behind the new building constructed near TA-55. The run-on to the western most drainage has been diverted away from the area of concern. The other drainage receives only direct rainfall, with minimal upslope sources.

Straw wattles were installed around the area to divert run-on and to impede sediment transport potential. The area was hand-raked, reseeded and straw mulched.

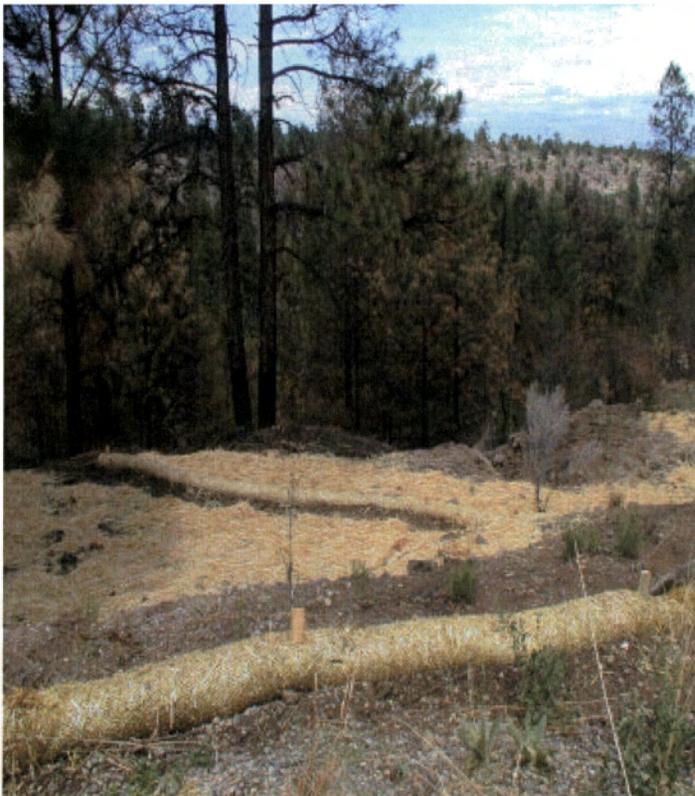
Revegetation efforts around the site have been mostly successful. The surrounding channel bank grasses have achieved a greater than 50% cover. The site appears stable and sediment migration at the site is minimal.

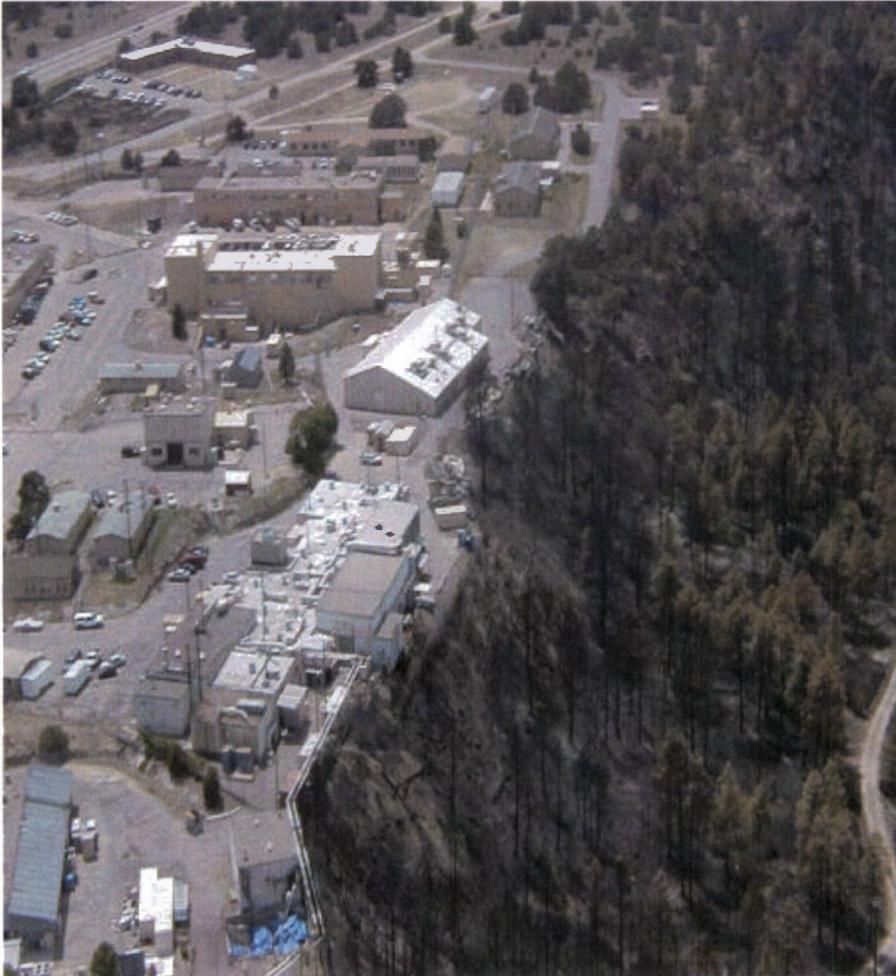
The area impacted is located on the northern edge of Mesita del Buey within the Middle Mortandad/Canada del Buey Watershed Aggregate. The entire north-facing slope below TA-46 was moderately to severely burned. Several buildings along the mesa edge were destroyed. The canopy and ground cover was mostly destroyed. The northern slope is extremely steep with several inactive outfalls, pipes and old infrastructure parts exposed.

This areal photograph was taken on May 25, 2000.

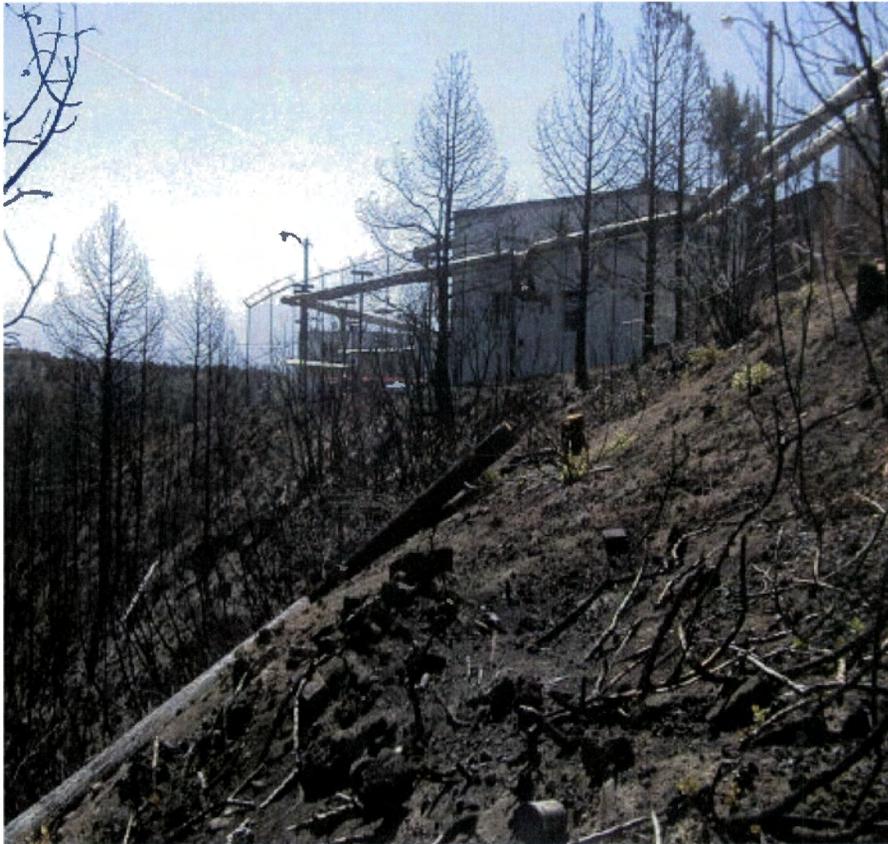
This photograph was taken on June 14, 2000. It shows the eastern most corner of the impacted north facing slope behind building 46-58. Several trees and power poles were cut down to protect the existing structures.

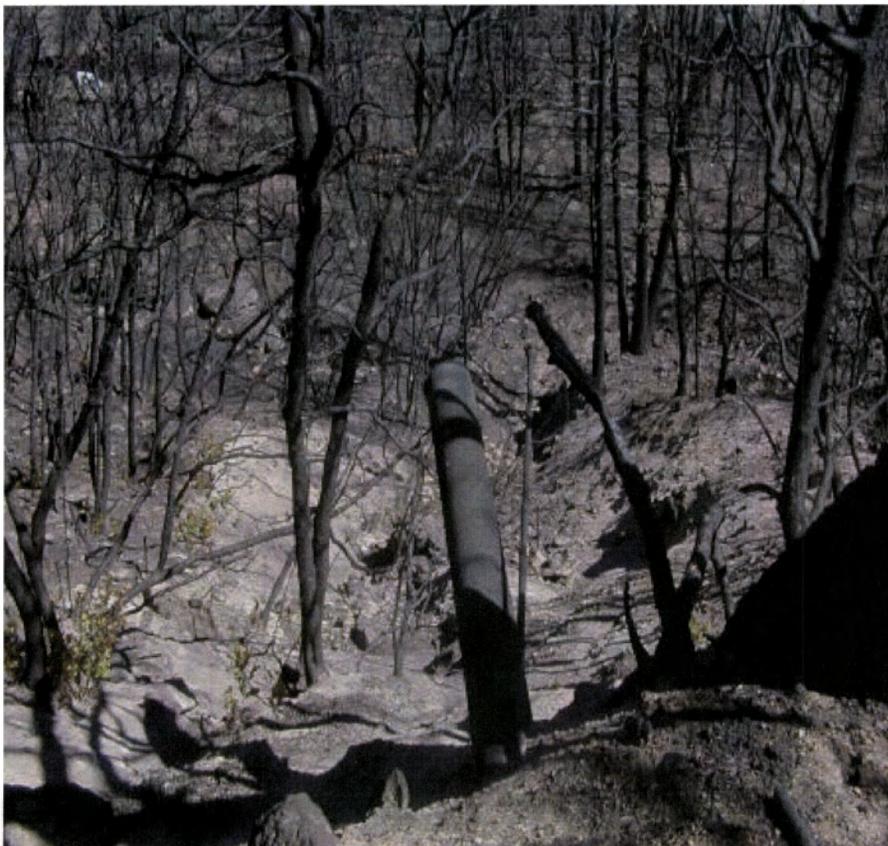
This photograph was taken on June 14, 2000. It shows one of the many inactive outfalls that discharged onto the slope below.

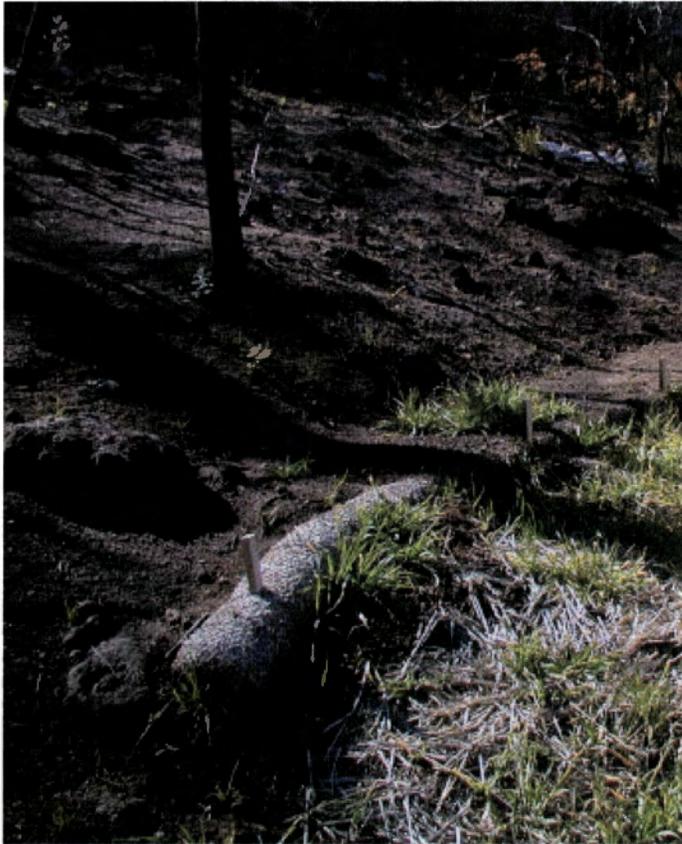
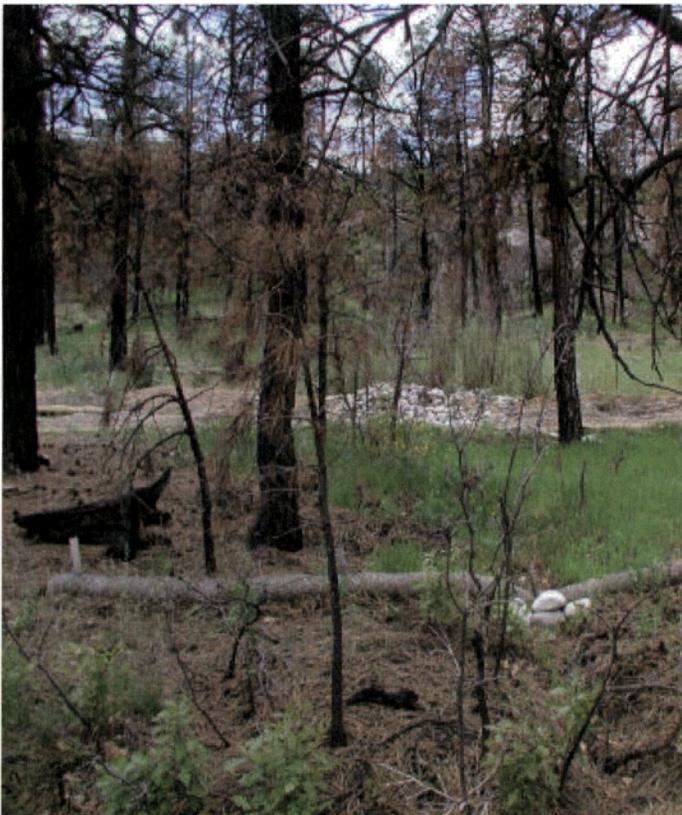
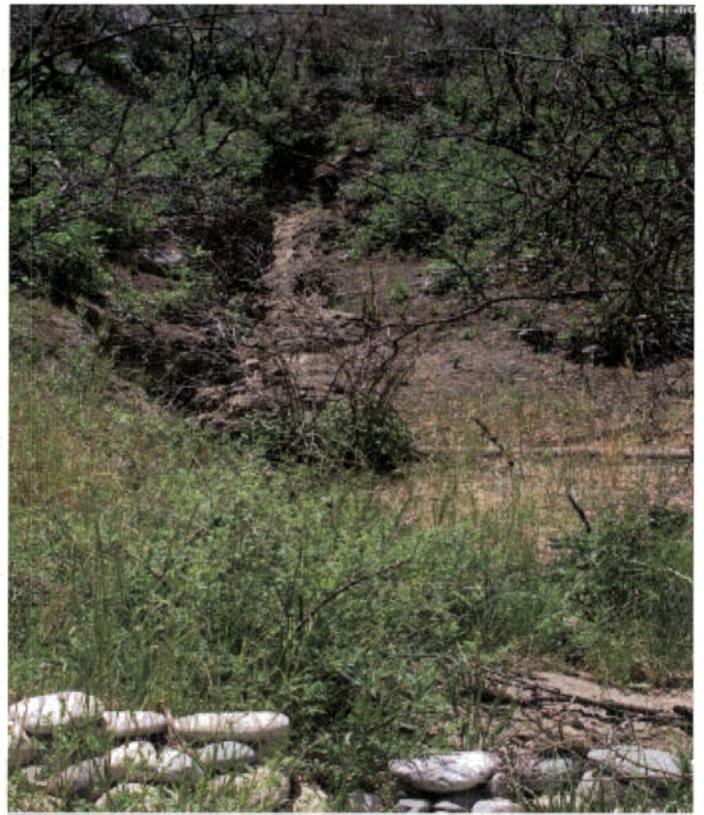
These photographs were taken during the April 2001 and June 2001 field inspections.

In April 2001, the earthen berm at the northern boundary of the site was patched in one location. Several additional straw wattles have been placed in various locations to reduce sediment migration potential.

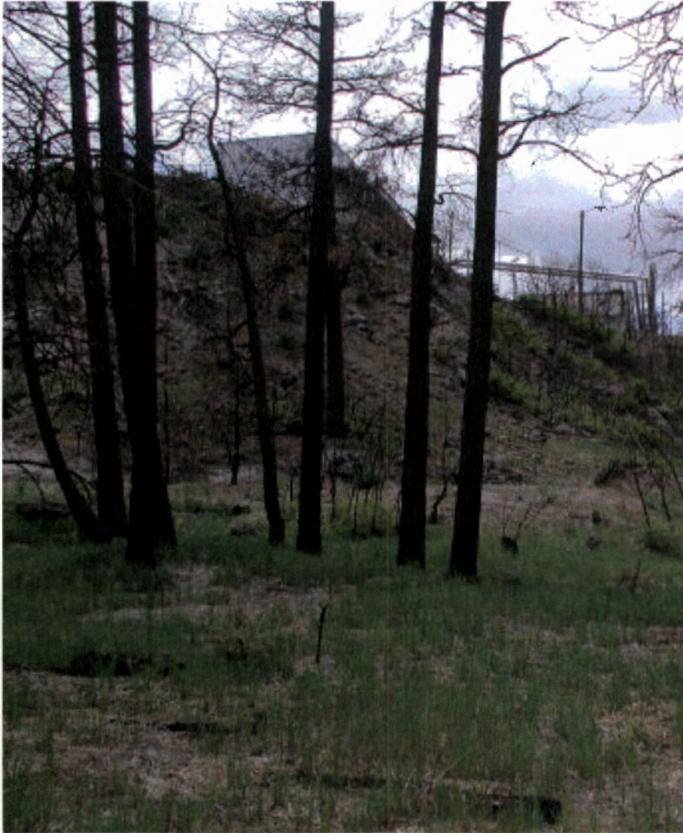
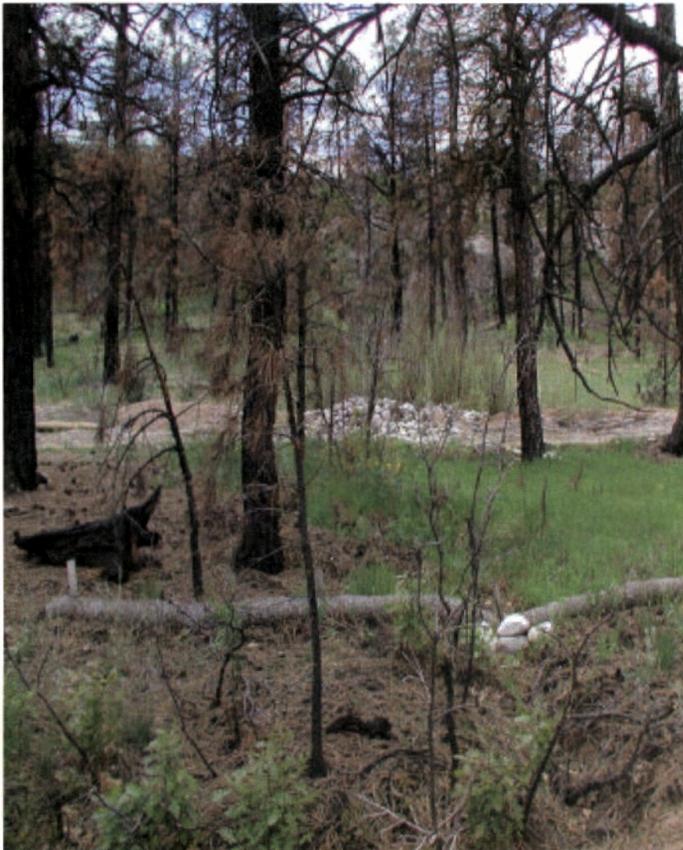
The vegetation on the north-facing slope and the bench area located below TA-46 that were impacted by the Cerro Grande Fire have recovered very well. The ground cover consisting of mixed native grasses is 6" to 18" deep, and the gamble oak trees have come back thicker than ever.

The multiple levels of erosion control including; rock check dams, straw wattles, contour tree felling and an earthen berm have been very effective in keeping sediment from migrating from the site.

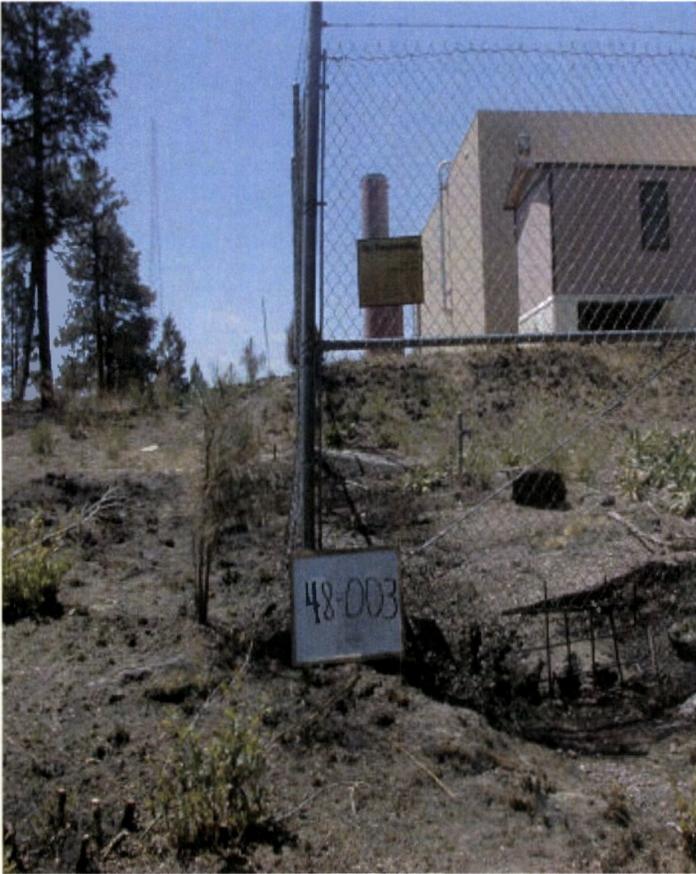
48-003 – *Erosion Matrix Score 40.7*. Inactive septic system. The system served TA-48 from 1957 through January 1986 when it was removed from service. The septic tank and filter bed were decommissioned and removed in 1986.

This site is located on the northern edge of Mortandad Canyon within the Upper Mortandad Watershed Aggregate. The northern part of TA-48 was moderately burned, with damage to ground cover and canopy.

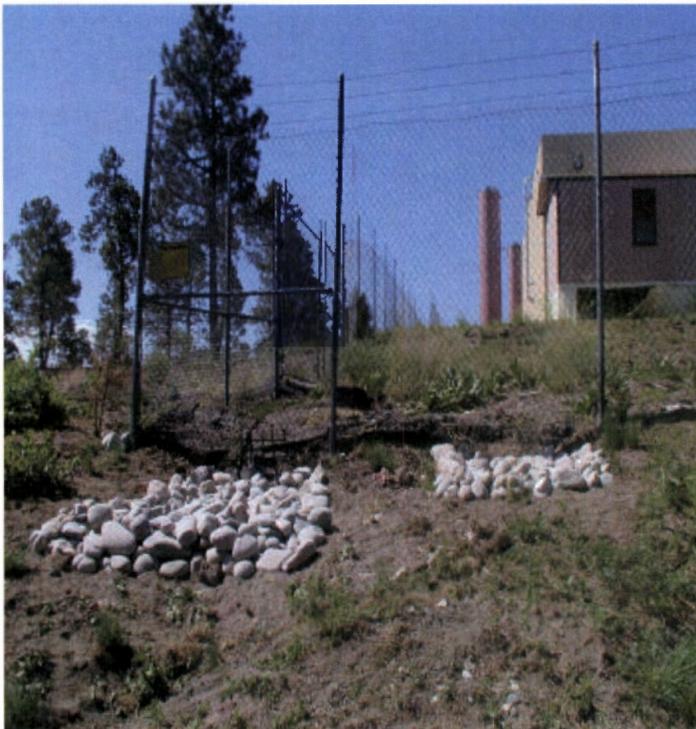
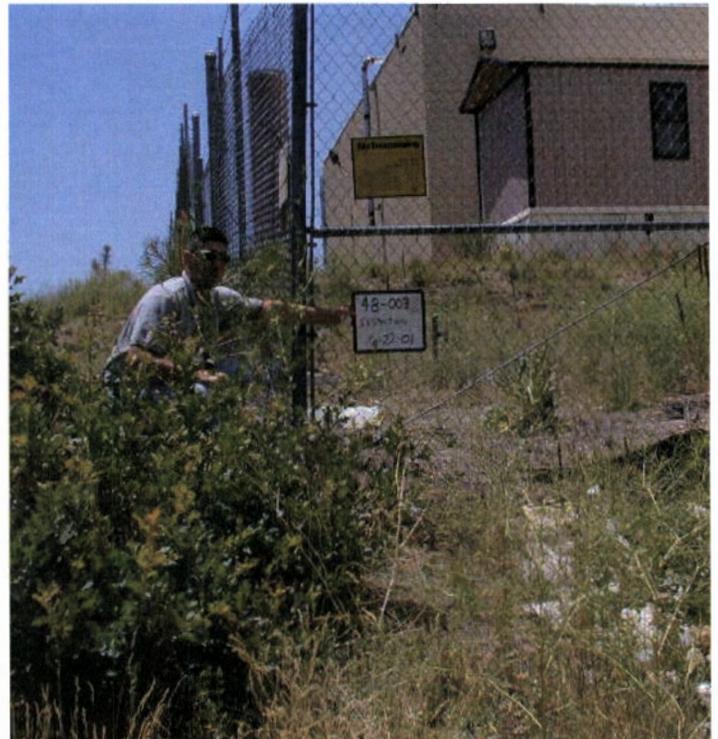
Site is in good condition, with vegetative cover of greater than 50%. The area appears stable with evidence of sediment migration being minimal.

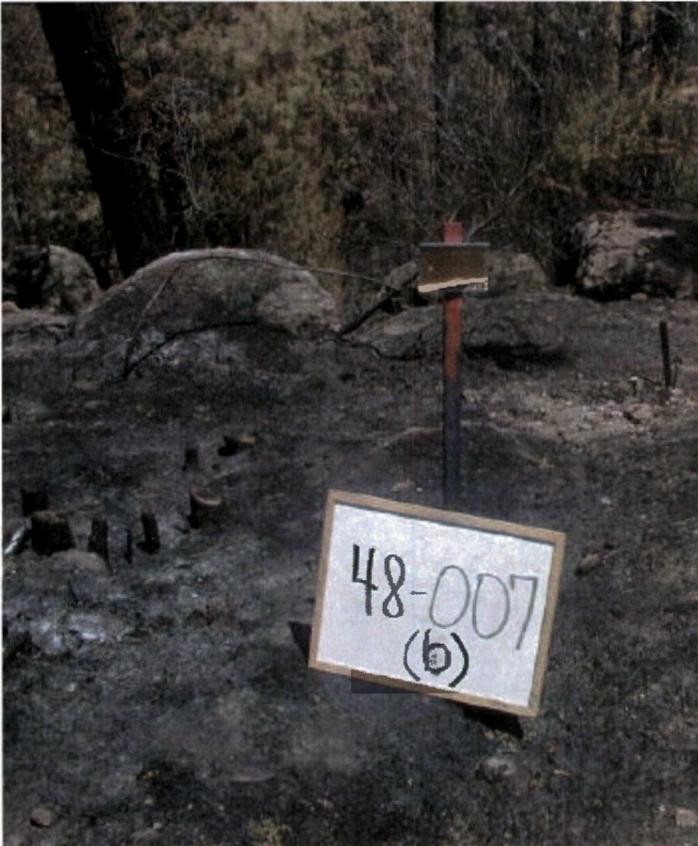
This site is located on the northern edge of Mortandad Canyon within the Upper Mortandad Watershed Aggregate. The northern part of TA-48 was moderately burned, with damage to ground cover and canopy.

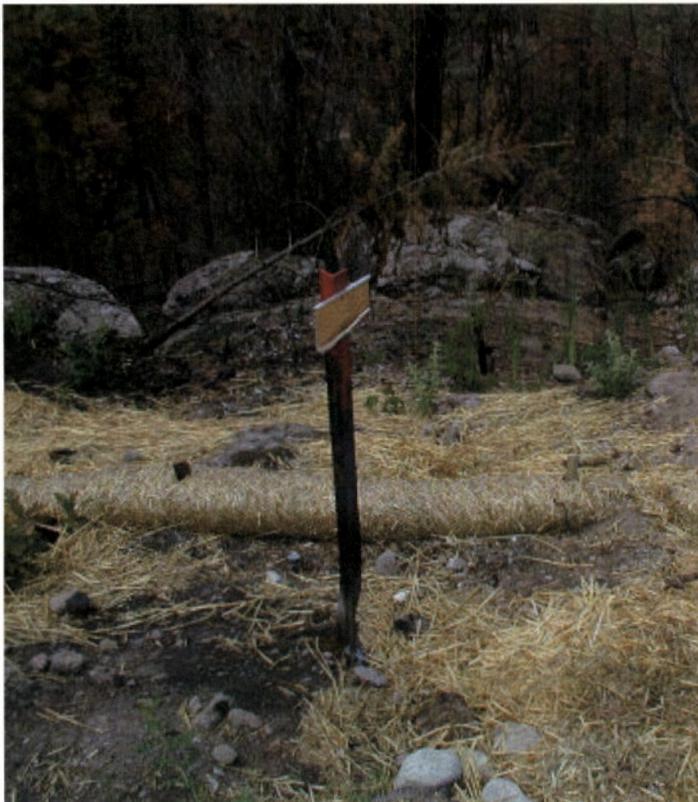
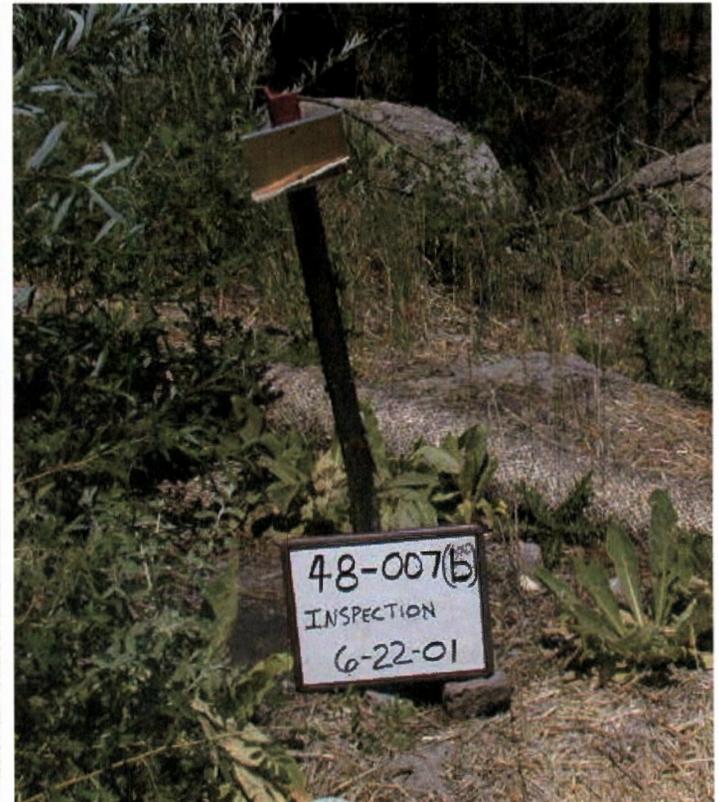
Site is in good condition, with vegetative cover of greater than 70%. The area appears stable with evidence of sediment migration being minimal.

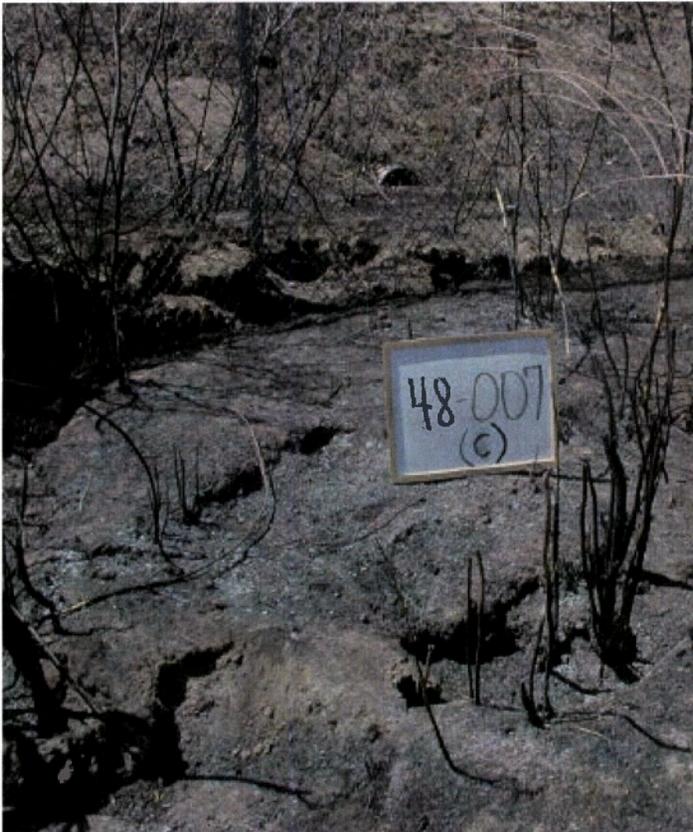
48-007(c) - Erosion Matrix Score 69.5. Outfall that discharges non-contact cooling water that cools vacuum pumps housed in building TA-48-1; the outfall was submitted for inclusion under the NPDES permit in 1987 (LANL 1991, 21557). It has NPDES Permit No. EPA 04A131.

This site is located on the southern edge of Mortandad Canyon within the Upper Mortandad Watershed Aggregate. The northern part of TA-48 was moderately burned, with damage to ground cover and canopy.

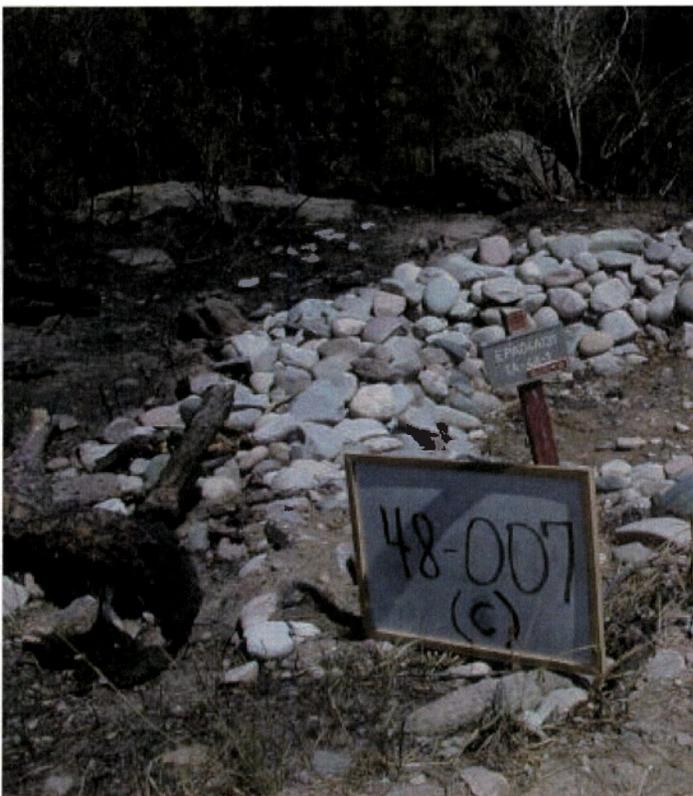
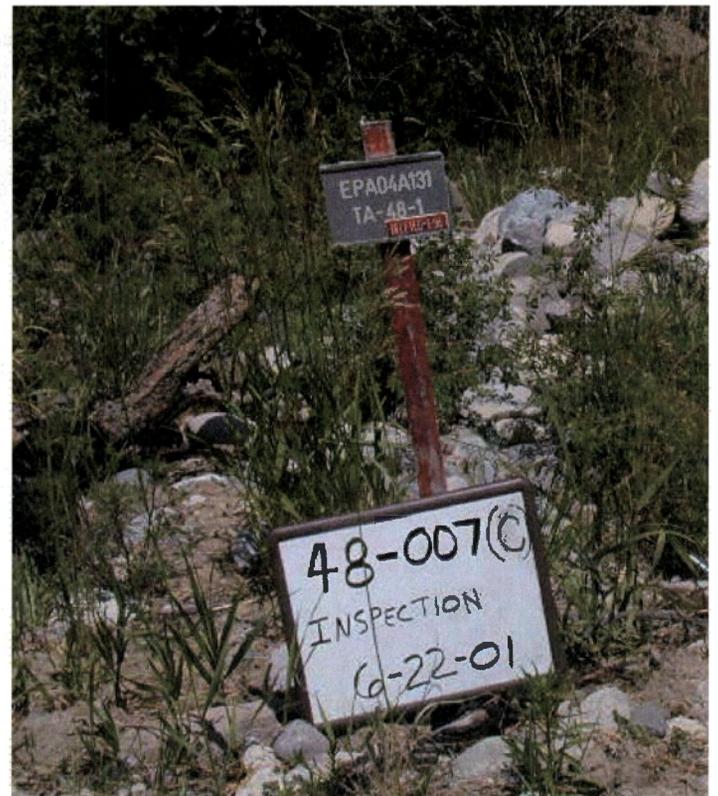
Site is in good condition, with vegetative cover of greater than 70%. The area appears stable with evidence of sediment migration being minimal.

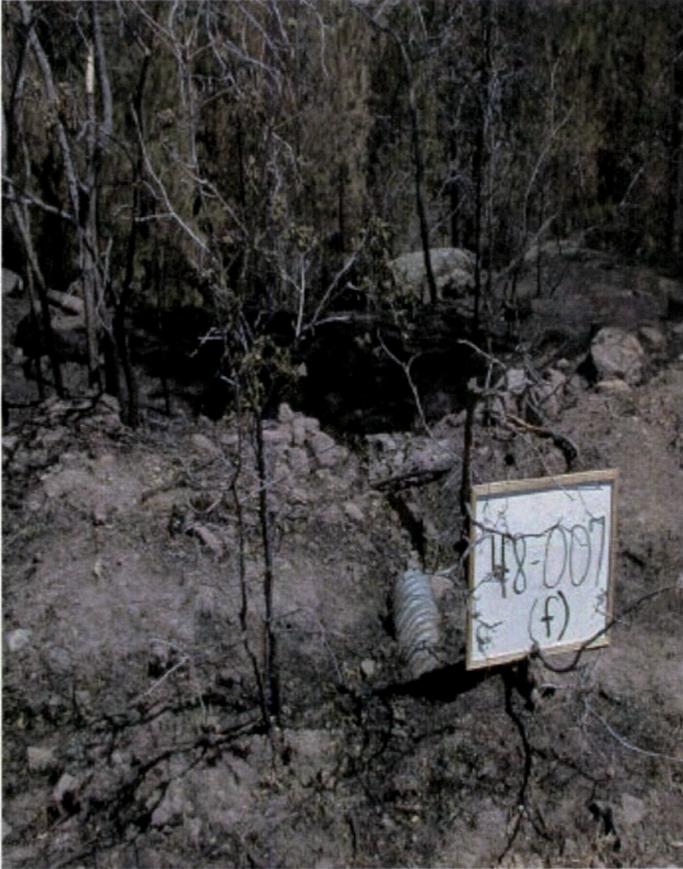
48-007(f) - *Erosion Matrix Score 76.5*. This outfall was submitted to the EPA in November 1987 for inclusion under the NPDES permit to discharge up to 100 gallons per day of non-contact cooling water from x-ray equipment located in building TA-48-46 (LANL 1990, 7511). It has Inactive NPDES 04A137.

This site is located on the southern edge of Mortandad Canyon within the Upper Mortandad Watershed Aggregate. The northern part of TA-48 was moderately burned, with damage to ground cover and canopy.

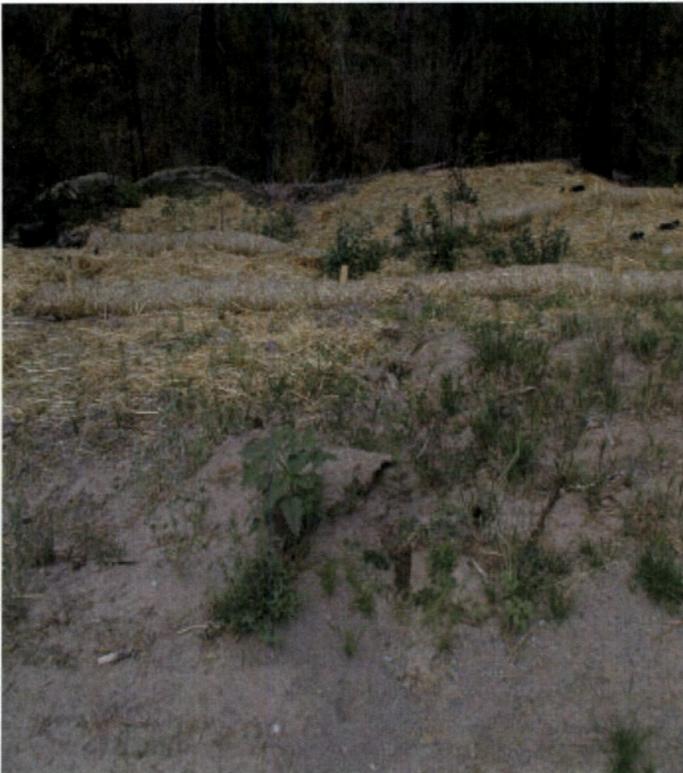
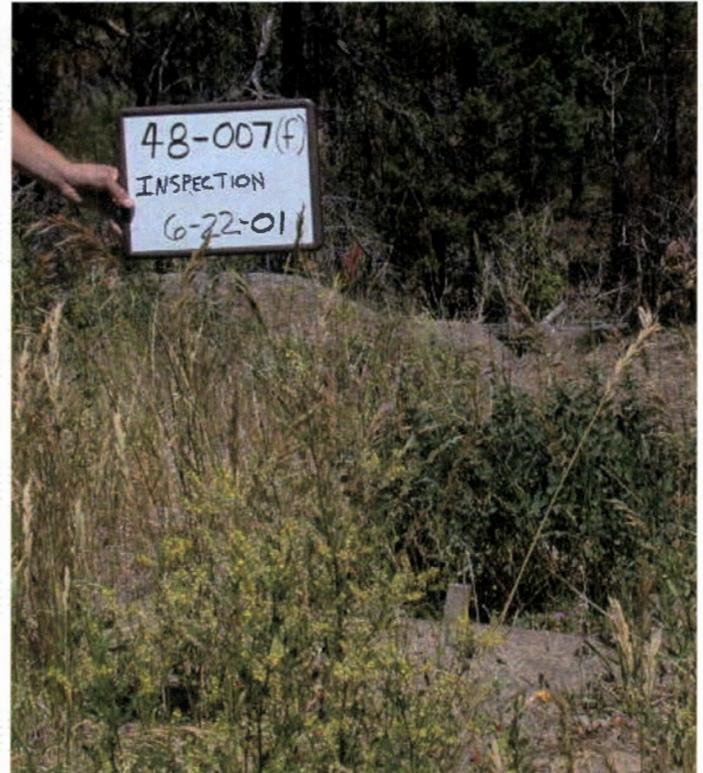
Site is in good condition, with vegetative cover of greater than 70%. The area appears stable with evidence of sediment migration being minimal.

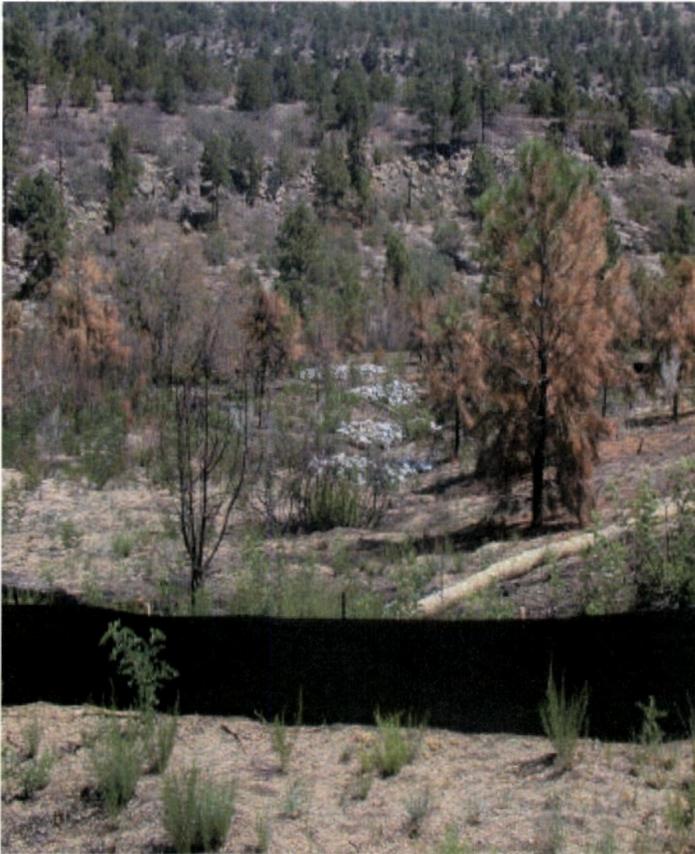
49-001(g) – *Erosion Matrix Score 59.2*. Surface contamination area from MDA AB activities.

This site is located on a tributary to Water Canyon within the Lower Water/Indio Watershed Aggregate. The area was lightly to moderately burned from MDA AB towards the canyon edge. All existing BMPs were destroyed

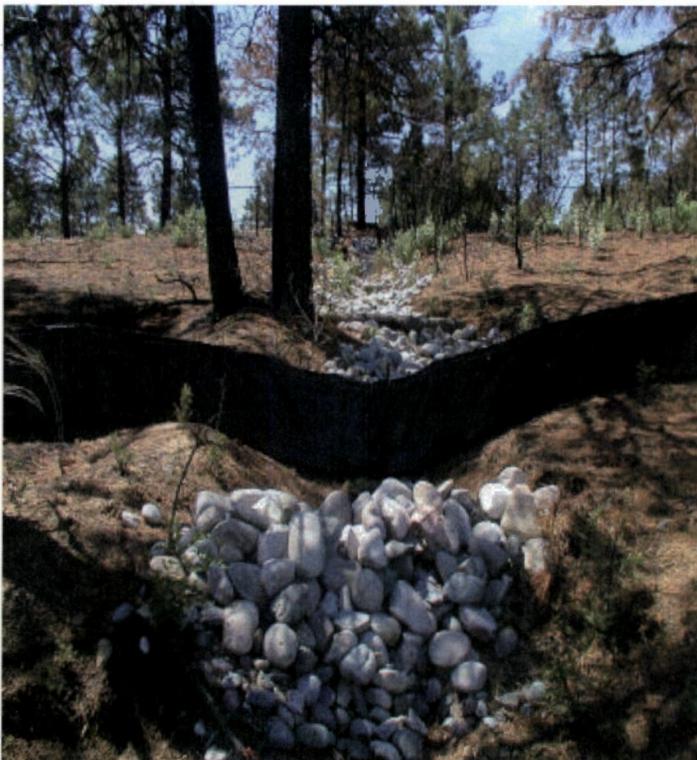
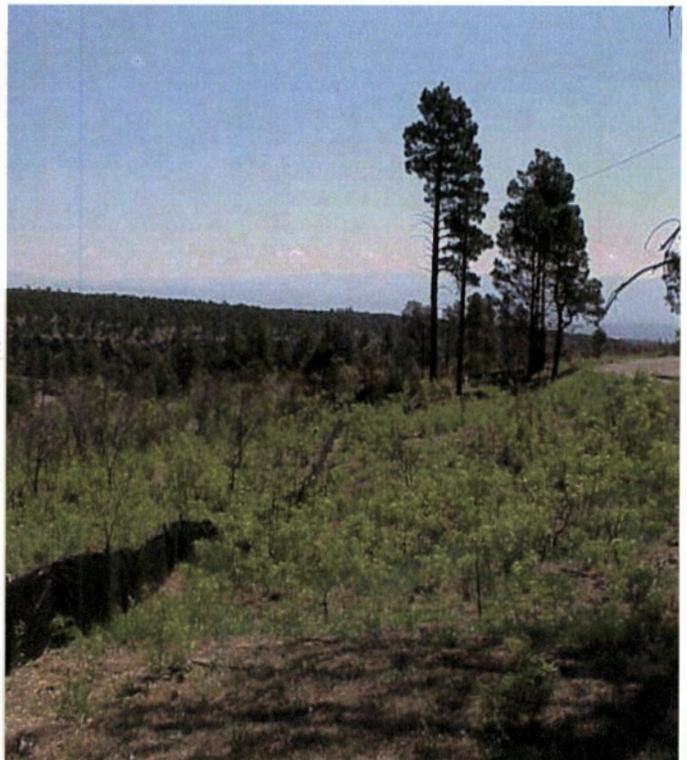
Site is in good condition, with vegetative cover of greater than 70%. The area appears stable with evidence of sediment migration being minimal.
