Title: CERRO GRANDE FIRE: ONE YEAR AFTER  
AN UPDATE ON ER ACTIVITIES TO REDUCE THE  
POTENTIAL MOVEMENT OF CONTAMINATION AT  
POTENTIAL RELEASE SITES

Author(s): Steven J. Veenis, CPESC  
Randy Johnson, IT Corporation

**CERRO GRANDE FIRE: ONE YEAR AFTER**  
**AN UPDATE ON ER ACTIVITIES TO REDUCE THE POTENTIAL MOVEMENT OF CONTAMINATION**  
**AT POTENTIAL RELEASE SITES**

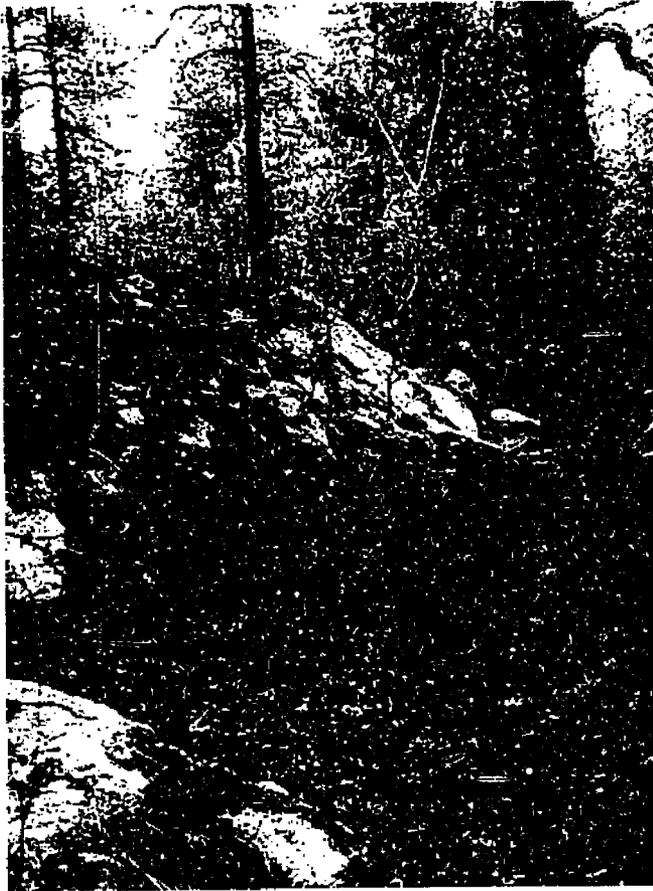
**14-009** - *Erosion Matrix Score 53.7*. Surface disposal area consisting of ruptured sand bags which were used for containment during explosives testing activity. Sand could be contaminated with lead, uranium, HE and beryllium.

**14-010** - *Erosion Matrix Score 51.5*. High explosive waste sump adjacent to TA-14-2. The site may have contained HE and other chemicals. The sump and drain-line were removed.

This site is located north of Canon de Valle within the Canon de Valle Watershed Aggregate. The entire south facing slope located to the south of TA-14 structures was moderately burned with substantial damage to the groundcover.

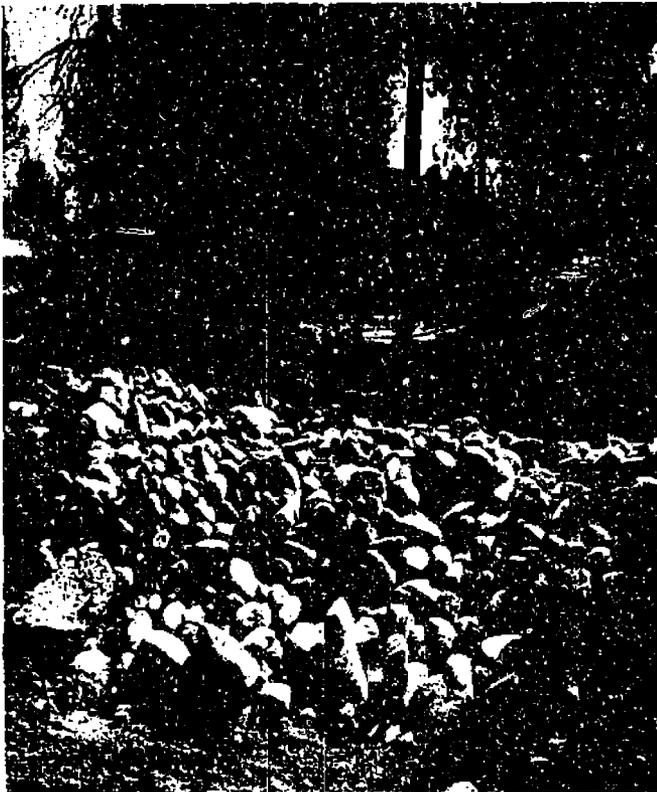
This photograph was taken on June 8<sup>th</sup>, 2000.  
The drainage shown is located below building  
14-43.

Straw wattles were installed across the drainage  
swale. The area was hand raked, reseeded and  
mulched. A rock check dam was installed at the  
lowest part of the drainage.

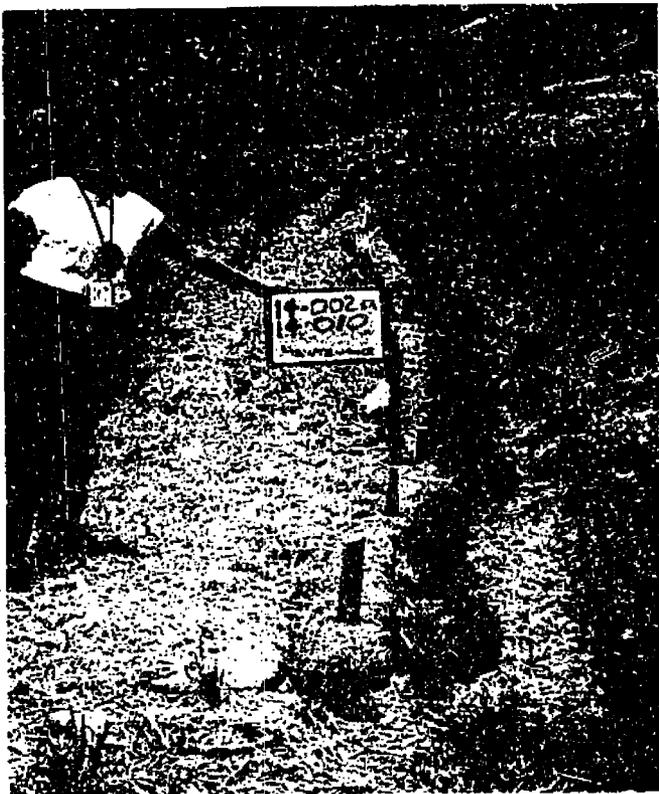
Site is in good condition, with vegetative cover of greater than 70% throughout the site. The area appears stable with evidence of sediment migration being minimal.

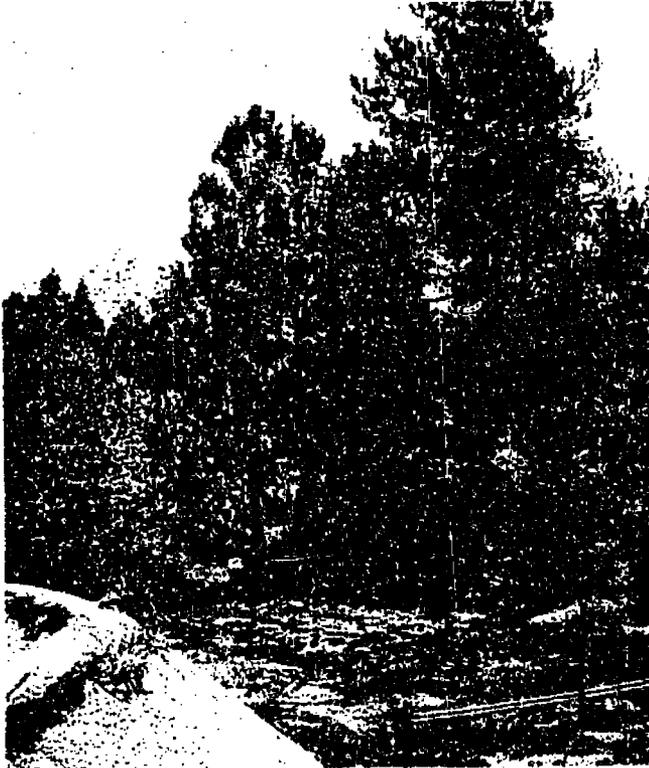
C-15-007 - *Erosion Matrix Score 51.5*. Stained soil noted during a 1988 ER site reconnaissance visit. A transportable building was placed over it. The area was sampled in 1997. C-15-010 - *Erosion Matrix Score 8.8*. Removed inactive underground fuel storage tank. 15-014(k) - *Erosion Matrix Score 3.6*. Concrete open trench drains. 15-011(a) - *Erosion Matrix Score 3.6*. Concrete trench drains. 15-014(l) - *Erosion Matrix Score 3.6*. Drain line from roof of building TA-15-194. 15-011(b) - *Erosion Matrix Score 87.0*. Dirt drainage ditch located southwest of Building R-194. Drainage may have received degreasers, solvents containing sulfuric acid, and/or hydrochloric acid. 15-011(c) - *Erosion Matrix Score 87.0*. Drainage, PRS 15-011(c), serves the outfalls from buildings within The Hollow that have had various uses as assembly building, laboratories, and shops. 15-014(j) - *Erosion Matrix Score 61.3*. PRS 15-014(j) consists of three outfalls from Building R-50 and a drainage channel that is partially asphalt just below the outfall leading towards the canyon.

This site is located near the confluence of Canon de Valle and Water Canyon within the Canon de Valle Watershed Aggregate. The site was moderately to severely damaged including several burned structures.
