SUBJECT SURVEY OF FIRING POINTS OPERATED BY M DIVISION

Radiation Survey  
of  
Firing Sites

Depleted Uranium - D38 ( $^{238}\text{U}$ )

## Radiological Survey on Firing Sites

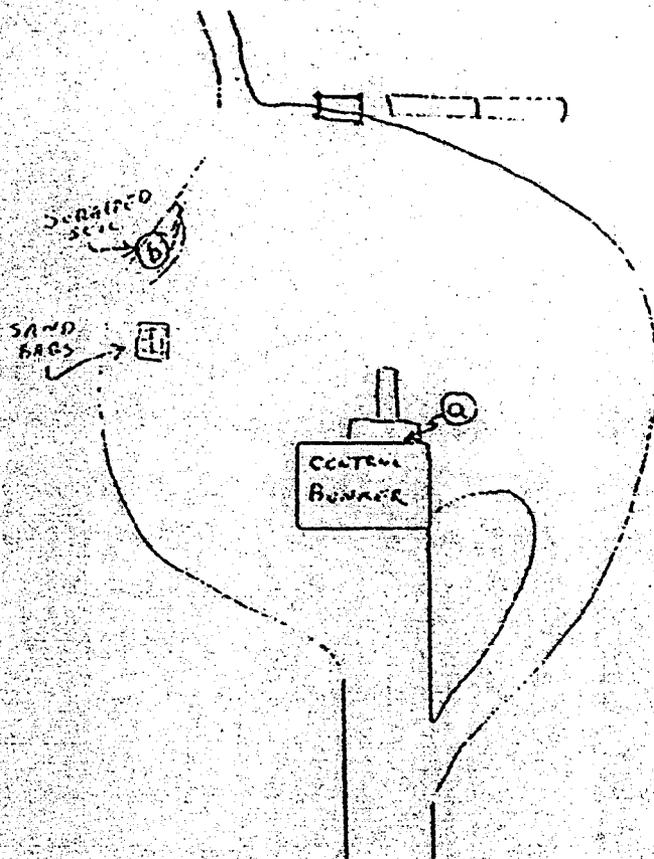
a. Diagram of Eenie Site

b. Background Radiation Levels. The general radiation background levels in this area is  $\approx 0.1$  mR/hr at 30 cm.

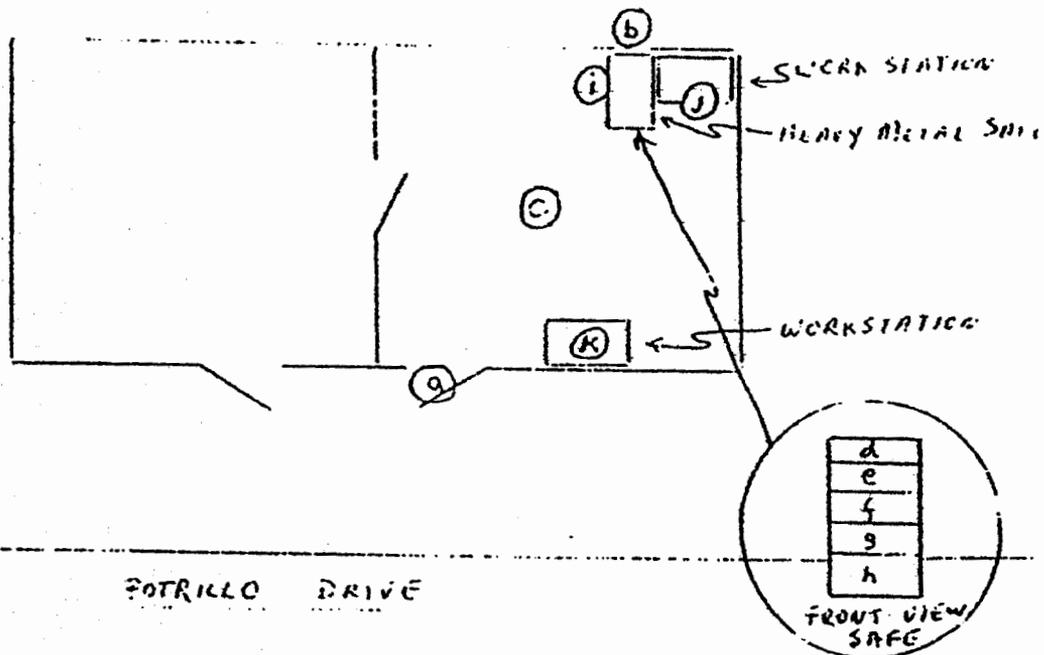
### a. Diagram of Daisy Mae Site

b. Background Radiation Levels. The general outside radiation background levels in this area is  $\approx 0.1$  mR/hr at 30 cm.

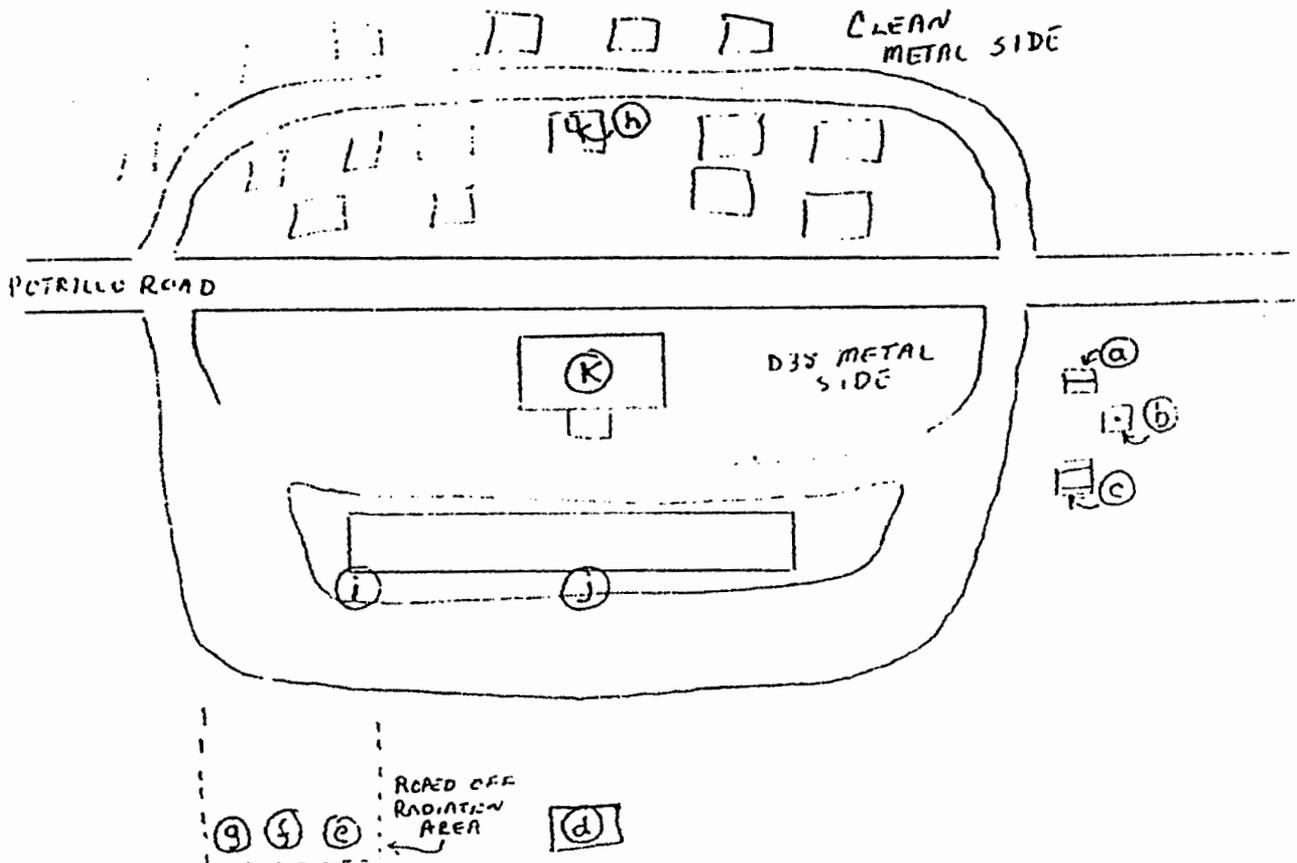
b. Diagram of Heavy Metal Site

c. **Background Radiation Levels.** The general outside radiation background levels in this area is  $\approx$  less than 0.1 mR/hr at 30 cm.

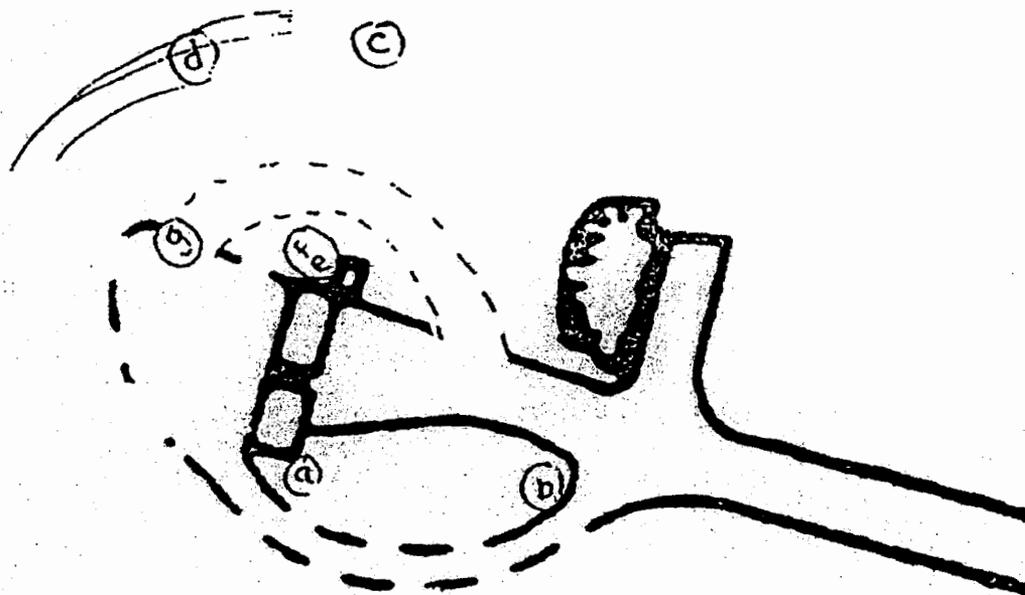
a. Diagram of Site 6.

b. Background Radiation Levels. The general outside radiation background levels in this area is  $\approx$  less than 0.1 mR/hr at 30 cm from the soil.

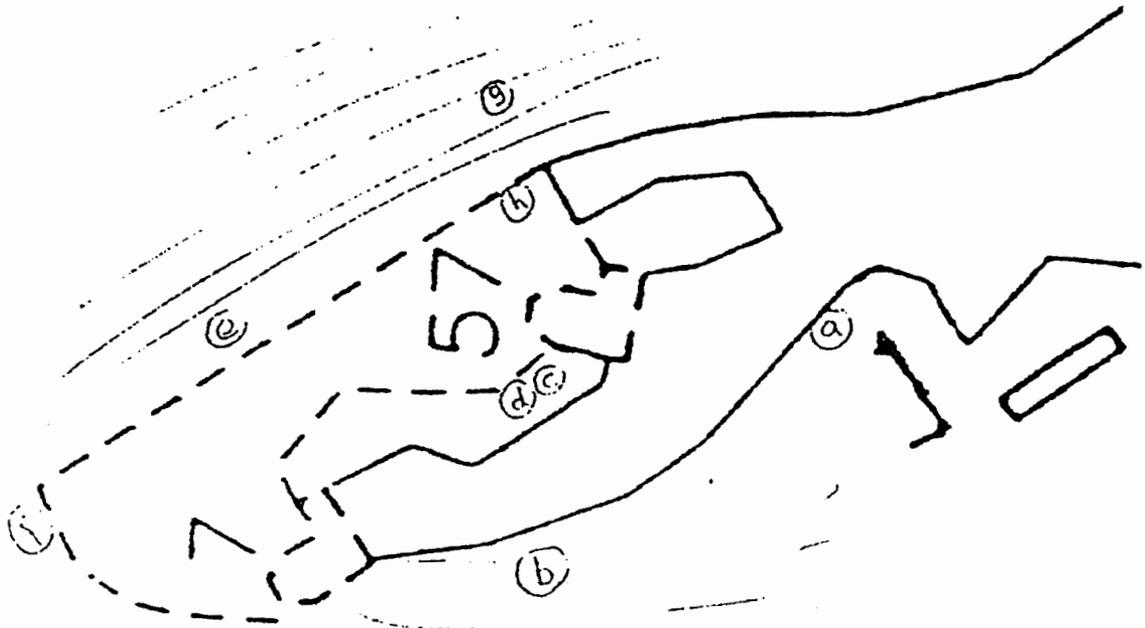
a. Diagram of Site 7/57.

b. Background Radiation Levels. The general outside radiation background levels in this area is  $\approx 0.1$  mR/hr at 30 cm from the soil.

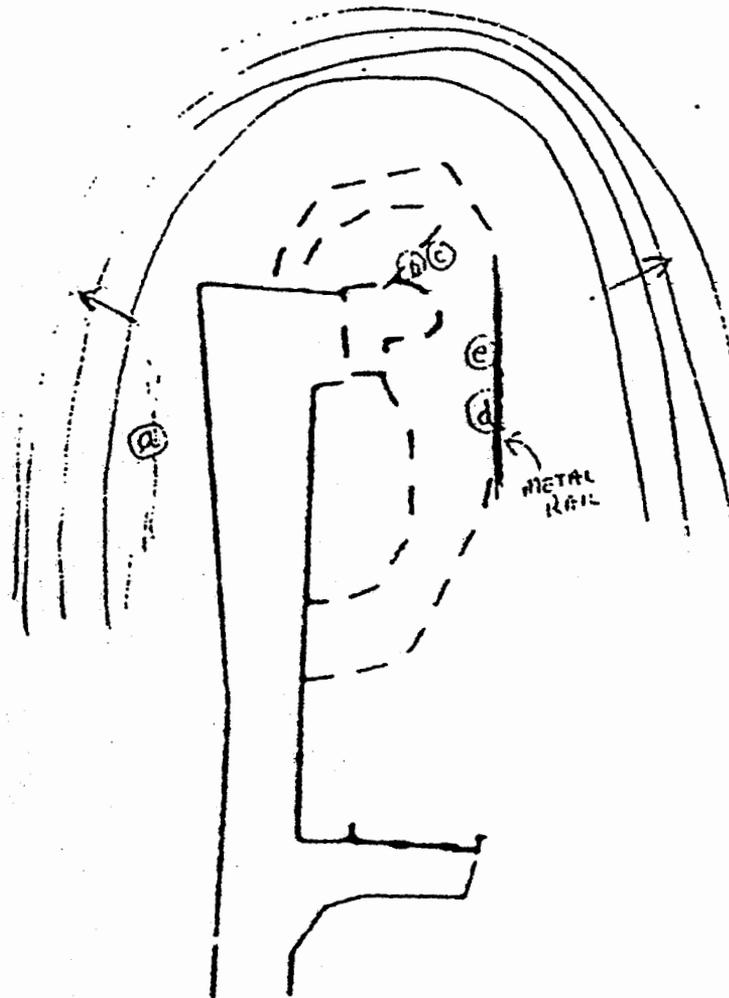
a. Diagram of Site 8.

b. **Background Radiation Levels.** The general outside radiation background levels in this area is  $\approx 0.1$  mR/hr at 30 cm from the soil.

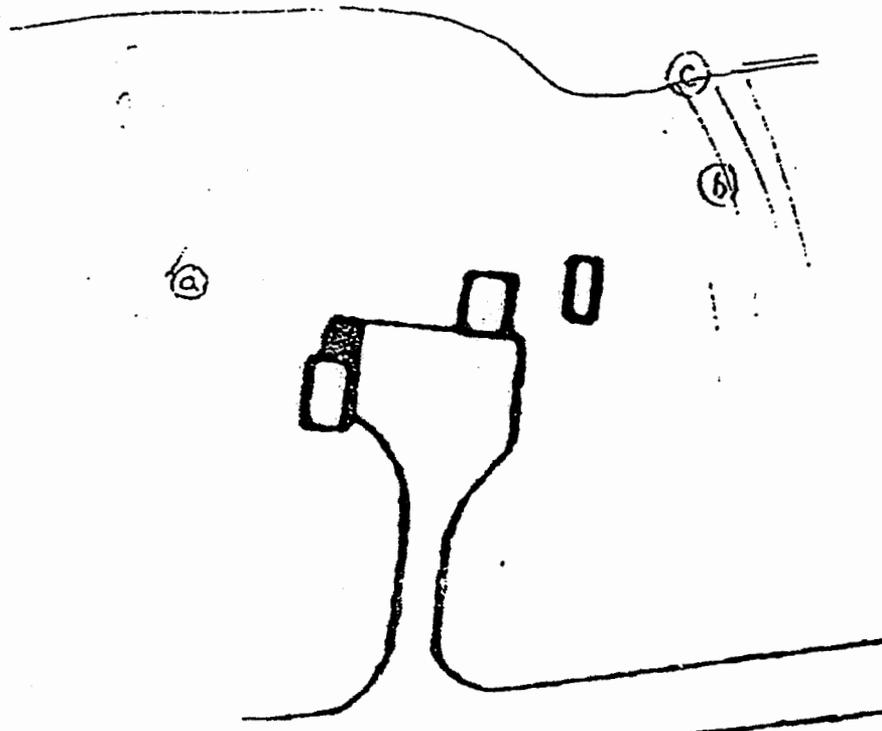
a. Diagram of Site 56.

b. Background Radiation Levels. The general outside radiation background levels in this area is  $\approx 0.1$  mR/hr at 30 cm from the soil.

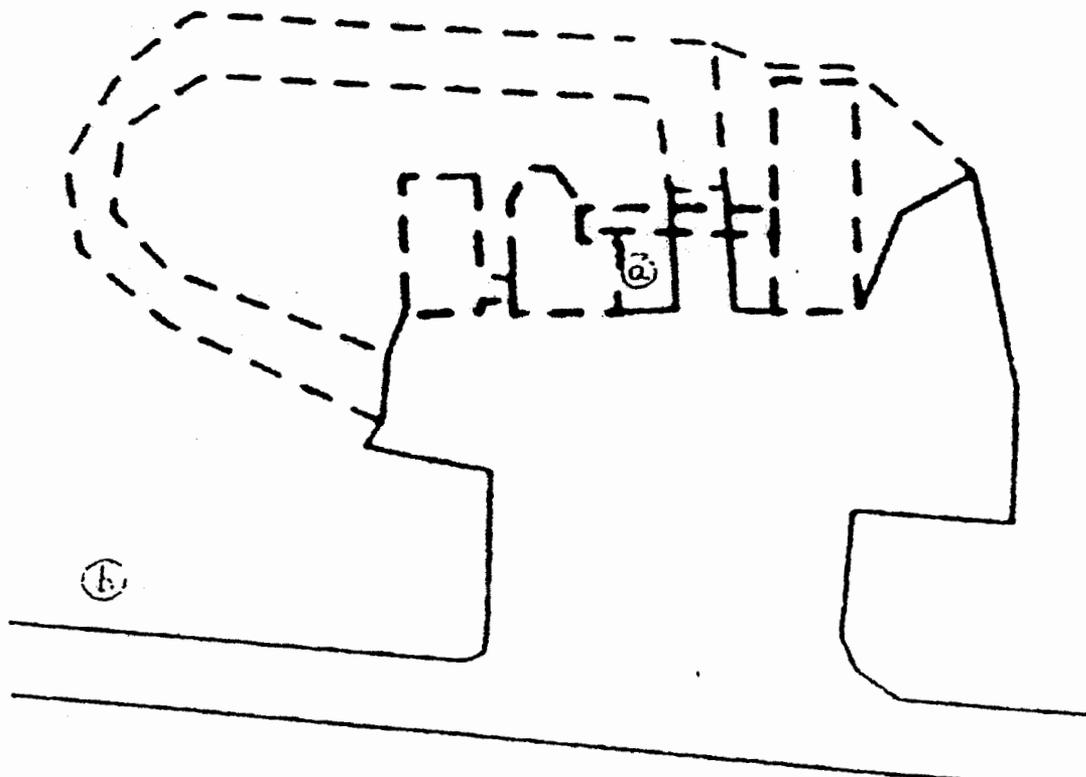
a. Diagram of Site 88.

b. Background Radiation Levels. The general outside radiation background levels in this area is  $\approx 0.1$  mR/hr at 30 cm from the soil.

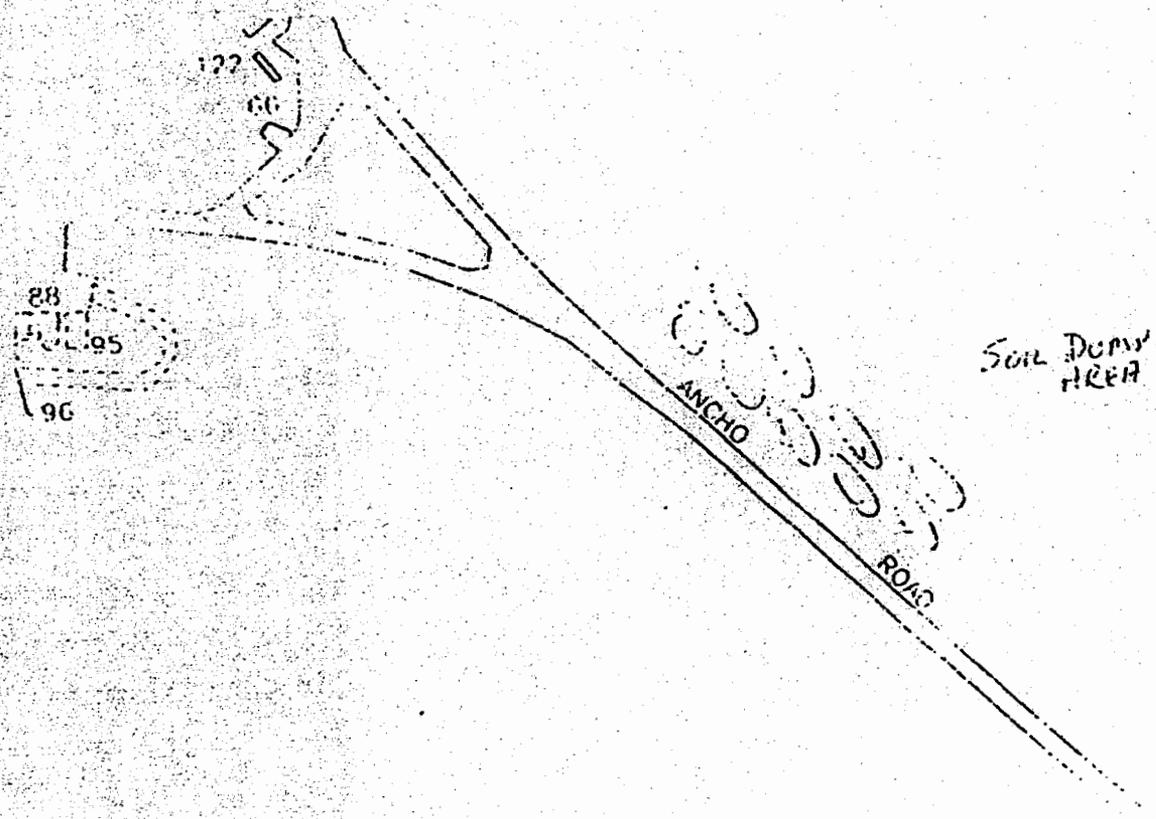
a. Diagram of Soil Dump Site.

b. Background Radiation Levels. The general outside radiation background levels in this area is ≈ 0.1 mR/hr at 30 cm from the soil.

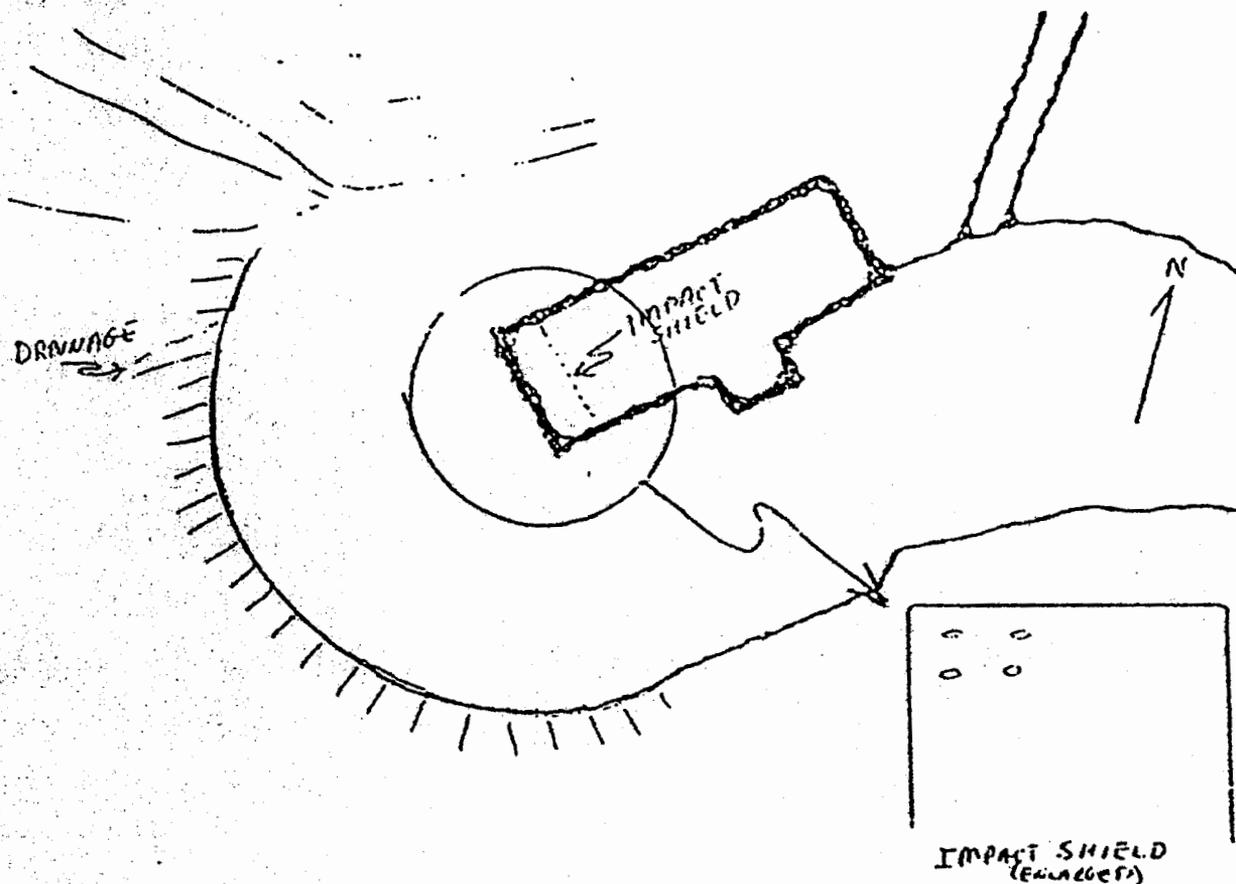
a. Diagram of Site 4.

b. **Background Radiation Levels.** The general outside radiation background levels in this area is  $\approx$  less than 0.1 mR/hr at 30 cm from the soil.
