Date: April 29, 2005
Refer To: ER2005-0239

SUBJECT: DP CANYON QUARTERLY INSPECTION REPORT FOR SECOND QUARTER, FY05

DP Canyon Quarterly Inspection Report for Second Quarter, Fiscal Year 2005

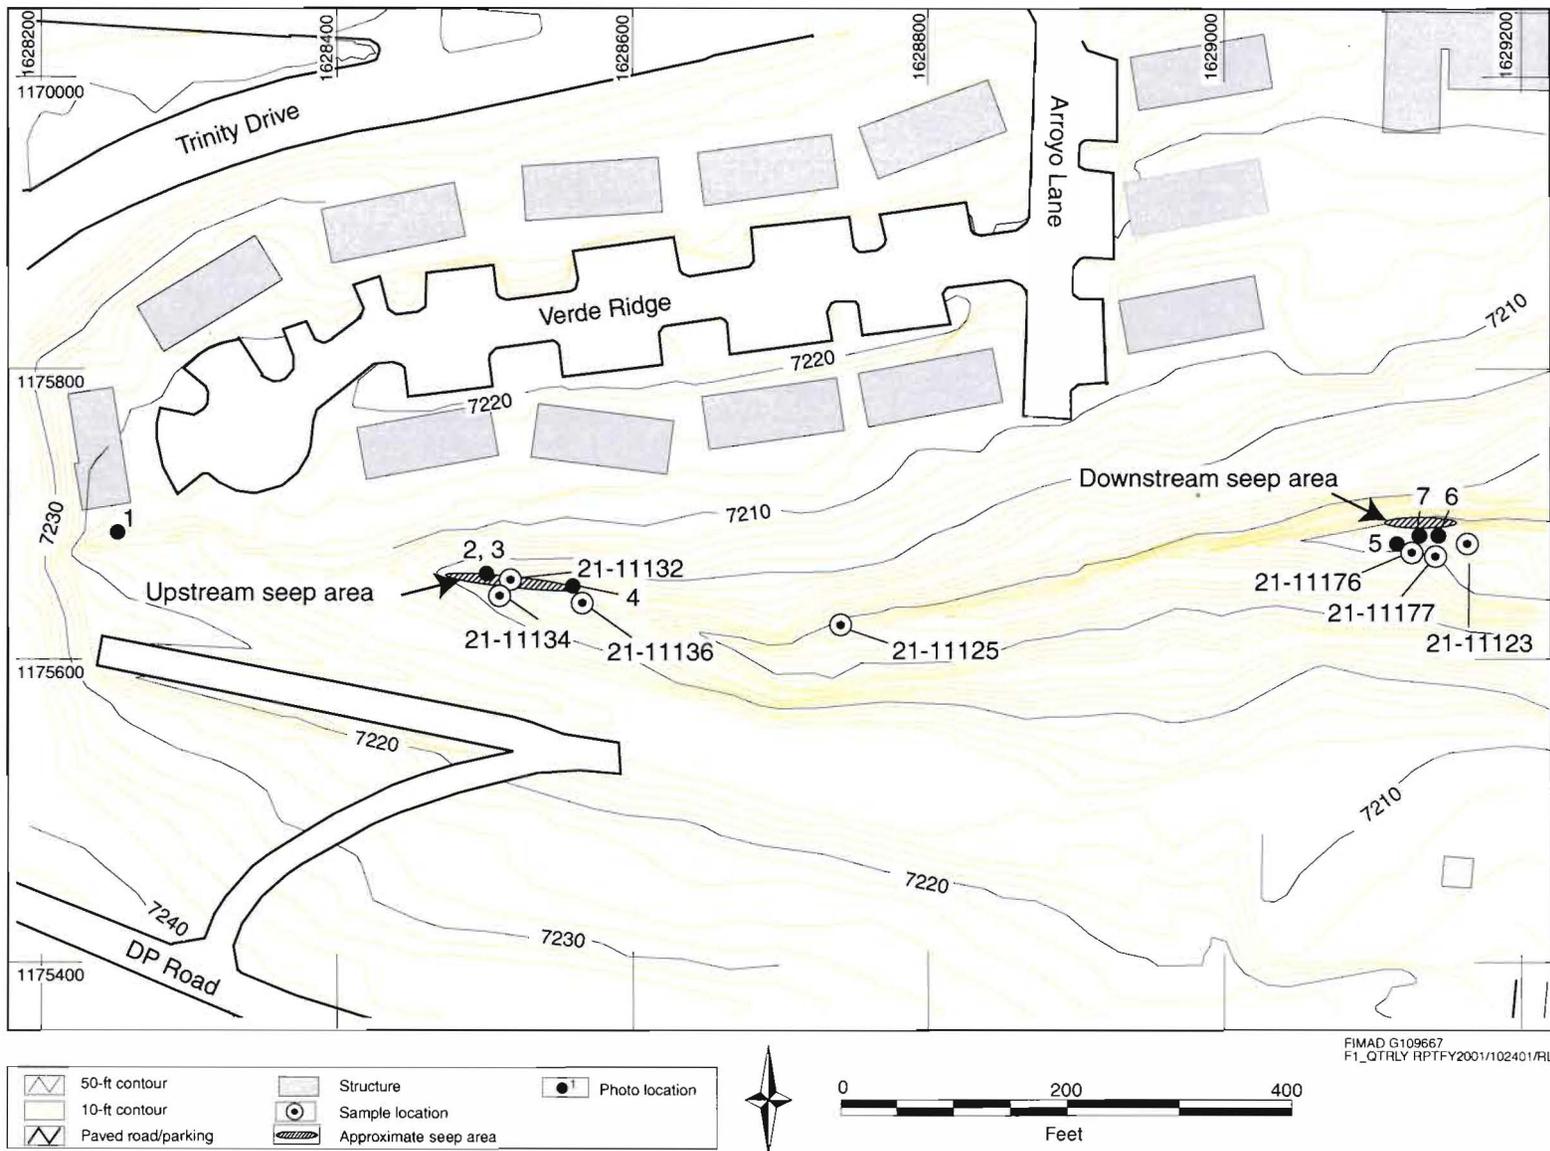
Figure 1. DP Tank Farm photo locations, seep areas, and sampling locations

Introduction: Regular inspections are conducted to assess the status of two petroleum hydrocarbon seeps in DP Canyon. These seeps, which are downgradient from Solid Waste Management Unit 21-029 (DP Tank Farm), are referred to as the upstream and downstream seeps (Figure 1). The frequency of the inspections has been reduced to quarterly, following nearly four years of monthly or semimonthly inspections. The results of these inspections are used to document any changes in the petroleum hydrocarbon seep areas in relation to seasonal changes and recent precipitation.

Location and intensity of odors, staining, or sheen (see Figure 1 for locations):

Air	Water	Soil/Sediment
Upstream Location	No petroleum hydrocarbon odor in air	No petroleum hydrocarbon sheen on standing water until sediments were disturbed	Petroleum hydrocarbon odor and sheen in disturbed sediments
Downstream Location	No petroleum hydrocarbon odor in air	No petroleum hydrocarbon sheen on standing water	Faint petroleum hydrocarbon odor in disturbed sediments
