Safety Kleen ABC 4/4/94

# INSPECTION REPORT

Site Name/Address SAFteyKleen 2720 Girard Albuquerque N.M.

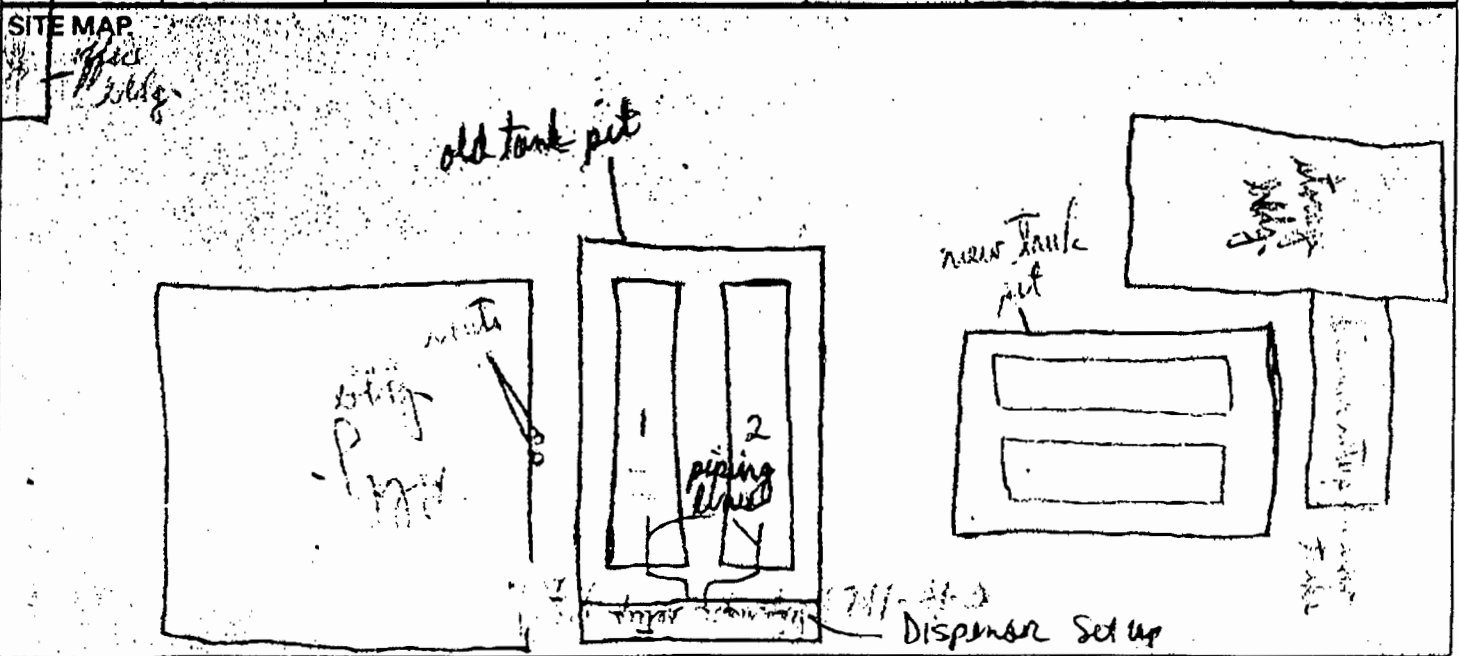
TANK NO.	SIZE	CONTENTS	INSTALLATION DATE	TANK CONSTRUCTION	PIPING CONSTRUCTION	TANK RELEASE DETECTION	PIPING RELEASE DETECTION	TANK STATUS
1	W 12000	miscel spirits	1978	Walt coat steel	steel-coat steel	N/A	N/A	removed
2	E 12000	waste miscel spirits	"	"	"	N/A	N/A	"
	(8'x32')

COMMENTS: *Tanks TOS since new tanks installed; also were awaiting closure  
have approval from Hazardous Waste Bureau. Tanks empty for 1 1/2 years, so  
no R.D. done during this 1 1/2 yr. period. Already a remediation site since  
when had serious release and spill; wanted to wait to finish on-site after tank  
removal. Tank #4 removed; looks very good w/ no corrosion holes. Pressure piping  
system on old tank until piping release, then changed to suction piping system.  
Tank #2 remained; also in very good condition. Damage (holes) in tank floor on  
surface to render the tanks unusable.*
