**SAFETY-KLEEN CORPORATION
NMD980698849
FARMINGTON, NEW MEXICO**

RCRA FACILITY ASSESSMENT REPORT

April 18, 1990

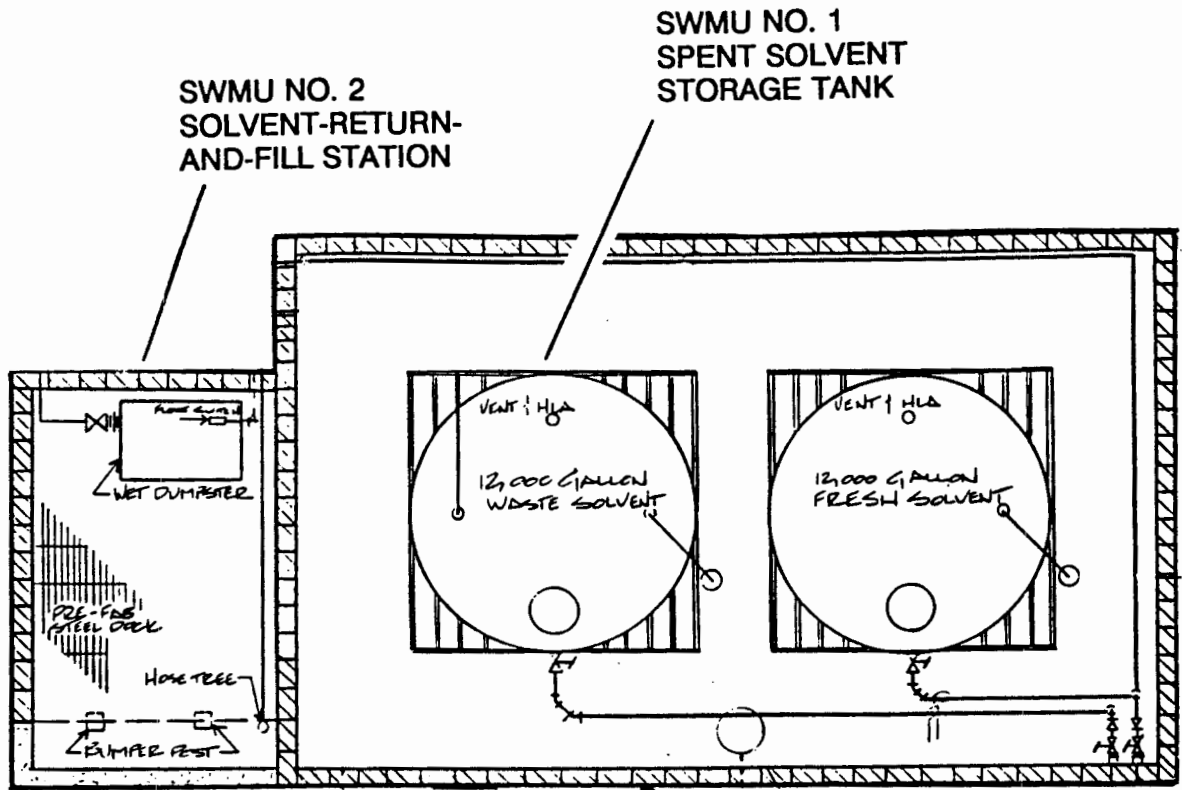
**TANK FARM PLAN,
SHOWING SWMUs NOS. 1 AND 2**

The Spent Solvent Storage Tank is located in a tank farm consisting of two aboveground tanks located in a secondary containment area having a poured concrete slab floor and a sealed concrete block dike wall. The secondary containment is about 23 feet wide, by 37 feet long, and has walls approximately three feet high (Figure 3), with a spill containment volume of 18,266 gallons (Safety-Kleen, 1989). The two 12,600 gallon tanks are about 12 feet in diameter and 15

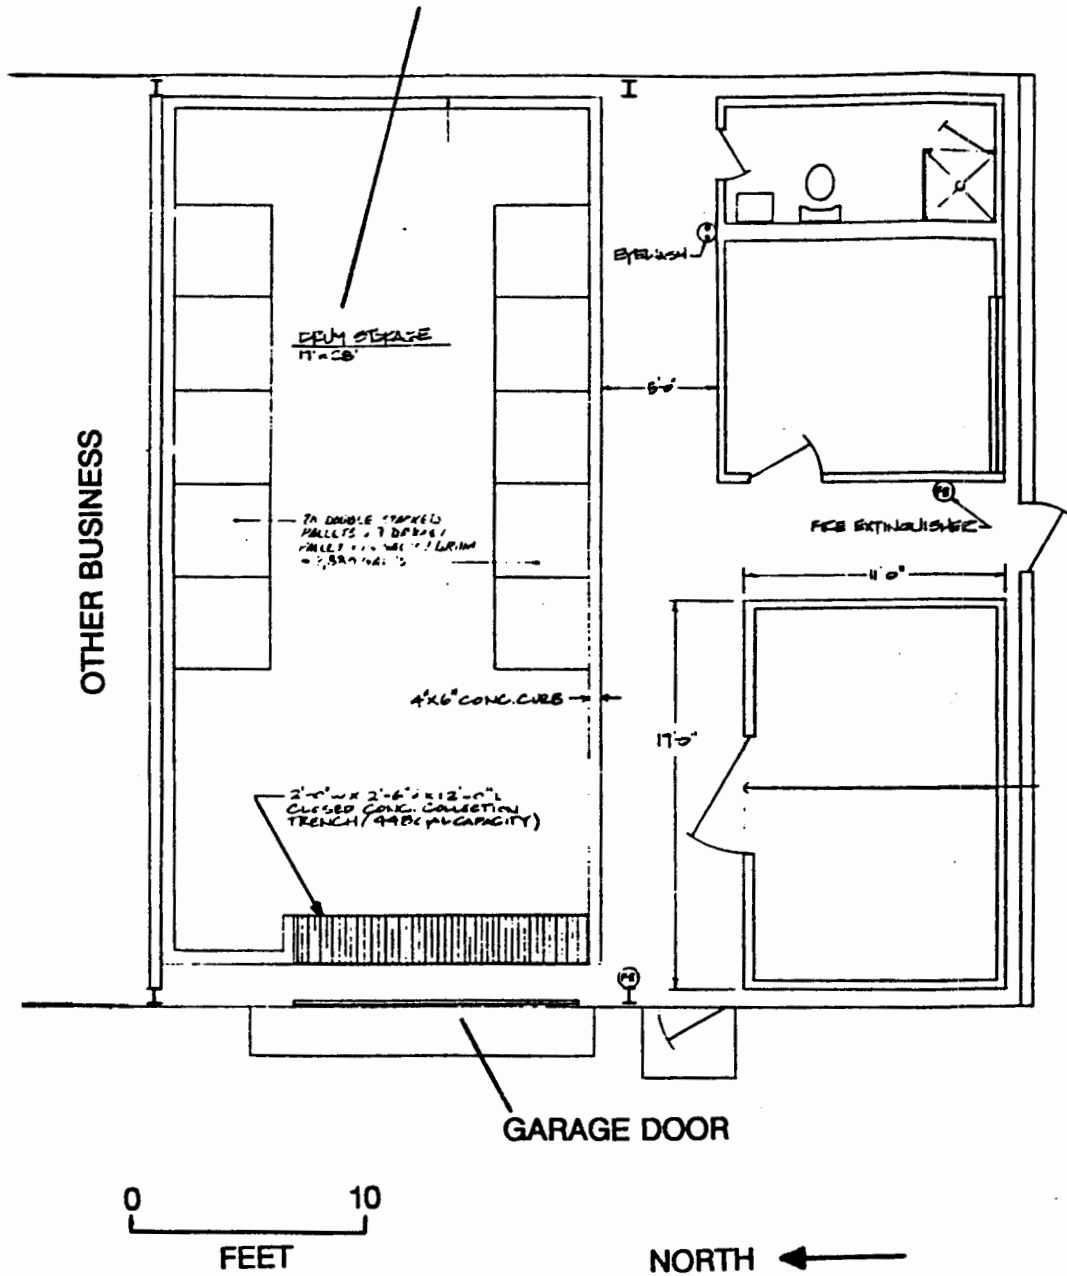
**CONTAINER STORAGE
AREA FLOOR PLAN**

The Container Storage Area occupies the northern portion of the Farmington Service Center's warehouse, as shown in Figure 4. The warehouse is a fully enclosed, 3080-square-foot sheet-metal building, of which Safety-Kleen occupies the southern portion (Figure 4). The northern half of the building, which was not inspected during the VSI, is leased to another business unrelated to Safety-Kleen.
