SUBJECT: Responses to the New Mexico Environment Department *Notice of Disapproval: Mixed Waste Landfill Corrective Measures Implementation Report, January 2010 Sandia National Laboratories, EPA ID NM5890110518, HWB-SNL-10-005*

In this MWL Corrective Measures Implementation (CMI) Report, the DOE and Sandia demonstrate that the deployment of the MWL alternative Evapotranspirative (ET) Cover (hereafter referred to as the ET Cover) was performed in accordance with the requirements, specifications, and design drawings presented in the MWL Corrective Measure Implementation Plan (CMIP) (SNL/NM November 2005). The MWL CMIP was conditionally approved by the New Mexico Environment Department (NMED) in December 2008 (Bearzi December 2008), and all NMED conditions related to construction of the MWL ET Cover were addressed and incorporated into the CMIP through replacement pages (Davis February 2009).

Figure 1-4  
Schematic Diagram of the Mixed Waste Landfill Alternative Evapotranspirative Cover

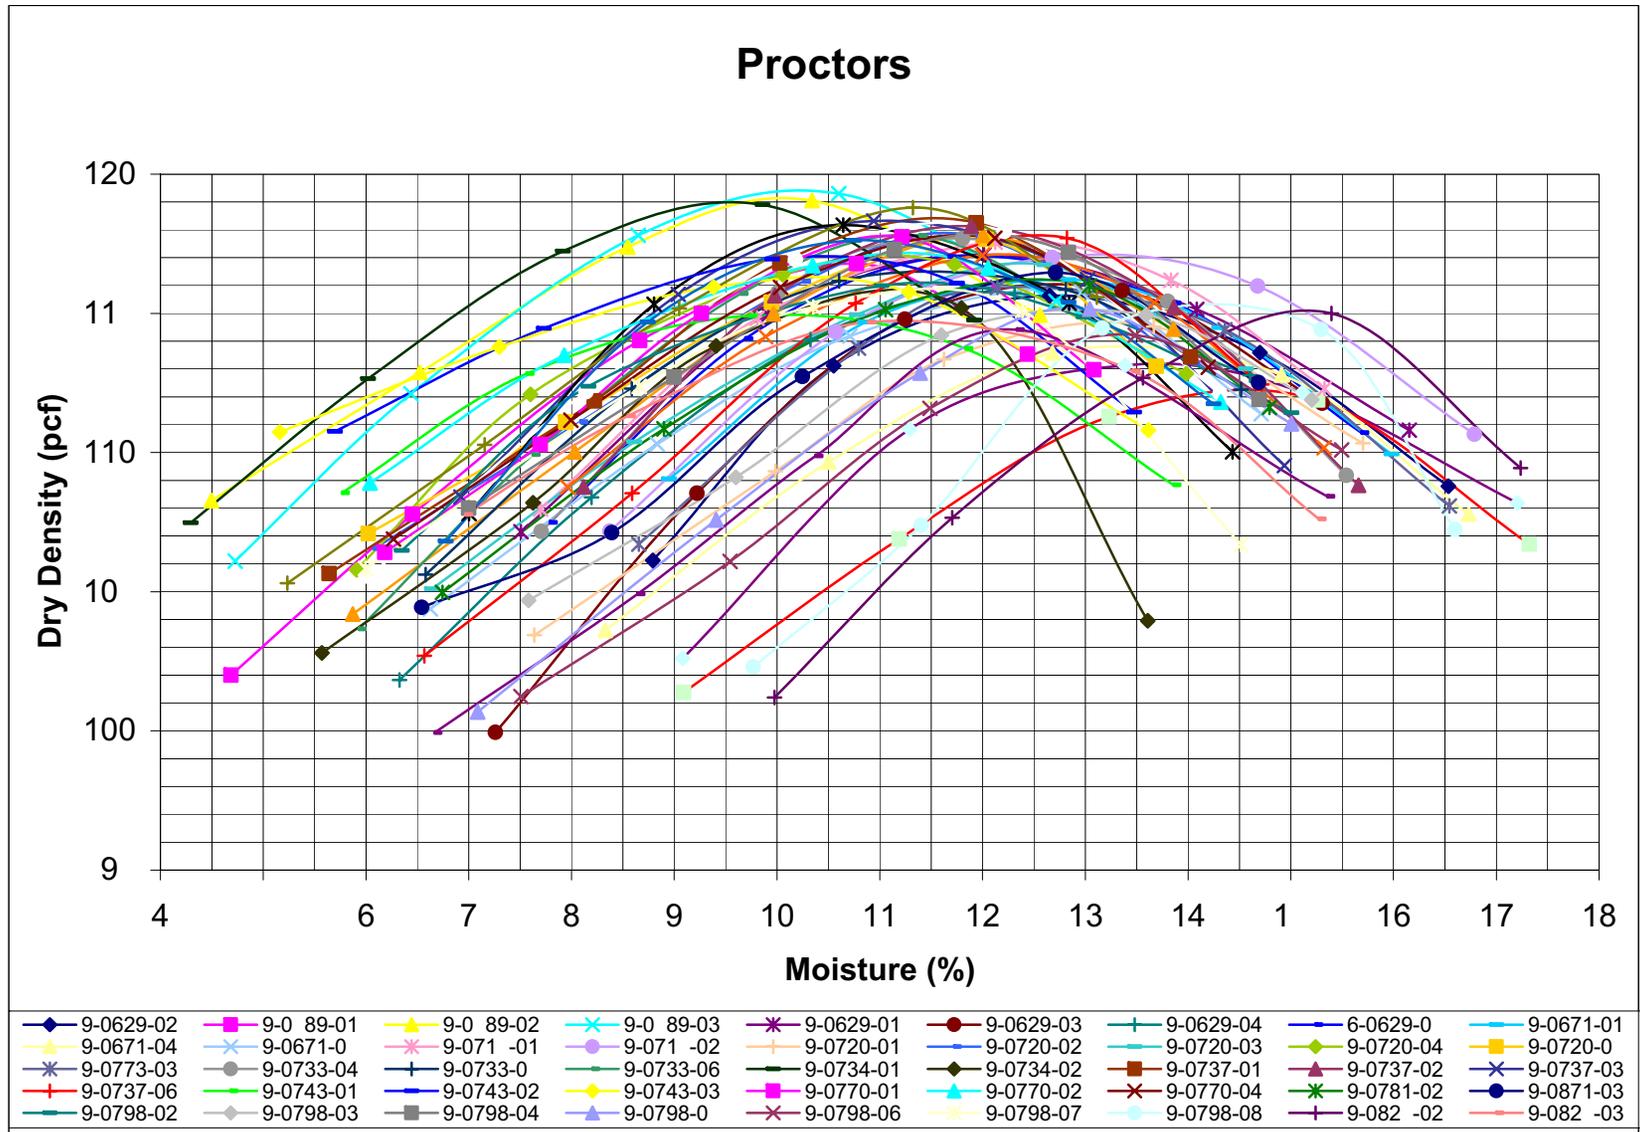
**Figure 20. Graphical Representation of all MWL Alternative Cover Standard Proctor Results**

As shown in Tables 4 and 5 and Figure 20, the Standard Proctor results for all of the fill material sampled in 2006 and 2009 are generally consistent, with a relatively narrow range of maximum dry density and optimum moisture content. For this reason, the CQA Engineer approved the use of three representative Proctor results throughout the 2009 Subgrade and Native Soil Layer field-testing program, with one of the samples being the 2006 MWL-SG-018. This decision by the CQA Engineer was based on experience gained during 2006 Subgrade Construction phase, a review of all available data (2006 and incoming 2009 results), ongoing field-testing results, field Proctor compaction tests, and visual inspections of the fill material during placement and testing. The method used to change the Proctor used for in-place density and moisture testing is described as follows.

During placement of Native Soil Layer Wedge Lift 1, the soil appeared to contain higher amounts of clay and silt than the materials previously tested in 2006 based upon visual inspection. Moisture and density readings confirmed slight variations in soil composition and, as a result, the Proctor was revised to more accurately reflect density and moisture percentage of the fill material being used. The revised Proctor was determined by collecting a sample of soil from the area of Wedge Lift 1 where the change was noted. This soil was then compacted using a Proctor mold in the field in accordance with ASTM standards (ASTM, 2007b). The compacted sample provided a theoretical maximum wet density at current moisture levels. The theoretical maximum density and moisture was plotted on a graph with all available Proctor curves (i.e., Figure 20). The plotted point lined up on a Proctor curve that indicated which Proctor was most appropriate for that specific fill material.

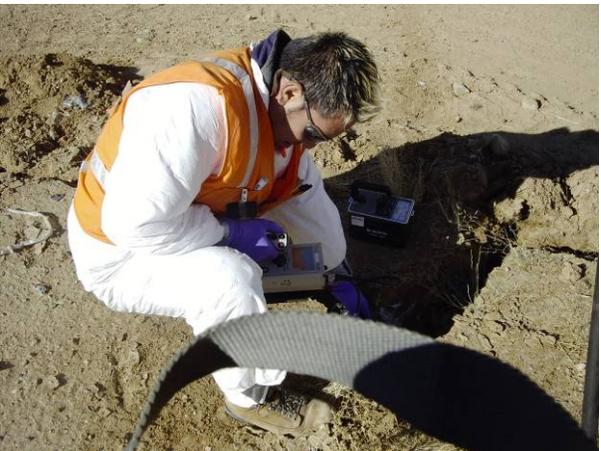
Description: Breaking up concrete pad in SE corner of classified area

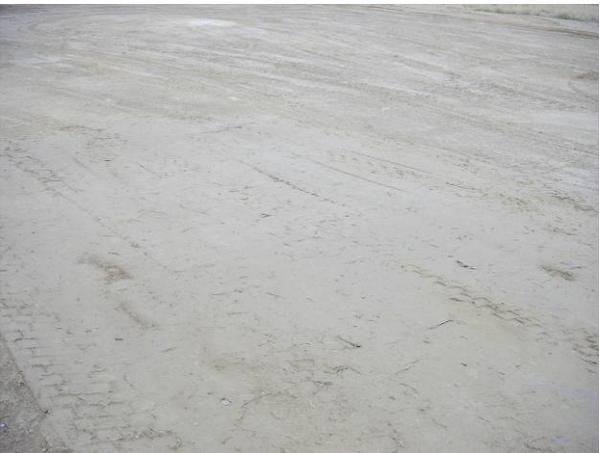
Description: Removal of concrete cap in SE corner of classified area

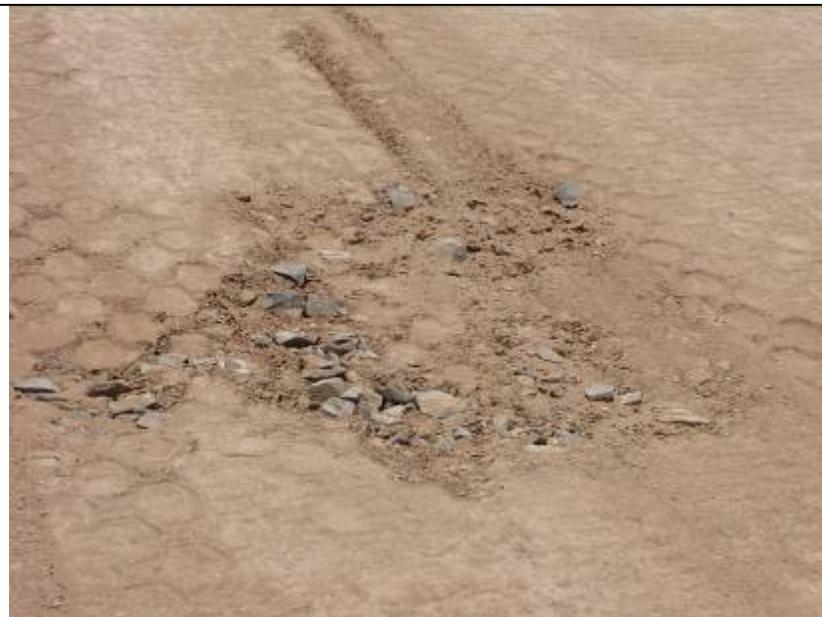
Description: Dry loose soil penetrating down into the rock layer filling the voids at the northwest corner

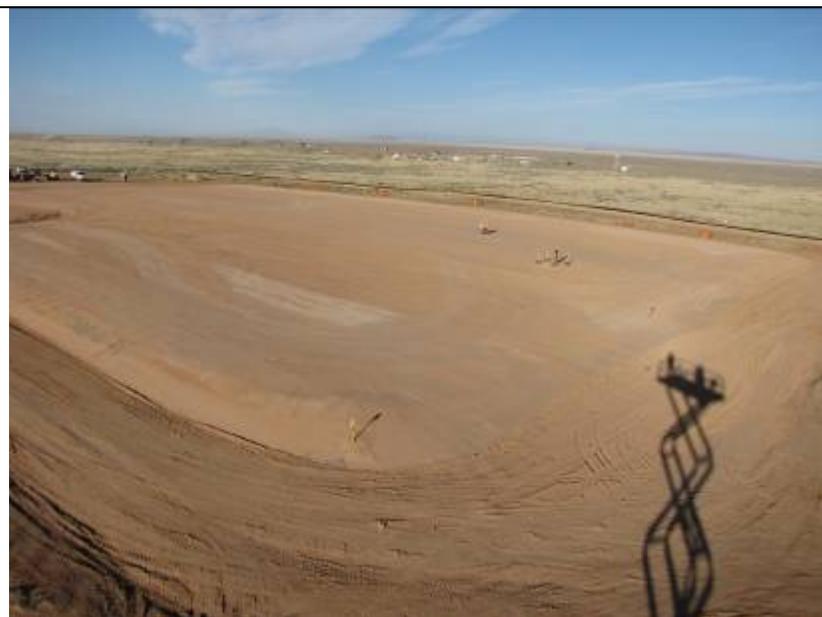
Description: Biointrusion rock showing through the thin soil layer – location was scraped with the grader to make sure the overlying soil layer was as thin as possible

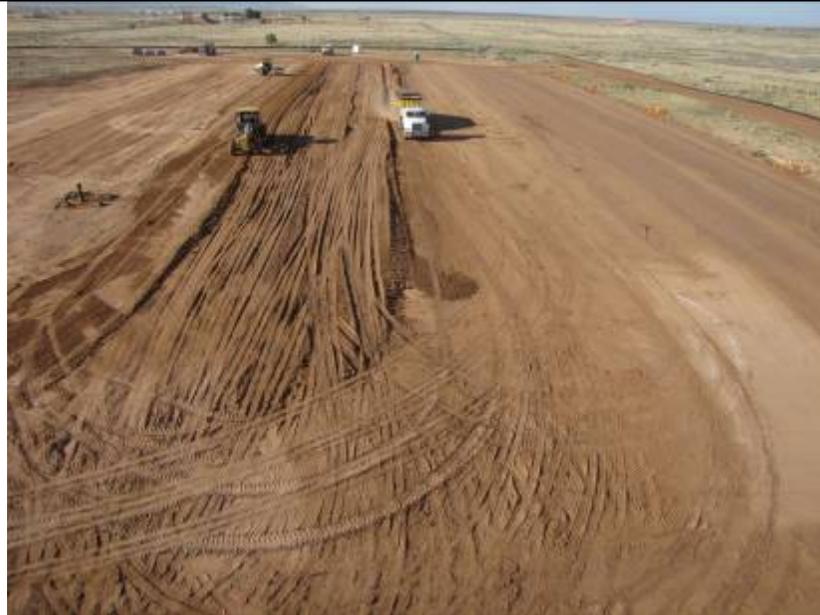
Date: 07/07/09      Time: 1604  
Photo Taken by: J. Schermerhorn  
Description: Adding water to increase the moisture to Lift 5 soil (grid blocks 1 and 2) after area ripped with grader scarifier shanks to a depth of ~6 inches after initial field compaction tests failed for moisture content  
Facing: South

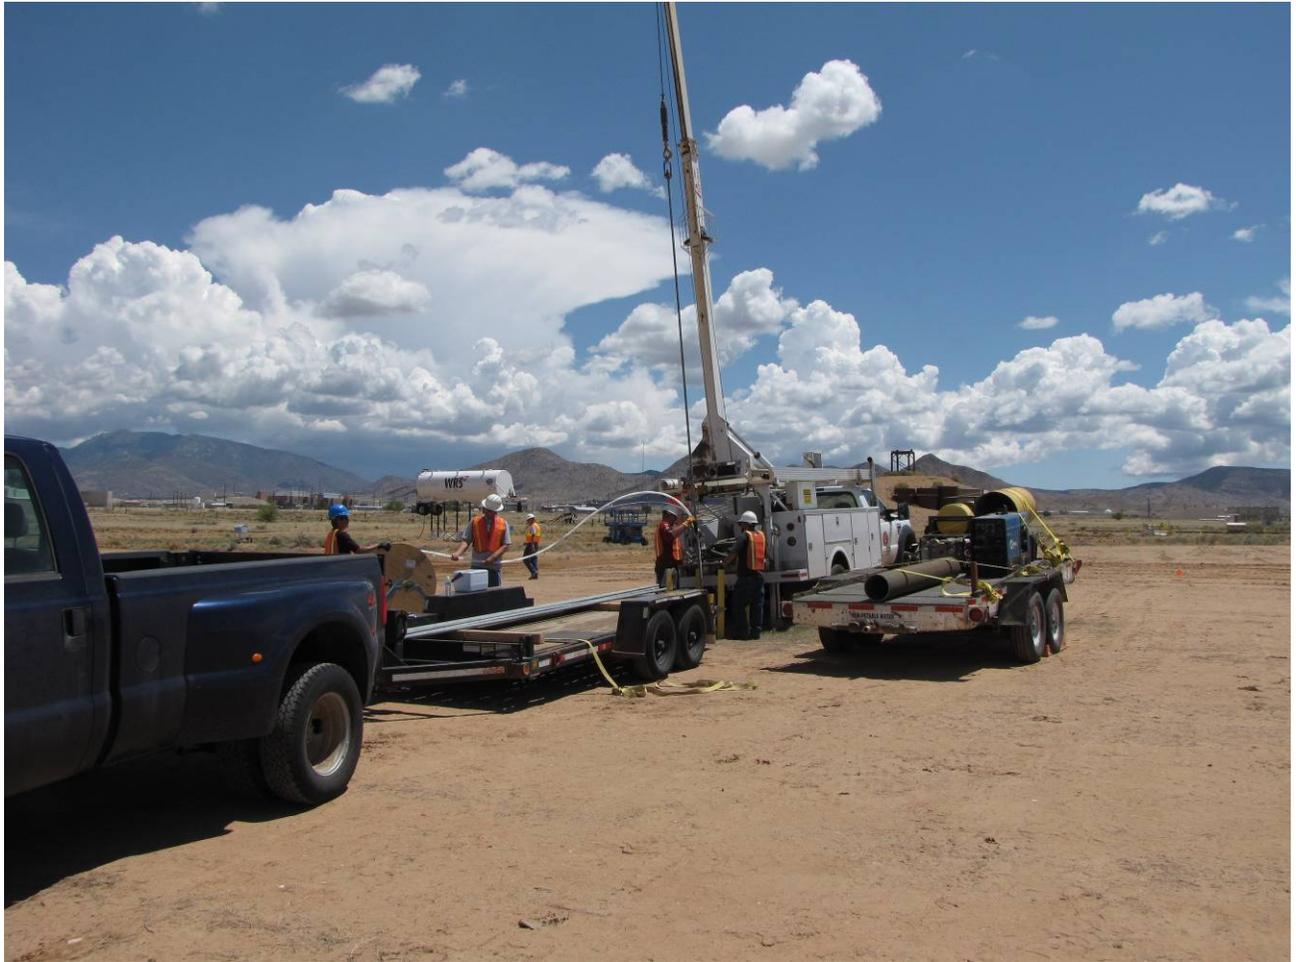
Figure 2-1  
Removing the packer assembly from well MWL-MW4,  
May 27, 2009. View to the east.

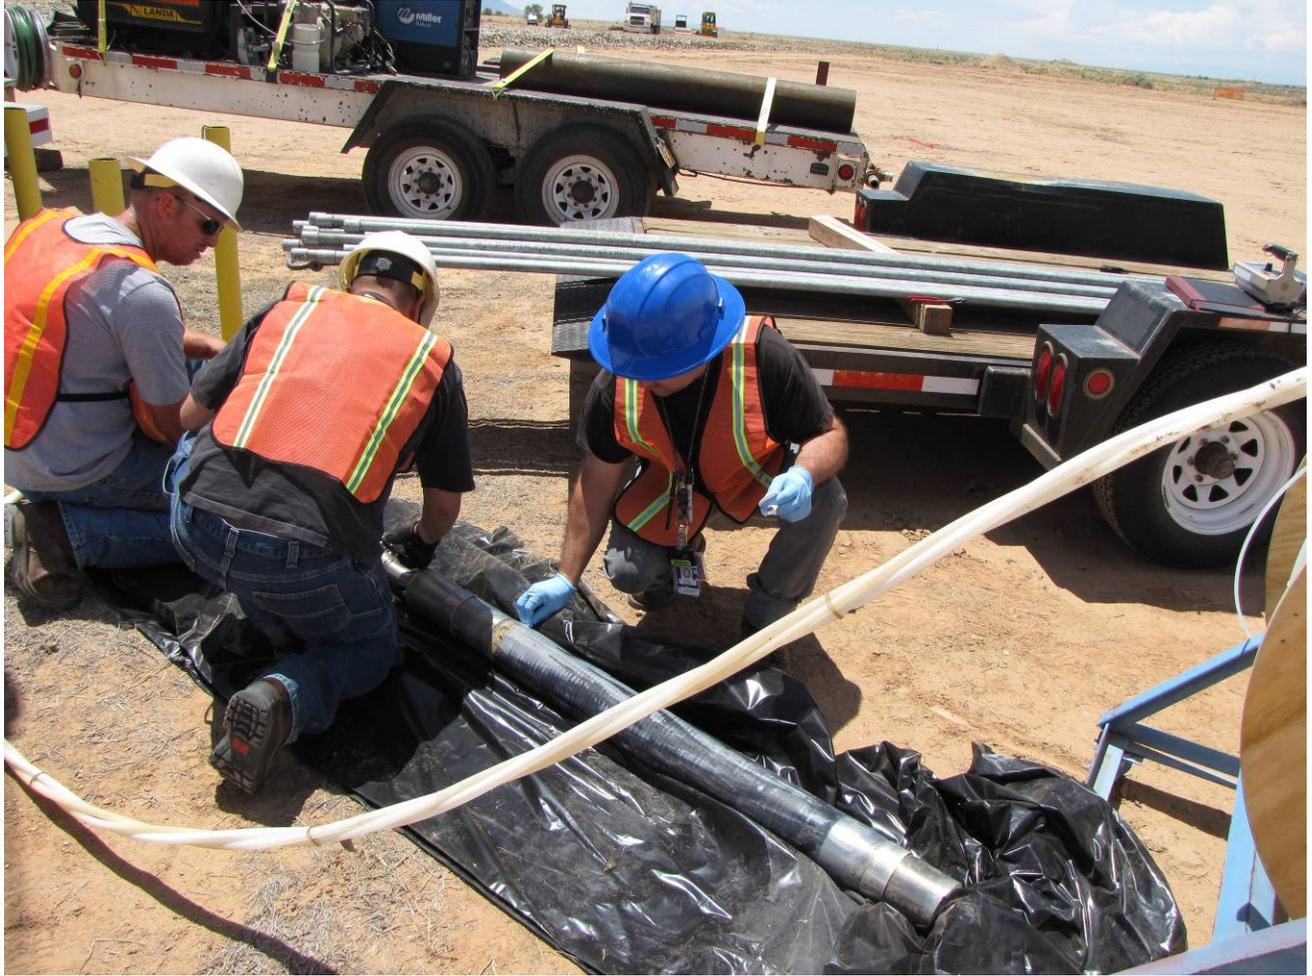
The MWL-MW4 well extension task consisted of removing the packer and then extending both the inner PVC well casing and the outer steel PC. On May 27, 2009, personnel and a monitoring well development rig provided by WDC were mobilized to the MWL. The development rig was positioned next to MWL-MW4 so that the packer could be pulled from the well. SNL/NM personnel from the ER Field Office assisted in the packer removal operation. The packer bladder was deflated, and the packer and pipe were removed from the well. The packer removal operation is shown in Figure 2-1. An SNL/NM Radiological Control Technician (RCT) also completed a radiological screening survey of the packer and pipe to verify the absence of radiological contamination as the equipment was removed from the well (Figure 2-2). The screening survey confirmed there was no radiological contamination on the packer or pipe.

Figure 2-2  
Screening the MWL-MW4 packer for radiological contamination by an RCT,  
May 27, 2009. View to the south.

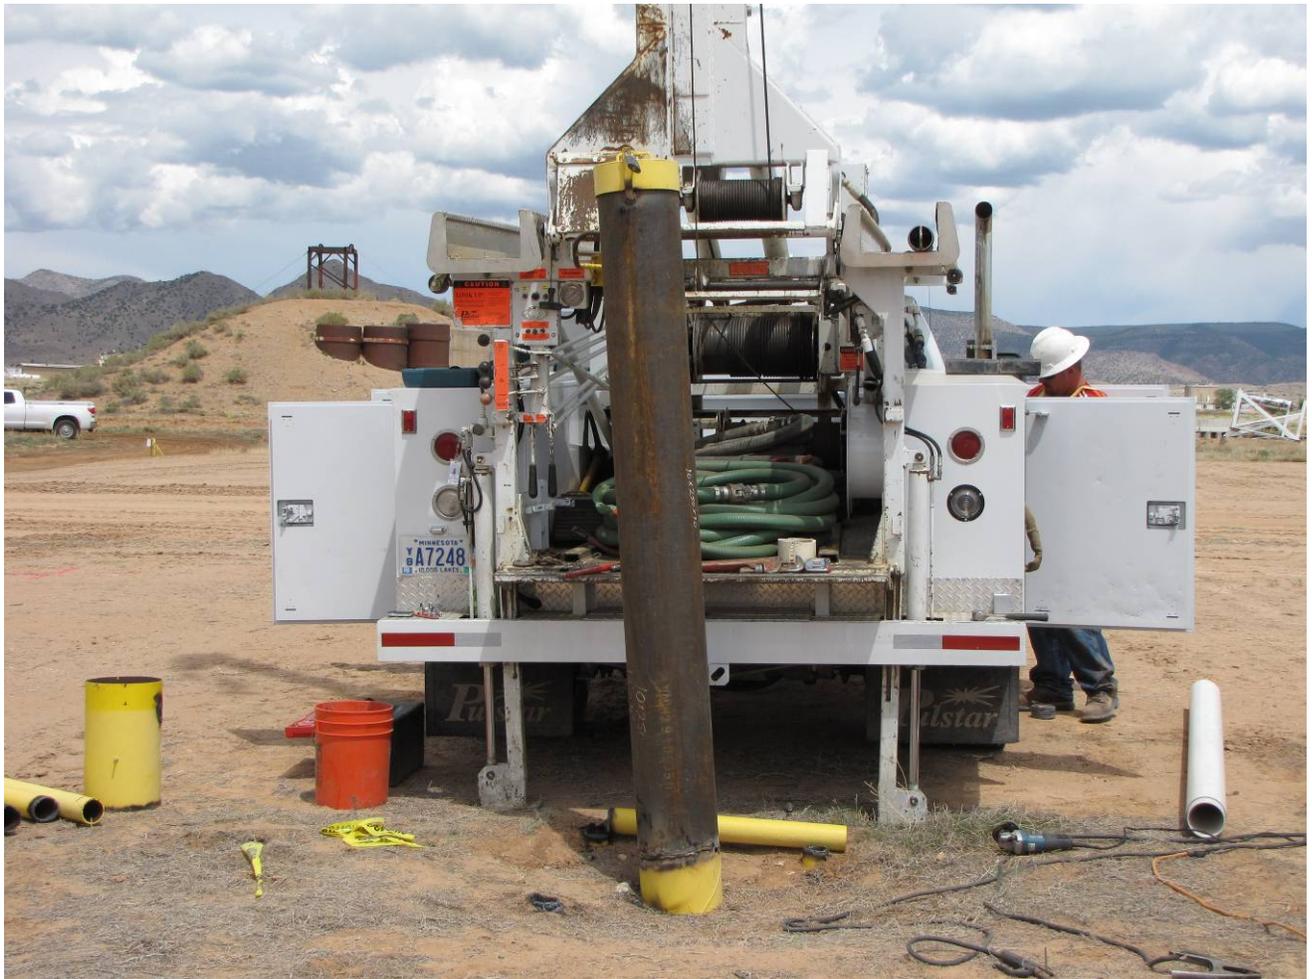
The final well extension step consisted of extending the steel PC above the top of the extended PVC casing. This was accomplished by lowering an approximate 8-ft-length of 10.75-inch OD steel PC over the extended PVC and welding it to the top of the PC (Figure 2-4). The final height of the extended PC is 8.39 ft above the original MWL surface, 2.50 ft above the completed ET Cover surface, and approximately 1 ft above the top of the extended PVC casing. The length of the extended PC was planned such that the new top of the PC would end up at approximately 3 ft above the final finished grade of the ET Cover. A well cap was installed to seal the PVC casing, and the outer locking well cap that was attached to the original well PC was reattached and locked with a keyed padlock.

Figure 2-4  
MWL-MW4 protective surface casing extension, welded to the  
existing protective surface casing, May 27, 2009. View to the east.

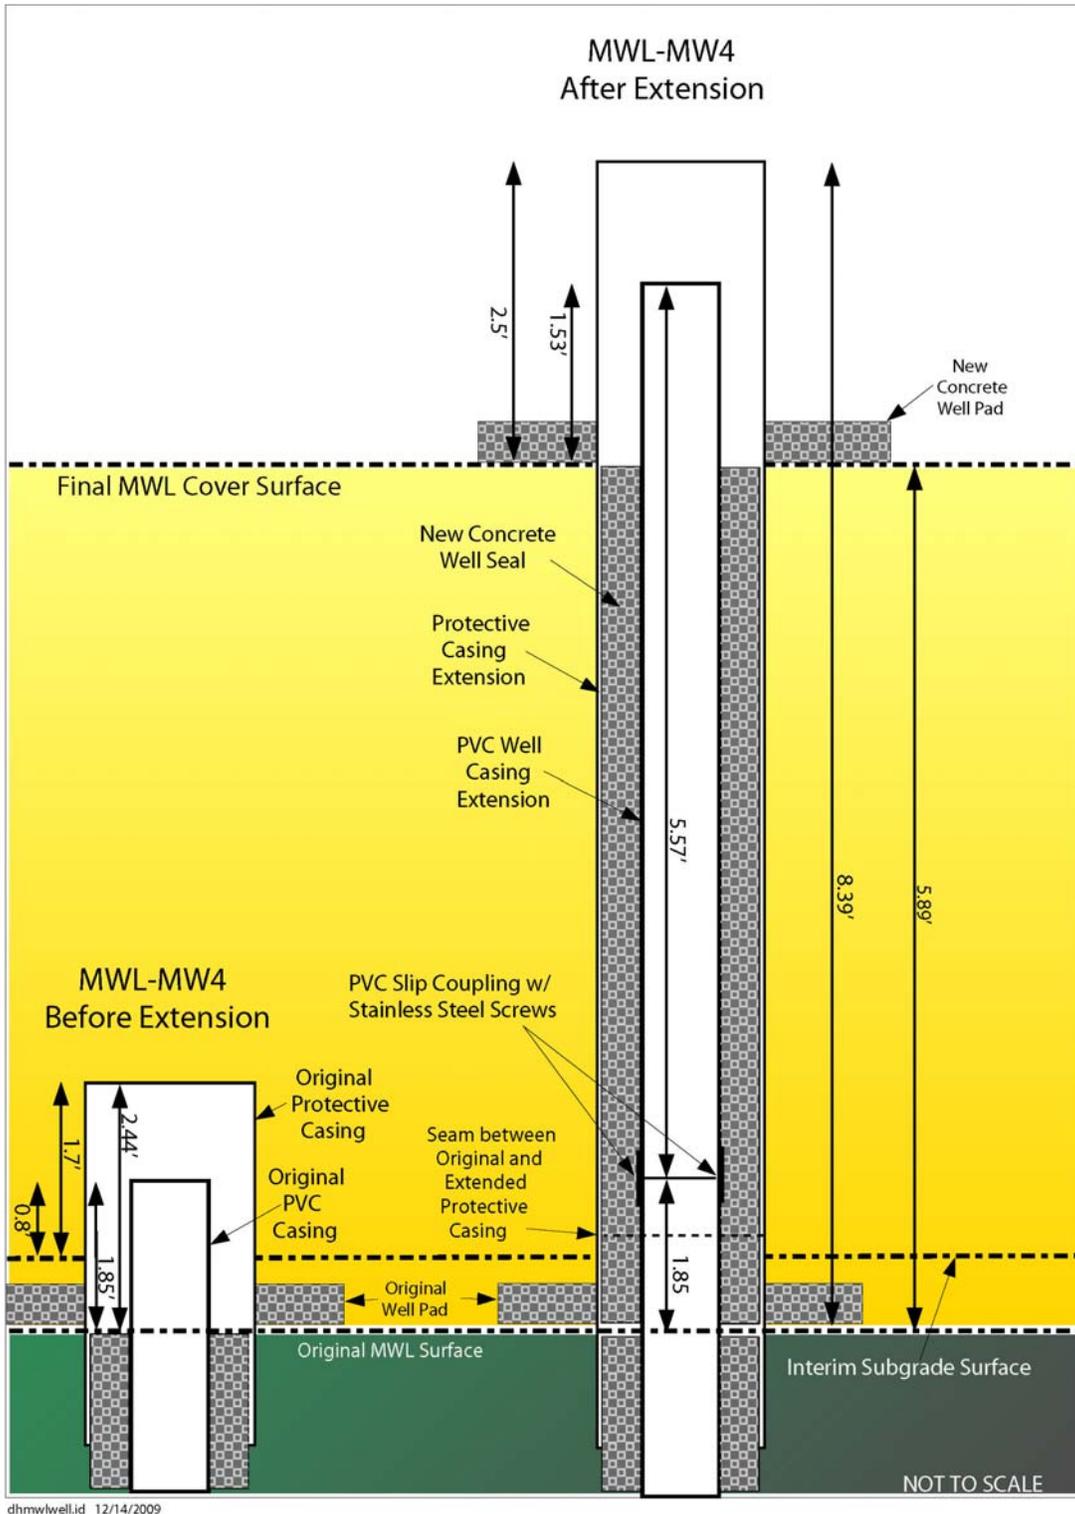
Figure 2-5  
Schematic MWL-MW4 PVC Well Casing and Protective Surface Casing Extension Diagram

A schematic profile diagram showing both the constructed configuration of MWL-MW4 when it was installed in 1993 and the well configuration after the PVC casing and PC were extended is provided in Figure 2-5, and a revised well construction diagram that contains the new survey coordinates and elevations is presented in Figure 2-6.

- Item 3 of Section 3.1 specifies that the existing MWL-MW4 Schedule 80 PVC well casing was to be extended such that the top of the PVC well casing is located a minimum of 2.5 ft above the final grade of the constructed ET Cover. As shown in Figure 2-5, the finished height of the extended PVC casing above the finished ET Cover surface is approximately 1.5 ft because the elevation of the finished ET Cover was slightly higher than originally planned (average ET cover thickness is approximately 1.2 ft greater than the minimum cover thickness specifications in the CMIP). MWL-MW4 is still fully functional, and the slightly reduced final height of the extended PVC casing above the ET Cover surface in no way hinders access to the well for future sampling.

**CQA Report, Attachment 8, Figure 2-5, center of figure: "PVC Slip Coupling w/ Stainless Steel Screens" should read "PVC Slip Coupling w/Stainless Steel Screws".**

**Response:** The error in Figure 2-5 of Attachment 8 in the CQA Report (Appendix A of the CMI Report, Volume 2), has been corrected. The associated revision to the CQA Report is tracked in Table 1 and documented in redline-strikeout format in Attachment 1. Attachment 2 of this comment response document provides the replacement page, and the revised figure is incorporated into the electronic version of the CMI Report (January 2010, Revision 1) provided on both CDs.

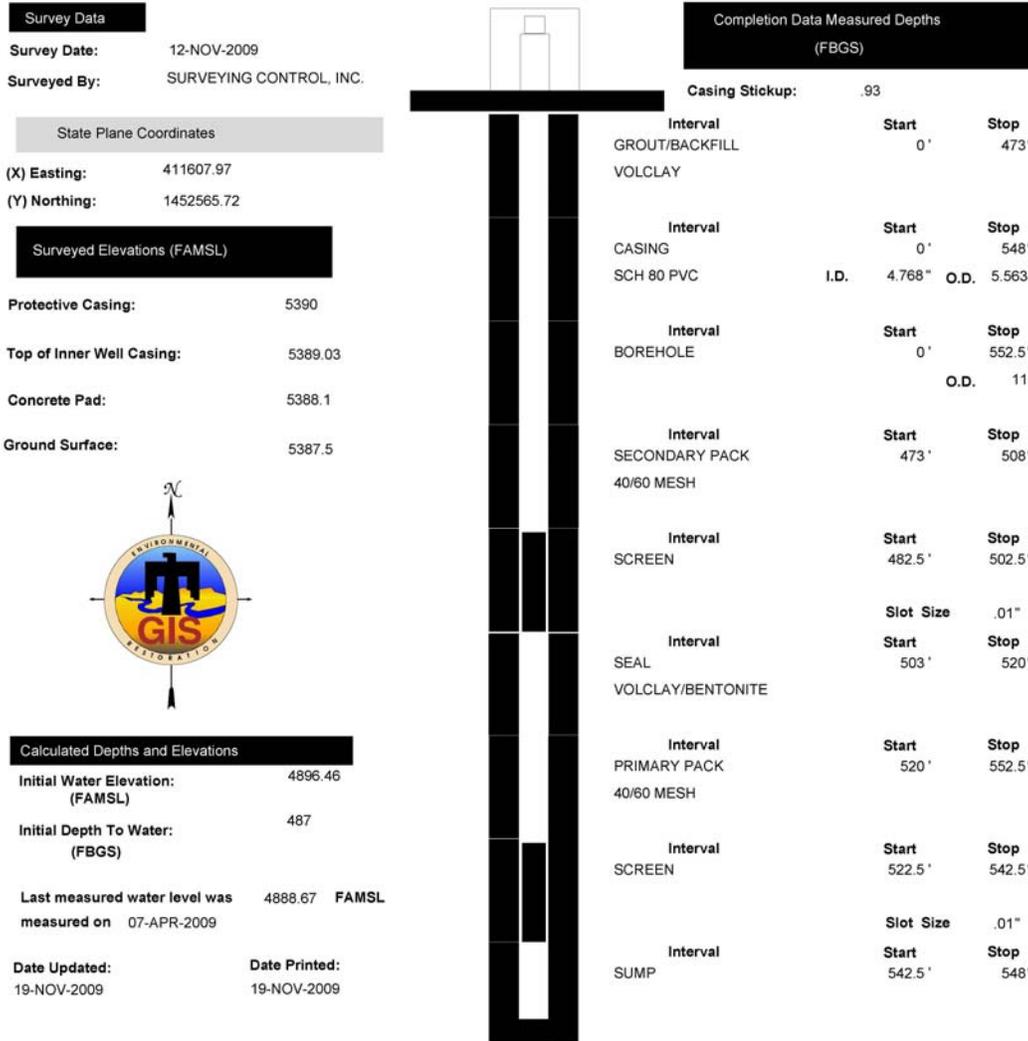
Figure 2-6  
MWL-MW4 Construction Diagram

<b>Project Name:</b> MIXED WASTE LANDFILL	<b>Geo Location:</b> TA III	
<b>ER ADS #:</b> 1289	<b>Well Completion Date:</b> 10-FEB-1993	
<b>Well Name:</b> MWL-MW4	<b>Completion Zone:</b> FINE MEDIUM SAND/GRAVELLY SAND	
<b>Owner Name:</b> SNL/NM	<b>Formation of Completion:</b> SANTA FE GROUP	
<b>Date Drilling Started:</b> 16-DEC-1992	<b>Well Comment:</b> MWL-MW4 IS AN ANGLE WELL, INSTALLED AT A 6-DEGREE ANGLE FROM VERTICAL. 2 SCREENED INTERVALS EXIST.	
<b>Drilling Contractor:</b> WATER DEVELOPMENT CORP.		
<b>Drilling Method:</b> SONIC/DRY		
<b>Borehole Depth:</b> 552.5 FBGS	WELL PVC & PROTECTIVE CASING EXTENDED ON 5/27/09 AND RE-SURVEYED 11/12/09. NEW N, E IS TOP CENTER OF PVC CASING.	
<b>Casing Depth:</b> 548 FBGS
