SPARTON TECHNOLOGY

This letter is written to inform you of the actions Sparton Technology, Inc. has taken to repair two cracks in the Pond Closure Cap at the Coors Road Facility. This repair was initiated and completed on September 17, 1992 by Rodgers and Company, Inc. No unusual or unforeseen circumstances were encountered during the repair procedure. The repair work was completed as outlined in our proposal letter to your office dated July 16, 1992.

Summary of field notes taken during the repair of two cracks in Sparton Technology's, Inc. Pond Closure Cap on September 17, 1992.

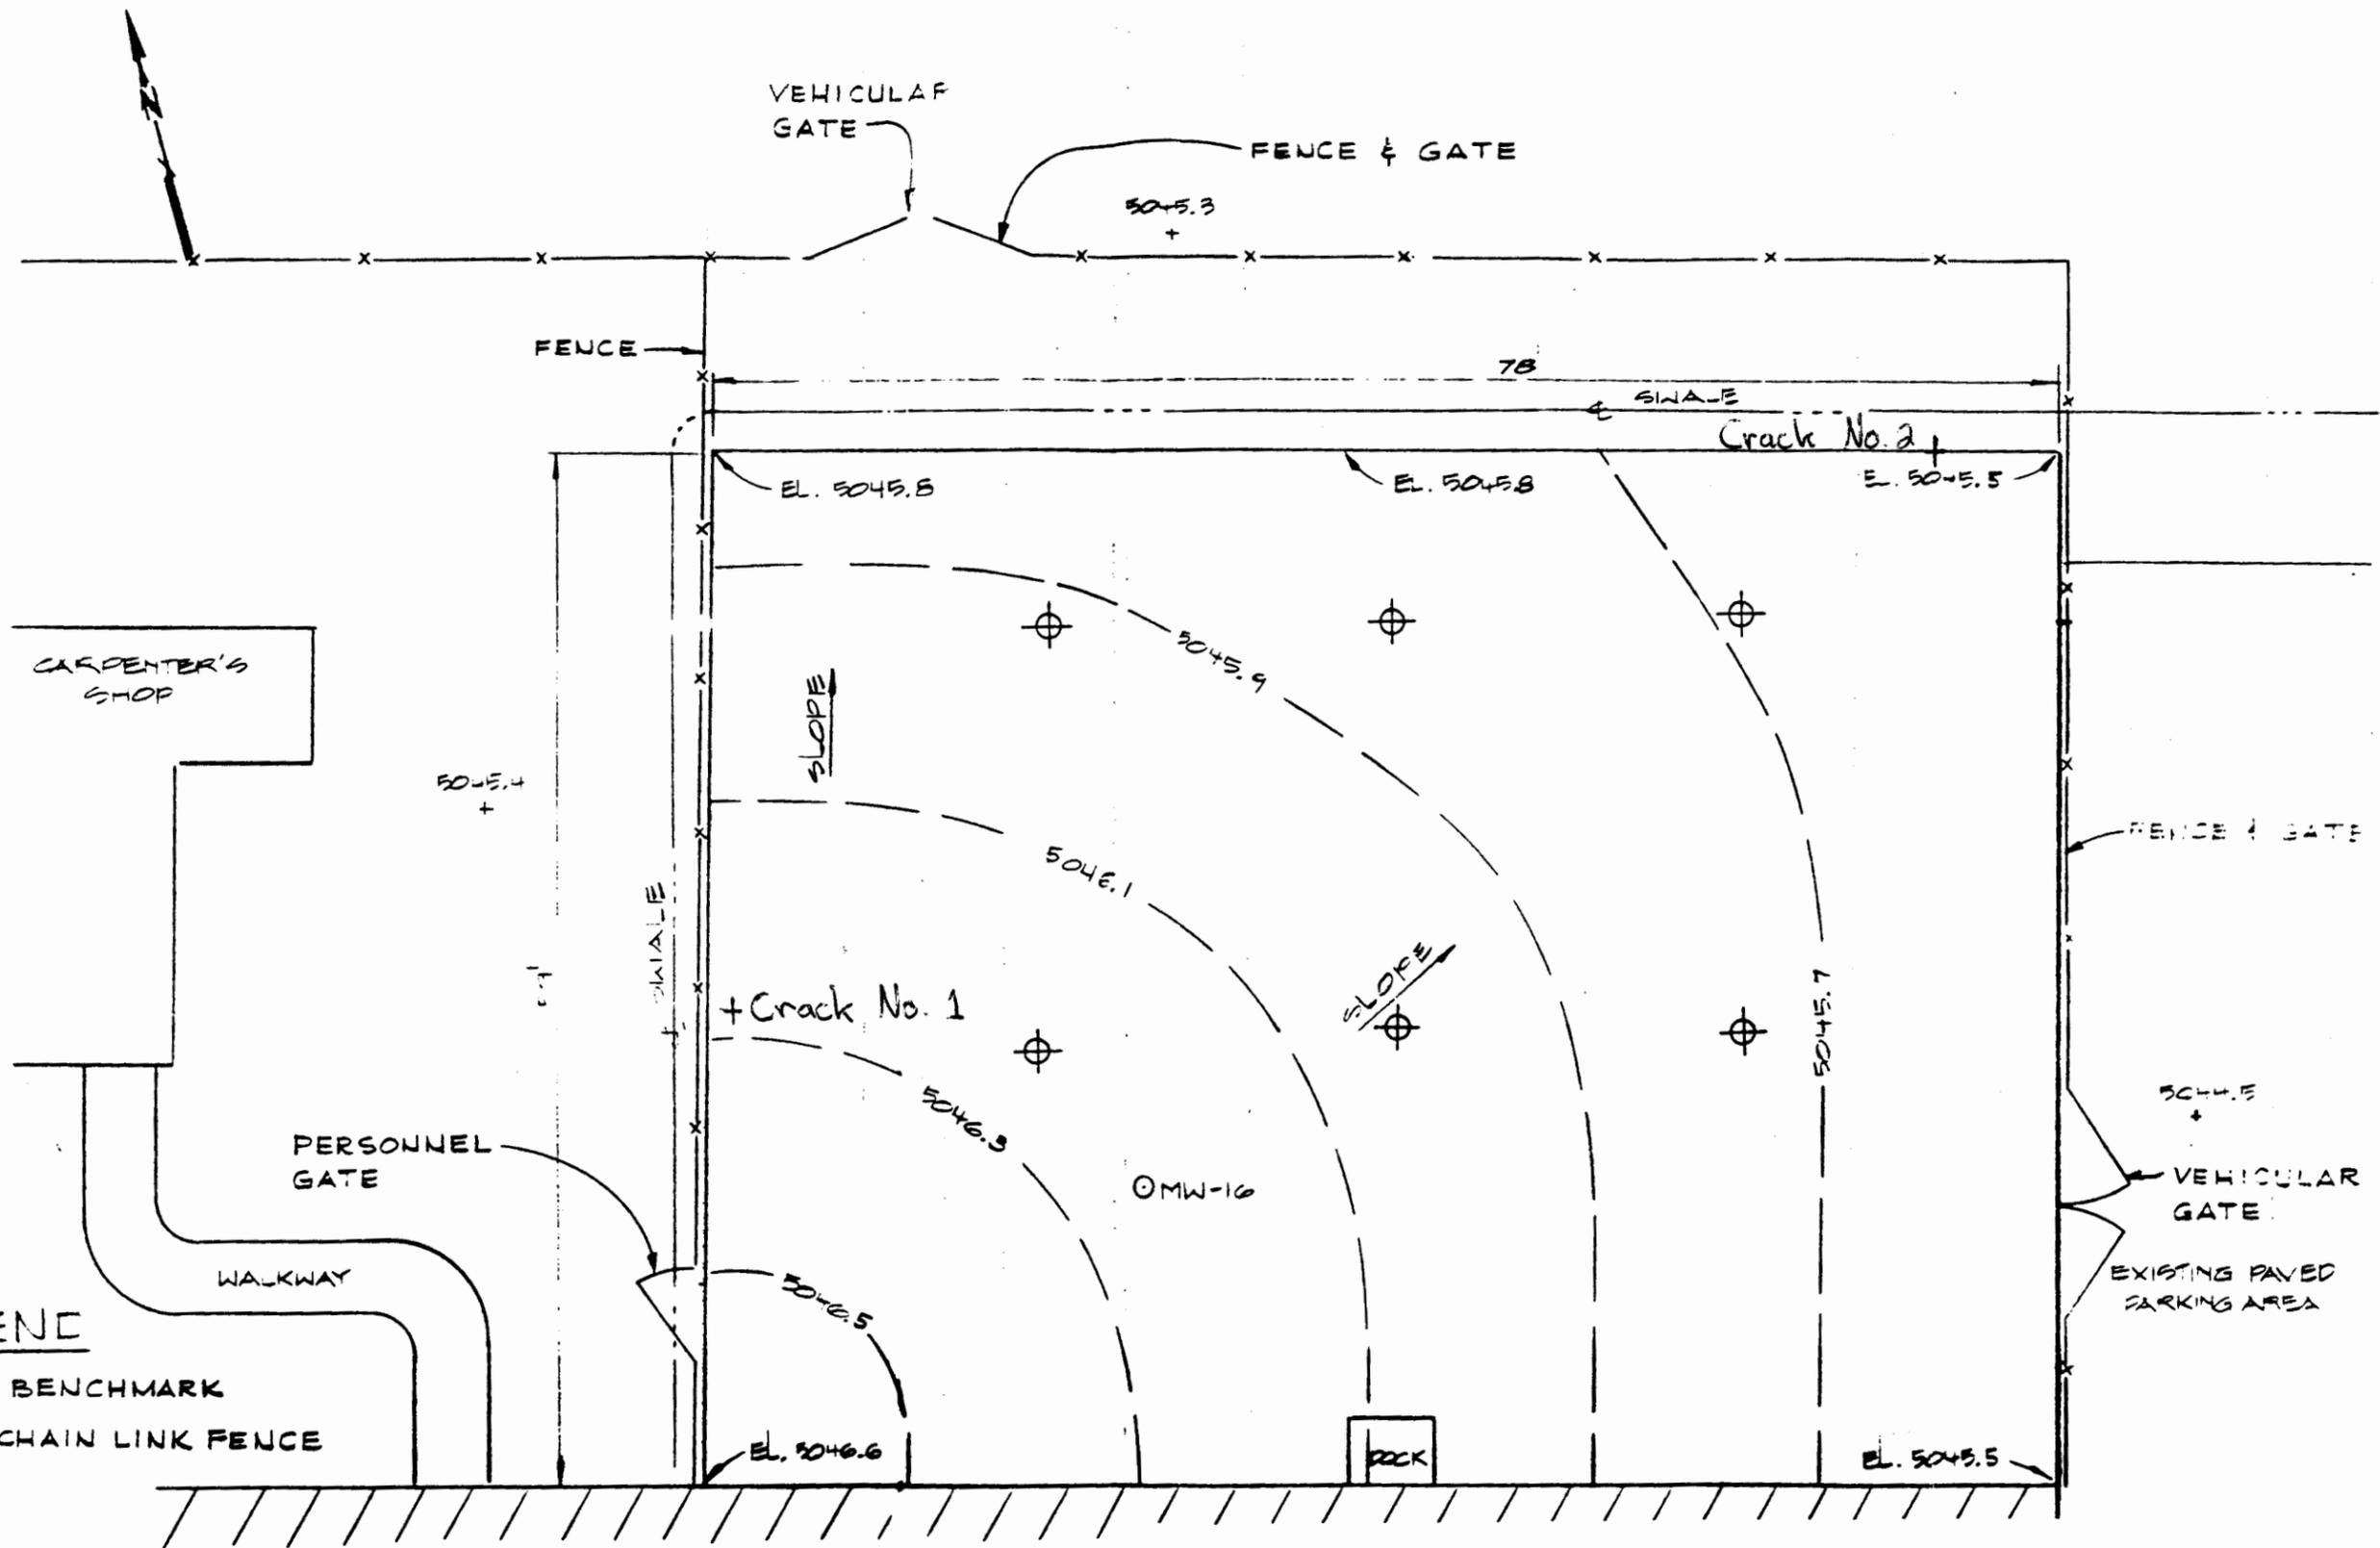
- 0940 Drilling commences on the northeast crack with a 14" carbide tipped hole saw, (No. 2 on the site plan, see photo. #1).
- 0950 Pond cap is cut to an average depth of 4", the surface or wear course detaches cleanly from the base course. No evidence of damage or cracks in the base course. A coating of water is present on both asphalt surfaces. No free standing water is present. Survey twine or string was found between the two asphalt layers, see photo. #2. Cracks in surface course apparently caused by delamination between the two layers.

- 1030 Moved drilling rig to southwest crack, (No. 1 on the site plan) see photo. #6 for condition of crack prior to repair.
- 1040 Commenced drilling, no clear separation between surface and base course. Surface course is 2 to 2.5" thick at this location. Cracks appear to penetrate the base layer of the asphalt.
