U.S. DEPARTMENT OF
ENERGY

WIPP Underground Fire Accident Investigation Summary February 5, 2014

Ted Wyka
Chairman, Accident Investigation Board
March 2014

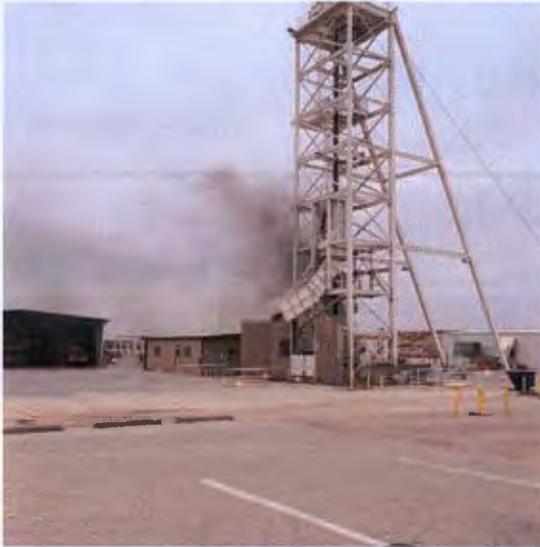
On February 5, 2014, at approximately 11:00 AM, the Waste Isolation Pilot Plant in Carlsbad, New Mexico suffered an underground fire in a salt hauler vehicle. There were 86 people in the mine at the onset of the fire, all exited the mine safely. Six personnel were transported to the Carlsbad Medical Center for smoke inhalation and an additional seven personnel were treated on-site.

The EIMCO Model 985, 15 ton haul truck is a diesel powered vehicle used to haul salt from the mine. This is an aged piece of equipment, approximately 29 years old.

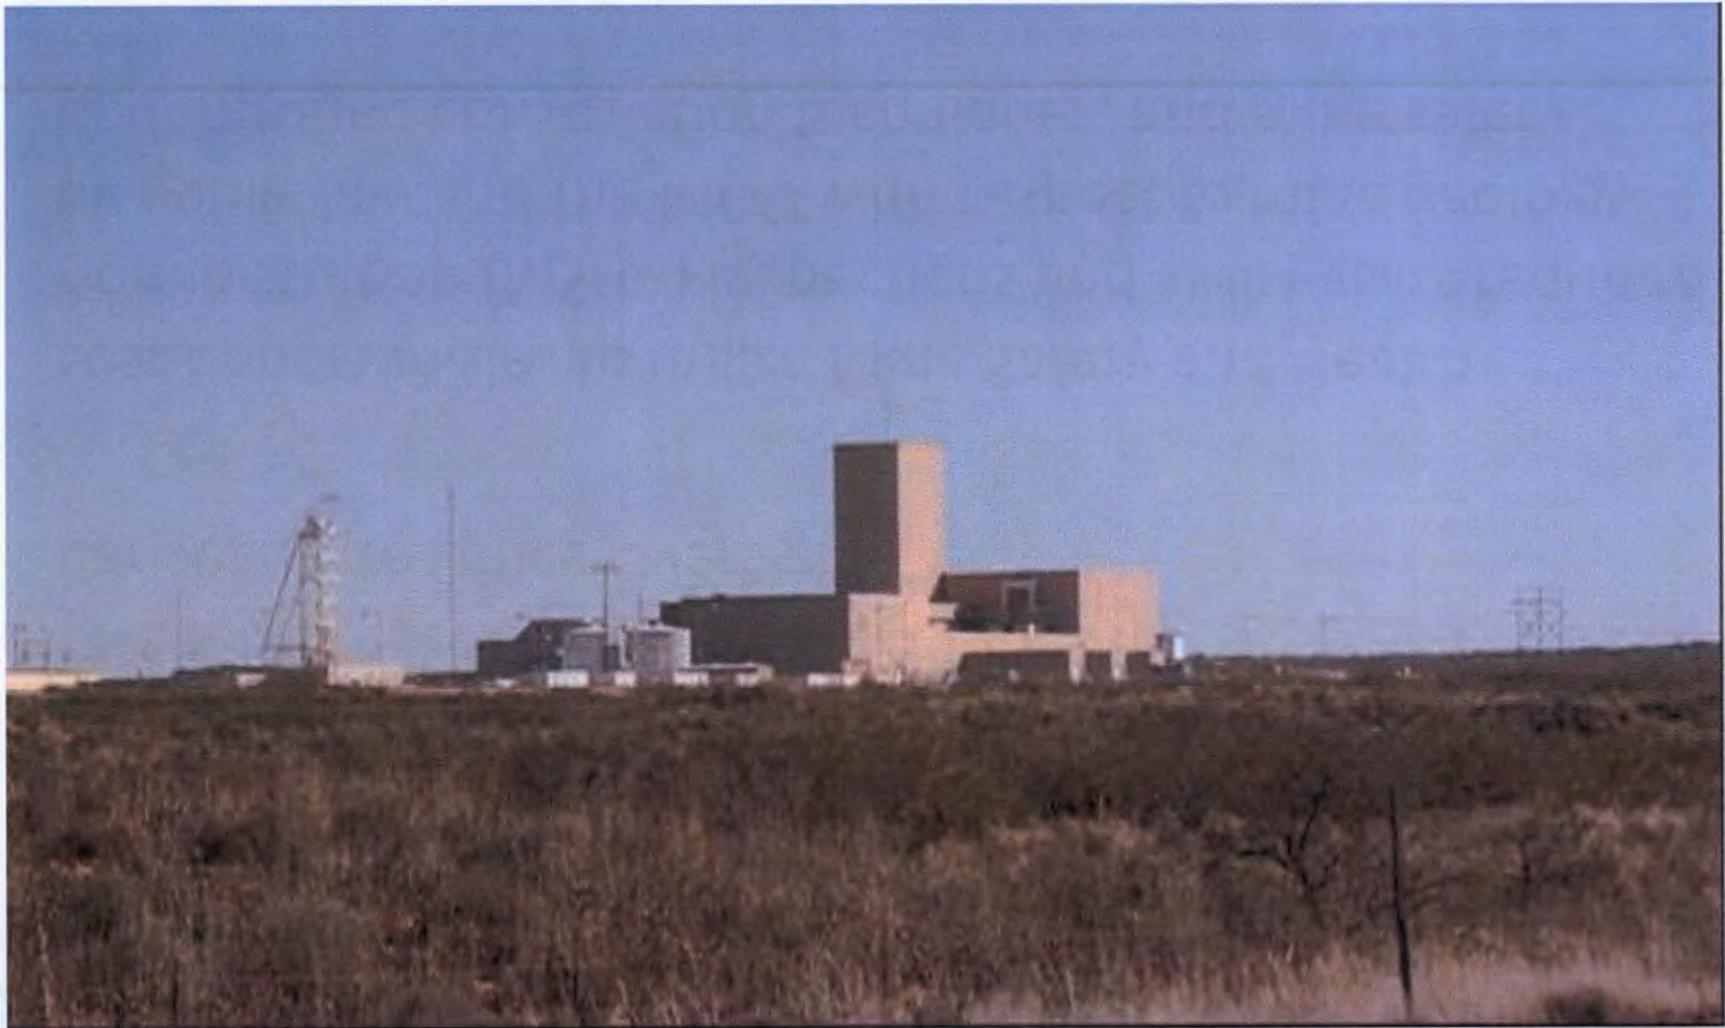
WIPP Fire Accident Investigation

- **Nuclear Facility vs., Mine Culture:** Difference in expectations between waste handling and non-waste handling vehicles; e.g., combustible buildup, manual versus automatic fire detection and suppression system, fire resistant hydraulic oil. Potential USQ with use of these vehicles at the waste face (LCO).

- No tactical and strategic role/inconsistent with DOE Order 151.1C.
 - Failure to classify and categorize, and make required notifications and declarations during both the fire and radiological events.

- **Inadequate combustible loading program in the underground.**
- **Inadequate Fire hazard Analysis** (i.e. analysis of a fire near a shaft)
- **Maintenance, Emergency Management/Preparedness programs and NWP contractor assurance system (CAS) and CBFO oversight** were evaluated as **ineffective.**

- **Inadequate Headquarters oversight:** ineffective emergency management Incident Command System (ICS) and exercises; inadequate corrective action and closure on repeat externally identified issues; need for technical expertise available at HQ to support CBFO in overseeing the operation of a Hazard Category 2 facility in a mine or leveraging technical expertise at MSHA.
