Subject: TERC Contract DACW45-94-D-0003, DO 11, WAD 3
Submittal of the Final Closure Report for the Phase II Remediation of POL-Contaminated Sites and Oil/Water Separator and Waste Oil Tank Removals, Holloman AFB, New Mexico

Foster Wheeler Environmental Corporation responses to comments on the Draft Closure Report for Phase II Remediation of POL-Contaminated Sites and Oil/Water Separator and Waste Oil Tank Removals, Holloman AFB, New Mexico

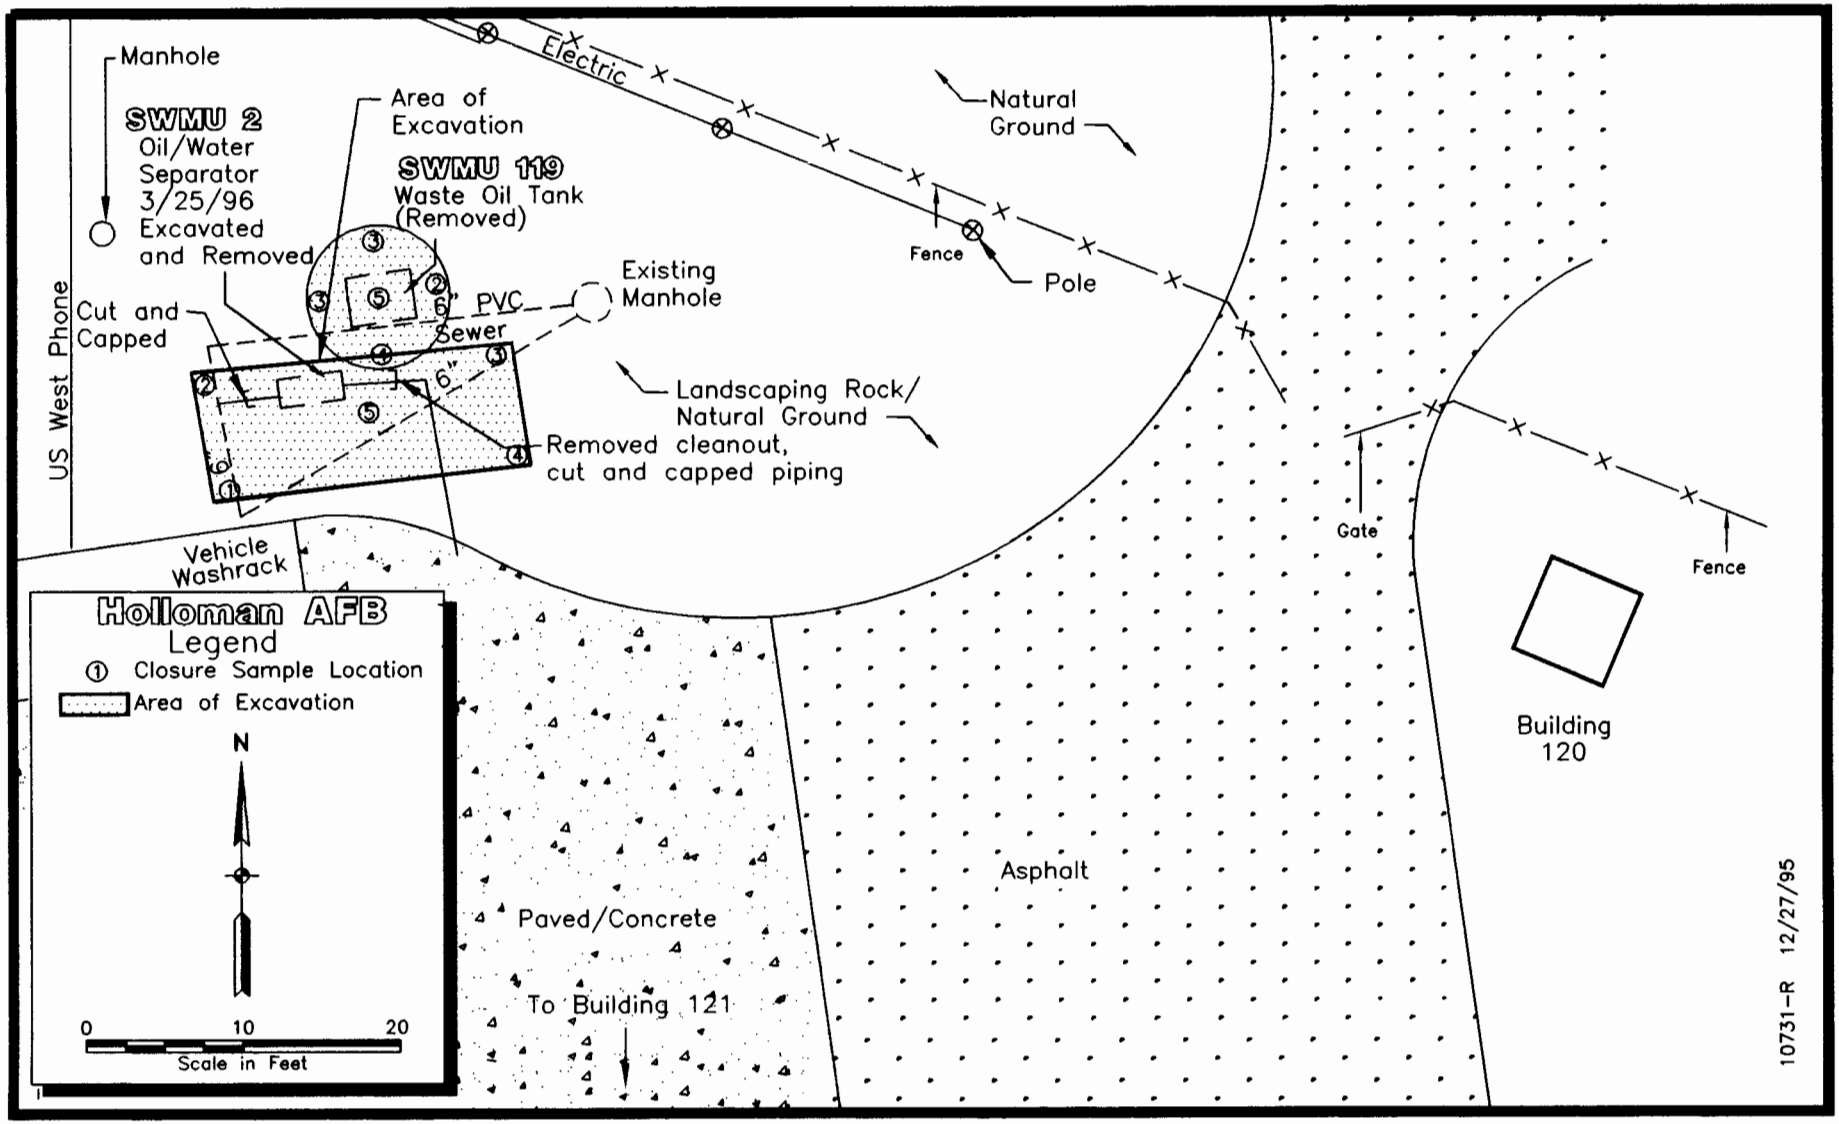
Figure 3-1. SWMUs 2 and 119- Site Map

Five closure samples were collected from each excavation at SWMU 2 and 119 and analyzed for TRPH, VOCs, and SVOCs. As indicated on Figure 3-1, closure samples were collected from each of the walls and the bottom of each excavation. Analytical results, which represent in-place soil conditions upon completion of excavation, were less than Base cleanup criteria for all closure samples.

The O/WS and WOT were removed and all closure samples contained less than 1,000 mg/kg TRPH. NFA is recommended for this site.

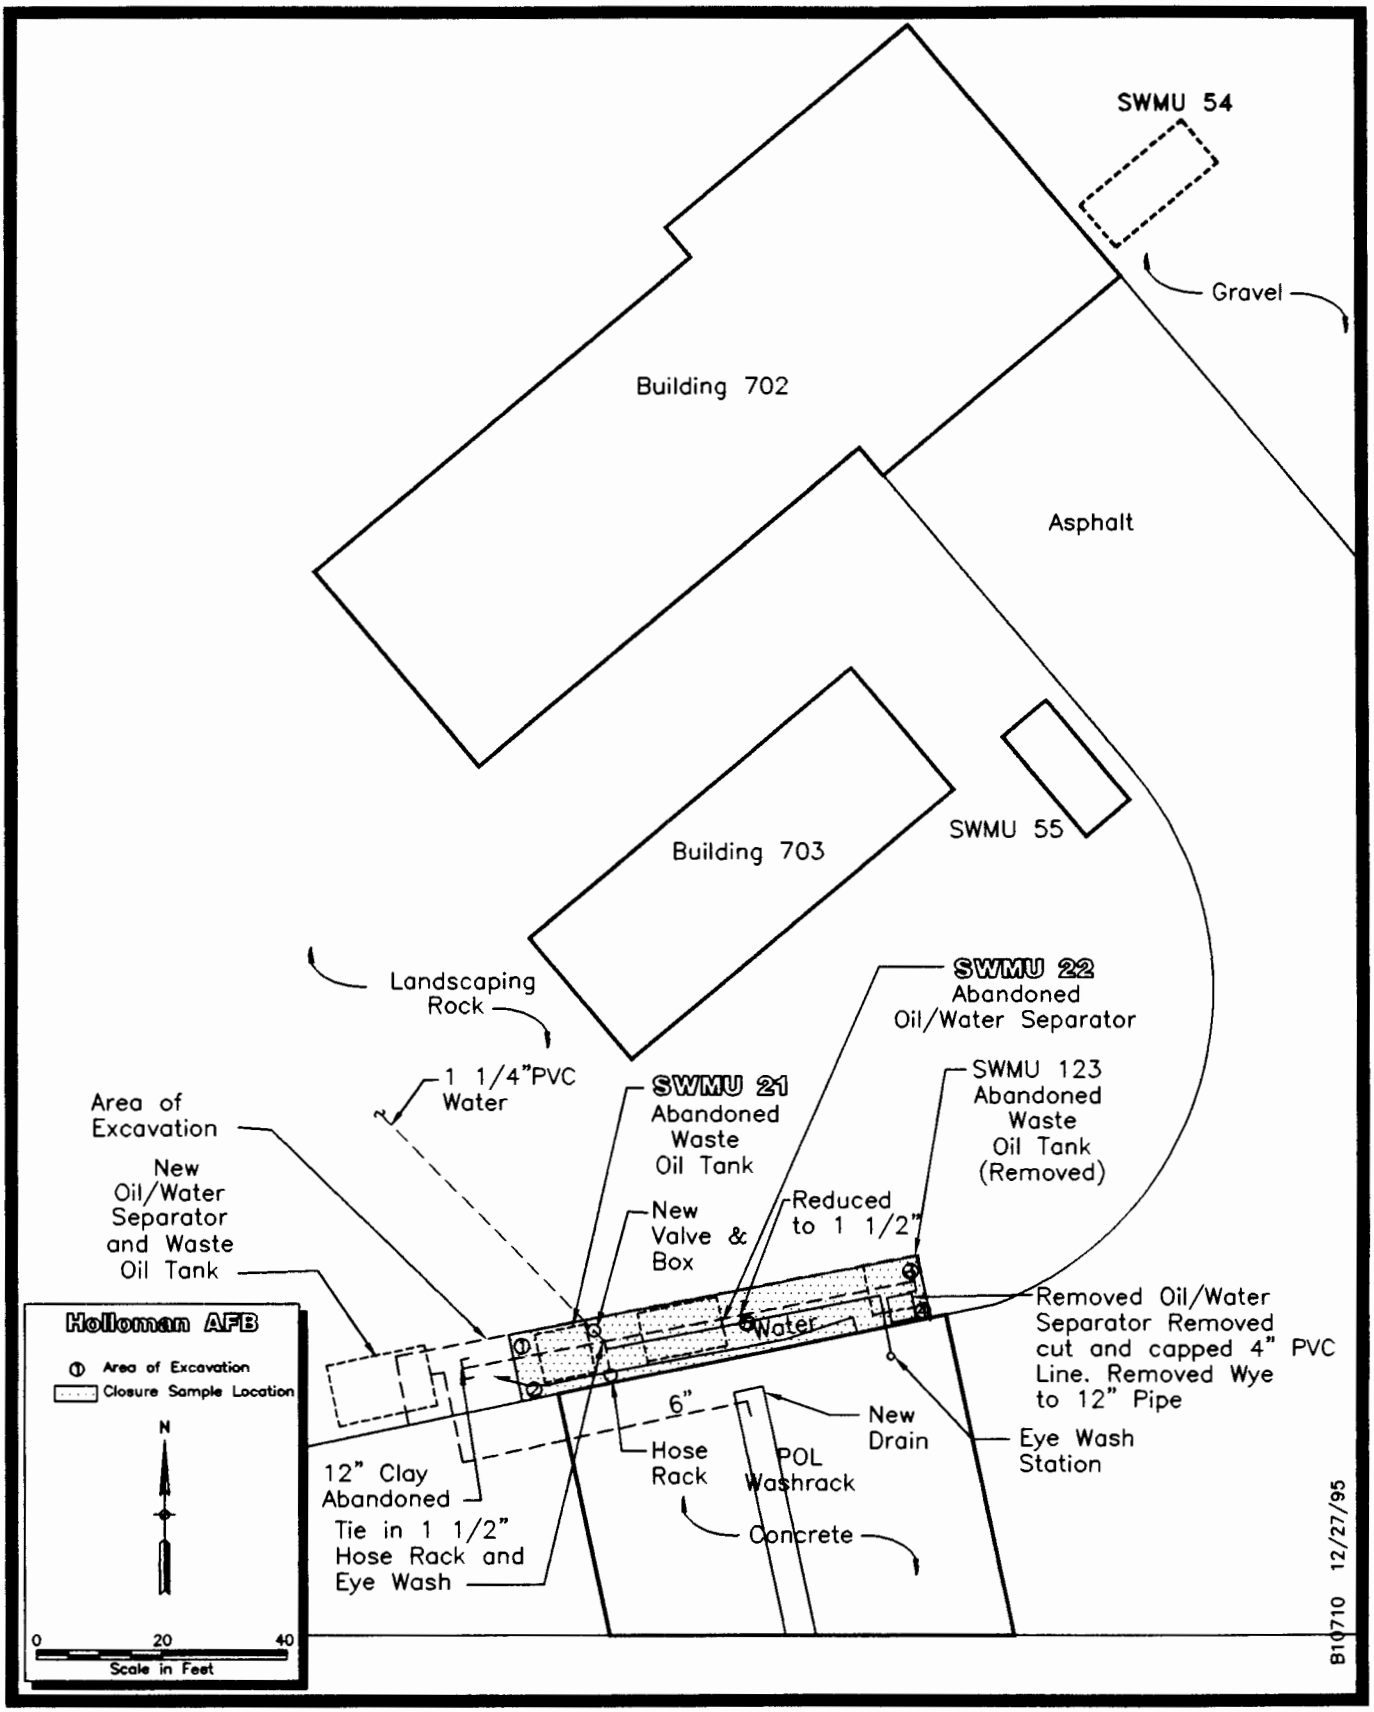
Figure 4-1. SWMUs 21 and 22 – Site Map

Five closure samples were collected from the excavation and analyzed for TRPH only. As indicated on Figure 4-1, closure samples were collected from each of the walls and the bottom of the excavation. Analytical results, which represent in-place soil conditions upon completion of excavation, were less than 1,000 mg/kg for all closure samples.

Only one O/WS was located during restoration activities at these sites. The other O/WS may have been removed during prior site restoration work. The O/WSs associated with SWMUs 21 and 22 are no longer present at these sites, and closure samples indicate that the excavated area meets Base cleanup criteria. NFA is recommended for these sites.

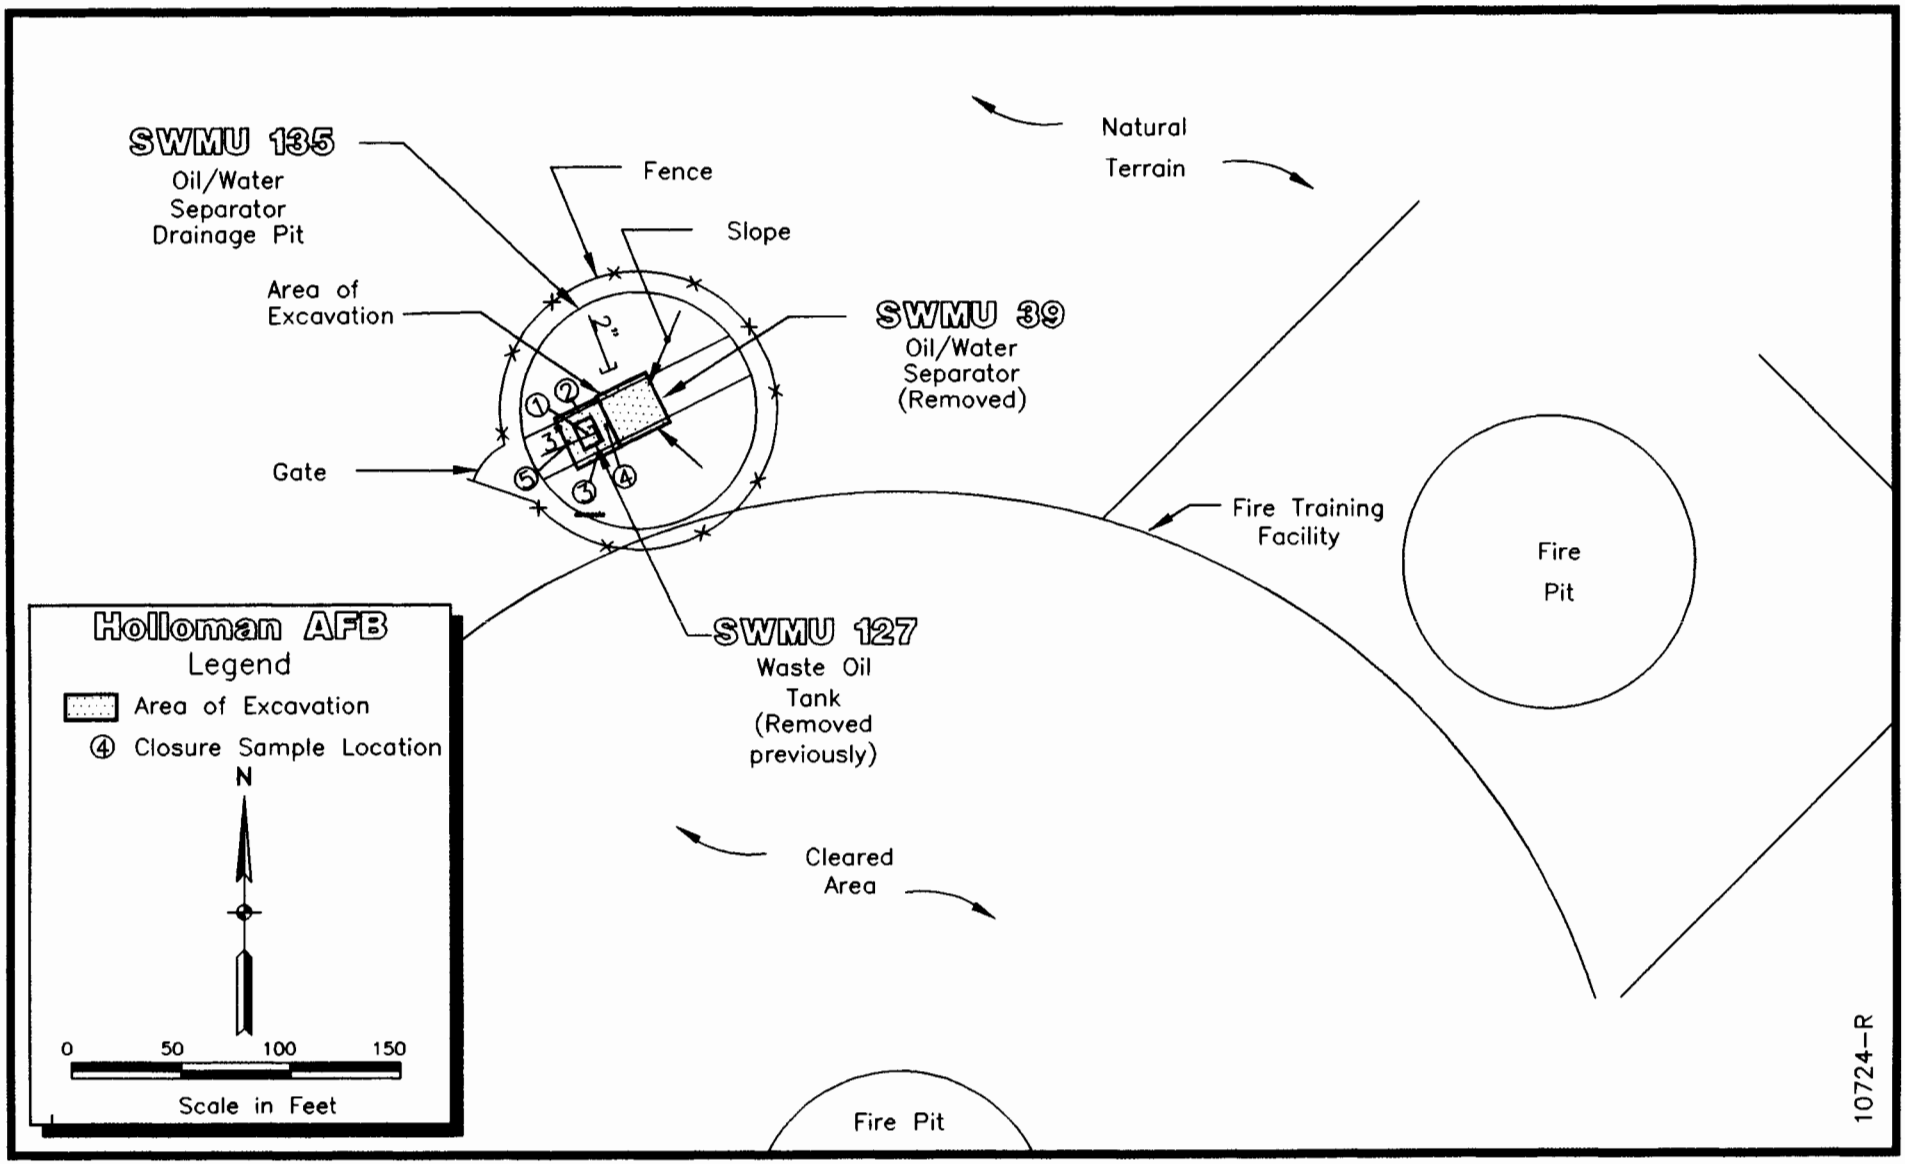
Figure 5-1. SWMU 39 and 127 - Site Map

Five closure samples were collected from the excavation and analyzed for TRPH and VOCs. As indicated on Figure 5-1, closure samples were collected from each of the walls and the bottom of the excavation. Analytical results, which represent in-place soil conditions upon completion of excavation, were less than less than Base cleanup criteria for all closure samples.

NFA is recommended for these sites based on the removal of the O/WS and WOT and the current remediation of the soil by the FT-31 system.

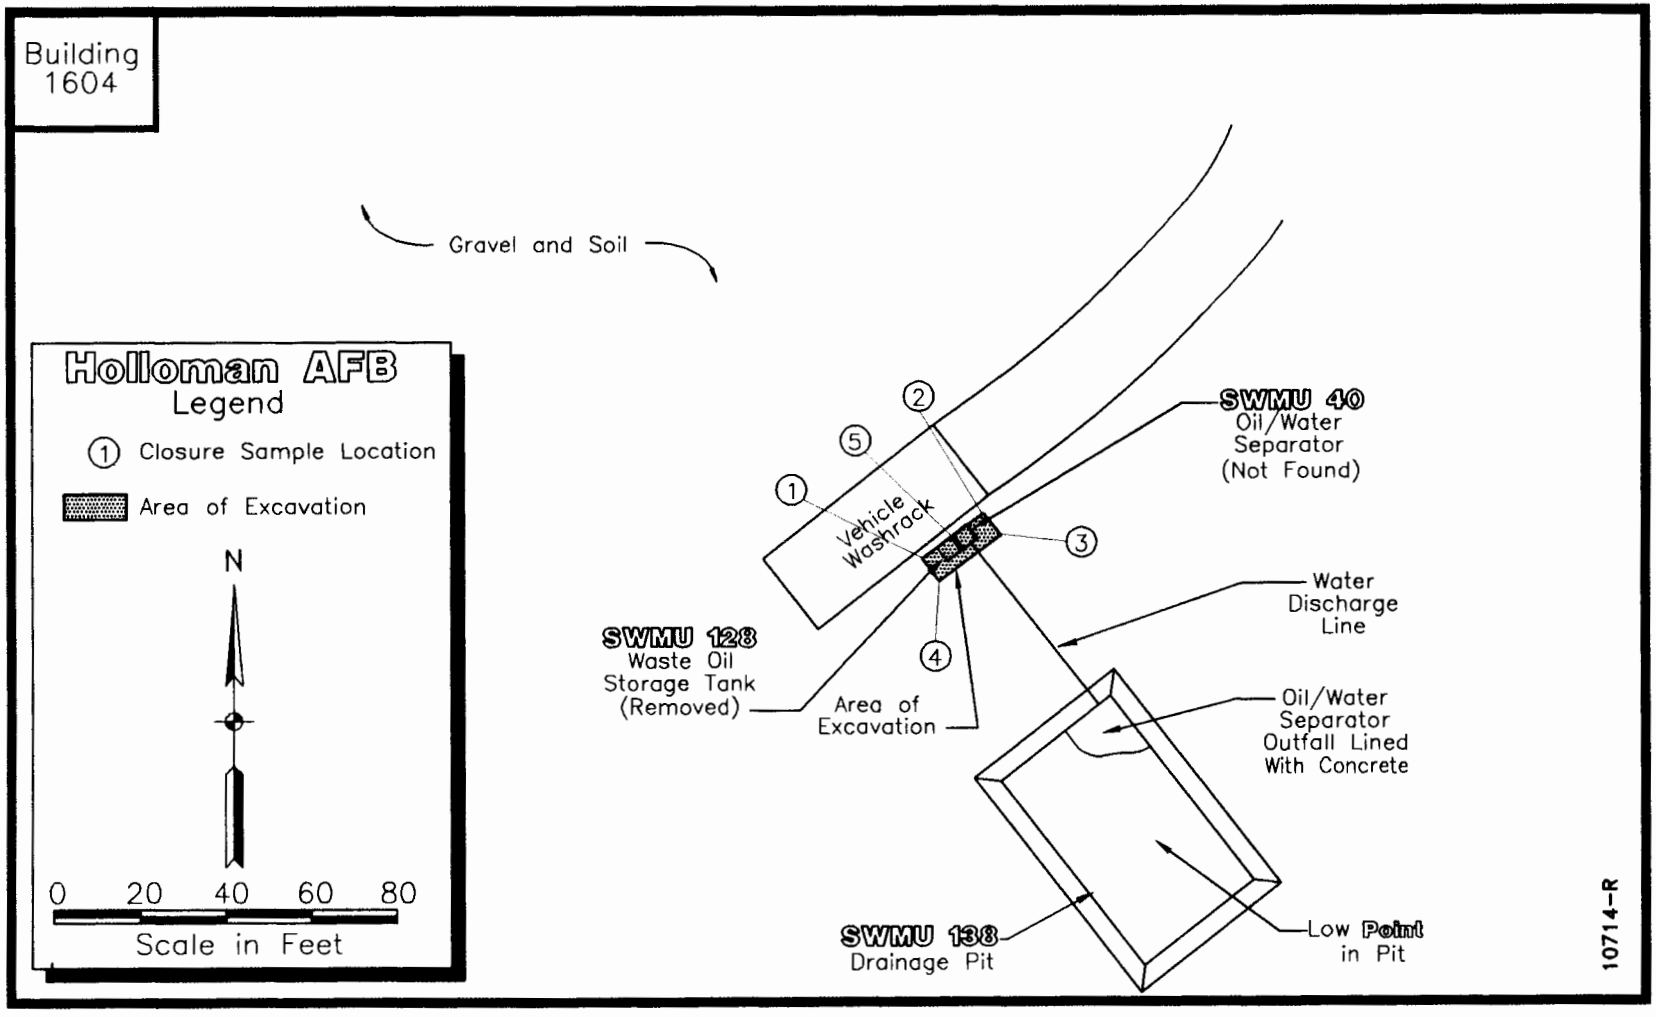
Figure 6-1. SWMU 40 and 128 - Site Map (BLDG. 1166)

One set of five closure samples was collected from the excavation at this site to represent both SWMUs. As indicated on Figure 6-1, closure samples were collected from each of the walls and the bottom of the excavation. Analytical results, which represent in-place soil conditions upon completion of excavation, were less than 1,000 mg/kg for all closure samples.

The WOT was removed and destroyed and closure samples indicate a clean site. The area was thoroughly examined using a backhoe and no O/WS was located. NFA is recommended.

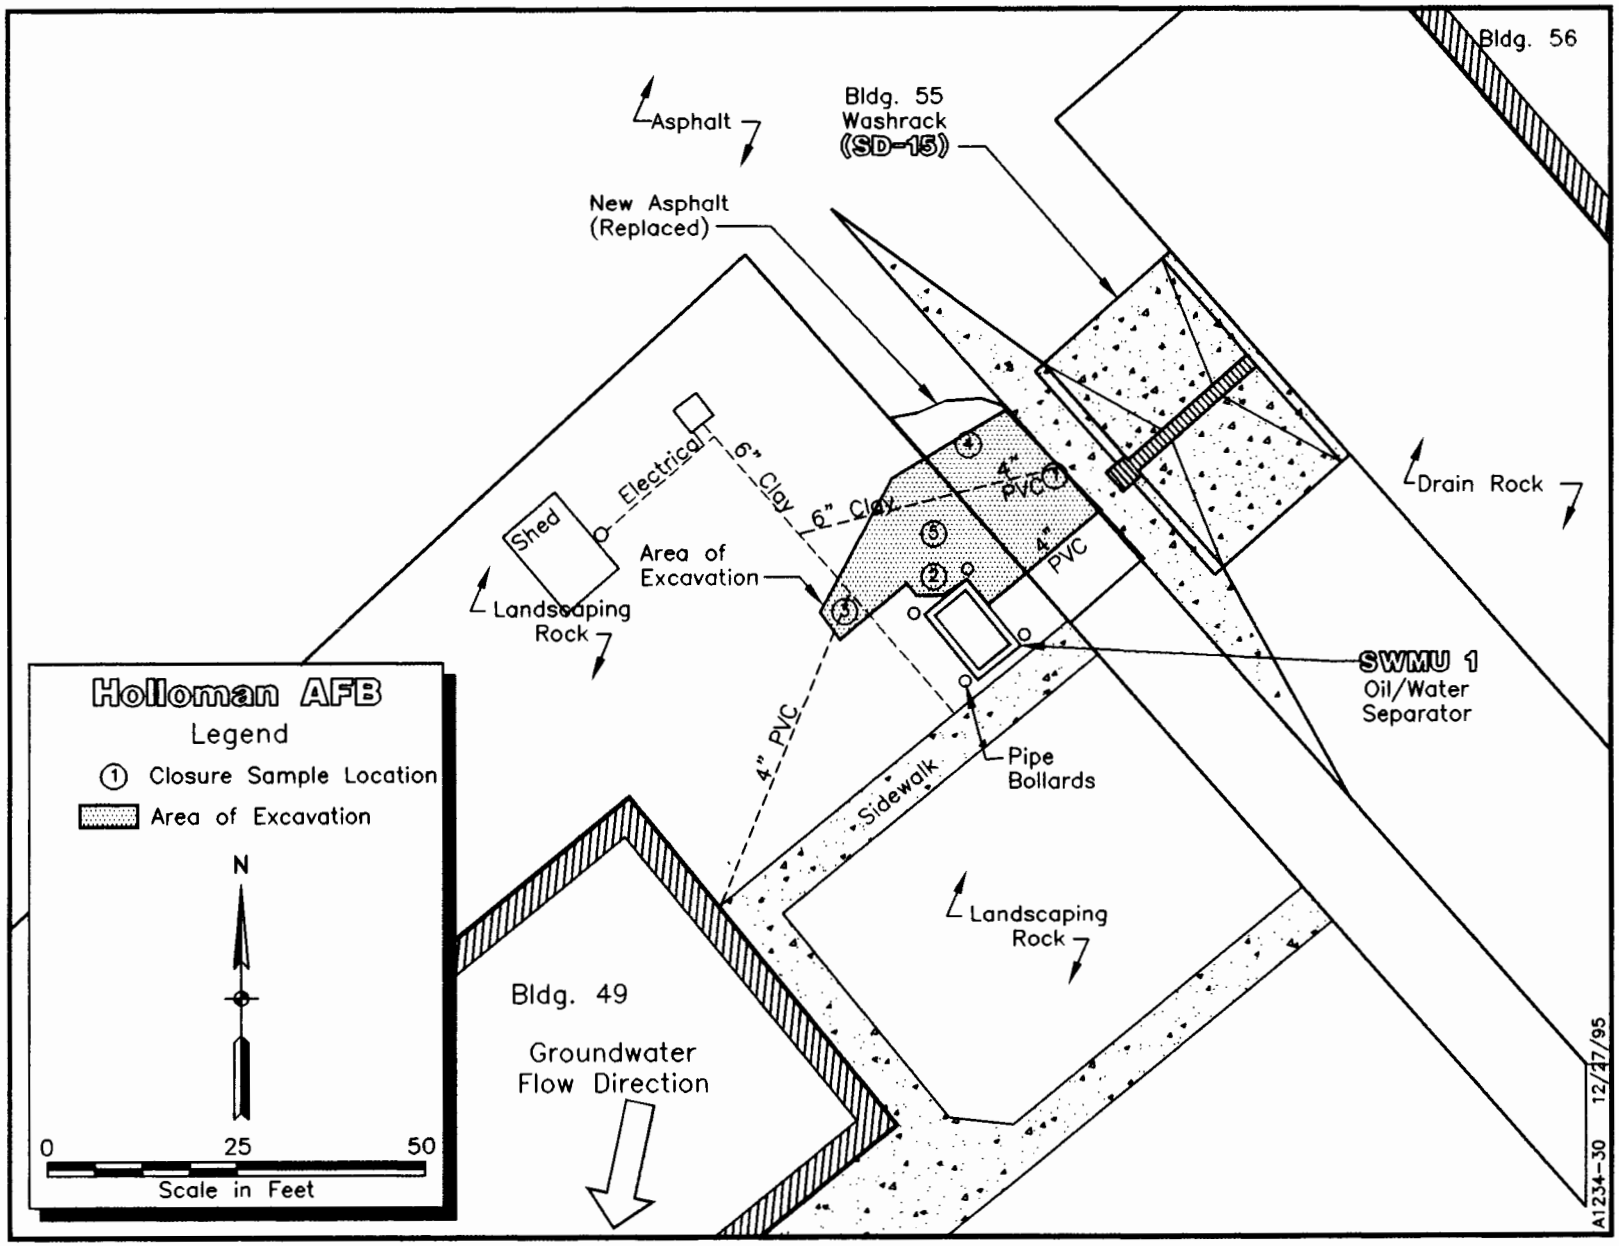
Figure 8-1. SWMU 1 – Site Map

Activities planned for this site included the excavation of soil containing TPH greater than 1,000 mg/kg in the vicinity of SWMU 1, which is located approximately 40 ft northeast of Building 49 (Figure 8-1). The O/WS is an active unit in good working order and has good integrity , and excavation of contaminated soil was attempted without removal of the O/WS. If excavation of contaminated soil had not been feasible without the removal of the O/WS, the removal of the O/WS would be evaluated at the time of excavation. The estimated area of soil contamination was determined during the RFI (Radian 1995).

Landscaping rock was stockpiled and approximately 372 cu yds of soil and 10 cu yds of asphalt were excavated from this site. Analytical results for soil stockpile samples indicated TRPH concentrations were below Base cleanup criteria; therefore, the stockpiled soil was spread. Additional fill was imported and the excavation was backfilled and compacted. Debris, including excavated asphalt, was transported off site for disposal at the Lincoln/Otero County Landfill. Asphalt was replaced in the roadway as indicated on Figure 8-1, landscaping rock was returned to the disturbed area, and a broken 6-inch-diameter clay pipe sewer line was repaired in several places.

Ten closure samples were collected from the excavation at this site. As indicated on Figure 8-1, samples were collected from each of the walls and the floor of the excavation. Samples 6 through 10 were duplicate samples of 1 through 5, respectively. A discussion of the comparison

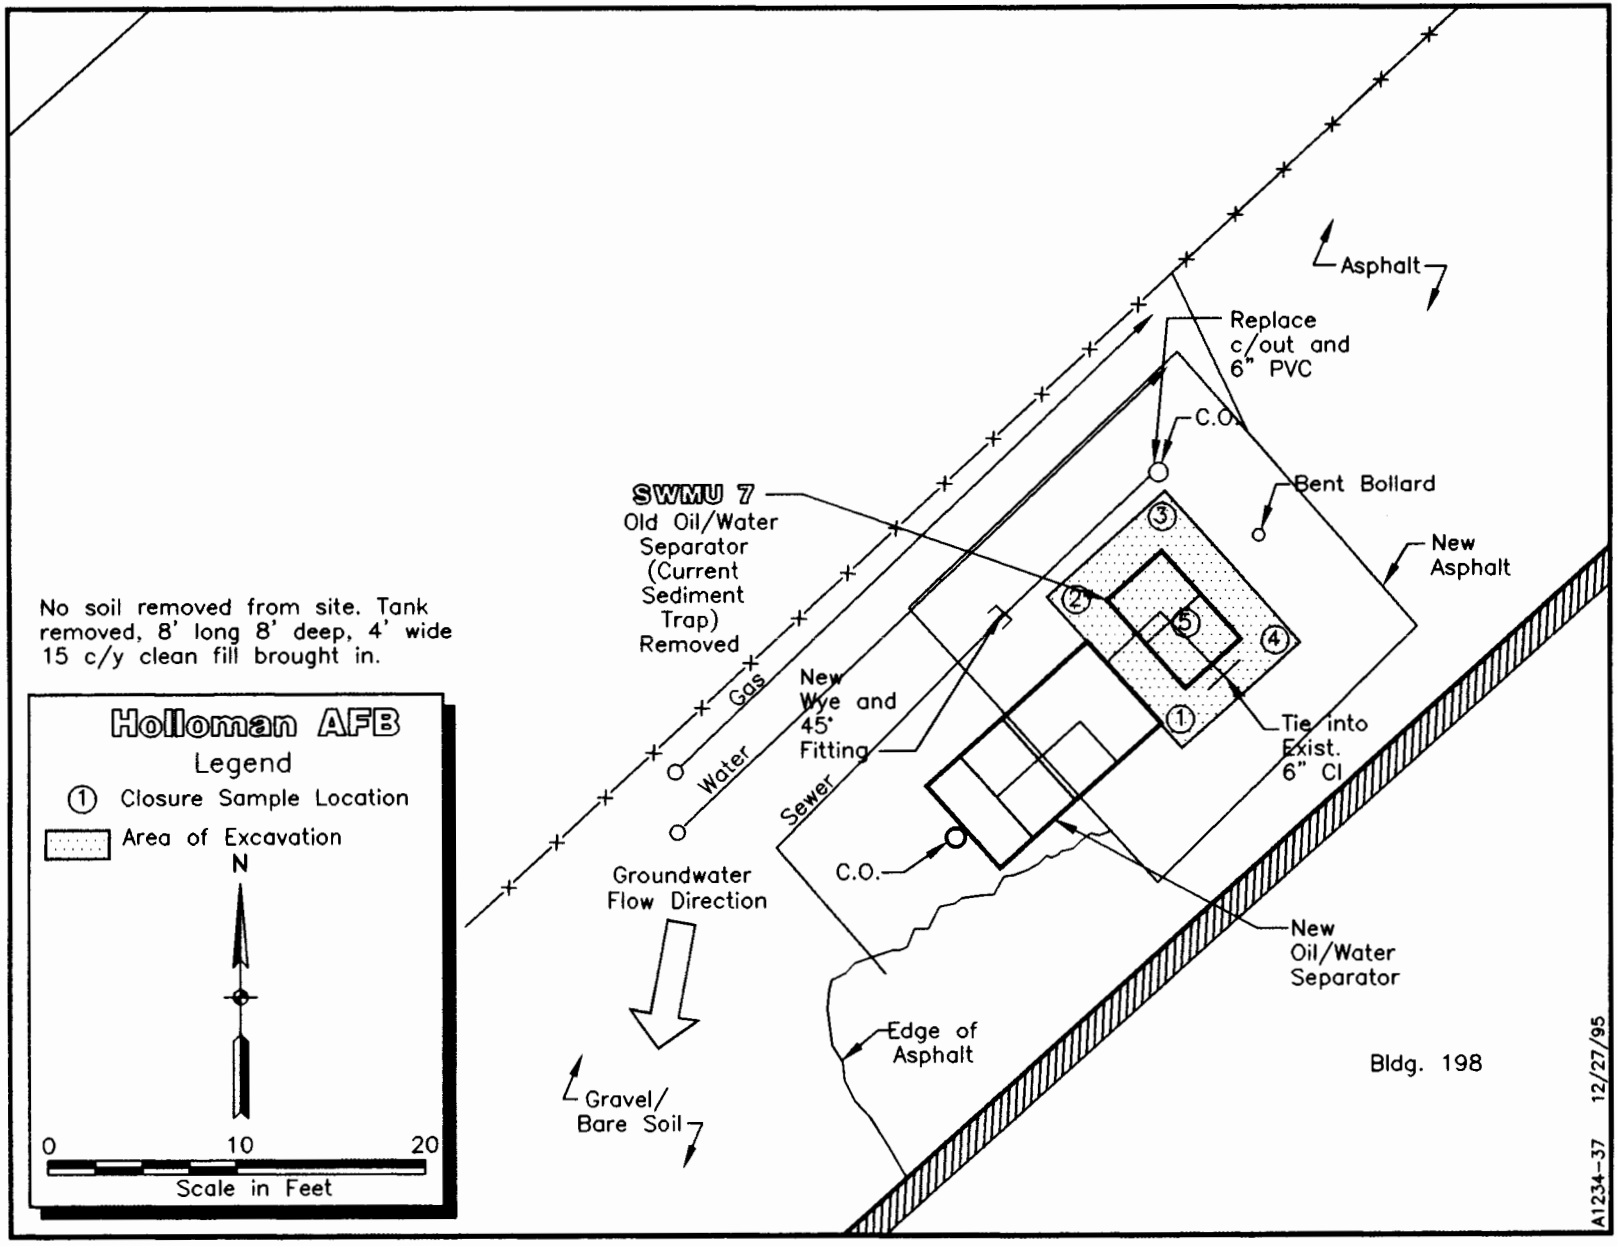
Figure 9-1. SWMU 7 – Site Map

Activities planned for this site included the removal of SWMU 7, which was located on the north side of Building 198 between the fence and the building, and the excavation of soil containing TPH greater than 1,000 mg/kg (Figure 9-1). The estimated area of soil contamination was determined during the RFI (Radian 1995).

Five closure samples were collected from the excavation and analyzed for TRPH only. As indicated on Figure 9-1, closure samples were collected from each of the walls and the bottom of the excavation. Analytical results, which represent soil conditions upon completion of excavation, were less than 1,000 mg/kg for all closure samples.

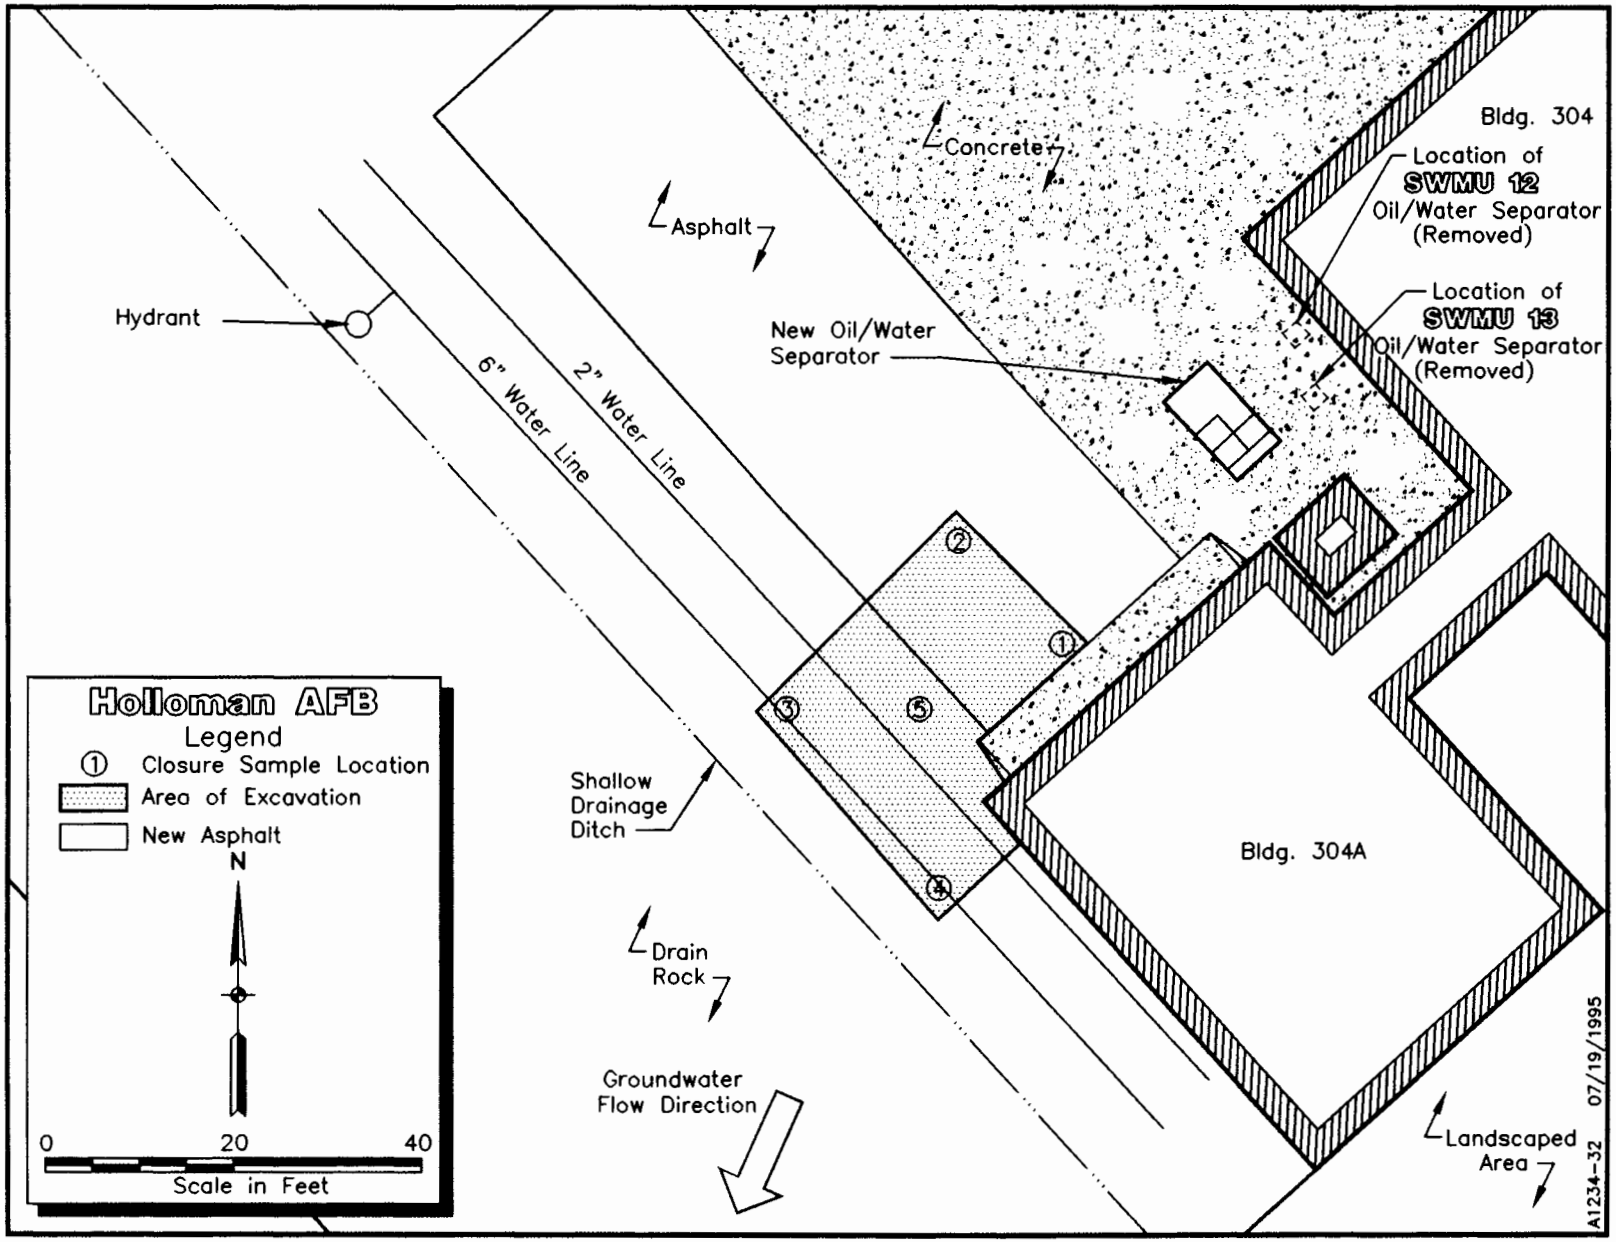
Figure 11-1. SWMUs 12 & 13 - Site Map

Activities planned for these sites included the removal of soil containing TPH greater than 1,000 mg/kg in the vicinity of SWMUs 12 and 13, which was located behind the Base Fire Department (Building 304) prior to their removal in 1993 (Figure 11-1). The estimated area of soil contamination was determined during the RFI (Radian 1995).

Five closure samples were collected from the excavation and analyzed for TRPH only. As indicated on Figure 11-1, closure samples were collected from each of the walls and the bottom of the excavation. Analytical results, which represent soil conditions upon completion of excavation, were less than 1,000 mg/kg for all closure samples.

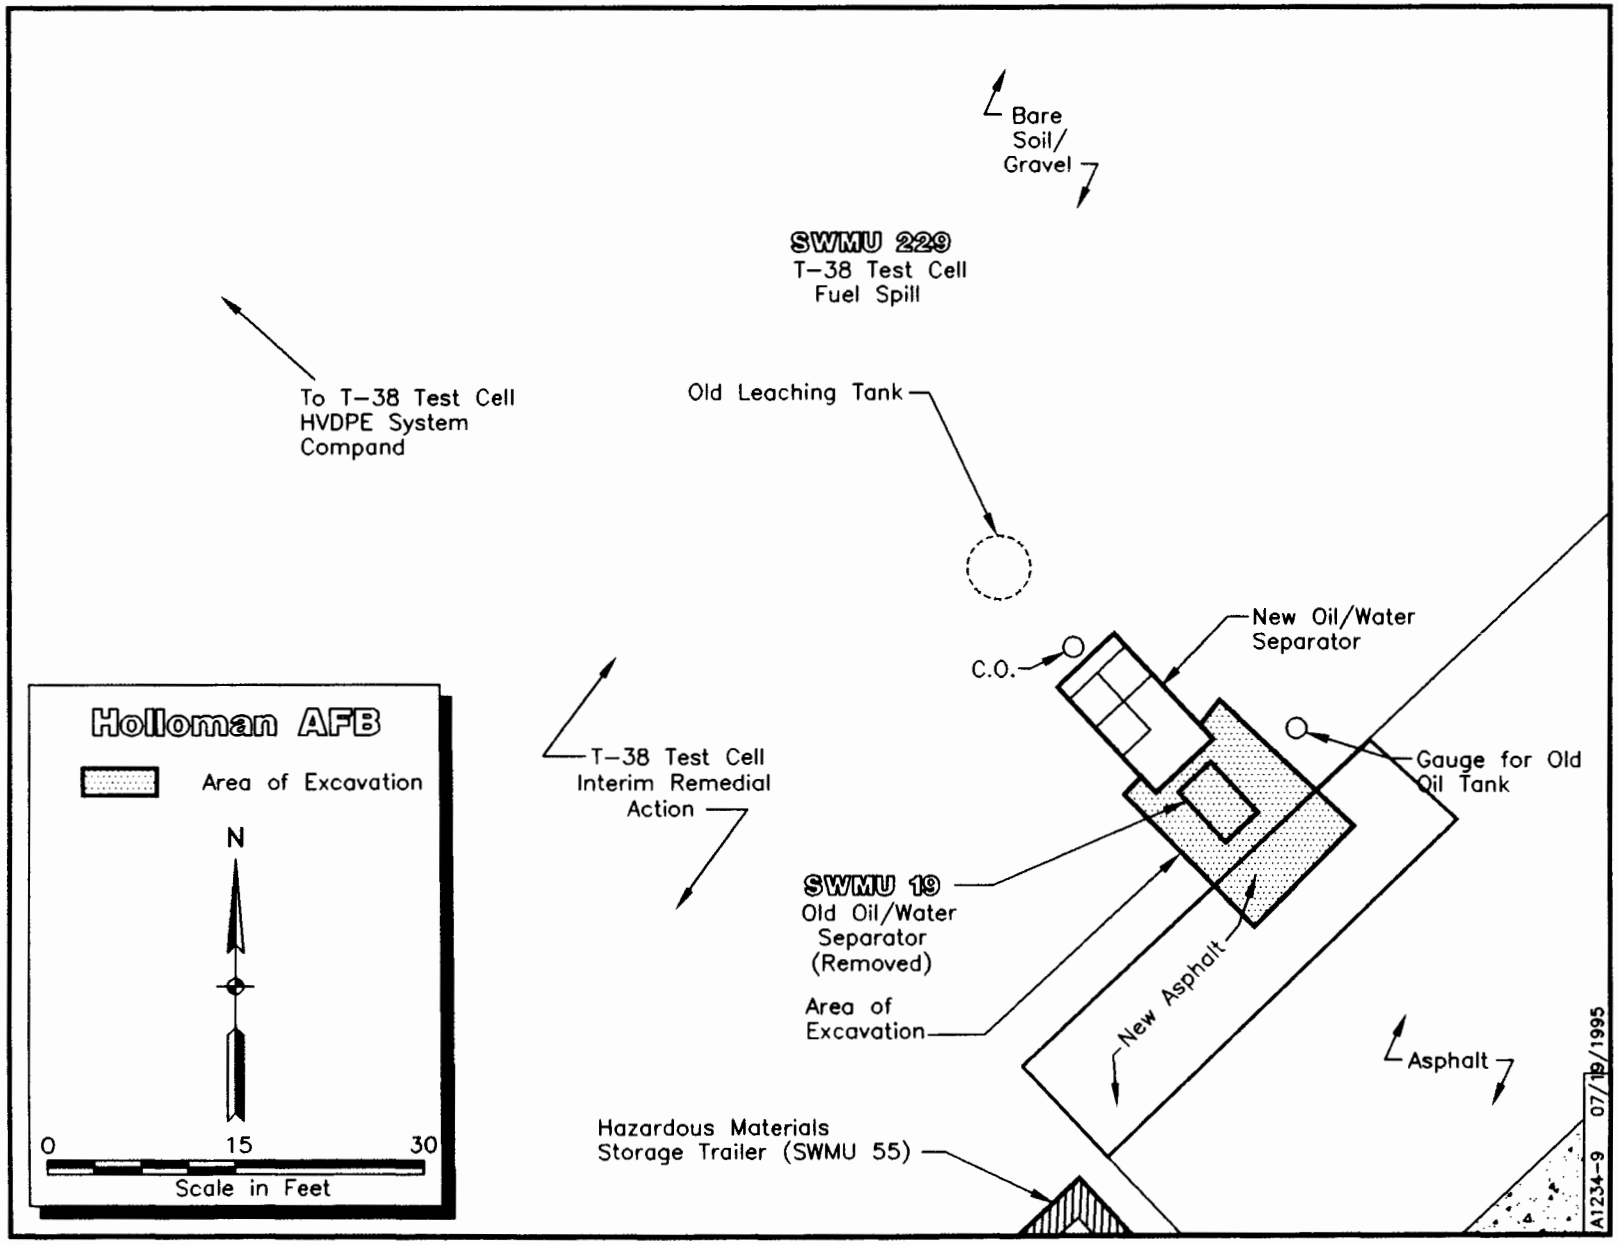
Figure 12-1. SWMU 19 - Site Map

The SWMU 19 O/WS was removed and the soil is currently being remediated in situ with the T-38 Test Cell HVDPE system; therefore, this site is recommended for NFA.

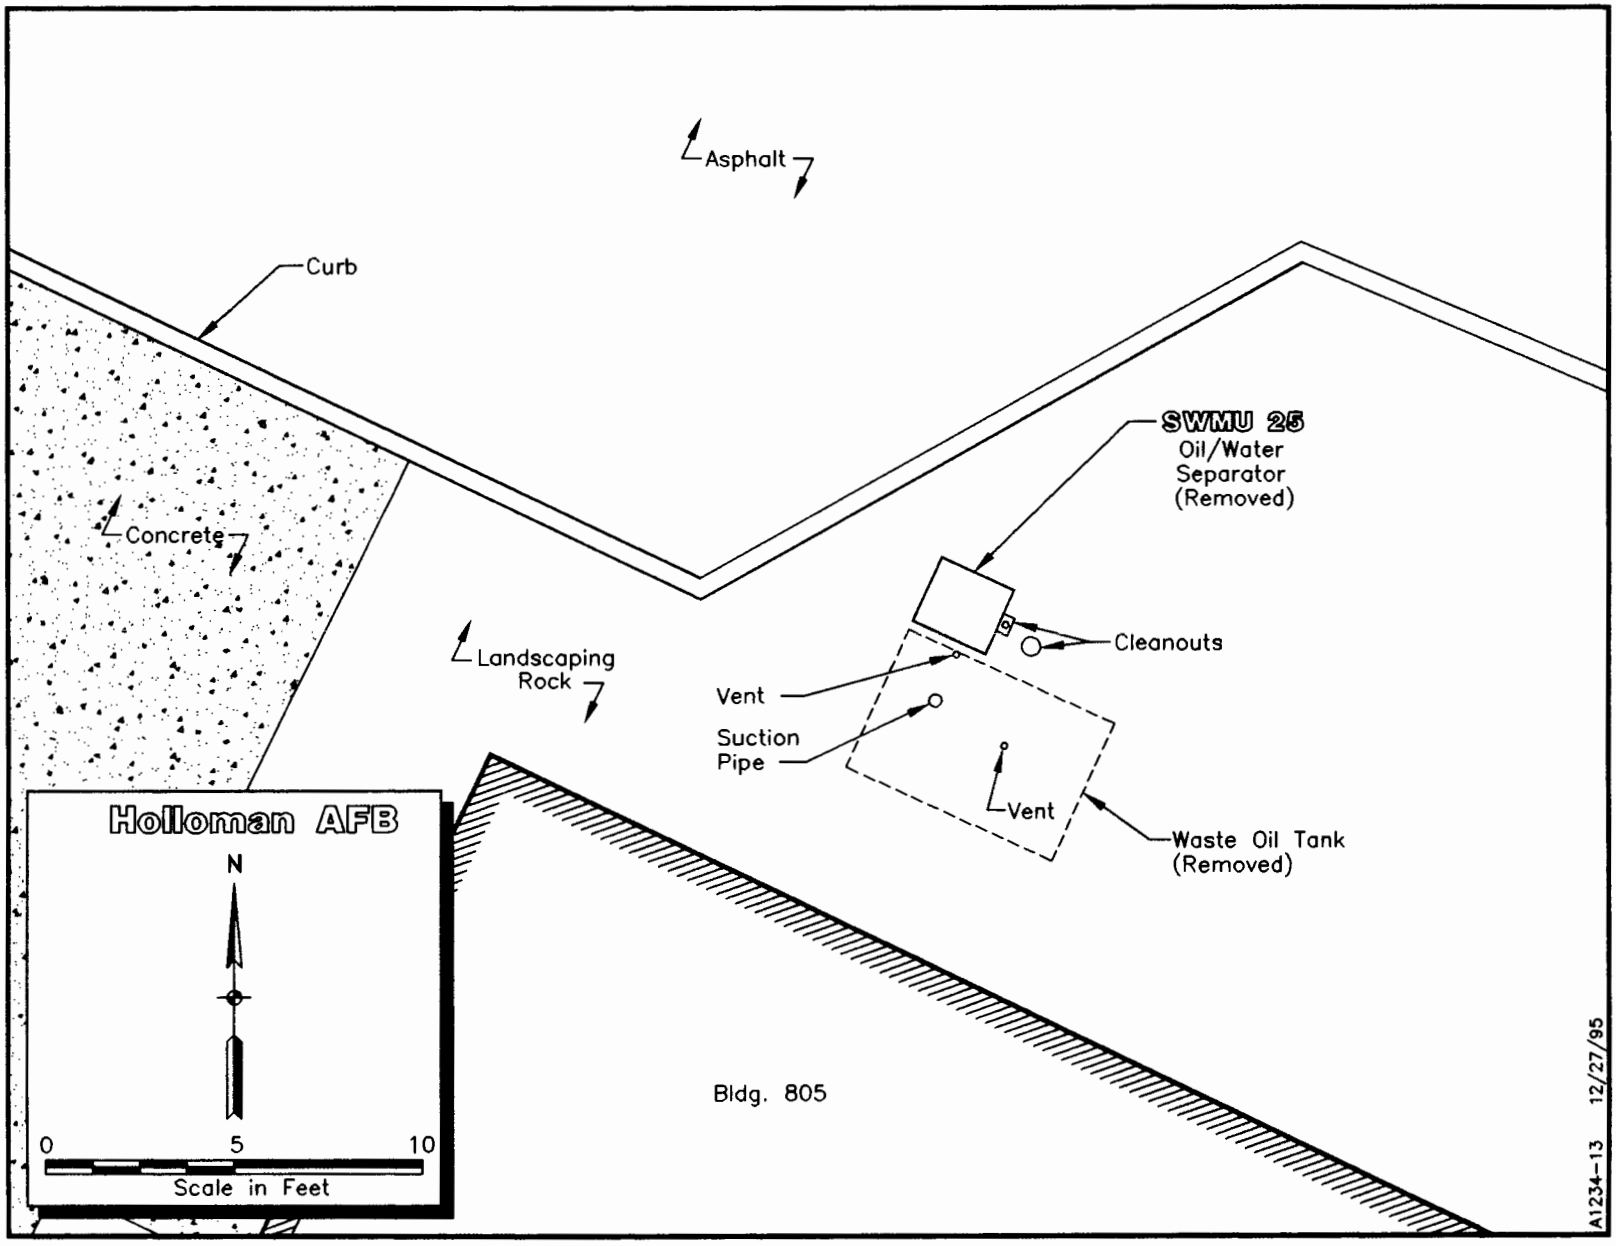
Figure 13-1. SWMU 25 - Site Map

Upon arrival at this site, FWENC was informed that the WOT and O/WS (SWMU 25) were removed prior to 1988 as part of a previous restoration and all lines were capped. Because the restoration at this site has already been completed, NFA is recommended.
