Subject: TERC Contract DACW45-94-D-0003, DO 11, WAD 3
Submittal of the Final Closure Report for the Phase II Remediation of POL-Contaminated Sites and Oil/Water Separator and Waste Oil Tank Removals, Holloman AFB, New Mexico

Foster Wheeler Environmental Corporation responses to comments on the Draft Closure Report for Phase II Remediation of POL-Contaminated Sites and Oil/Water Separator and Waste Oil Tank Removals, Holloman AFB, New Mexico

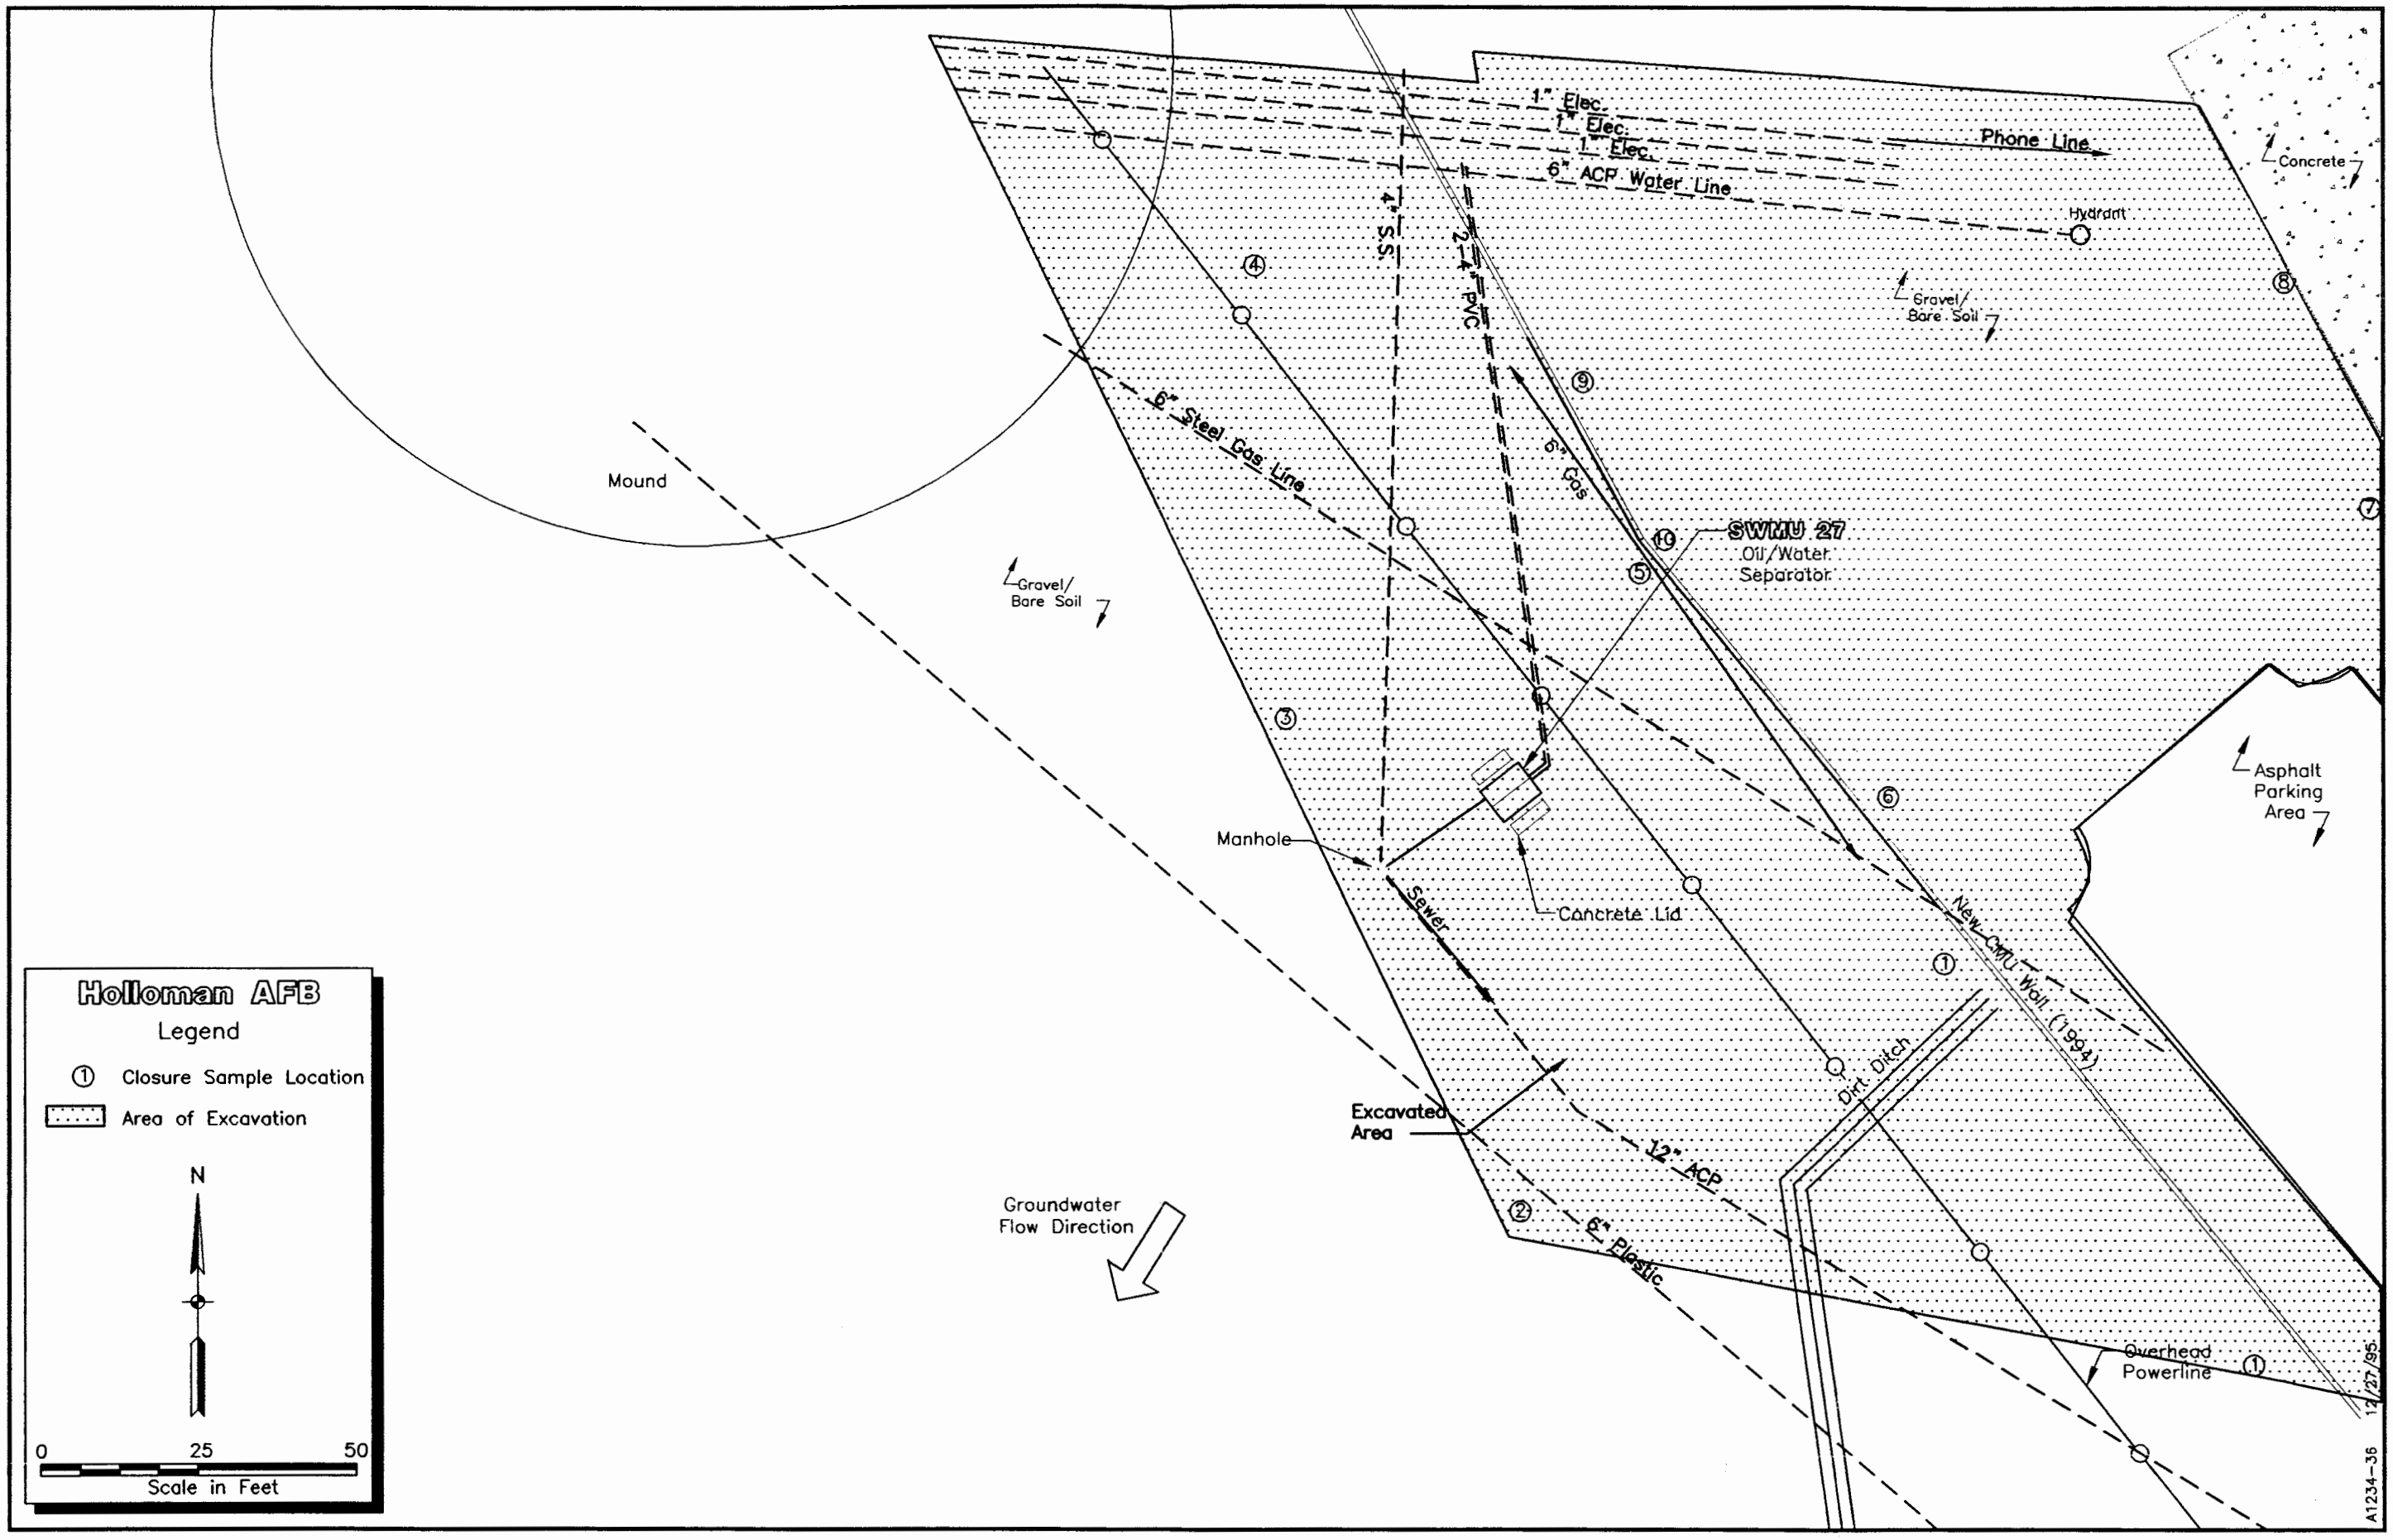
Figure 14-1. SWMU 27 - Site Map

Activities planned for this site included the removal of SWMU 27, which was located approximately 1/4 mile northwest of the Hush Houses, excavation of soil containing TPH greater than 1,000 mg/kg, and recovery of LNAPL, if present (Figure 14-1). The estimated area of soil contamination and location of LNAPL was determined during the RFI (Radian 1995).

Ten closure samples were collected from the excavation for site closure and analyzed for BTEX, TRPH, SVOCs, and lead. As indicated on Figure 14-1, five closure samples were collected from the walls and five closure samples were collected from the bottom of the excavation. Analytical results, which represent soil conditions upon completion of excavation, were less than Base cleanup criteria for all closure samples. Bis(2-ethylhexyl) phthalate was detected at 400 mg/kg, which approaches the EPA Region III RBC of 410 mg/kg for an industrial-based soil

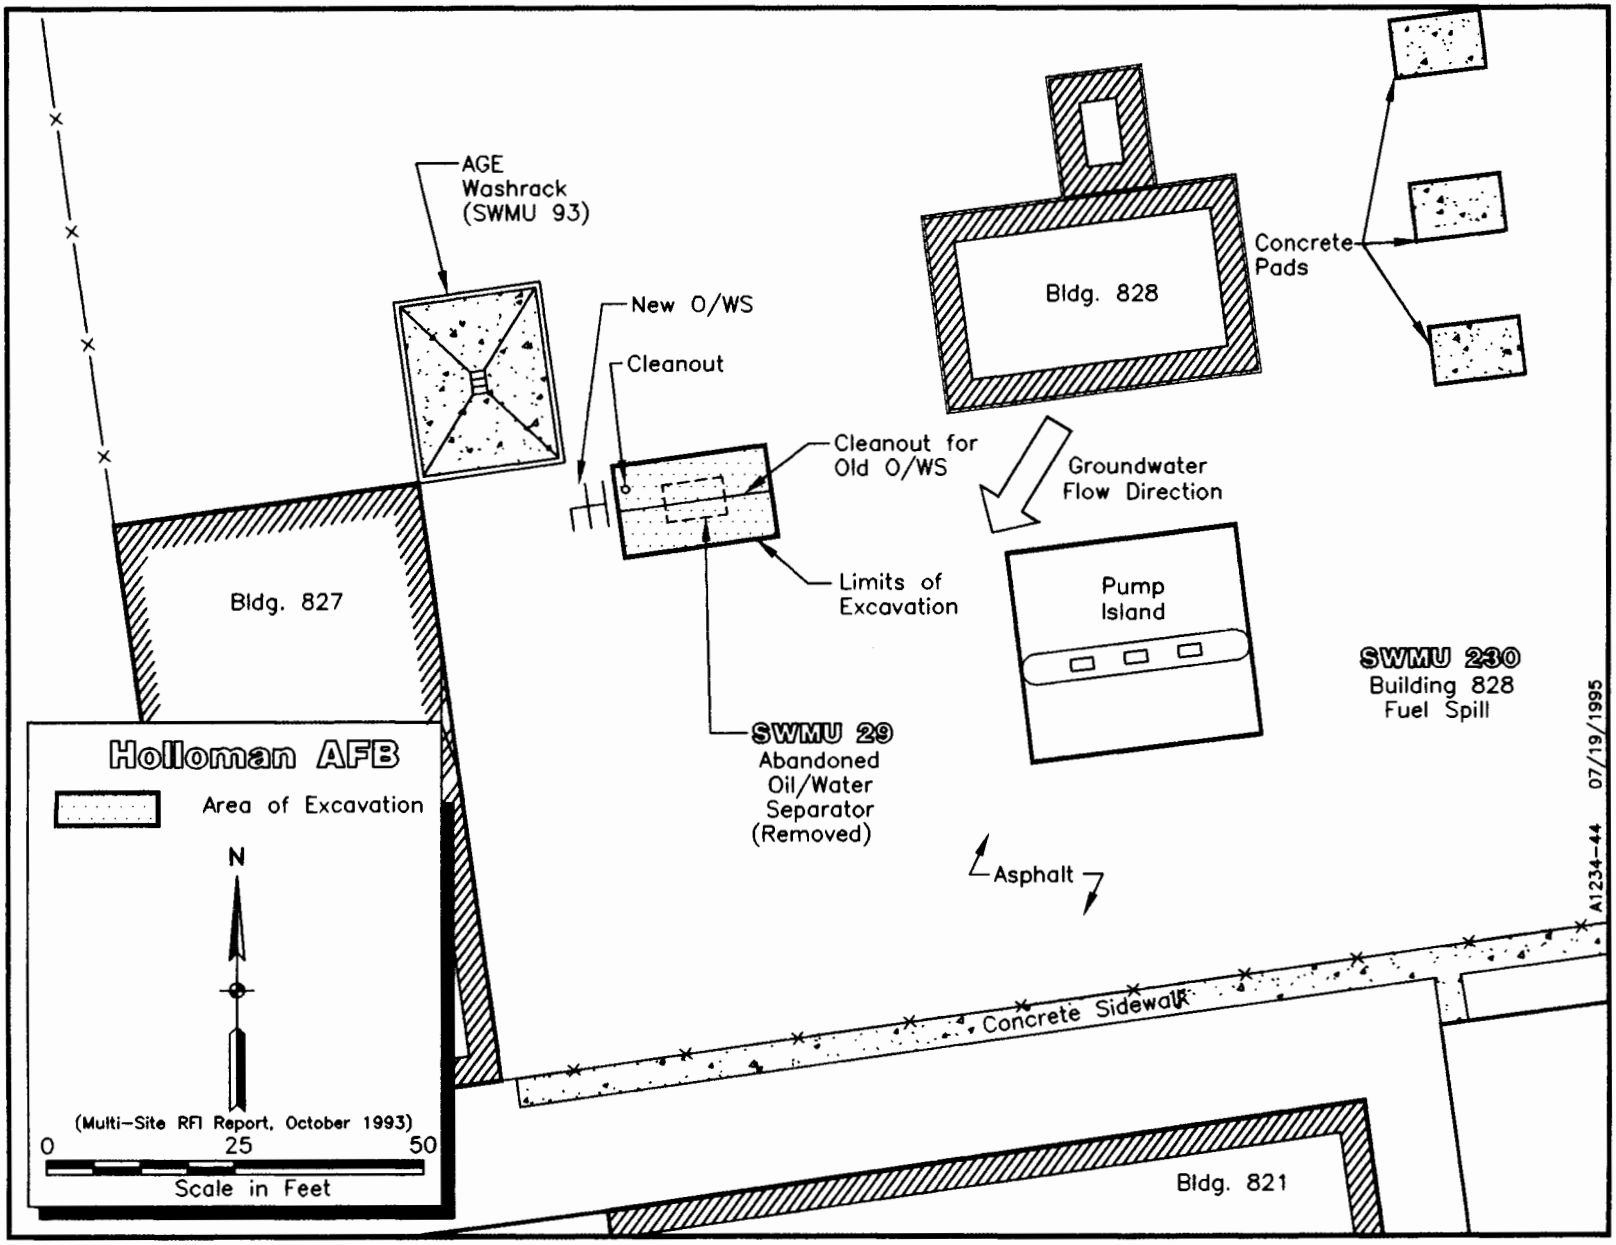
Figure 15-1. SWMU 29 - Site Map

The SWMU 29 O/WS has been removed and all soil is currently being remediated by the Building 828 HVDPE system. NFA is recommended for this site.

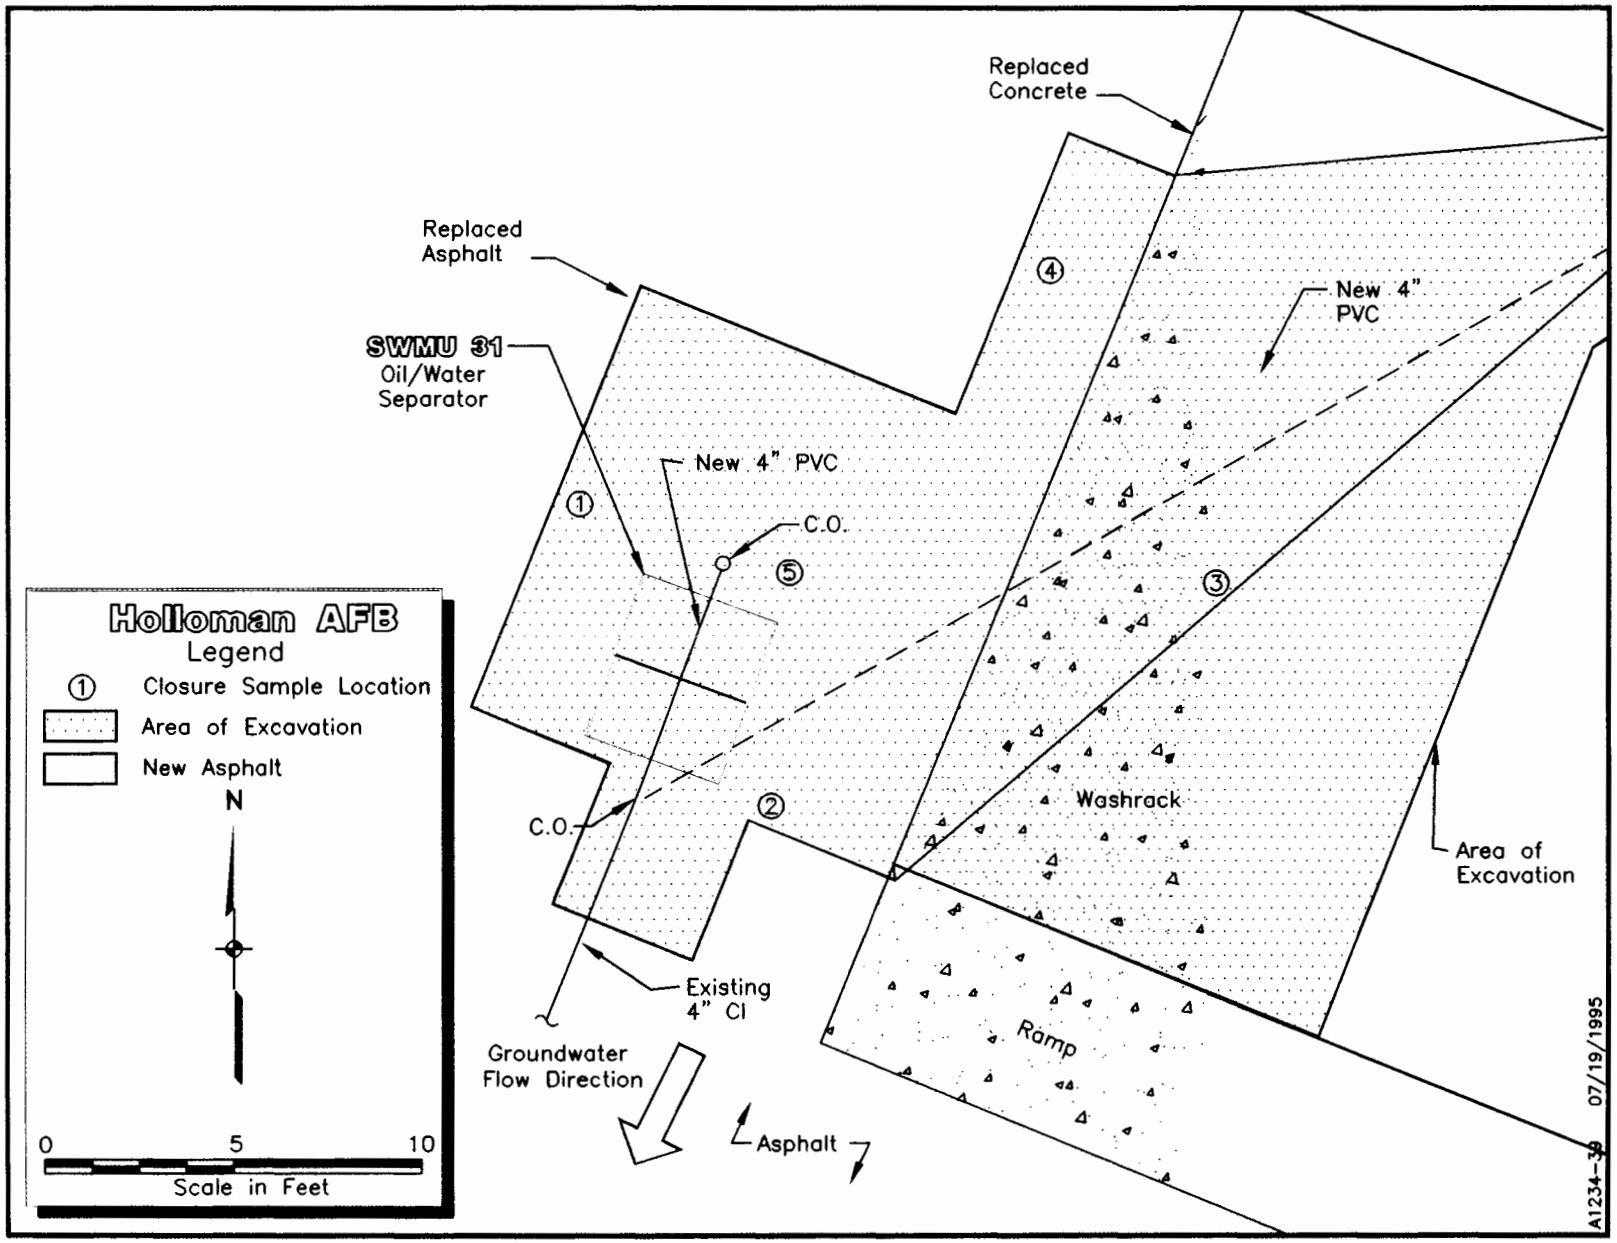
Figure 16-1. SWMU 31 - Site Map

Activities planned for this site included the removal of SWMU 31 (Figure 16-1), which was located adjacent to the washrack near Building 855, and the excavation of soil containing TPH greater than 1,000 mg/kg. The estimated area of soil contamination was determined during the RFI (Radian 1995).

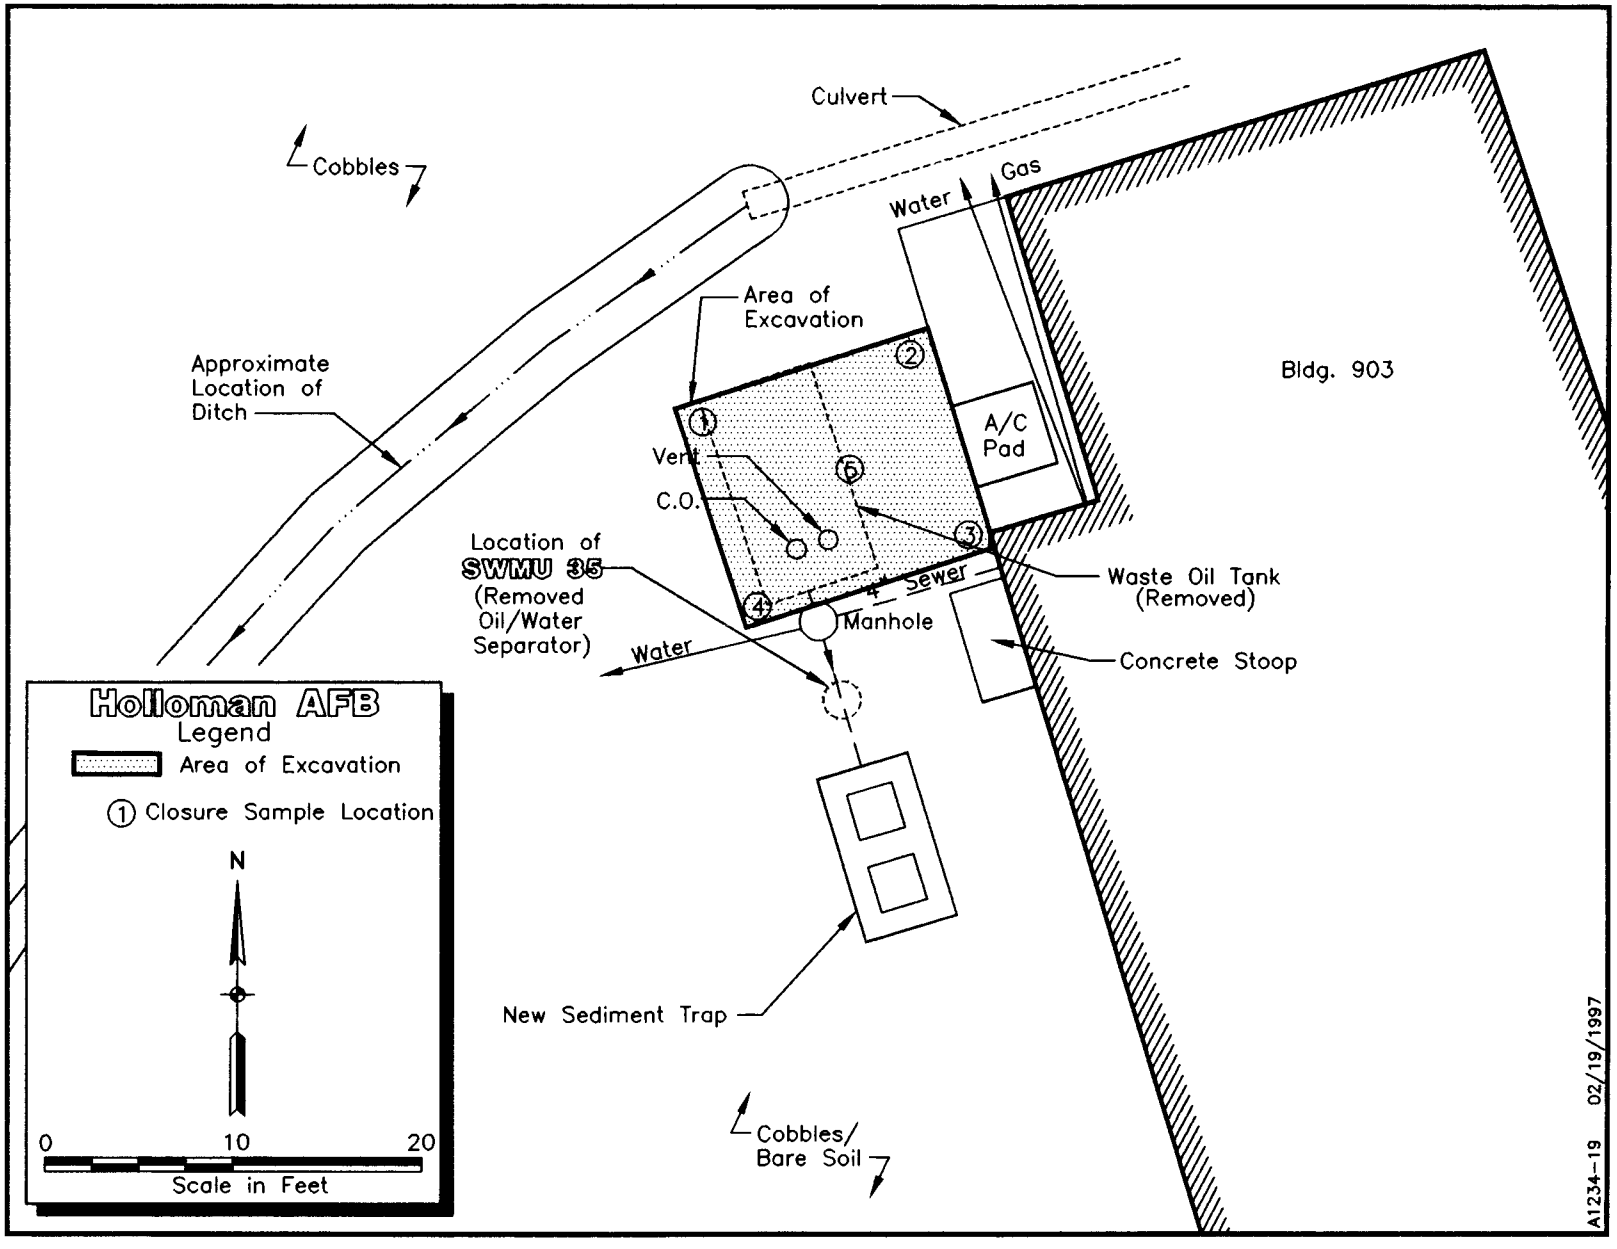
Figure 17-1. SWMU 35 - Site Map

Activities planned for this site include the removal of the WOT related to SWMU 35, which was located north of the new sediment trap in the vicinity of the cleanout, vent, and manhole, approximately 10 ft west of Building 903, and the excavation of soil containing TPH greater than 1,000 mg/kg (Figure 17-1). The estimated area of soil contamination was determined during the RFI (Radian 1995).

Five closure samples were collected from the excavation and analyzed for TRPH only. As indicated on Figure 17-1, closure samples were collected from each of the walls and the bottom of the excavation. Analytical results, which represent soil conditions upon completion of excavation, were less than 1,000 mg/kg for all closure samples.

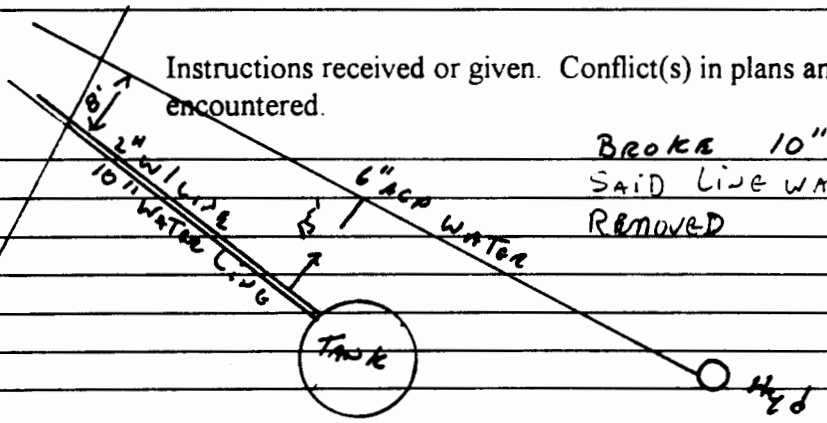
BROKE 10" W/LINE BASE ODS SAID LINE WAS DEAD, PIPE WAS REMOVED
