SPILL PREVENTION CONTROL AND COUNTERMEASURES PLAN

STEAM PLANT TA-21-357

Los Alamos National Laboratory

Revision 1: February 2002

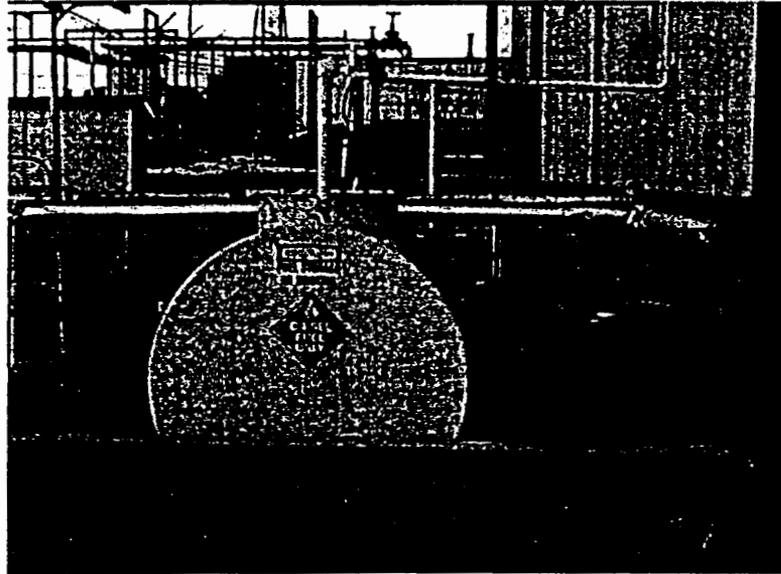
Photograph 5 – 600-Gallon "Day" Tank

Direction: A release from this AST would be contained by the 1,100-gallon concrete secondary containment unit, which surrounds this AST. The secondary containment would hold the entire contents of this AST (see Photograph 5).

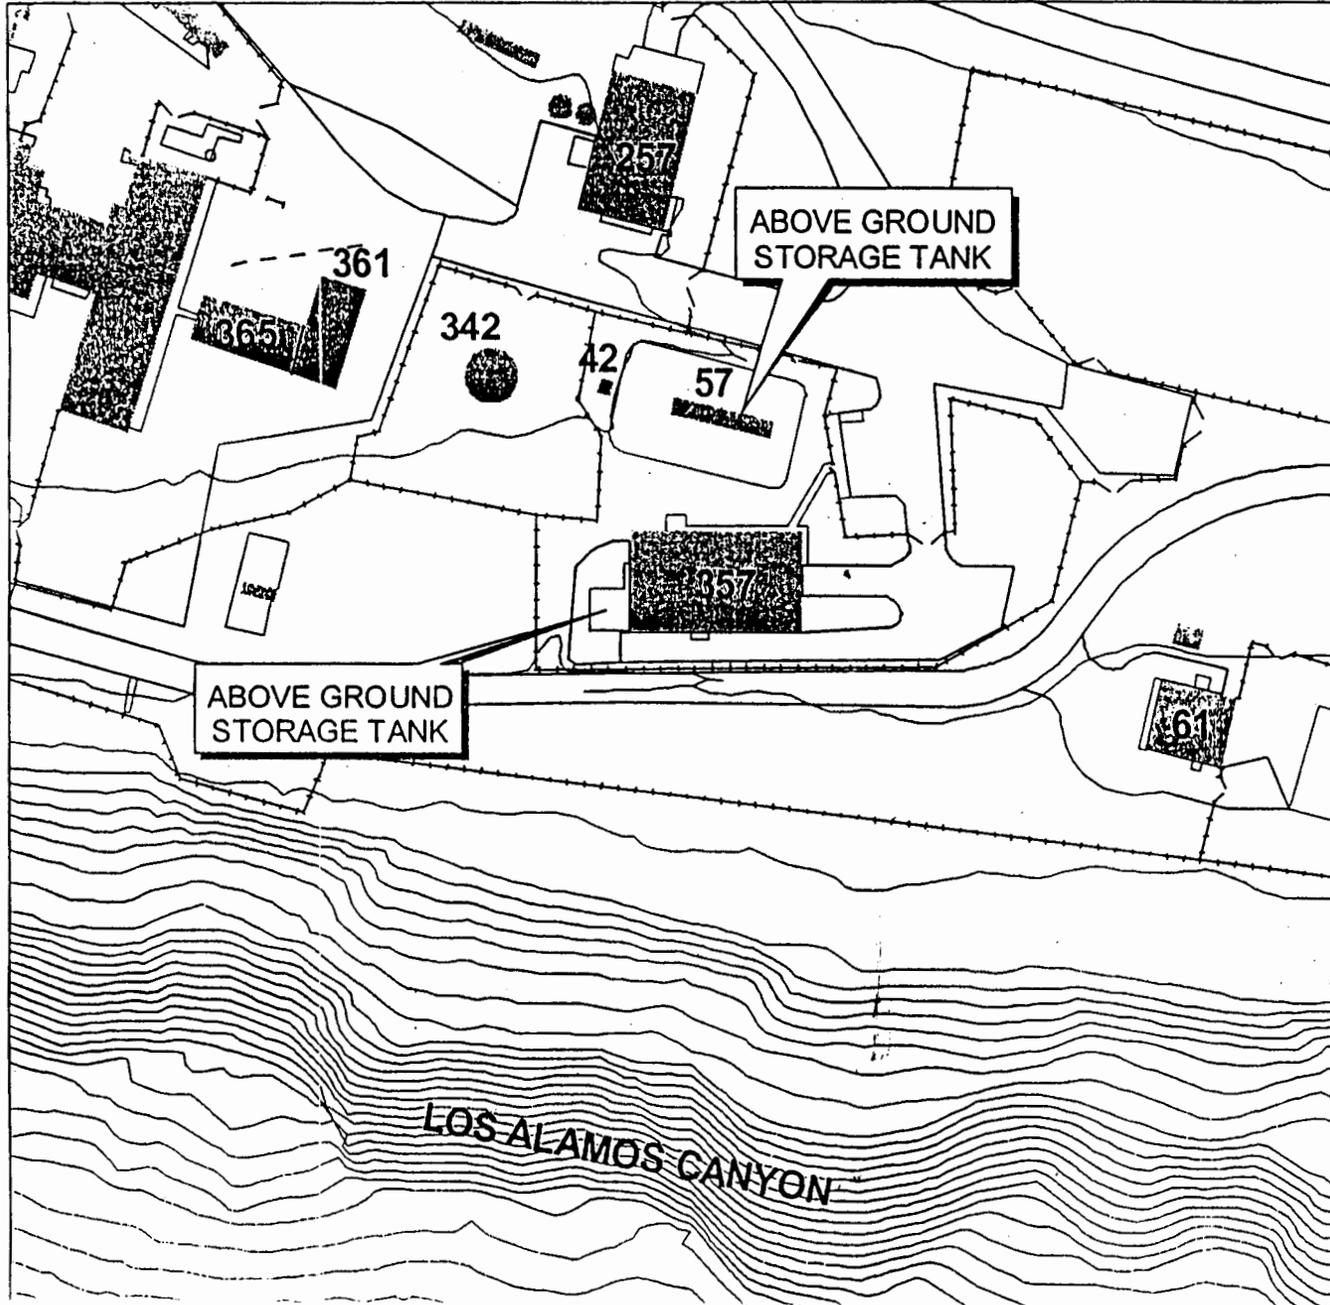
**SPCC FACILITY
SITE MAP FOR TA-21
STEAM PLANT
(TA-21-0357)**

TA-21 Steam Plant Site Map
