SUBJECT: Response to Notice of Deficiency (NOD), Closure Report for Petroleum, Oil and Lubricant (POL) Contaminated Sites

1. In response to your 25 Jun 97 NOD, Holloman AFB (HAFB) submits the revised Final Closure Report for Phase II Remediation of POL-Contaminated Sites and Oil/Water Separators and Waste Oil Tank Removals (Atch 1) and the following informational comments. First, in response to Global Comment 1, all previous reports that identified chemicals of concern (COCs) detailed that information in regards to contaminant level and affected media. All future reports will also list any identified COCs. However, the attached report listed no COCs due to the fact that none were identified. Each of the Solid Waste Management Units (SWMUs) described in this report was subjected to either a qualitative or quantitative risk assessment. Appendix C of the previously-submitted Phase I Table 2 RCRA Facility Investigation Report (RFI) and Appendix D of the previously-submitted Table 3 RFI Report detail the methodology used to identify COCs. Therefore, no COCs are listed in the updated report submitted under this cover. ← Yes, verified. CA. OK

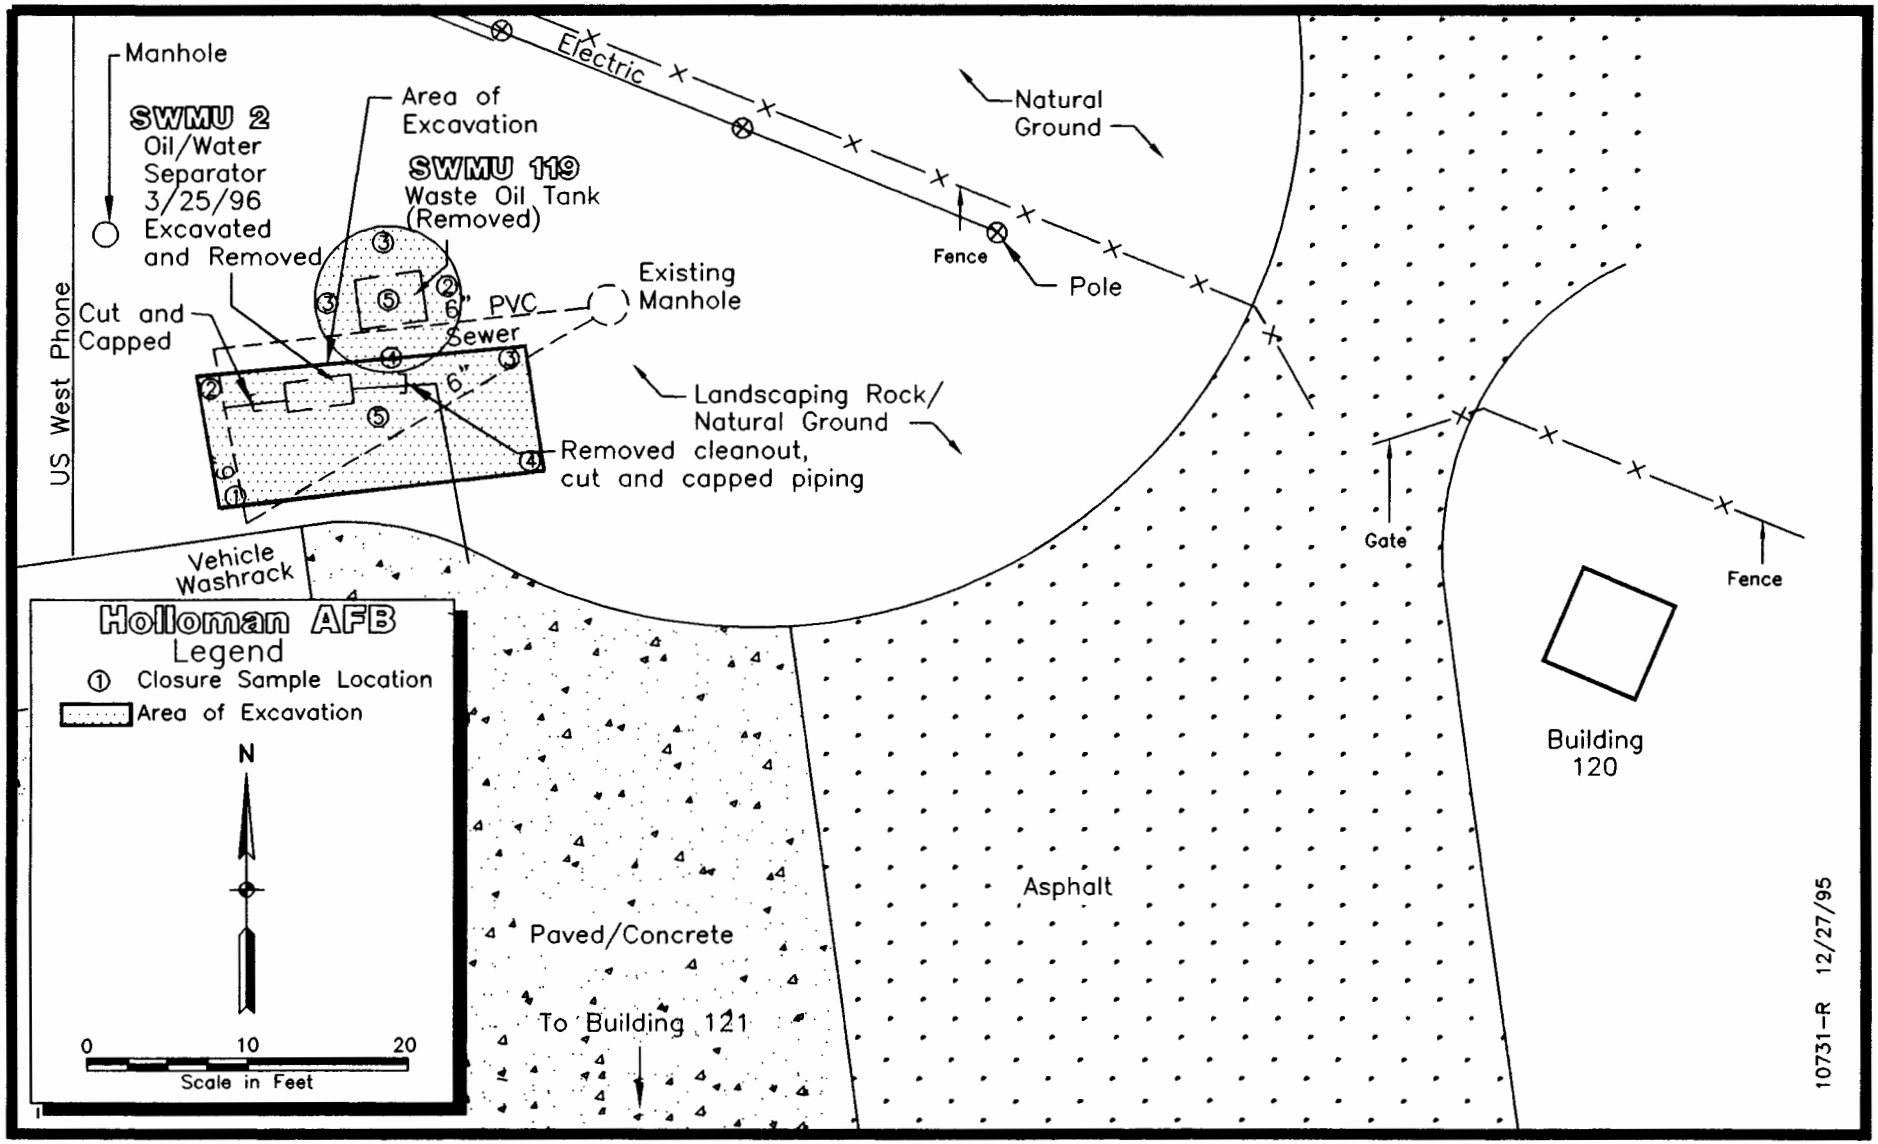
Figure 3-1. SWMUs 2 and 119- Site Map

The O/WS and WOT were removed and all closure samples contained less than 1,000 mg/kg TRPH. NFA is recommended for this site.

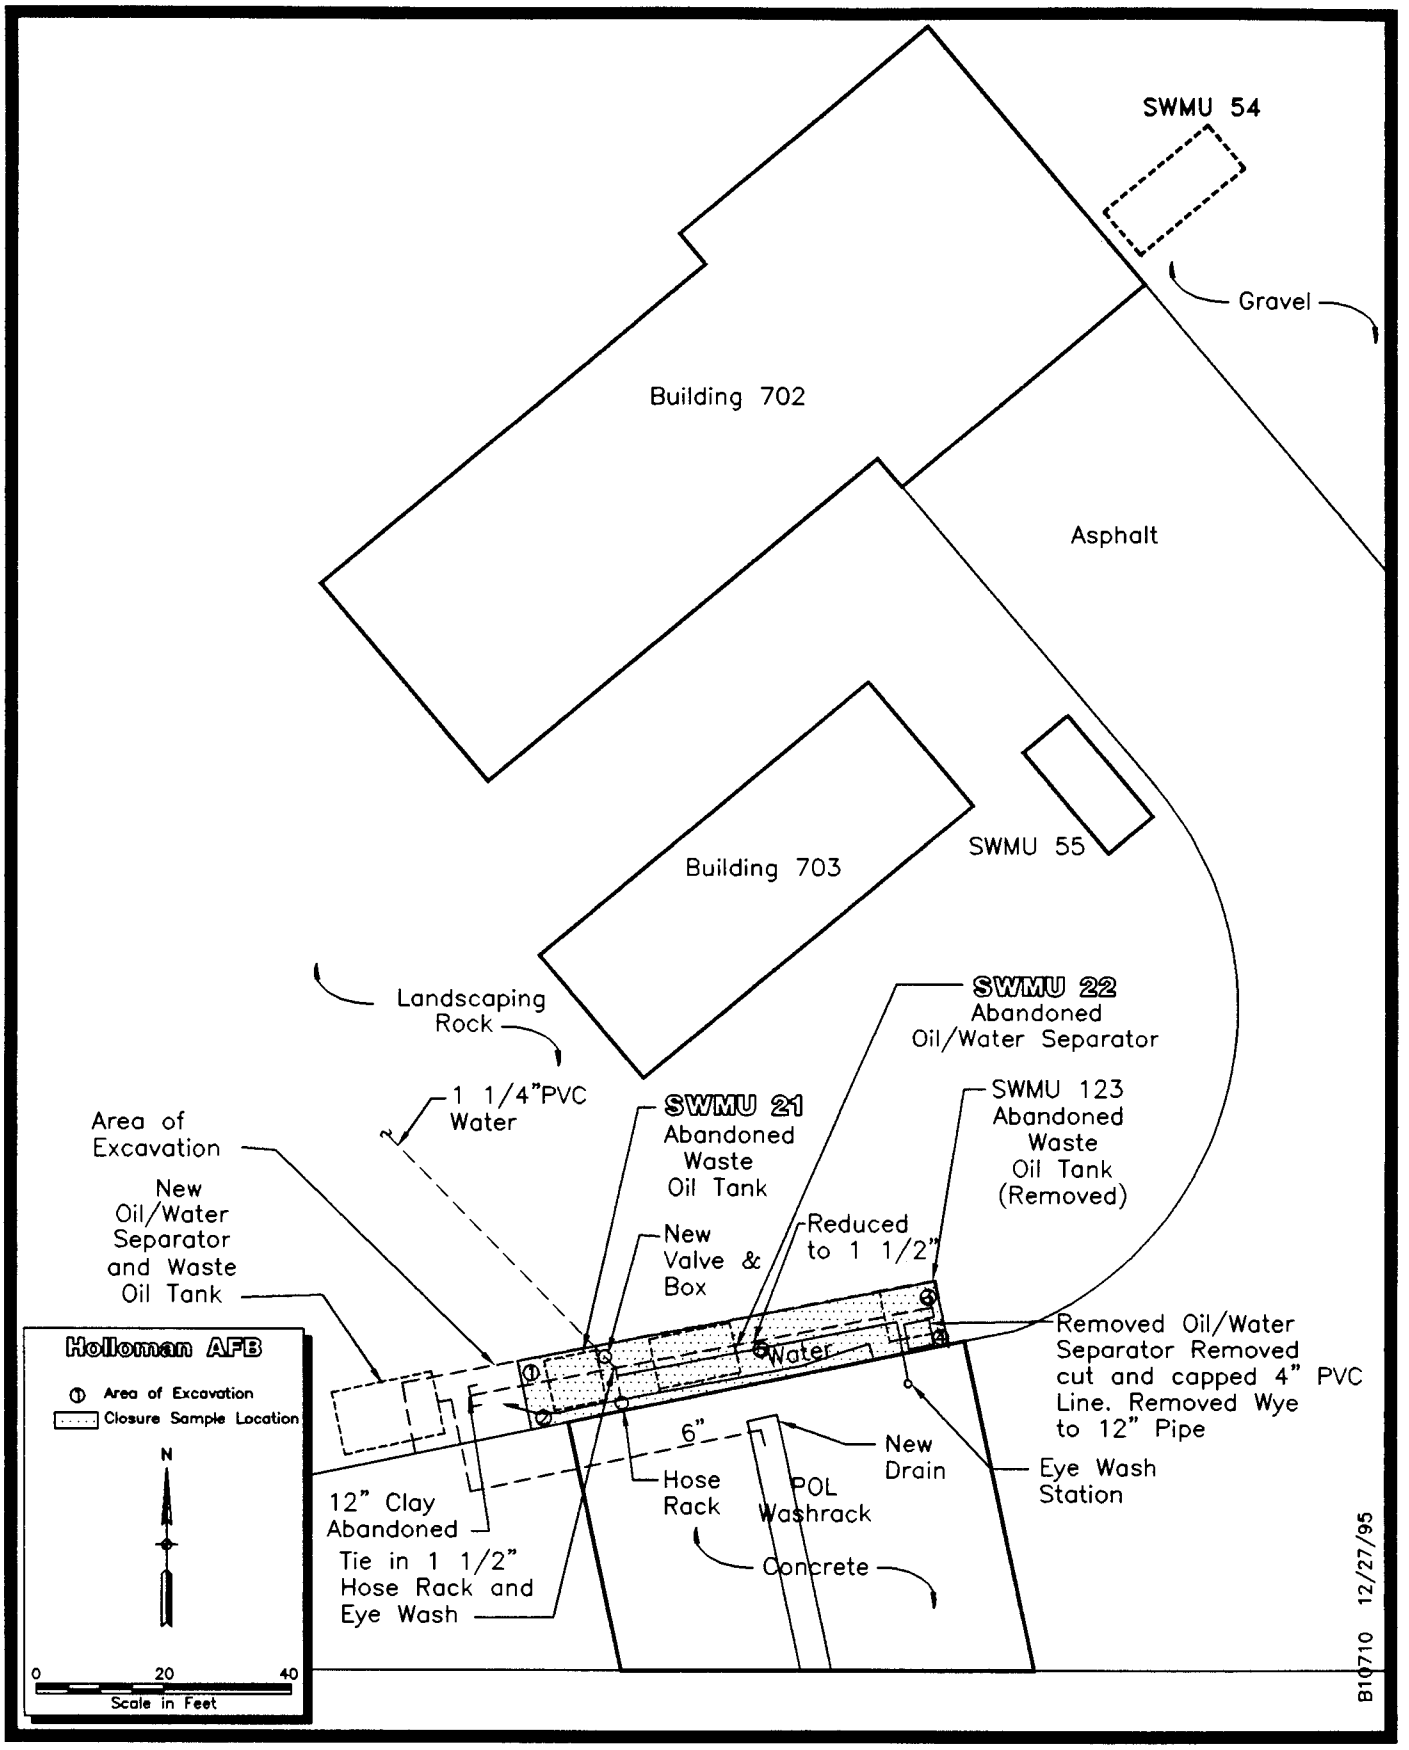
Figure 4-1. SWMUs 21 and 22 – Site Map

Five closure samples were collected from the excavation and analyzed for TRPH only. As indicated on Figure 4-1, closure samples were collected from each of the walls and the bottom of the excavation. Analytical results, which represent in-place soil conditions upon completion of excavation, were less than 1,000 mg/kg for all closure samples.

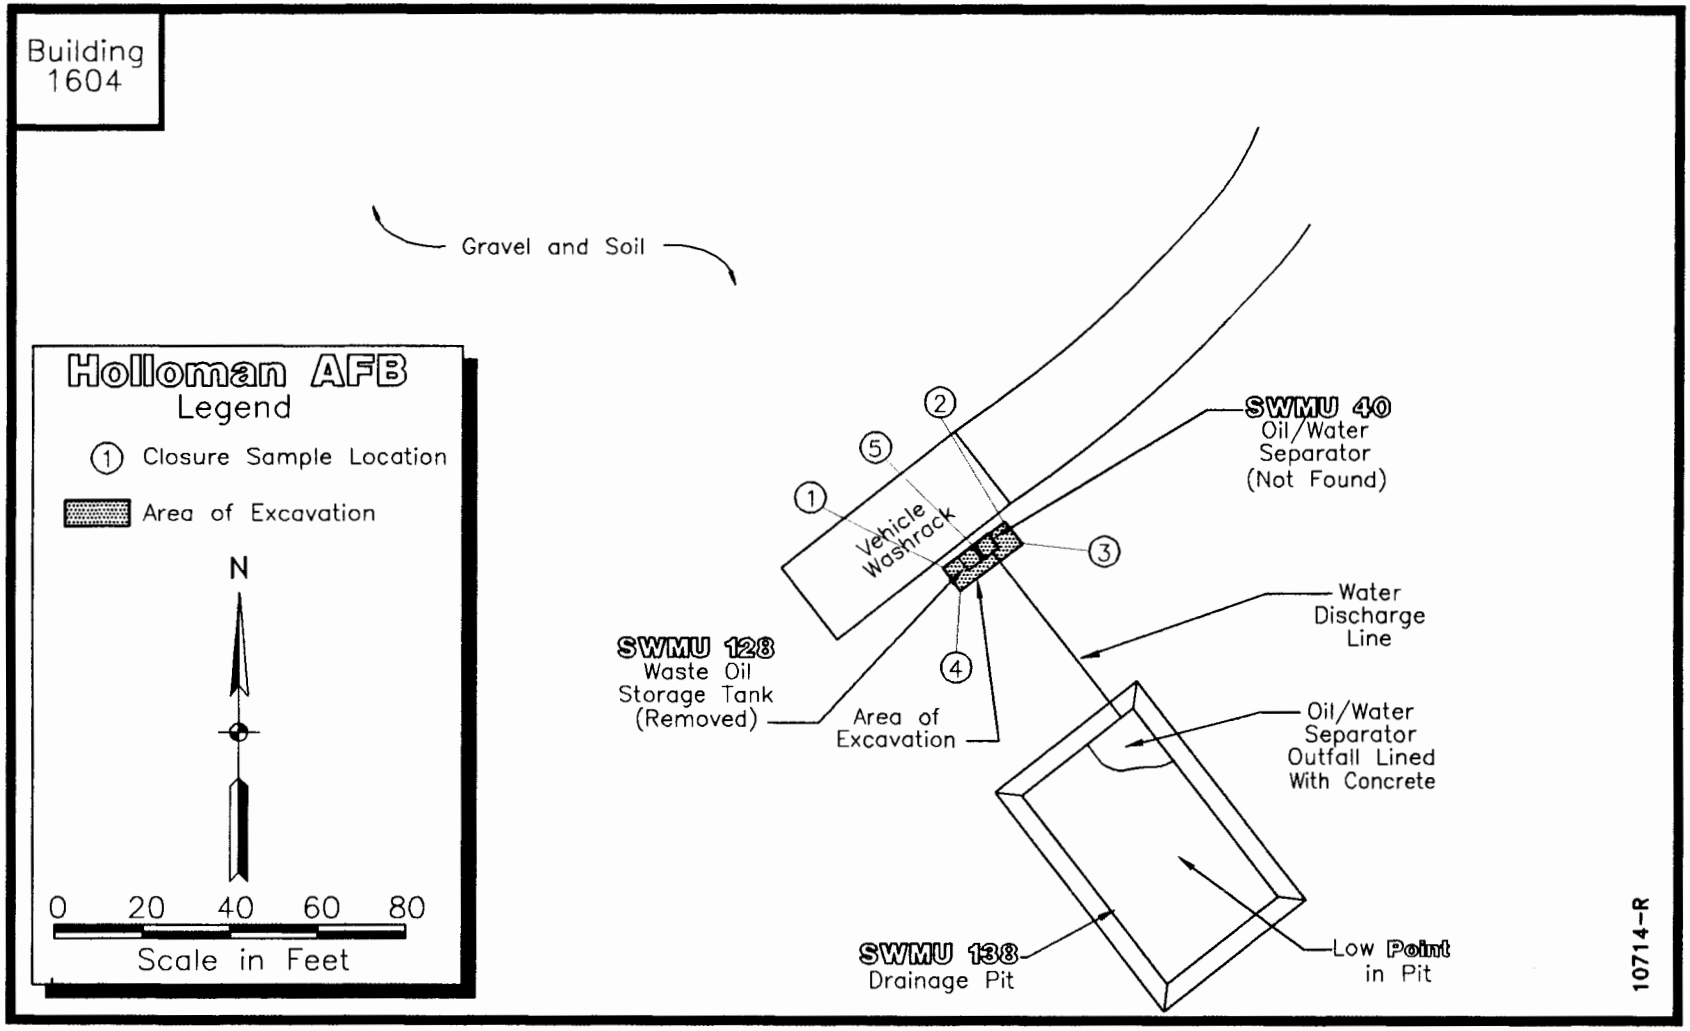
Figure 6-1. SWMU 40 and 128 - Site Map (BLDG. 1166)

Activities planned for these sites included the removal of SWMUs 40 and 128, which were located approximately 200 ft south and slightly east of Building 1604 adjacent to the vehicle washrack, and the excavation of soil containing TPH greater than 1,000 mg/kg (Figure 6-1). The estimated area of soil contamination was determined during the RFI (Radian 1994).

One set of five closure samples was collected from the excavation at this site to represent both SWMUs. As indicated on Figure 6-1, closure samples were collected from each of the walls and the bottom of the excavation. Analytical results, which represent in-place soil conditions upon completion of excavation, were less than 1,000 mg/kg for all closure samples.

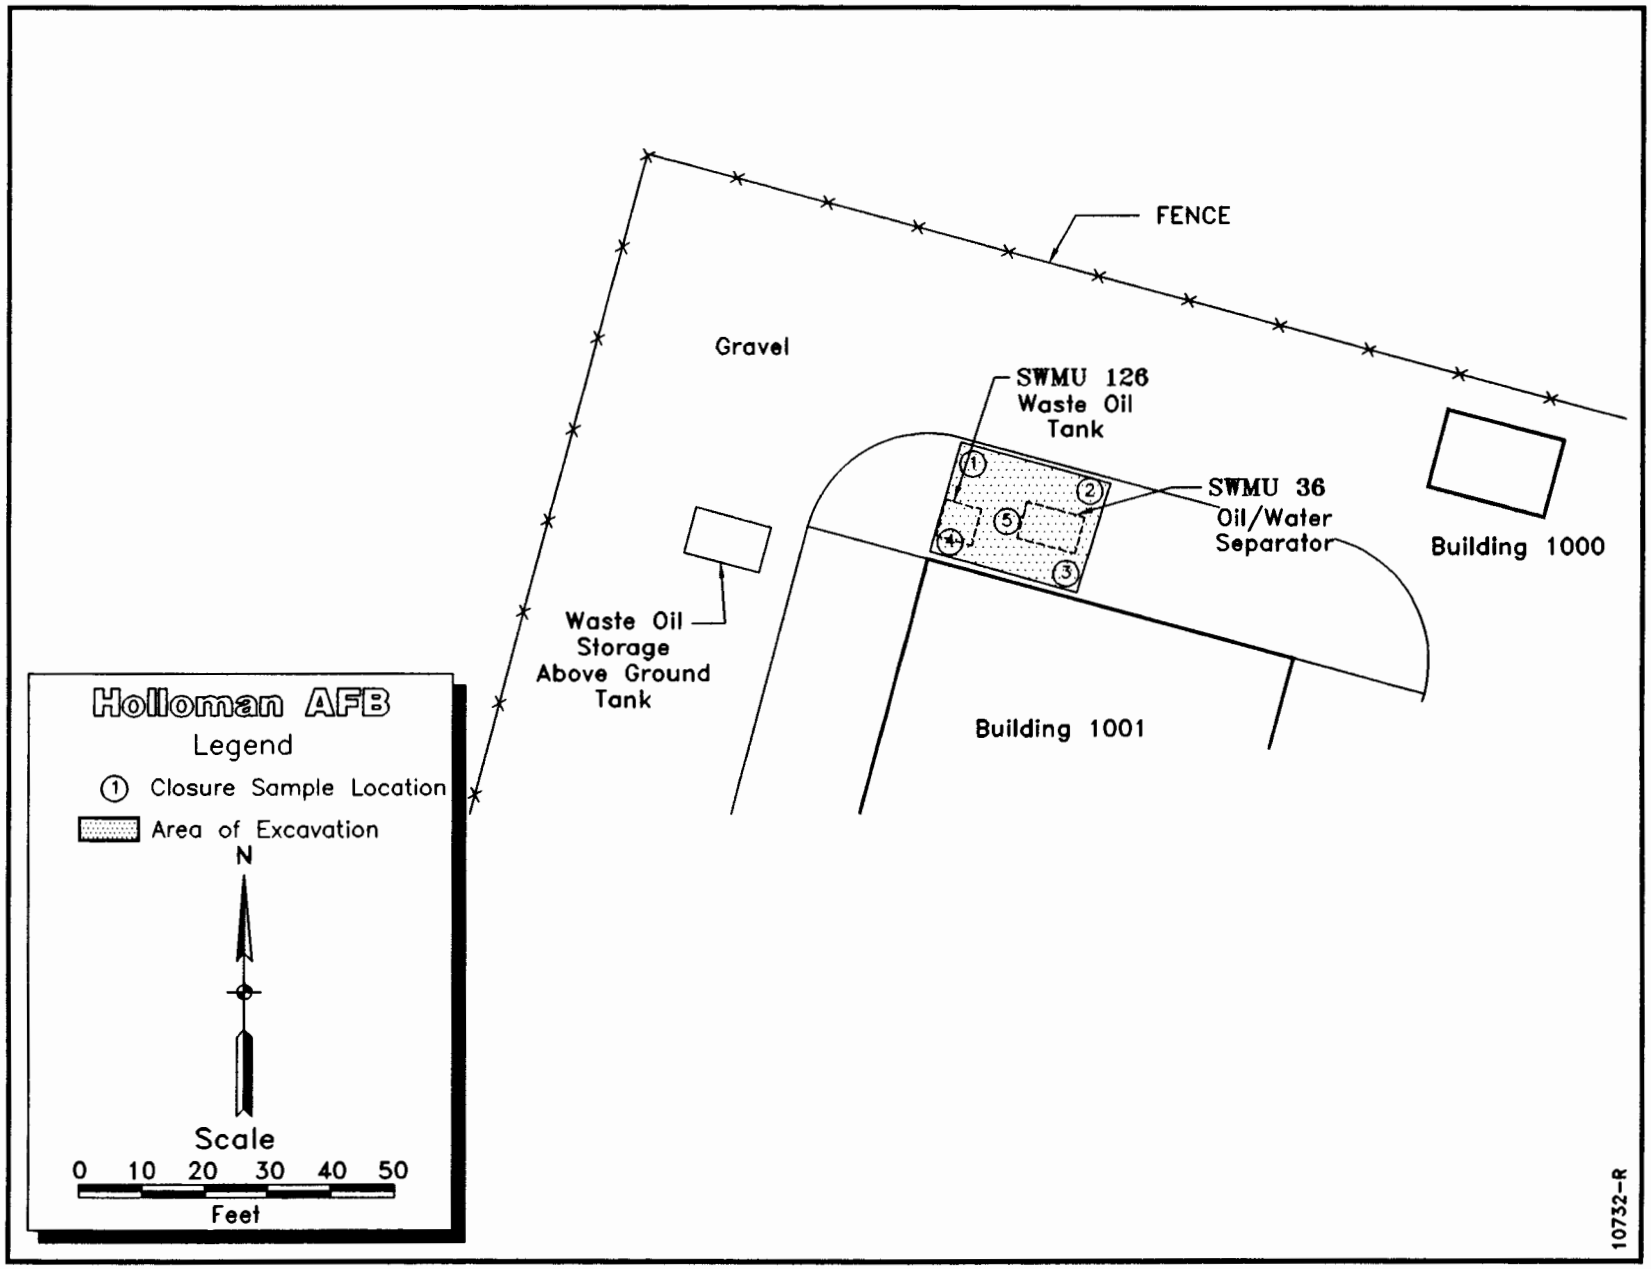
Figure 7-1. SWMUs 36 and 126 - Site Map

Activities planned for this site included the removal of SWMU 126, which is the WOT adjacent to Building 1001, and the excavation of soil at SWMUs 36 and 126 containing TPH greater than 1,000 mg/kg (Figure 7-1). The estimated area of soil contamination was determined during the RFI (Radian 1994).

Five closure samples were collected from the excavation at this site. As indicated on Figure 7-1, samples were collected from each of the walls and the floor of the excavation. The analytical results, which represent in-place soil conditions upon completion of excavation, were less than 1,000 mg/kg TRPH for all closure samples.

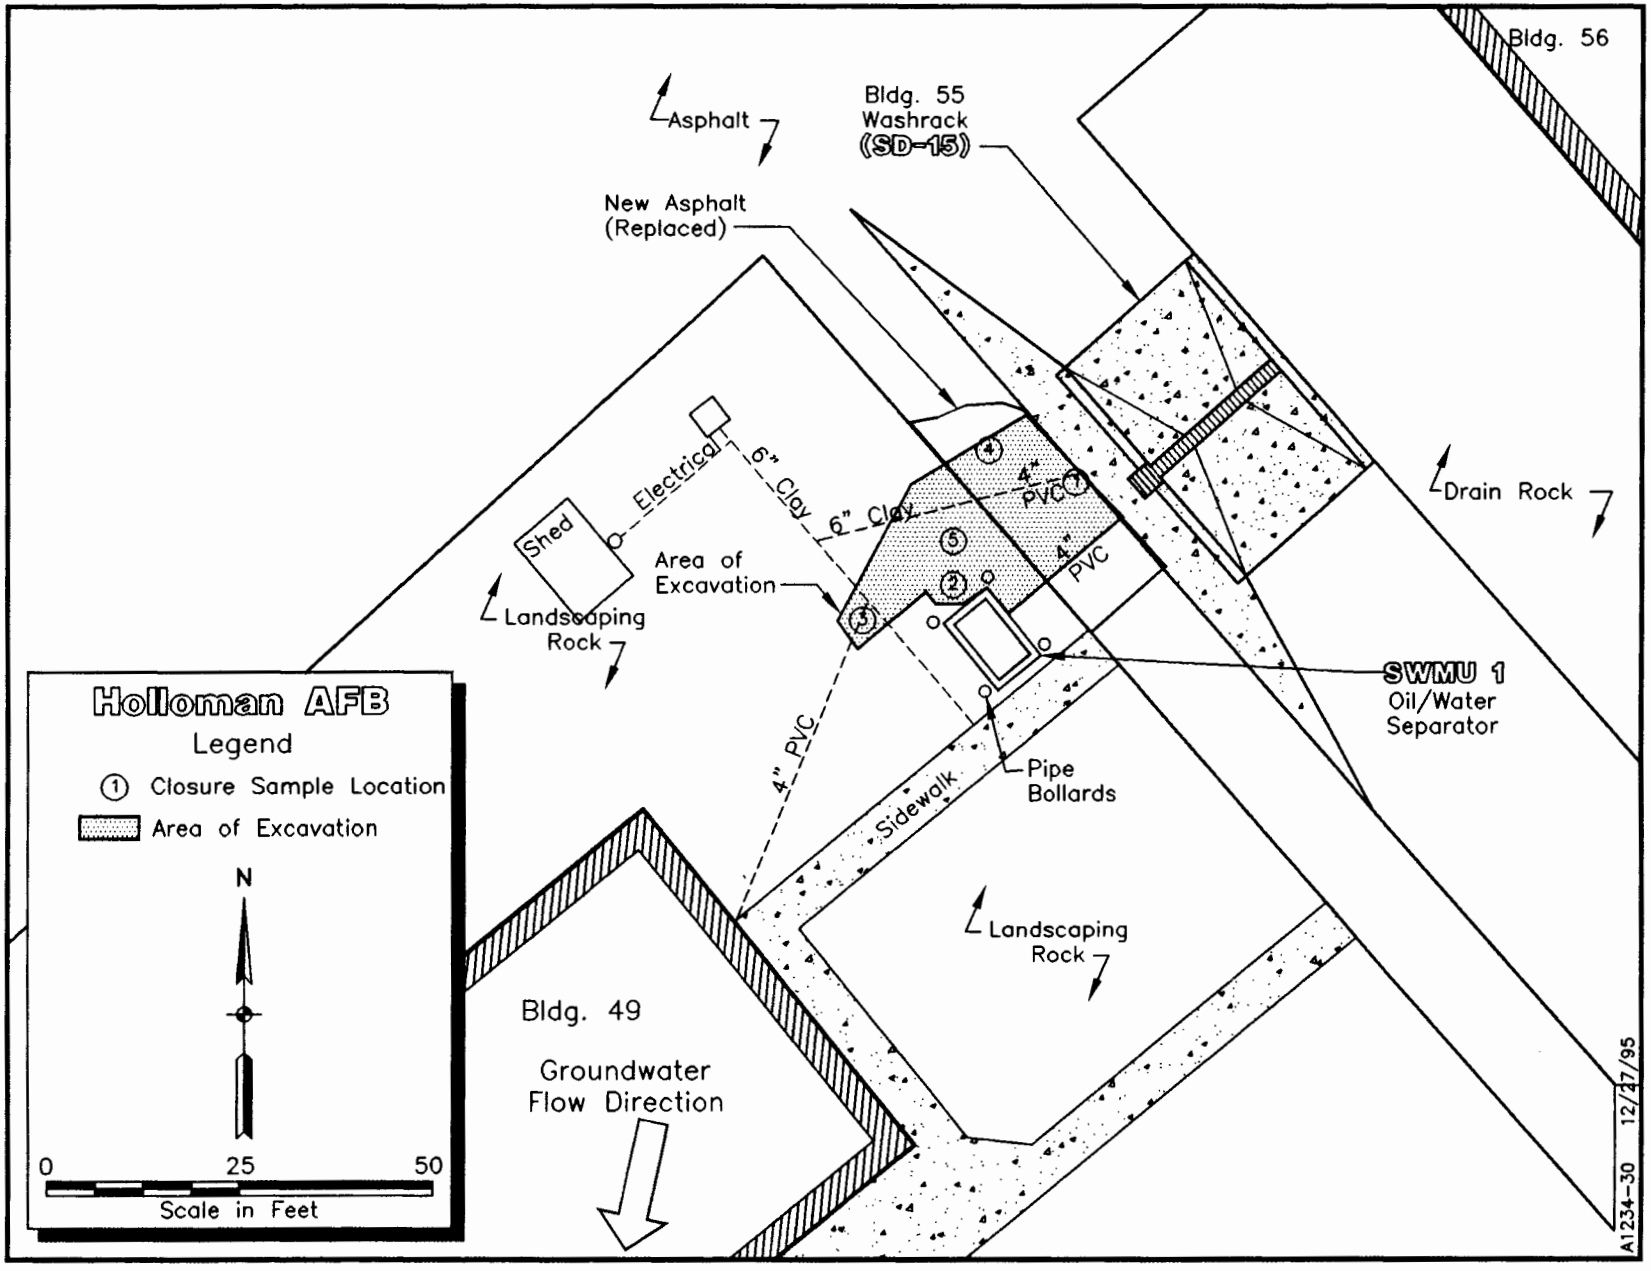
Figure 8-1. SWMU 1 – Site Map

Activities planned for this site included the excavation of soil containing TPH greater than 1,000 mg/kg in the vicinity of SWMU 1, which is located approximately 40 ft northeast of Building 49 (Figure 8-1). The O/WS is an active unit in good working order and has good integrity , and excavation of contaminated soil was attempted without removal of the O/WS. If excavation of contaminated soil had not been feasible without the removal of the O/WS, the removal of the O/WS would be evaluated at the time of excavation. The estimated area of soil contamination was determined during the RFI (Radian 1995).

Landscaping rock was stockpiled and approximately 372 cu yds of soil and 10 cu yds of asphalt were excavated from this site. Analytical results for soil stockpile samples indicated TRPH concentrations were below Base cleanup criteria; therefore, the stockpiled soil was spread. Additional fill was imported and the excavation was backfilled and compacted. Debris, including excavated asphalt, was transported off site for disposal at the Lincoln/Otero County Landfill. Asphalt was replaced in the roadway as indicated on Figure 8-1, landscaping rock was returned to the disturbed area, and a broken 6-inch-diameter clay pipe sewer line was repaired in several places.

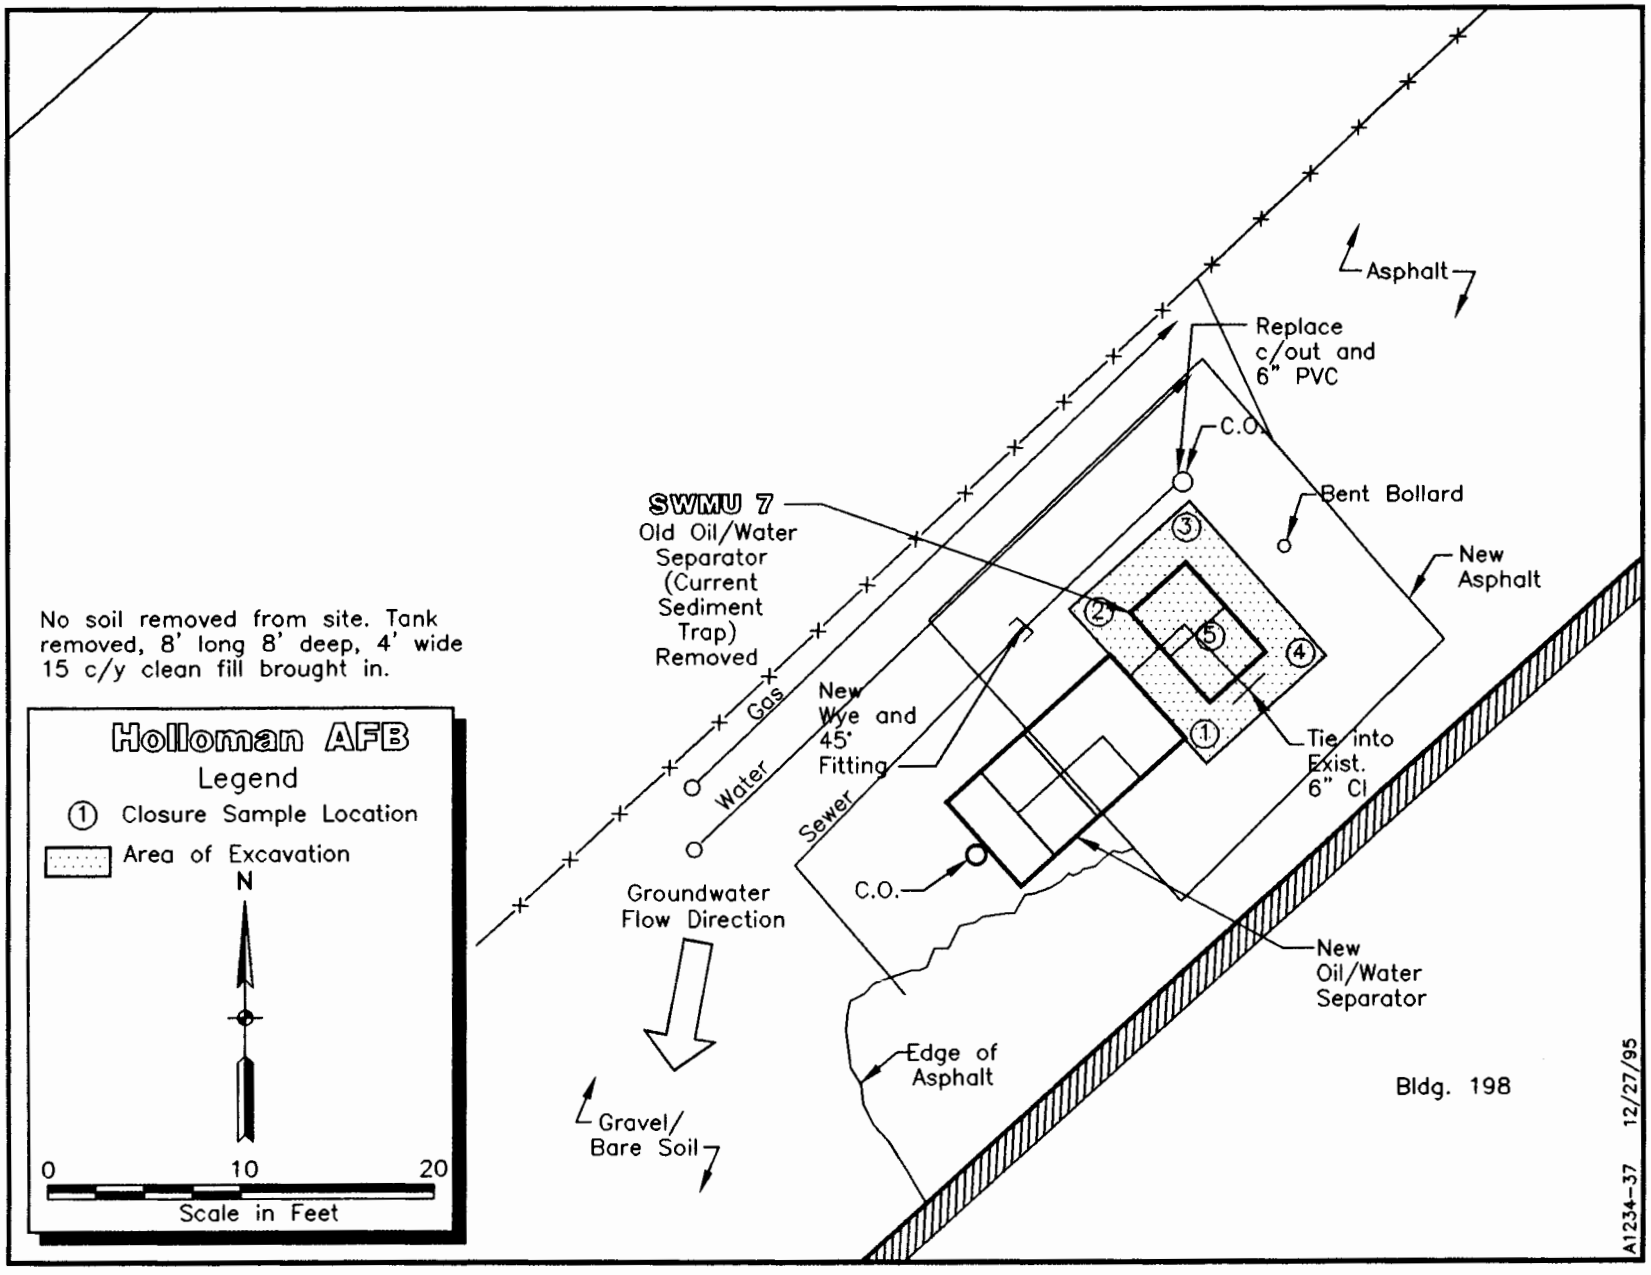
Figure 9-1. SWMU 7 - Site Map

Five closure samples were collected from the excavation and analyzed for TRPH only. As indicated on Figure 9-1, closure samples were collected from each of the walls and the bottom of the excavation. Analytical results, which represent soil conditions upon completion of excavation, were less than 1,000 mg/kg for all closure samples.

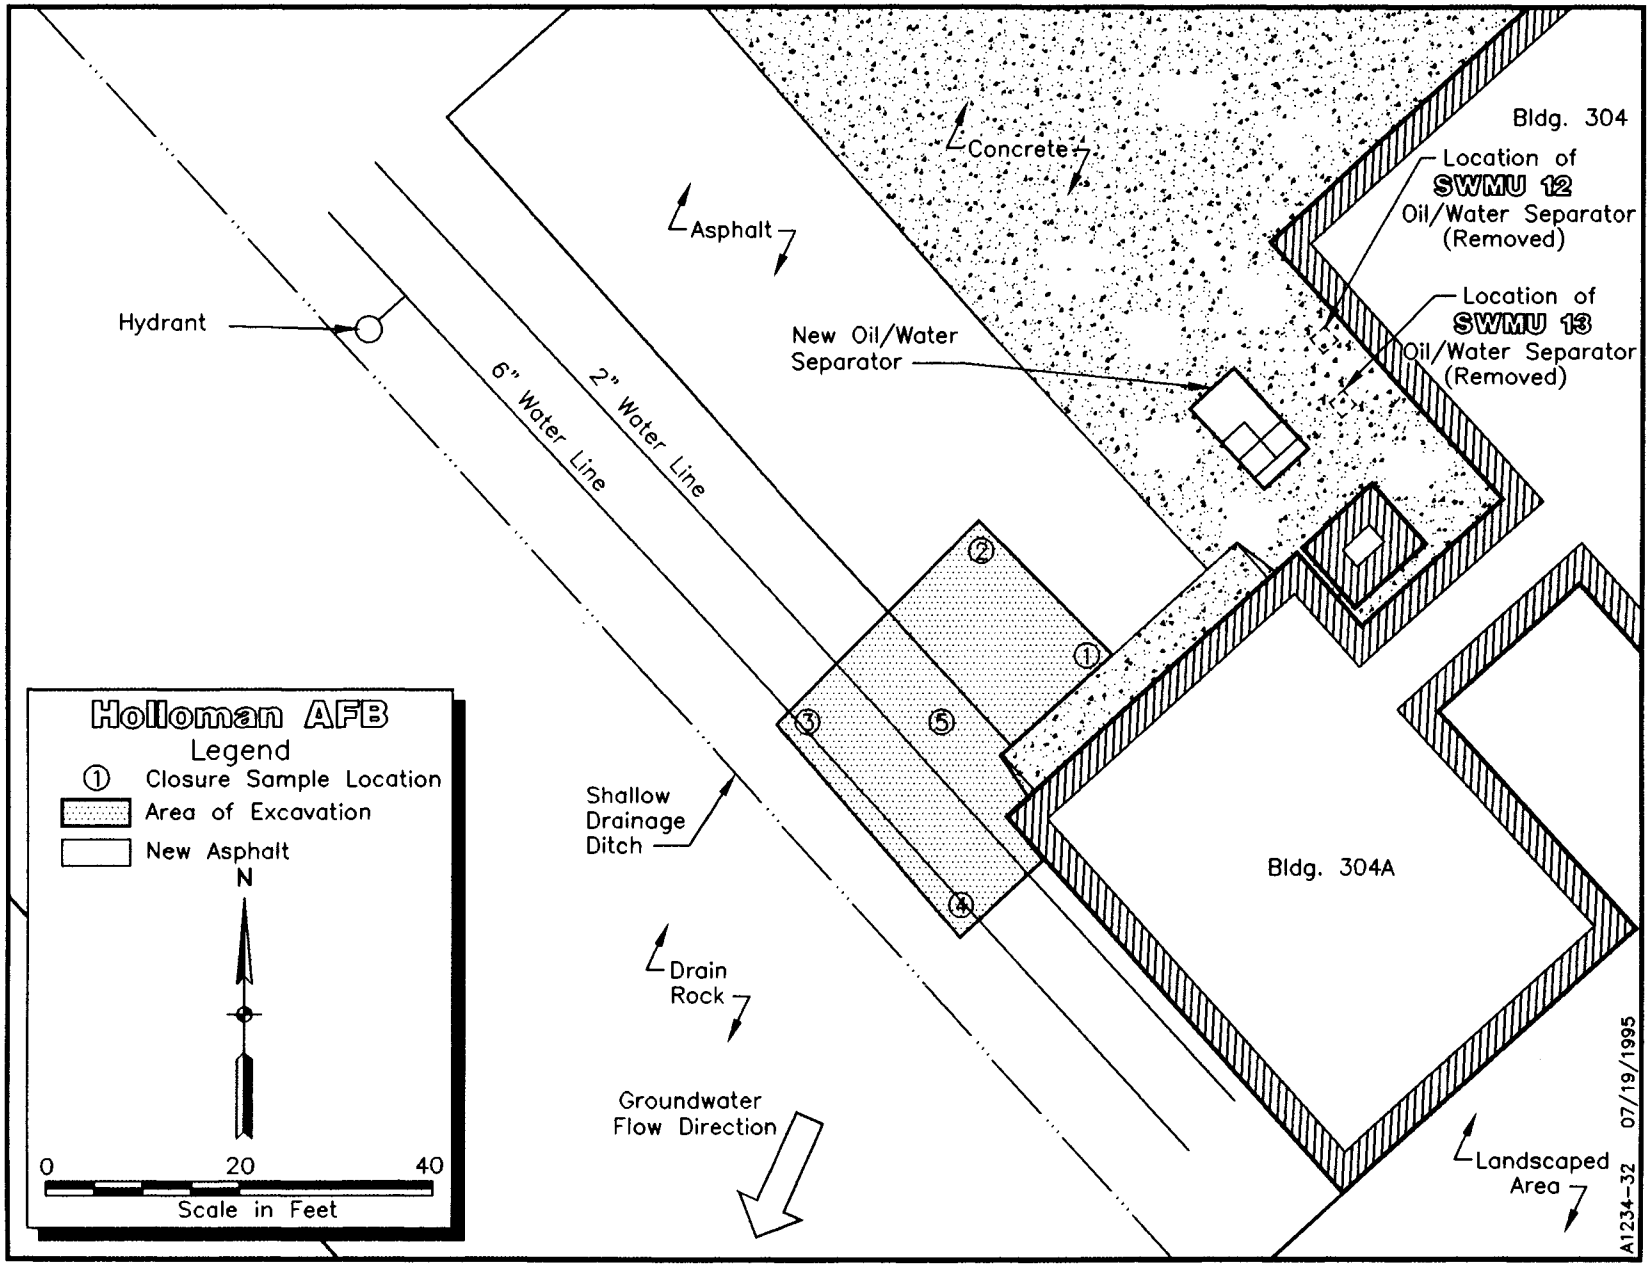
Figure 11-1. SWMUs 12 & 13 - Site Map

Five closure samples were collected from the excavation and analyzed for TRPH only. As indicated on Figure 11-1, closure samples were collected from each of the walls and the bottom

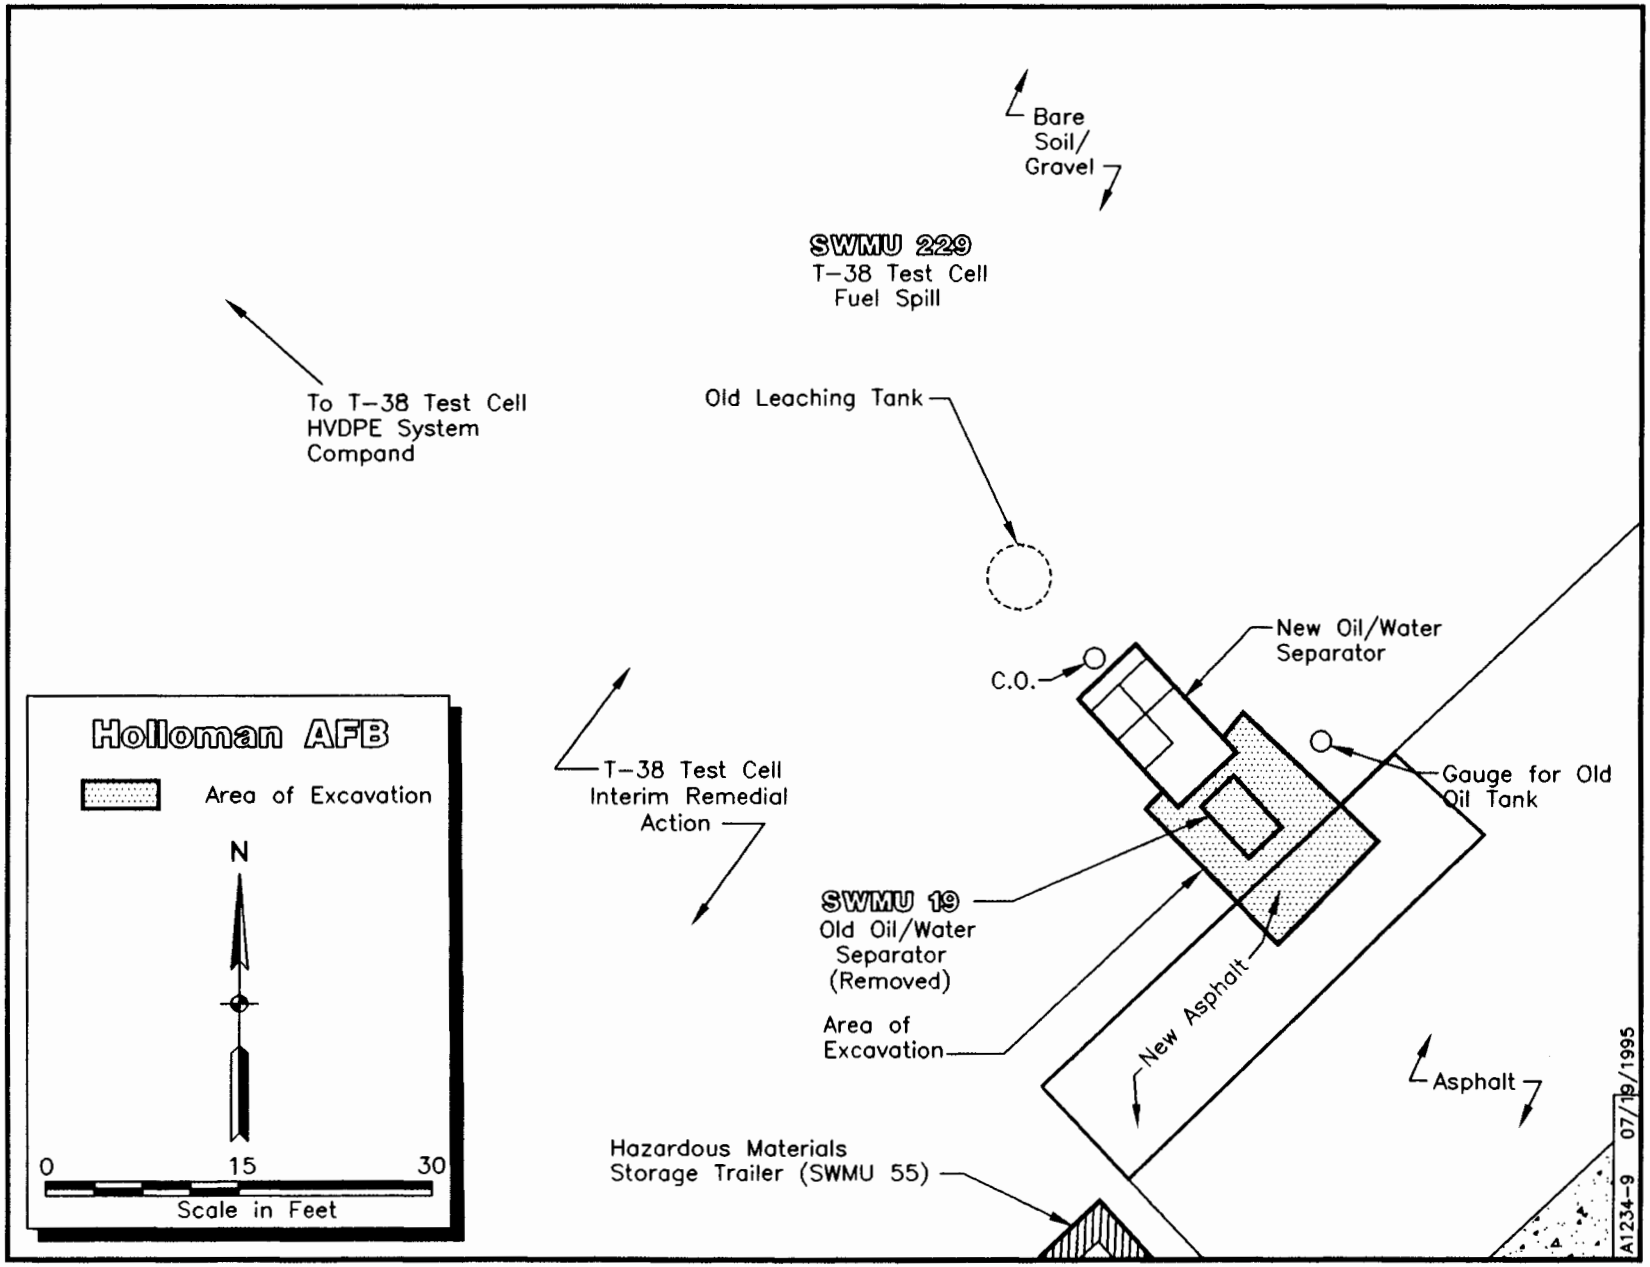
Figure 12-1. SWMU 19 - Site Map

The SWMU 19 O/WS was removed and the soil is currently being remediated in situ with the T-38 Test Cell HVDPE system. The T-38 Test Cell HVDPE system is anticipated to operate through 2001. Confirmation borings will be taken across the site, including the area where SWMU 19 was located, to insure that the system has remediated the site to less than 1,000 mg/kg.

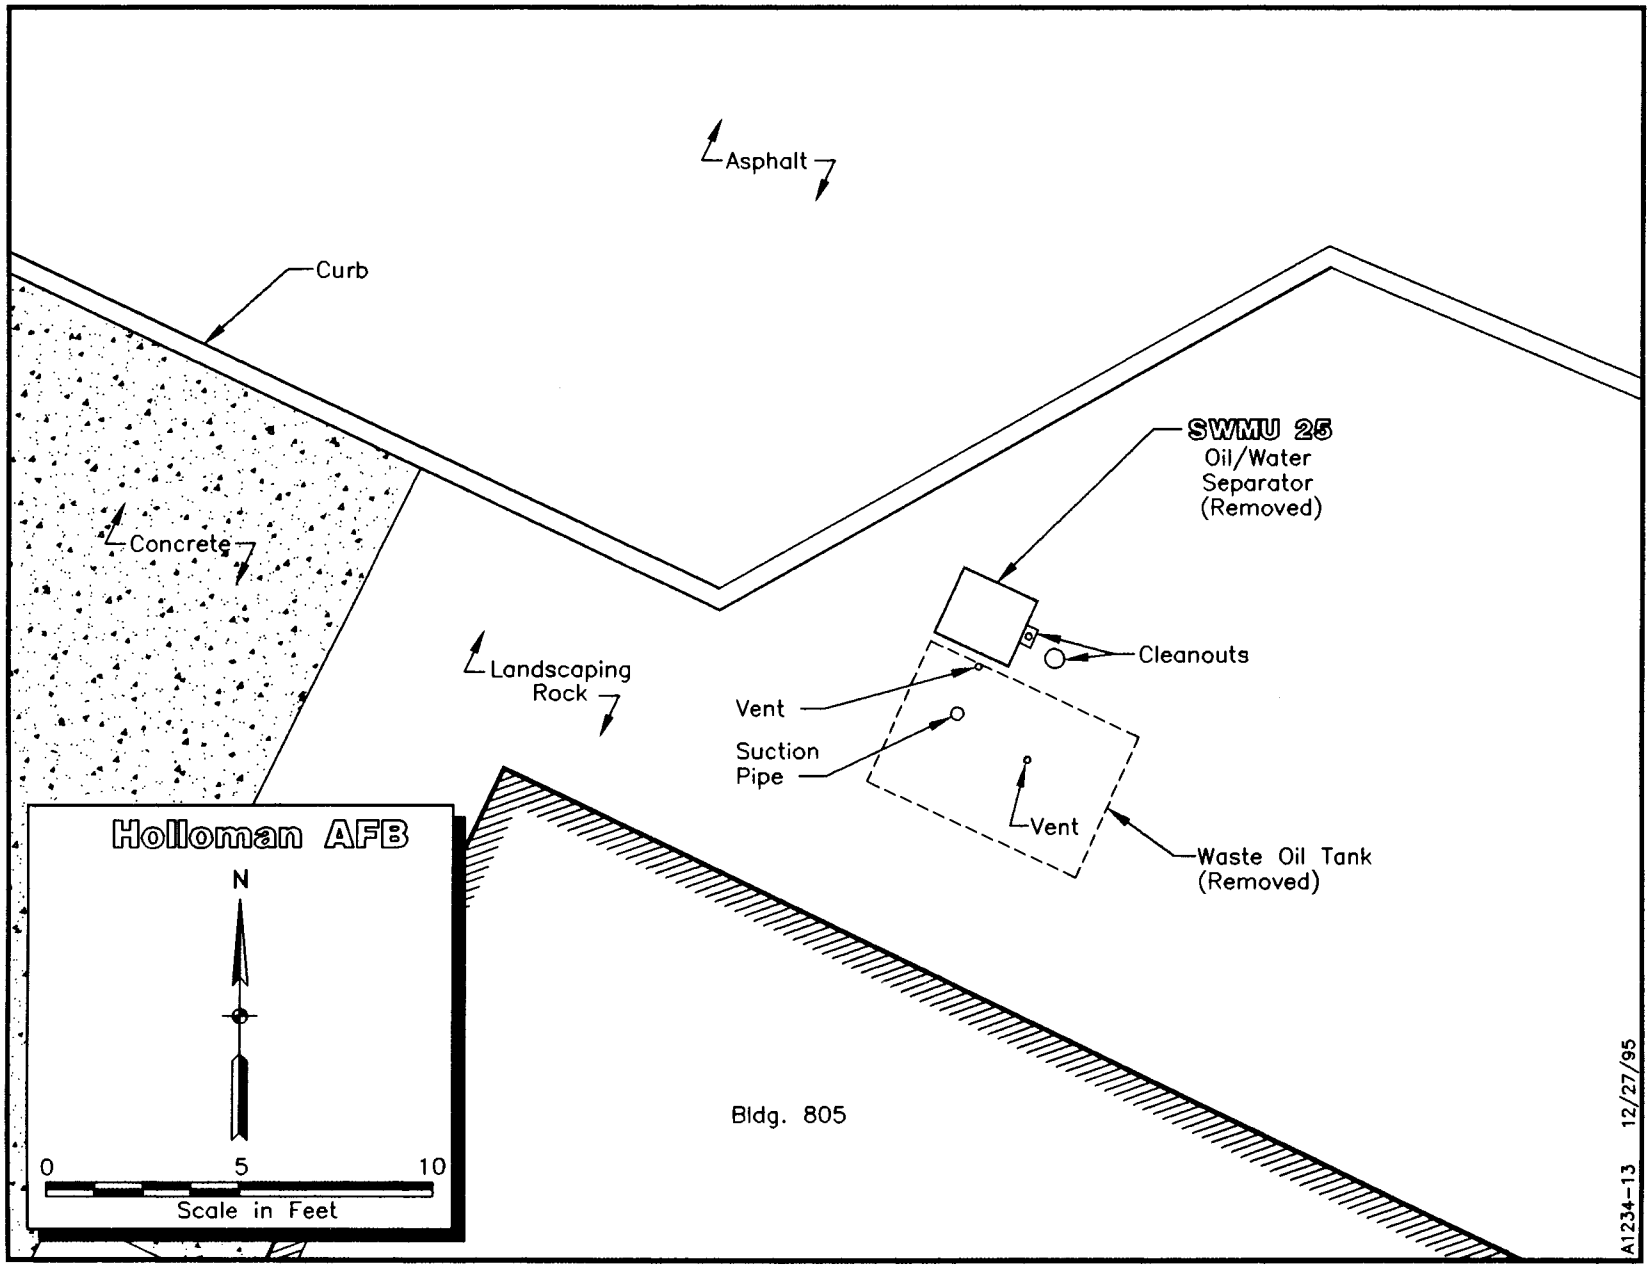
Figure 13-1. SWMU 25 - Site Map

Upon arrival at this site, FWENC was informed that the WOT and O/WS (SWMU 25) were removed prior to 1988 as part of a previous restoration and all lines were capped. Because the restoration at this site has already been completed, NFA is recommended.
