SUBJECT: Response to Notice of Deficiency (NOD), Closure Report for Petroleum, Oil and Lubricant (POL) Contaminated Sites

1. In response to your 25 Jun 97 NOD, Holloman AFB (HAFB) submits the revised Final Closure Report for Phase II Remediation of POL-Contaminated Sites and Oil/Water Separators and Waste Oil Tank Removals (Atch 1) and the following informational comments. First, in response to Global Comment 1, all previous reports that identified chemicals of concern (COCs) detailed that information in regards to contaminant level and affected media. All future reports will also list any identified COCs. However, the attached report listed no COCs due to the fact that none were identified. Each of the Solid Waste Management Units (SWMUs) described in this report was subjected to either a qualitative or quantitative risk assessment. Appendix C of the previously-submitted Phase I Table 2 RCRA Facility Investigation Report (RFI) and Appendix D of the previously-submitted Table 3 RFI Report detail the methodology used to identify COCs. Therefore, no COCs are listed in the updated report submitted under this cover. ← Yes, verified. CA. OK

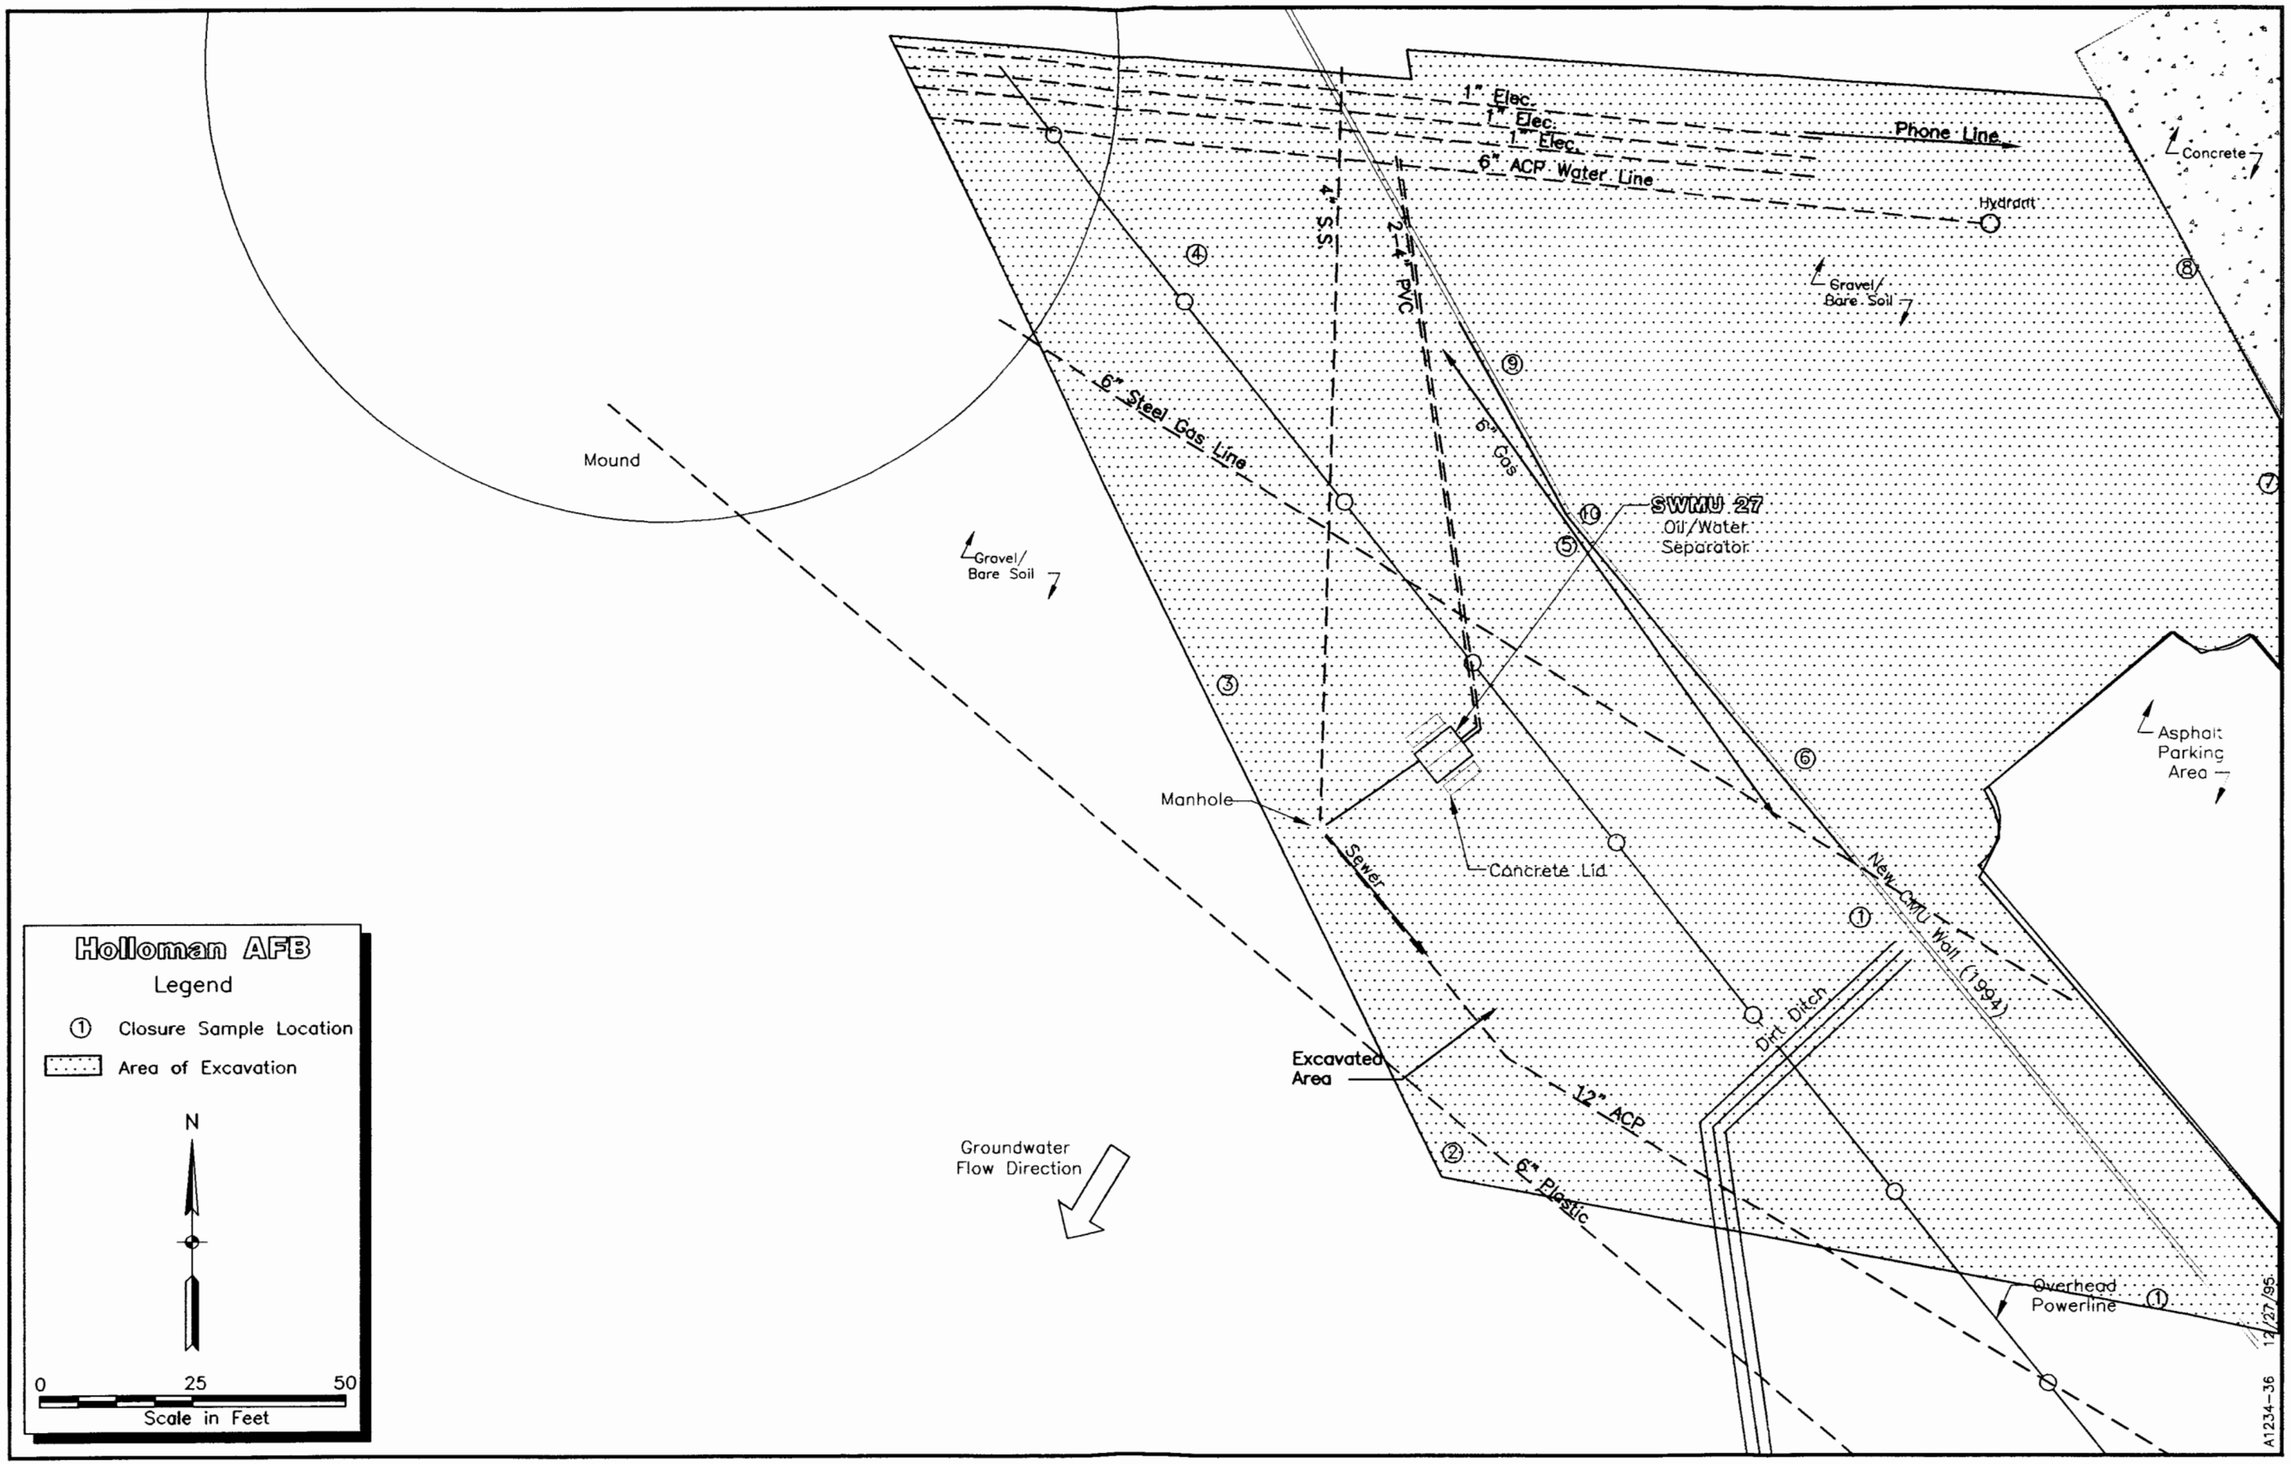
Figure 14-1. SWMU 27 - Site Map

Activities planned for this site included the removal of SWMU 27, which was located approximately 1/4 mile northwest of the Hush Houses, excavation of soil containing TPH greater than 1,000 mg/kg, and recovery of LNAPL, if present (Figure 14-1). The estimated area of soil contamination and location of LNAPL was determined during the RFI (Radian 1995).

Ten closure samples were collected from the excavation for site closure and analyzed for BTEX, TRPH, SVOCs, and lead. As indicated on Figure 14-1, five closure samples were collected from the walls and five closure samples were collected from the bottom of the excavation. Analytical results, which represent soil conditions upon completion of excavation, were less than Base cleanup criteria for all closure samples. Bis(2-ethylhexyl) phthalate was detected at 400 mg/kg, which approaches the EPA Region III RBC of 410 mg/kg for an industrial-based soil classification; however, this analyte is a common laboratory contaminant. The highest historical detection of bis(2-ethylhexyl) phthalate was 0.648 mg/kg.

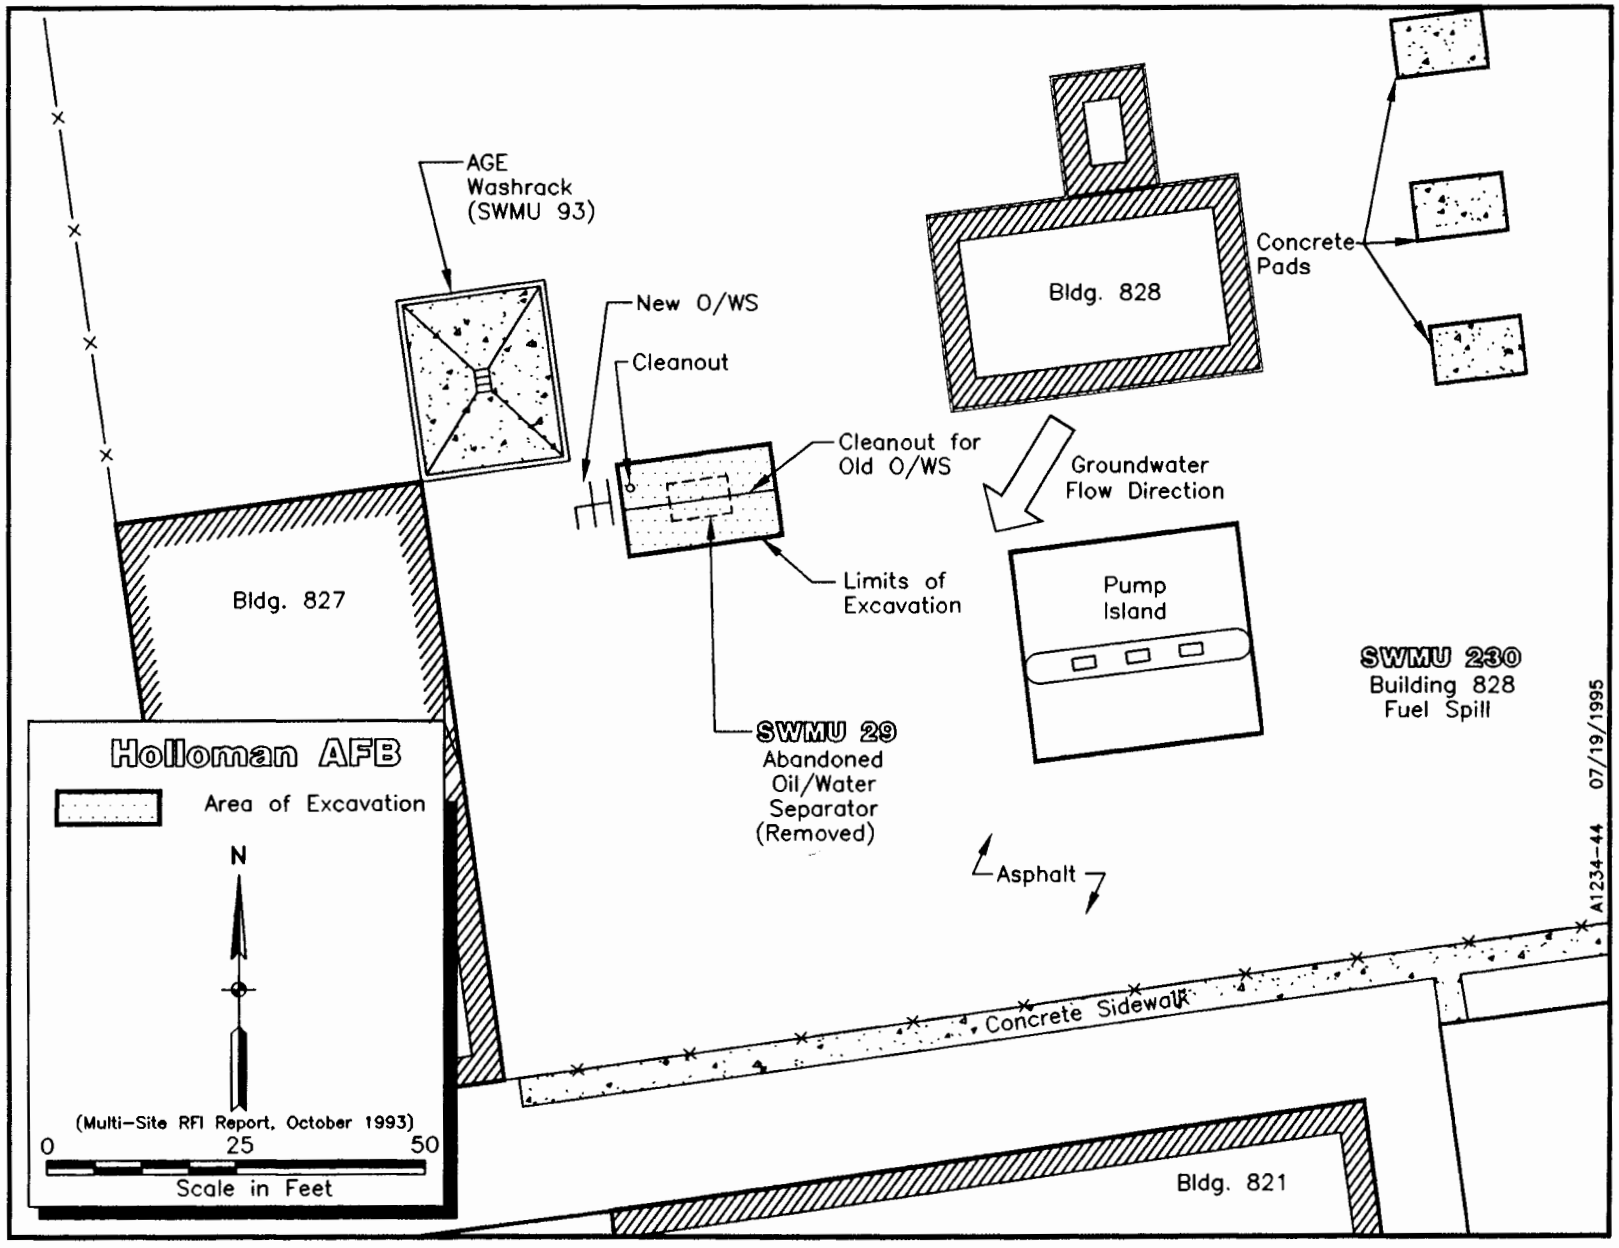
Figure 15-1. SWMU 29 – Site Map

Prior to its removal, SWMU 29 was located in the contaminated plume associated with the Building 828 Fuel Spill Site (SWMU 230). SWMU 230 has a HVDPE system, which has been in place since 1996. This system will remediate the entire area, including the area where SWMU 29 was previously located, to less than 1,000 ppm TPH. Construction workplans and design drawings were submitted to NMED and EPA prior to installation of the HVDPE system. SWMU 93, the AGE Washrack, is located in proximity to SWMU 29. SWMU 93 was recommended for NFA during the RFA and as such is not listed on Holloman AFB's HSWA permit and is shown for reference purposes only.

No closure samples were taken for this site because the contaminated soil will be remediated by the Building 828 (SWMU 230) HVDPE system. The Building 828 system is anticipated to operate through 1998. Confirmation borings will be taken across the site, including the area where SWMU 29 was located to insure that the system has remediated the site to less than 1,000 mg/kg.

Asphalt was repaired over the area indicated on Figure 15-1. Additional restoration activities included the replacement of the cleanout and repair of O/WS inlet piping. After restoration was complete, an USACE representative performed a final site inspection. A copy of the site inspection closure report is included in Appendix D.

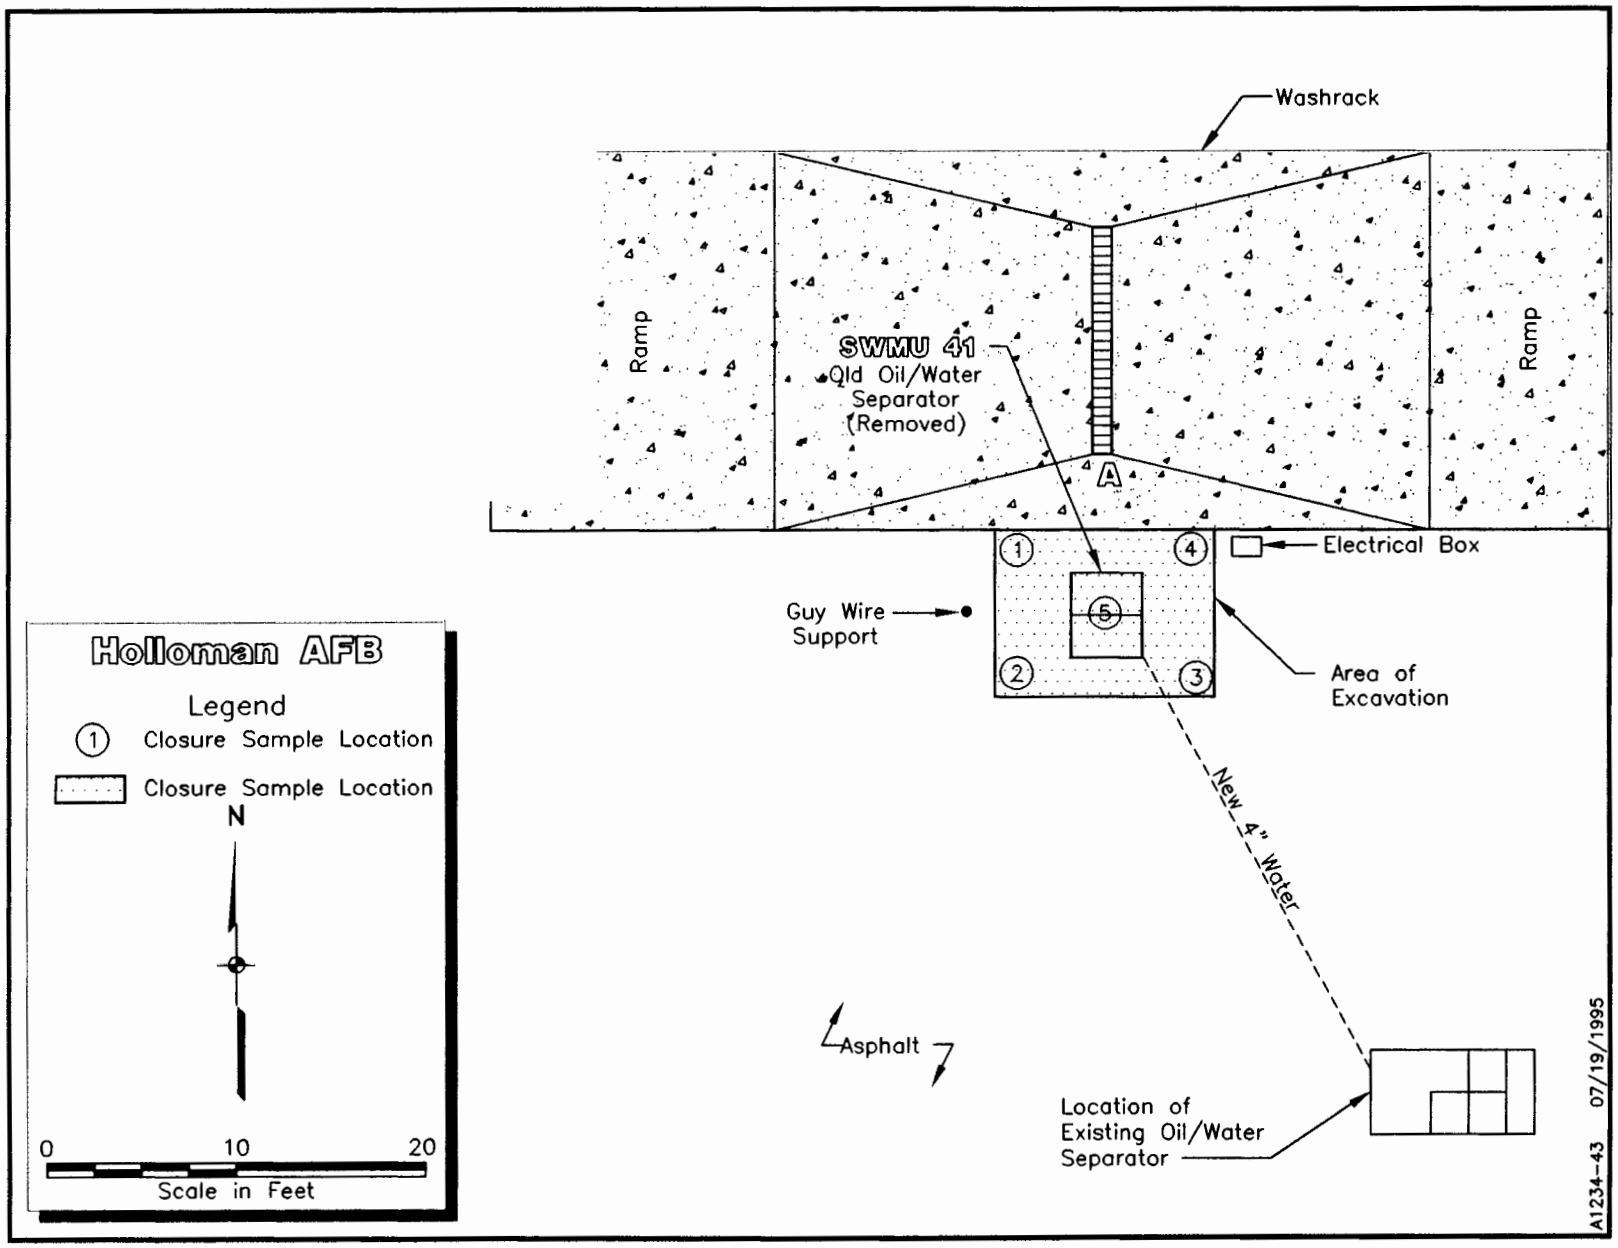
Figure 18-1. SWMU 41 - Site Map

Activities planned for this site include the excavation of soil containing TPH greater than 1,000 mg/kg in the vicinity of SWMU 41, which is located adjacent to the washrack at Building 1266 (Figure 18-1). The estimated area of soil contamination was determined during the RFI (Radian 1995).

Five closure samples were collected from the excavation and analyzed for TRPH only. As indicated on Figure 18-1, closure samples were collected from each of the walls and the bottom of the excavation. Analytical results, which represent soil conditions upon completion of excavation, were less than 1,000 mg/kg for all closure samples.
