Voluntary Corrective Action Completion Report for

Potential Release Site
3-022
Dielectric Oil Containment Sump

February 1996
Revision 0

LA-UR-96-205

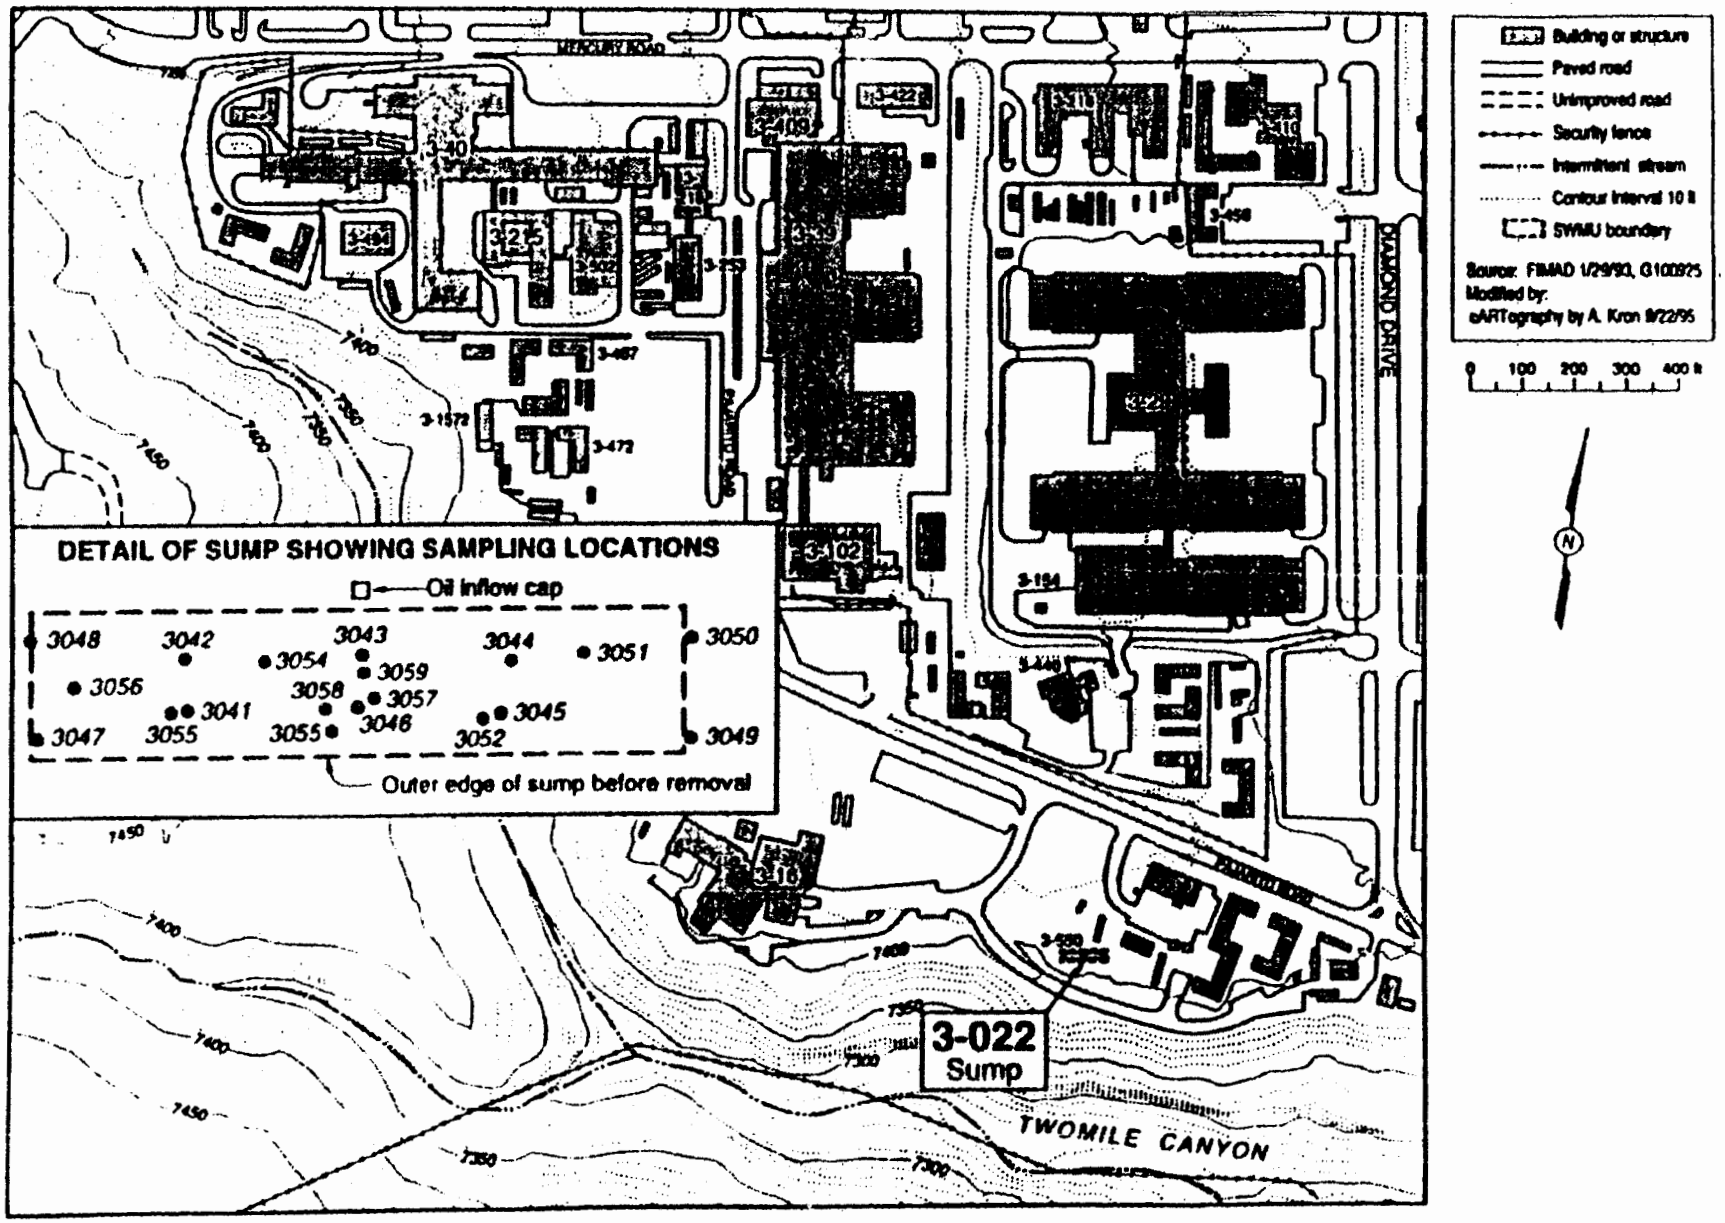
Figure 1. Sampling locations for VCA of SWMU 3-022 at TA-3.

On September 12, 1995, the sump was excavated to approximately 2 ft bgs at the east end and 2.5 ft bgs at the west end. Approximately 90 cu yds (6 dump trucks) of contaminated soil were excavated and transported for off-site disposal to the Colorado Springs facility. Six verification samples were collected (Figure 1) and analyzed for TPH. Analytical results (Table 1) showed the TPH concentrations ranged from non-detect to 3 570 ppm. One sample was greater than the cleanup level of 2 600 ppm.

On September 14, 1995, the center of the sump was excavated another 2 ft in depth, for a lateral extent of approximately 18 ft. Approximately 30 more cu yds (2 dump trucks) of contaminated soil were excavated and transported to the Colorado Springs facility. Two verification samples were collected from the excavated area (Figure 1) and analyzed for TPH. Analytical results obtained (Table 1) showed the TPH concentrations ranged from 257 to 862 ppm; the cleanup level of 2 600 ppm was met.

Verification sample locations are presented on a site map, Figure 1, and analytical results are presented in Table 2 Any characterization and/or screening data will be made available upon request. Cleanup verification was based on analytical results and visual inspection, as specified in the VCA Plan.
