S.S. PAPADOPULOS & ASSOCIATES, INC.
ENVIRONMENTAL & WATER-RESOURCE CONSULTANTS

Subject: **Approval with Modification of the 2017 Annual Report
Sparton Technology, Inc. - Former Coors Road Plant Remedial Program
EPA ID No. NND083212332
ST-18-002**

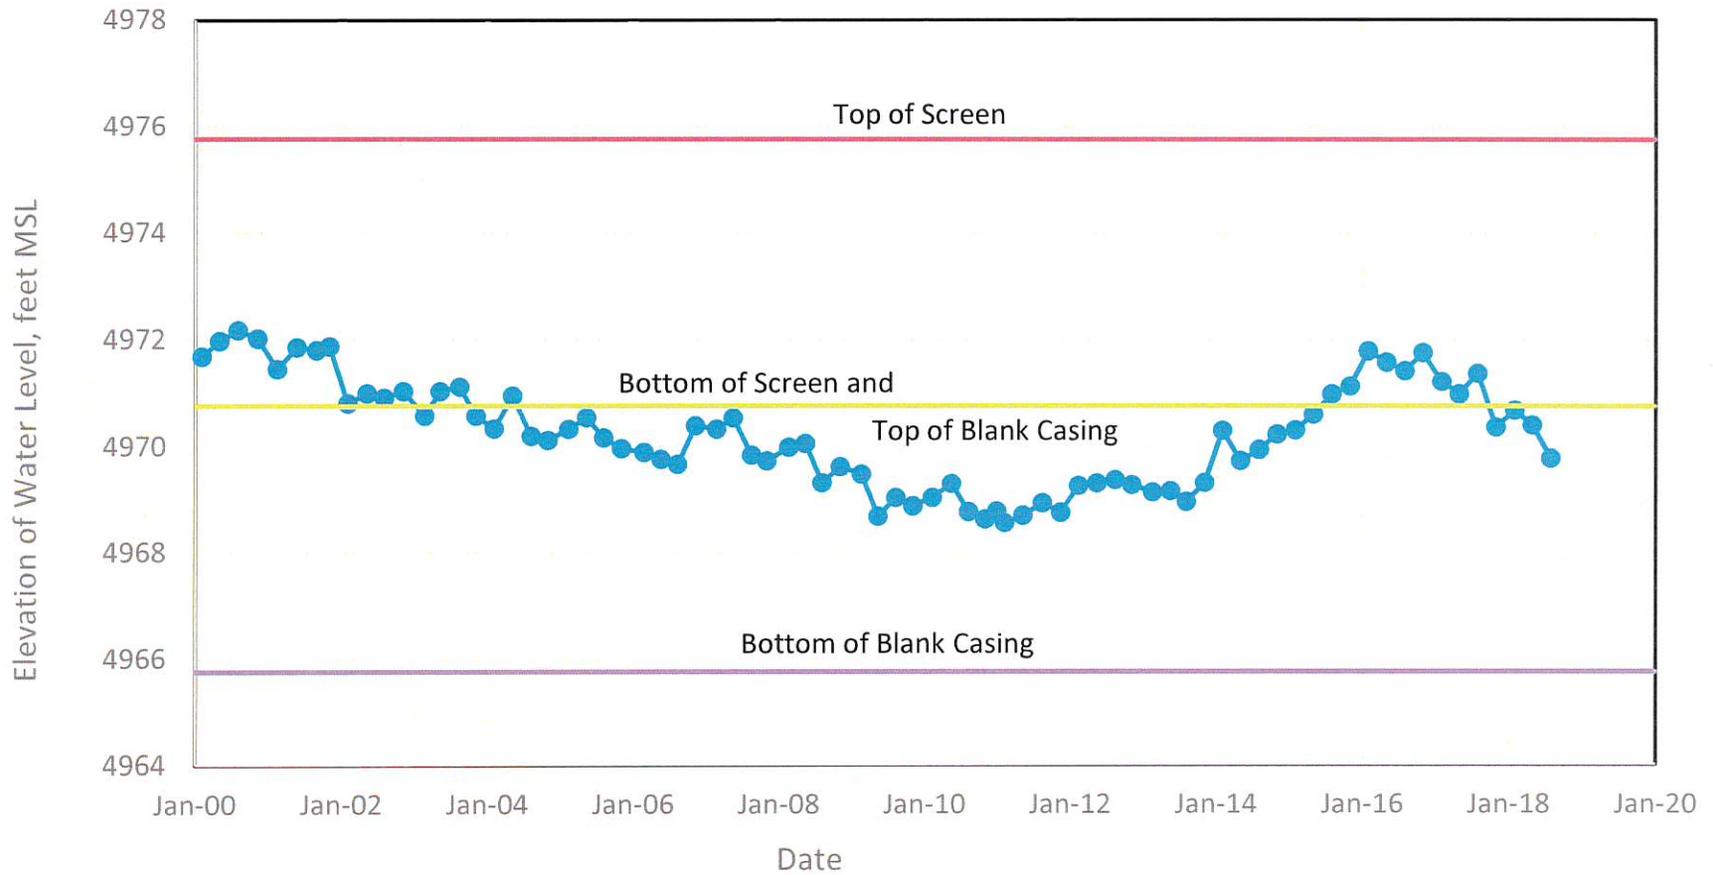
Figure 1 - Hydrograph of Monitoring Well MW-09

The 4th Quarter of 2017 was not the first time the water level in MW-09 was below the bottom of the screen. The well has 5 feet of screen with 5 feet of blank casing below the bottom of the screen, and the water-level in the well has been below the screen bottom and within the blank casing section for most of the time since the start of the current remedial operations, as indicated by the hydrograph of the well, presented in Figure 1. The blank casing does not have a bottom plug, and when the water level in the aquifer is below the bottom of the screen, groundwater flows in or out of the well through the open bottom of the blank casing. The hydrograph of the well (Figure 1), indicates that, besides the screened interval, the well is also connected to the aquifer through its bottom and that the water level in the well continues to respond to water-level changes in the aquifer even during periods when it is below the bottom of its screen. A comparison of the hydrograph of this well to the hydrograph of the nearby monitoring well MW-12 (see Figure 2), in which the water level has always been above the bottom of the screen, further supports the conclusion that MW-09 is connected to the aquifer through the bottom of the blank casing.
