RE: Approval with Modifications, Annual Facility Wide Ground Water Monitoring
Report: Gallup Refinery - 2013
EPA ID # NMD000333211, HWB-WRG-14-006

Western Refining, Gallup Refinery has prepared the following responses to the comments in your letter of May 18, 2016 regarding the above referenced report.

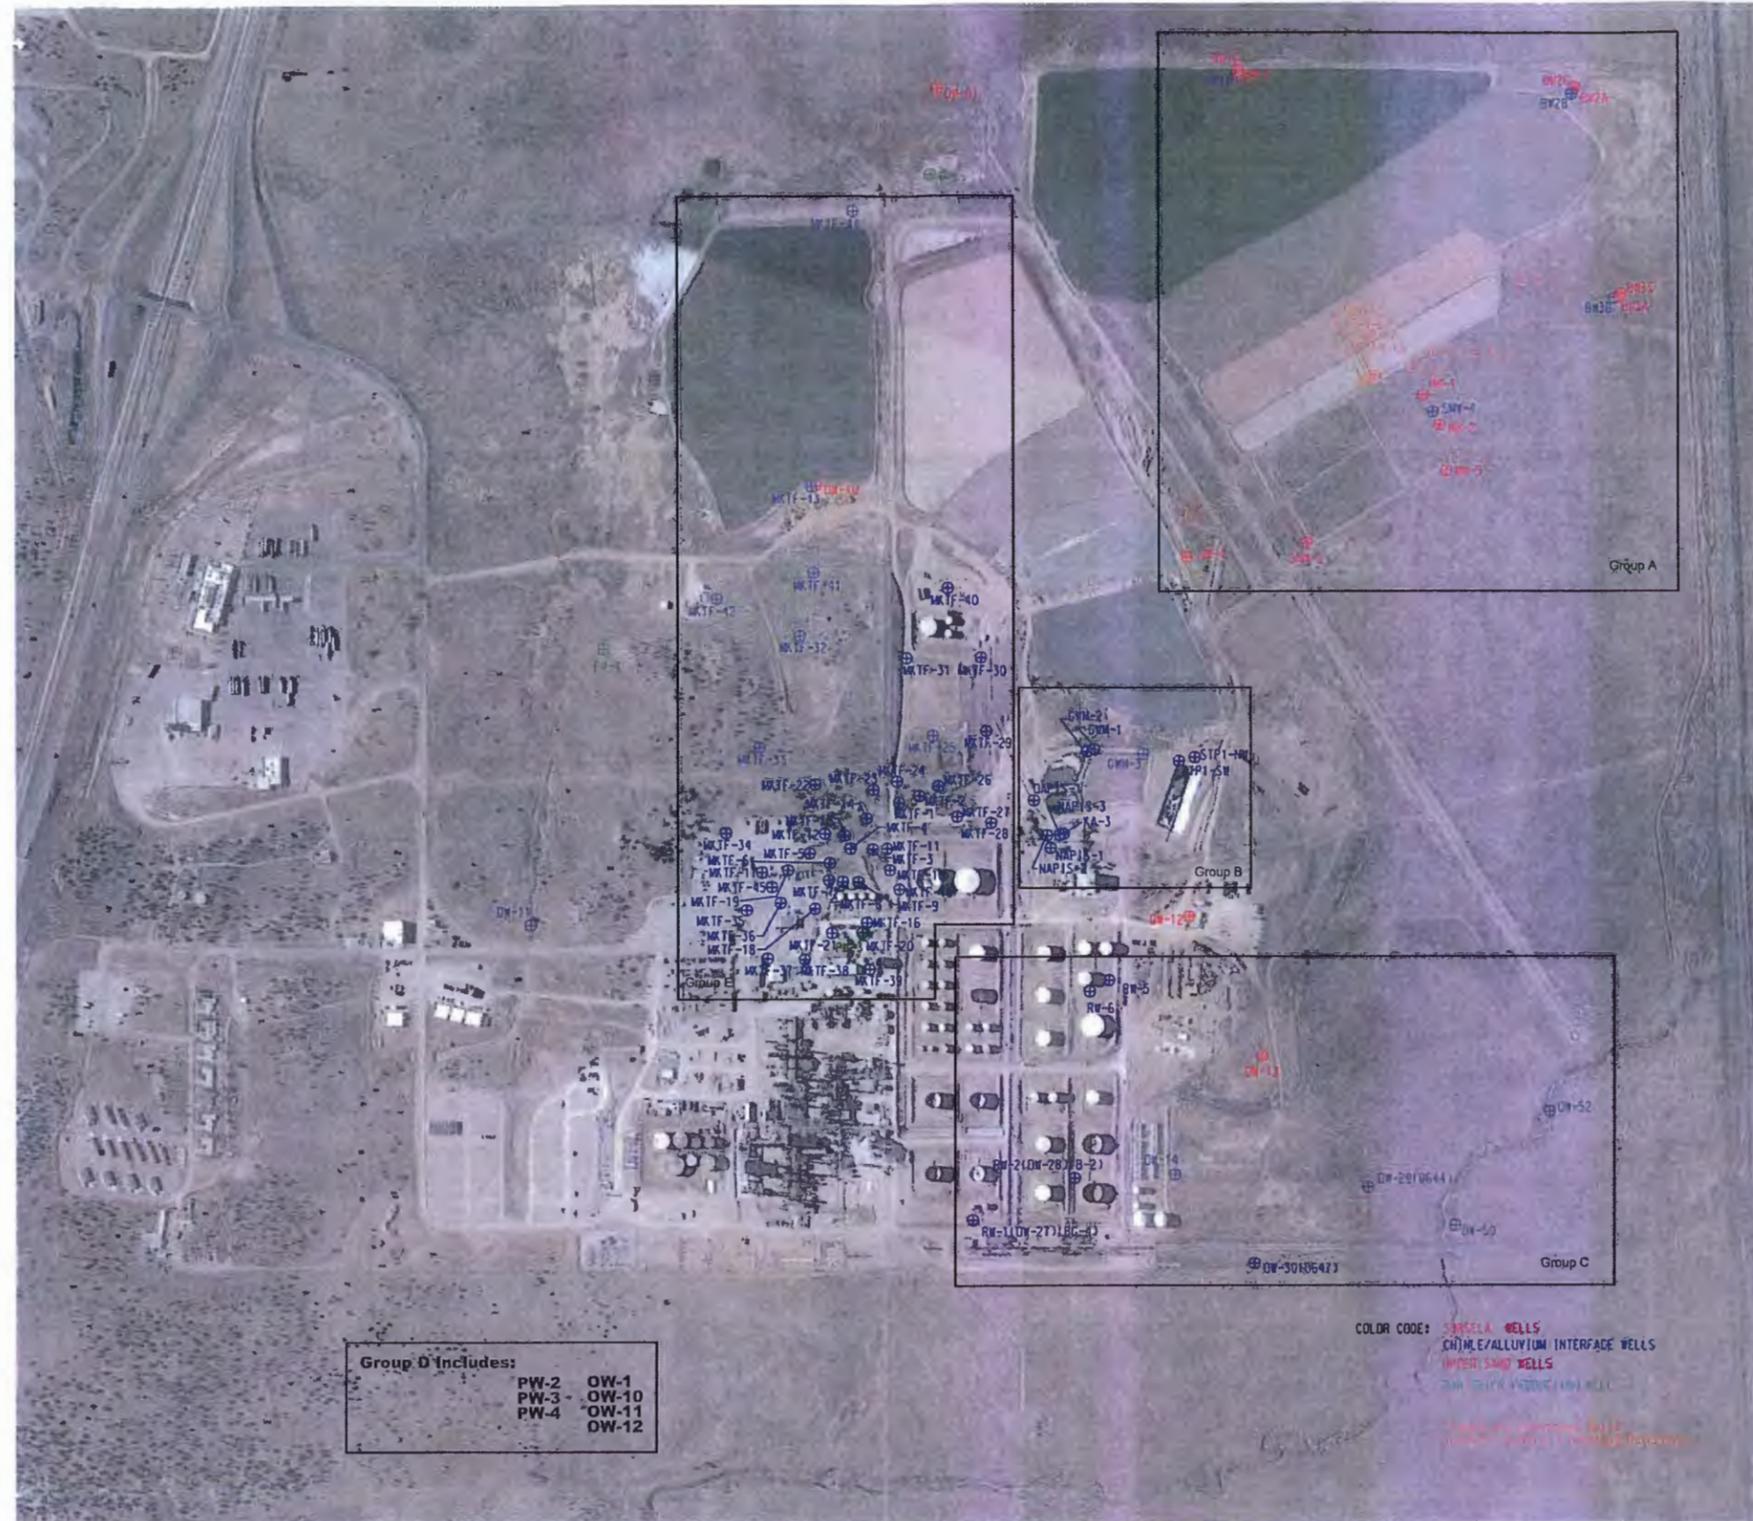
Figure 6
FACILITIES AND WELL GROUPS
 WESTERN REFINING - GALLUP REFINERY

Group D includes:
 PW-2 OW-1
 PW-3 OW-10
 PW-4 OW-11
 OW-12

COLOR CODE:
 SAND WELLS
 CHALK/ALLUVIUM INTERFACE WELLS
 UPPER SAND WELLS
 LOWER SAND WELLS

Figure 8(S-N Section Westerly Plant Area) does not correlate to the information provided in Figure 6. For example, wells OW-05 and OW-03 and OW-24 are not shown on Figure 6. Provide updated figures that show the locations of all ground water monitoring wells. If the wells have been abandoned, note this on the figures. Where appropriate, provide replacement figures with the response letter.

***Response:** Figure 6 and Figure 8 have been revised with an explanation that wells OW-05, OW-03 and OW-24 are abandoned/closed wells and were only used for cross section lithology reference points only. (Revised Figures 6 and 8 attached)*

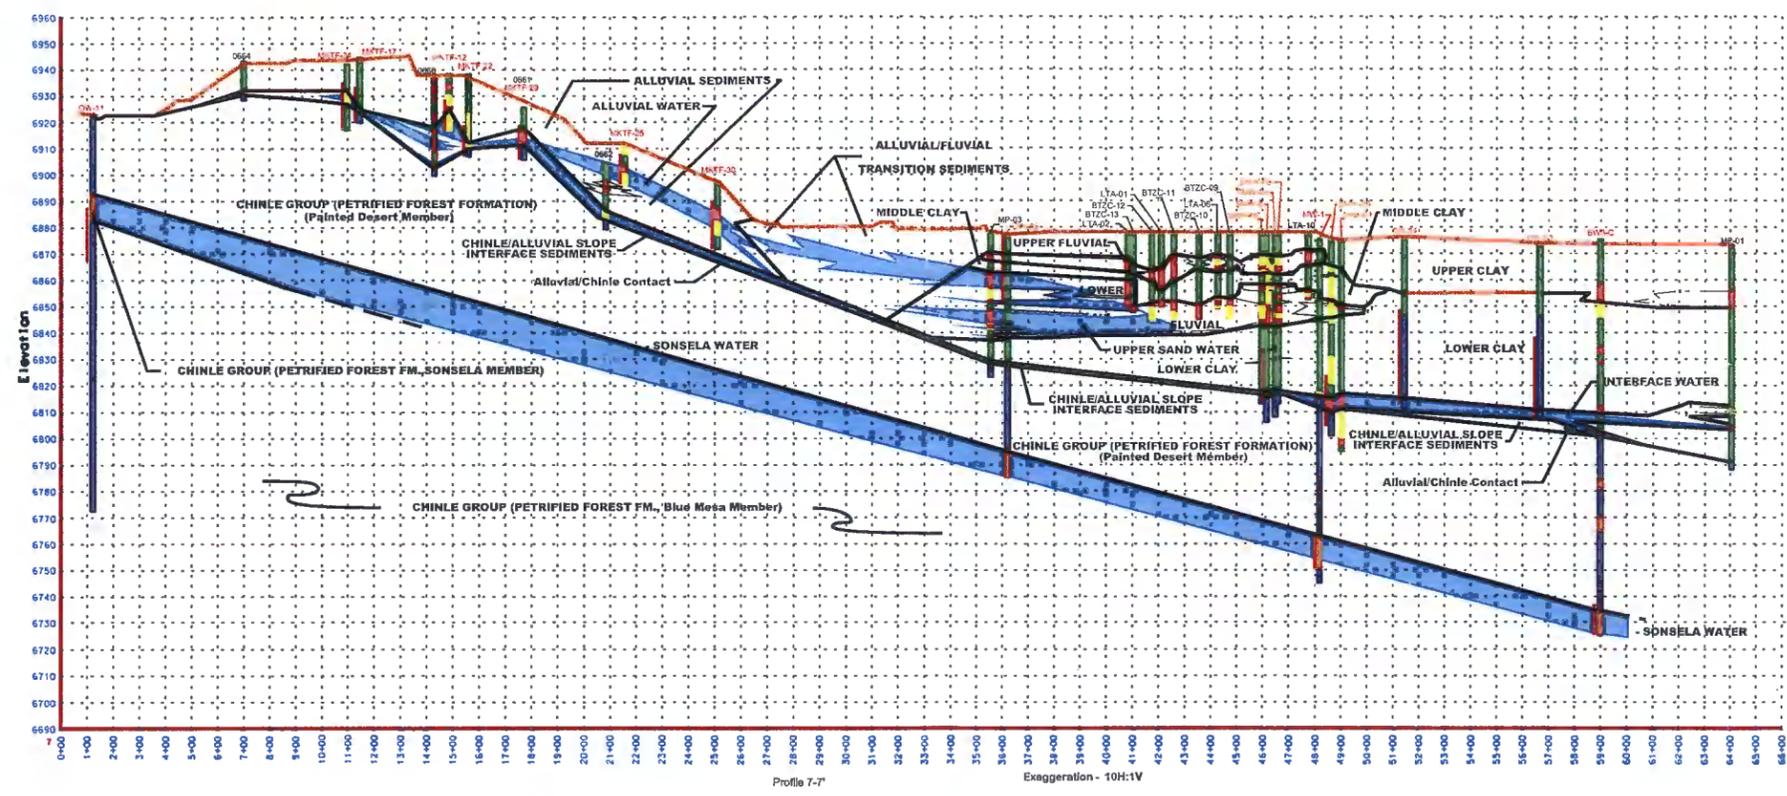
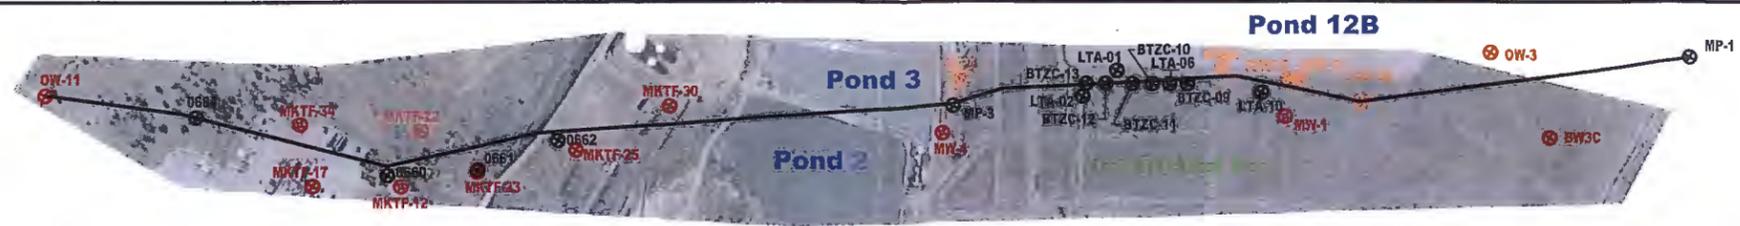
LEGEND

- CLAY	- SHALE (CHINLE GROUP)	- Closed and Abandoned Wells Logs Used for Lithology Reference
- SANDY CLAY OR CLAYEY SAND	- SANDSTONE (NOT PART OF THE SONSELA)	- WATER BEARING ZONE
- SAND	- SONSELA SANDSTONE MEMBER (CHINLE GROUP)	- SCREENED INTERVAL
- SILT	- PROFILE LINE	- OW-XX - MW-XX - MKTF-XX - BW3-C } ACTIVE MONITORING WELL
		- LTA-10 - BORING REFERENCE
