Andeavor
I-40 Exit 39
Jamestown, NM 87347

April 30, 2018

**RE: SECOND DISAPPROVAL
SANITARY LAGOON INVESTIGATION
REVISED INTERIM MEASURES REPORT HYDROCARBON SEEP AREA
WESTERN REFINING SOUTHWEST INC., GALLUP REFINERY
EPA ID # NMD000333211
HWB-WRG-15-002**

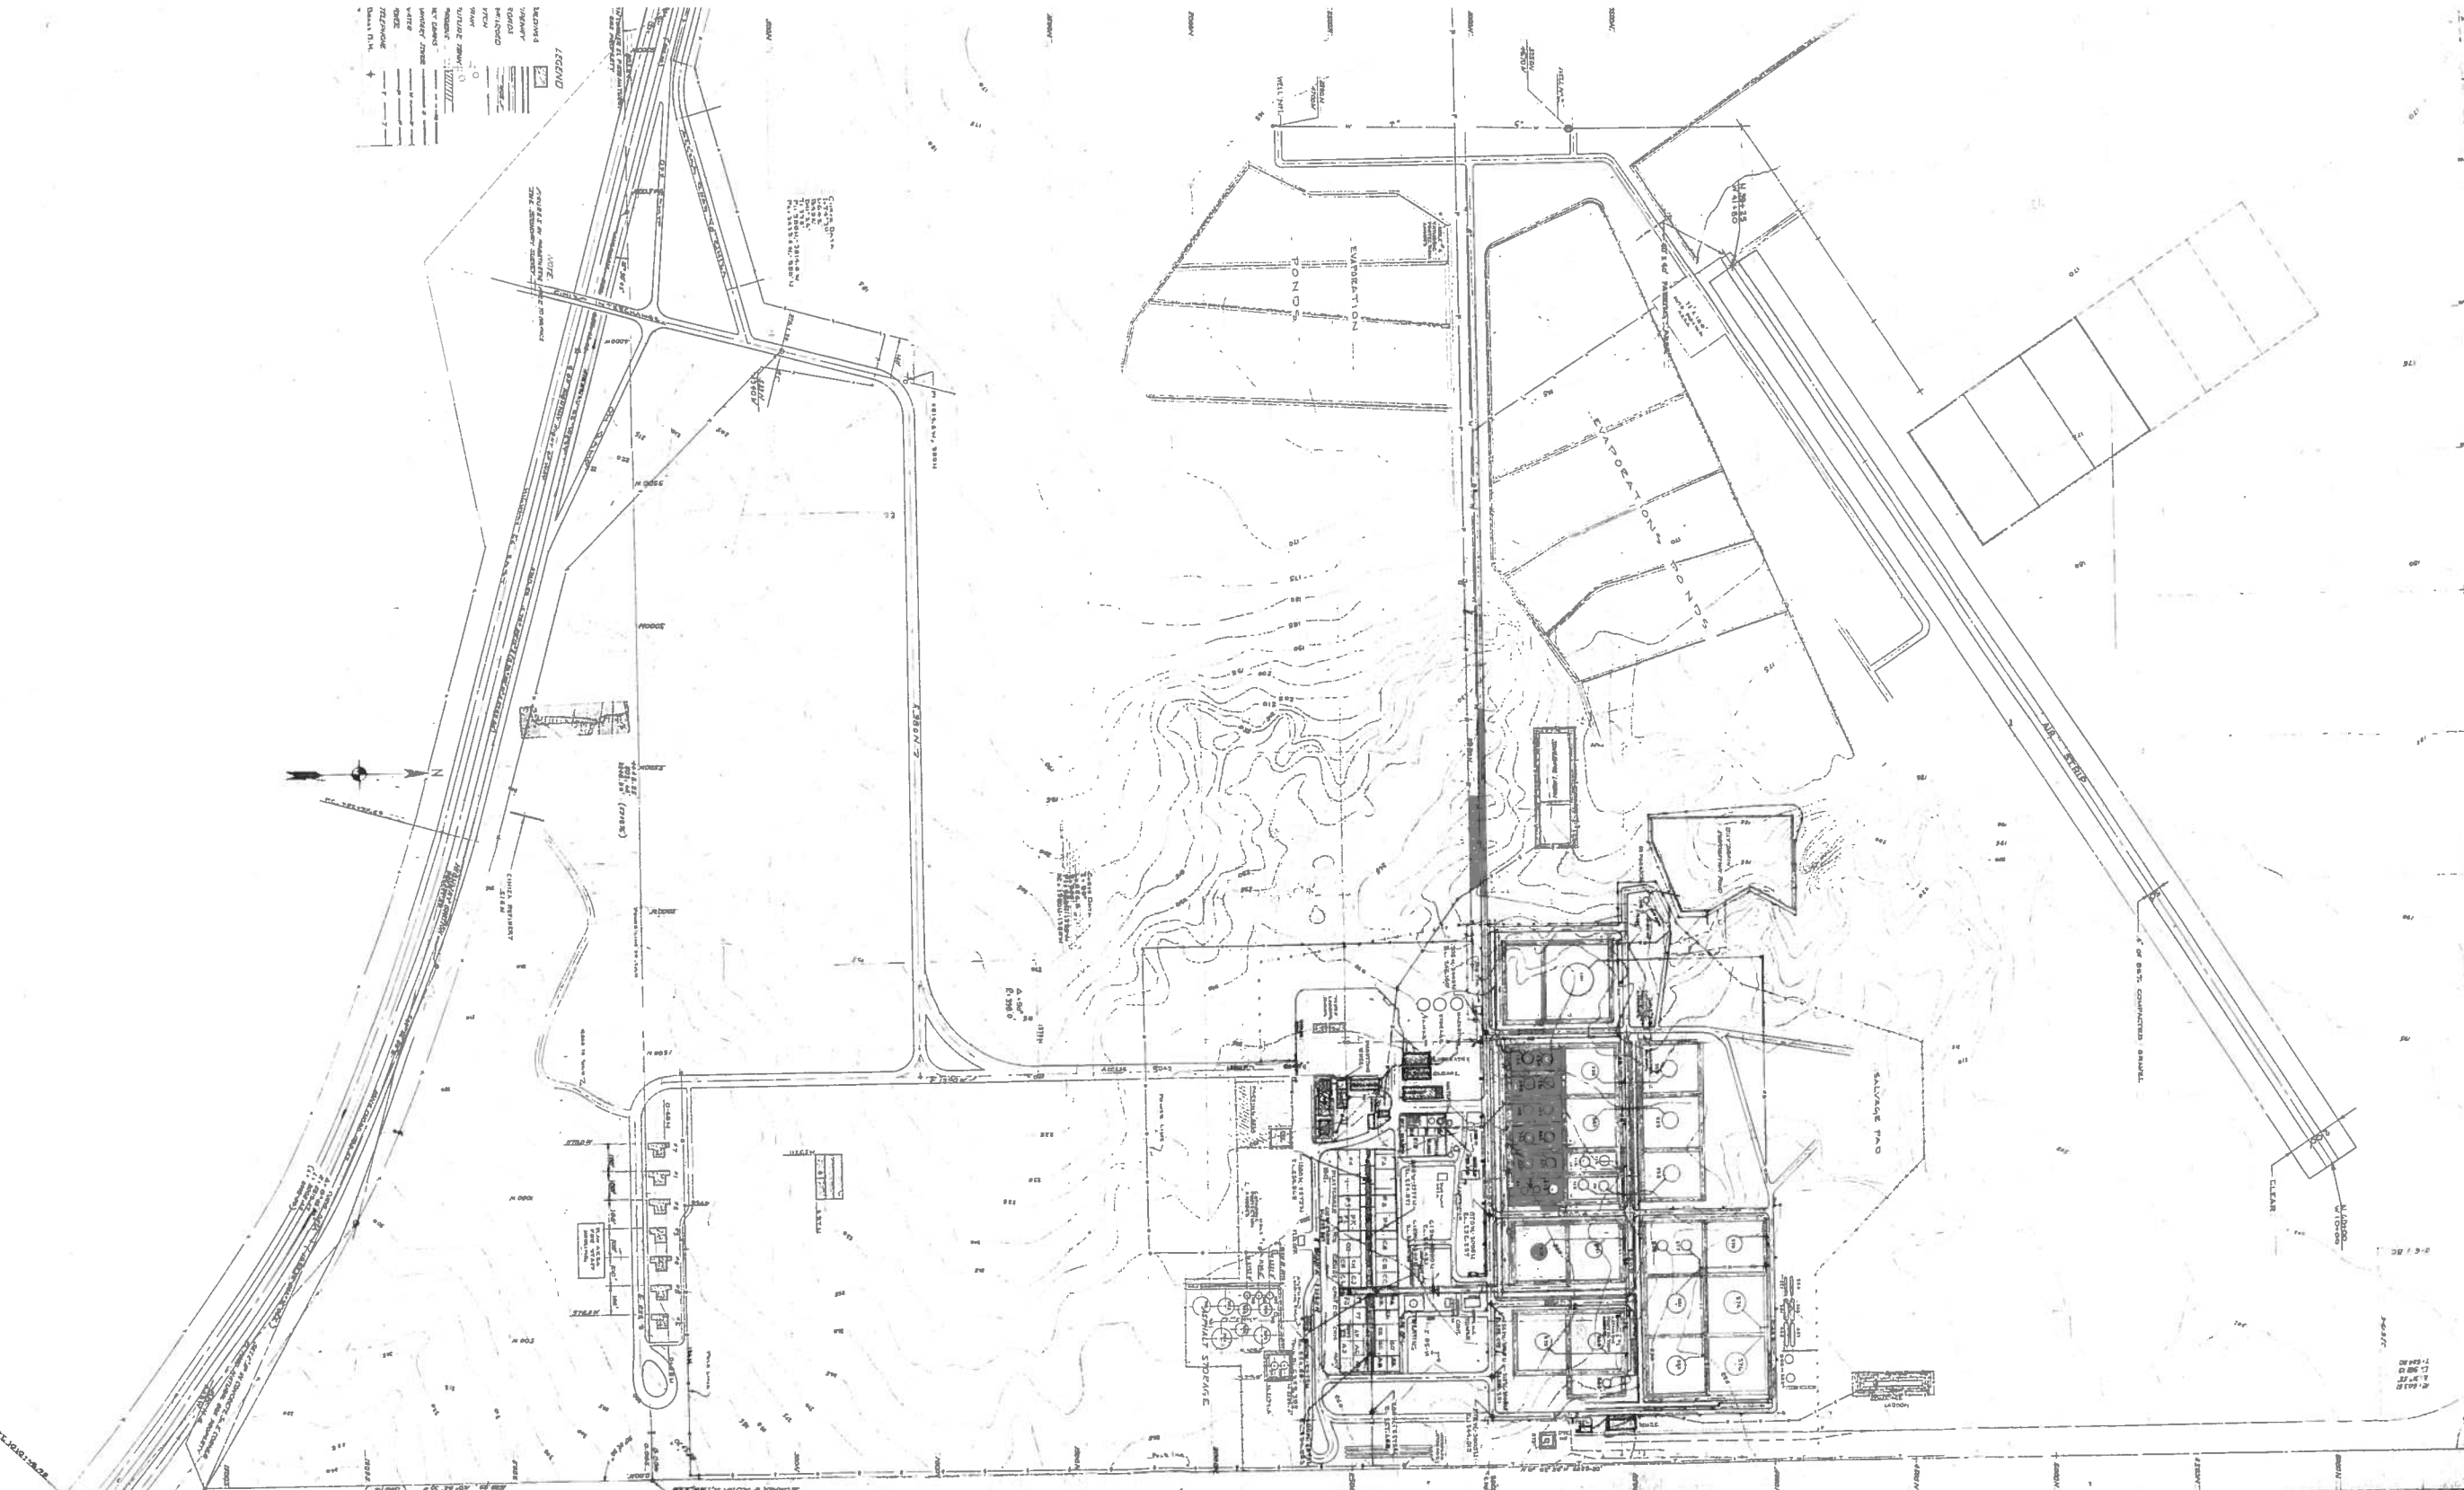
1.75" = 100' (VERTICAL SCALE)
1" = 100' (HORIZONTAL SCALE)
DATE: 11/15/50
DRAWN BY: J. H. BROWN
CHECKED BY: J. H. BROWN
APPROVED BY: J. H. BROWN

Response: Attachment A and Attachment B are drawings that were evaluated for identification of possible sources of sanitary discharges to the sewage lagoon. A dye test at the warehouse bathroom was conducted on April 27, 2018.

In response to OCD's question regarding the period of time for the discharge, the Permittee states, "[t]he discharge has been occurring since at least 1957 (the date of the attached sewerage map)." The discharge was likely a continuous source of groundwater recharge, as well as a source for potential soil and groundwater contamination. The discharge to the sewage lagoon represents a routine and systematic release of hazardous constituents to the environment, which meets the definition of a solid waste management unit (SWMU). At this time NMED will not add the pond to the RCRA Permit as a SWMU.
