SUBJECT: PRS 55-009 ADDENDUM TO NOTICE OF DETERMINATION FOR REQUESTS FOR PERMIT MODIFICATION: UNITS PROPOSED FOR NO FURTHER ACTION, MARCH AND SEPTEMBER 1995

Enclosure: PRS 55-009 Addendum to Notice of Determination for Requests for Permit Modification: Units Proposed for No Further Action, March and September 1995

DESCRIPTION AND OPERATIONAL HISTORY OF PRS 55-009

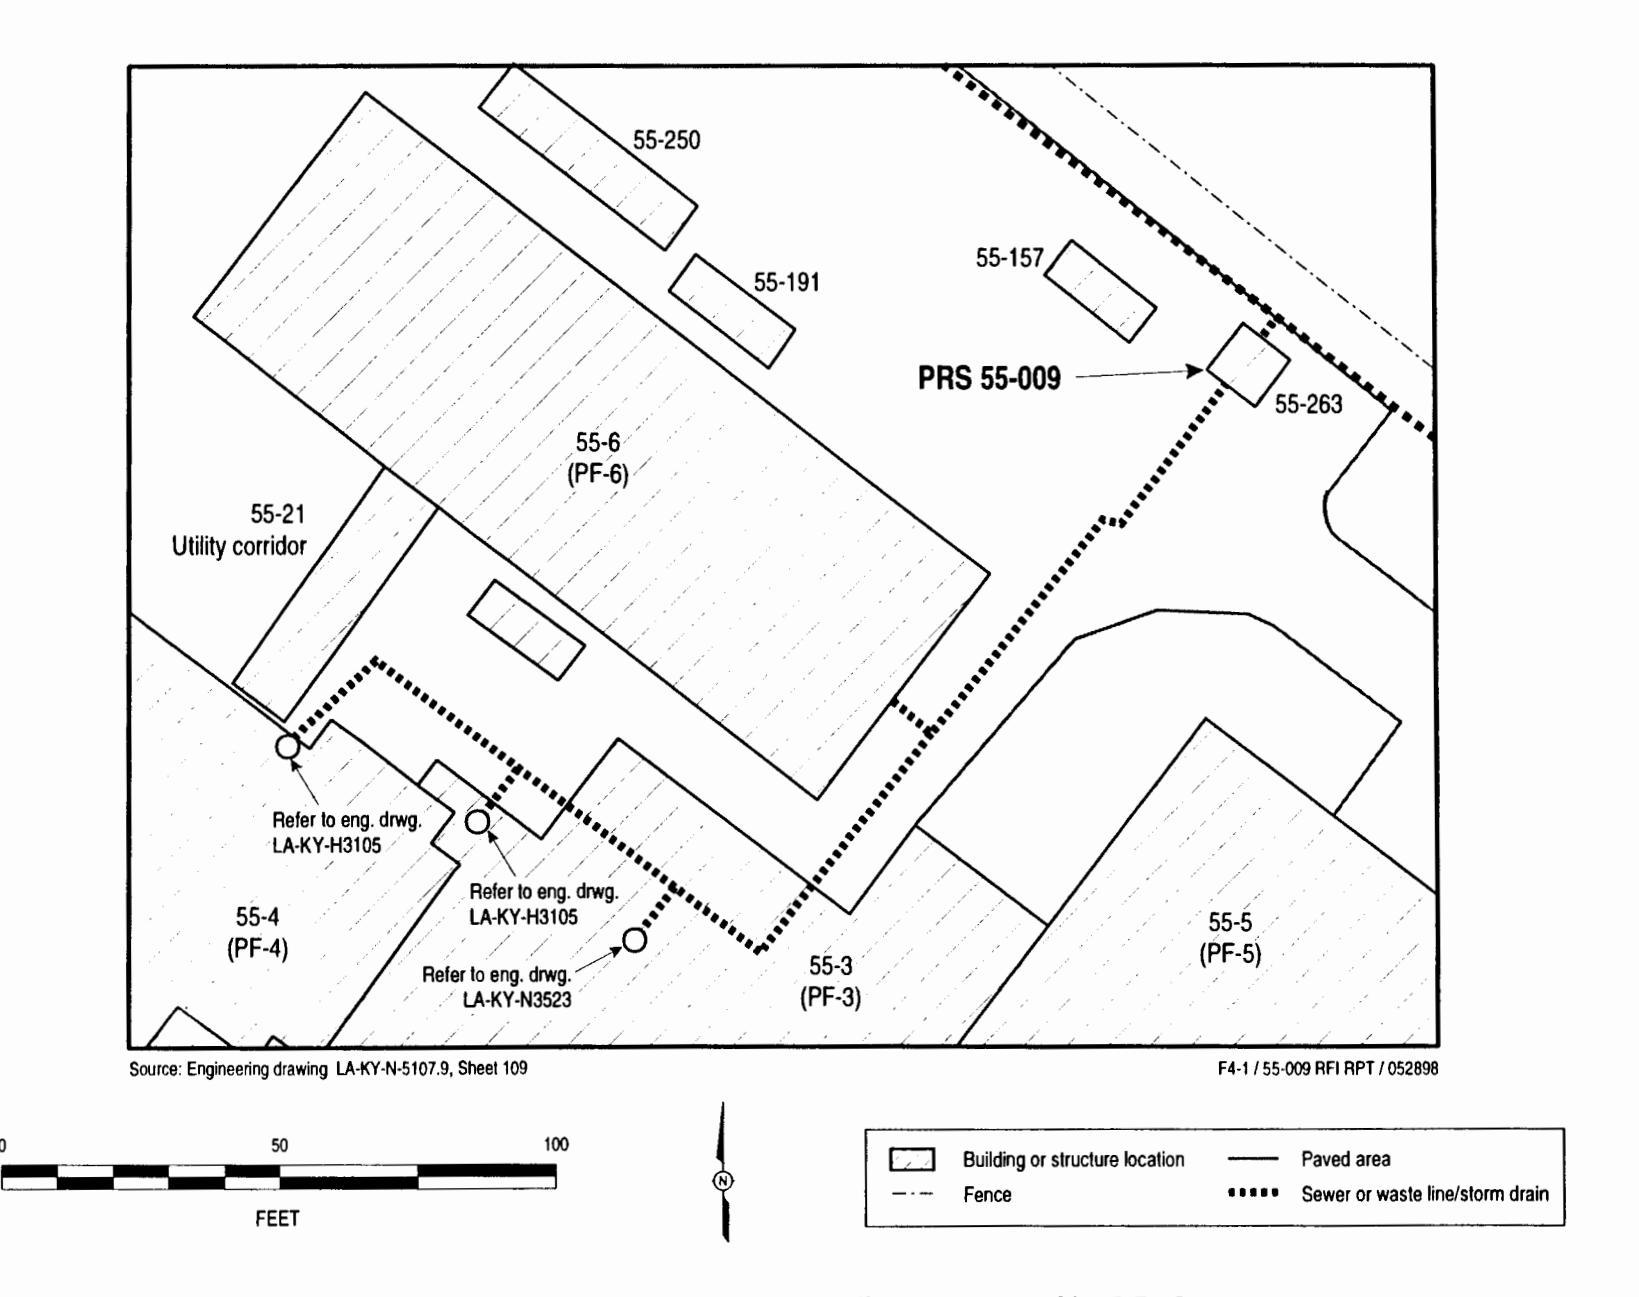
Figure 4-1. Connections to the TA-55 north sanitary sewer line upstream of PRS 55-009.

There are three TA-55 buildings served by the north TA-55 sewer system which connect upstream of PRS 55-009 (Refer to Figure 4.1). [Please note that security issues over the functions of TA-55 prevent unrestricted public release of the engineering drawings referenced in this document. On request to the ER Project Office, they are available for review at LANL.] The main plutonium facility, PF-4, discharges no industrial wastewater to the sanitary system; only sanitary waste from bathrooms and drinking fountains are discharged to the sanitary system. Interviews of TA-55 employees verify the sources of waste to the sanitary sewer (Attachment C). Building PF-3 is a chemical laboratory and general support facility that historically could have been a source of dilute chemical waste to the sanitary sewer from laboratory sinks and floor drains. A list of common laboratory chemicals used at PF-3 that may have been discharged to the sanitary sewer is presented in Attachment D, a memo to file about sanitary sewer connections and waste sources derived from interviews of key TA-55 personnel. In 1994 to 1995 all chemical laboratory drains and sinks were plugged. Finally, the Operations Center for TA-55 located between buildings PF-3 and PF-4 has a floor drain that may have received water with a trace of oil. Other buildings in TA-55 are served by the north sanitary sewer system, however, these buildings connect downstream of PRS 55-009 (Attachment B).
