SAND94-0786 • UC-721
Unlimited Release
Printed April 1994

Feasibility of Permeation Grouting for Constructing Subsurface Barriers

B. P. Dwyer

Efforts are being made to devise technologies that provide interim containment of waste sites while final remediation alternatives are developed. Permeation grouting, a technique used extensively in the civil and mining engineering industry has been investigated as a method for emplacing a subsurface containment barrier beneath existing waste sites. Conceptually an underlying barrier is placed by injecting grout into the formation at less than fracturing pressure from a series of directionally drilled boreholes beneath the waste site. This study evaluated the penetration and performance characteristics in varying soil conditions of four different grout materials (two microfine cements, mineral wax, and sodium silicate) at a field scale.

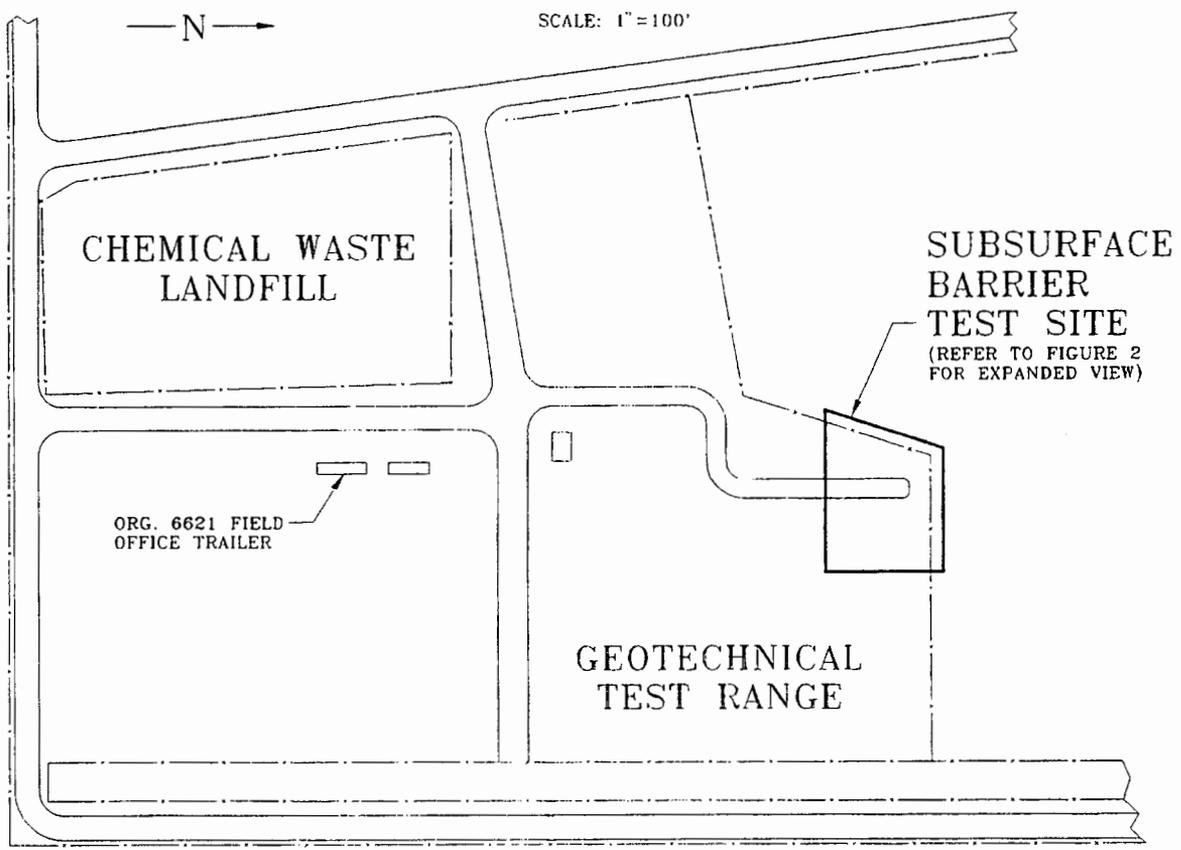
FIGURE 1. SOUTHEAST CORNER OF TECH AREA III, GEOTECHNICAL TEST RANGE LOCATION

The Subsurface Barrier Emplacement Demonstration Site is located in the Southeast Corner of Technical Area III, Sandia National Laboratories, Albuquerque, New Mexico (Refer to Figure 1). The area typically has a dry, semi-arid climate.

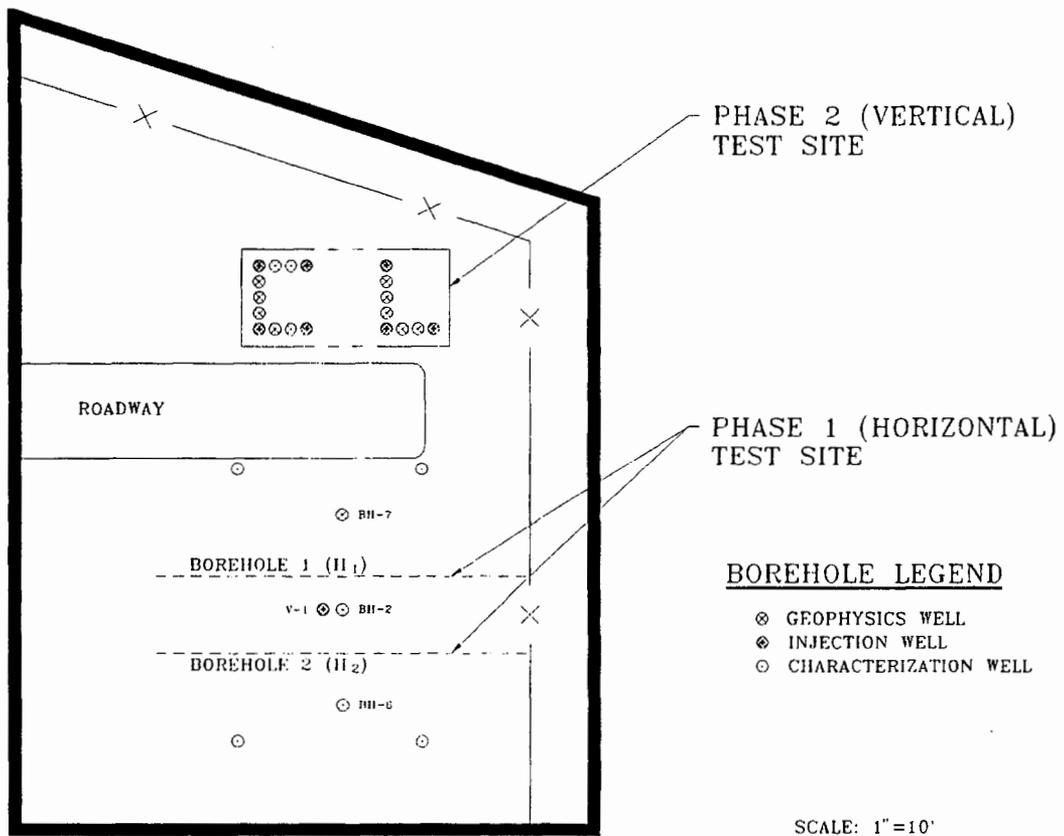
FIGURE 2. PHASE 1 AND 2 SUBSURFACE BARRIER TEST SITE PLAN VIEW

S & S Harris and Associates directionally drilled two horizontal boreholes and installed tube-a'-manchette (sleeve) pipe (Figure 2 & 4) casing in the boreholes during drill string withdrawal. Denver Grouting Services, Inc. grouted the sleeve pipe annulus with a relatively weak neat cement/bentonite grout to eliminate preferential flow along the grout pipe annulus during actual grouting operations. Permeation grouting requires grouting the sleeve pipe annulus with a brittle grout material prior to injection with the selected grout(s). The purpose of the annulus grout is to eliminate flow paths along the annular space left between the drilled borehole and the inserted sleeve pipe. After the annulus grout cures the "real" grout is then injected at a pressure sufficient to fracture (perpendicular to the sleeve pipe direction) the relatively weak annulus grout; thereby, directing grout flow radially into the formation at that designated interval only. During actual grouting operations, the Denver Grouting Services, Inc. foreman indicated that the annulus grout may have settled at the low points causing discontinuities and thus partial ineffectiveness of the annular grout. The annulus grout was allowed to cure for 24 hours prior to commencement of actual grouting operations.

Vertical observation wells (refer to Figures 2 & 4) were drilled to a depth of 52 feet for the purpose of crosswell seismic data acquisition. The holes were cased with 6" I.D. steel casing and grouted in place. Caution was taken during grouting of the casing to minimize invasion into the formation. During the test, seismic velocity tomograms were generated between two pairs of wells; the west pair (BH-7 and BH-2) and the east pair (BH-2 and BH-6). The horizontal tube-a'-manchette pipes (boreholes 1 and 2) intersect the vertical planes between well pairs near the center point. Tomograms were generated before and after grout injection. Data acquisition parameters were identical for the before and after surveys; therefore, changes in measured seismic travel times between pre- and post-injection surveys are presumed to be the result of grout invasion in the vicinity of borehole 1 and 2.

SHB Agra, Inc. drilled a series of single boreholes and installed tube-a'-manchette (sleeve) pipe casing in the boreholes during drill string withdrawal. Figure 2 shows a plan view of the test area including both grout injection and geophysical measurement boreholes; Figure 5 shows a typical cross section of the site. The grout injection boreholes were arranged in this pattern to allow connection of grout fronts in adjacent boreholes. Denver Grouting Services, Inc. grouted the sleeve pipe annulus with a relatively weak neat cement/bentonite grout to eliminate vertical preferential flow along the grout pipe annulus during actual grouting operations. The annulus grout was allowed to cure for

Figures 2 and 5 show plan and profile views of the geophysical wells used during Phase II. Geophysical measurements were taken prior to, during and after grout injection. Variation in soil properties such as electrical conductivity, and the dielectric constant are used to map grout location. The geophysical methods employed during Phase II testing are listed in Table 2.

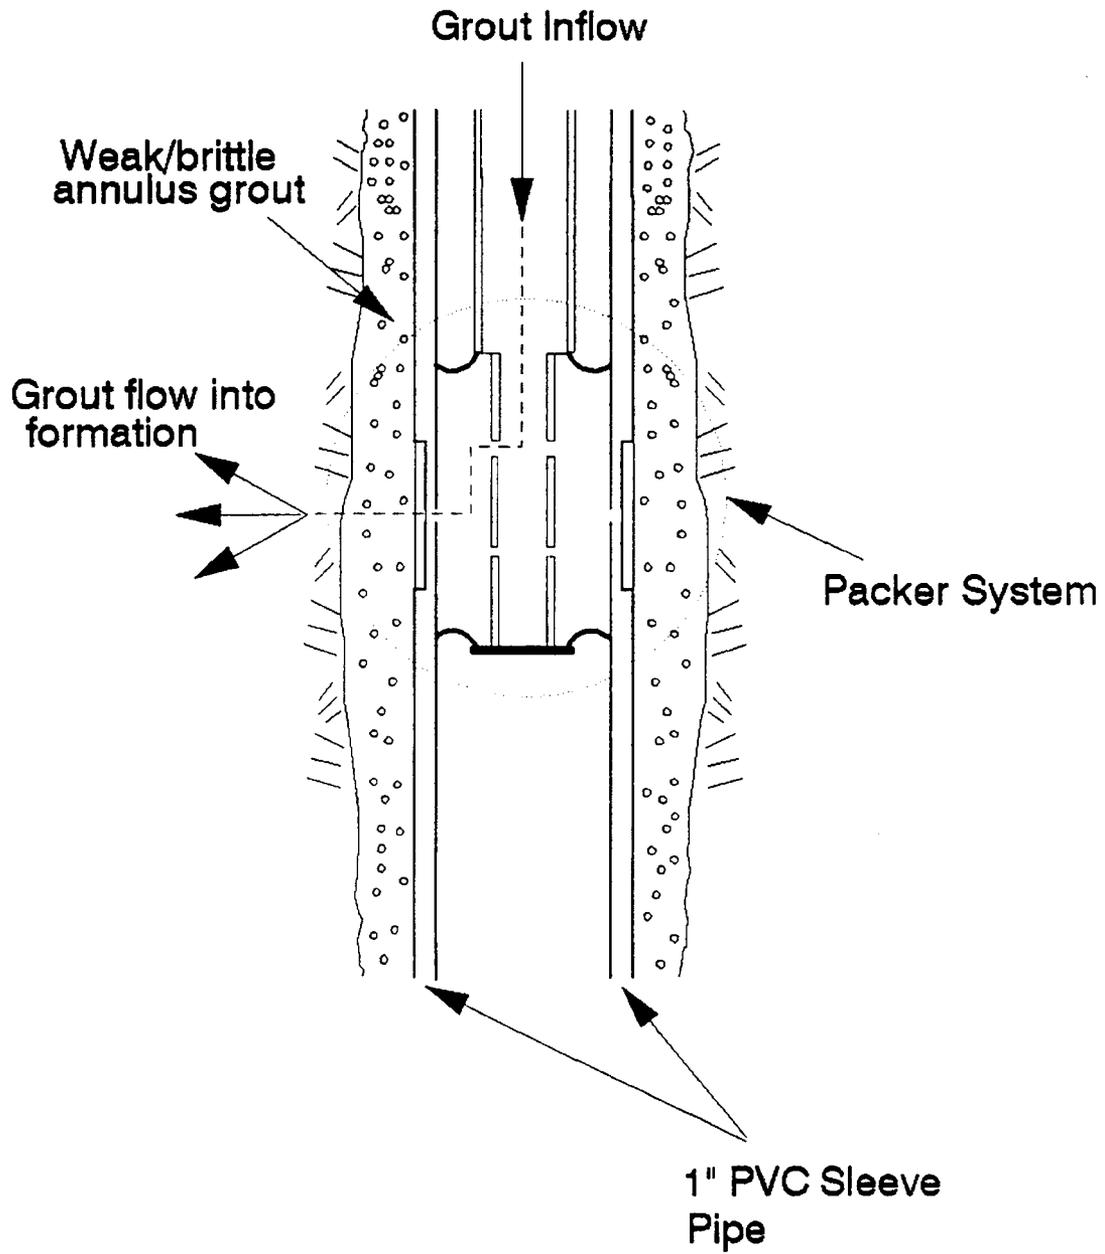
Figure 3. Tube-a'-manchette Cross Section Permeation Grouting Method

The tube-a'-manchette casing allows for selective grout injection at designated locations. A packer system located inside the tube-a'-manchette isolates the interval to be grouted. During actual grouting operations, grout is injected at a carefully monitored high pressure in order to fracture the brittle annulus grout. Once the annulus grout fractures (indicated by large pressure drop), the injection pressure is immediately lowered to ensure permeation and not hydrofracturing of the formation.

Denver Grouting Services, Inc. injected the grout materials in one-foot stages using a tube-a'-manchette with a double packer system (Figure 3). Completion of each stage was designated using the following pre-determined cutoff criteria:

Grout was injected in one-foot vertical stages using a double packer system located inside the sleeve pipe (Figure 3). Again completion of each stage was designated using the following pre-determined cutoff criteria:

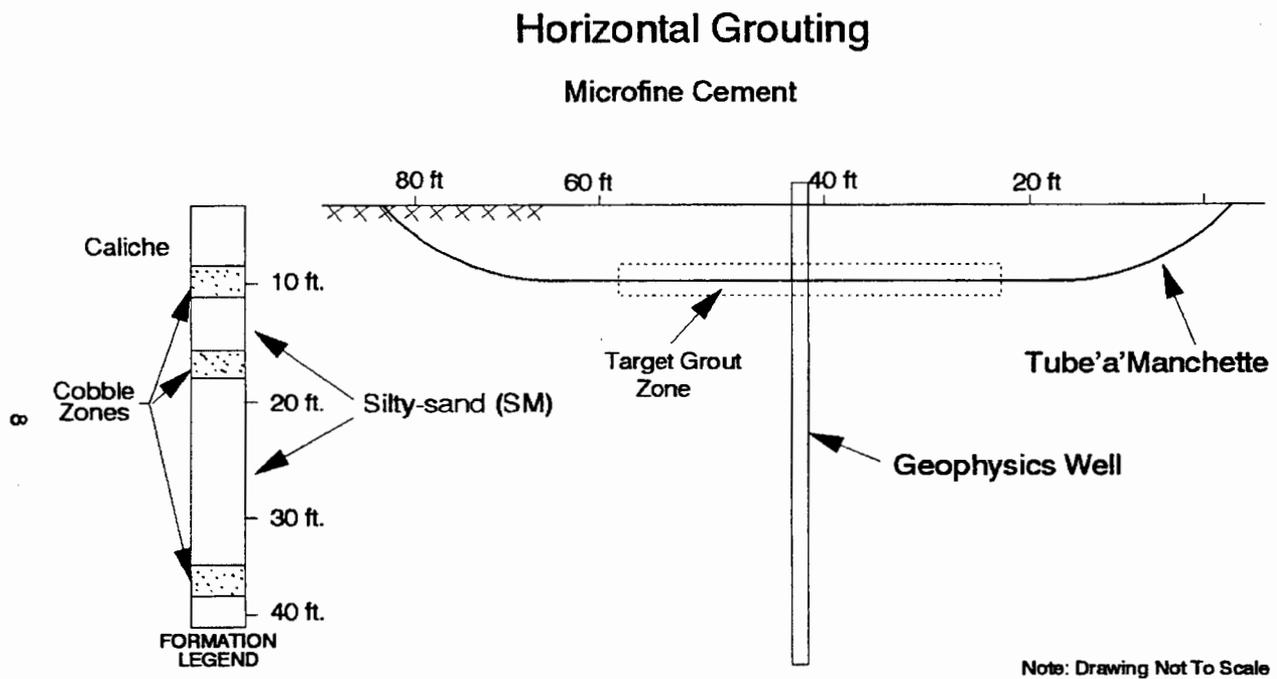
Figure 4. Phase 1 Grout Site Cross Section.

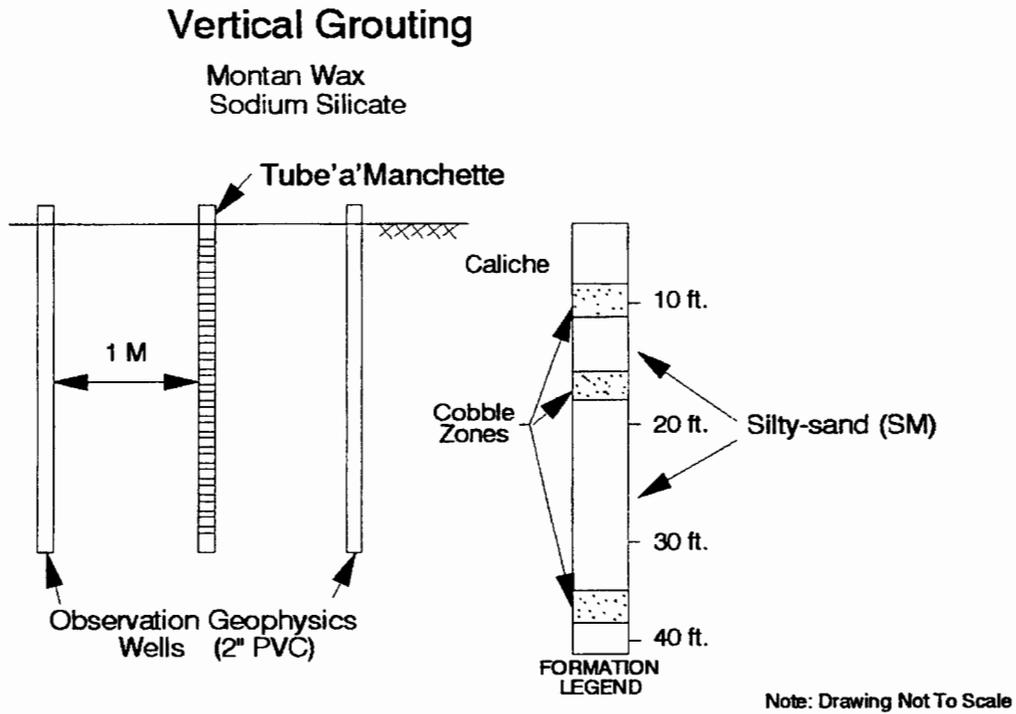
Figure 5. Typical Phase 2 Grout Site Cross Section.

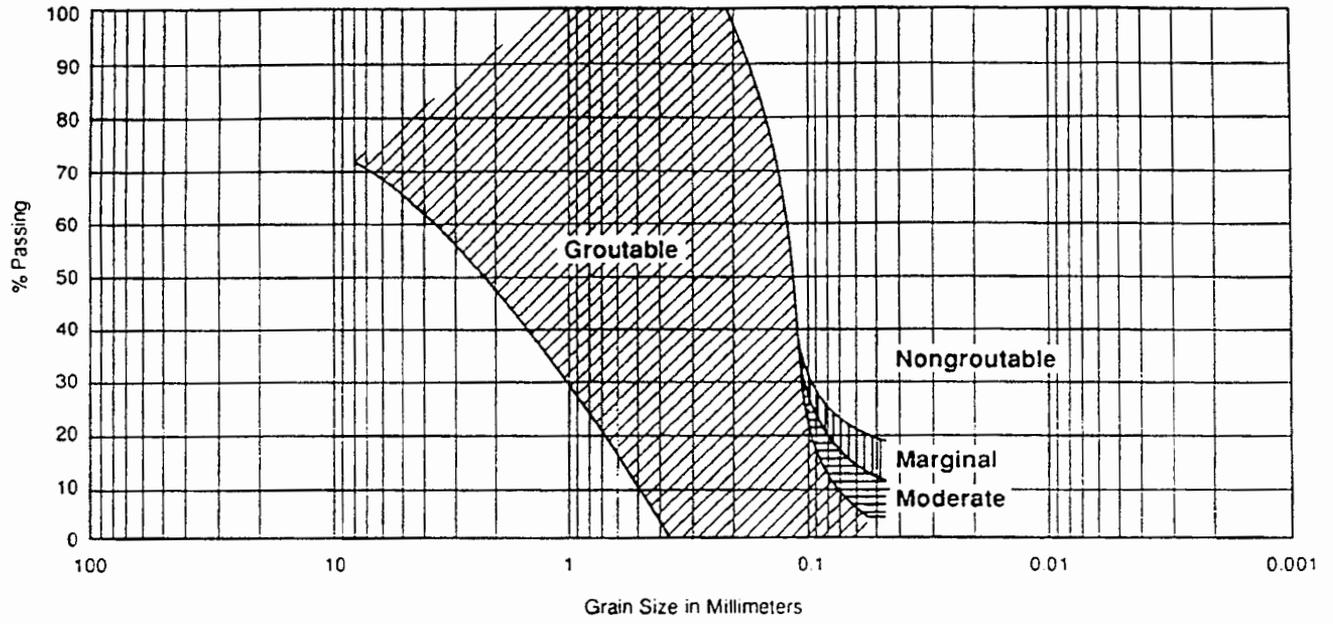
Figure 6. Range of Soils Suitable For Grouting. (Karol, 1990)

As exemplified in Figures 6 and 8, the literature suggests that permeation grouting with low viscosity grout is appropriate for gravels and sands, but only marginal for silts or clays. Figure 7 summarizes the range of results of particle size distribution analyses on test site soil samples. (Golder, 1994) Direct comparison of Figures 6 and 7 indicates that the geologic conditions at the test site are marginal for permeation grouting; however, the soil logs (Appendix A) indicate the presence of higher permeability zones at approximately 8 to 10 ft., and 16 to 17 ft. These layers contain a poorly graded mixture of cobble (3" to 10"), coarse sand and gravel, and silty sand.

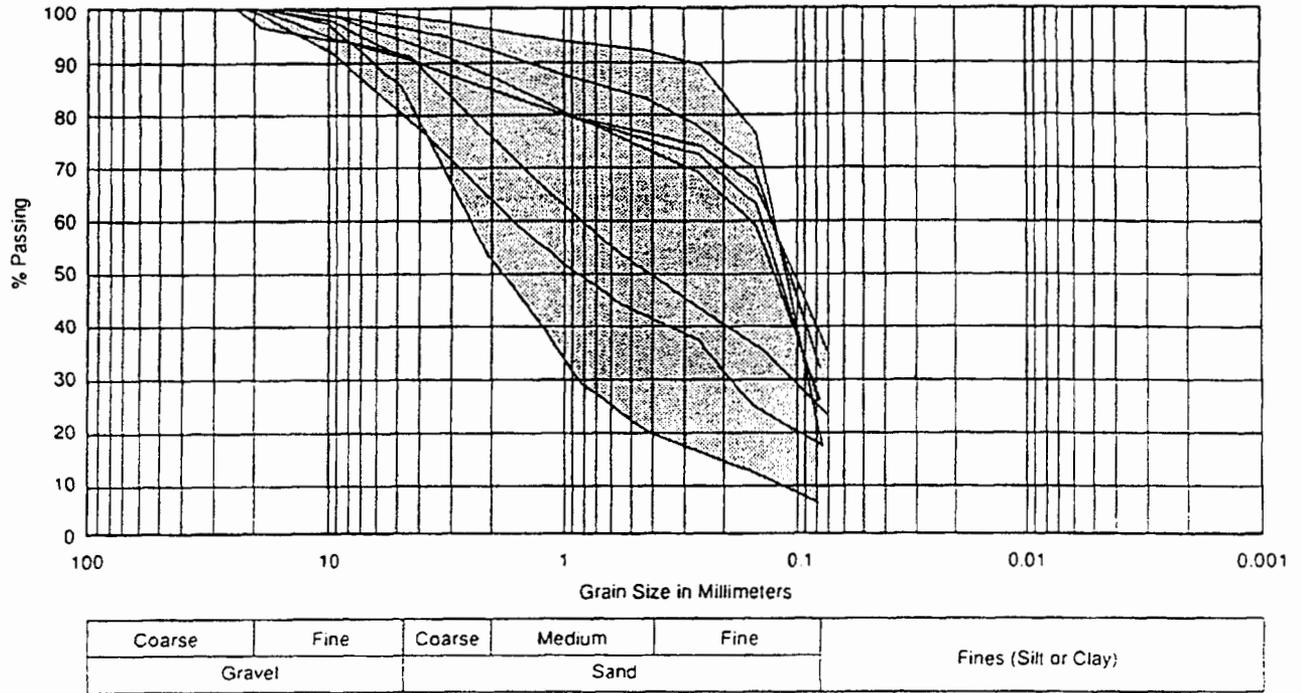
Figure 7. Test Site Particle Size Distribution. (Golder, 1994)

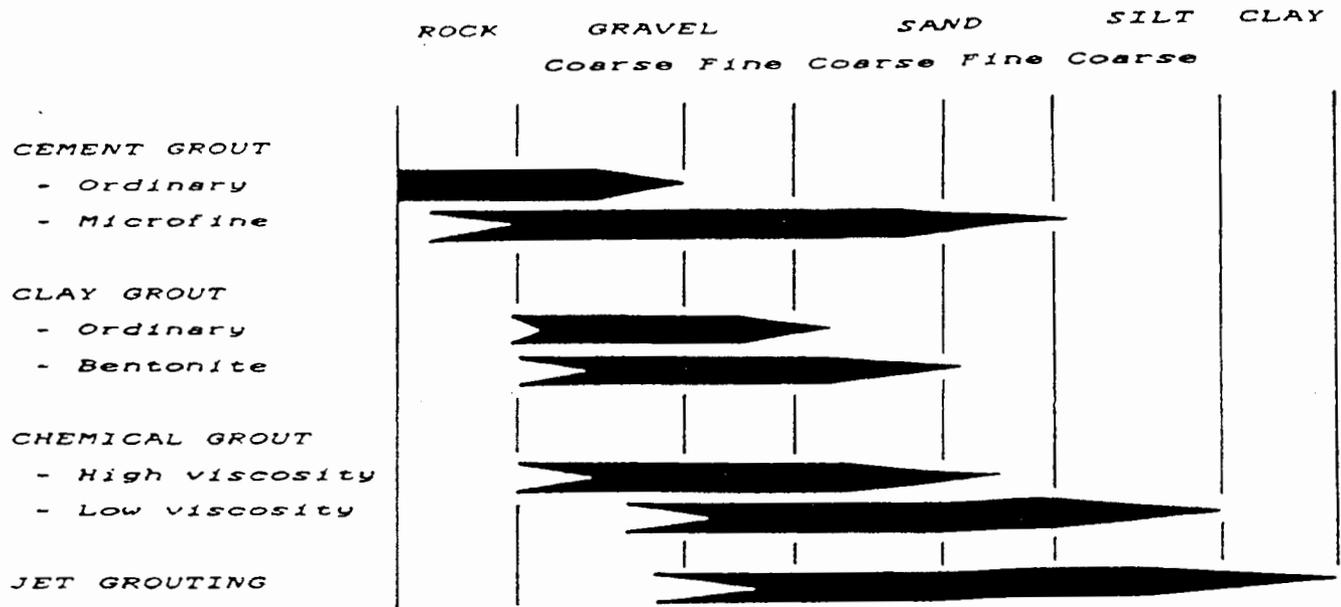
Figure 8. Permeation of Grouts in Different Porous Media.
 (Naudts, 1989)

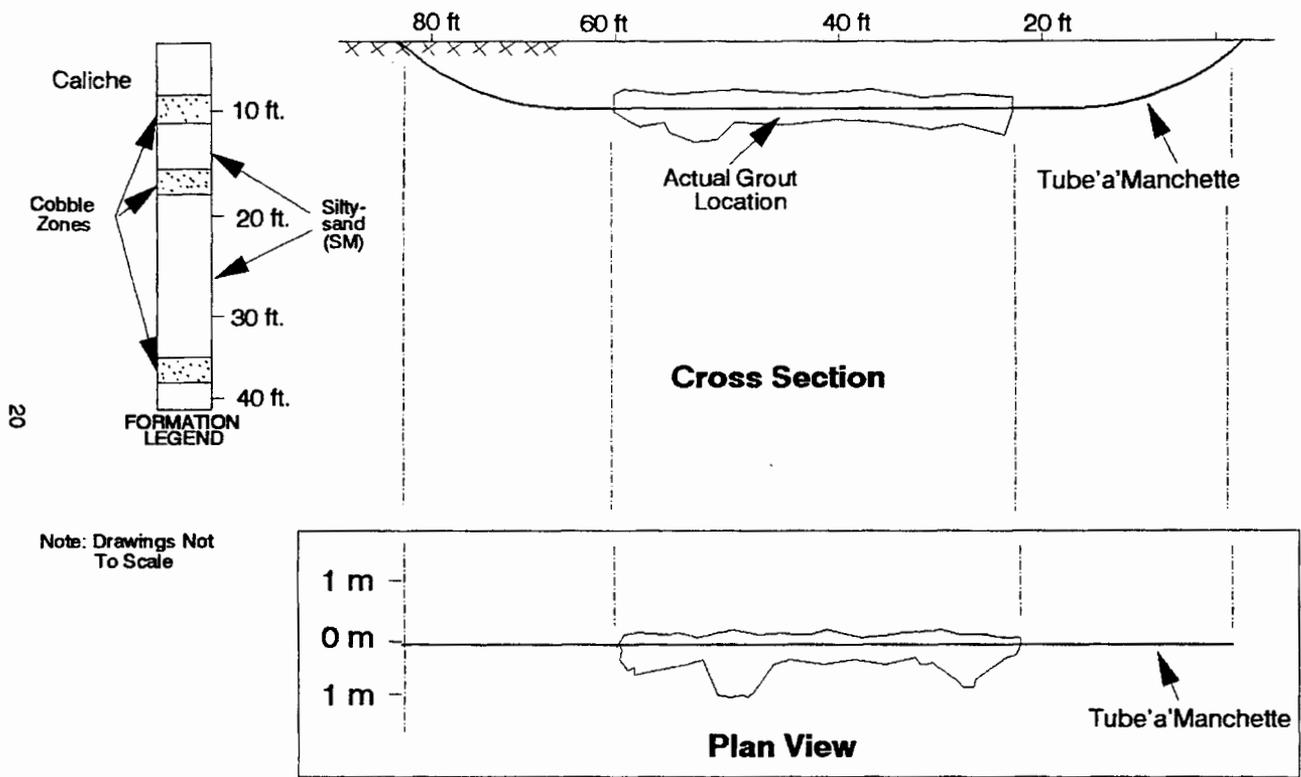
Figure 9. Phase 1, Borehole 1 - Observed Grout Penetration. Microfine Cement

Based on the empirically derived literature, a PR of approximately one to two meters was expected because of the high content of silty sand. Excavation and exposure of the test site revealed grout flow primarily in the horizontal plane as expected. This can be attributed primarily to the variation of porosity vertically through the soil strata, i.e., a "loose" layer bounded by "tight" layers. The grout followed the path of least resistance. Figure 9 shows a profile and plan view of the observed grout permeation in horizontal Borehole 1. Borehole 2 was also excavated, but the results were less impressive. It was not clearly evident where the grout flowed. The borehole 1 horizontal sleeve pipe was approximately eight feet deep, while the borehole 2 sleeve pipe was about 12' deep. The excavation unit used had a depth limitation of 12'; therefore, final exposure of the borehole 2 sleeve pipe was accomplished by hand digging. The grout was not continuous and only large chunks of grouted soil were found in tact. It is possible however, that the grout mass was damaged during excavation with the backhoe because grout was not seen during excavation until the backhoe had already contacted the sleeve pipe.

The non-uniformity in the grout permeation may have to a lesser degree also been the result of preferential grout flow along the sleeve pipe annulus. Table 6 shows the measured pressure and volume for each stage during grouting of borehole 1. The irregular volumes injected per stage coincide with the presumption that preferential flow occurred; unfortunately, the volume fluctuations do not correspond with the grout location shown in Figure 9.

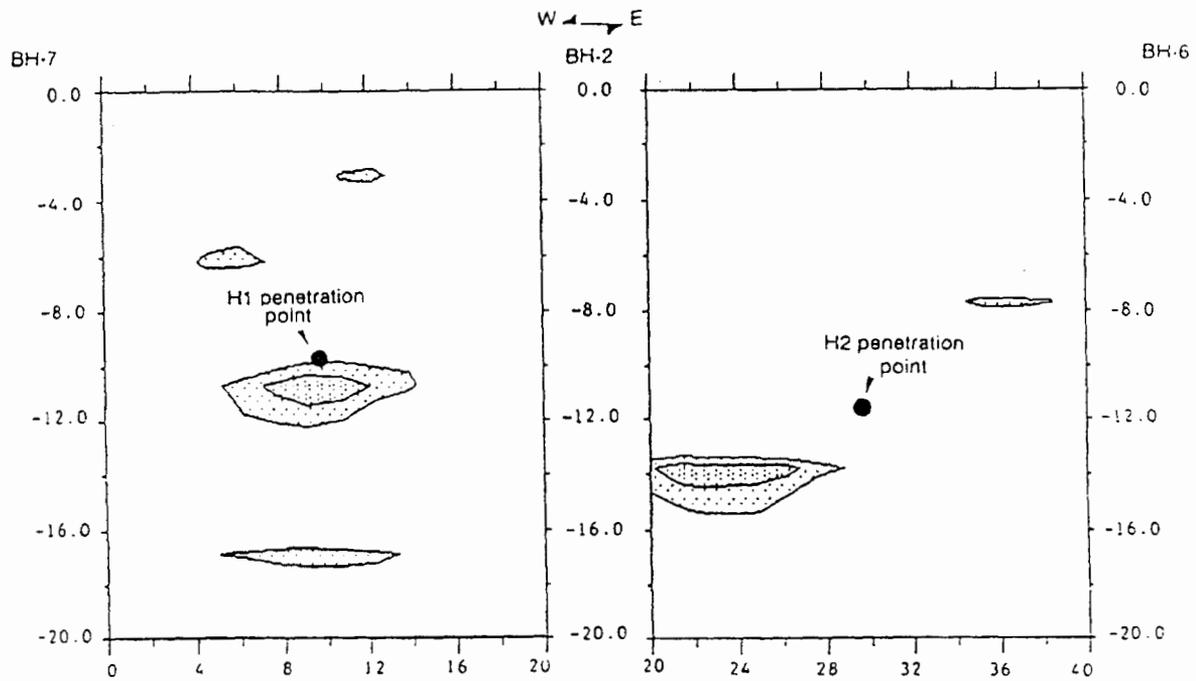
Figure 10. Crosswell Seismic Velocity Difference (%) Tomograms.
(Harding, 1994)

SEISMIC P-WAVE VELOCITY DIFFERENCE (%) TOMOGRAMS
PERMEATION GROUT MONITORING
MWLID SITE - SANDIA, ALBUQUERQUE

The east tomogram indicates no anomalous velocity near H2. This is also consistent with the difficulty finding continuous grout during excavation. However, adjacent to BH-2 there apparently was sufficient grout invasion from V1 (Figure 2), a vertical hole used to inject excess grout at the end of the experiment. The excess grout was injected at a depth of 13 feet, consequently to deep for excavation. It appears that grout invasion from V1 caused a significant seismic anomaly between BH-6 and BH-2 at a depth of 13.5 to 15 feet.

Since the large grout mass in borehole 1 and the excess grout injected in V1 were outside the tomographic imaging plane, it is likely that the anomalies are caused by grouted soil outside the imaging planes. This can occur where the higher velocity of an out-of-plane feature is sufficient to compensate the longer transmission path of out-of-plane rays.
