Subject: Submittal of Documentation of Completion for Construction of the Wing Ditch in Pueblo Canyon

Completion Documentation for Construction of the Wing Ditch in Pueblo Canyon

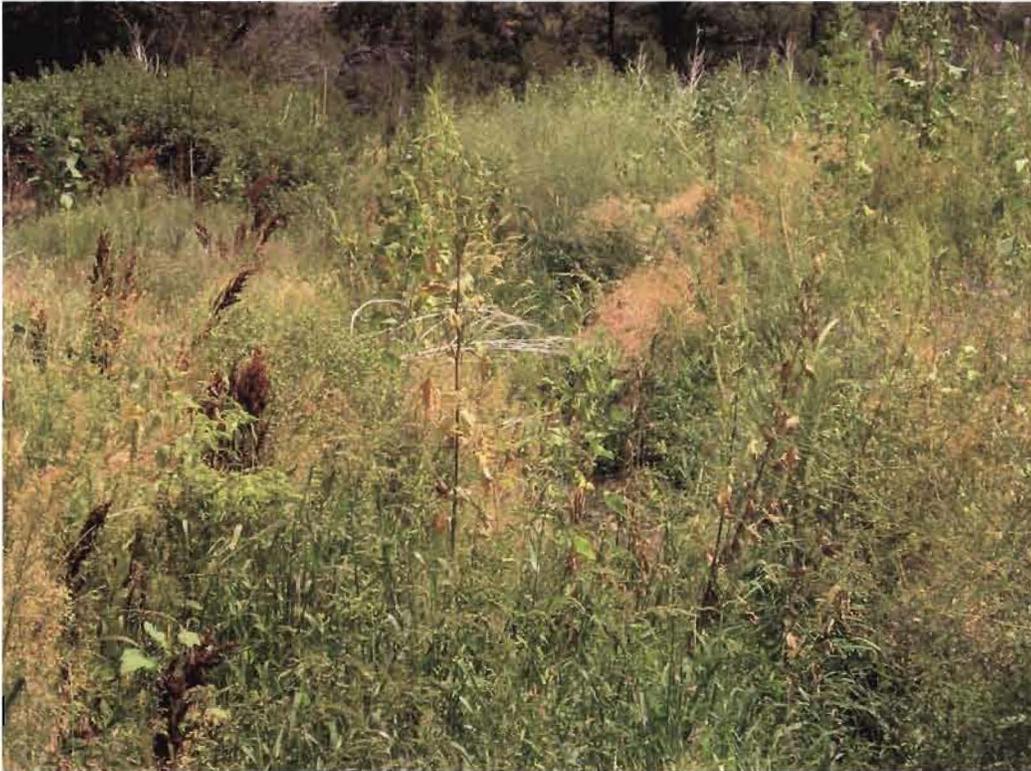
Figure 1 Wing ditch site before excavation

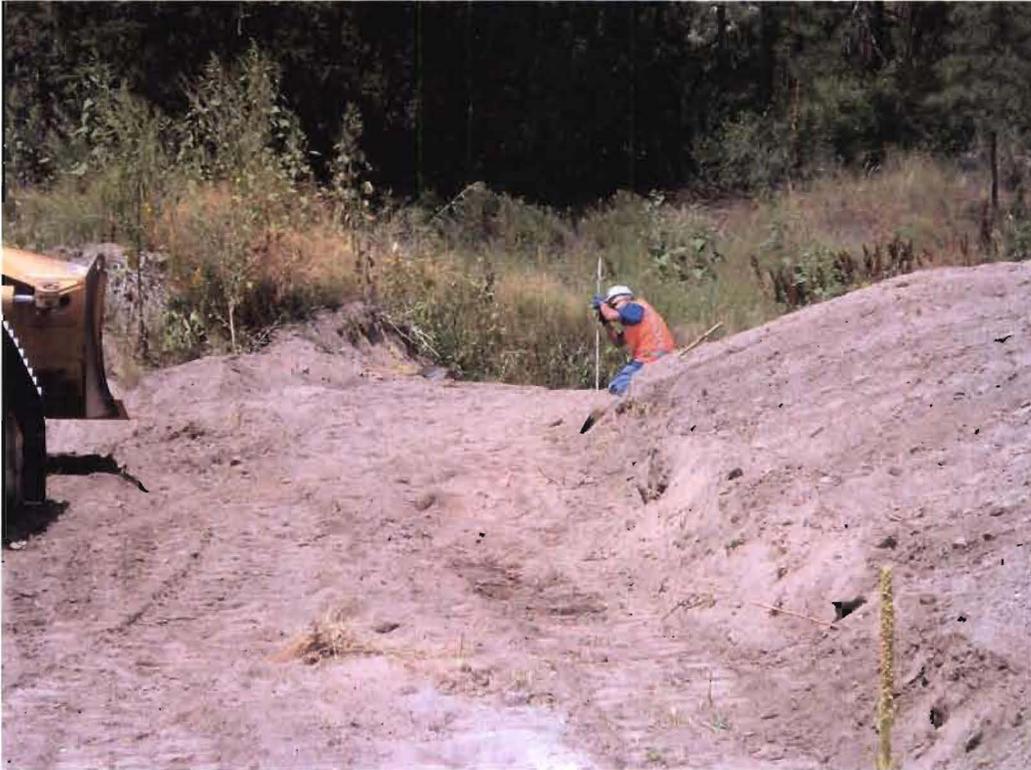
Figure 2 View looking upgradient along wing ditch towards existing channel. Initial excavation and surveying for grade.

The ditch is approximately 77 ft long and 10 ft wide with a 2% grade. It is lined with a geotextile fabric overlain by 6- to 12-in. cobbles. The downstream (east) side of the ditch is bermed to direct flow within the ditch towards the former (currently dry) channel on the floodplain. The former channel sits at an elevation approximately 2 ft above the current active channel. The berm is constructed from material excavated for the wing ditch.

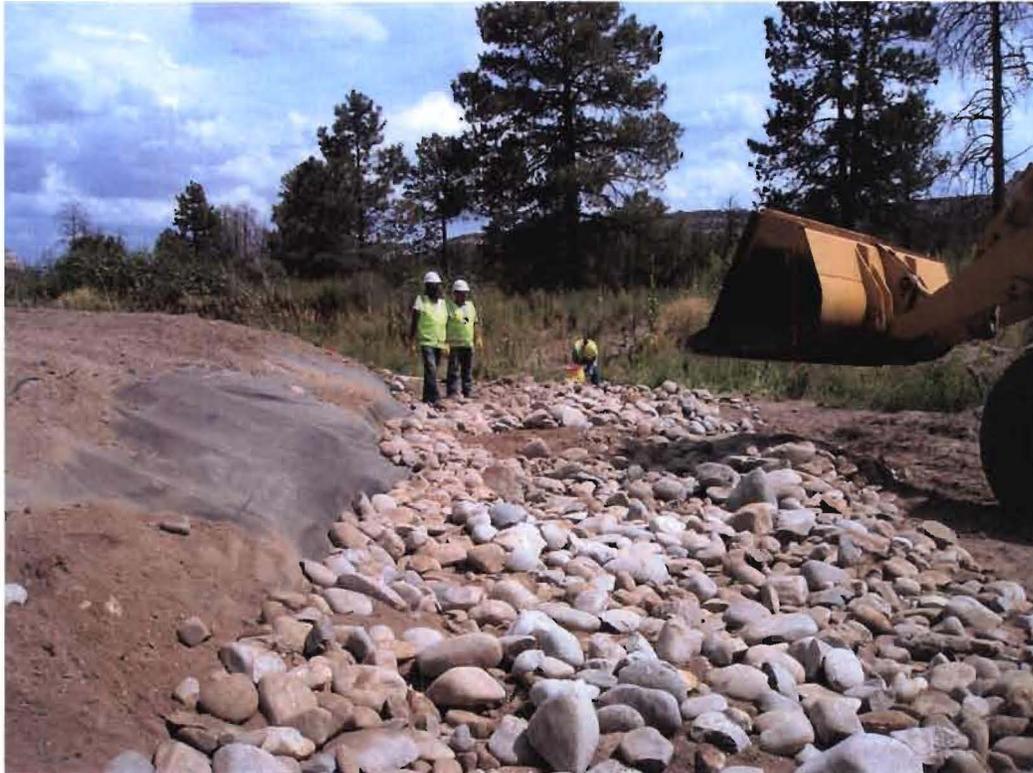
Figure 3 View looking downgradient along wing ditch. Emplacement of geotextile and rock liner.

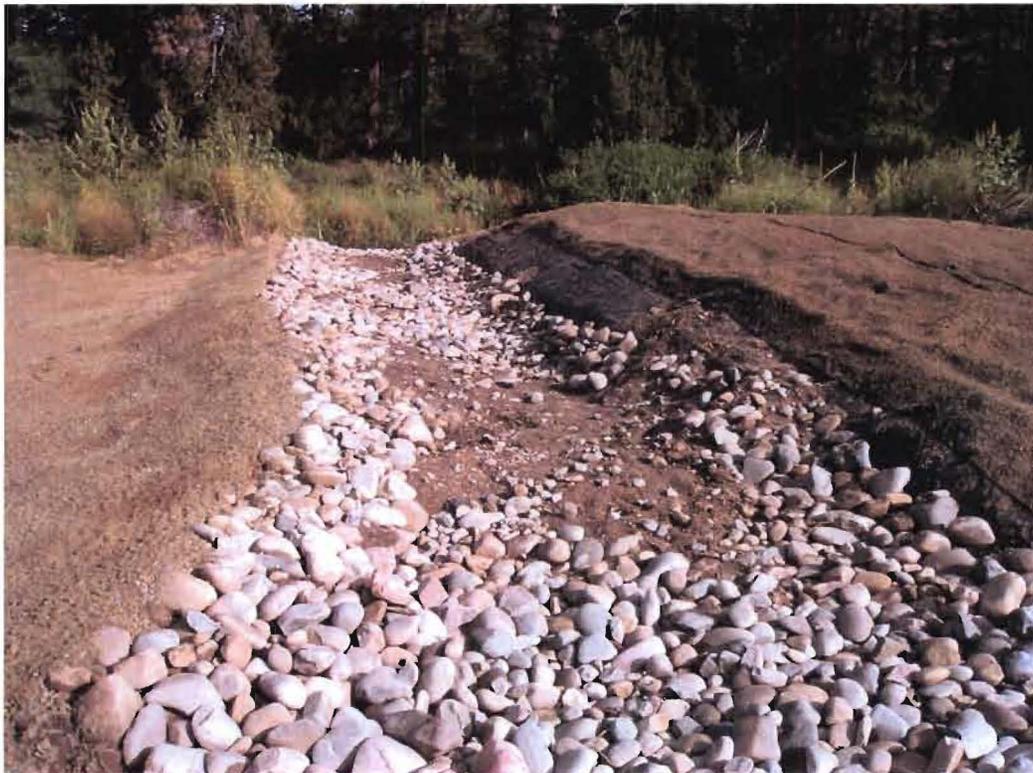
Figure 4 View looking upgradient along wing ditch after stabilization and hydromulching

The wing ditch is stabilized as described above. Excavated sediment was used for the berm on the downstream side of the wing ditch. The berm was draped with Enkamat, then seeded and hydromulched. The seeds in the excavated material were inherently incorporated into the berm and are expected to germinate and contribute to stabilization. Immediate stabilization is in place because all exposed soil was seeded and hydromulched.

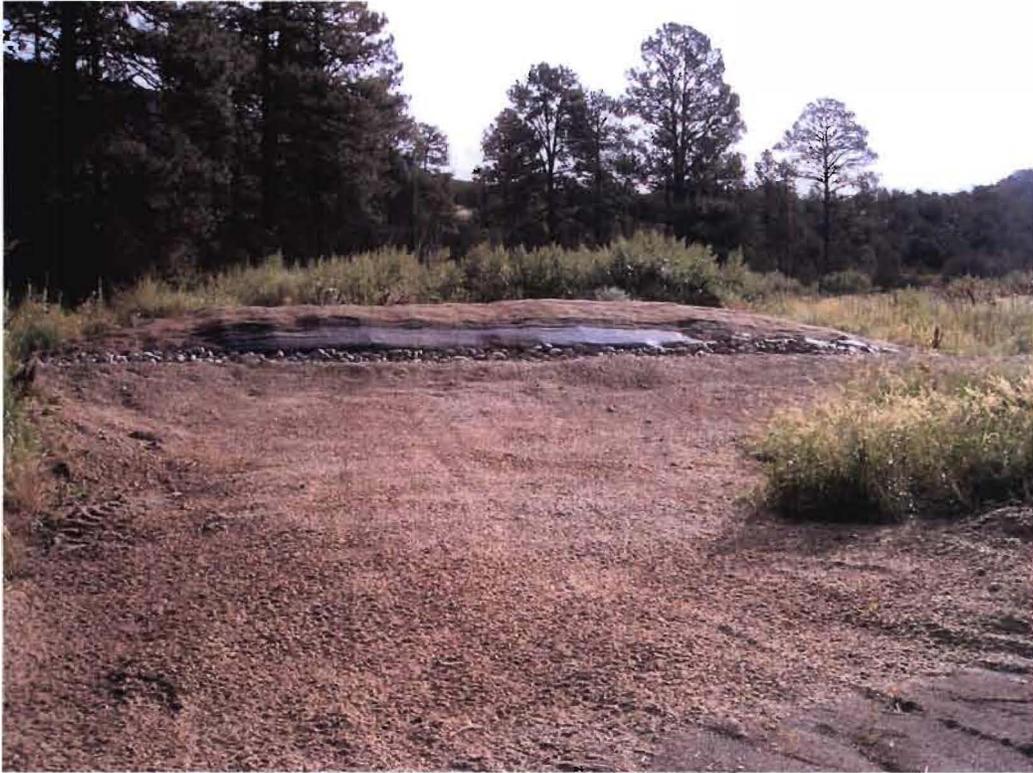
Figure 5 View looking down Pueblo Canyon. Stabilized wing ditch berm and rock liner are visible. Hydromulched surface is visible in foreground. Main Pueblo Canyon channel is just to the left of area shown in the photo.
