# Los Alamos National Laboratory

**SUBJECT: SUBMITTAL OF THE RESOURCE CONSERVATION AND RECOVERY ACT FACILITY INVESTIGATION (RFI) REPORT FOR TECHNICAL AREAS (TAs) -3, -59, -60, AND -61**

# **RFI Report for**

## **53 Potential Release Sites in**

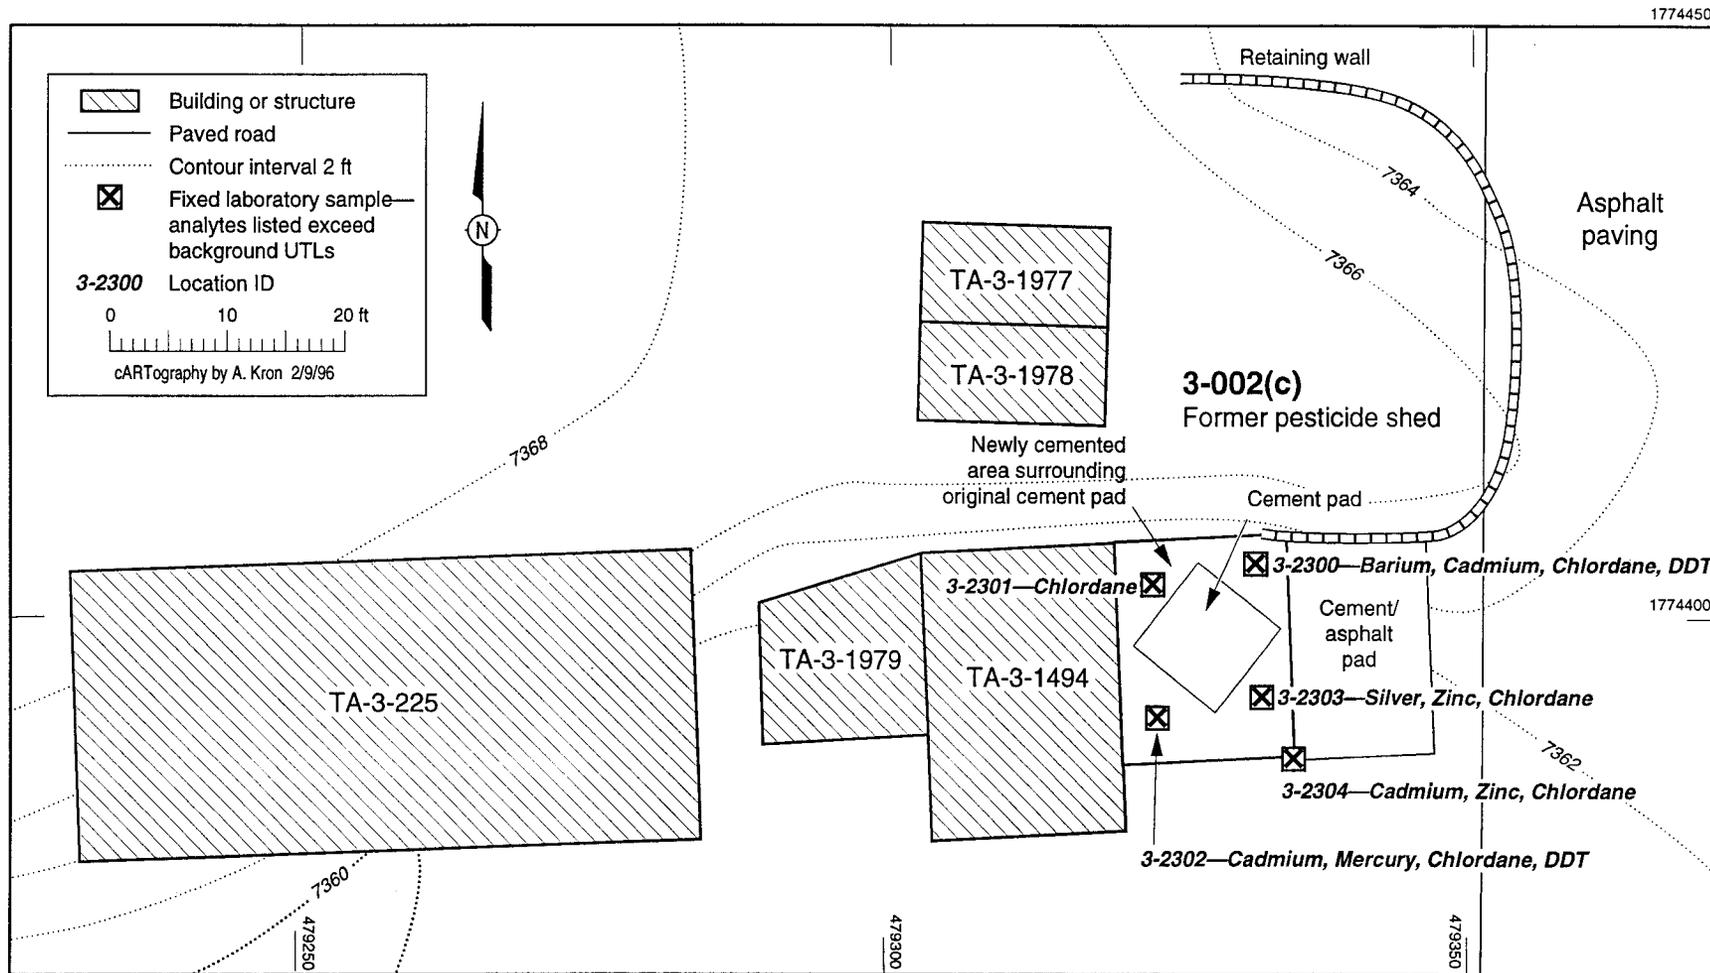
Fig. 5.1.4-1 PRS 3-002(c) 1994 sample collection locations.

The sample locations in the area under the former shed were cut into the new concrete. The sample locations were positioned either directly adjacent to the original shed location or directly downgradient to maximize the chance of detecting releases. These sample locations were located radially northeast, northwest, southwest, and southeast of the original concrete pad. The remaining sample location was selected based on the surface runoff from the formerly bermed concrete pad. This sample was positioned downgradient (southwest) of the pad. The sample locations are shown in Fig. 5.1.4-1 and are summarized in Table 5.1.4-1.

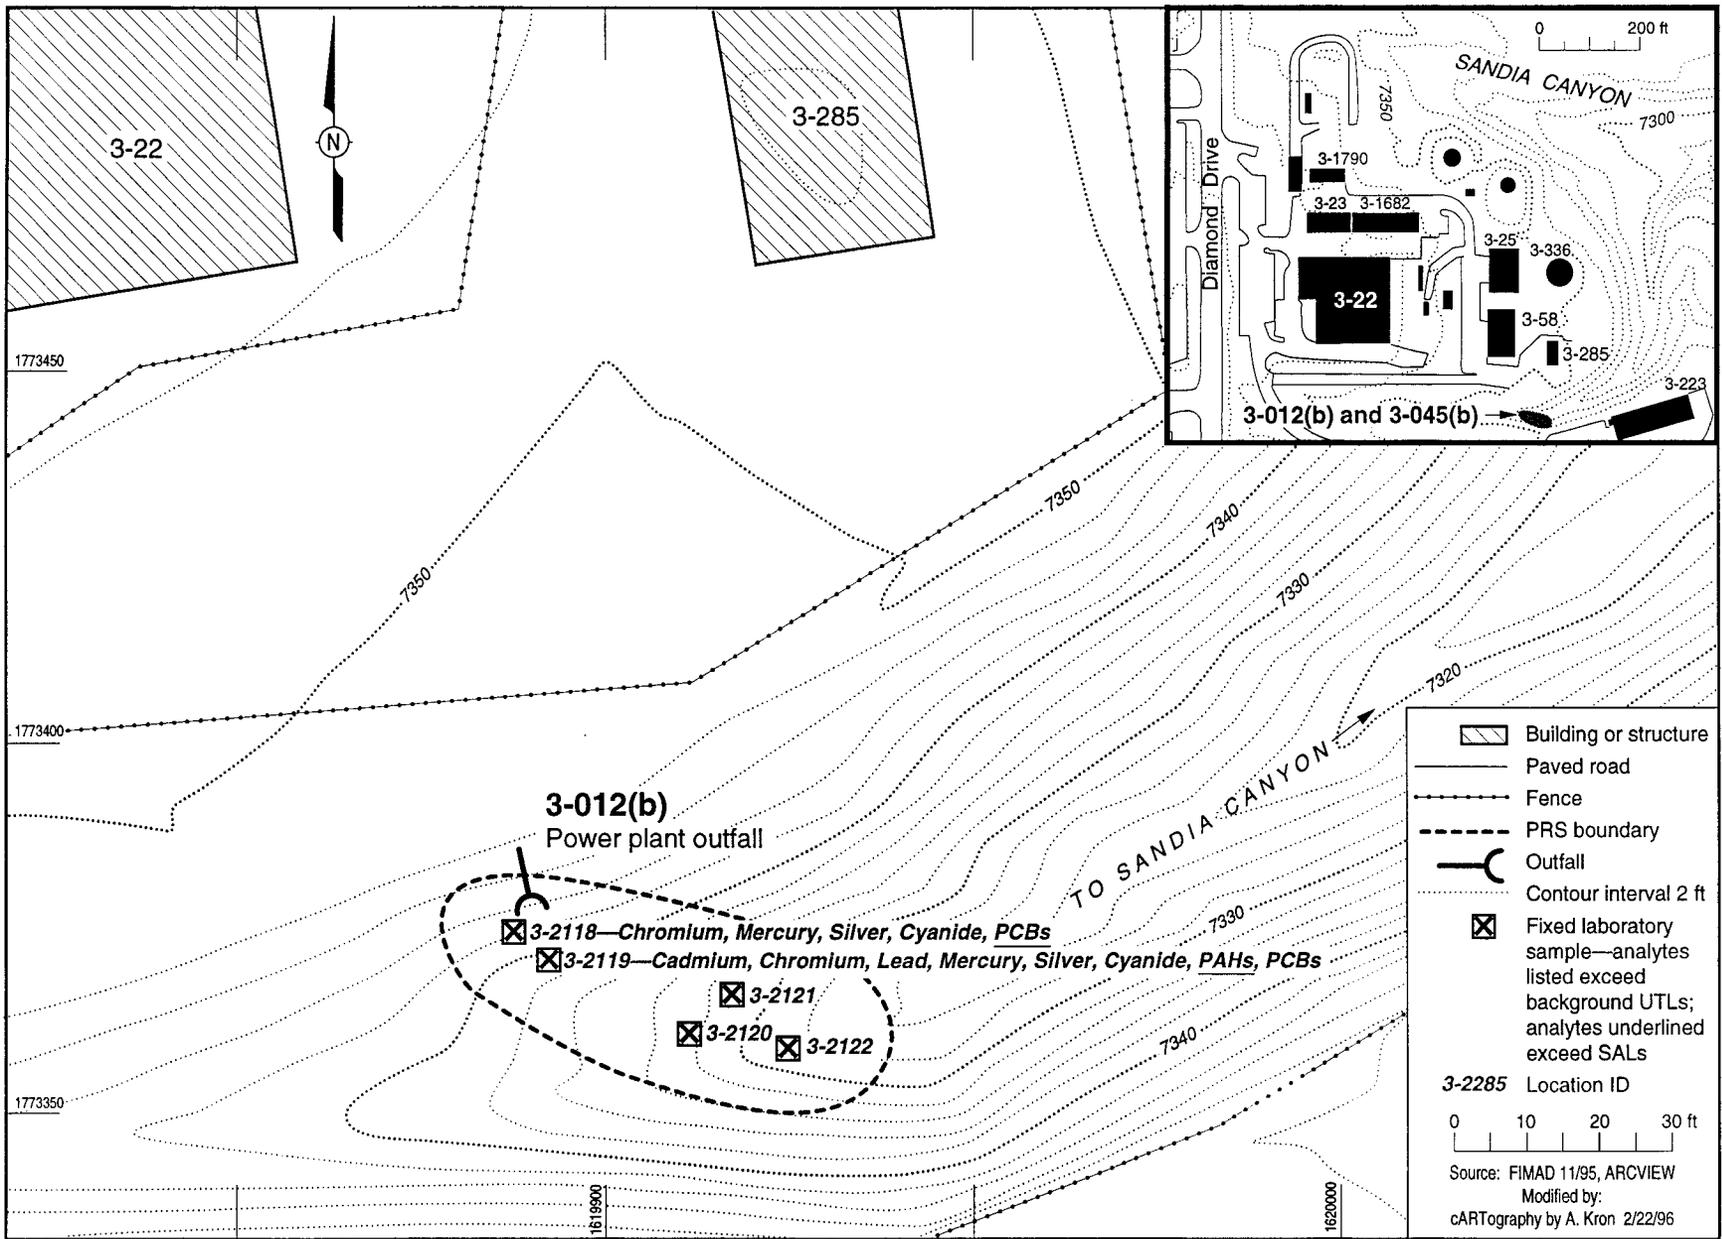
Fig. 5.3.4-1 PRS 3-012(b) and collocated PRS 3-045(b) 1994 sample collection locations.

The biased sample locations indicated in Fig. 5-9 of the RFI Work Plan for OU 1114 were located using the outfall and the channel as reference points (LANL 1993, 1090). Three downstream sample locations were included in the sampling program in order to characterize the sediments in the outfall channel. To meet the sampling objectives, the sample locations were adjusted in the field from those specified in the RFI Work Plan for OU 1114 (LANL 1993, 1090). A summary of samples collected at PRS 3-012(b) and collocated PRS 3-045(b) are shown in Fig. 5.3.4-1, and summarized in Table 5.3.4-1.

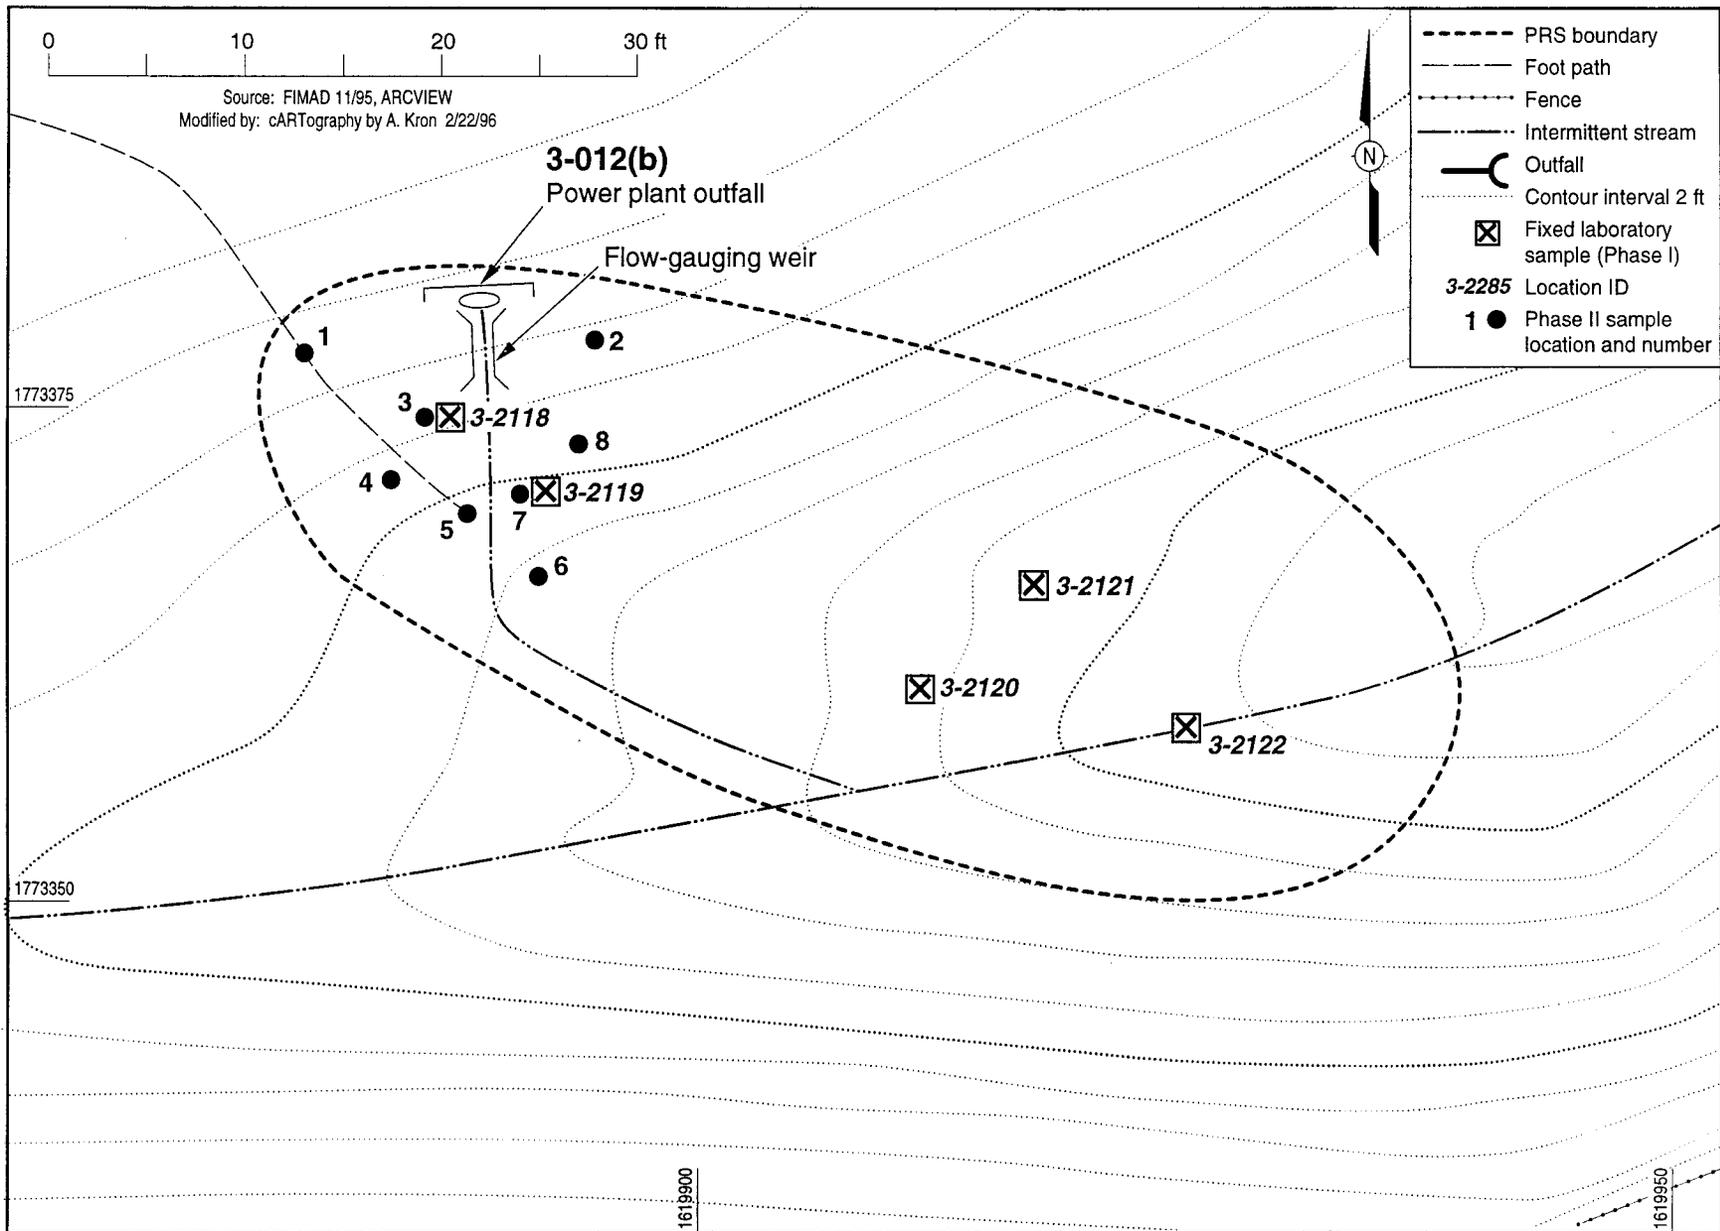
Fig. 5.3.11-1. PRSs 3-012(b) and 3-045(b) Phase II sample locations.

At each sample location, the 0- to 6-in. interval will be sampled using LANL-ER-SOP-06.09, Spade and Scoop Method for Collection of Soil Samples. A second sample will be collected from the 6- to 12-in. interval if the soil profile is of sufficient depth.

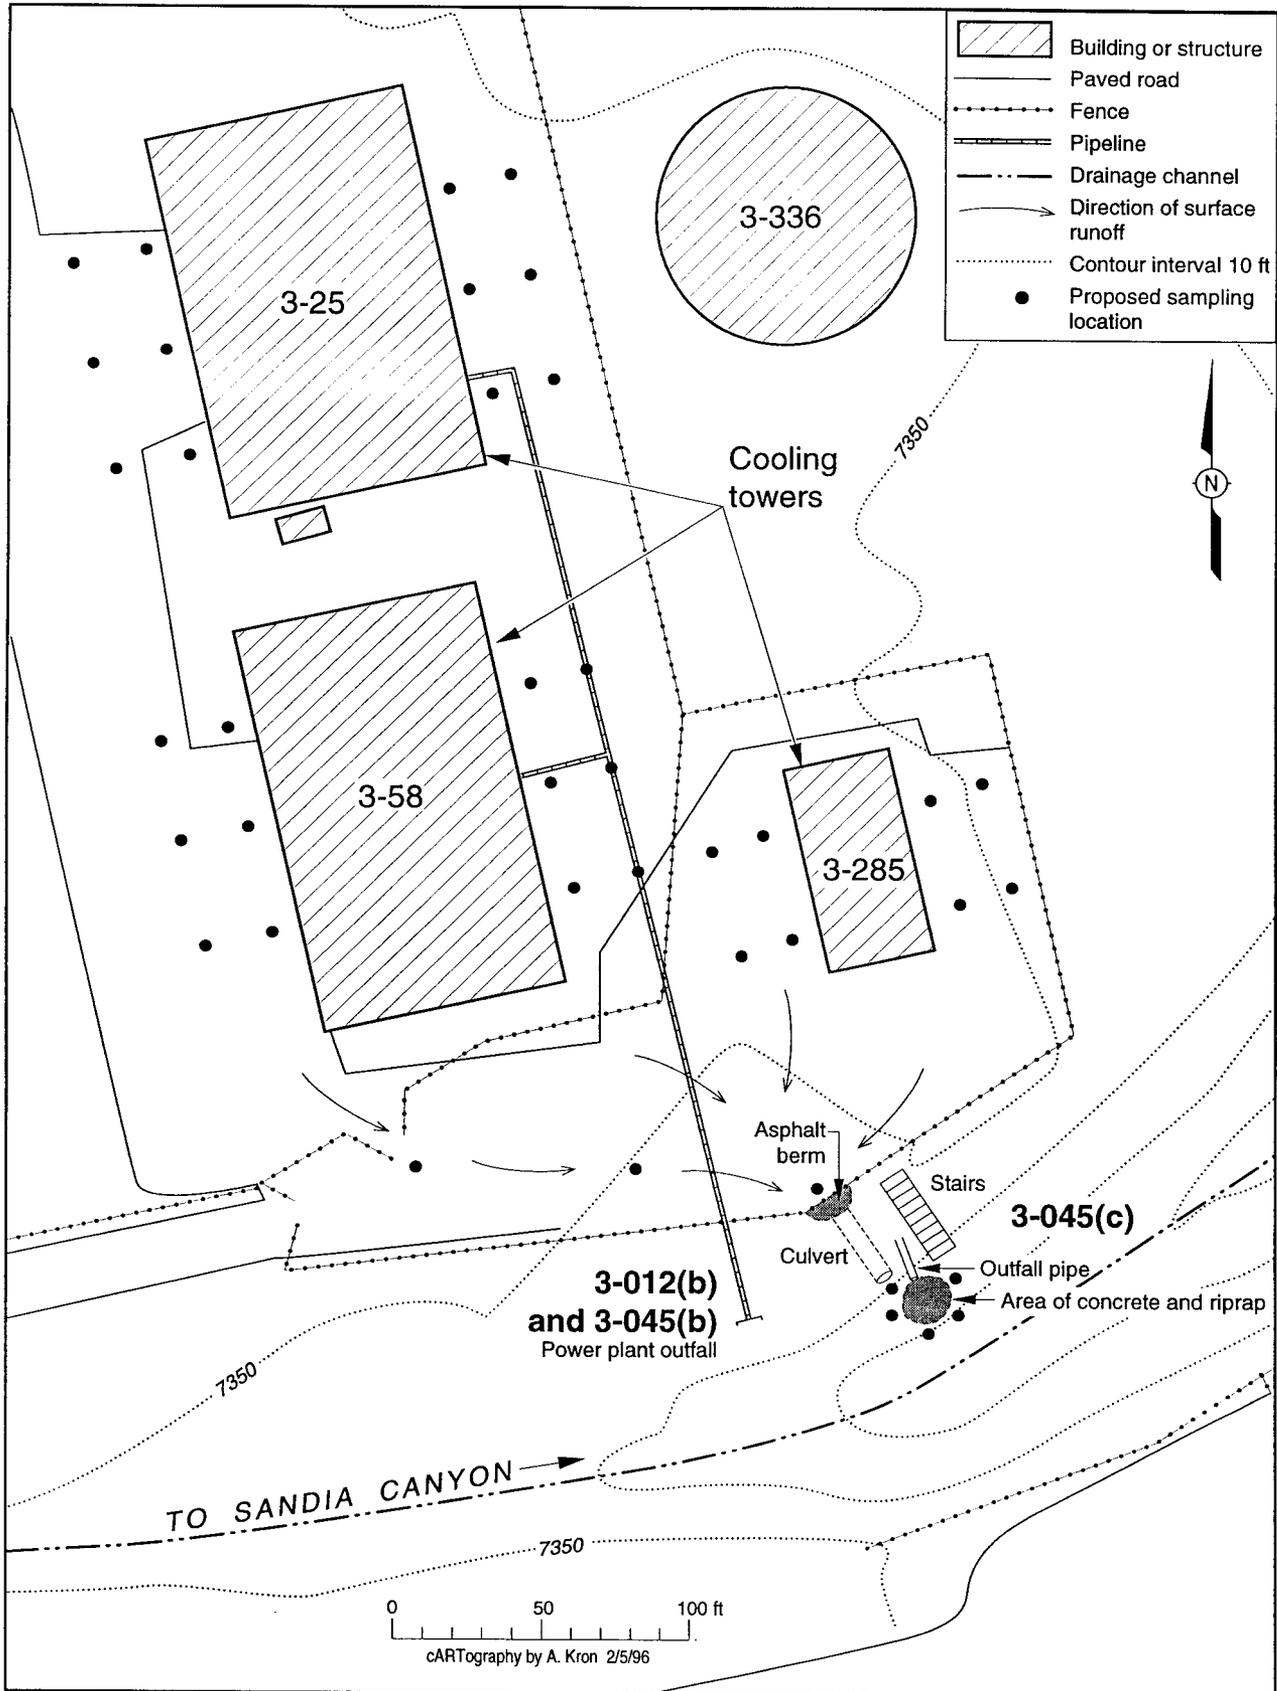
Fig. 5.3.11-2. PRs 3-012(b) and 3-045(b,c) Phase II cooling tower sample locations.

The cooling tower sampling locations depicted on Fig. 5.3.11-2 are paired, with one location close to the cooling tower and within the zone of maximum wetting by overspray, and the second location away from the tower and outside the zone of maximum wetting. Because of concrete aprons and other concrete projections adjacent to the cooling tower foundations, the sampling points closest to the towers will, in most cases, be located immediately next to the apron, but no more than 10 ft from the foundation if possible. The paired sampling points will then be located away from the foundation, approximately 20 ft from the initial locations. Three additional sampling locations will be positioned south of the cooling towers within the primary drainage pathway leading from the cooling tower area. Two samples will be collected at each sampling location, from the 0- to 6-in. interval and the 6- to 12-in. interval using LANL-ER-SOP-6.09, Spade and Scoop Method for Collection of Soil Samples. If asphalt paving exists at a sampling location, the asphalt and subgrade will be removed before sampling proceeds.

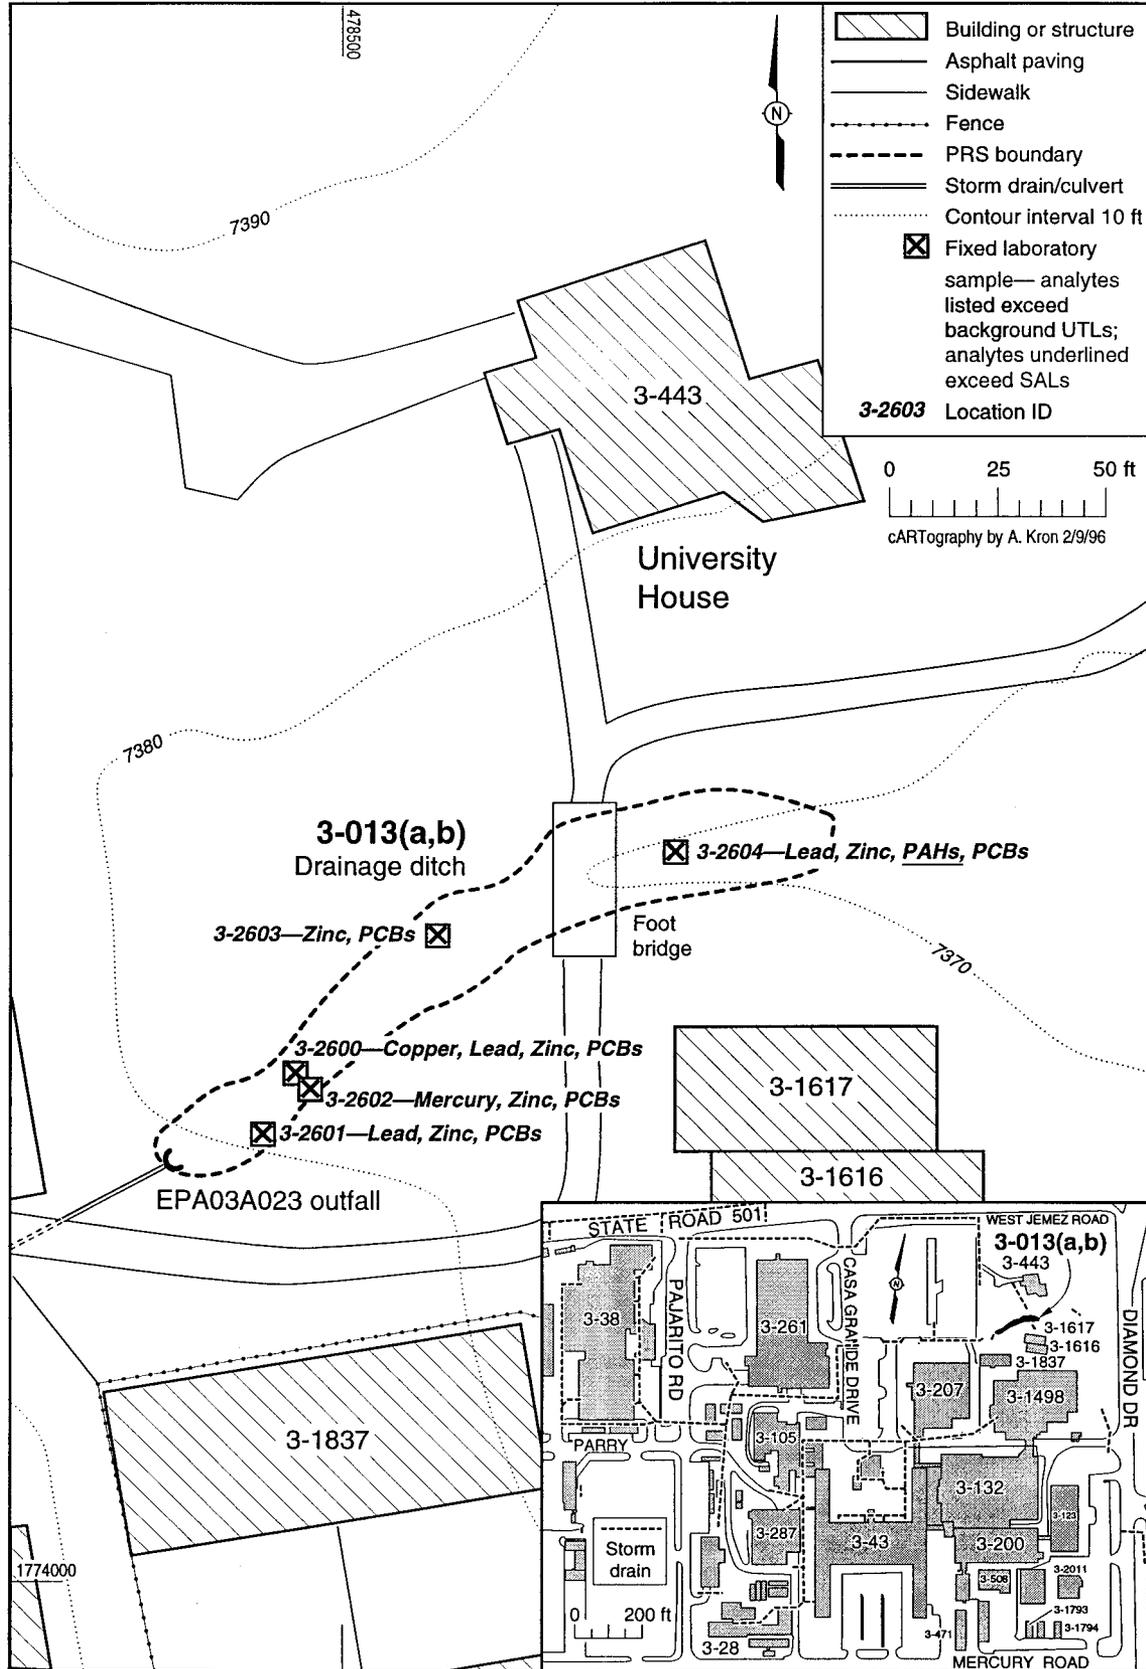
Fig. 5.4.4-1. PRSs 3-013(a,b) and collocated PRS 3-052(f) 1994 sample collection locations.

The biased sample locations indicated in Fig. 5-15 of the RFI Work Plan for OU 1114 (LANL 1993, 1090) were located using the outfall and channel as reference points. Sample locations were biased to areas where sediments could be collected and where it was likely that contaminants would be retained. The sample locations were adjusted in the field to meet the sampling objectives. Sample locations are shown in Fig. 5.4.4-1 and summarized in Table 5.4.4-1.

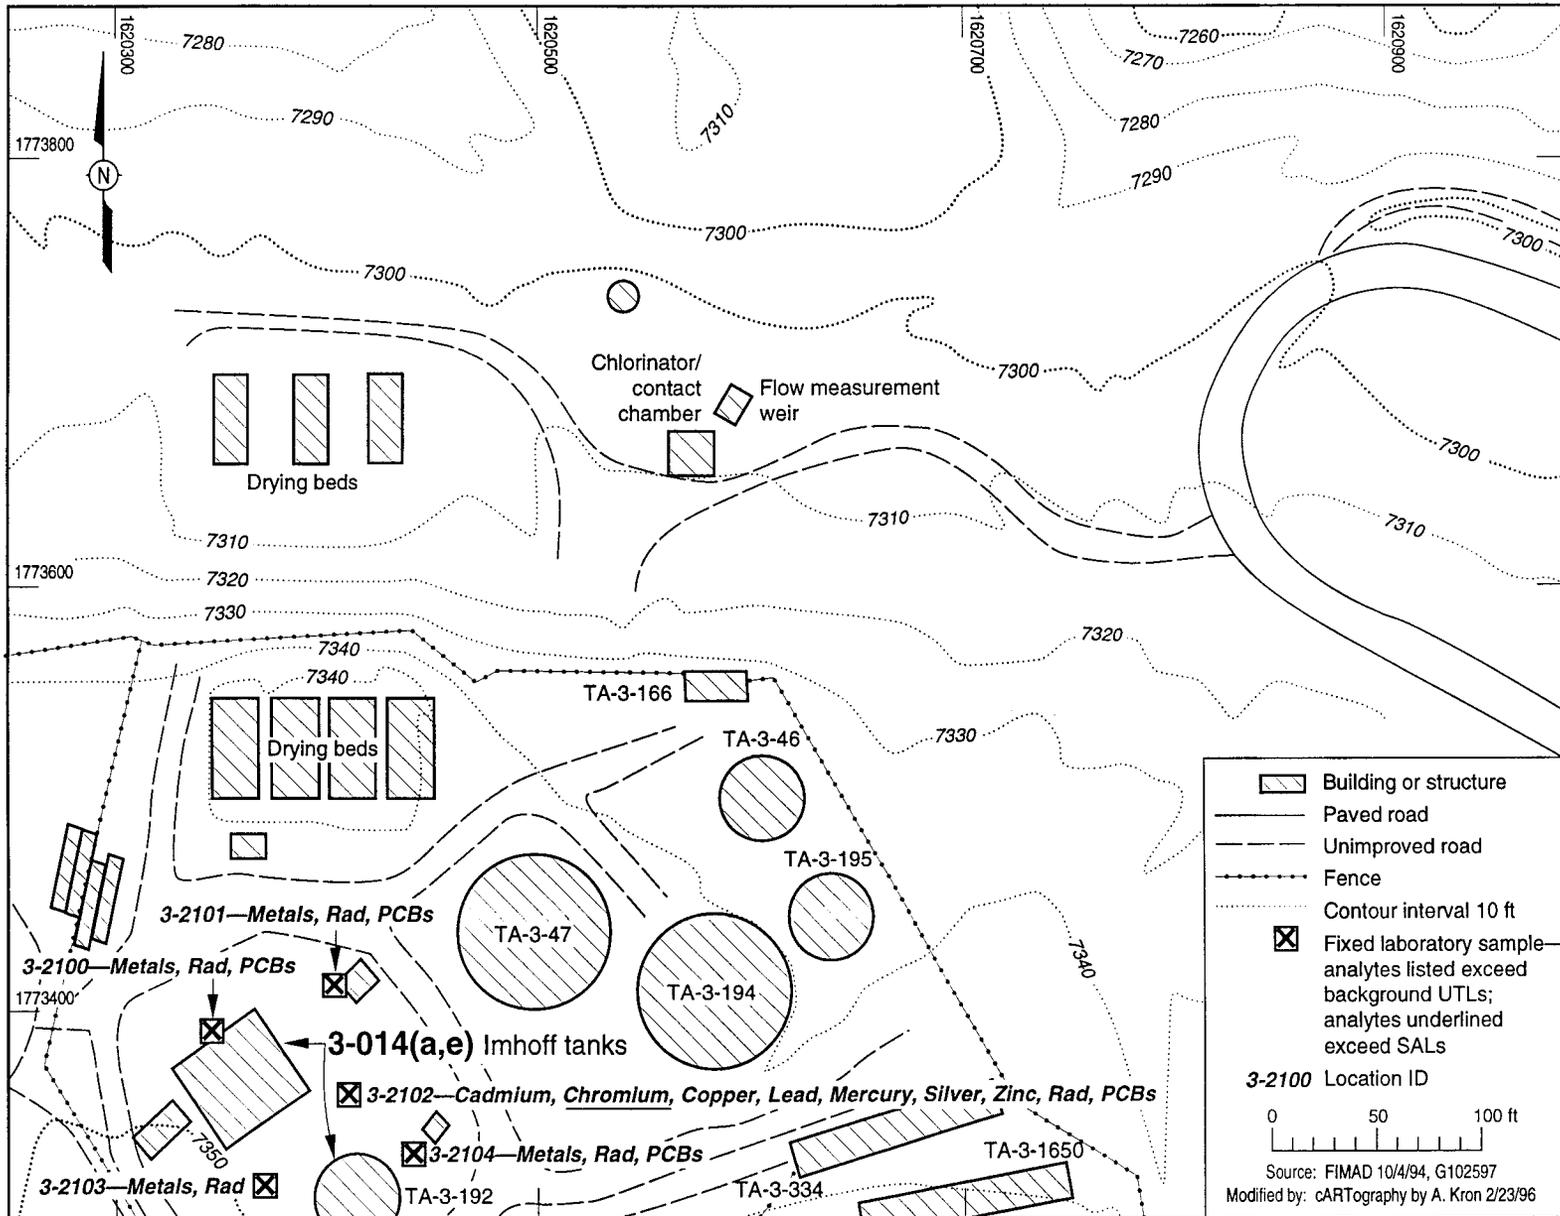
Fig. 5.5.4-1. PRSs 3-014(a,e) 1994 sample collection locations.

The biased sample locations indicated in Fig. 5-10 of the RFI Work Plan for OU 1114 (LANL 1993, 1090) were located using the Imhoff tanks as reference points. The actual sample locations shown in Fig. 5.5.4-1 were adjusted in the field to meet the sampling objectives. The areas that were sampled were typically downgradient from the Imhoff tanks, except sample location 03-2103, which was positioned between the Imhoff tanks in a slightly upgradient location. A summary of samples collected is presented in Table 5.5.4-1

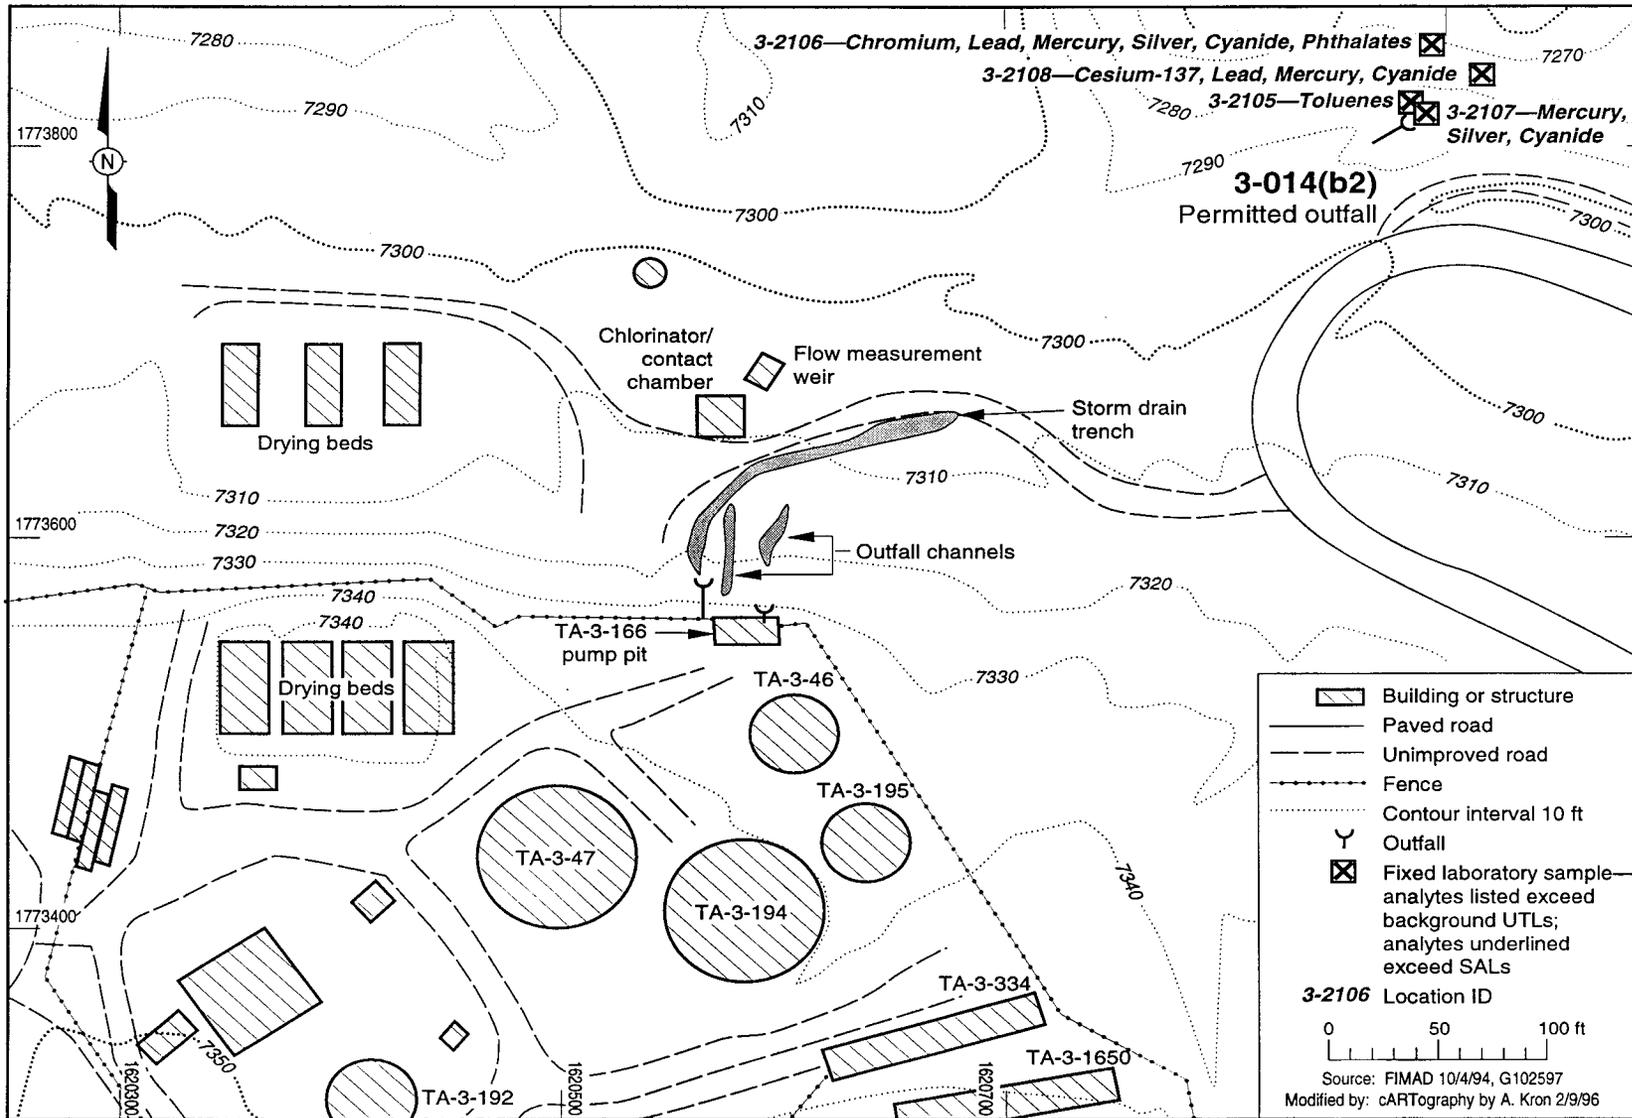
Fig. 5.6.4-1. PRS 3-014(b2) 1994 sample collection locations.

The biased sample locations indicated in Fig. 5-10 of the RFI Work Plan for OU 1114 were located using the outfall channel and the outfall as reference points (LANL 1993, 1090). However, the actual sample locations as shown on Fig. 5.6.4-1 were adjusted in the field from those specified in the work plan to meet the sampling objectives. Table 5.6.4-1 summarizes the samples collected at PRS 3-014(b2). The sediment areas sampled were along the channel and in the outfall flow path. Because of the tuff outcrop at the outfall, effluent drained mainly over exposed tuff, with few areas containing sediments. The areas sampled included sediments trapped by vegetation roots. Because most of the steep, rocky outfall is continually washed by the effluent, the most significant area of sediment accumulation downgradient from the outfall was located within a wetlands area on the canyon floor. This area will be sampled by the Canyons Field Unit of the Environmental Restoration Project.

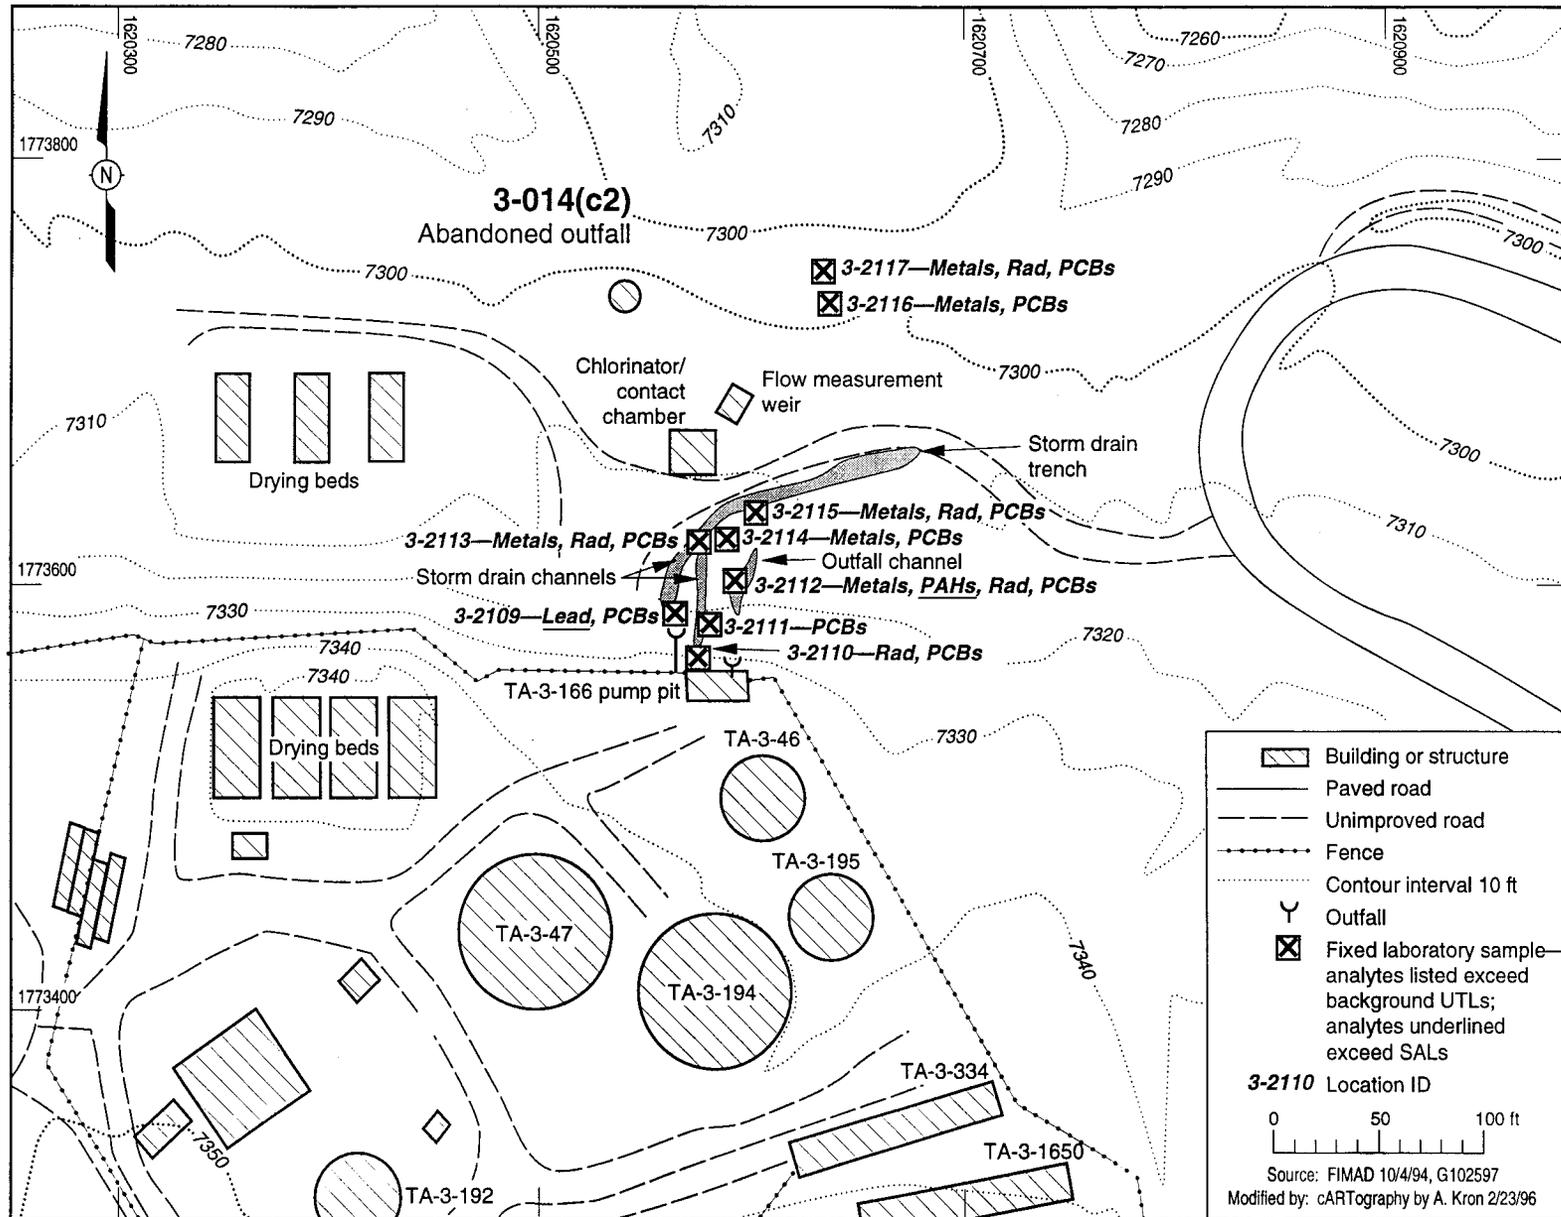
Fig 5.7.4-1. PRS 3-014(c2) 1994 sample collection locations.

The biased sample locations indicated in Fig. 5-10 of the RFI Work Plan for OU 1114 were located using the pump house overflow outfall channel, the roadway, and TA-3-166 as reference points (LANL 1993, 1090). The sample locations were adjusted in the field to meet the sampling objectives. The actual sample locations are shown in Fig. 5.7.4-1 and summarized in Table 5.7.4-1.

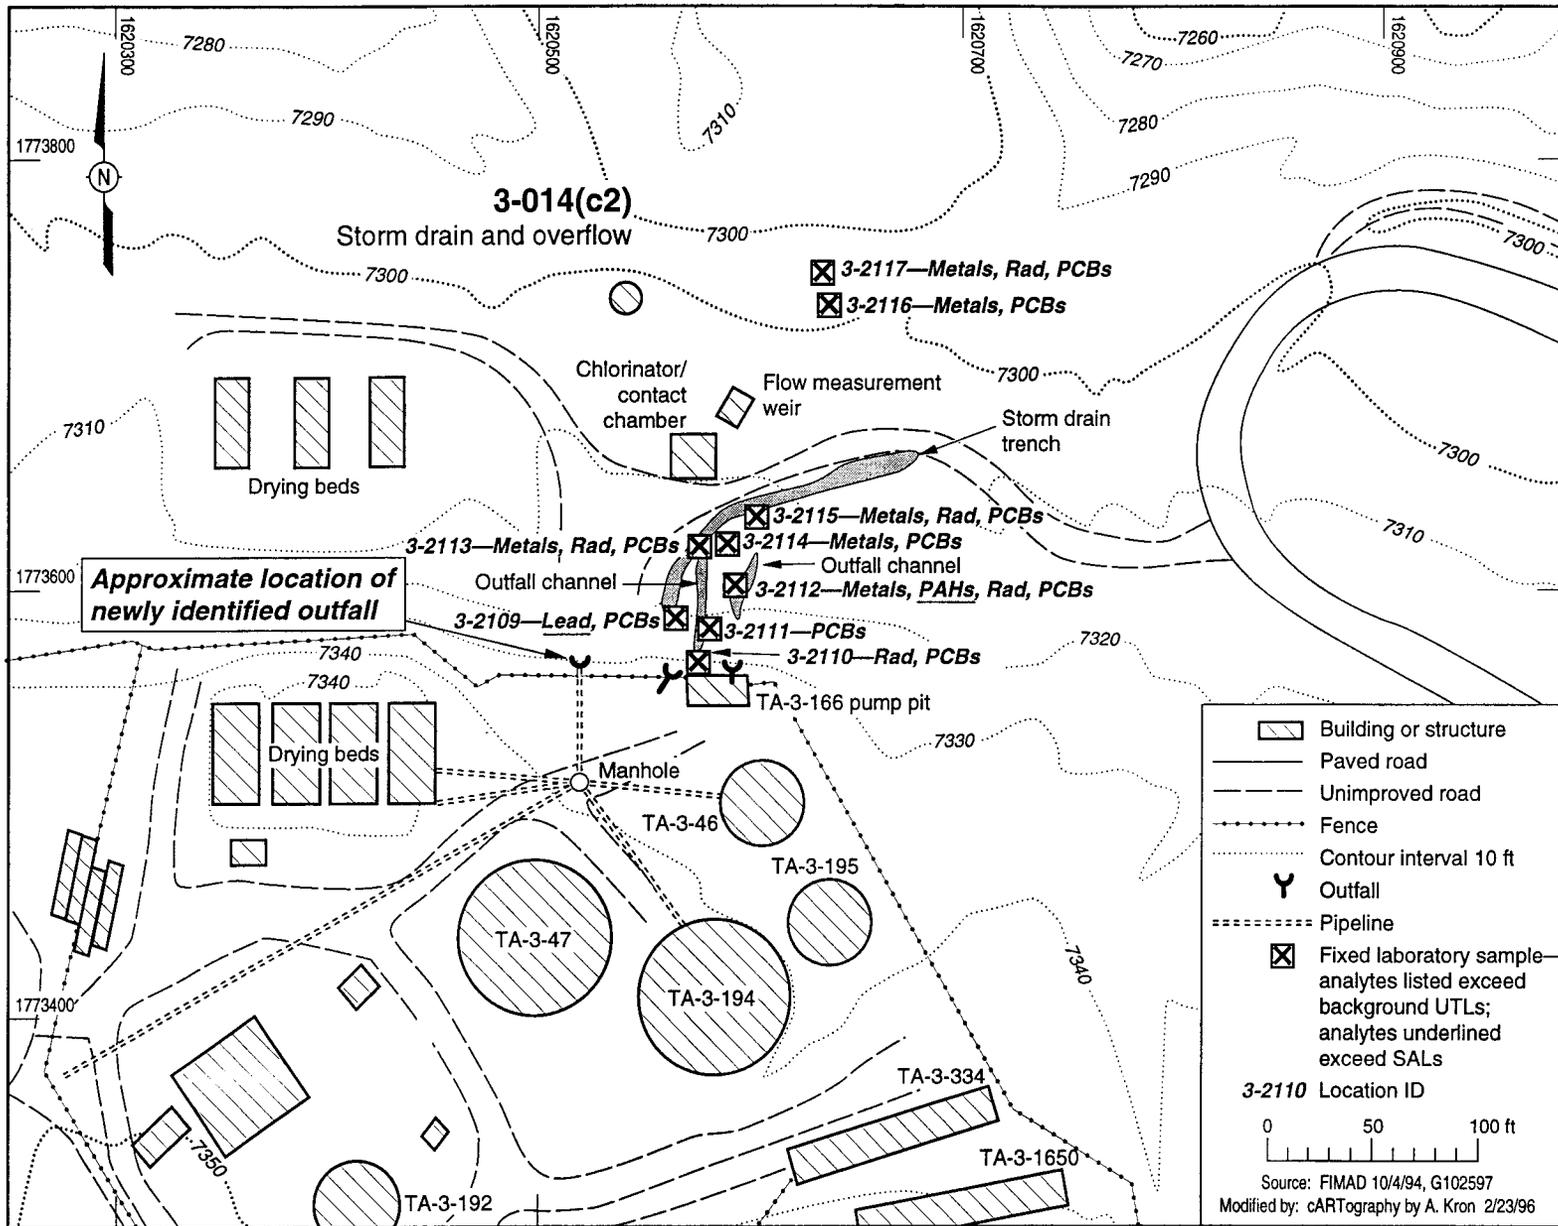
Fig. 5.7.11-1. PRS 3-014(c2) location map.

PRS 3-014(c2) is a pump house overflow outfall (former NPDES permit number NM 0024210) located on the north side of the pump building (TA-3-166). Both the overflow outfall and pump building are associated with the WWTP east of the mechanical utilities shop (TA-3-223) and on the southern rim near the head of Sandia Canyon (Fig. 5.7.11-1). The overflow pipe outfall discharged into a storm water erosion channel which flowed into a tributary of Sandia Canyon. The WWTP was decommissioned in the autumn of 1992 when the SWCS came on line. However, effluent is still routed from the SWCS plant to the TA-3 WWTP outfall because of permit issues.

A re-examination of the WWTP blueprints revealed the location of the original treated effluent outfall 20–30 ft west of the storm water channel and overflow outfall that was abandoned. A combined Phase I/Phase II investigation of this abandoned outfall has been included in this Phase II sampling and analysis plan. It was definitively concluded that the asbestos cement pipe immediately west of the pump building is for surface drainage purposes and is not part of the WWTP. Three of the Phase I samples, including sample AAB5907 with the elevated lead concentration, were located in or beside the storm drain channel leading from this asbestos cement pipe.

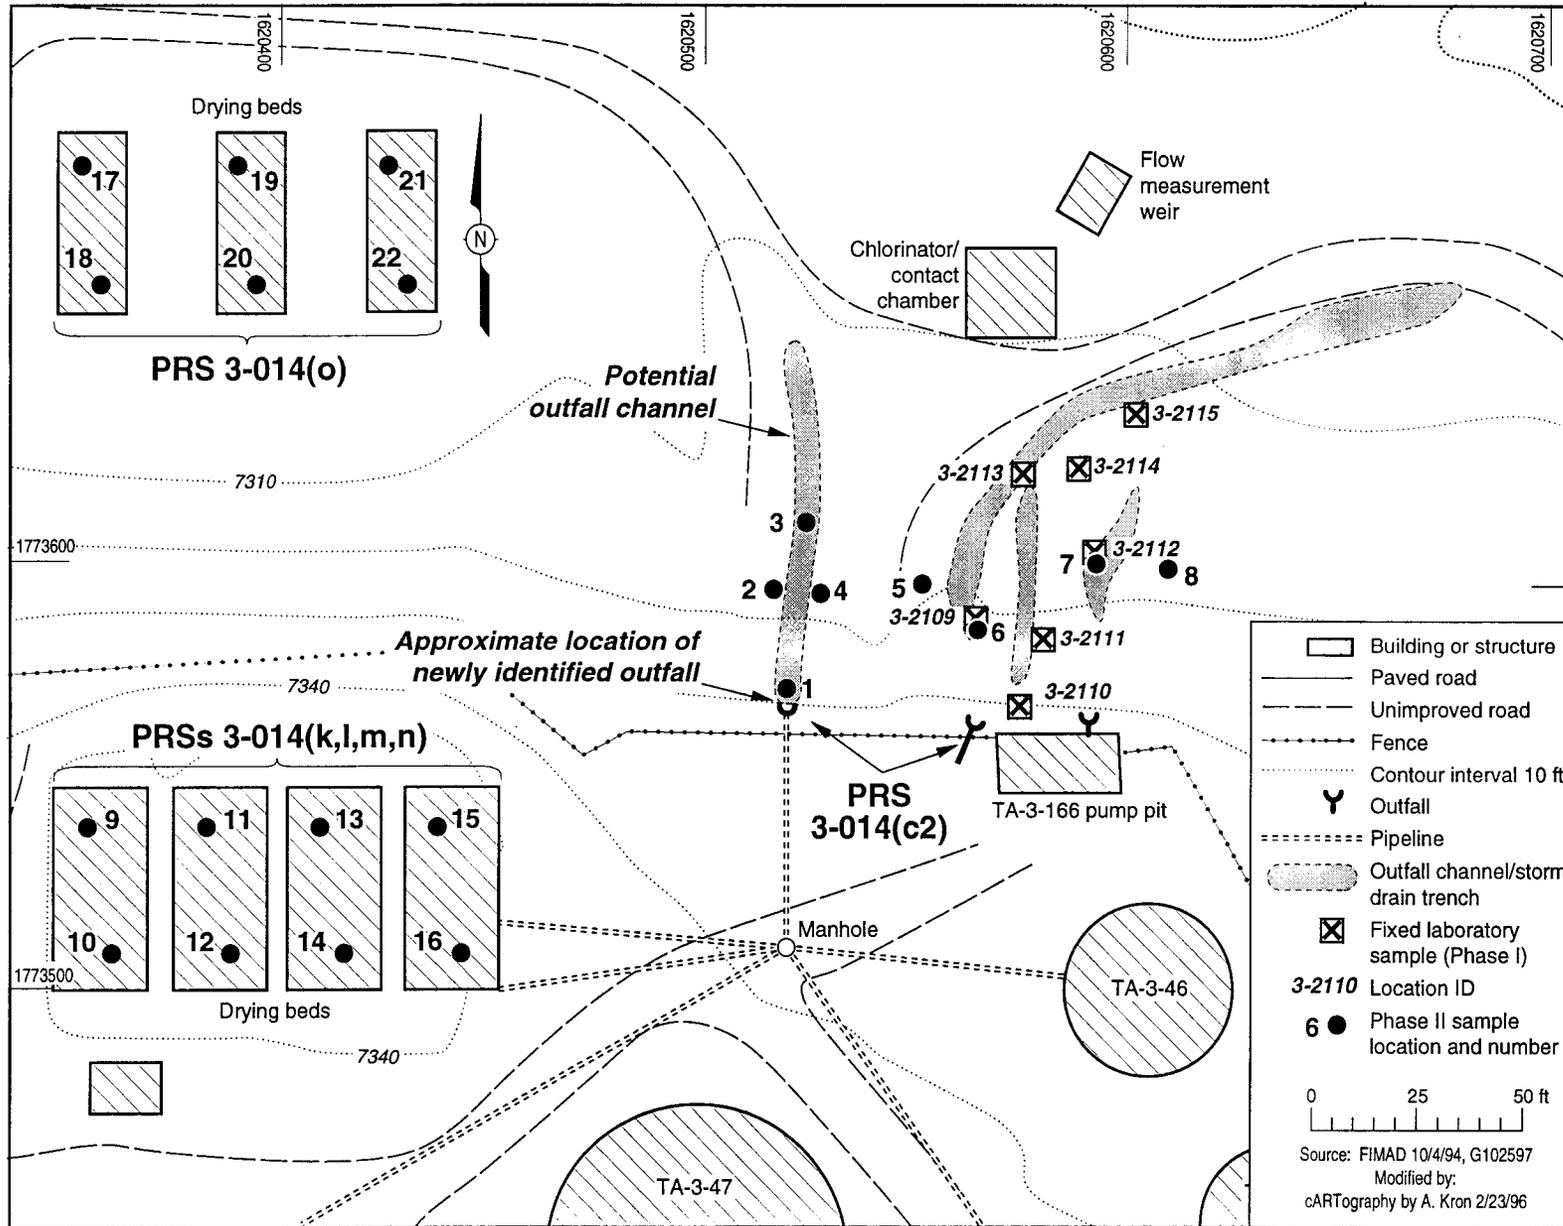
Fig. 5.7.11-2. PRS 3-014(c2,k,l,m,n,o) Phase II sample locations.

Locations 5 through 8 are positioned to provide information regarding the reproducibility of the Phase I analytical results, and the lateral and vertical extent of the potentially affected area. These locations were selected based on the assumption that potential contaminants would be concentrated along the primary drainage pathways leading from PRS 3-014(c2). Because of the linear nature of the drainage pathways, it is anticipated that the affected areas will be localized. Locations 6 and 7 are to be positioned as close as possible to the Phase I locations 03-2109 and 03-2112, respectively. Additional samples will be collected, as necessary, to define the nature and extent of the affected area.
