# Los Alamos National Laboratory

**SUBJECT: SUBMITTAL OF THE RESOURCE CONSERVATION AND RECOVERY ACT FACILITY INVESTIGATION (RFI) REPORT FOR TECHNICAL AREAS (TAs) -3, -59, -60, AND -61**

# **RFI Report for**

## **53 Potential Release Sites in**

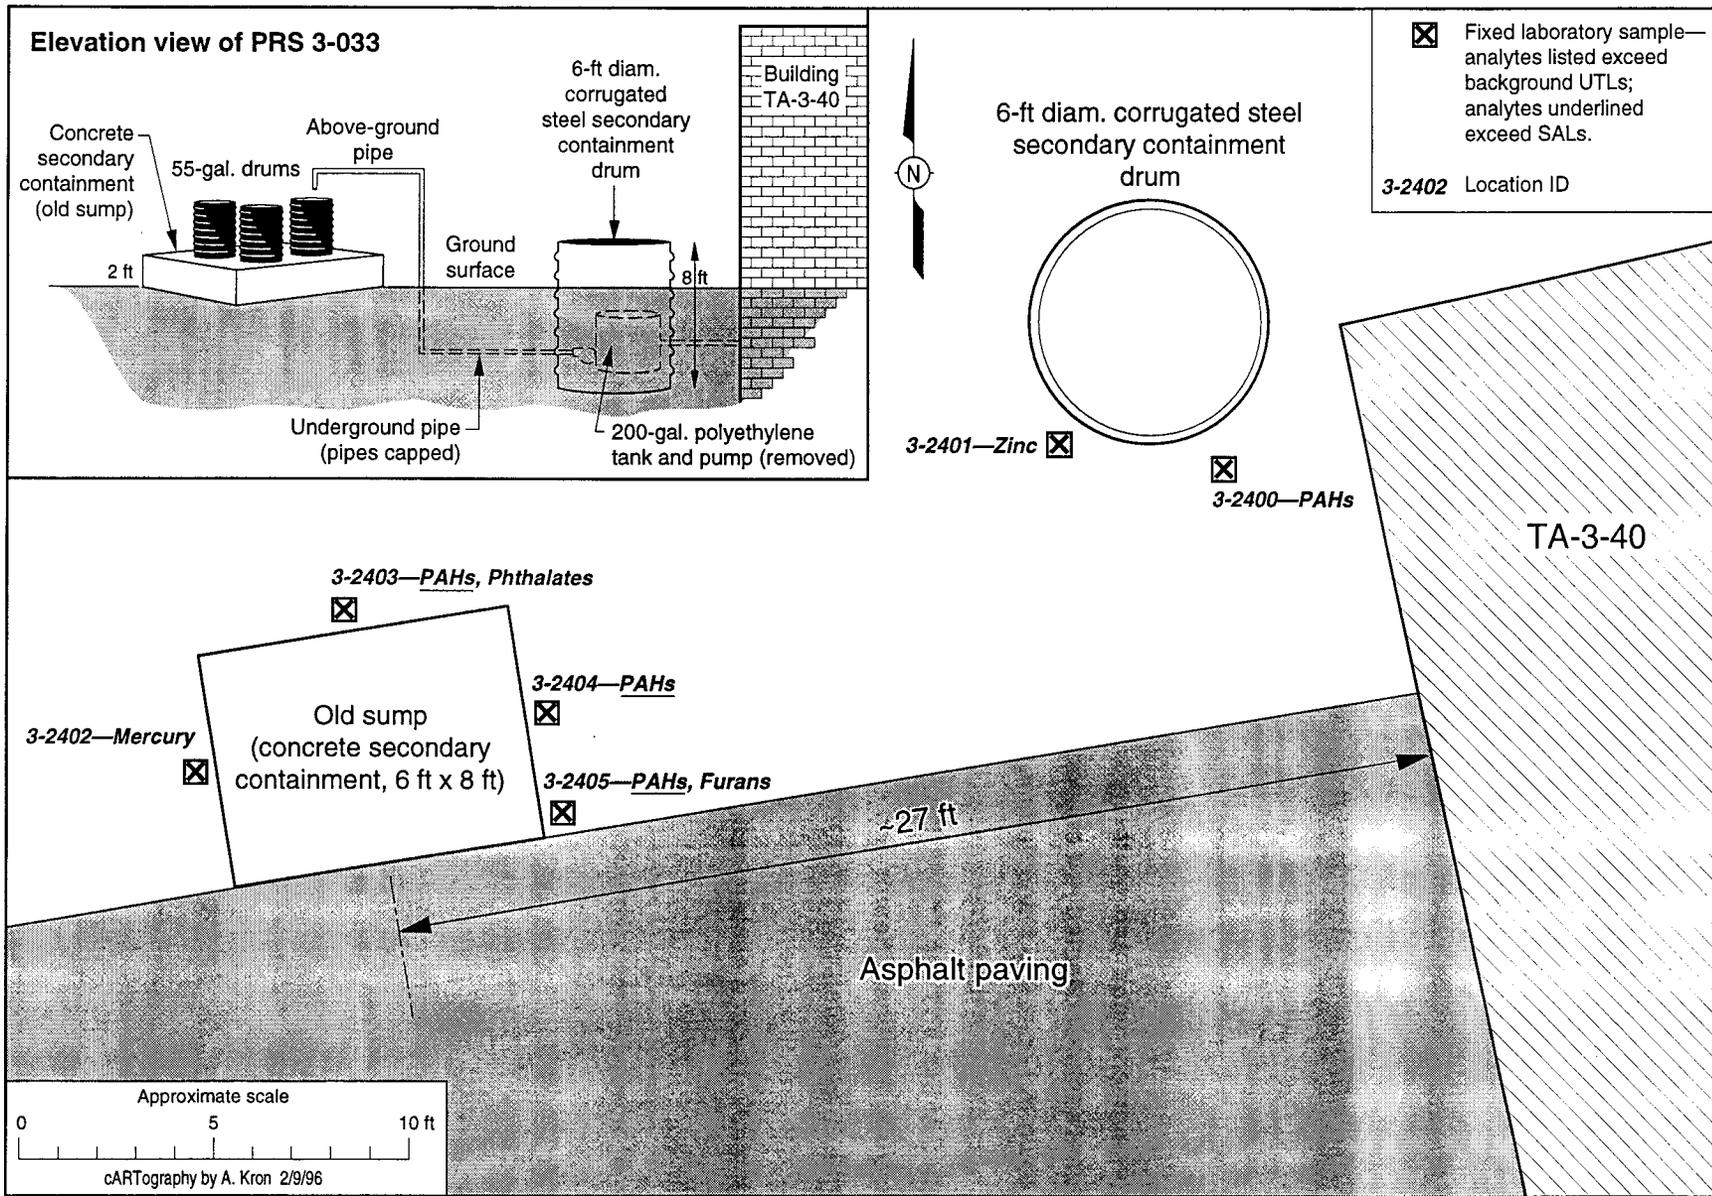
Fig. 5.9.1-1. PRS 3-033 1994 sample collection locations.

The sample locations indicated in the work plan were located using the containment structure, TA-3-40, and the parking lot as reference points. The samples were collected downgradient of the containment vault and on three sides of the sump (the three sides with soil), with an additional sample collected just outside of the southeast corner of the sump. Sample locations are shown in Fig. 5.9.1-1 and summarized in Table 5.9.4-1. One additional planned sample from the material in the sump was not collected. The initial inspection of the sump revealed the presence of live and dead mice, lizards, and nests. Under the Laboratory's health and safety procedures, additional health and safety approvals were necessary in order to sample the material. It was determined that these conditions would not allow any sampling in the sump because the required treatment for Hantavirus (which involves application of a bleach solution) would itself introduce contamination. Therefore, the material in the sump was not sampled.

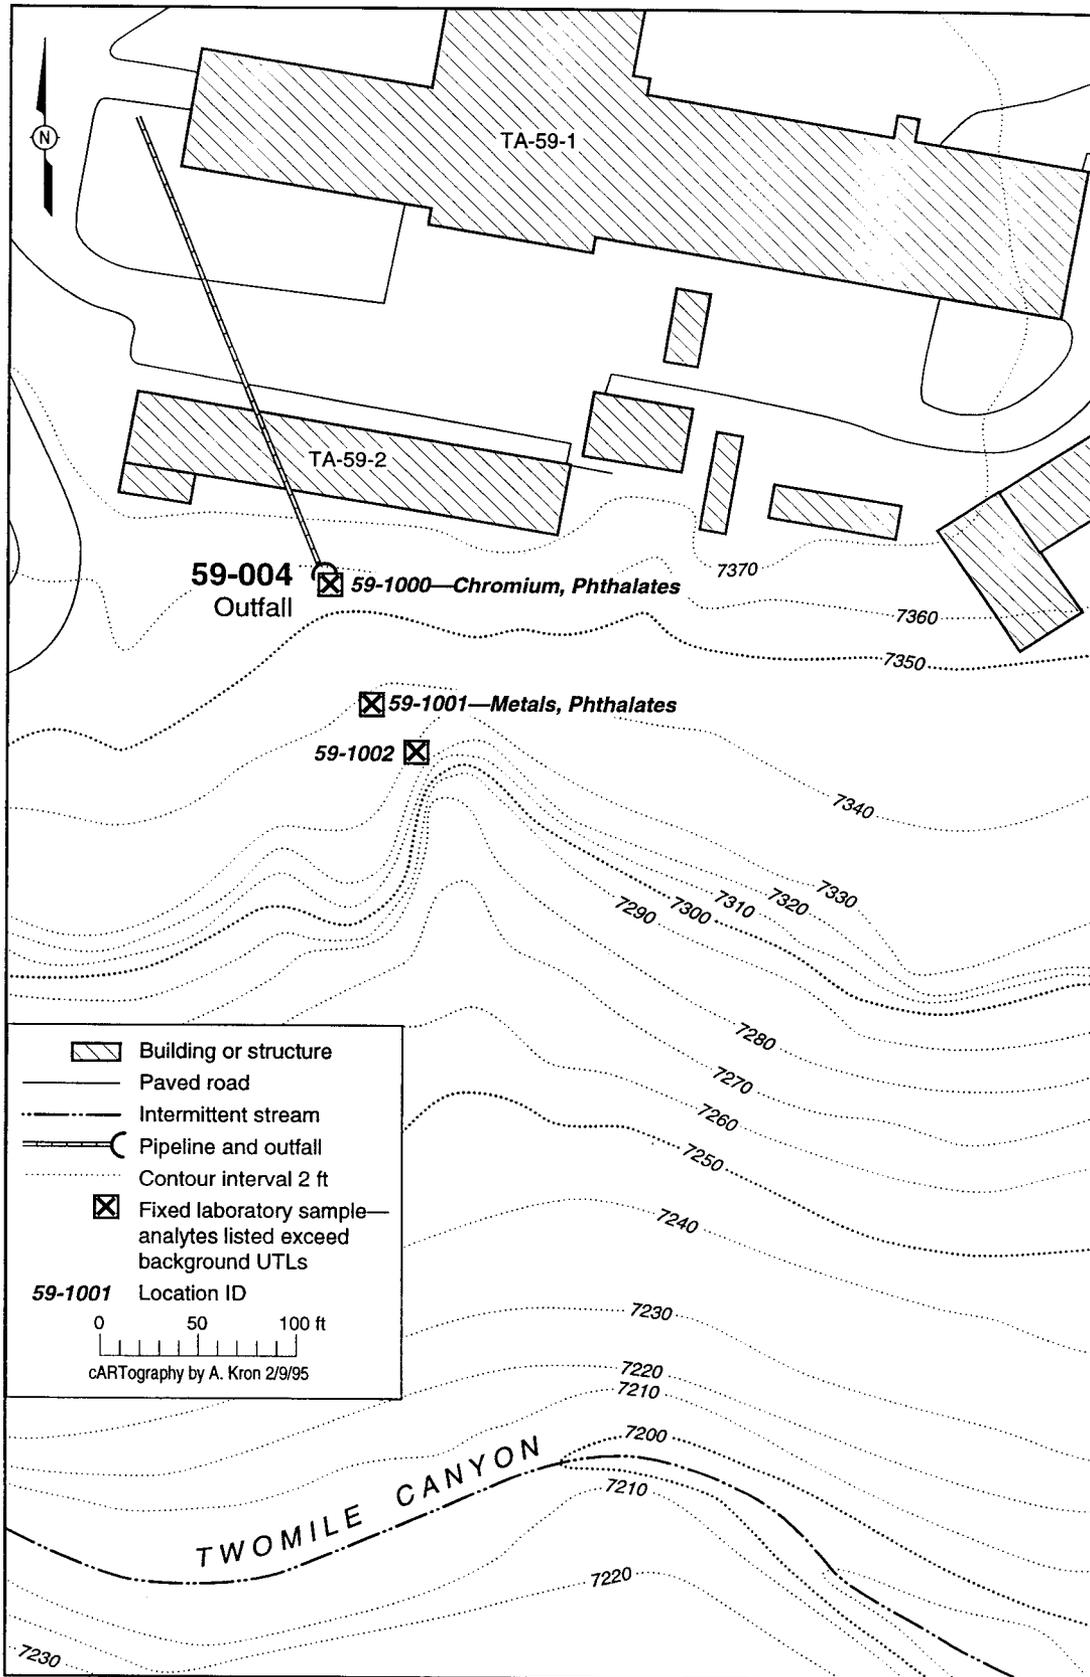
Fig. 5.10.4-1. PRS 59-004 1994 sample collection locations.

The biased sample locations indicated in Fig. 5-7 of the RFI Work Plan for OU 1114 were located using the outfall channel as a reference point (LANL 1993, 1090). The sample locations are shown in Fig. 5.10.4-1 and summarized in Table 5.10.4-1. The sample locations were adjusted in the field to meet the sampling objectives.

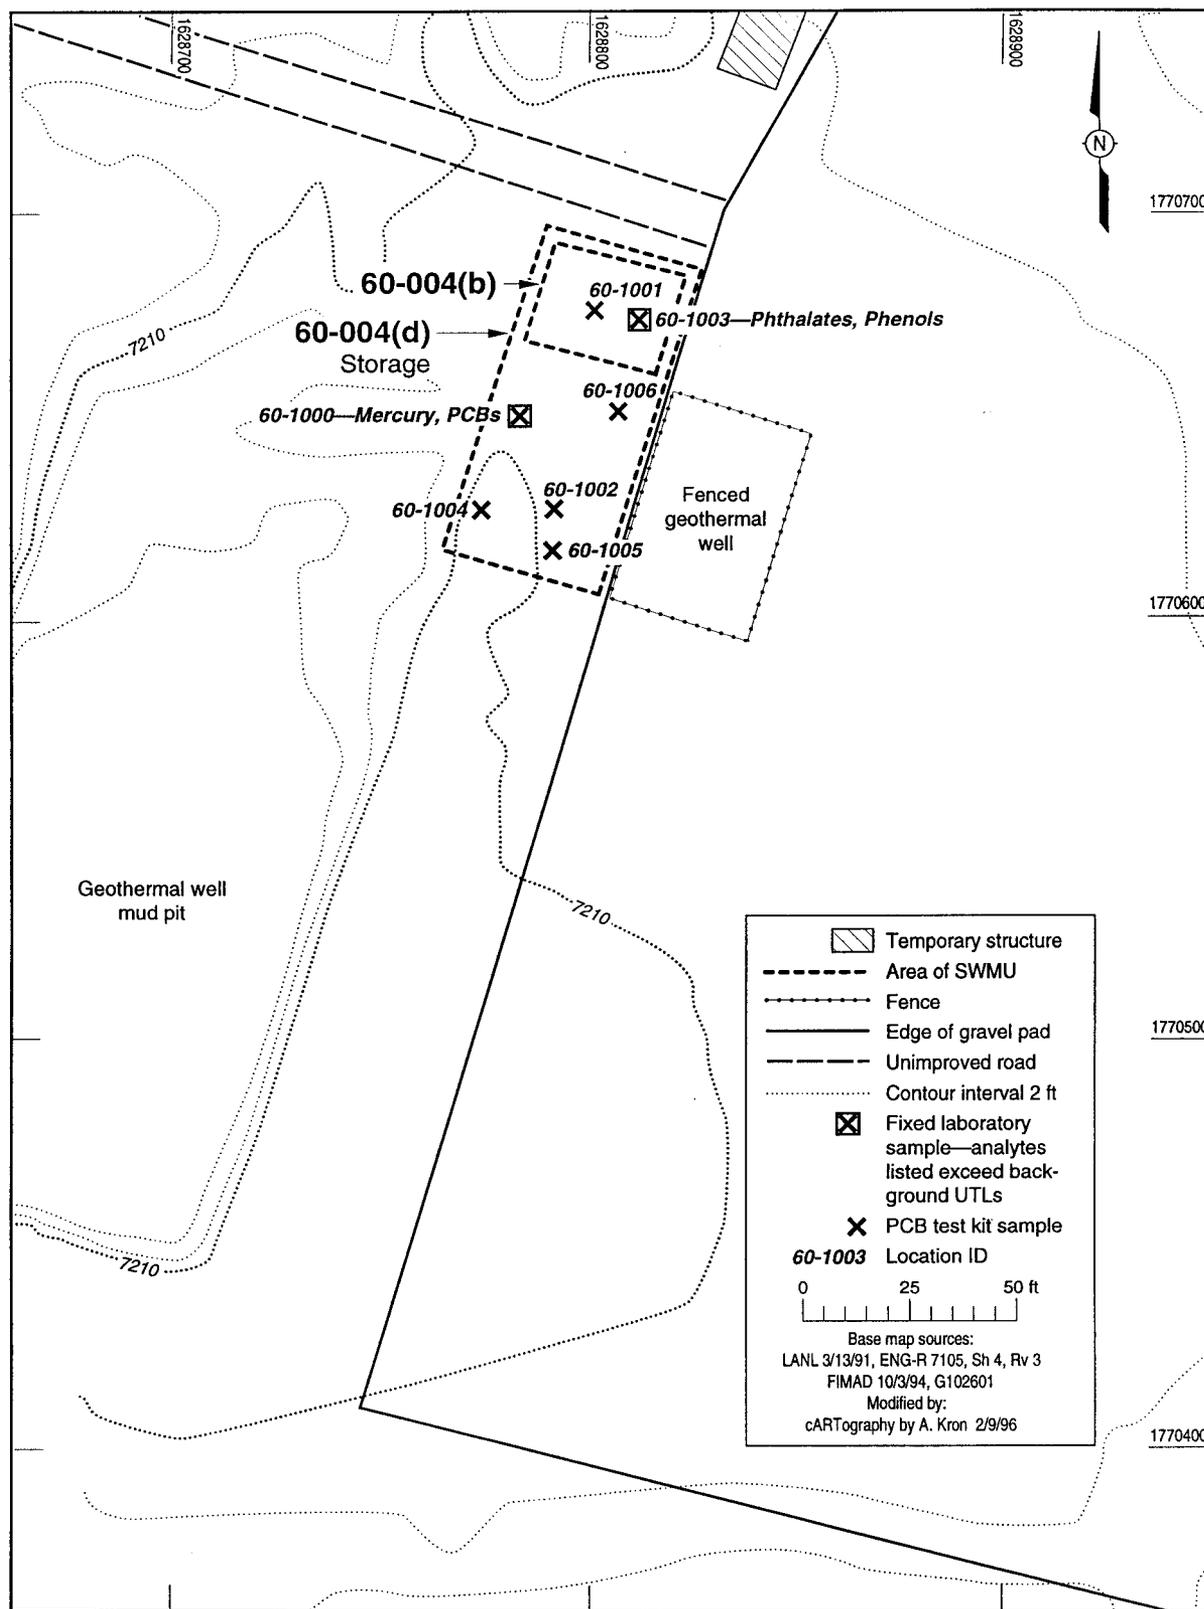
Fig. 5.11.4-1. PRSs 60-004(b,d) 1994 sample collection locations.

The biased sample locations indicated in the work plan were located in stained areas. Because some debris remained at the site from the tank-dismantling operations, one sample location was also placed where a piece of steel tank was found. Sampling locations are shown in Fig. 5.11.4-1 and summarized in Table 5.11.4-1.

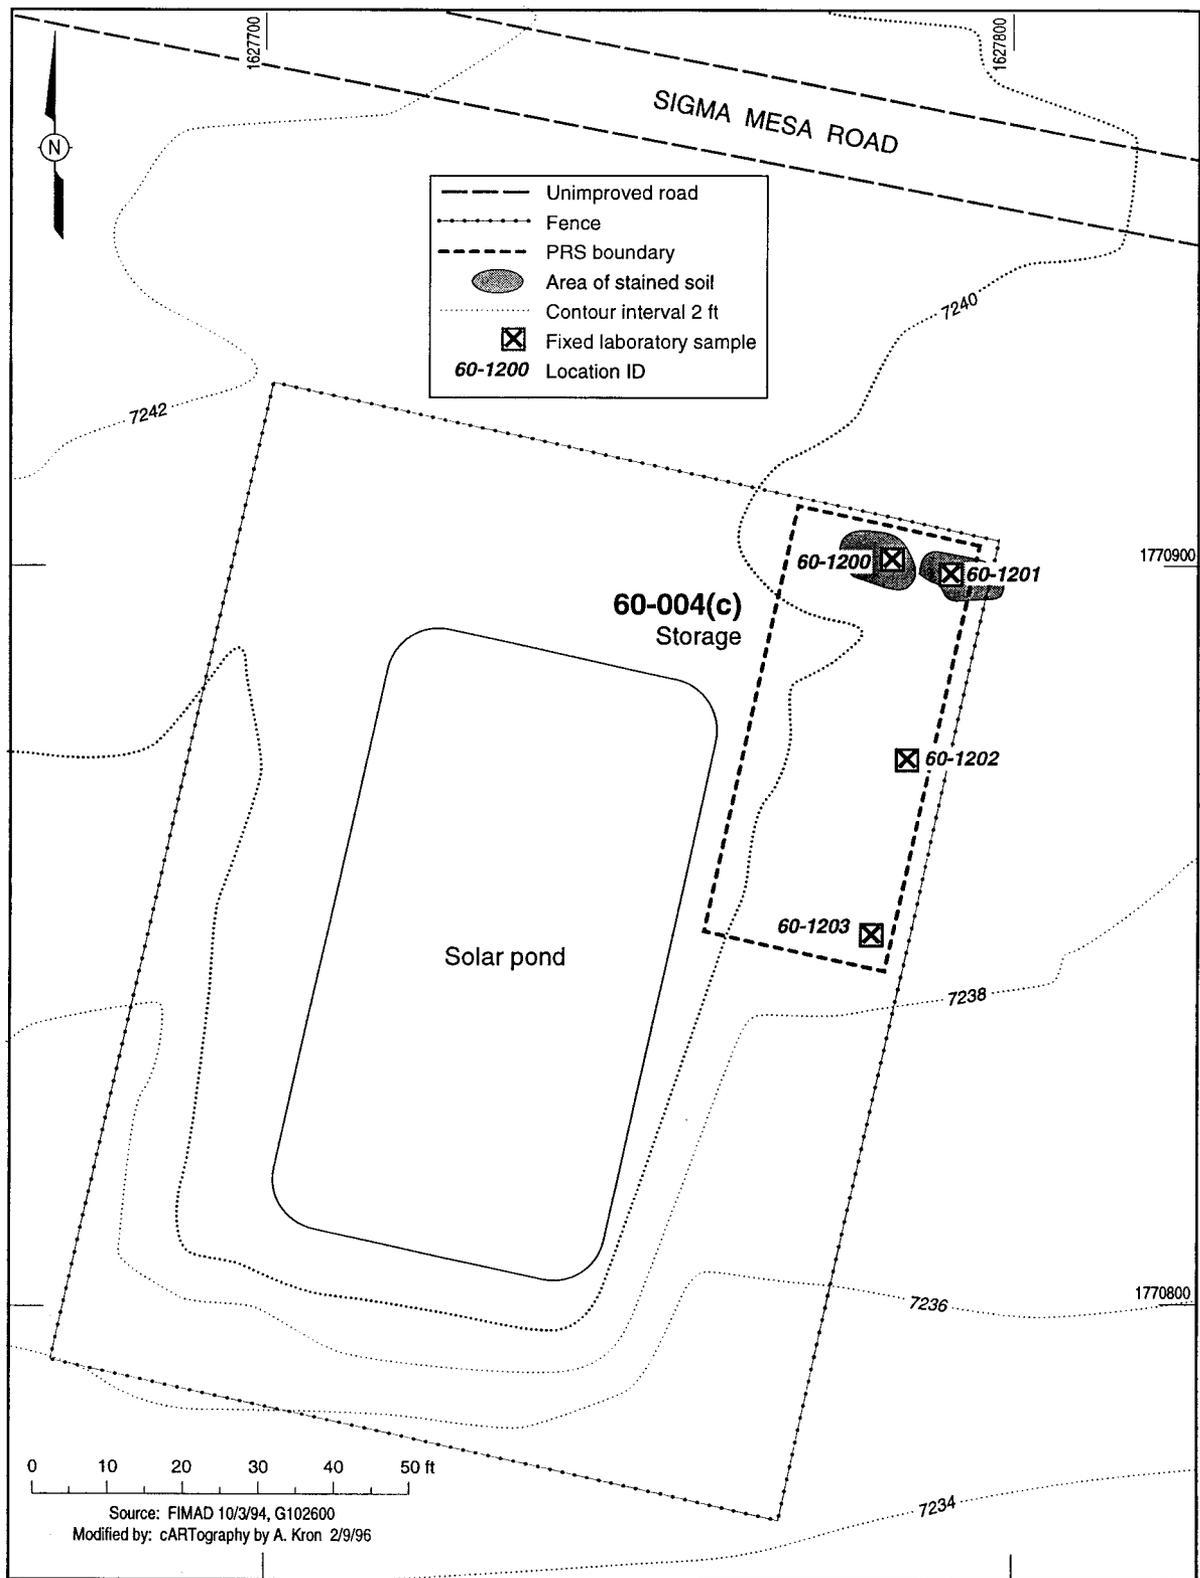
Fig. 5.12.4-1. PRS 60-004(c) 1994 sample collection locations.

The biased sample locations indicated in Fig. 5-14 of the RFI Work Plan for OU 1114 were located using the stained areas near the gate and the east fence as reference points (LANL 1993, 1090). These sampling locations, 60-1200 through 60-1203, are shown in Fig. 5.12.4-1 and summarized in Table 5.12.4-1.

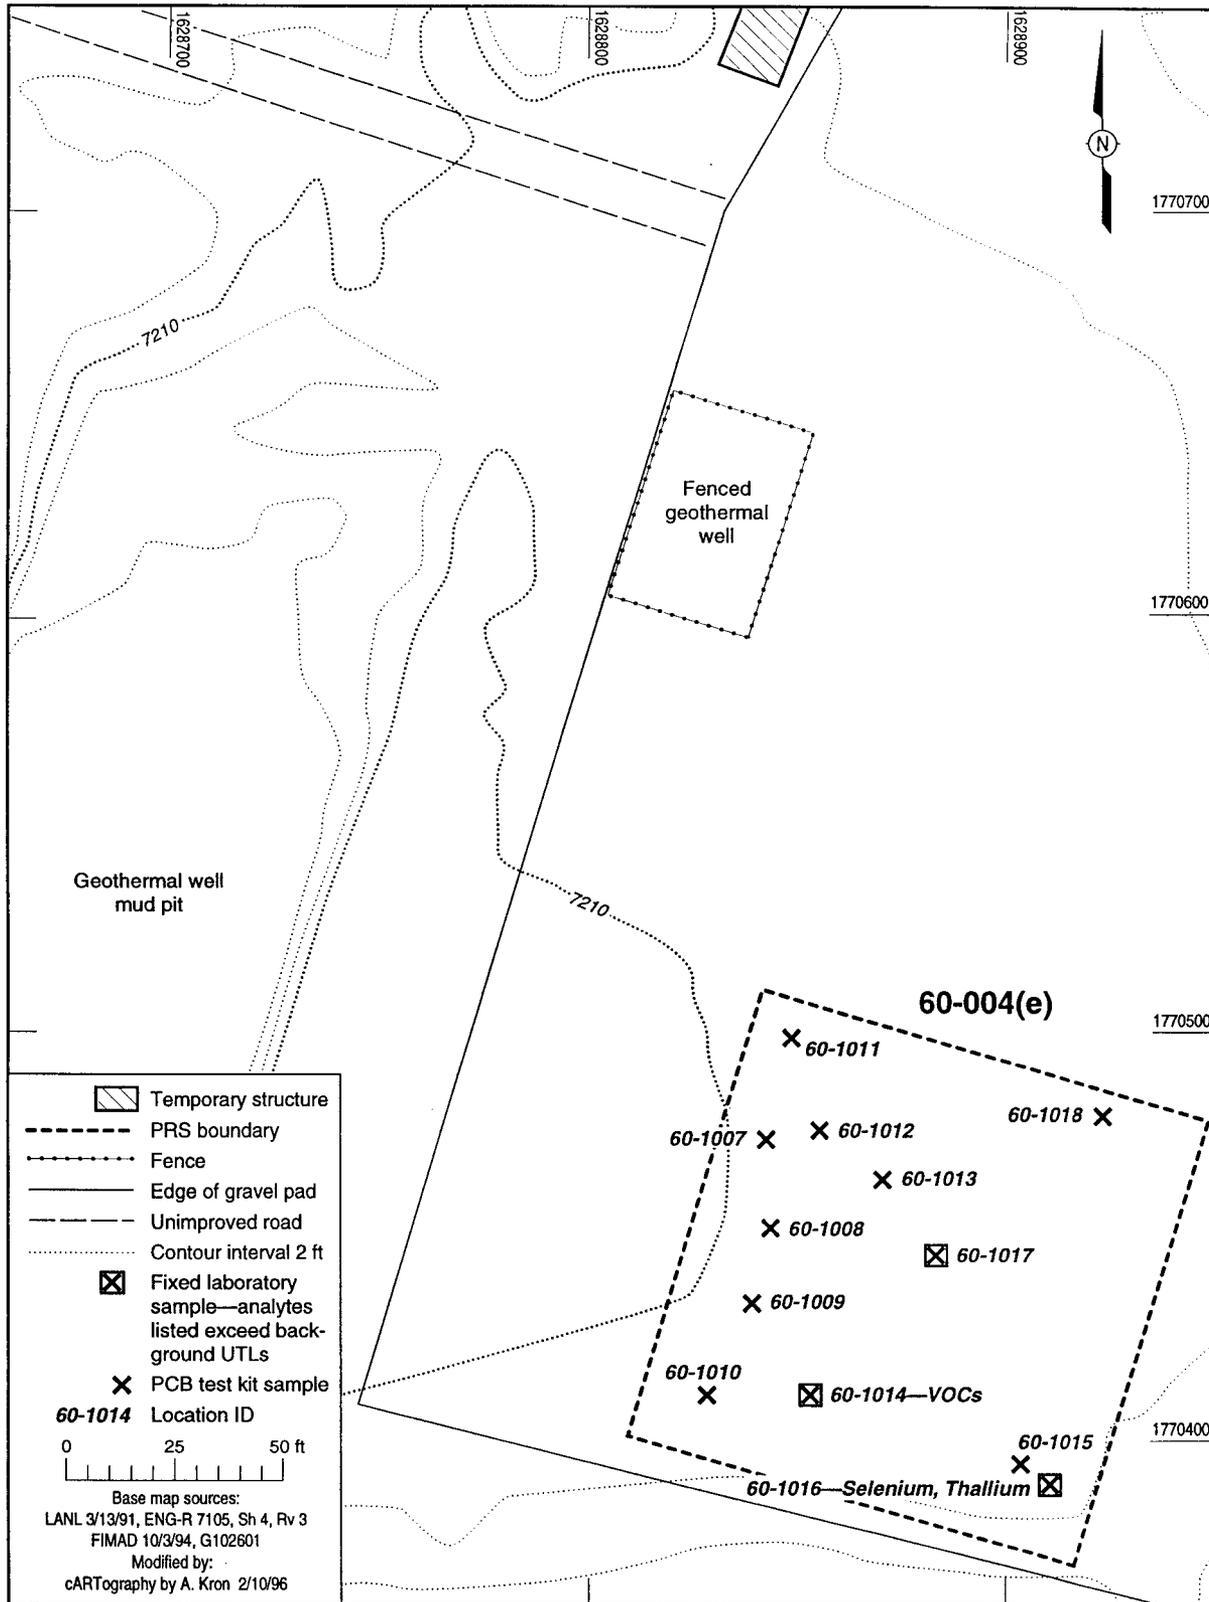
Fig. 5.13.4-1. PRS 60-004(e) 1994 sample collection locations.

The biased sample locations indicated in the RFI Work Plan for OU 1114 (LANL 1993, 1090) were identified using the location of formerly stained areas now filled with new gravel as reference points. For soil samples collected in the area formerly remediated, the gravel was removed and the soil samples were collected from the subsequent 0- to 12-in. depth interval. The sampling locations are shown in Fig. 5.13.4-1 and summarized in Table 5.13.4-1.

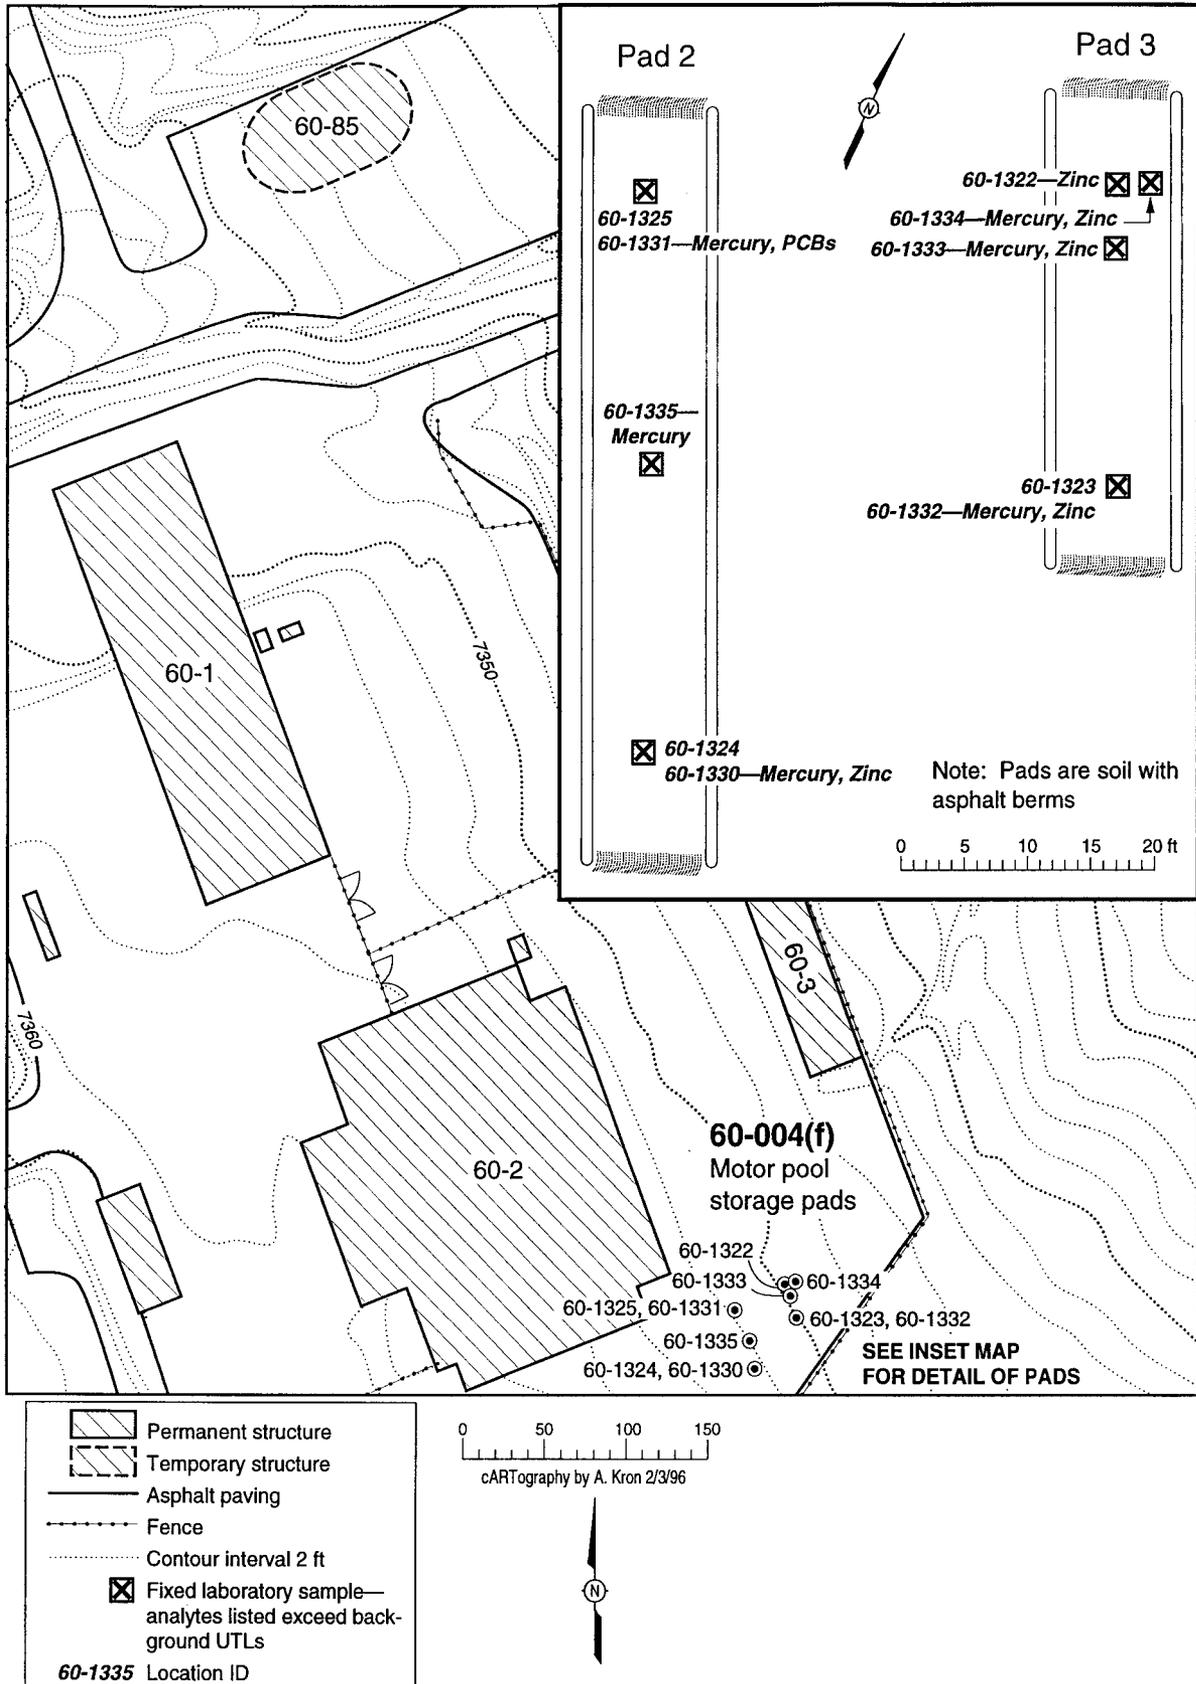
Fig. 5.14.4-1. PRS 60-004(f) 1994 sample collection locations.

The biased sample locations indicated in Fig. 5-5 of the RFI Work Plan for OU 1114 (LANL 1993, 1090) were located using the berms around the pads and the stained areas as reference points (LANL 1993, 1090). Sample locations are shown in Fig. 5.14.4-1 and summarized in Table 5.14.4-1.

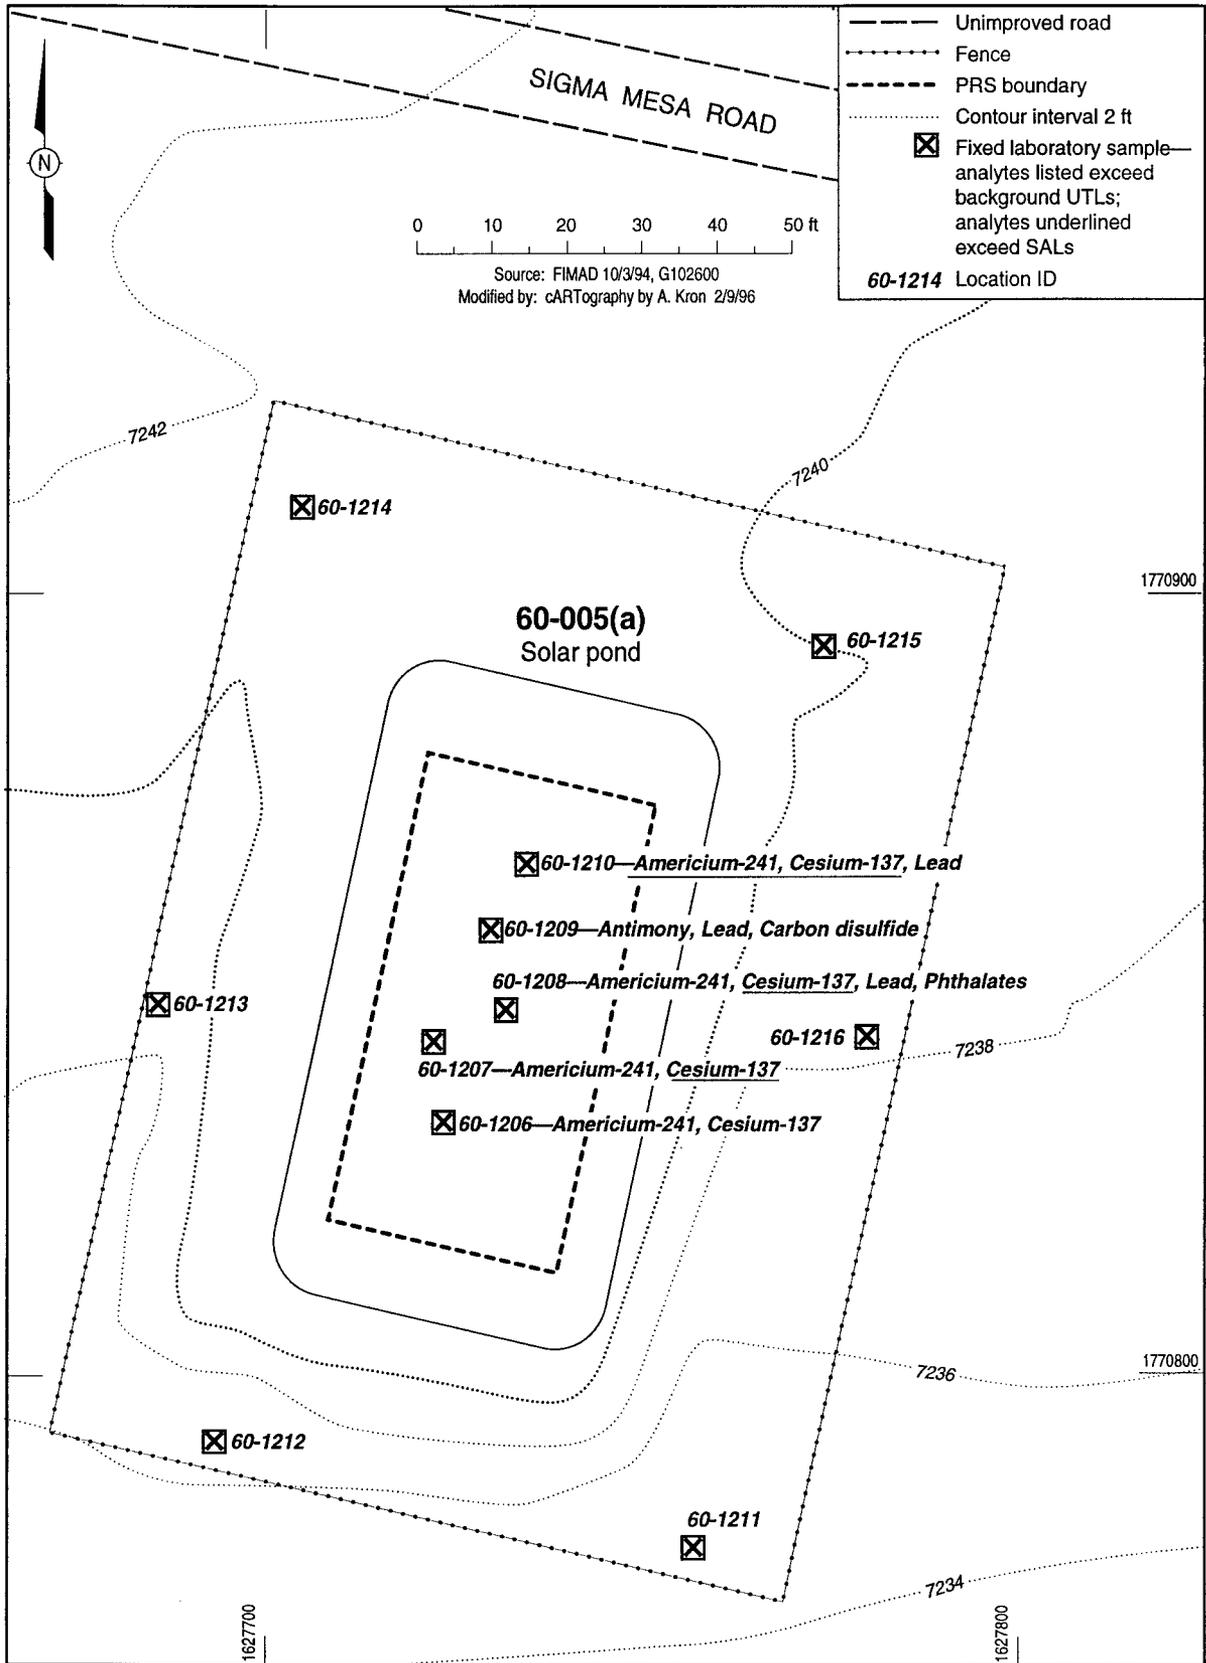
Fig. 5.15.4-1. PRS 60-005(a) 1994 sample collection locations.

Samples were collected from six locations outside of the pond and five locations within the pond as shown in Fig. 5.15.4-1 and summarized in Table 5.15.4-1.

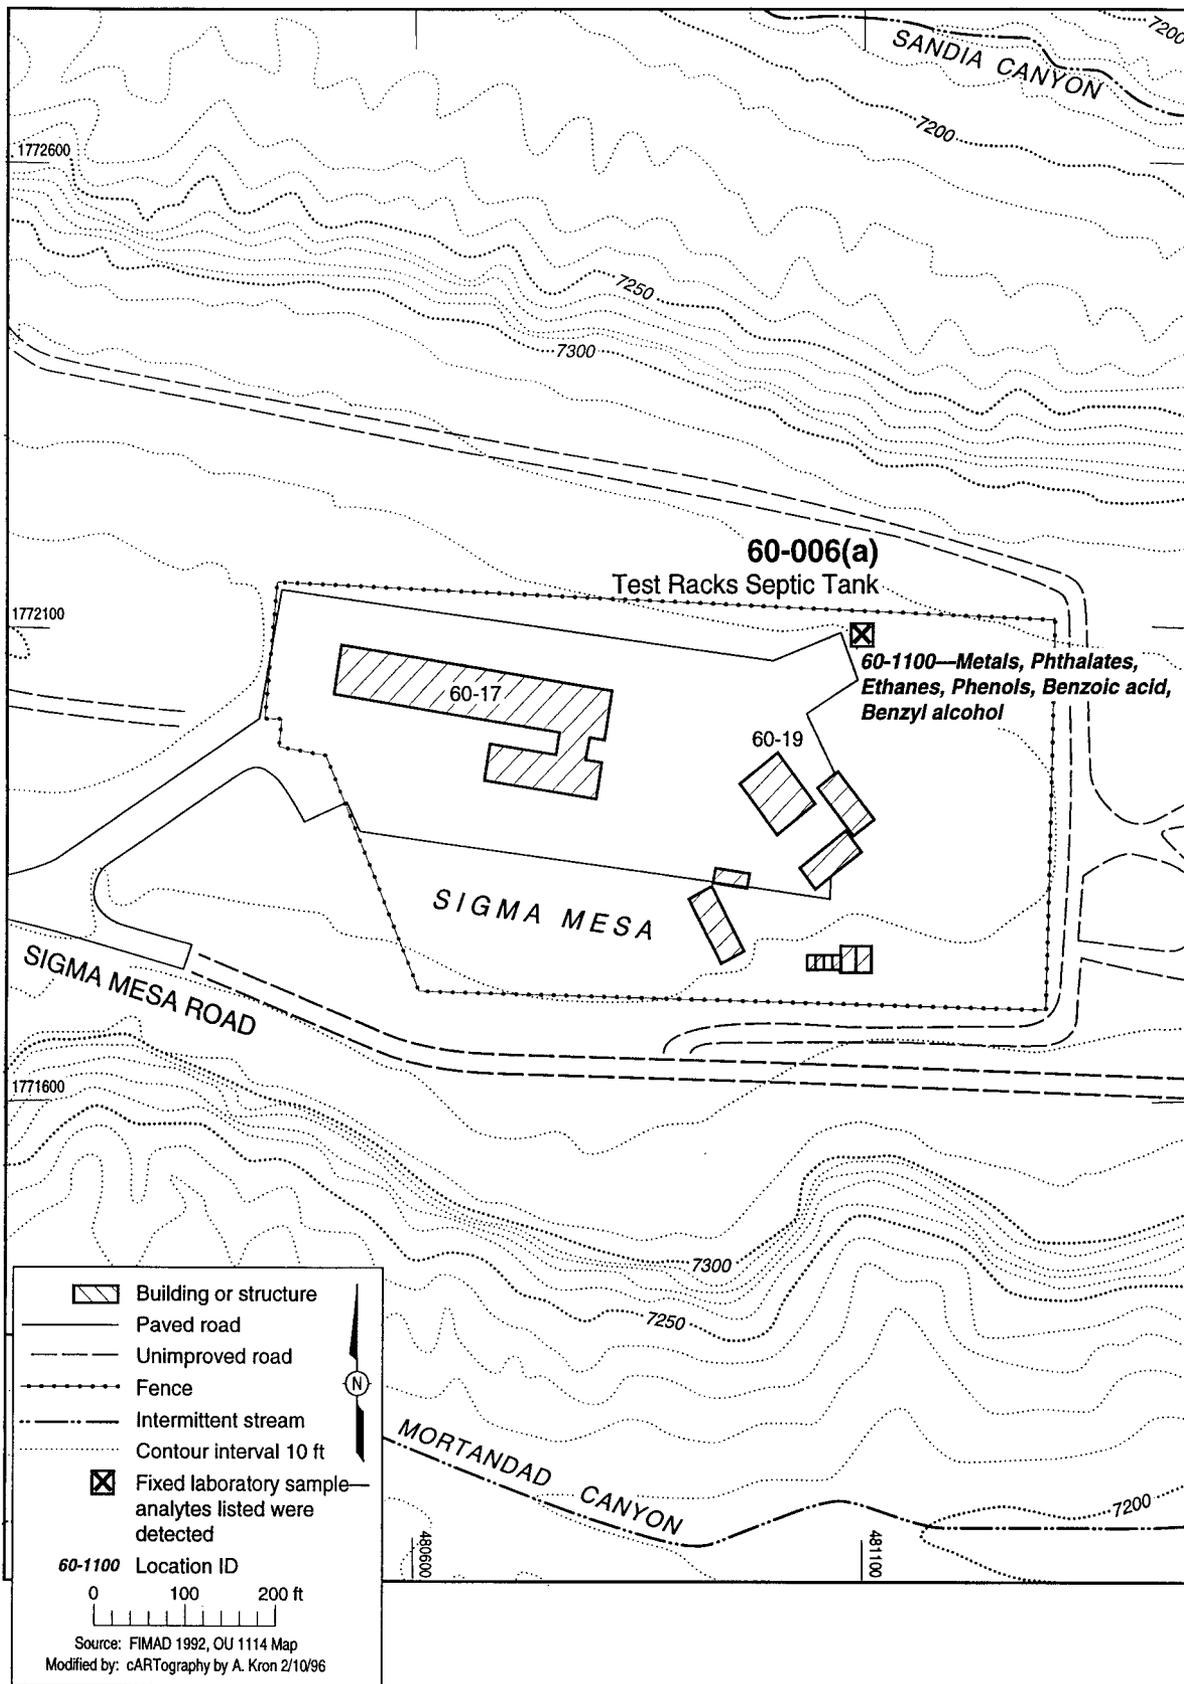
Fig. 5.16.4-1. PRS 60-006(a) 1994 sample collection locations.

Two samples each of the liquid and sludge were collected from one location shown in Fig. 5.16.4-1. The samples are summarized in Table 5.16.4-1. The two liquid samples were submitted for analysis of VOCs. The two liquid sludge samples were submitted for analysis for SVOCs, PCBs, and TAL metals. In addition to the samples collected, the work plan called for measurements of the tank and sludge depths and measurement of the VOCs in the tank atmosphere. The tank atmosphere was sampled using a PID with a Tygon™ tubing extension in order to obtain atmosphere samples from specific heights above the liquid in the tank; measurements were taken 8 ft, 4 ft, and 2 in. above the liquid in the tank. In addition, the tank atmosphere was sampled continuously while the other samples were collected. No VOCs were detected with the PID during this sampling event.

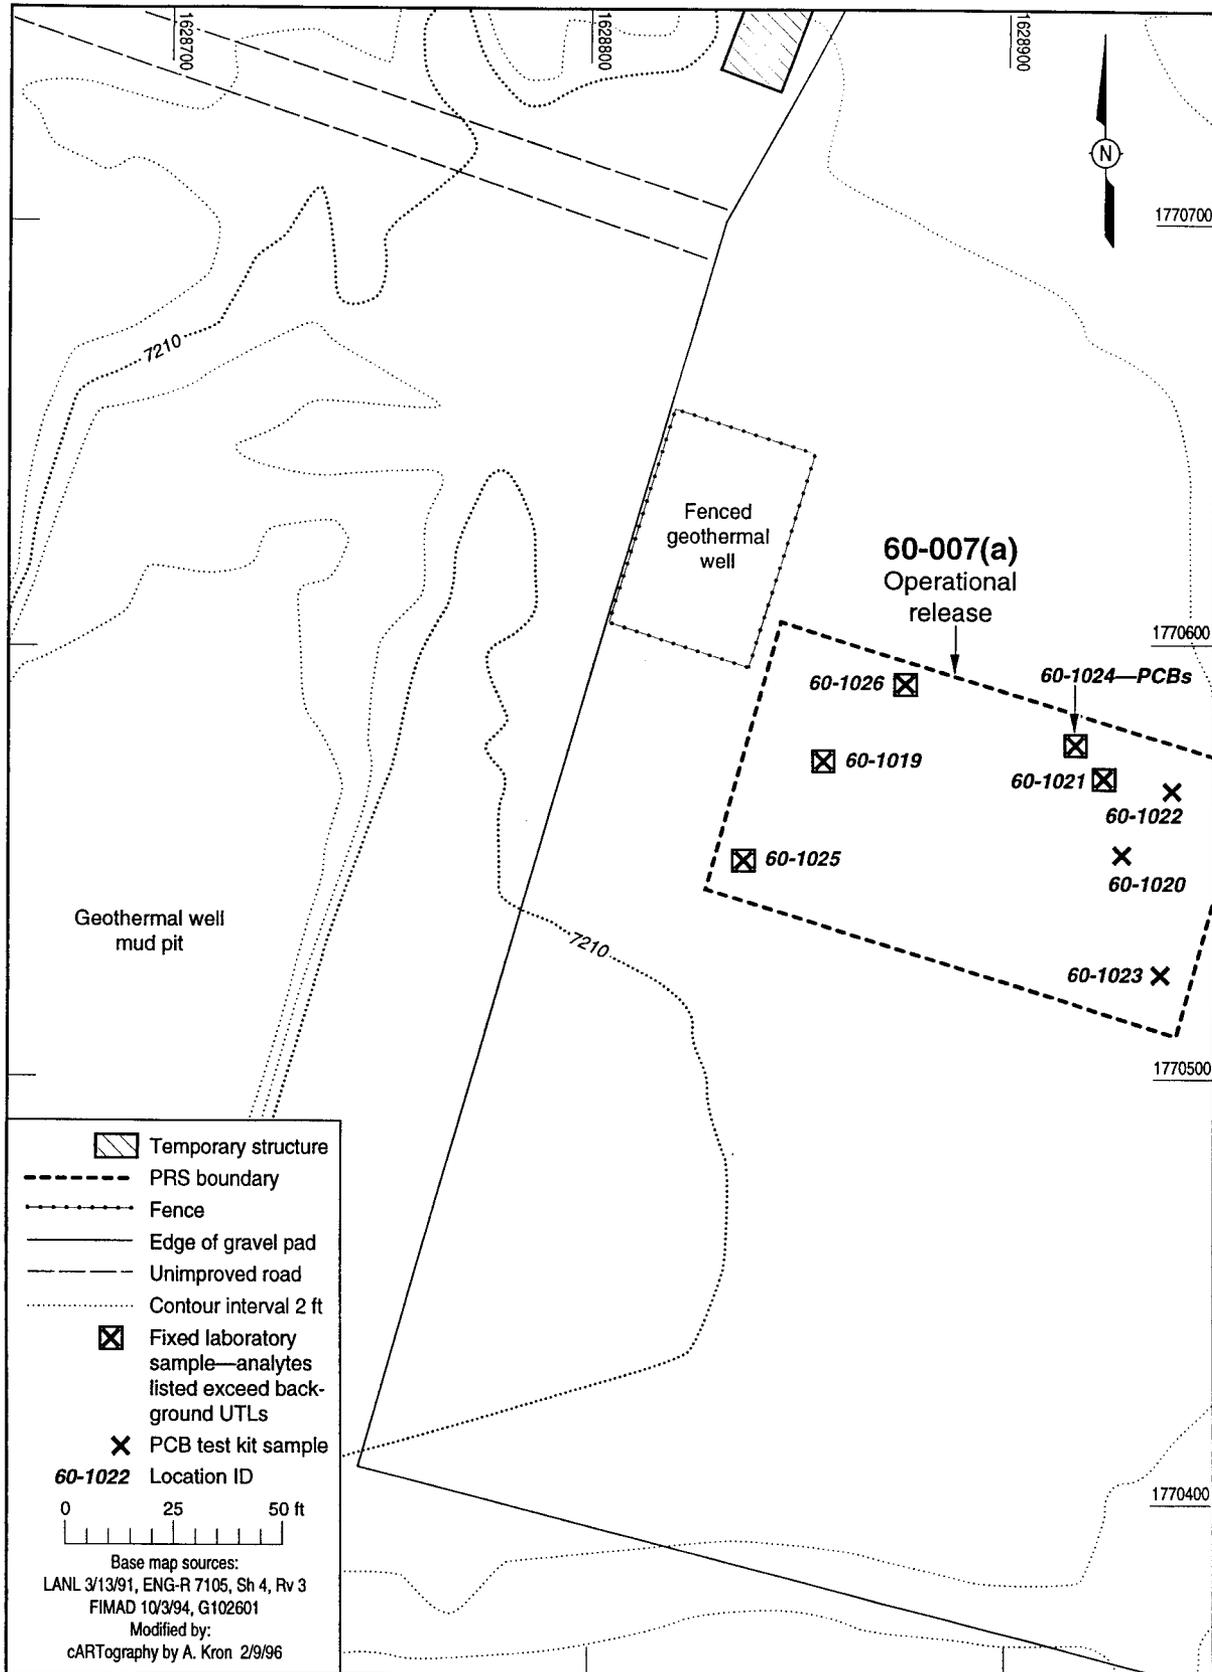
Fig. 5.17.4-1. PRS 60-007(a) 1994 sample collection locations.

The biased sample locations indicated in the RFI Work Plan for OU 1114 were located using the previously stained areas now covered with new gravel and the geothermal well as reference points (LANL 1993, 1090). For the biased sample locations, the gravel was removed and the samples were collected from the soil 0–12 in. below the surface. The sampling locations are shown in Fig. 5.17.4-1 and summarized in Table 5.17.4-1.

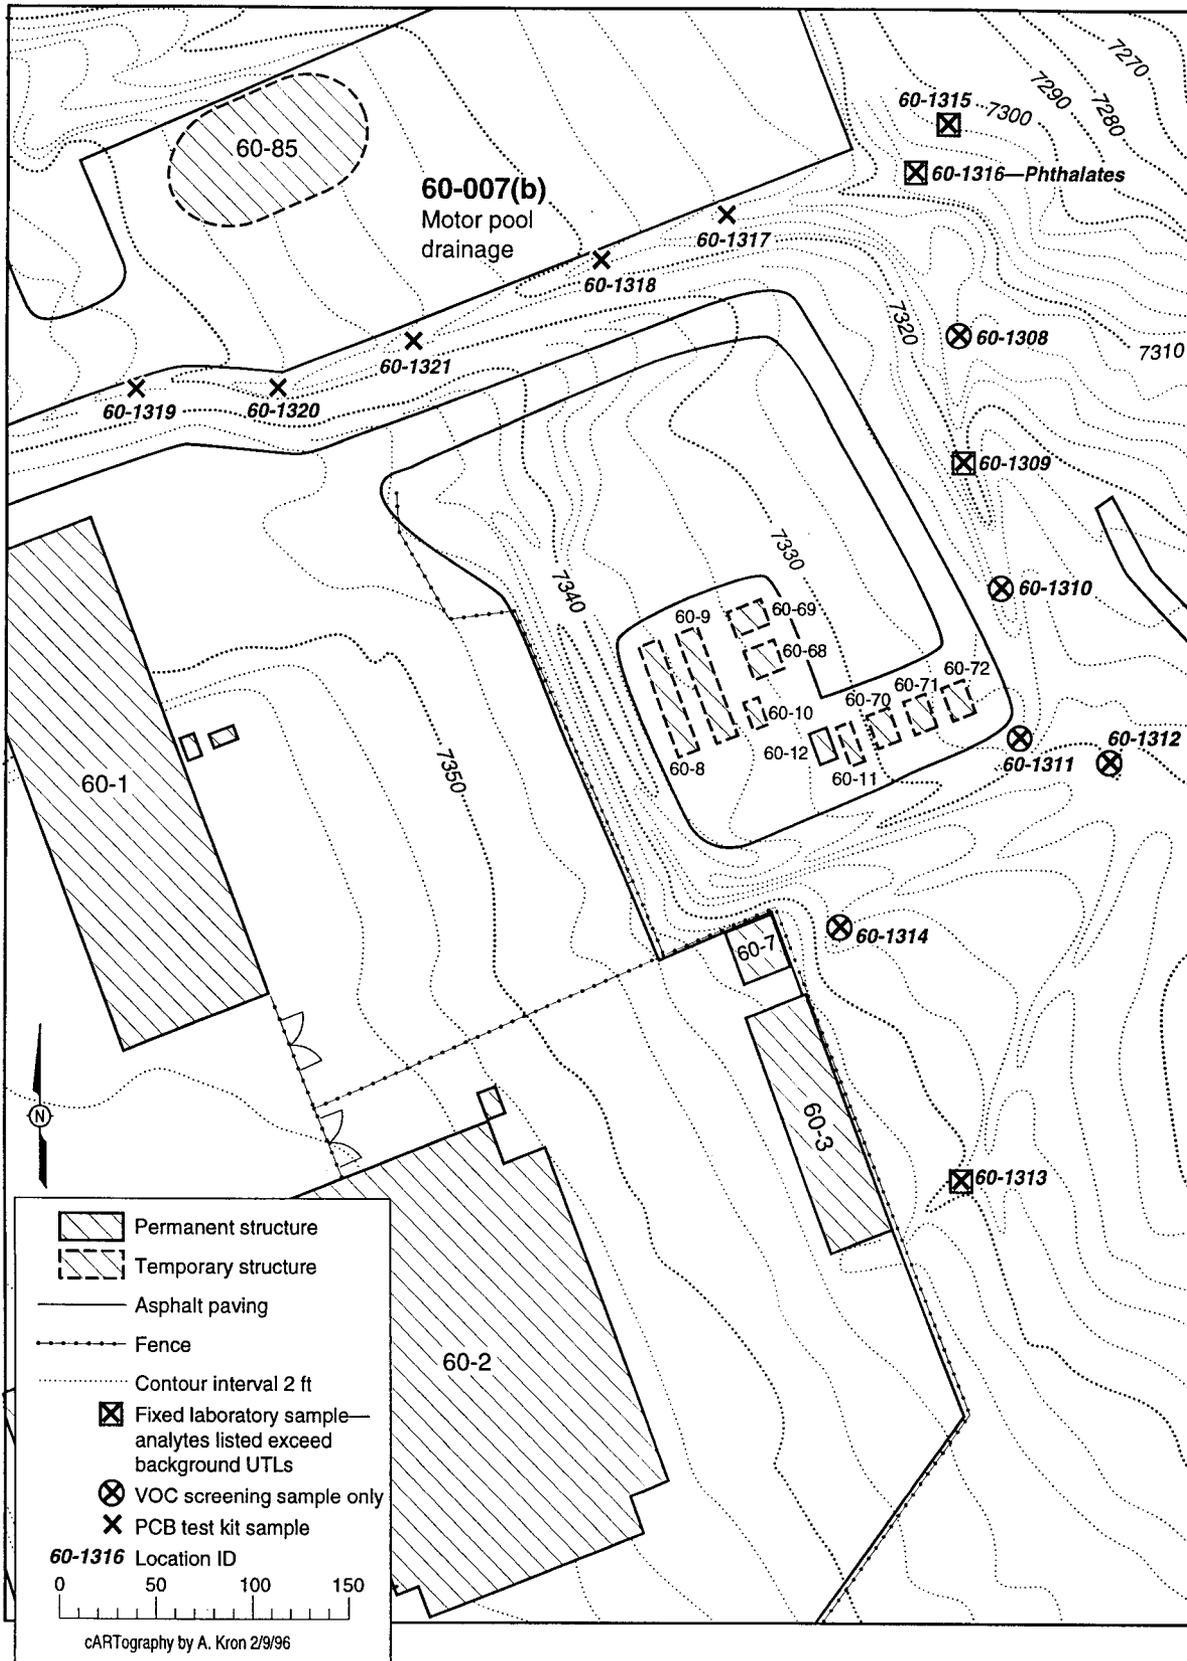
Fig. 5.18.4-1. PRS 60-007(b) 1994 sample collection locations.

Samples were collected using LANL-ER-SOP-06.09, Spade and Scoop Method for Collection of Soil Samples. Samples to be analyzed for VOCs were placed in 125 ml glass, wide-mouth containers with Teflon™-lined lids.

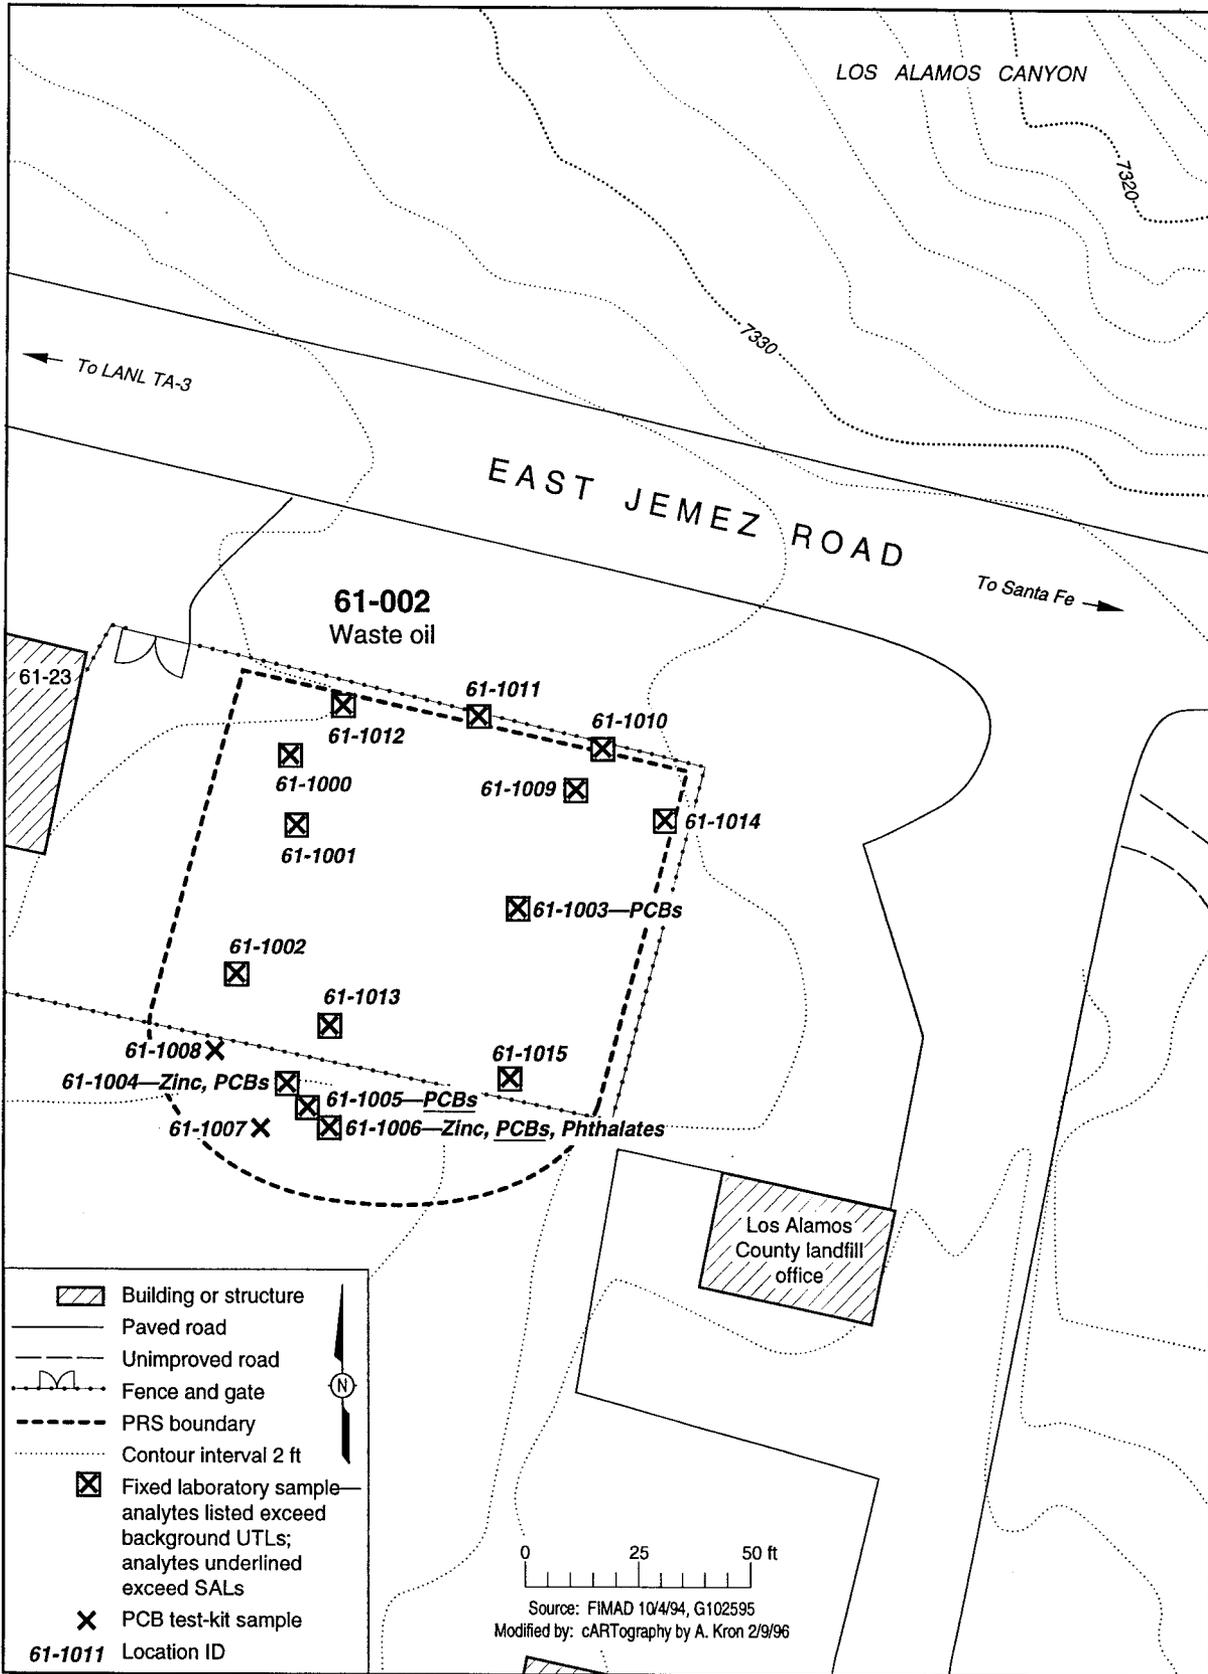
Fig. 5.19.4-1. PRS 61-002 1994 sample collection locations.

For the asphalt sample areas, the first 2 in. of asphalt was removed using a hammer and chisel following LANL-ER-SOP-06.28, Chip Sampling of Porous Surfaces. All asphalt sample locations were screened for VOCs using the FID as the asphalt was chipped. Soil sampling locations downgradient from the asphalt were screened for VOCs within the hole at the 6-in. depth using the FID.
