# Los Alamos National Laboratory

**SUBJECT: SUBMITTAL OF THE RESOURCE CONSERVATION AND RECOVERY ACT FACILITY INVESTIGATION (RFI) REPORT FOR TECHNICAL AREAS (TAs) -3, -59, -60, AND -61**

# **RFI Report for**

## **53 Potential Release Sites in**

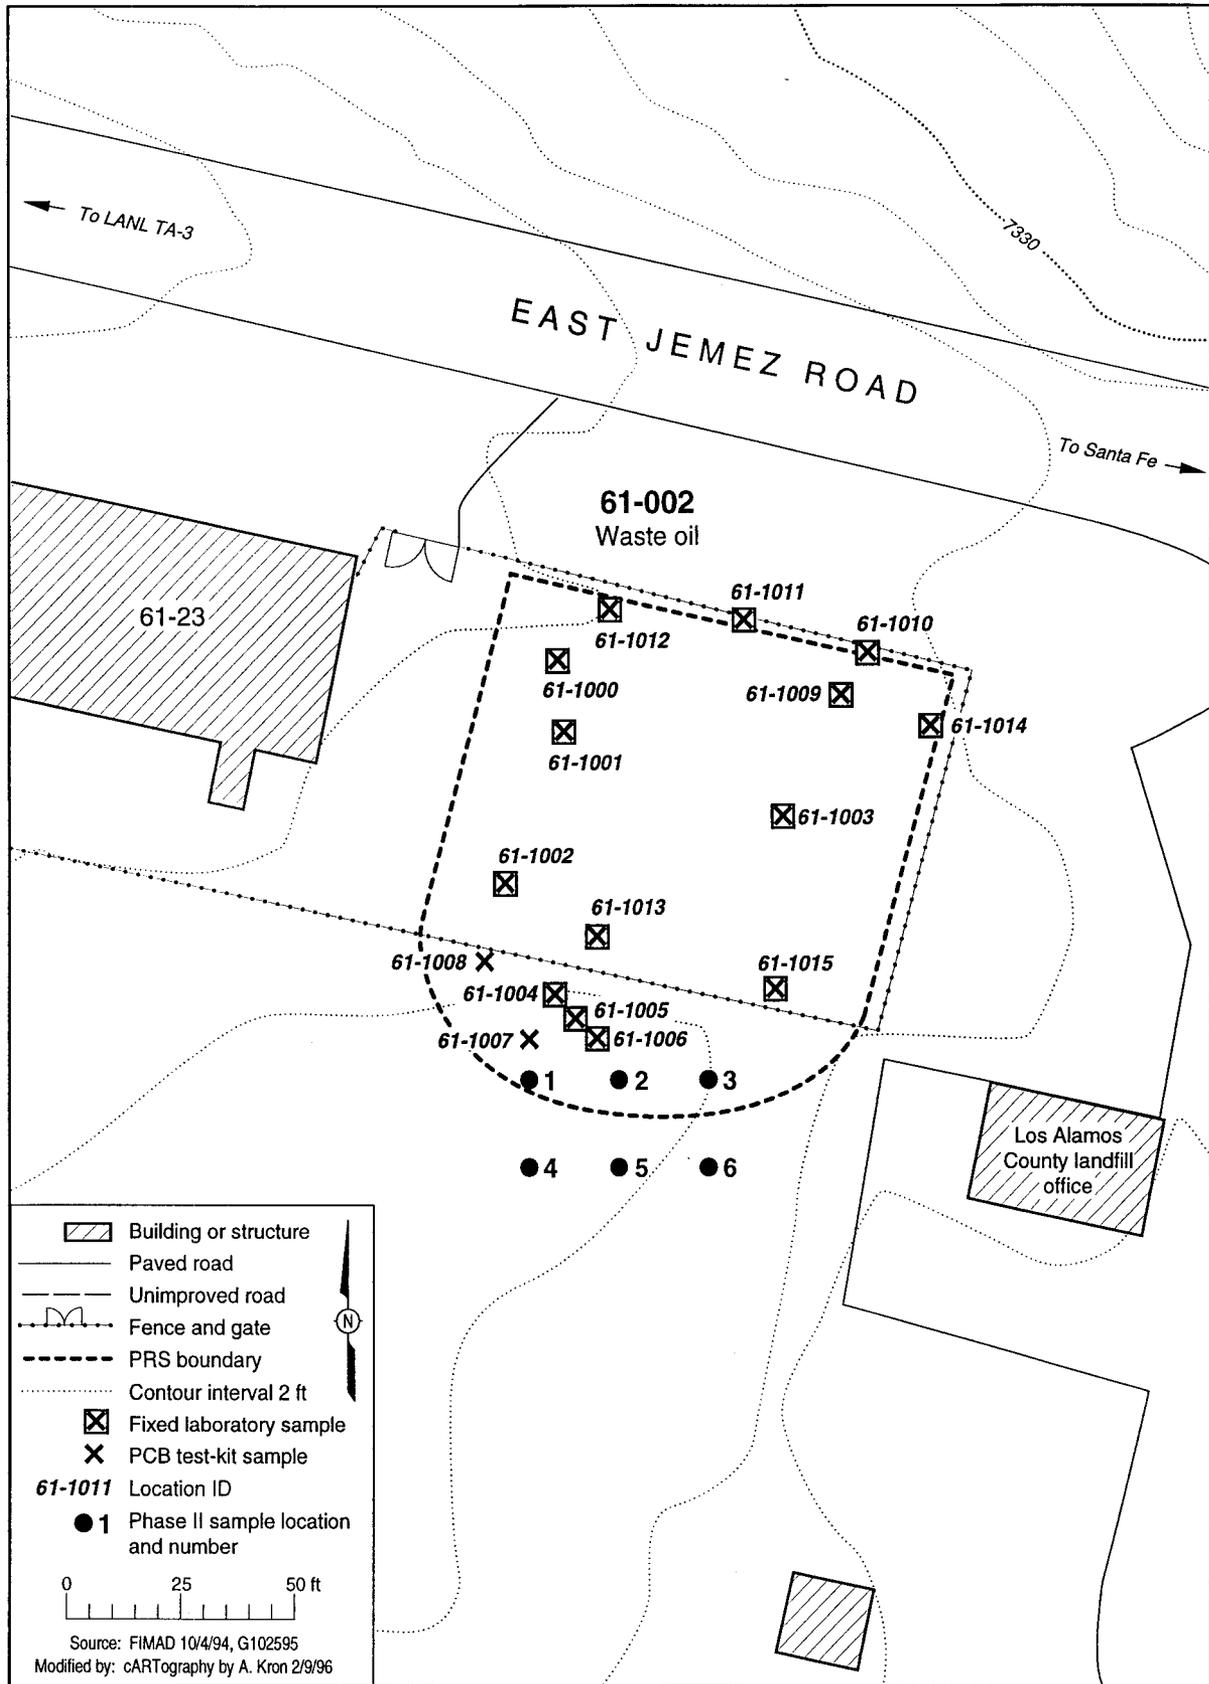
Fig. 5.19.11-1 PRS 61-002 Phase II sample locations.

The original samples were collected from asphalt (0- to 2-in. interval) and soil (0- to 6-in. interval) using LANL-ER-SOP-06.28, Chip Sampling of Porous Surfaces and LANL-ER-SOP-06.09, Spade and Scoop Method for Collection of Soil Samples. At each of the planned locations, the 0- to 2-in. interval (if asphalt is present), or 0- to 6-in. interval (if soil is present) will be sampled using the appropriate collection methods. The 6- to 12-in. soil interval will also be sampled to provide information regarding vertical extent.
